National Park Service
Cultural Landscapes Inventory
September 2006

West Kabetogama Ranger Station
Voyageurs National Park

Cultural Landscapes Inventory – General Information

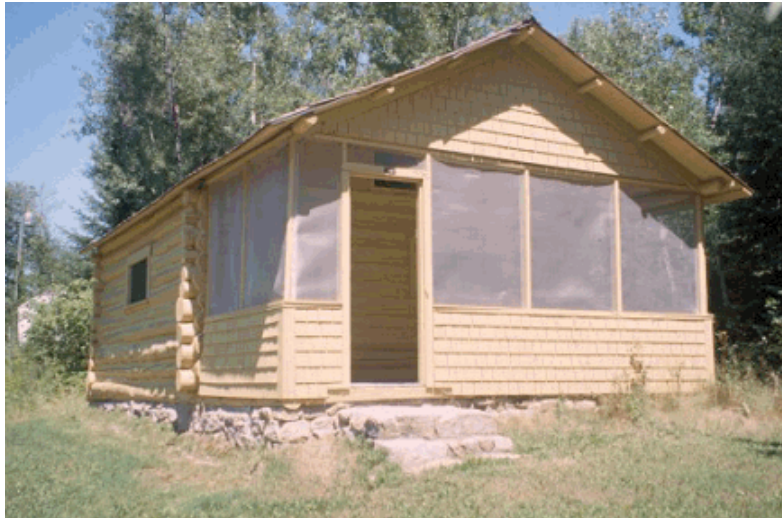
1921 Patrol Cabin (all photos CLI survey 7/2006)

Patrol Cabin (contributing): The Minnesota Forest Service built the cabin in 1921 to provide housing for the ranger stationed at Kabetogama Lake. CCC workers moved it to its current location in 1933, and it underwent a minor rehabilitation in 1937 with the construction of a new foundation. It continued to be used for seasonal housing into the 1980s. The building is currently used as storage space.

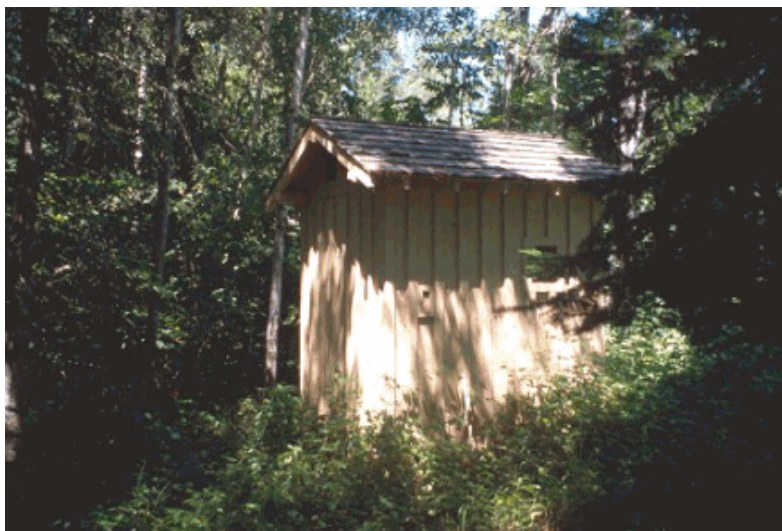
1937 privy

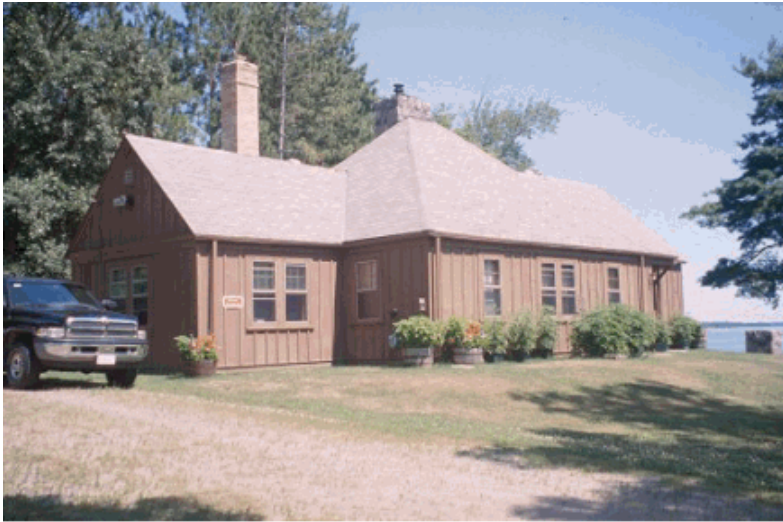
1935 Ranger Station

Ranger station (contributing): The CCC constructed this building in 1935 as a replacement for the previous cabin that had been moved. In addition to housing, the Minnesota Division of Forestry also used the cabin for administrative housing and office space. Currently the cabin is used exclusively as housing for the district ranger.

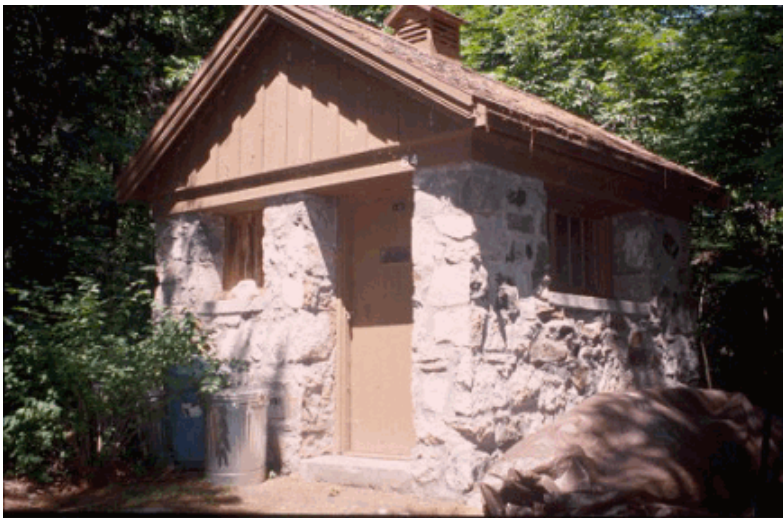
1936 Oil House

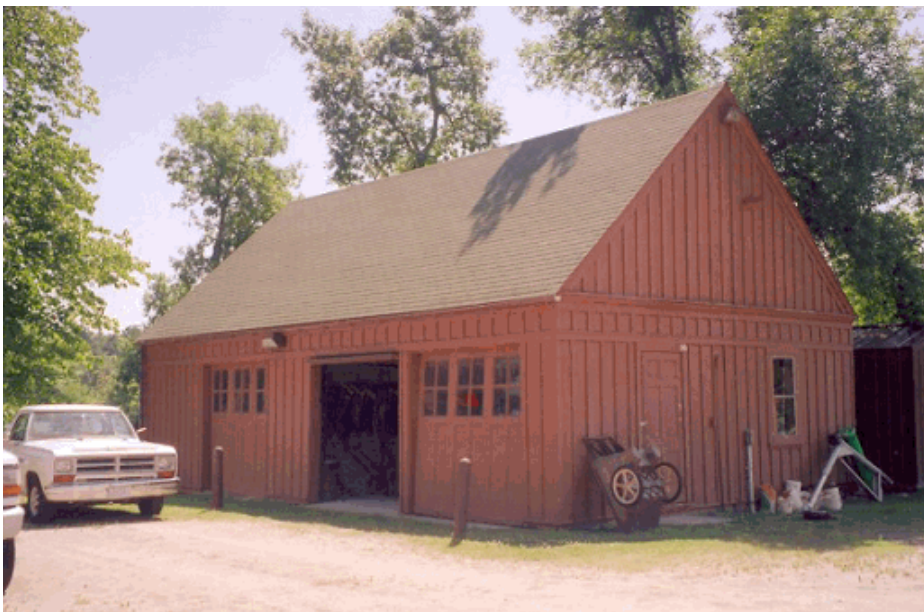
1935 Warehouse

Warehouse (contributing): The CCC constructed this building in 1935 to provide storage and repair facilities for the Minnesota Division of Forestry. NPS continues to use this facility for general maintenance purposes, storage and repair. The building has remained in continuous use, and as originally intended.

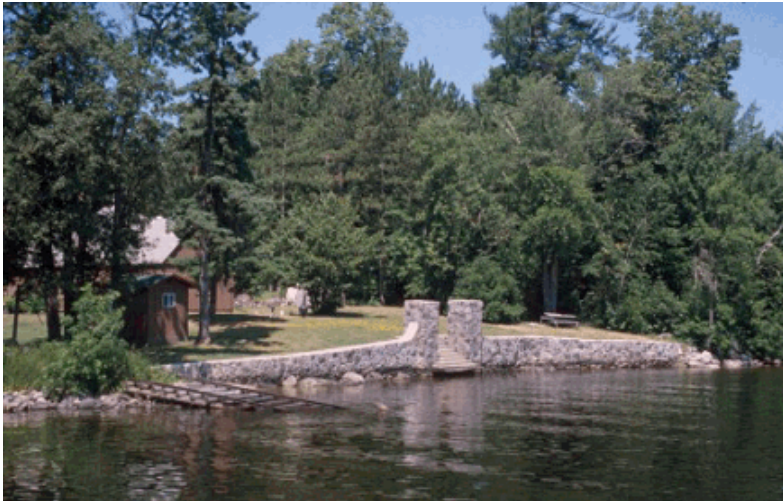
1933 Retaining Wall

Retaining Wall (contributing): John “Dad” Dyhrman, working with the CCC, built the retaining wall, piers, and steps in 1933 using local stone. Originally the steps led down to a floating dock that extended along the lake’s edge. The dock no longer exists so that the steps now descend into the lake. The wall, piers and steps are all in good condition and provide protection from lake erosion along this side of the property.

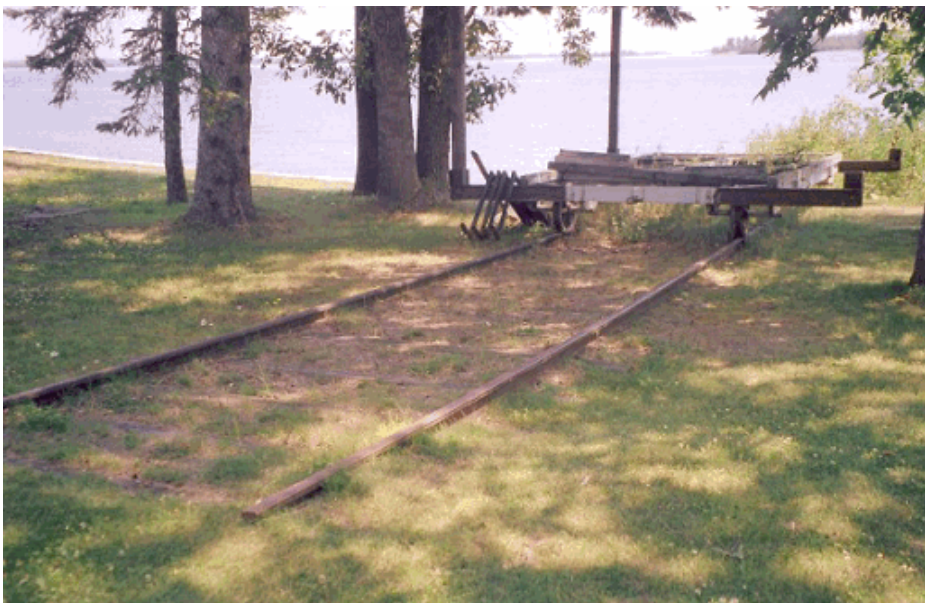
Ca. 1936 Tramway

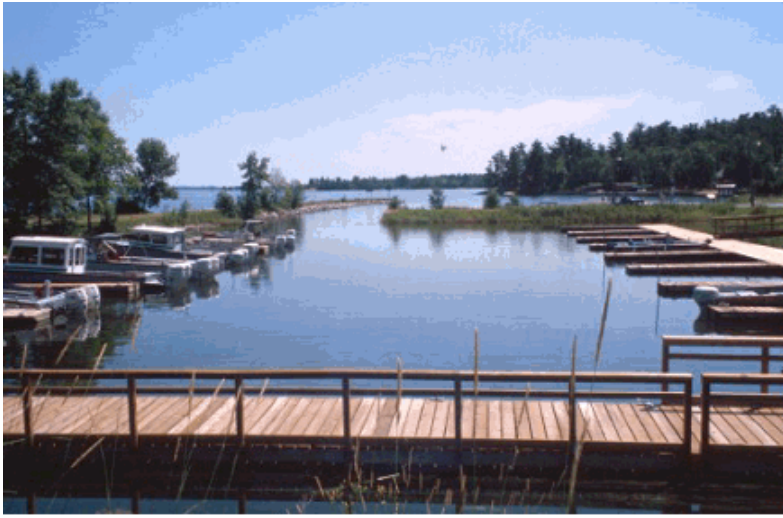
Moorage basin with breakwater in left background

Breakwater and moorage basin (contributing): The CCC originally built a combination breakwater/dock in 1936 to protect the moorage area along the lakefront and to provide access to the steps built in 1933. This first breakwater proved inadequate, and the CCC built a more substantial and extensive breakwater in 1939-1940. Also, a more extensive moorage area was needed and the CCC dredged the area that became the current basin between 1938-1941. The CCC also installed retaining walls, wood pilings, and plantings around the basin at this time. The Minnesota Forest Service drained and re-excavated the basin and rip-rapped the shore line in 1950-1951. NPS extended the breakwater in the 1980s.
