Structural characterization of rockfall sources in Yosemite Valley from remote sensing data: toward more accurate susceptibility assessment

2011 Pan-Am CGS
Geotechnical Conference

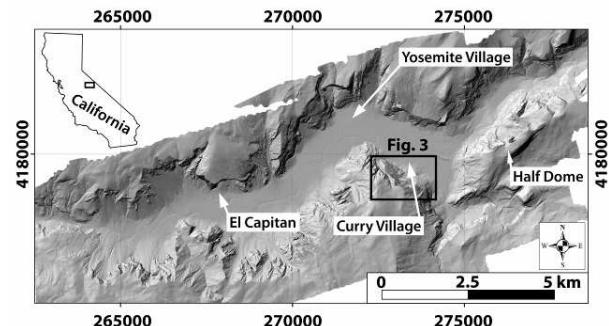
Figure 1: 1 m Digital Elevation Model (DEM) of Yosemite Valley derived from Aerial Laser Scanning (ALS) data. The black box shows the location of the cliff beneath Glacier Point shown in Figure 3.

these features (Fig. 2; Table 1). This was achieved using the 1m cellsize Digital Elevation Model (DEM) of the valley derived from Aerial Laser Scanning (ALS) data, new Terrestrial Laser Scanning (TLS) data, and field surveys of specific rockfall sites.

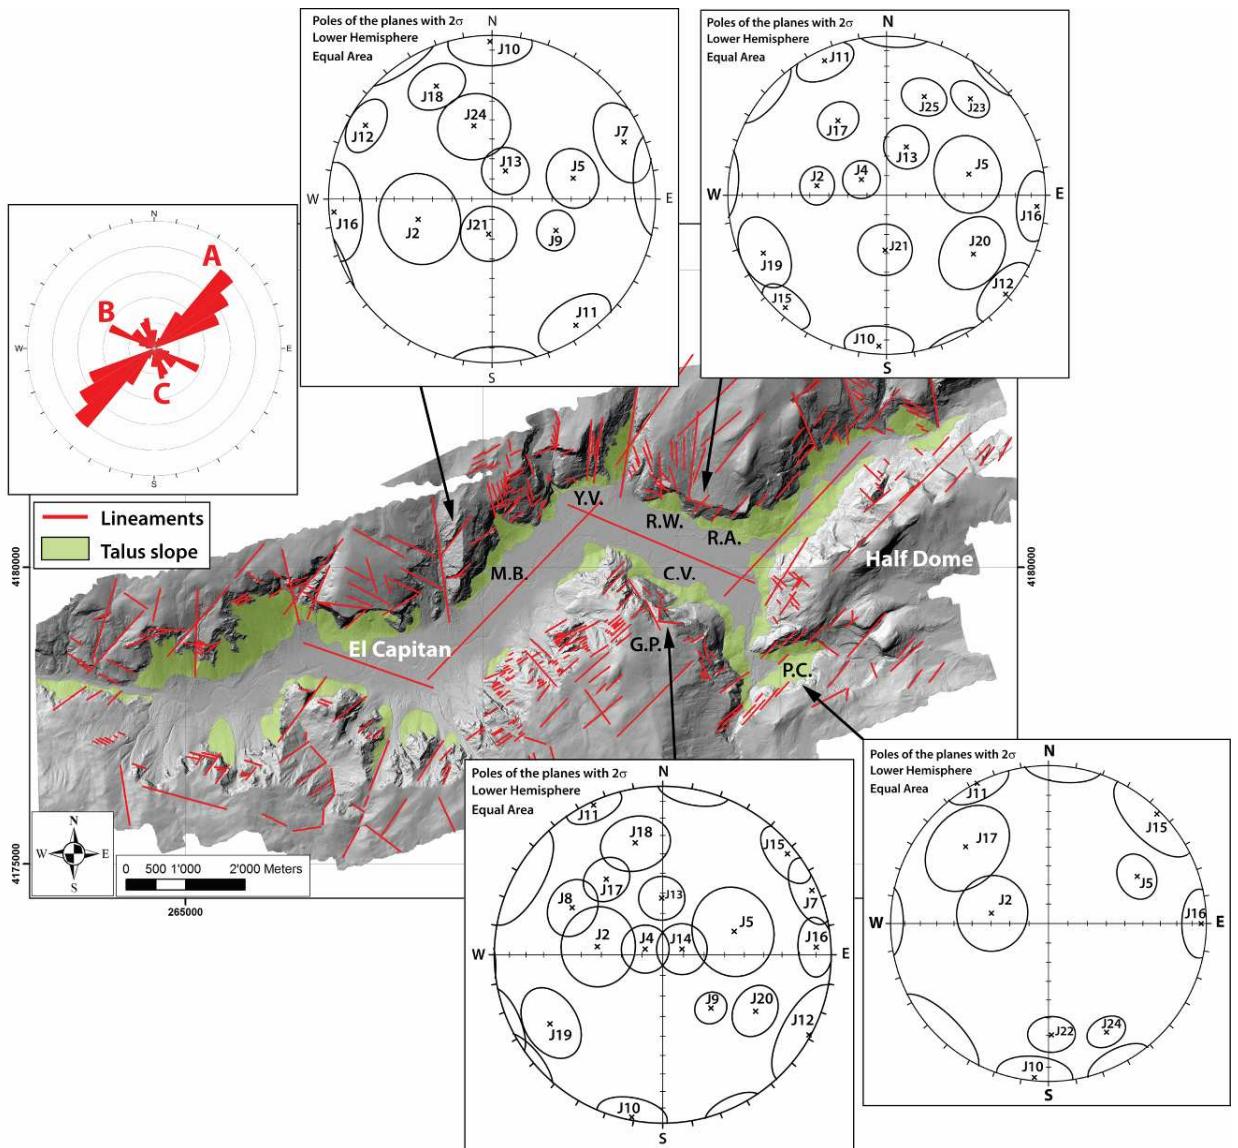
Figure 2: Map of the major lineaments in Yosemite Valley with rosette plot of their orientation (A, B and C). The four Schmidt stereoplots represent different structural domains (Middle Brother (M.B.), Rhombus Wall (R.W.)-Royal Arches (R.A.), Glacier Point (G.P.), and the Panorama Cliff (P.C.)) based on the results of the TLS, ALS and field data analysis. Abbreviations Y.V. and C.V. mean respectively Yosemite Village and Curry Village.

Analysis of the 1m ALS DEM allowed us to identify three main regional lineations in Yosemite Valley (Fig. 2). These lineations are likely responsible for the overall orientation of the Valley (Matthes, 1930; Huber, 1987, Ericson et al. 2005).

A) The most well represented and persistent lineation structure is oriented SW-NE, and affects the orientation of prominent cliff faces such as the northwest face of Half Dome (Fig. 2).

B) A second structure oriented WNW-ESE is persistent, but less represented than the first one. This structure affects the orientation of cliff faces such as the Rhombus Wall. Yosemite Valley appears to have been carved following these two lineation sets (A and B) (Fig. 2).

C) The third structure is oriented NNW-SSE and is more closely linked to the formation of numerous lateral tributary streams and gullies, such as LeConte Gully at Glacier Point (Fig. 2; Wieczorek et al. 2008).

The joint sets J2, J5, J10, J11, J16 are very persistent and visible throughout the valley (Fig. 2). Subhorizontal planes due to the joint sets J4, J13, J14 or J21 are also very common and are often responsible for forming roofs. J7 is another principal set present throughout the valley, except in the Rhombus Wall - Royal Arches cliff and in the Panorama Cliff, where it is substituted by J15. J12 has an orientation similar to J11 and is present in all the cliffs we examined, except in the Panorama Cliff. The couple J17-J18 forms SE-dipping planes existing in all the valley walls.

The lineation set A) of Fig. 2 is mainly linked to the vertical sets J12, J11 and partially to the less steep sets J8, J9, J17, J18 and J20. The lineation set B) of Fig. 2 is mainly linked to J7 and partially to the other similar vertical sets J15 and J16. The less steep sets J2, J5 and J19 likely contribute to this fracturing direction. The lineation set C) is linked to the ubiquitous J10 set and partially to J15. In the Panorama Cliff area, J22 contributes to this fracturing direction, as well as J23 and J25 in the Rhombus Wall-Royal Arches area.

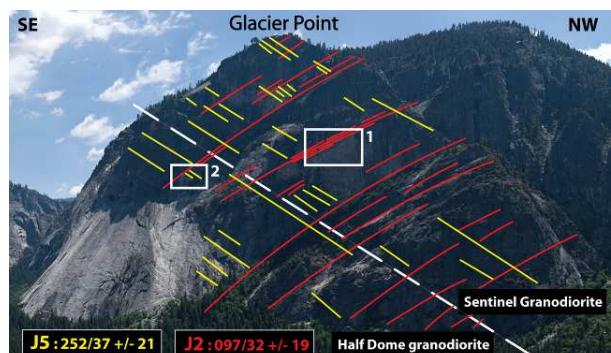
Figure 3: View looking south of the cliff beneath Glacier Point, with traces of the prominent joint sets J2 (red) and J5 (yellow) shown. The white dashed line represents the approximate contact between the Half Dome granodiorite (SE) and the Sentinel granodiorite (NW) (Calkins et al., 1985; Peck, 2002). The white boxes numbered 1 and 2 represent respectively the source areas of the 7-8 October 2008 rockfalls and of the 1998-1999 rockfalls.

On 7 and 8 October 2008 two large rockfalls occurred from an area of previous instability located in the middle of the cliff beneath Glacier Point (Fig. 3) (Stock et al.

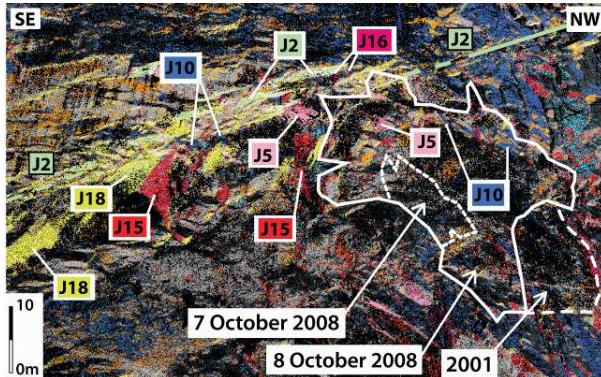
Figure 4: Visualization of the TLS point cloud with Coltop3D for the 7-8 October 2008 rockfall source area. The area is represented on Fig. 3 by the white box numbered 1. Coltop3D assigns a color to every point according to the orientation of the point with respect to its neighbourhood. The white line shows the detachment area of the 8 October 2008 rockfall. The white dashed lines show detachment areas for the 7 October 2008 and 2001 rockfalls.

Figures 4, 5 and 6 show the results of our structural analysis of the rockfall source area. They are based on high resolution photographs and detailed TLS data ($15 \times 15 \text{ cm}$) that we analyzed with Coltop3D to obtain the orientations of the joint planes.

In addition to the sheeting joint (027/89) and overlying J2, we show on Figs. 4, 5 and 6 the significance of five other joint sets that likely contributed to the fracturing of this part of the cliff (J5, J10, J15, J16, J18). Joints J2, J18, and in part J5 form the large roofs at the top of the rockfall source area. The orientation of J10 is very similar to the local topography, perhaps accentuating the exfoliation process.

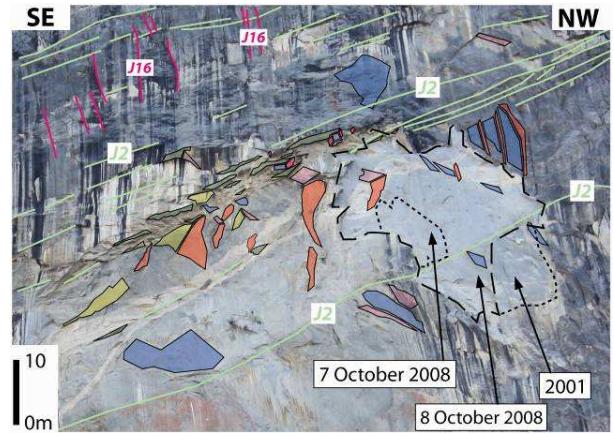
Figure 6: Photograph of the area displayed on Fig. 4 with colored polygons delineating the most important joint planes. The colored lines show traces of J2 and J16 joints.

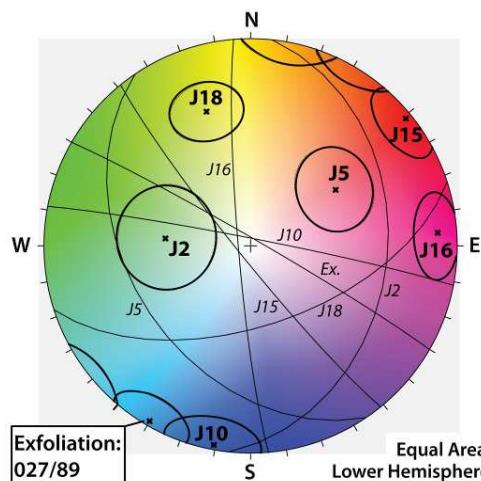
Figure 5: Stereoplot of the joint sets at the 2008 rockfall source area displayed in Fig. 4, with 2σ variability. The local topographic orientation is very similar to the local exfoliation orientation.

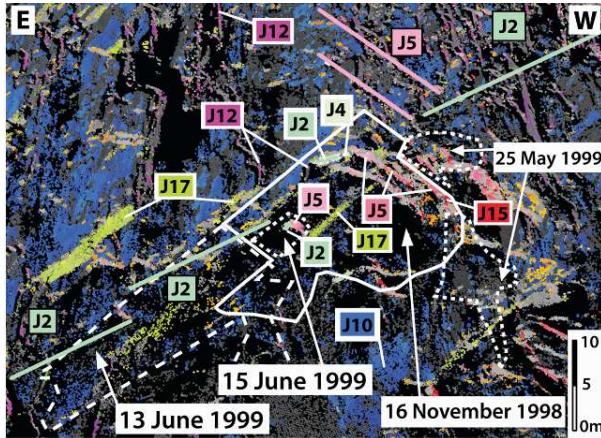
Figure 7: Visualization of the TLS point cloud with Coltop3D for the 1998-1999 rockfall source area. The area is represented on Fig. 3 by the white box number 2. The white line shows the detachment area of the 16 November 1998 rockfall. The white dashed lines show the three detachment areas of subsequent rockfalls that occurred in May and June 1999.

Our recent investigations of TLS data identify seven joint sets affecting this part of the cliff (Fig. 7, 8 and 9). As with the 2008 release area, the 1998-1999 rockfall occurred along a sheeting (exfoliation) joint. Also similarly, the 1998-1999 source area is located beneath a persistent J2 discontinuity. J2, J4 and J17 form ENE-SE dipping roofs within and adjacent to the source area. J5 is a prominent discontinuity that is very persistent (and well visible on Fig. 3) that forms W-SW dipping roofs. The source area is located within a convergence of J2 and J5. J15 and J12 are vertical discontinuities cutting the cliff respectively NW-SE and NE-SW. J10 is a joint set subparallel to the topography and to the local exfoliation surface, which here is oriented 355/78.

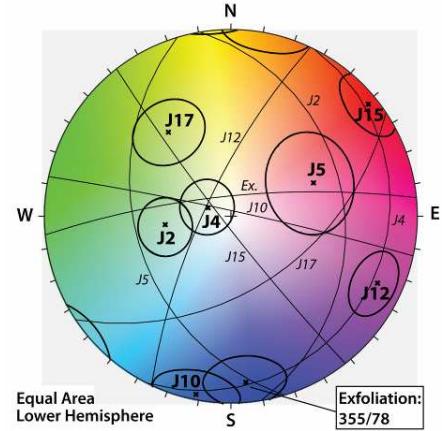
Figure 8: Stereoplot of the joint sets at the 1998-1999 rockfall source area displayed in Fig. 7, with 2σ variability. The local topographic orientation is very similar to the exfoliation.

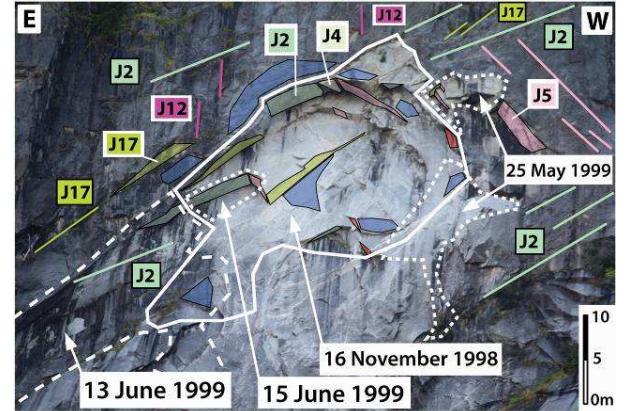
Figure 9: Photograph of the area displayed on Fig. 7 with colored polygons delineating the most important joint planes. The colored lines show traces of J2, J5, J12 and J17 joints.
