# Anatomy of a Rockslide

Jim Snyder

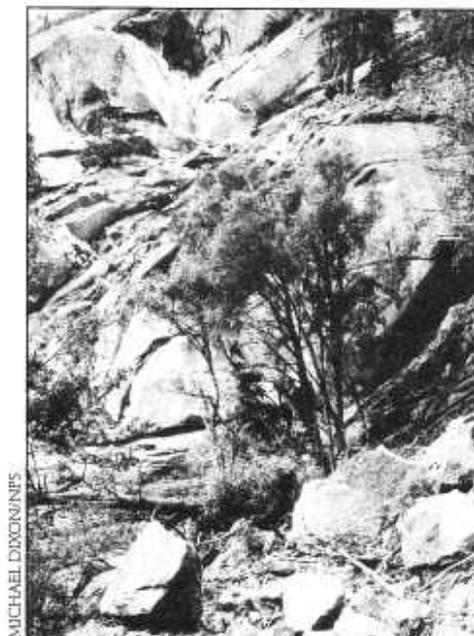
1. The release point of the Feb. 7 slide is in upper left center just above the thinly stratified rock crossing the picture. The dark splotch on the release point is a mat of liveoak roots left from a tree that came down in the slide. Liveoaks at the top of the release point were active agents in producing the second slide.

upper center of photograph #1 and the lower center of photograph #3. The slope of the rock face and of the long slip joint lying underneath the failed blocks is about 70°, dipping sharply south toward both river and trail. Another plane of fracturing shows in the remaining roof of the slide in photograph #2 dipping gradually north away from the river. And there is a series of vertical joints as well. This complex system of fractures, greatly oversimplified in the illustration, means that the rock has little to hold it in the long sense of geologic time. Other forces and gravity work slowly to chip away at the mass, converting it to talus along the Merced River at this point.

Liveoak roots are the toughest of all, forming thick mats in the cracks. The dark mass on the release point shown in photograph

#1 is one of these liveoak root mats. Liveoaks initiated the first slide by loosening a block that was foundation for several blocks above it. The trees' search for maintenance, in other words, is their undoing, and their living is the source of their demise.

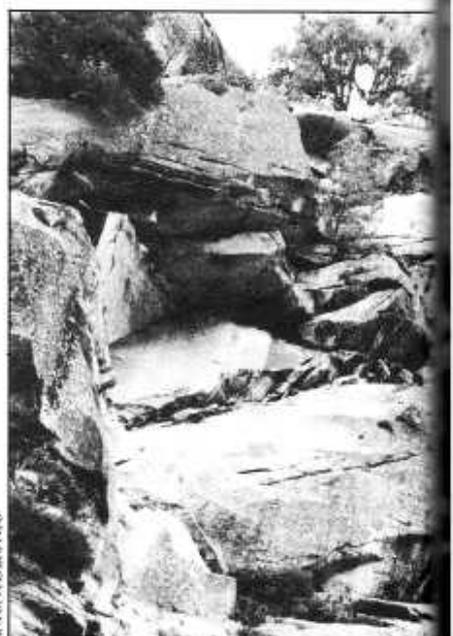
2. The release point of the Feb. 13 slide shows the three major planes of cross-jointing. The fir at upper left and the small pine on the right contributed to the third slide. Lighter streaks on the fresh rock are calcareous deposits from water seepage.
