# Yosemite National Park

## Merced Wild and Scenic River Values Final Baseline Conditions Report

September 2012

Prepared by ESA for the  
National Park Service, Yosemite National Park

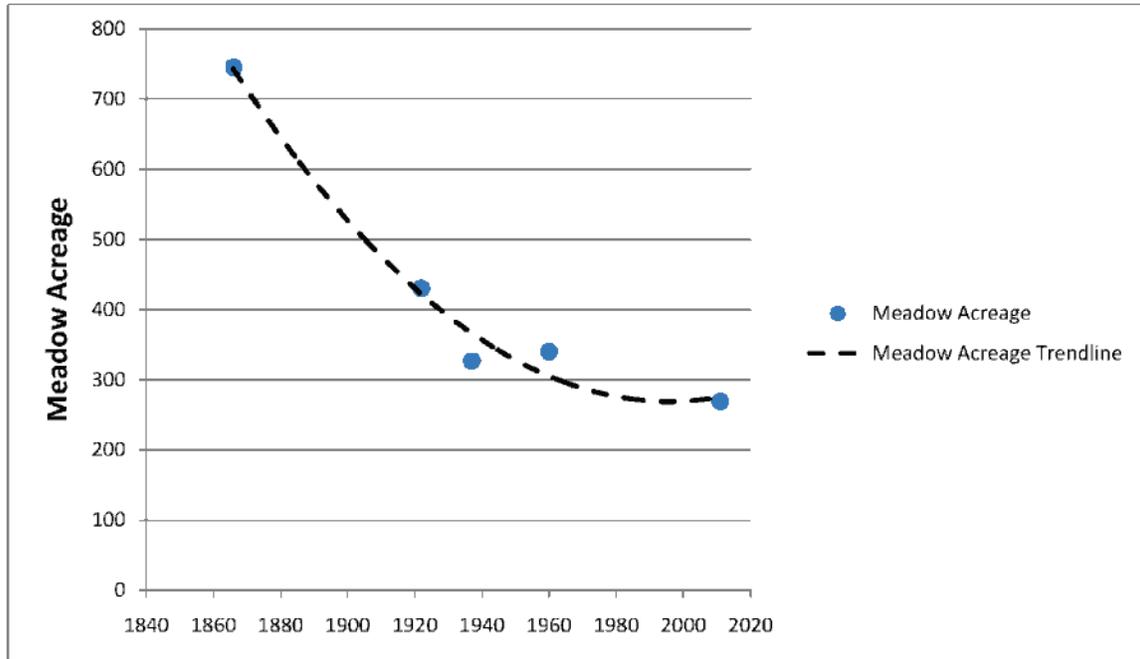
**FIGURE 1-3: MEADOW ACREAGE IN YOSEMITE VALLEY (1866-2011)**

SOURCES: Whitney 1868; Gibbens and Heady 1964; Heady and Zinke 1978; Cooper and Wolf 2008; Ballenger et al. 2011

The net effect of these changes is that, over the past century, the acreage of meadows in Yosemite Valley has decreased. According to Cooper and Wolf (2008) conifers likely colonized meadows for several reasons: (1) the installation of drains, water diversions, and other facilities caused hydrologic changes that lowered the summer water table; (2) the cessation of burning by Native Americans allowed tree seedlings to persist; (3) disturbance caused by plowing meadows and planting hay crops and apple orchards allowed conifers to invade the bare soils after the densely-rooted, sod-forming meadow species were destroyed; and (4) placement of fill to raise the ground elevation allowed upland species to invade (Photo 1-6).

The widening of the Merced River in east Yosemite Valley—attributable to human causes, such as trampling of riparian vegetation and bridges too narrow to adequately accommodate high flows (Madej et al., 1994)—may also be a factor altering groundwater hydrology, which appears to be a contributing factor to conifer colonization (Cooper and Wolf, 2008). This colonization has produced a reduction in areal coverage of meadows in Yosemite Valley due to forest encroachment (Gibbens and Heady 1964; Heady and Zinke 1978). Historic photos and accounts add perspective to the current conditions of Yosemite Valley meadows. In 1866, State Geologist J.D. Whitney (1868) mapped 745 acres of meadows in Yosemite Valley. In 1937, the NPS mapped 327 total meadow acres in Yosemite Valley. By 2010, botanists mapped only 269 total meadow acres, a 64% decrease from the 1866 Yosemite Valley survey (Ballenger et al. 2011) (Photo 1-7) (Figure 1-3 and 1-4).

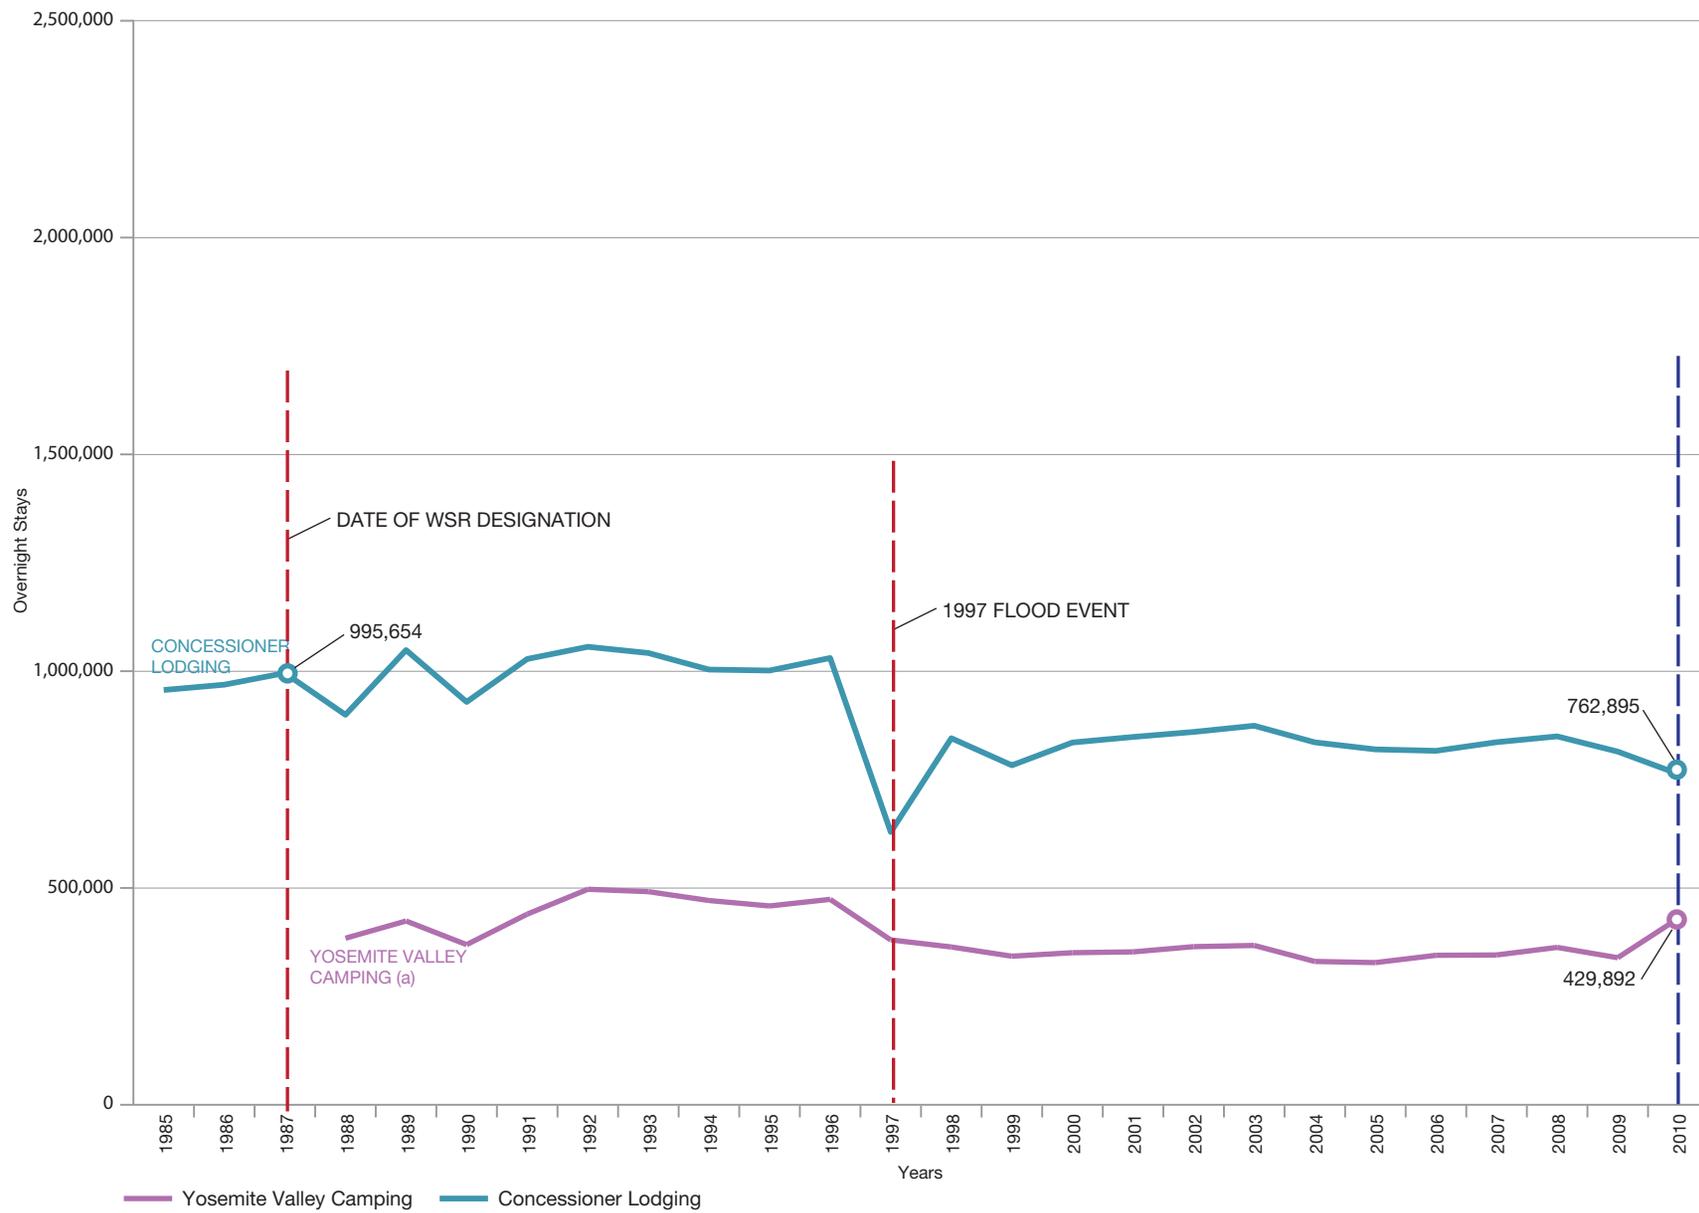
**Figure 2.2-3**  
 Yosemite National Park Total Park Visitors  
 and Overnight Visitor Use (1985-2010)

(a) Pre-1988 overnight visitor use counts do not include Yosemite Valley camping numbers.

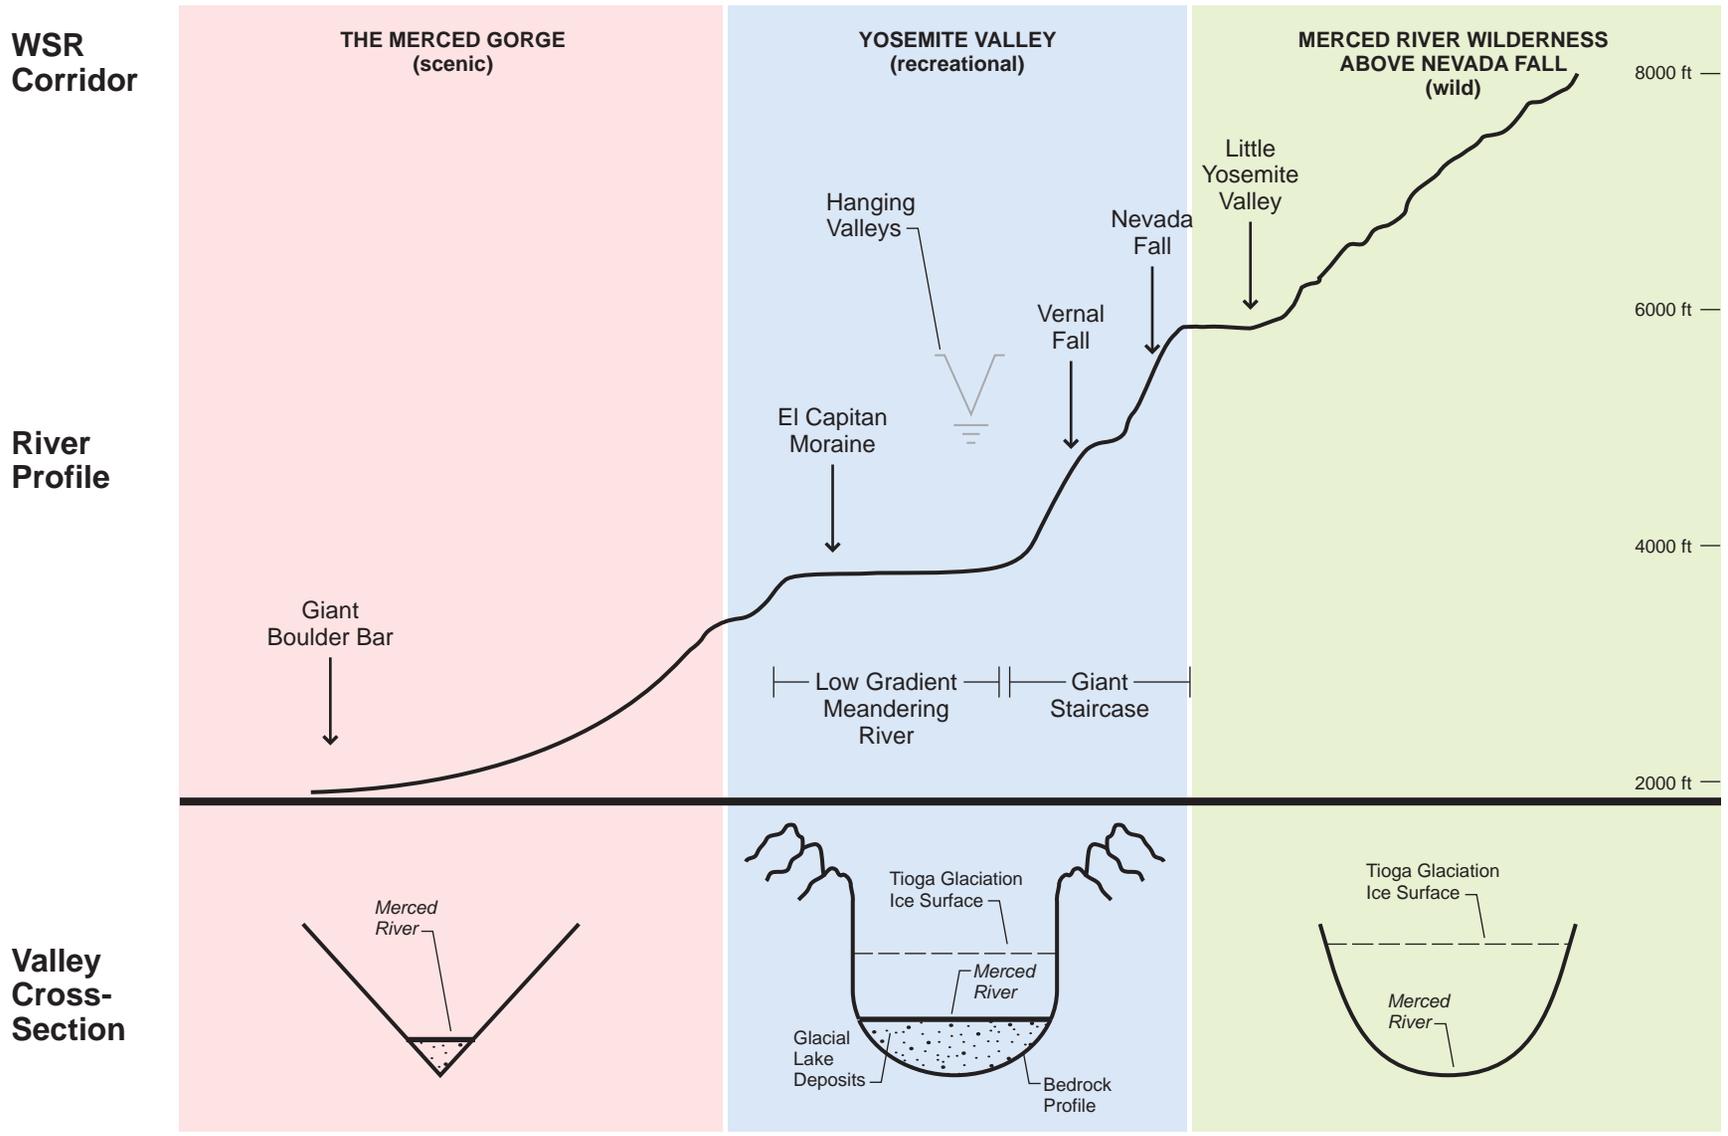
Note: River profile adapted from California Division of Mines and Geology Bulletin 182, 1962  
Not to scale

3) *Geologic Processes*: The rocky cliffs, cascades, and broad valleys along the Merced River represent a nationally significant example of a glaciated landscape. The general Sierran landforms were all well established before glaciation, and the major stream drainages provided the avenues that the glaciers would later follow. The course of the present-day Merced River is determined by the path of glaciers that came and went during the geological epoch known as the Pleistocene (10,000 to 1.8 million years ago) (Table 3-1). These glaciers transformed valleys from V-shaped to U-shaped, left hanging valleys along their lower reaches, and deposited thick packages of glacial till—ultimately shaping the iconic landscapes for which Yosemite Valley and the upper Merced River are now known (Figure 3-2). Most researchers agree that at least three major glacial advances, or stages, have taken place: the Tioga, the Tahoe, and a much older pre-Tahoe (possibly the Sherwin). The Tioga glaciation is considered to have peaked around 20,000 years BP, but the precise timing of the earlier stages is still a topic of debate.

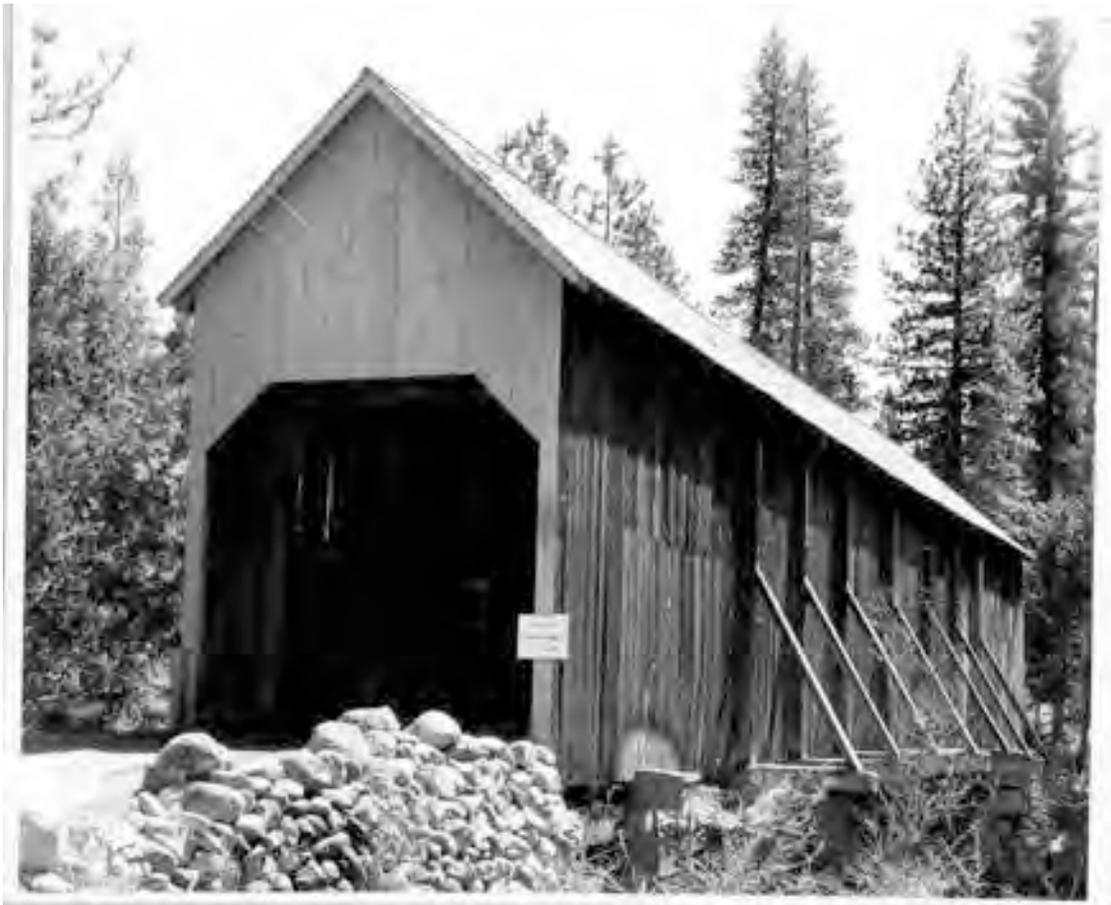
**PHOTO 5-1: WAWONA COVERED BRIDGE 1957 (NPS 1957)**

**Wawona Covered Bridge.** At the time of the 1987 Wild and Scenic River designation, the Wawona Covered Bridge had recently undergone structural safety improvements. NPS had dismantled and reconstructed the bridge in 1956-1957, employing hand-hewn timber construction in the same style as the original bridge (Photo 5-1). Some timbers were replaced in 1961 and again in 1983 when NPS corrected structural safety hazards following an inspection of the bridge (Greene 1987).

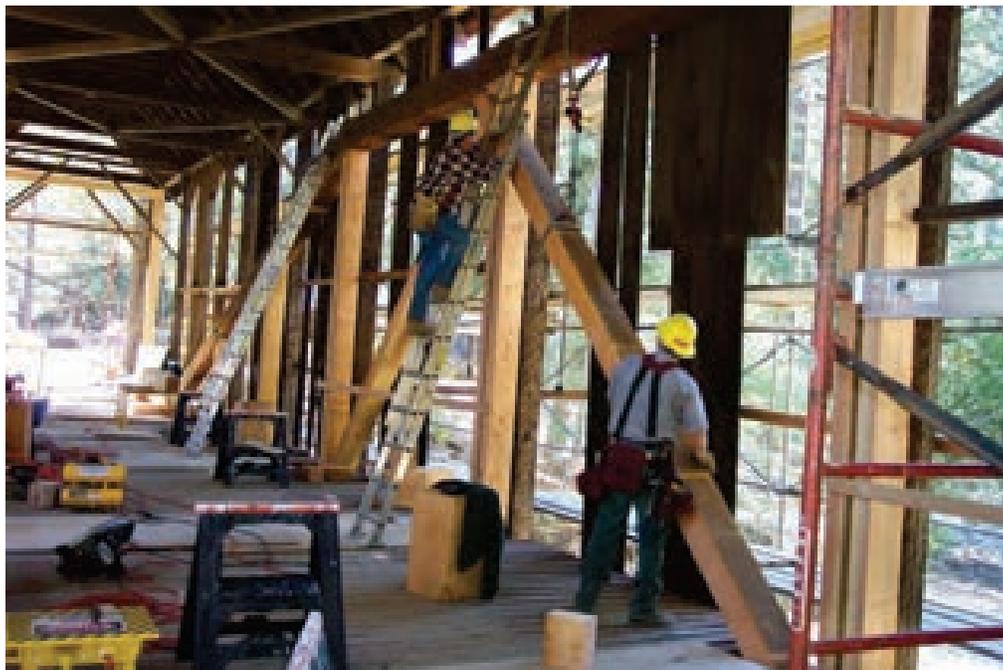
**PHOTO 5-2: WAWONA COVERED BRIDGE 2005 (NPS 2005)**

**Wawona Covered Bridge.** Between 2002 and 2005, the Wawona Covered Bridge underwent a restoration effort to improve the deteriorating timber structure. Hand-hewn timbers were used to repair the structure in a manner similar to the original 19th-century construction (NPS 2005, Photo 5-2). Preservation of the bridge also included:

- Constructing shoring to support the 115,000-pound timber-frame of the bridge
- Removing the 8-inch sag from the superstructure, leveling the bridge
- Removing and replacing all seven of the deteriorated 14-square-inch by 30-foot transverse floor beams
- Repairing the bridge pier masonry in the riverbed
- Restoring the structural stability of the upstream and downstream timber-frame truss assemblies
- Replacing the undersized timber components to resist wind and snow loading
- Replicating hand-hewed timbers using broad axes and traditional craftsmanship from 19th-century practices

All bridge restoration activities were designed to meet the Secretary of the Interior's *Standards for the Treatment of Historic Properties*, thereby ensuring that the bridge retains its historical integrity. Completion of the bridge restoration project inaugurated the creation of the Pioneer Yosemite History Center, with the restored bridge as a central feature.
