SPRINGDALE STREETSAPES AND MULTI-MODAL CONNECTIVITY ANALYSIS AND RECOMMENDATIONS

Section Overview

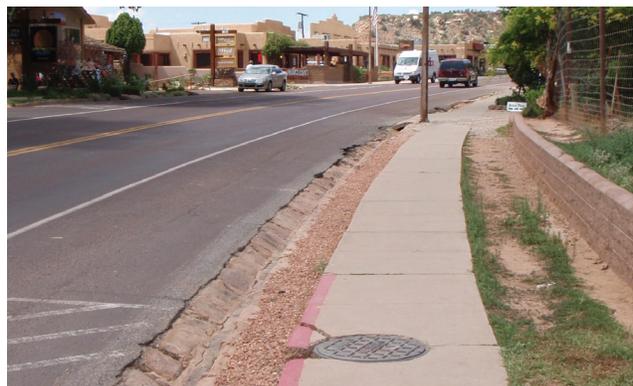
- Sidewalks are worn and deteriorating in some places. Signs of deterioration include spalling and erosion of edges/corners.
- In many instances, sidewalks that cross driveways are not up to Americans with Disabilities Act (ADA) guidelines.
- Where sidewalks cross gravel driveways or are adjacent to gravel surfaced parking areas, gravel is spilling over onto sidewalk surface in some locations.
- See sidewalk gap details in Table 4-1.

Sidewalk cracking at manhole cover

- Repair and/or replace all sidewalks that are worn and unsafe.
- Repair and/or replace sidewalks at driveway entrances to meet ADA standards.
- Add sidewalk in areas where it is missing

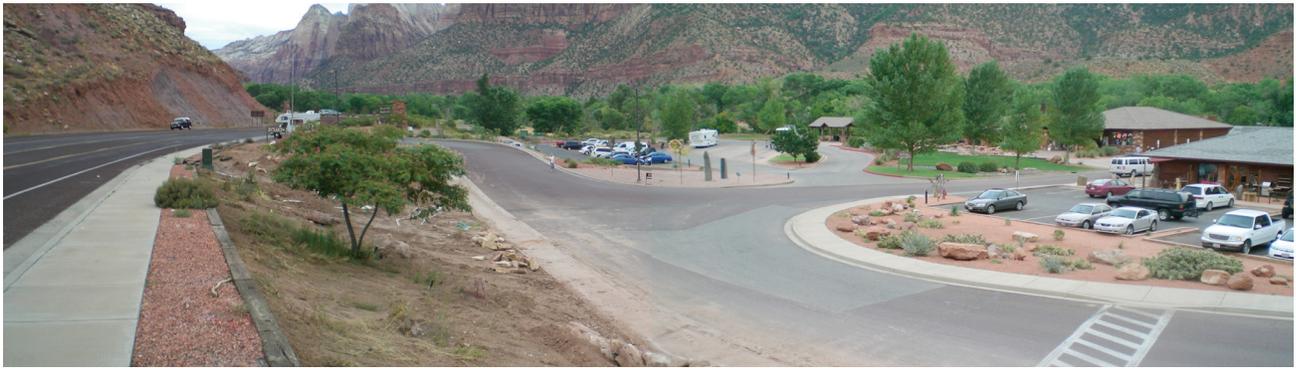
The view of the park pedestrian entrance and shuttle stop from Zion Park Boulevard. (Topographic conditions are steeper than this photo depicts.)

- There are circulation and accessibility challenges at the Zion Canyon Giant Screen Theater driveway entrances, shuttle stop, and pedestrian entrance to the park. It is difficult to spot the pedestrian entrance from Zion Park Boulevard as well as when disembarking the shuttle.

- Create a clear, designated pedestrian connection (sidewalk or markings in pavement) between Zion Park Boulevard and the pedestrian park entrance.
- Further study of the pedestrian circulation between the Zion Canyon Giant Screen Theater shuttle stop and visitor center is recommended. Improvements could include reconfiguration of the space, a hierarchical network of wayfinding signs, and/or a pattern in the sidewalk to clearly direct visitors to the park entrance.

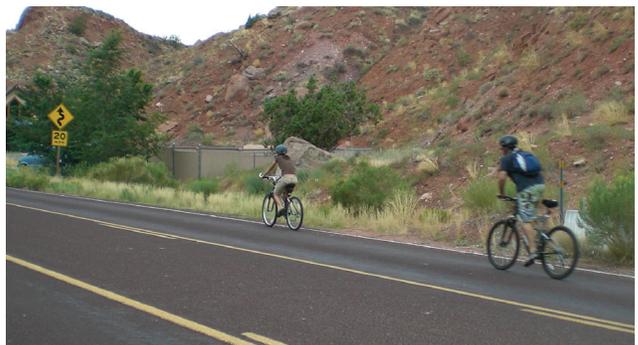
Bicyclists riding in the travel lane at the landslide area

- Southbound, between the park vehicular entrance gate and the Cliffrose flag stop, there is no shoulder. The roadway has become pinched by a landslide area, forcing bicycles to travel in the vehicle travel lane.

- Designate a bicycle lane in the road or place shared use bicycle symbol (sharrow) in the roadway especially at constricted areas. Sharrows indicate that motorists should expect to see and share the lane with bicycles. Unlike bicycle lanes, sharrows do not designate a particular part of the roadway for the use of bicyclists, but rather that the roadway is to be shared.
- Implement the proposed Zion Canyon Trail (begins in Rockville and continues to park) and create connections between Springdale shuttle stops and the multi-use trail.

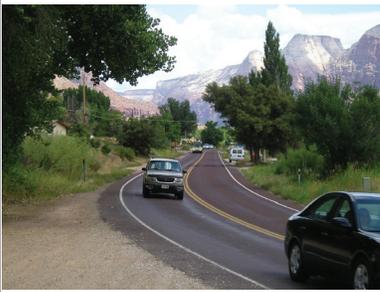
The typical road condition in this segment has asphalt/gravel shoulders on both NB and SB lanes. Springdale is in the process of constructing the first phase of the Zion Canyon Trail. The first section will start in the dirt pull-out south of Majestic View Lodge and continue to Silver Bear. The trail will be on the NB side of the road.

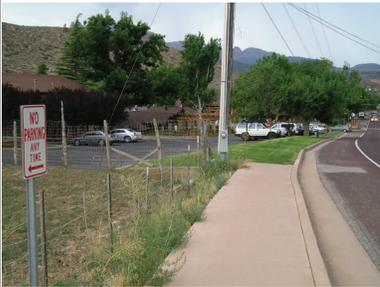
There is no sidewalk between the Driftwood Lodge shuttle stop and the northern property line of the Driftwood Lodge. It is currently lawn.

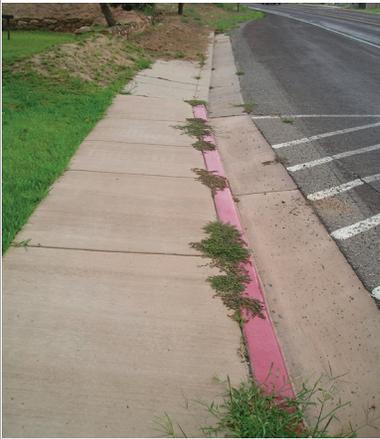
The sidewalk ends just north of the Quality Inn. It becomes an asphalt/gravel shoulder.

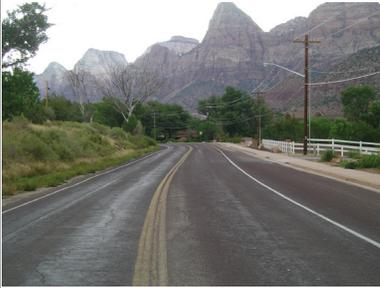
The typical road condition between Driftwood Lodge and Zion Park Inn is an asphalt/gravel shoulder on the NB side and a concrete sidewalk on the SB lane.

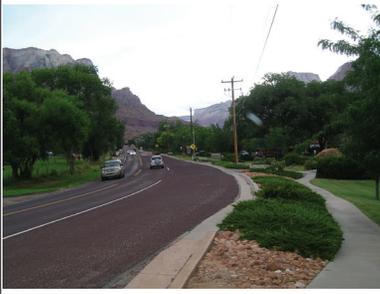
Along the Zion Park Inn frontage, the sidewalk ends at the northern driveway. A regular sidewalk adjacent to the road continues NB from here.

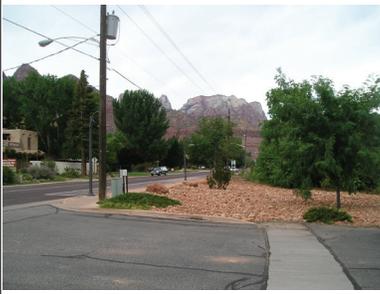
The sidewalk ends in a planting bed at the Zion Park Inn northern driveway.

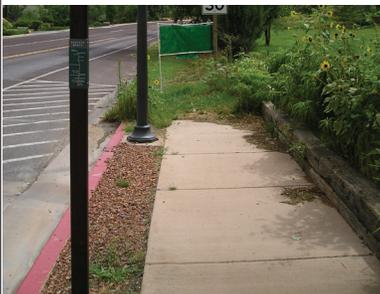
The SB side sidewalk ends at the Bit and Spur shuttle stop and becomes grass.
	•	Shell Station Driveway

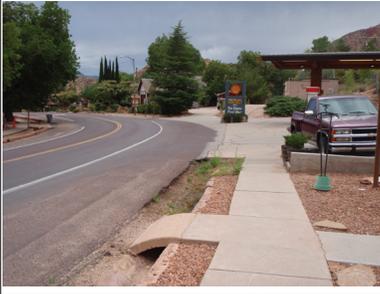
The driveway is concrete, with no sidewalk, and is spalling heavily.
•		Zion Park Motel Driveway to the Springdale Candy Company/Simply Birkenstock Storefront

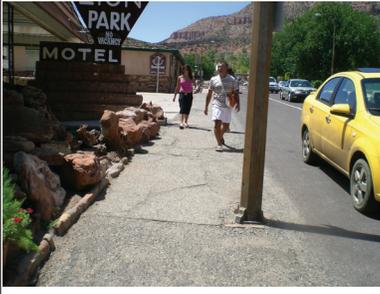
The material in this area is asphalt, with no adjacent sidewalk, and is exhibiting many cracks and buckles.

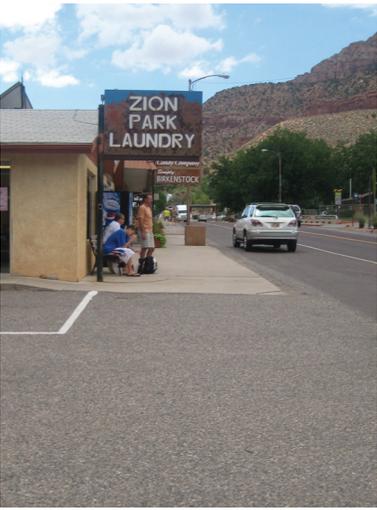
Asphalt surface with no sidewalk adjacent to Zion Park Laundry
	•	Big Chief Frontage

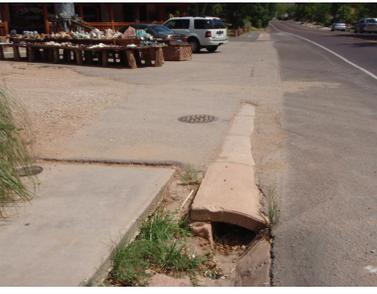
Asphalt surface with no sidewalk at Big Chief
	•	Canyon Ranch Frontage

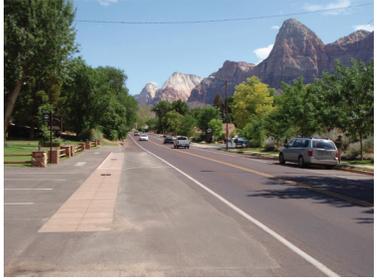
There is no sidewalk at Canyon Ranch. There is a shuttle stop near the driveway with asphalt surfacing. A concrete strip covers utilities at the shuttle stop. The town plans to install a sidewalk in the future on the Canyon Ranch side of the road.
	•	Canyon Ranch Motel to the North Side of Lion Boulevard

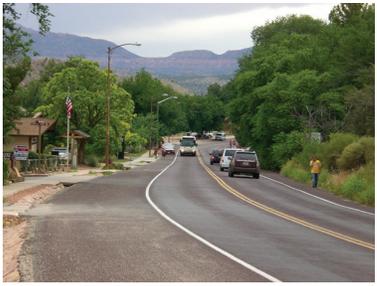
The SB lane is an asphalt/gravel shoulder and the NB lane has a continuous concrete sidewalk. Many pedestrians opt to use the SB shoulder instead of crossing the street to the sidewalk.

along Zion Park Boulevard. As previously mentioned, the town is proceeding to build sidewalks as funding allows. The southbound lane of Zion Park Boulevard north of Canyon Ranch is a high priority area as pedestrians are currently using the shoulder in this area.

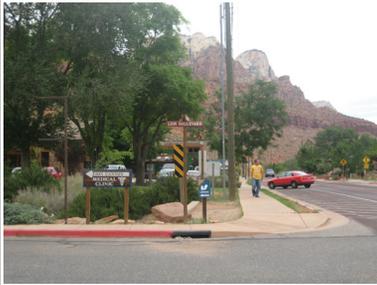
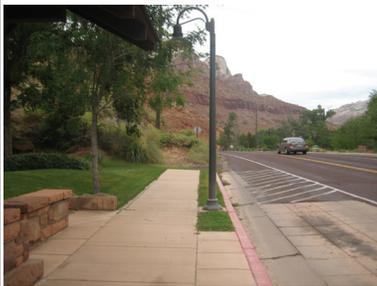
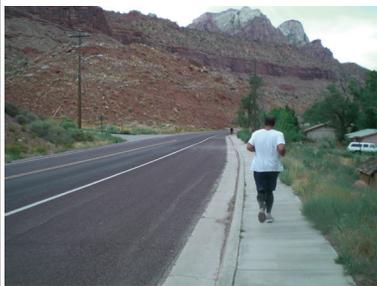
<p>There is a short concrete sidewalk segment at the Flanigan’s frontage. It ends just north of the shuttle stop, where it becomes asphalt/gravel shoulder.</p> <p>There is only an asphalt shoulder on the SB side of the road, but the NB side has a continuous concrete sidewalk.</p>	
	<ul style="list-style-type: none"> Tsunami Juice & Java Café to the Park Entrance.

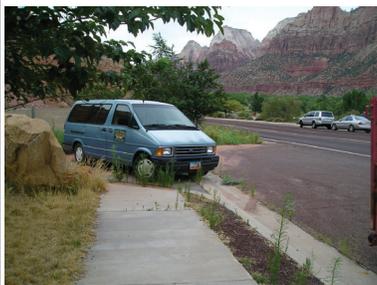
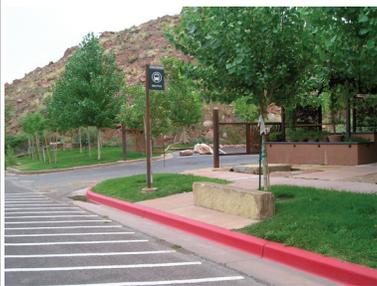
<p>There is a short segment of concrete sidewalk at the Cliffrose shuttle stop in this gap area, but otherwise it is an asphalt/gravel shoulder.</p>

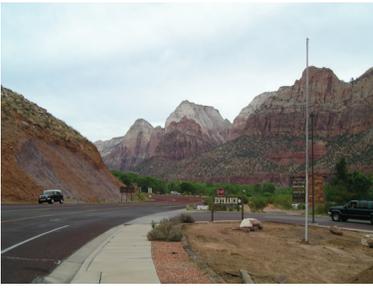
The sidewalk ends just beyond the northern driveway to the Zion Canyon Giant Screen Theater.

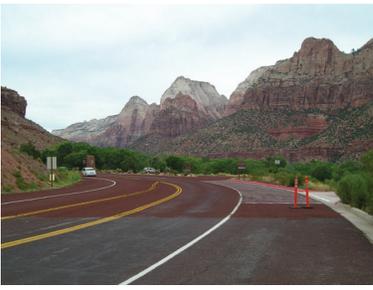
The road north of the Zion Canyon Giant Screen Theater leading to the park entrance has wide asphalt shoulders for parking.
		South Side of Lion Boulevard

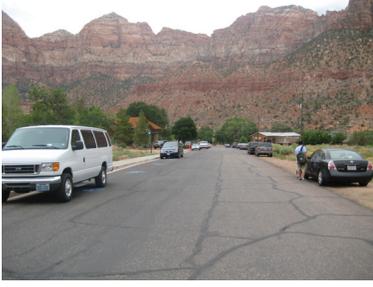
Lion Boulevard has concrete sidewalks on the northern side of the road, but only wide dirt shoulders for parallel parking on the southern side.

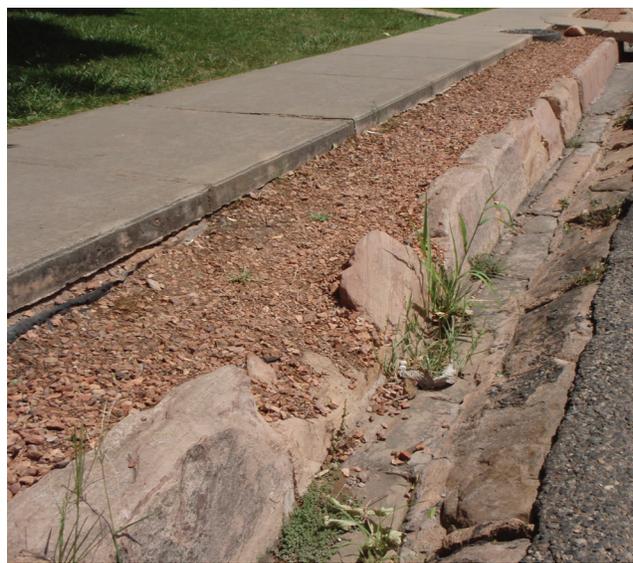
Rock ditch in disrepair between the elk ranch and Pioneer Lodge

- The existing historic stone curb and gutter is in disrepair in several locations.
- Some utility boxes and conduits are in need of repair.
- Debris is building up in the curb and gutter/ditch at some locations.

- Repair the historic stone curb and gutter where it is cracking, eroding, or falling apart.
- Keep the gutter clear of debris along the entire corridor.
- Repair utility boxes and conduits where needed.

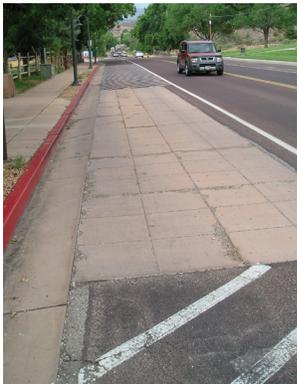
Concrete shuttle pad at Driftwood Lodge

Concrete shuttle pads are chipping and spalling in places, maintenance is recommended; restripe "no parking" zones

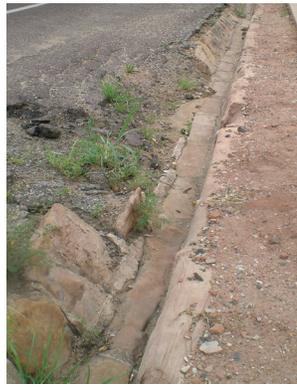
Eroding gutter at Terrace Brook Lodge

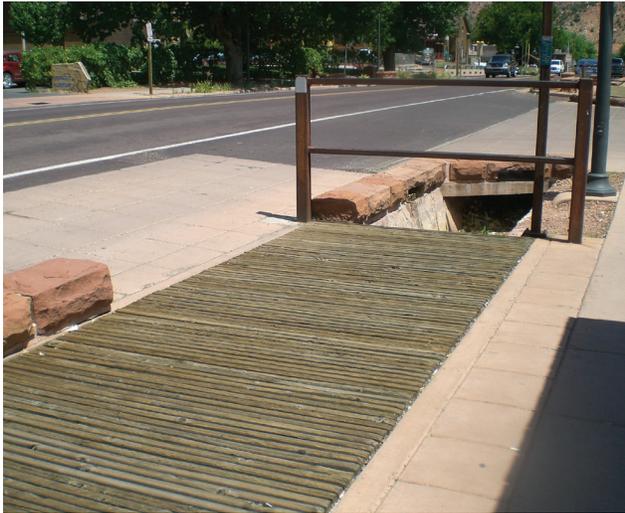
Wood slat platform at Bumbleberry/Zion's Bank shuttle stop platform

- The Bumbleberry/Zions Bank shuttle stop has a platform made of wood slats (2x4s on end). These slats have large gaps in between them that are difficult to pass over for wheelchair or stroller users. Multiple concerns and problems have been raised about this shuttle stop, in addition to the wood slat surface. The metal railing on either end of the wood slat decking provides some protection from the ditch drop down on either side, but it does not meet typical standards. Shuttle operators have reported that it is a difficult location to pull in and out of due to the proximity of nearby driveways for the bank drive through. These conditions also make pedestrian access to and from this stop more challenging. The location is surrounded by activity and businesses signs, and as such, the shuttle stop is not as highly visible or “legible” as some of the other locations.

- Reorienting the wooden slats to run horizontally at the Bumbleberry/Zions Bank shuttle stop is recommended, or potentially moving this stop. Improvements

should be made here to the surfacing and railing. As an alternative, this stop could be relocated and rebuilt at a nearby location. There is an open area adjacent to the street in front of the Zion Park Motel, and the owners there have indicated a willingness to consider moving the stop to that location. To construct the stop here, parking places (which appear to be little used) in front of the motel and pool area would need to be removed. This could be a better location for the shuttle stop because it aligns more directly across from the southbound stop and it is located in place with less vehicular conflict/driveway activity.

- Consider relocating Zions Bank shuttle stop to improve safety and legibility. A potential site for relocation is in front of the Zion Park Motel, which would place it directly across the roadway from the Pizza & Noodle shuttle stop.
- Convert the Canyon Ranch, Cliffrose, and Desert Pearl/Post Office shuttle stops from flag stops to regular stops with shelters. See Figure 4-1 for details.
- Repair or replace shuttle pads as described in Figure 4-1.

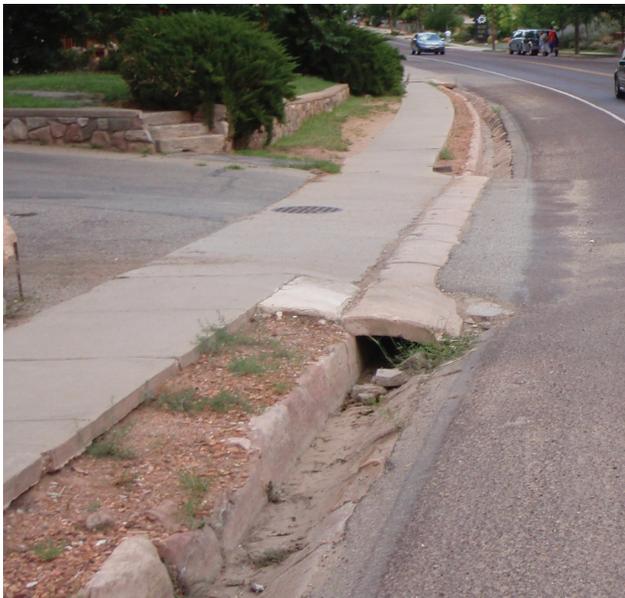
Debris in gutter and deterioration of the rock ditch wall at the elk ranch

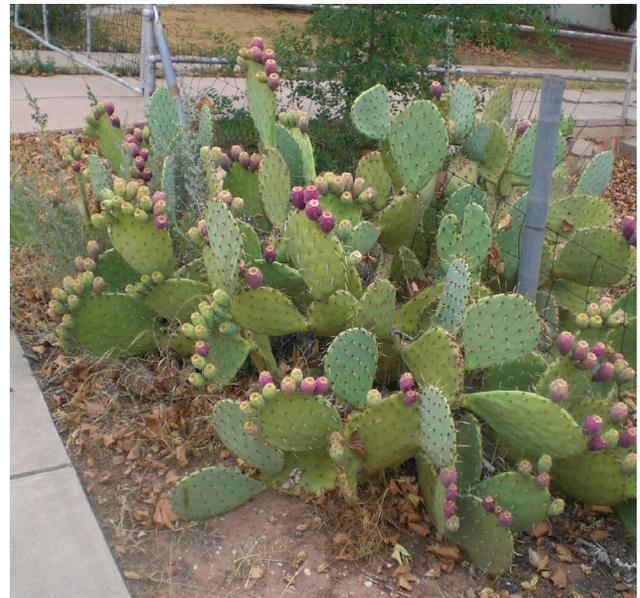
Prickly pear along the sidewalk, heading north towards Lion Boulevard

- There are many plants along the sidewalk that have thorns or sharp spines. These plants are not pedestrian friendly.
- The red rock mulch in the planting beds has shifted in many areas, exposing the black geotextile fabric beneath.
- The landscape areas in the vicinity of the Giant Screen Theater need improvement. The planting beds are mostly exposed soil.
- Lion Boulevard and Zion Park Boulevard are in need of vegetation maintenance.

- Replace thorny and spiny plants with other plants.
- Use native and low maintenance plants. The landscape should extend the park environment into Springdale.
- Replace and add red rock mulch where it is missing.
- Keep planting beds free of weeds.
- Consider engaging the community in a clean up and vegetation maintenance program.
- Improve the landscaping in the planting beds at the Giant Screen Theater area.
- Plant shade trees where space allows, without blocking important scenic vistas, and continue to enhance the pedestrian environment along Zion Park Boulevard (working closely with adjacent property owners) to encourage walkability and pedestrian activity.

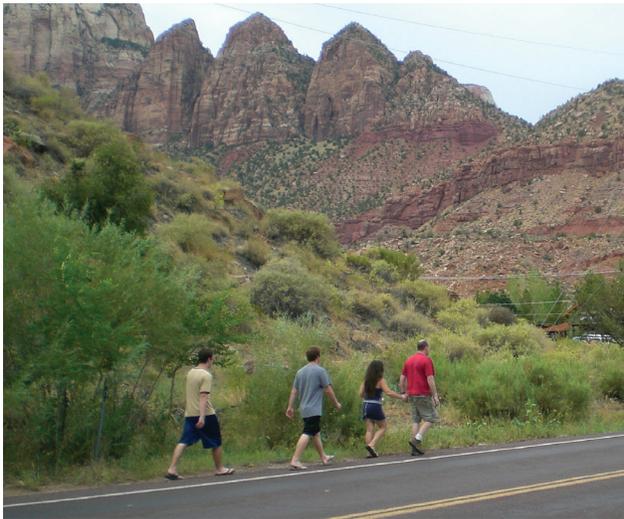
People walking on road shoulder, just south of Lion Boulevard

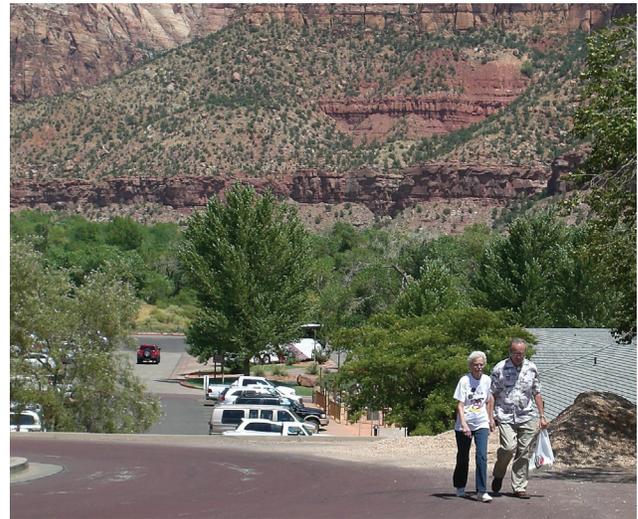
Pedestrians on driveway to pedestrian park entrance; notice how they are walking on the side of the road with no sidewalk because this is less steep

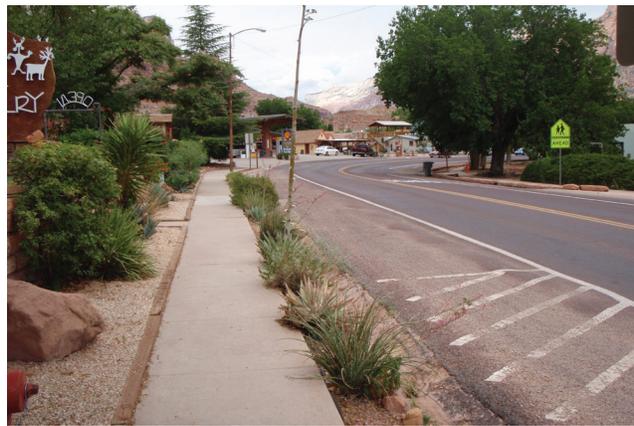
Spiky plants in planting bed near Red Rock Jewelry
