Subject: Adding New Entrances to Historic Buildings

Applicable Standards: 2. Retention of Historic Character
9. Compatible New Additions/Alterations

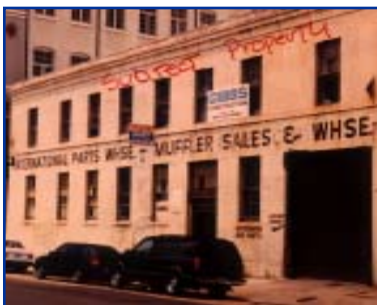
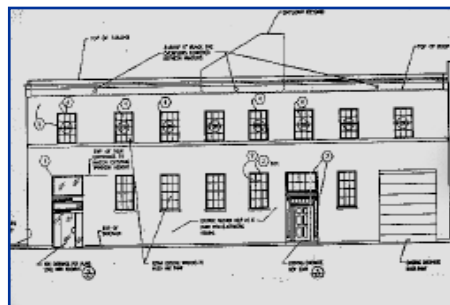
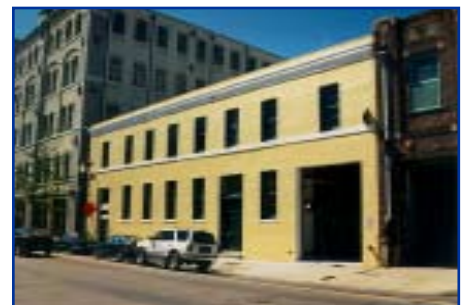
This building was constructed with a single pedestrian entrance in 1886, and a garage door was added later (left). When the building was rehabilitated for office use, an existing window was removed from the end bay and replaced with a new glazed entryway (center and right).

Application 1 (Compatible treatment): This two-story, eight-bay masonry structure was built in 1886 as an ice manufacturing plant. Originally constructed with only one entryway, a garage door had been added later when the building served as a warehouse. As part of the building's conversion into offices, a second pedestrian entrance was added to the street elevation during the rehabilitation to make it easier to get to some of the offices. The size of the new opening is the same as that of the existing historic entrance. But, the new entrance is almost entirely glazed, and consists of a simple butt-mounted glass door with sidelights, and a single-light transom. It is clearly a compatible, contemporary design that does not draw attention to itself. It cannot be confused with the historic entrance, and it does not change the character of the building. Thus, it meets the Standards.

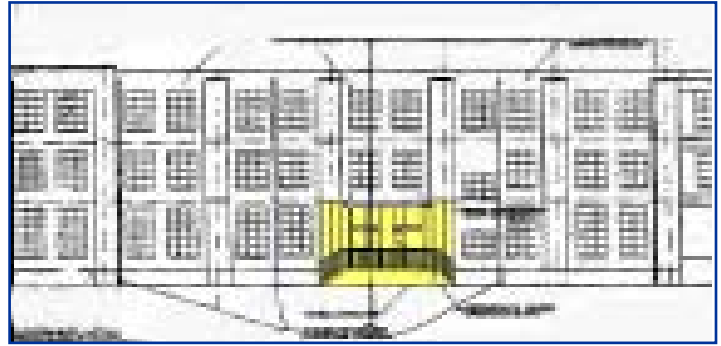
A compatible, new entrance was added to the fourth side of the building during rehabilitation.

Application 2 (Compatible treatment): A larger, free-standing, three-story warehouse building constructed in 1922, with a 1940s addition, was to be rehabilitated into commercial and retail spaces on the first floor with residential apartments on the upper floors. The building featured a loading dock on one side and three utilitarian, non-significant entrances on various elevations. As part of the rehabilitation a new entrance was proposed to be added on a side of the building that never had an entrance. An entrance on this elevation would improve visibility and access to the new shops and businesses, and it would also help increase security for the upstairs apartments since existing entrances could be restricted for residential tenant use. Accordingly, a new glass and steel entryway which reflects the industrial character of the building and its historic metal windows was designed for this side of the building. The new entrance is compatible with the character of the historic building. It is unobtrusive and it does not noticeably impact or change the appearance of this elevation or of the warehouse building as a whole.
