# 4 PRESERVATION BRIEFS

## Roofing for Historic Buildings

U.S. Department of the Interior  
National Park Service  
Cultural Resources  
Heritage Preservation Services

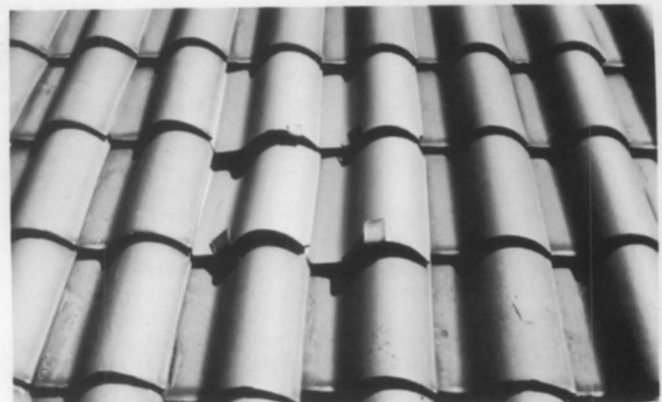
*Repairs on this pantile roof were made with new tiles held in place with metal hangers. (Main Building, Ellis Island, New York)*

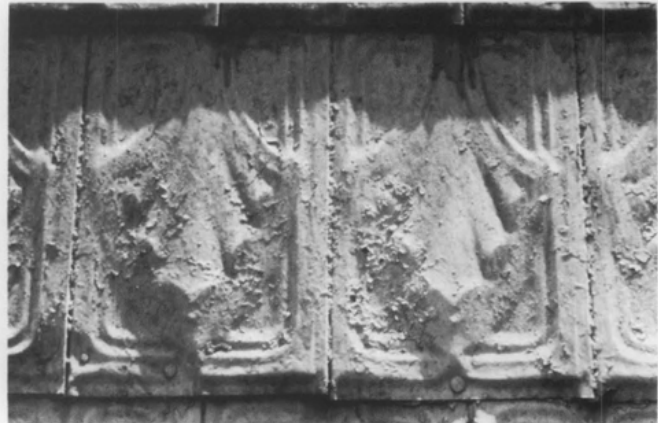
Tin shingles, commonly embossed to imitate wood or tile, or with a decorative design, were popular as an inexpensive, textured roofing material. These shingles  $8\frac{3}{8}$  inch by  $12\frac{1}{2}$  inch on the exposed surface) were designed with interlocking edges, but they have been repaired by surface nailing, which may cause future leakage. (Ballard House, Yorktown, Virginia, photo by Gordie Whittington, National Park Service)

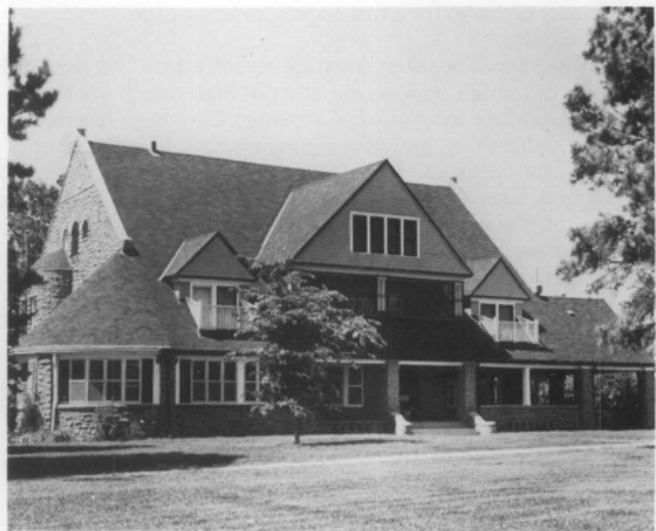
*These two views of the same house demonstrate how the use of a substitute material can drastically affect the overall character of a structure. The textural interest of the original tile roof was lost with the use of asphalt shingles. Recent preservation efforts are replacing the tile roof. (Frank House, Kearney, Nebraska, photo courtesy of the Nebraska State Historical Society, Lincoln, Nebraska)*

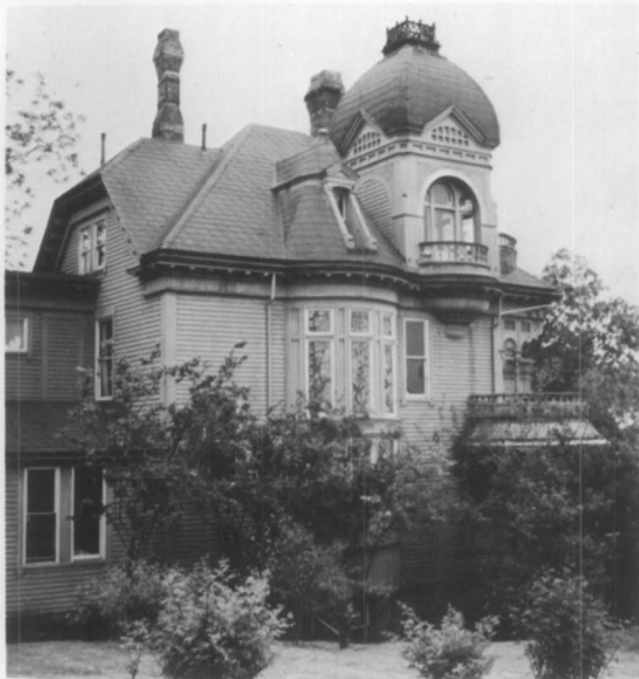
*Special problems inherent in the design of an elaborate historic roof can be controlled through the use of good materials and regular maintenance. The shape and detailing are essential elements of the building's historic character, and should not be modified, despite the use of alternative surface materials. (Gamwell House, Bellingham, Washington)*
