16 PRESERVATION BRIEFS

The Use of Substitute Materials on Historic Building Exteriors

National Park Service
U.S. Department of the Interior
Technical Preservation Services

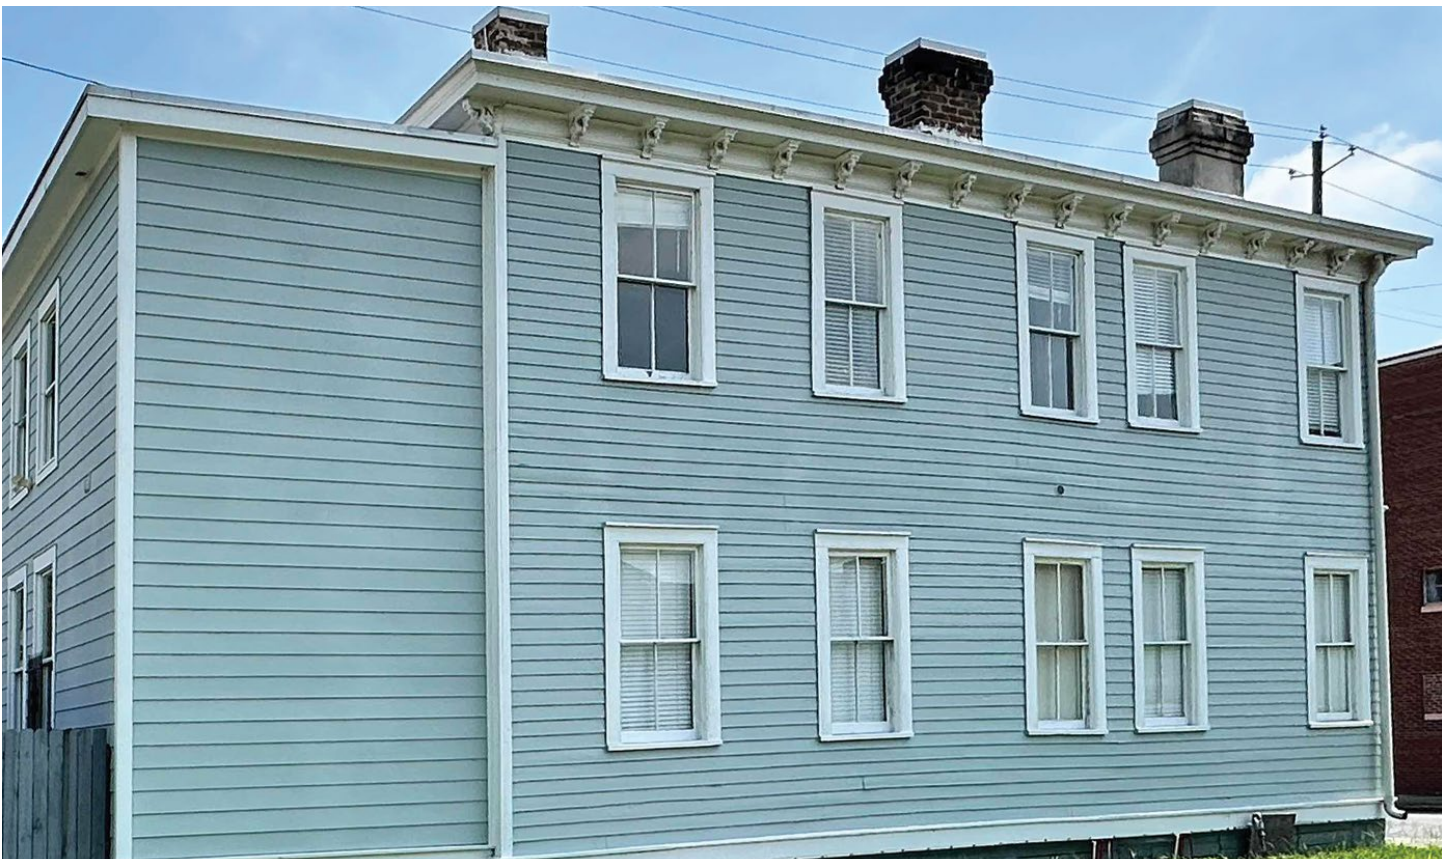
Figure 7. A new addition replaced non-historic construction on the rear elevation of this building. Fiber cement gives the addition a compatible appearance without replicating the exposure for thickness of the historic siding. Photo: Ward Architecture + Preservation.

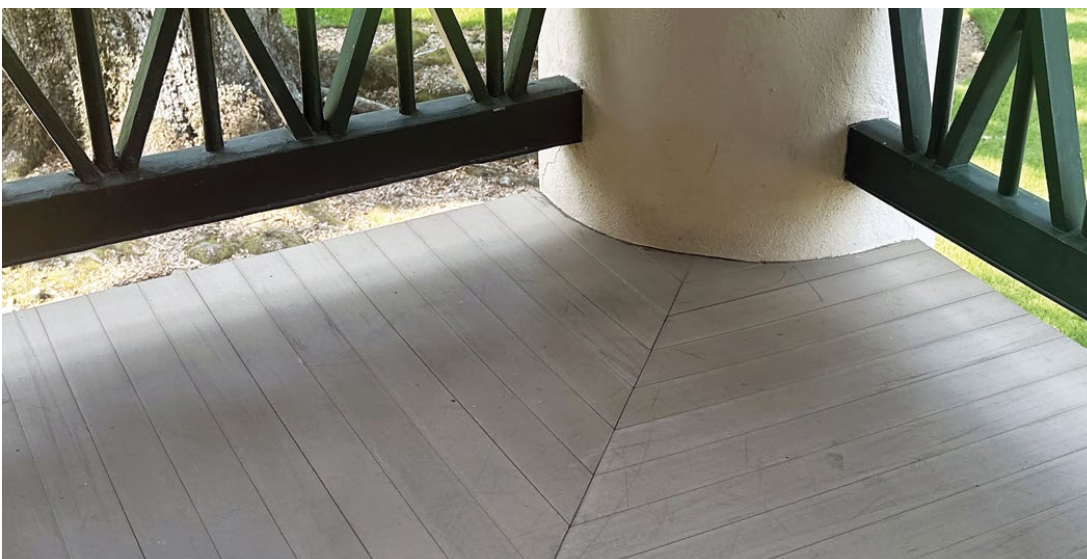
Figure 15. Tongue-and-groove porch flooring is manufactured in several different substitute materials. Each type has different properties, though most are more moisture-resistant than wood. The prefinished product shown can be painted when worn, but repainting is not recommended for some product choices. Photo: Oak Alley Foundation.

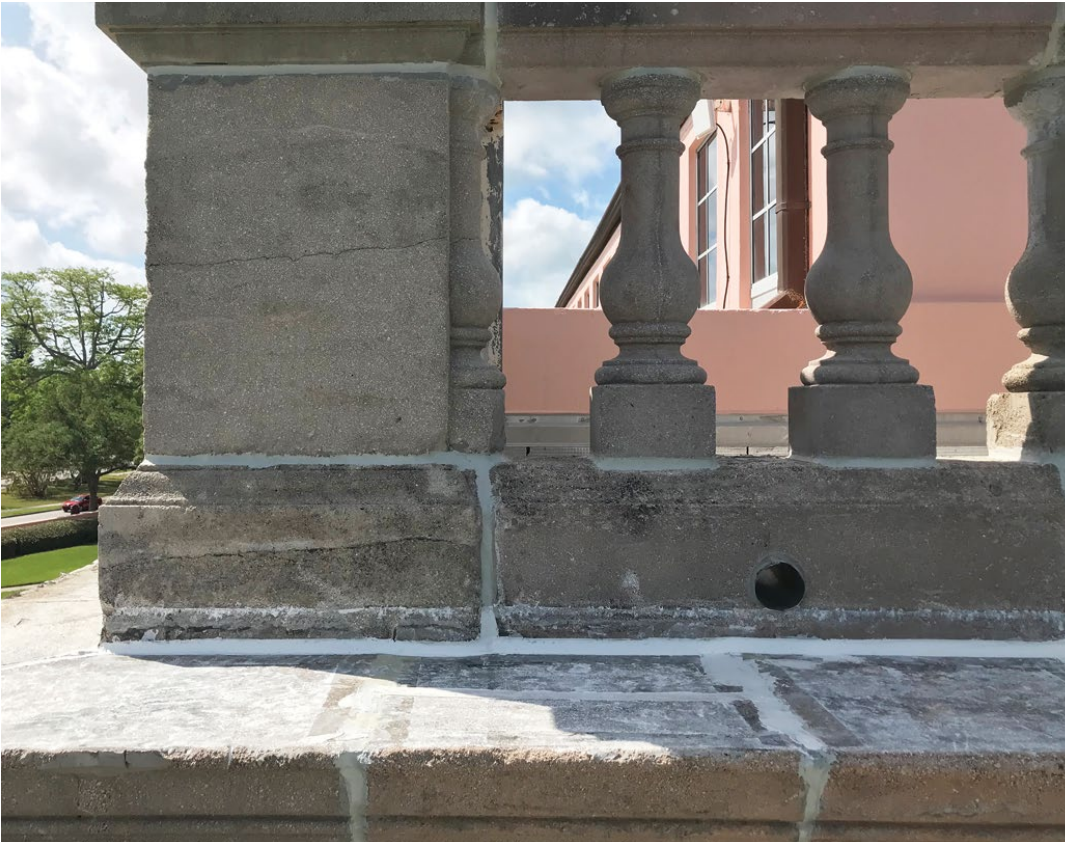
Figure 17. The balustrade consists of multiple prior campaigns of using cast stone to replace the natural stone. The effective match for the surface texture and color of the original stone allowed individual elements to be incrementally replaced only when they had failed, thus retaining the maximum amount of original material as long as possible. Photo: EverGreene Architectural Arts.

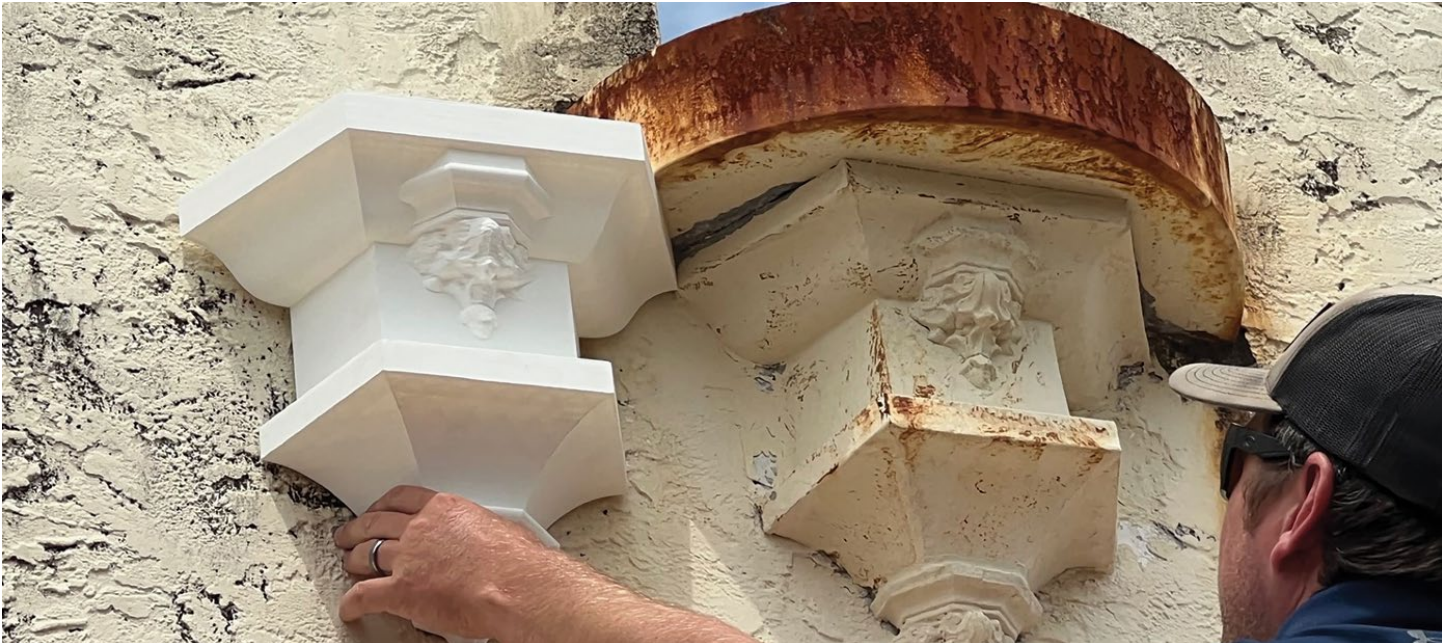
Figure 23. 3-D printing using various polymers is occasionally used to replicate missing metal or wood features. This new application is continually being refined, but the application can be successful when a painted, lightweight feature needs to be replicated. Photo: NPS.

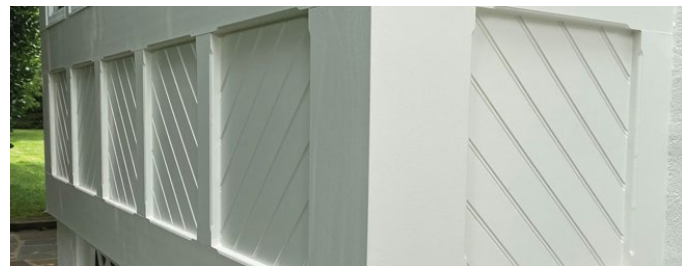
Figure 24. Cellular PVC when painted can be used to replace deteriorated wood features. This beadboard set in a wood frame was not historically designed to shed water effectively and had deteriorated. Cellular PVC was able to match the appearance of the wood details, while its properties were well matched to the shady location, painted finish, and limited size and configuration within the overall assembly; thus, it should provide a long-lasting solution for this application. Photo: Jennifer Balson Alvarez, NPS.
