# 44 PRESERVATION BRIEFS

## The Use of Awnings on Historic Buildings: Repair, Replacement, and New Design

Chad Randl

National Park Service  
U.S. Department of the Interior

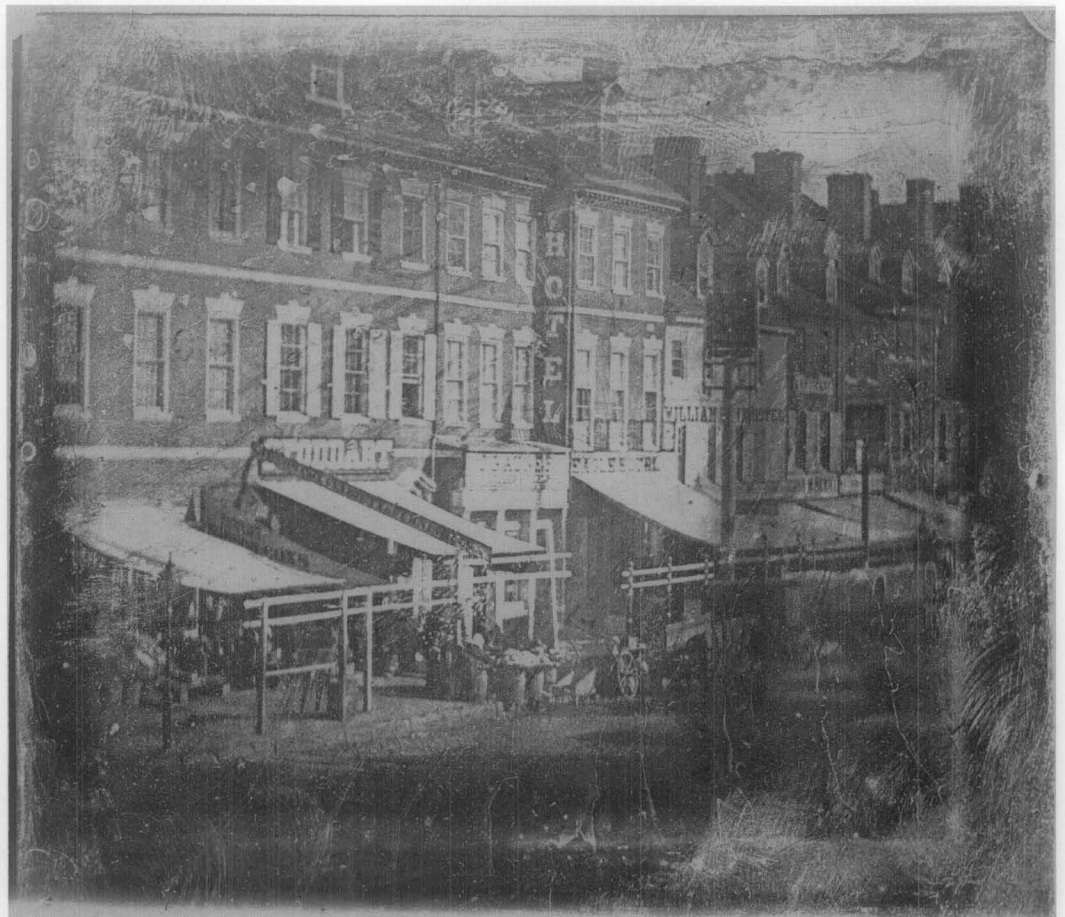
Figure 3. Early 19th century awnings featured canvas coverings stretched between the building facade and post-supported front bars. Projecting frameworks of extension bars were not common until later in the century. Photo: Second Street, Philadelphia, c. 1841, Print and Photo Collection, The Free Library of Philadelphia.

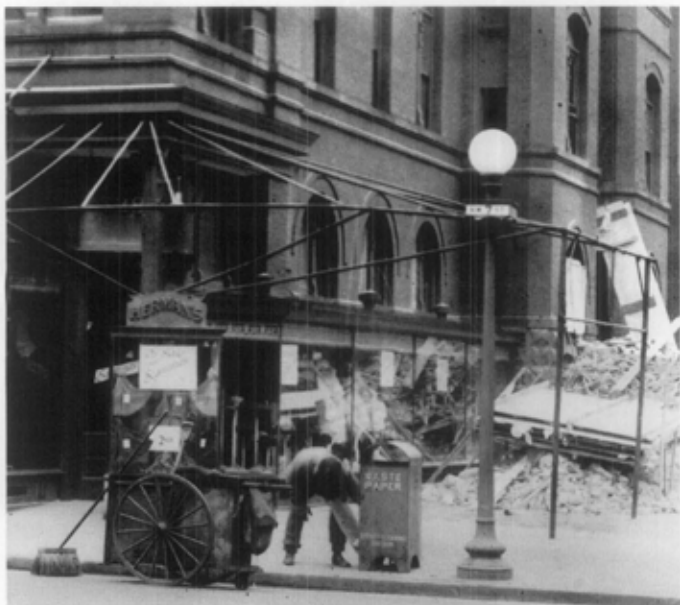
Figure 5. During the second half of the 19th century, iron plumbing pipe became a popular material for fixed awning frames. Here, a pipe frame without its canvas cover extends around the corner of a building in Washington, D.C. Photo: Library of Congress, Prints and Photographic Division, LC-USZ62-121160.

Awnings became a common feature in the years after the Civil War. Iron plumbing pipe, which was quickly adapted for awning frames, became widely available and affordable as a result of mid-century industrialization. It was a natural material for awning frames, easily bent and threaded together to make a range of different shapes and sizes (Fig. 5). At the same time the advent of the steamship forced canvas mills and sail makers to search for new markets. An awning industry developed offering an array of frame and fabric options adaptable to both storefronts and windows.

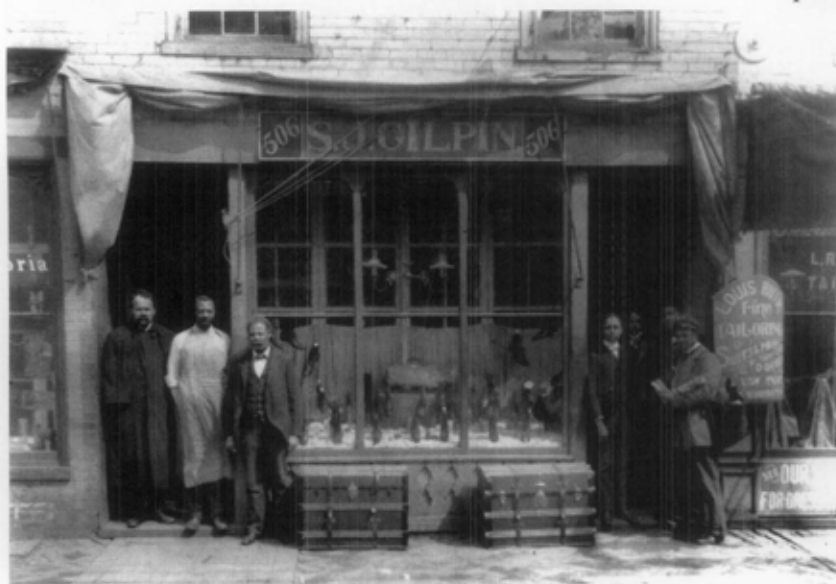
Figure 6. A 19th century shoe store in Richmond, Virginia, had an operable awning retracted against the building facade. Hinged extension arms were raised and lowered allowing for an awning configuration easily changed in response to weather conditions. This photo shows how the fabric gathered and was exposed to the elements when retracted—part of the reason roller awnings later became prevalent. Photo: Library of Congress, Prints and Photographic Division, LC-USZ62-99053.

**Operable Awnings.** In the second half of the 19th century, manufactured operable awnings grew in popularity (Fig. 6). Previously, most awnings had fixed frames—the primary way to retract the covering was to roll it up the rafters by hand. Operable systems for both storefront and window awnings had extension arms that were hinged where they joined the facade. The arms were lowered to project the awning or raised to retract the awning using simple rope and pulley arrangements. Because the canvas remained attached to the framework, retractable awnings allowed a more flexible approach to shading—shopkeepers and owners could incrementally adjust the amount of awning coverage depending upon the weather conditions. When the sun came out from behind clouds, the awning could be deployed with ease. In case of sudden storms, owners could quickly retract the awning against the building wall where it was protected from wind gusts.

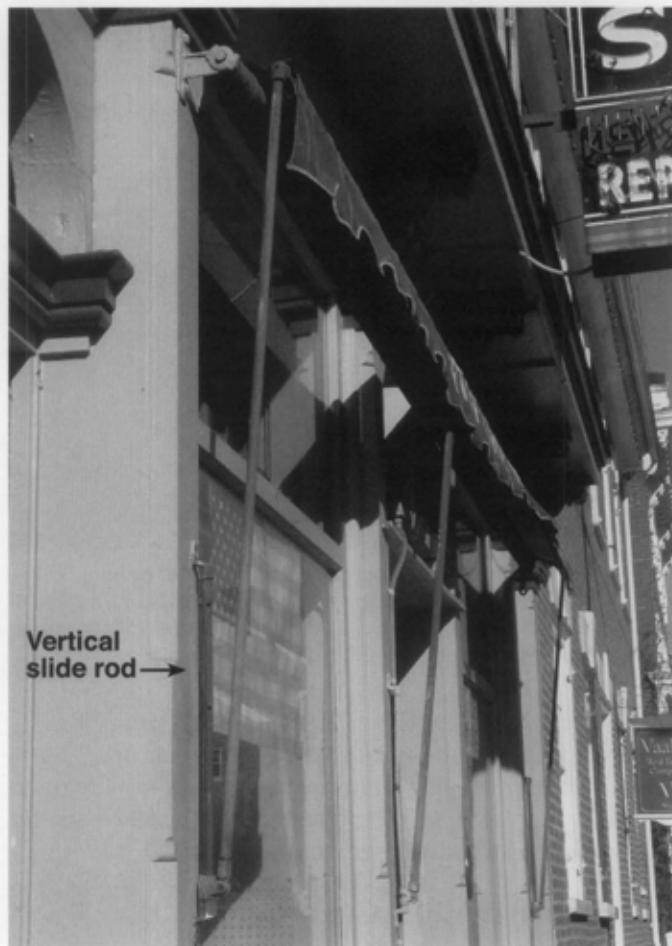
Figure 8. The roller bar at the top of a fixed-arm awning is cranked to release the fabric. As the canvas unfurls the vertical arms swing downward from their lower point. Because the pictured awning had a large projection, extending far from the building wall, the lower hinges were mounted on vertical slide rods affixed to the facade. When the awning is lowered, the bottom hinges of the arms travel up the slide rod to increase headroom beneath the fully extended awning.

Most 19th century roller awnings had fixed arms that were similar to those found on the earlier operable awnings. The arms hinged flush to the building when the awning was retracted and, with the help of gravity, straightened out over the sidewalk when extended. When a storefront awning’s projection exceeded its drop by more than a foot, its long arms were connected to an adjustable slide rod rather than hinged directly to the building facade—increasing head room along the sidewalk (Fig. 8).

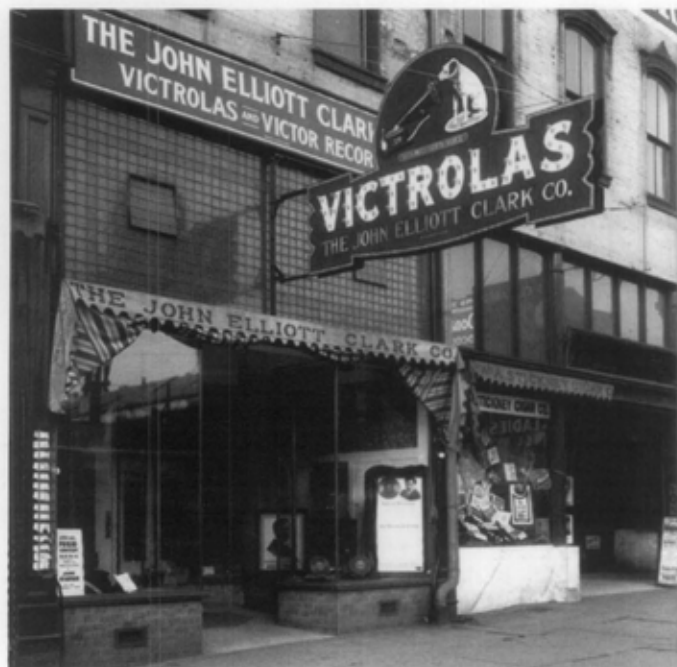
Figure 7. Early 20th century photo showing two operable awnings, an early version on the left and a next-generation roller awning on the right. The roller awning, with no side panels and just the valance showing, presented a clean storefront appearance. Photo: Utah State Historical Society, used by permission, all rights reserved.

**Roller Awnings.** Addressing the drawbacks of the original hinged awning, new roller awnings featured a wood or metal cylinder around which the canvas was stored when the awning was retracted. When fully retracted, only the valance was visible (Fig. 7). The roller was usually bolted to a backboard set against the building and protected beneath a wood or galvanized metal hood. In some cases it was installed in a recessed box built into the facade. A long detachable handle (called a “winding brace”), or a gearbox and crankshaft attached to the building, was used to turn the roller. Some later models were operated by electric motor. Rollers, especially those on window awnings, often contained a spring that helped retract the awning and kept the canvas from sagging excessively.

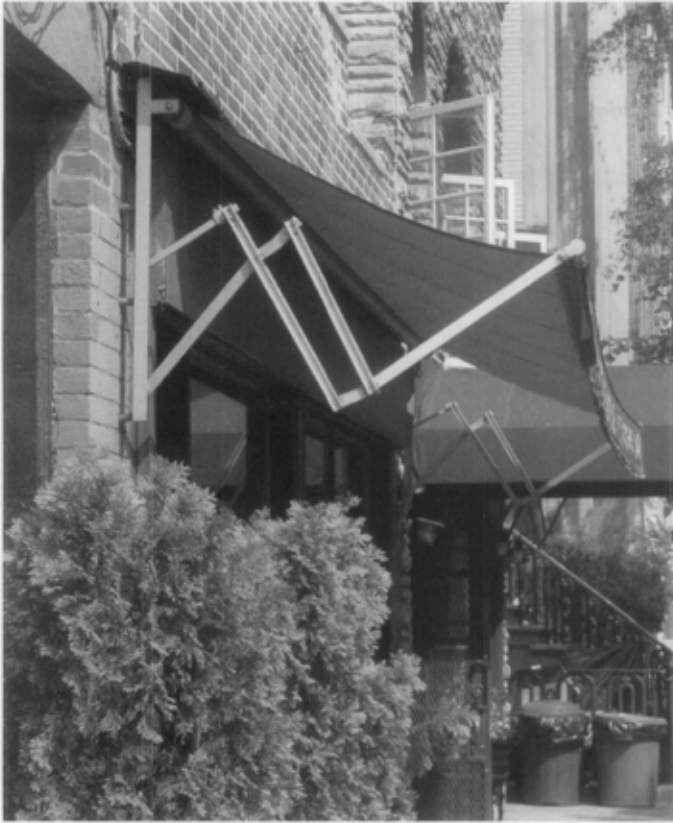
Figure 12. Scissors-arm awnings have a pair of vertical, hinged arms on either side of the assembly supporting the front bar. To unfurl the awning, the roller is cranked and the arms extend outward pulling the cover away from the roller.

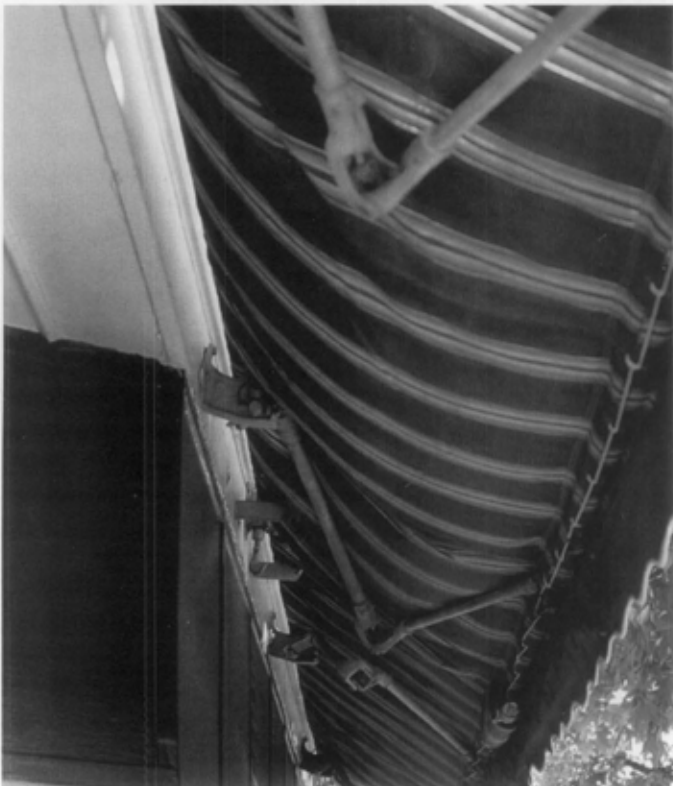
Figure 13. Lateral-arm awnings were preferred on long elevations, especially those with sheet glass (where vertical arms could not be fastened to the building facade). When lateral arm awnings were installed across a broad storefront or porch, manufacturers recommended spacing the arms at approximately eight foot intervals.

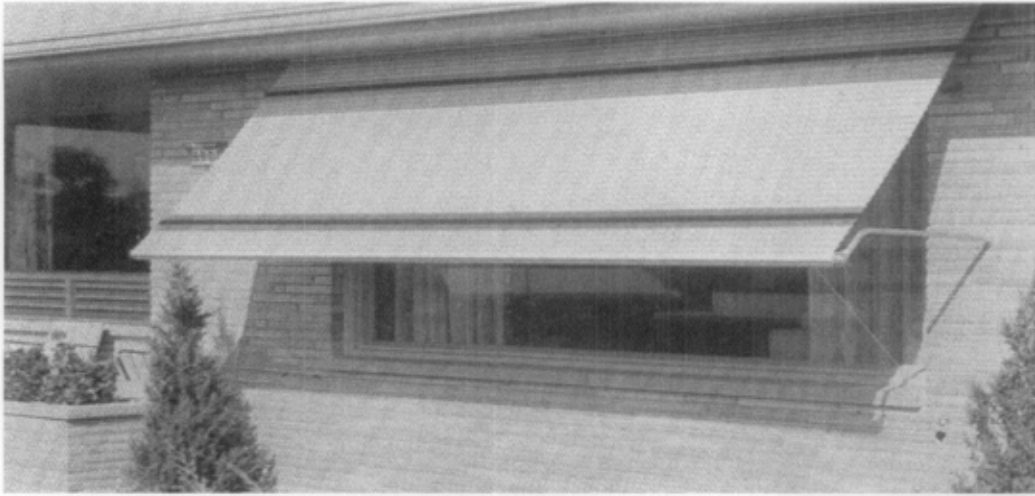
Figure 14. The years after World War II saw the widespread adoption of aluminum awnings on both storefronts and residences. Operable aluminum awnings incorporated a spring-loaded roller into the frontbar.

Widely available by the 1950s, aluminum awnings were touted as longer-lasting and lower-maintenance than traditional awnings. Though used on small-scale commercial structures, they were especially popular with homeowners. Aluminum awnings were made with slats called "pans" arranged horizontally or vertically. For variety and to match the building to which they were applied, different colored slats could be arranged to create stripes or other decorative patterns. While aluminum awnings were usually fixed, in the 1960s several operable roller awnings were developed, including one with the trade name Flexalum Roll-Up (Fig. 14).

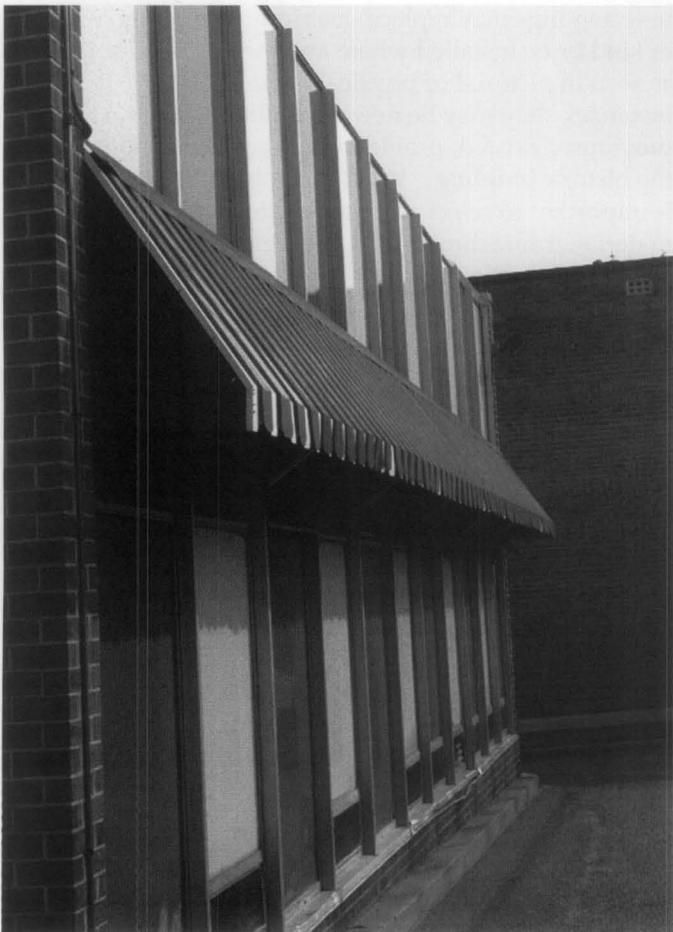
*Figure 15. This 1950s-era dry cleaner has an aluminum awning that, with its vertical pattern and alternating stripes, complements the facade's porcelain enamel panes and aluminum mullions. The awning forms an essential element of the building's historic character.*

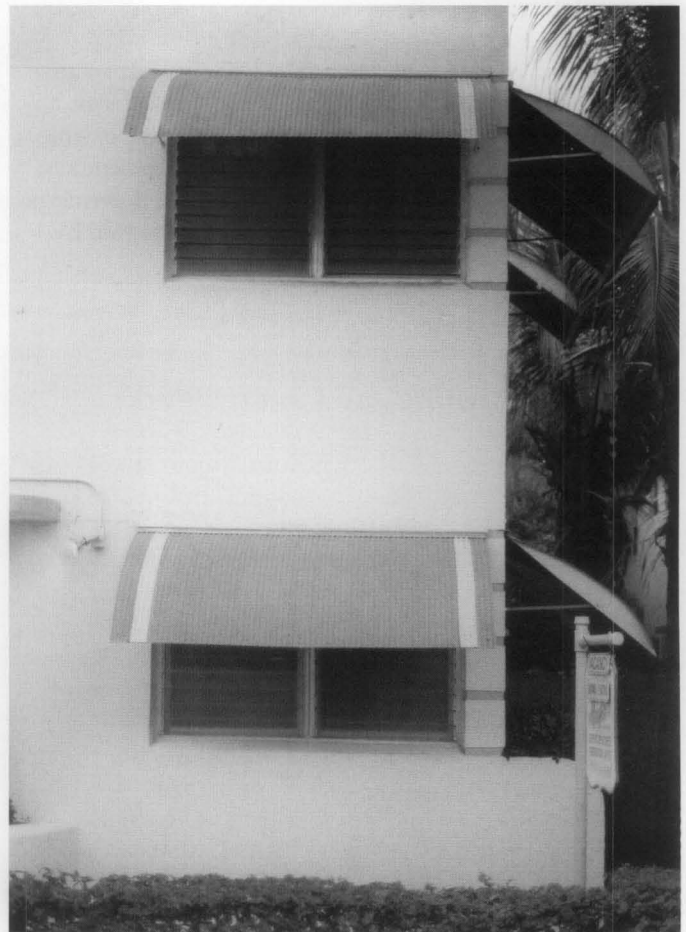
*Figure 16. These fiberglass "clamshell" awnings, although not as old as the 1930s building to which they were affixed, are important features that have acquired significance. They were retained when the building was recently rehabilitated.*

If awnings already exist on a historic building, they should be evaluated to determine whether they are appropriate to the age, style, and scale of the building, using the criteria identified below. Backlit awnings and dome awnings are usually inappropriate for 19th century and other historic buildings, while aluminum awnings may be perfectly compatible with buildings from the 1950 or 60s (Fig. 15). The time is approaching when some aluminum awnings may even be considered appropriate to older buildings, if the awnings formed part of an updated storefront, or are central features of an intact postwar refashioning of the building's exterior (Fig. 16).

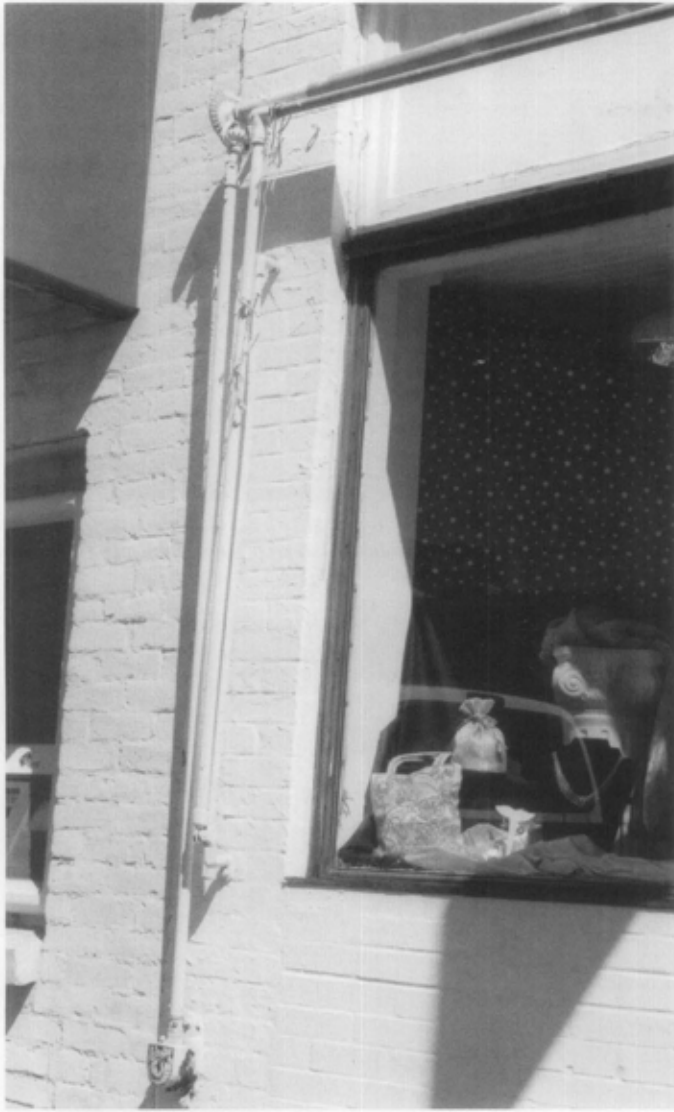
Figure 17. A gearbox, slide rod, roller, front bar, and extension arm reveal that this 19th century building once featured a retractable awning. It is likely that with minor repairs the surviving hardware could again be made operable, recovered with a canvas or acrylic fabric, and reused to service the storefront.

awning installation. Fittings or other marks on the side of the entrance or windows, for example, suggest that a fixed-arm awning was present rather than a lateral-arm awning. Gearboxes point to a retractable rather than a fixed awning.

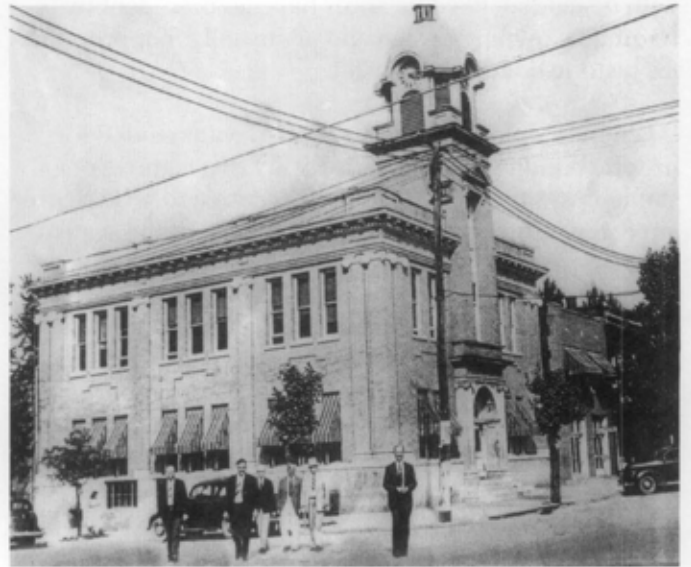
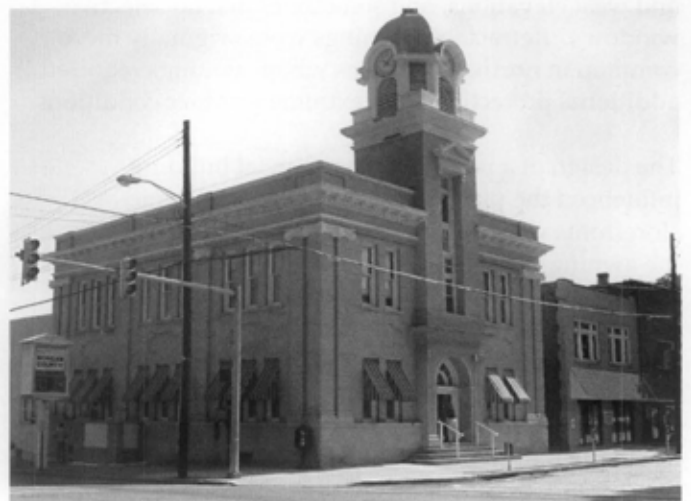
Figure 18. (Above) When the county clerk in Morgan County, West Virginia, was looking to reduce glare in the courthouse offices she located a 1940s photo showing sets of awnings on the first floor. (Below) Using the historic photos as a guide, new awnings with a similar shape and stripe pattern were installed increasing the comfort of employees and protecting county records from direct sunlight. Above photo: Frances Widmeyer and Debra Kesecker.

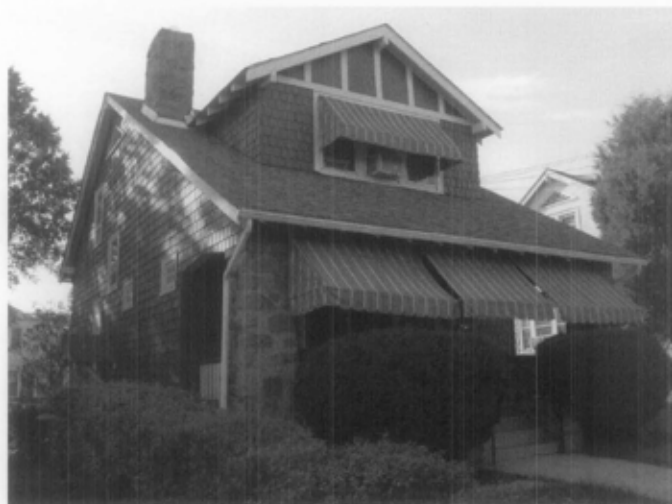
Figure 19. Simple shed-type awnings with acrylic or canvas coverings and free-hanging valances are appropriate for most historic residences featuring rectilinear openings.

**Shape.** Traditionally, both residential and commercial awnings were triangular in section, usually with a valance hanging down the outside edge (Fig. 19). Early examples of these "shed" awnings had simple

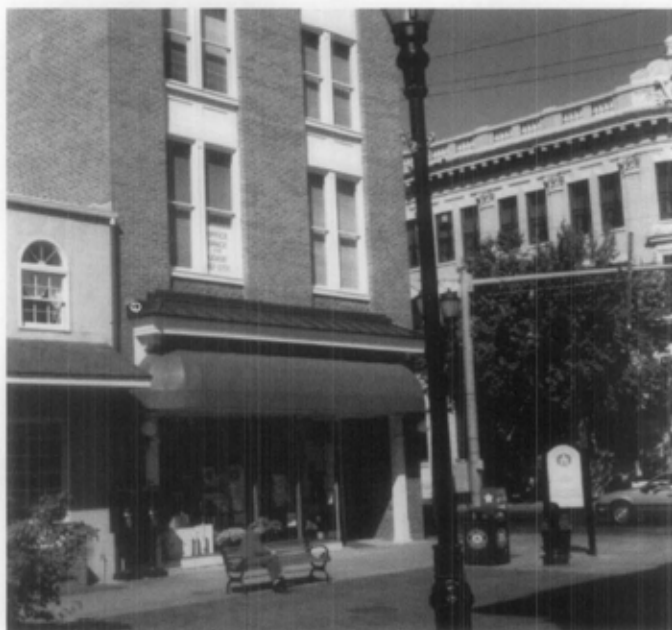
Figure 20. A dome awning was an inappropriate addition to this circa 1890s building. In order to qualify for historic tax credits the new vinyl awning was replaced with a shed awning with a canvas-like woven acrylic covering.

Generally, traditional shed awnings are appropriate for most historic window, door, and storefront installations. It is preferable (and in some historic districts, required) that these awnings have free-hanging valances, the flapping bottom pieces so characteristic of historic awnings. Quarter-round awnings, modern mansard awnings, and other contemporary commercial designs with distended, fixed valances have no precedent in traditional awning design and are usually inappropriate for historic buildings (Fig. 20).

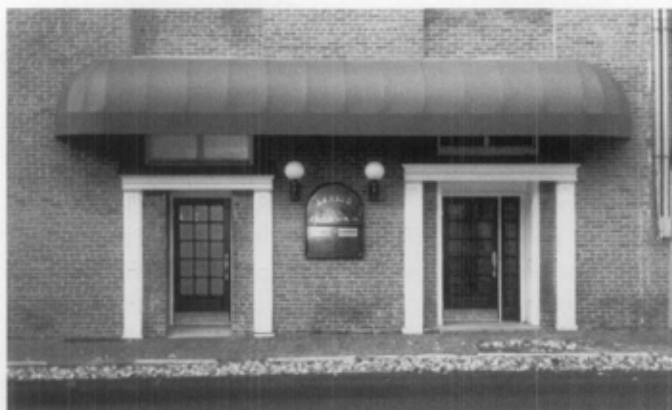
Figure 21. Single awnings should not be set over more than one door or window bay. A separate shed awning with a canvas or acrylic covering would be more appropriate over each of these openings.

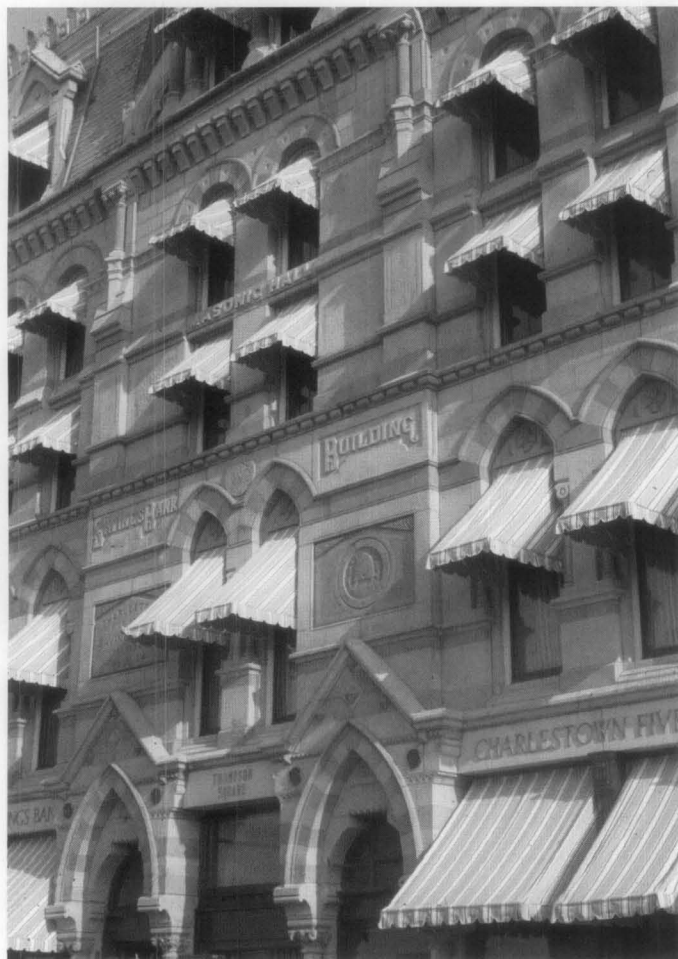
Figure 22. These window awnings today match what would have appeared in the 19th century. The fabric is slightly loose on the frames, the valances hang freely, each window bay has its own awning, and the awning frames are set within the openings. Photo: Mike Jackson.

when installing new awnings on historic buildings to ensure that the covering not obscure the building's distinctive architectural features (Fig. 22). Also, new awning hardware should not be installed in a way that damages historic materials. Clamps and fasteners used to attach awning frames should penetrate mortar joints rather than brick or other masonry surfaces. If new backboards and rollers are installed, care needs to be taken not to damage cornices or transoms. Finally, awning placement, size, and shape must be compatible with the historic character of the building (Figs. 23 and 24).

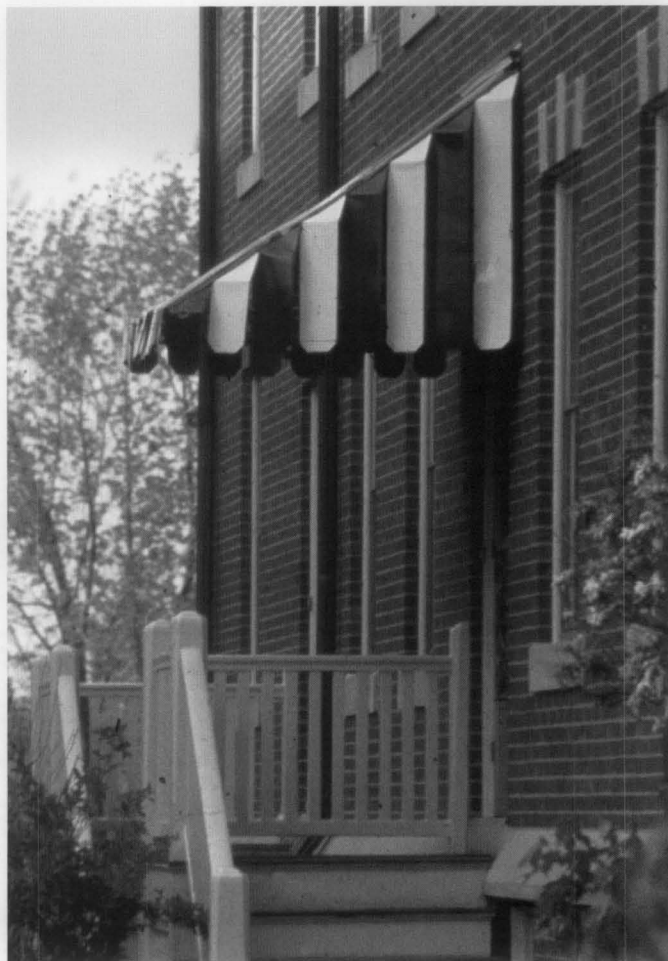
Figure 23. This postwar aluminum awning does not contribute to the character of this 19th century residence and could be replaced during a rehabilitation project with a fabric shed awning more in keeping with the building's age and appearance.

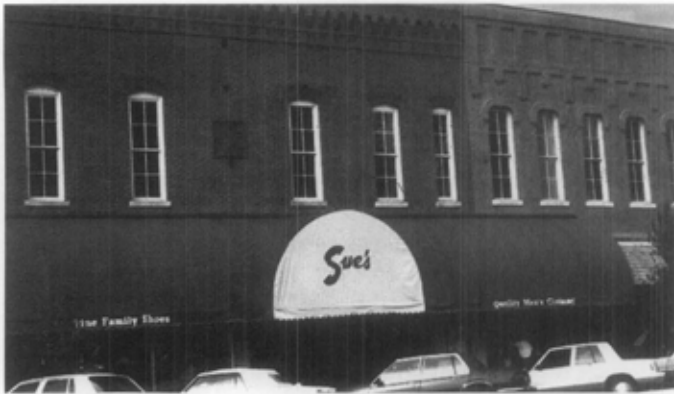
Figure 24. This awning, extending across much of the building, is incompatible in shape. Of greater concern, however, is that its size wholly overshadows the modest historic building behind.

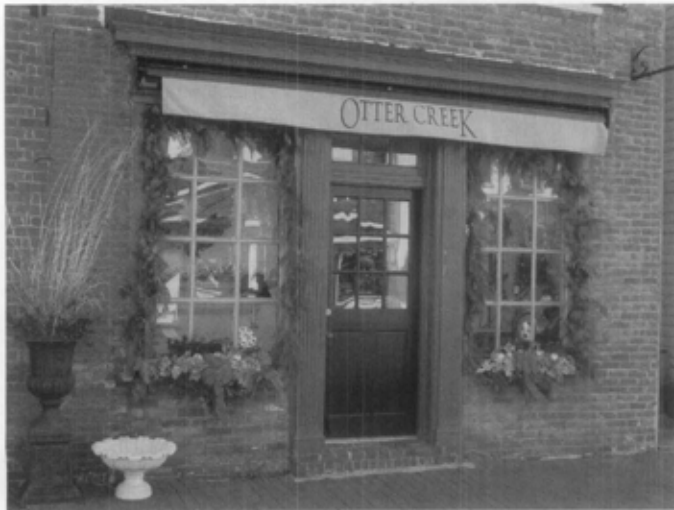
Figure 25. Appropriate lettering, as on this roller awning valance, can function as distinctive signage without detracting from the historic character of the building.

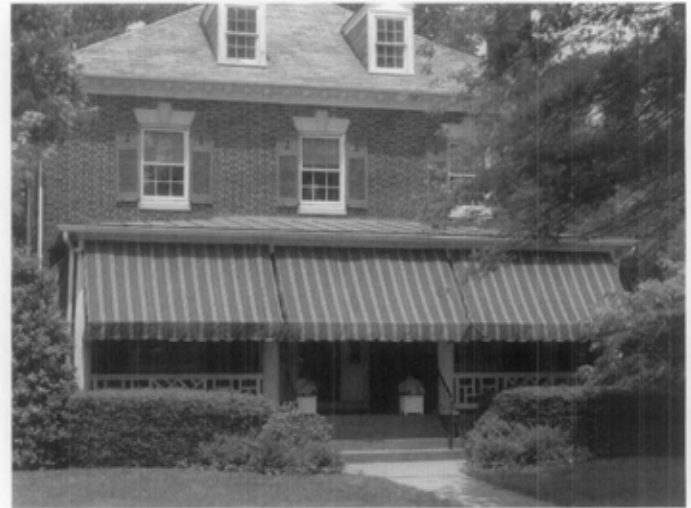
Figure 26. The green and burgundy stripes that decorate these porch awnings complement the matching shutters and brick facade.

**Color.** As in the past, variety in awning color is an appropriate characteristic when reintroducing awnings in historic districts. Since the 19th century, awnings have featured a range of different stripe patterns and an extensive color palette (Fig. 26). These lively, even whimsical,

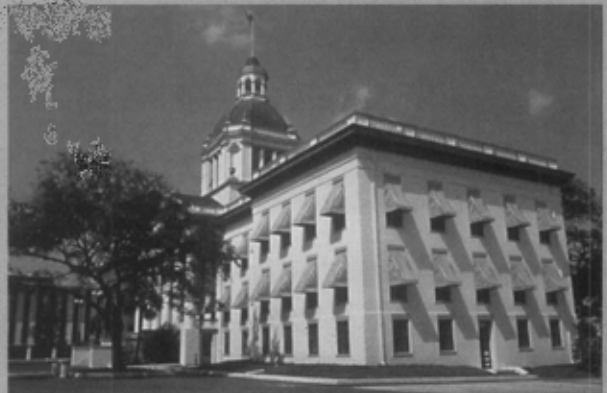
*Awnings were reinstalled on the east, west, and south windows of the Florida State Capitol in the 1980s. With a design based on those seen in historic photographs of the building, the new awnings allowed a downsizing of the HVAC system by 25 tons. After installation, the exposed glass surface in a typical first floor office accounted for only 46% of the required cooling load, down from 72%. Photo: Division of Historical Resources, Florida Department of State.*
