# 15 PRESERVATION BRIEFS

## Preservation of Historic Concrete

Paul Gaudette and Deborah Slaton

National Park Service  
U.S. Department of the Interior  
Heritage Preservation Services

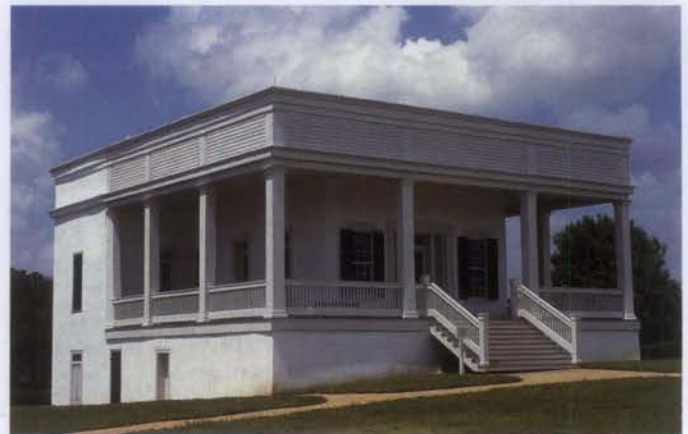
Figure 1. The Sebastopol House in Seguin, Texas, is an 1856 Greek Revival-style house constructed of lime concrete. Lime concrete or “limecrete” was a popular construction material, as it could be made inexpensively from local materials. By 1900, the town had approximately ninety limecrete structures, twenty of which remain. Photo: Texas Parks and Wildlife Department.

publicized in the second edition of Orson S. Fowler's *A Home for All* (1853) which described the advantages of "gravel wall" construction to a wide audience. The town of Seguin, Texas, thirty-five miles east of San Antonio, already had a number of concrete buildings by the 1850s and came to be called "The Mother of Concrete Cities," with approximately ninety concrete buildings made from local "lime water" and gravel (Fig. 1).

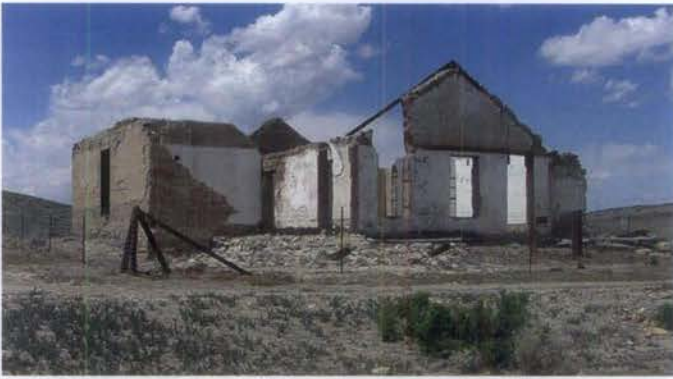
*Figure 2. Chatterton House was the home of the post trader at Fort Fred Steel in Wyoming, one of several forts established in the 1860s to protect the Union Pacific Railroad. The walls of the post trader's house were built using stone aggregate and lime, without cement. The use of this material presents special preservation challenges.*

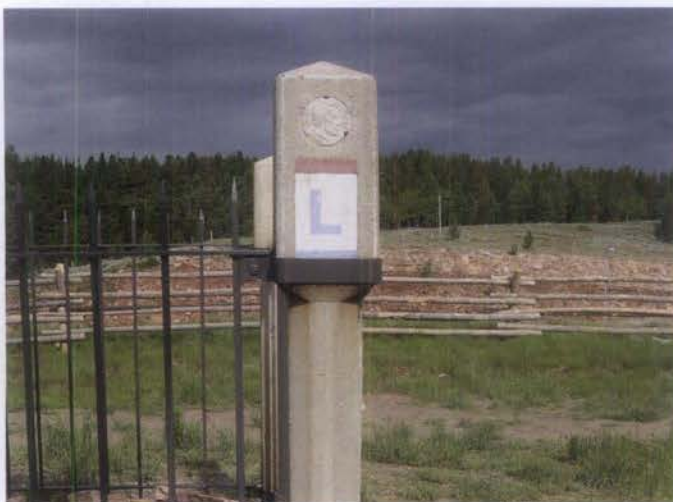
*Figure 3. The Lincoln Highway Association promoted construction of a high quality continuous hard surface roadway across the country. The Boys Scouts of America installed concrete road markers along the Lincoln Highway in 1928.*

Highway as an example. Concrete “seedling miles” were constructed in remote areas to emphasize the superiority of concrete over unimproved dirt. The Association believed that as people learned about concrete, they would press the government to construct good roads throughout their states. Americans’ enthusiasm for good roads led to the involvement of the federal government in road-building and the creation of numbered U.S. routes in the 1920s (Fig. 3).

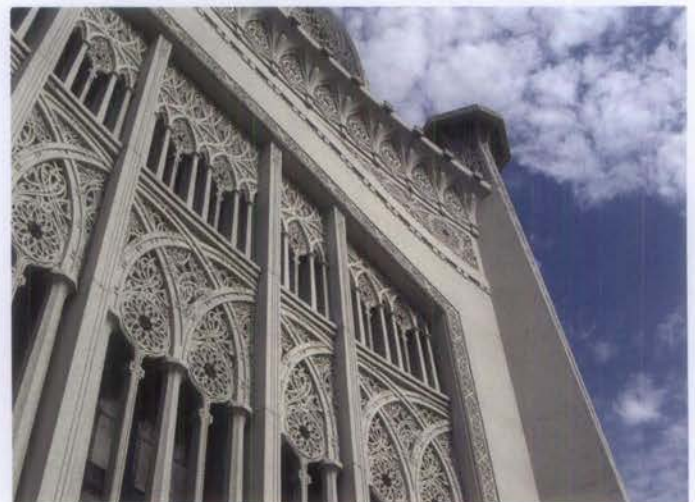
*Figure 4. The highly ornamental concrete panels on the exterior facade of the Baha'i House of Worship in Wilmette, Illinois, illustrate the work of fabricator John J. Earley, known as "the man who made concrete beautiful."*

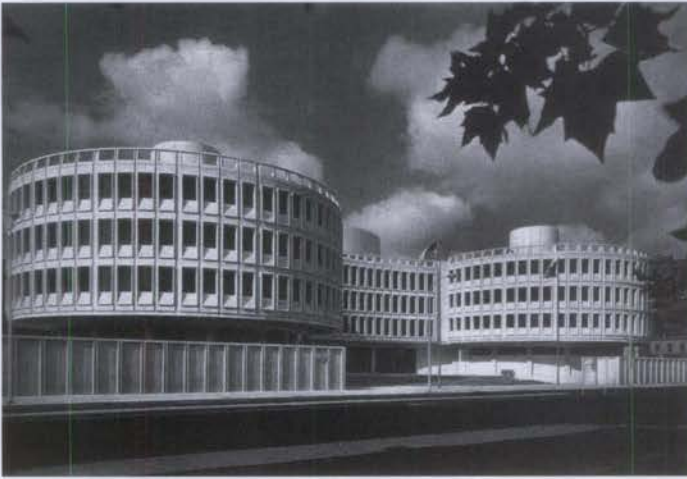
Figure 5. Following World War II, architects and engineers took advantage of improvements in concrete production, quality control, and advances in precast concrete to design structures such as the Police Headquarters building in Philadelphia, Pennsylvania, constructed in 1961. Photo: Courtesy of the Philadelphia Police Department.

During the early twentieth century, Ernest Ransome in Beverly, Massachusetts, Albert Kahn in Detroit, and Richard E. Schmidt in Chicago, promoted concrete for use in “Factory Style” utilitarian buildings with an exposed concrete frame infilled with expanses of glass. Thomas Edison’s cast-in-place reinforced concrete homes in Union Township, New Jersey (1908), proclaimed a similarly functional emphasis in residential construction. From the 1920s onward, concrete began to be used with spectacular design results: examples include John J. Earley’s Meridian Hill Park in Washington, D.C.; Louis Bourgeois’ exuberant, graceful Baha’i Temple in Wilmette, Illinois (1920–1953), for which Earley fabricated the concrete (Fig. 4); and Frank Lloyd Wright’s Fallingwater near Bear Run, Pennsylvania (1934). Continuing improvements in quality control and development of innovative fabrication processes, such as the Shockbeton method for precast concrete, provided increasing opportunities for architects and engineers. Wright’s Guggenheim Museum in New York City (1959); Geddes Brecher Qualls & Cunningham’s Police Headquarters building in Philadelphia, Pennsylvania (1961); and Eero Saarinen’s soaring terminal building at Dulles International Airport outside Washington, D.C., and the TWA terminal at Kennedy Airport in New York (1962), exemplify the masterful use of concrete achieved in the modern era (Fig. 5).

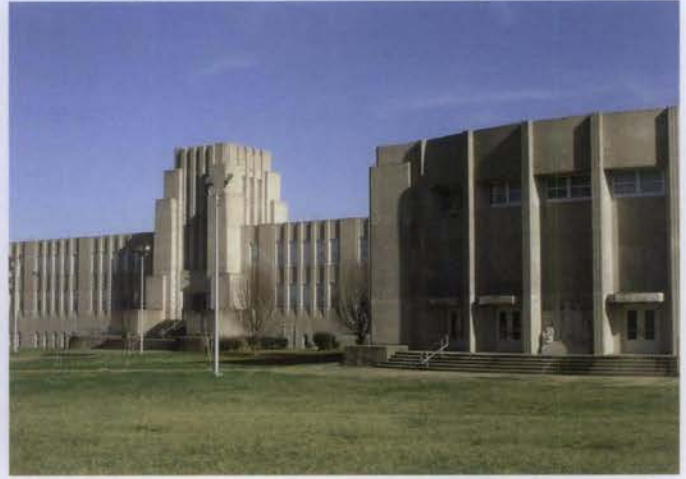
Figure 6. The Bailey Magnet School in Jackson, Mississippi, was designed as the Jackson Junior High School by the firm of N.W. Overstreet & Town in 1936. The streamlined building exemplifies the applicability of concrete to creating a modern architectural aesthetic. Photo: Bill Burris, Burris/Wagnon Architects, P.A.

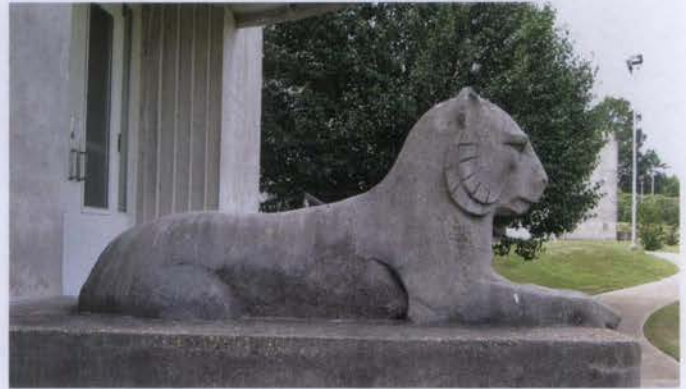
Figure 7. Detailed bas reliefs as well as sculptures, such as this lion at the Bailey Magnet School, could be used as ornamentation on concrete buildings. Sculptural concrete elements were typically cast in molds.

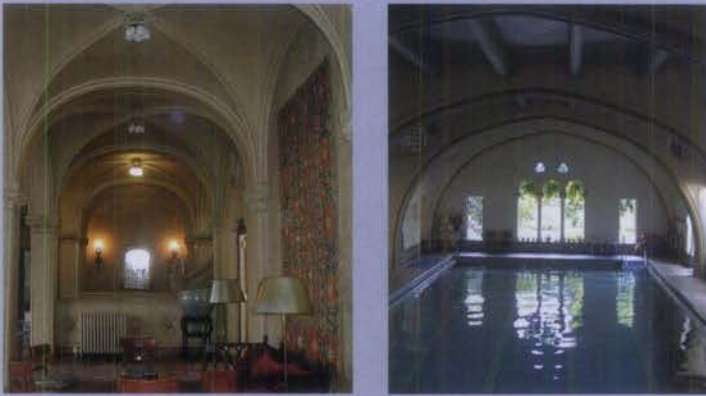
Figure 10. The Berkeley City Club has significant interior spaces and features of concrete construction, including the lobby and pool. Photos: Una Gilmartin (left) and Brian Kehoe (right), Wiss, Janney, Elstner Associates, Inc.

The expanded use of concrete provided new opportunities to create dramatic spaces and ornate architectural detail on the interiors of buildings, at a significant cost savings over traditional construction practices. The architectural design of the Berkeley City Club in Berkeley, California, expressed Moorish and Gothic elements in concrete on the interior of the building (Fig. 10). Used as a woman's social club, the building was designed by noted California architect Julia Morgan and constructed in 1929. The vaulted ceilings, columns, and ornamental capitals of the lobby and the ornamental arches and beamed ceiling of the "plunge" are all constructed of concrete.

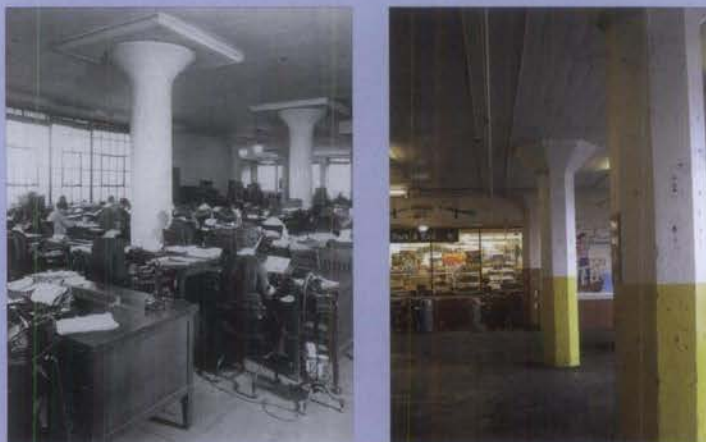
Figure 11. Whether in a circa 1925 office (left) or in a parking garage and retail facility (right), exposed concrete structures help characterize these building interiors. Photo: Minnesota Historical Society (left).

The historic character of a building's interior can also be conveyed in a more utilitarian manner in terms of concrete features and finishes (Fig. 11). The exposed concrete structure—columns, capitals, and drop panels—is an integral part of the character of this old commercial building in Minneapolis. In concrete warehouse and factory buildings of the early twentieth century, exposed concrete columns and formboard finish concrete slab ceilings are common features as seen in this warehouse, now converted for use as a parking garage and shops.

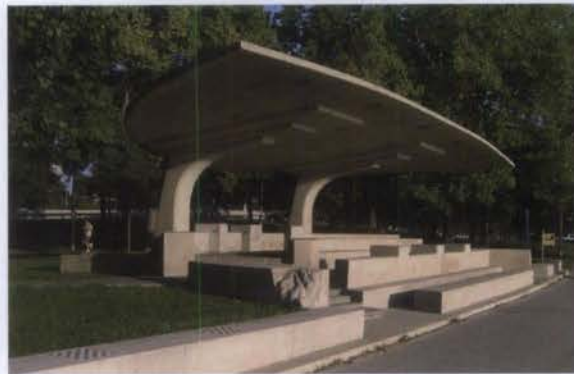
*Figure 8. The Chess Pavilion in Chicago's Lincoln Park was designed by architect Morris Webster and constructed in 1956. The pavilion is a distinctive landscape feature, with its reinforced concrete cantilevered slab that provides cover for chess players.*

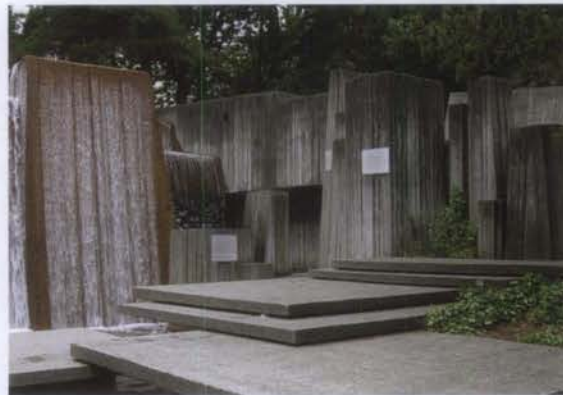
*Figure 9. The Ira C. Keller Fountain in Portland, Oregon, was designed by Lawrence Halprin and constructed in 1969. The fountain is constructed primarily of concrete pillars with formboard textures and surrounding elements, patterned with geometric lines, which facilitate the path of water. Photo: Anita Washko, Wiss, Janney, Elstner Associates, Inc.*

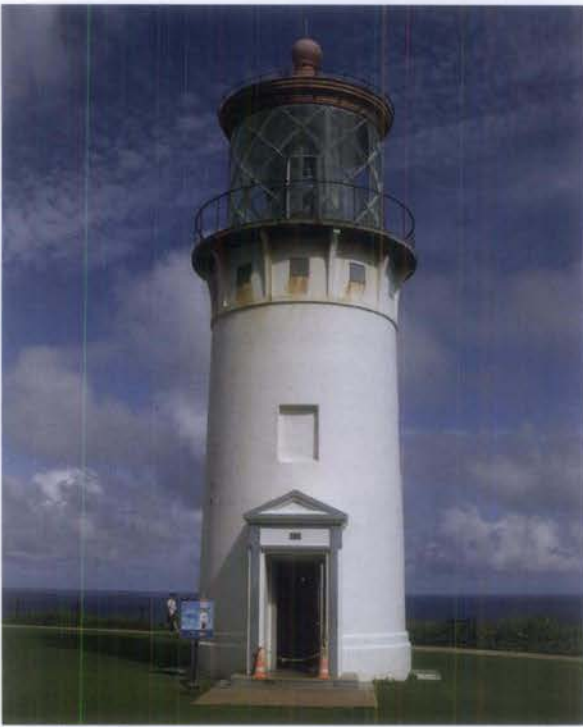
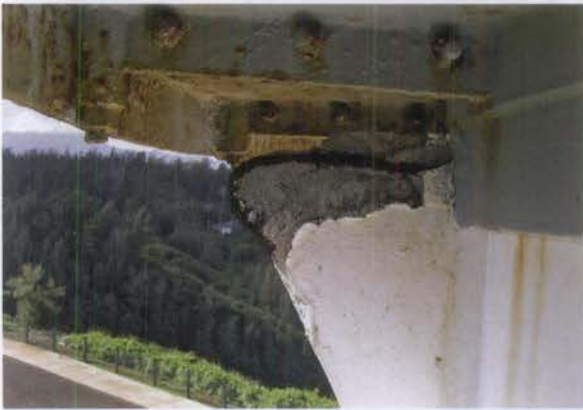
*Figure 12. The concrete lighthouse at the Kilauea Point Light Station, Kilauea, Kauai, Hawaii, was constructed circa 1913. The concrete, which was a good quality, high strength mix for its day, is in good condition after almost one hundred years in service. Deterioration in the form of spalling related to corrosion of embedded reinforcing steel has occurred primarily in areas of higher ornamentation such as projecting bands and brackets (see close-up photo).*

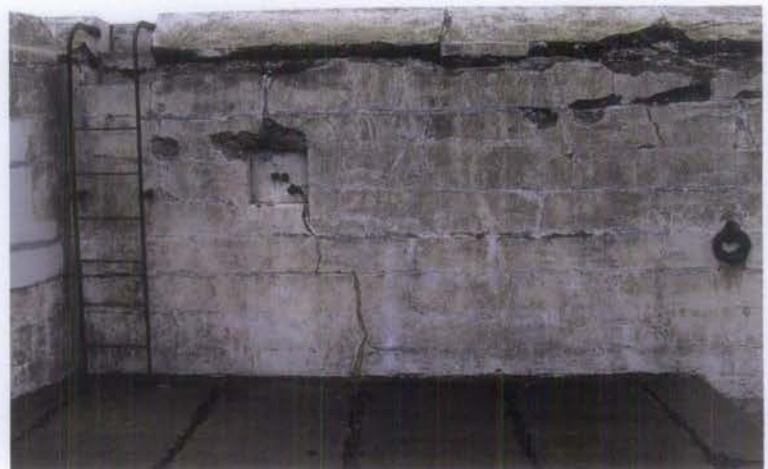
*Figure 13. Fort Casey on Admiralty Head, Fort Casey, Washington, was constructed in 1898. The lift lines from placement of concrete are clearly visible on the exterior walls and characterize the finished appearance.*

In concrete structures built prior to the First World War, concrete was often placed into forms in relatively short vertical lifts due to limitations in lifting and pouring techniques available at the time. Joints between different concrete placements (often termed cold joints or lift lines) may sometimes be considered an important part of the character of a concrete element (Fig. 13). However, wide joints may permit water to infiltrate the concrete, resulting in more rapid paste erosion or freeze-thaw deterioration of adjacent concrete in cold climates.

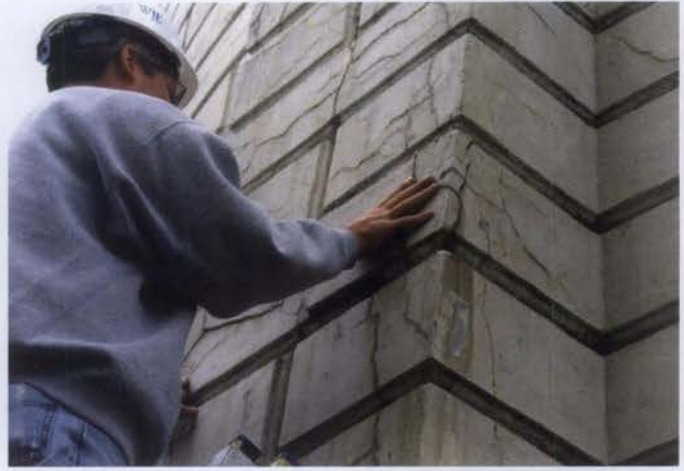
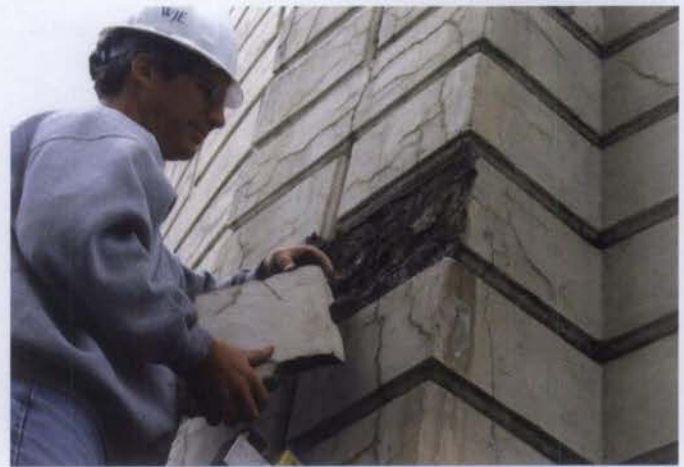
*Figures 14. Layers of architectural concrete that have debonded (spalled) from the surface were removed from a historic water tank during the investigation performed to assess existing conditions. Photos: Anita Washko, Wiss, Janney, Elstner Associates, Inc.*

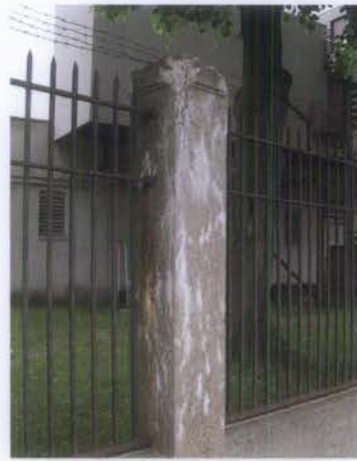
Figure 15. Evidence of moisture movement through concrete is apparent in the form of mineral deposits on the concrete surface. Cyclic freezing and thawing of entrapped moisture, and corrosion of embedded reinforcement, have also contributed to deterioration of the concrete column on this fence at Crocker Field in Fitchburg, Massachusetts, designed by the Olmsted Brothers.

Staining of the concrete surface can be related to soiling from atmospheric pollutants or other contaminants, dirt accumulation, and the presence of organic growth. However, stains can also indicate more serious underlying problems, such as corrosion of embedded reinforcing steel, improper previous surface treatments, alkali-aggregate reaction, or efflorescence, the deposition of soluble salts on the surface of the concrete as a result of water migration (Fig. 15).

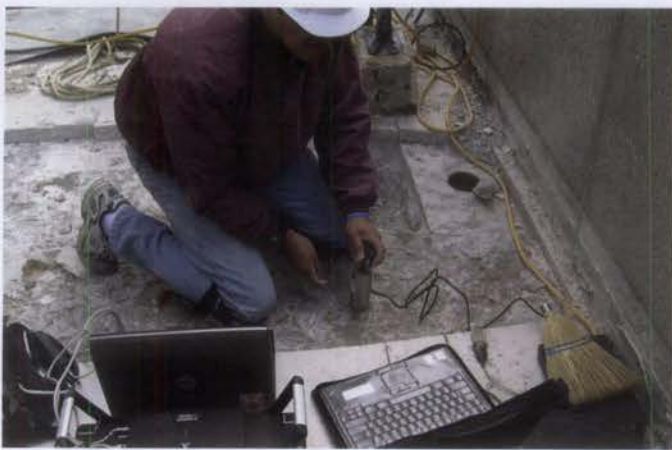
*Figure 16. Impact echo testing is performed on a concrete structural slab to help determine depth of deterioration. In this method, a short pulse of energy is introduced into the structure and a transducer mounted on the impacted surface of the structure receives the reflected input waves or echoes. These waves are analyzed to help identify flaws and deterioration within the concrete.*

A number of nondestructive testing methods can be used in the field to evaluate concealed conditions. Basic techniques include sounding with a hand-held hammer (or for horizontal surfaces, a chain) to help identify areas of delamination. More sophisticated techniques include impact-echo testing (Fig. 16), ground penetrating radar, pulse velocity, and other methods that characterize concrete thickness and locate voids or delaminations. Magnetic detection instruments are used to locate embedded reinforcing steel and can be calibrated to identify the size and depth of reinforcement. Corrosion measurements can be taken using copper-copper sulfate half-cell tests or linear polarization techniques to determine the probability or rate of active corrosion of the reinforcing steel.

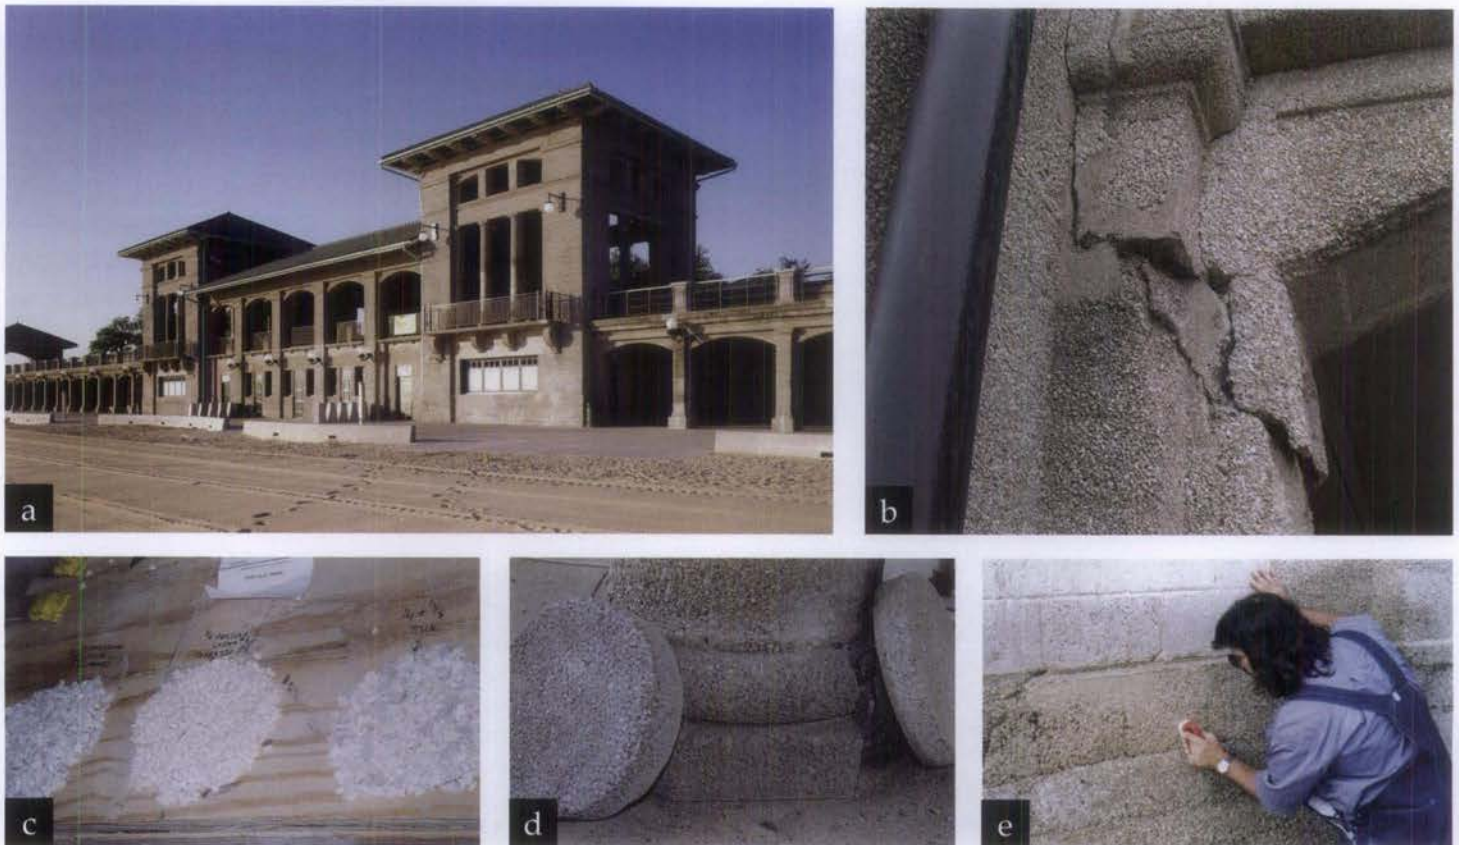
Figure 17. (a) The 63rd Street Beach House was constructed on the shoreline of Chicago in 1919. The highly exposed aggregate concrete of the exterior walls of the beach house was used for many buildings in the Chicago parks as an alternative to more expensive stone construction. Photo: Leslie Schwartz Photography. (b) Concrete deterioration included cracking, spalling, and delamination caused by corrosion of embedded reinforcing steel and concrete damage due to cyclic freezing and thawing. (c) Various sizes and types of aggregates were reviewed for matching to the original concrete materials. (d) Mock-ups of the concrete repair mix were prepared for comparison to the original concrete. Considerations included aggregate type and size, cement color, proportions, aggregate exposure, and surface finish. (e) The craftsman finished the surface to replicate the original appearance in a mock-up on the structure. Here, he used a nylon bristle brush to remove loose paste and expose the aggregate, creating a variable surface to match the adjacent original concrete.

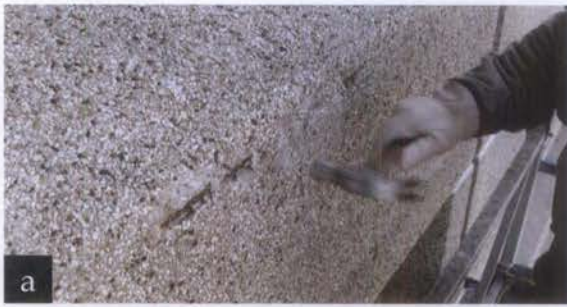
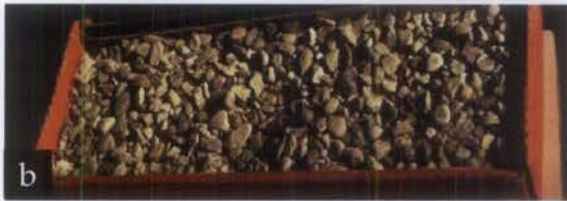
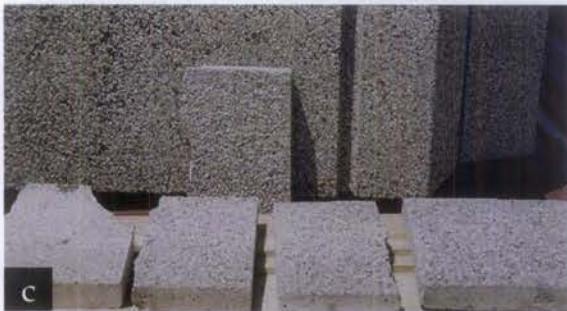
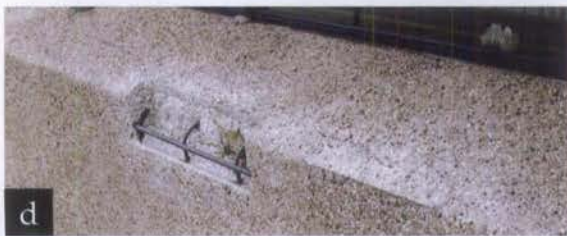
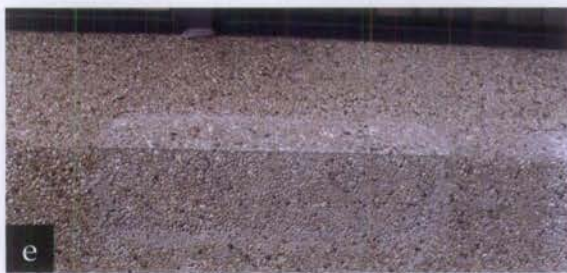
Figure 18. (a) Exposed aggregate precast concrete is sounded with a hammer to detect areas of deterioration. Corrosion of the exposed reinforcing steel bar has led to spalling of the adjacent concrete. (b) Samples of aggregate considered for use in repair concrete are compared to the original concrete materials in terms of size, color, texture, and reflectance. (c) Various sample panels are made using the selected concrete repair mix design for comparison to the original concrete on the building, and the mix design is adjusted based on review of the samples. (d) After removal of the spall, the concrete surface is prepared for installation of a formed patch. (e) Prior to placement of the concrete, a retarding agent is brush-applied to the inside face of the formwork to slow curing at the surface. After the concrete is partially cured, the forms are removed and the surface of the concrete is rubbed to remove some of the paste and expose the aggregate to match the original concrete.

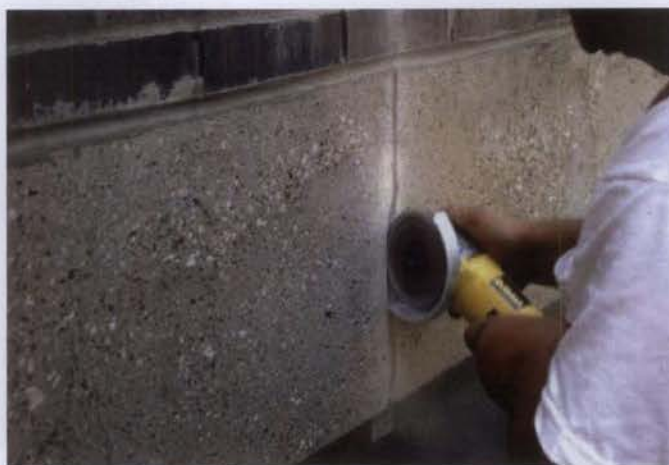
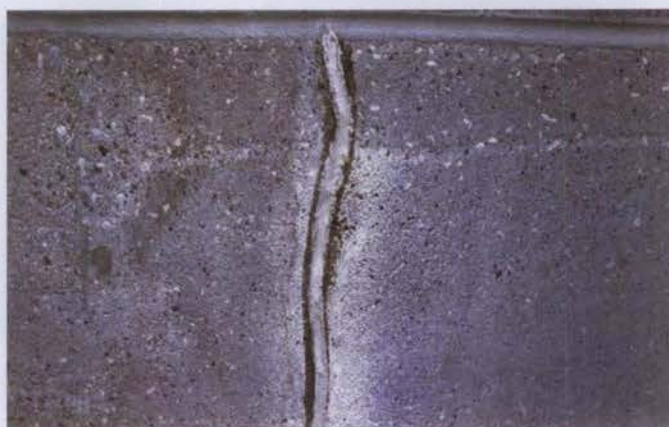
Figure 19. A high-speed grinder is used to widen a crack in preparation for installation of a sealant. This process is called "routing." After the crack is prepared, the sealant is installed to prevent moisture infiltration through the crack. Although sealant repairs can provide a durable, watertight repair for moving cracks, they tend to be very visible.

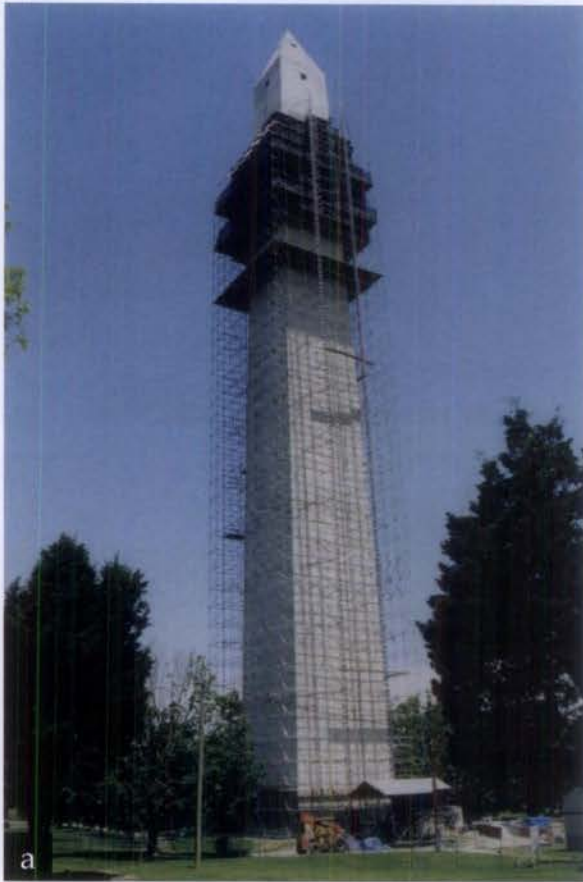
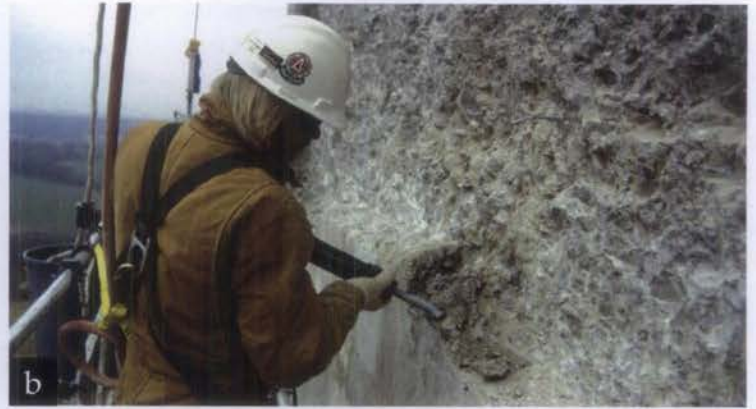
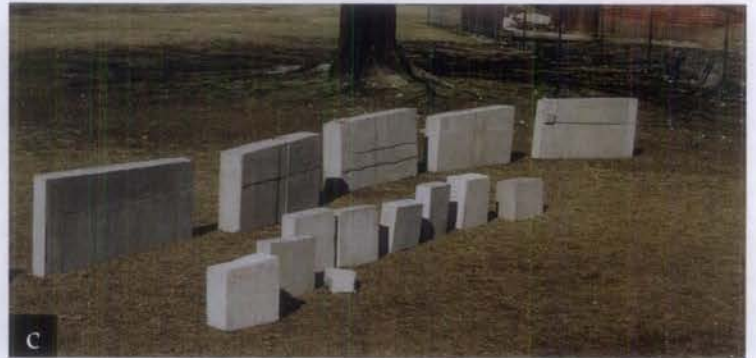
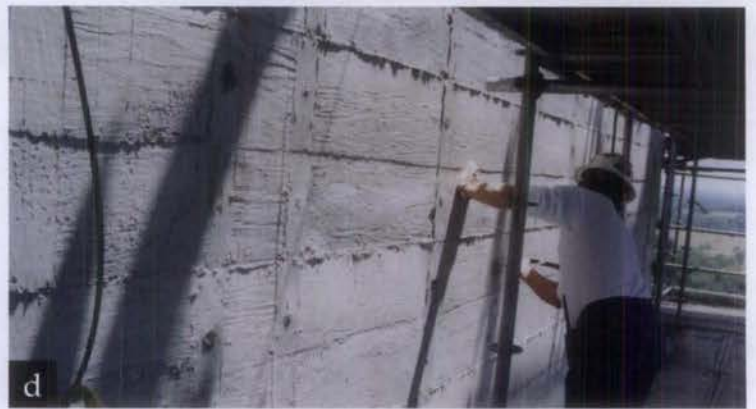
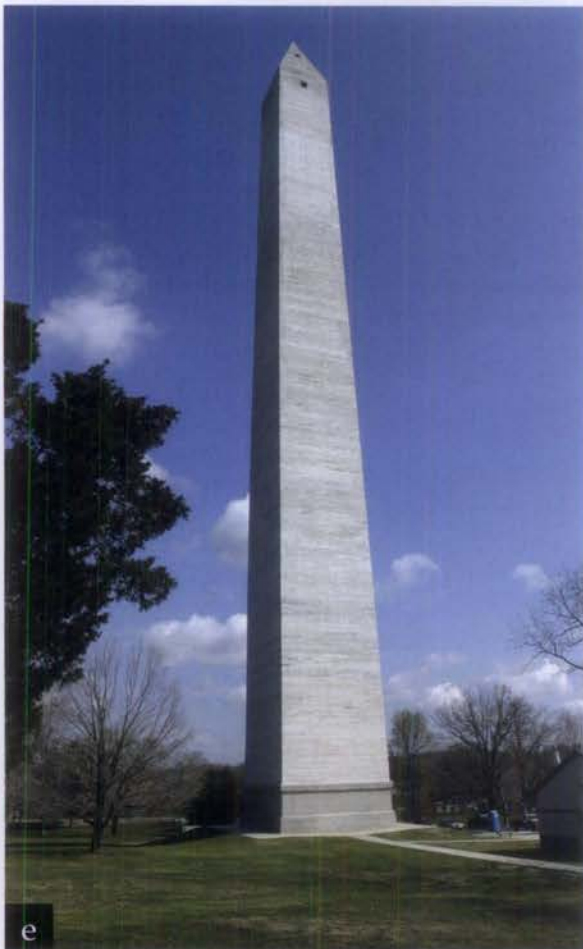
Figure 20. (a) The Jefferson Davis Memorial in Fairview, Kentucky, constructed from 1917–1924, is 351 feet tall and constructed of unreinforced concrete. The walls of the memorial are 8 feet thick at the base and 2 feet thick at the top of the wall. Access to the monument for investigation was provided by rappelling techniques, while ground supported and suspended scaffolding was used to access the exterior during repairs. (b) The concrete was severely deteriorated at isolated locations, with spalling and damage from cyclic freezing and thawing of entrapped water. In addition, previous repairs were at the end of their service life and removal of deteriorated concrete and failed previous repairs was required. Light duty chipping hammers were used to avoid damage to adjacent material when removing deteriorated concrete to the level of sound concrete. (c) Field samples were performed to match the color, finish, and texture of the original concrete. A challenge in matching of historic concrete is achieving variability of appearance. (d) The completed surface after repairs exhibits intentional variability of the concrete surface to match the appearance of the original concrete. Some formwork imperfections that would normally be removed by finishing were intentionally left in place, to replicate the highly variable finish of the original concrete. (e) The Jefferson Davis Memorial after completion of repairs in 2004. Photo e: Joseph Lenzi, Senler, Campbell & Associates, Inc.

due to original construction techniques, architectural design, or differential exposure to weather. Trial repairs and mock-ups are used to evaluate the proposed replacement concrete work and to refine construction techniques (Fig 20).
