# 20 PRESERVATION BRIEFS

## The Preservation of Historic Barns

Michael J. Auer

U.S. Department of the Interior  
National Park Service  
Cultural Resources  
Heritage Preservation Services

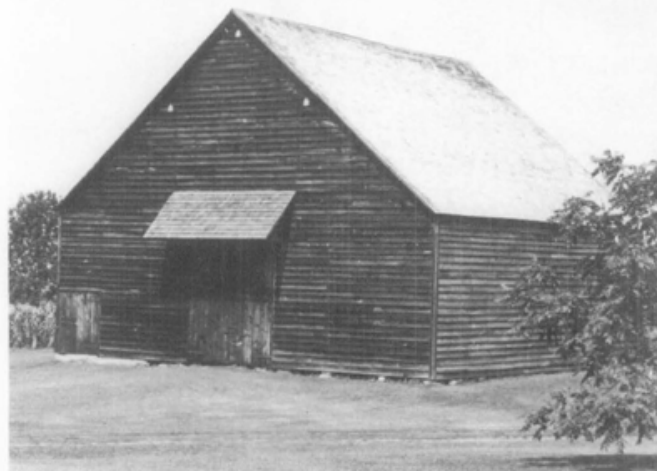
Built in the late 1700s, this New York Dutch barn survives in excellent condition. Gable roof, center wagon doors with pent roof, stock door at the corner and horizontal clapboarding are all typical features of the Dutch barn. Three holes for martins, traditional features of Dutch barns, can be seen near the top of the facade (they have been plugged and are lighter than the surrounding clapboards). Photo: Clarke Blair.

The first great barns built in this country were those of the Dutch settlers of the Hudson, Mohawk, and Schoharie valleys in New York State and scattered sections of New Jersey.<sup>2</sup> On the exterior, the most notable feature of the Dutch barn is the broad gable roof, which in early examples (now extremely rare), extended very low to the ground. On the narrow end the Dutch barn features center doors for wagons and a door to the stock aisles on one or both of the side ends. A pent roof (or pentice) over the center doors gave some slight protection from the elements. The siding is typically horizontal, the detailing simple. Few openings other than doors and traditional holes for martins puncture the external walls.<sup>3</sup> The appearance is of massiveness and simplicity, with the result that Dutch barns seem larger than they actually are.

To many observers the heavy interior structural system is the most distinctive aspect of the Dutch barn. Mortised, tenoned and pegged beams are arranged in "H"-shaped units that recall church interiors, with columned aisles alongside a central space (here used for threshing). This interior arrangement, more than any other characteristic, links the Dutch barn with its Old World forebears. The ends of cross beams projecting through the columns are often rounded to form "tongues," a distinctive feature found only in the Dutch barn.

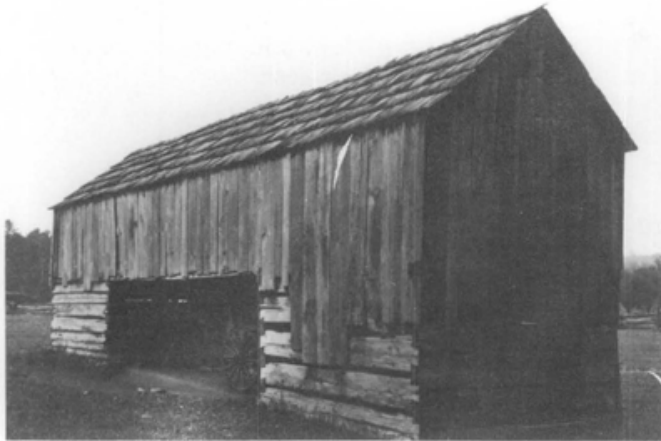
*This late-nineteenth century crib barn is located in eastern Tennessee, in what is now the Great Smoky Mountains National Park. The central driveway between the cribs allowed a team and wagon to drive through after unloading. The materials and details are typical of the region. They include, on the exterior: hand-hewn saddle notched logs on the lower, crib portion; board framing on the upper, loft area; wood shingle roof. The interior features wood hinges on the crib doors and earth floor. Photo: Robert Madden.*

crib barns form another barn type significant in American agriculture. Found throughout the South and Southeast, crib barns are especially numerous in the Appalachian and Ozark Mountain States of North Carolina, Virginia, Kentucky, Tennessee and Arkansas. Composed simply of one, two, four or sometimes six cribs that served as storage for fodder or pens for cattle or pigs, crib barns may or may not have a hayloft above. Crib barns were typically built of unchinked logs, although they were sometimes covered with vertical wood siding. Unaltered examples of early crib barns normally have roofs of undressed wood shingles. In time, shingle roofs were usually replaced with tin or asphalt. The rustic appearance of crib barns is one of their most striking features.

The cribs sometimes face a covered gallery or aisle running across the front. In another arrangement, the cribs are separated by a central driveway running through the building. This latter arrangement defines the *double crib barn*.

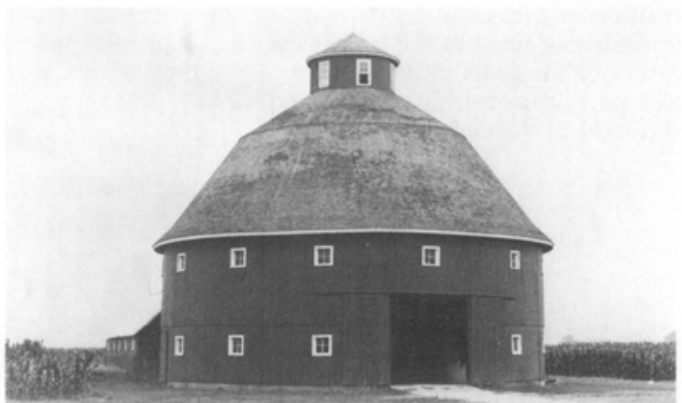
*Circular barns are found throughout the country, but are especially numerous in the Midwest. This 1911 Illinois round barn is 60 feet in diameter. The cupola atop the hipped roof is 60 feet above ground. Its 10 single and 5 double stalls on the ground floor were fed from a loft. The square windows spaced at regular intervals around the perimeter add a note of simple contrast to the overall circular motif. Photo: Keith A. Sculle, Illinois Historic Preservation Agency.*

Round barns were promoted for a number of reasons. The circular form has a greater volume-to-surface ratio than the rectangular or square form. For any given size, therefore, a circular building will use fewer materials than other shapes, thus saving on material costs. Such barns also offer greater structural stability than rectangular barns. And because they can be built with self-supporting roofs, their interiors can remain free of structural supporting elements, thereby providing vast storage capabilities. The circular interior layout was also seen as more efficient, since the farmer could work in a continuous direction.

In general, multi-sided barns—frequently of 12 or 16 sides—are earlier than “true round” barns. Earlier examples also tend to be wood sided, while later ones tend to be brick or glazed tile. Interior layouts also underwent an evolution. Early round barns placed cattle stanchions on the first floor, with the full volume of the floor above used for hay storage. In later barns, the central space rose from the ground floor through the entire building. Cattle stanchions arranged around a circular manger occupied the lower level; the circular

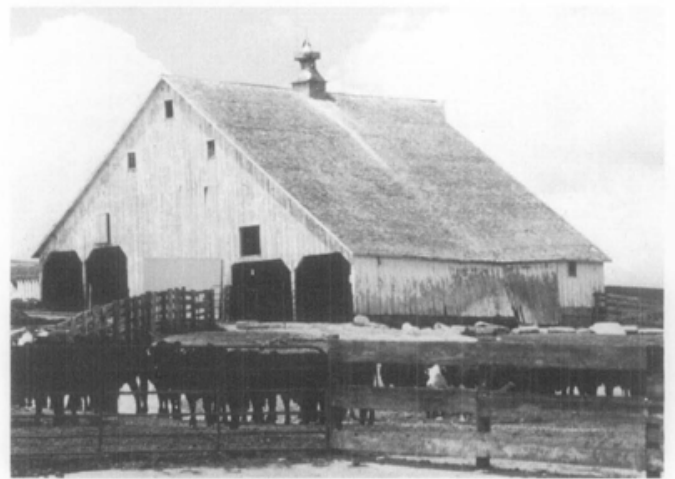
*The long, sweeping roof is a characteristic of the Prairie or Western barn. The projecting peak over the hayloft is another. This Iowa barn was built about 1910. Photo: Mary Humstone.*

A peak roof projecting above a hayloft opening is one of the most familiar images associated with barns. The feature belongs to the prairie barn, also known as the Western barn. The larger herds associated with agriculture in the West and Southwest required great storage space for hay and feed. Accordingly, prairie barns are on average much larger than the other barns discussed in this brief.<sup>6</sup> Long, sweeping roofs, sometimes coming near the ground, mark the prairie barn; the extended roof created great storage space. (Late in the nineteenth century, the adoption of the gambrel roof enlarged the storage capacity of the haymow even more.)

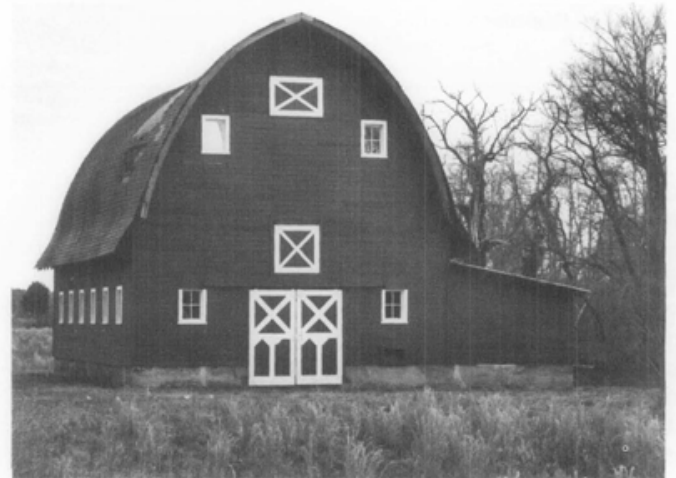
*In the early 20th century barn patterns were developed by agricultural schools and prefabricated units were sold by mail-order firms. This Maryland barn was bought about 1920 from a Sears catalogue. Photo: Robert J. Hughes*

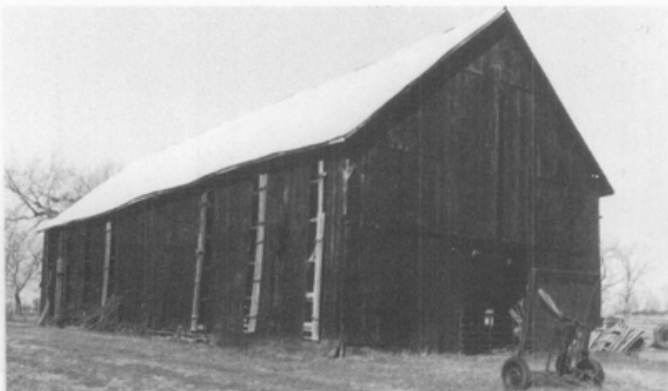
*Panels on this 1900 Kentucky tobacco barn open to aid in the curing process. Photo: Christine Amos, Kentucky Heritage Council.*

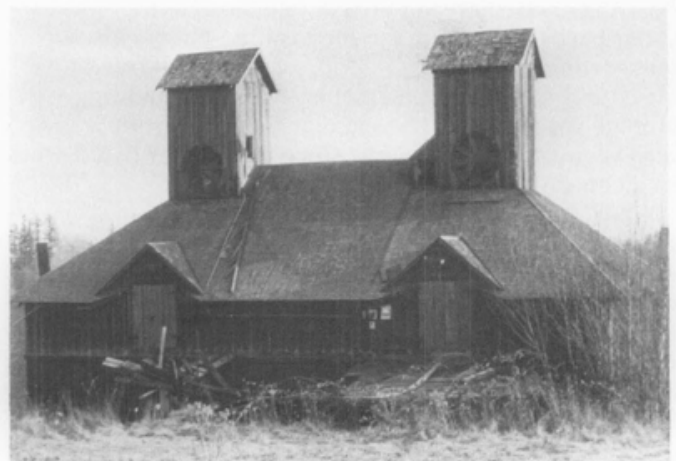
*The two ventilating towers are the character-defining aspect of this Oregon hop-drying barn. Photo: Allan Nelson.*

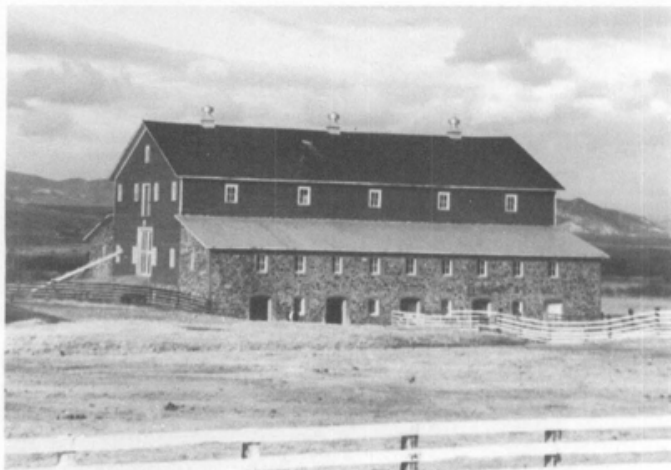
Fig. 2. Mountains, fields, fences, sheds, trees: The setting of this enormous Montana barn is an important element of its character. The barn was built in 1887-1889 after disastrous livestock losses in the winter of 1886-1887. It could hold 500 cattle and store a quarter-million cubic feet of hay. Photo: John N. DeHaas, Jr., Montana Historical Society.

**Setting.** Setting is one of the primary factors contributing to the historic character of a barn (see Fig. 2). Farmers built barns in order to help them work the land; barns belong on farms, where they can be seen in relation to the surrounding fields and other structures

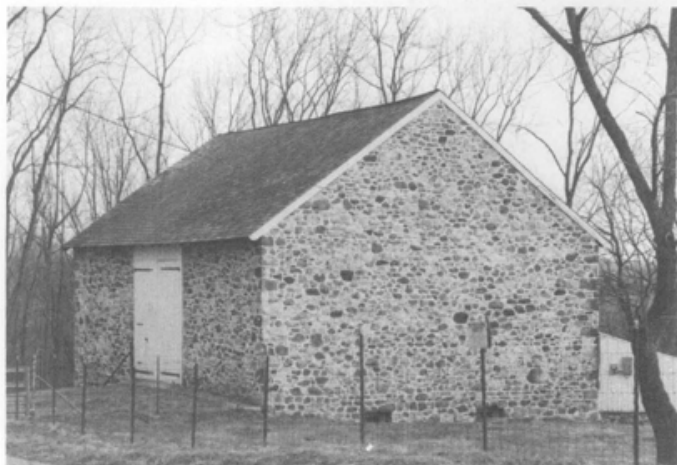
Fig. 3. The stone walls of this Delaware barn are its most notable feature. Built about 1810, the barn is a bank barn. Photo: Valerie Cesna, Delaware Bureau of Archeology and Historic Preservation.

**Materials.** Among the major impressions given by well-maintained historic barns are those of strength, solidity and permanence (see Fig. 3). These impressions largely result from the durability and ruggedness of the materials used in them. Weathered wood siding, irregularly shaped stones, or roughhewn logs on the exterior; dressed beams, posts scarred by years of use, and plank flooring on the interior all contribute to the special character of barns.

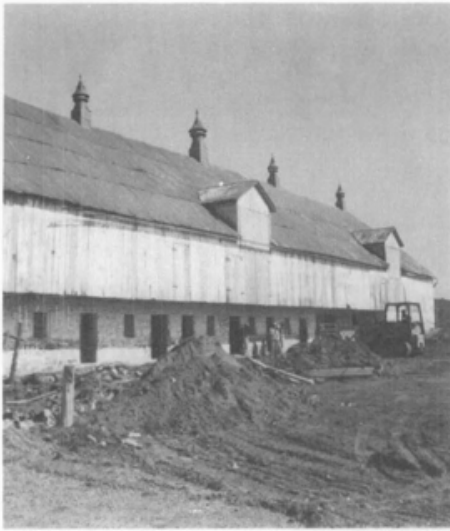
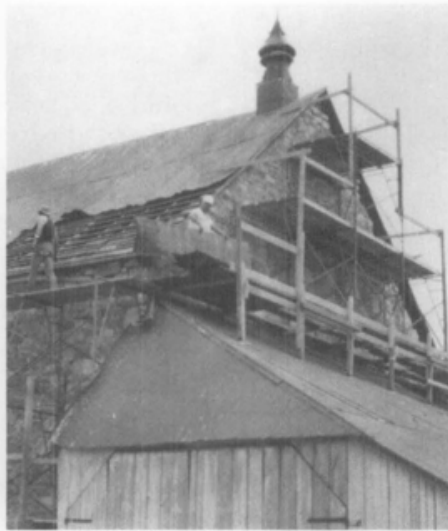
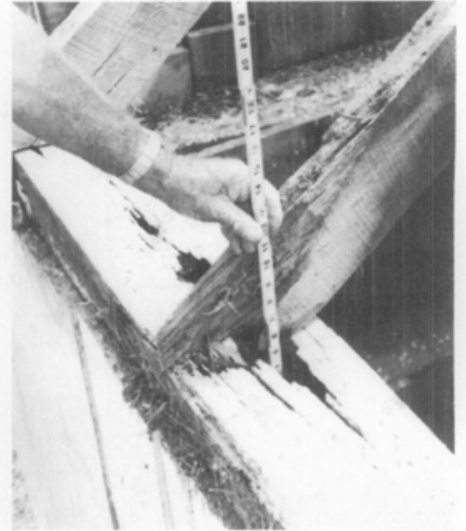
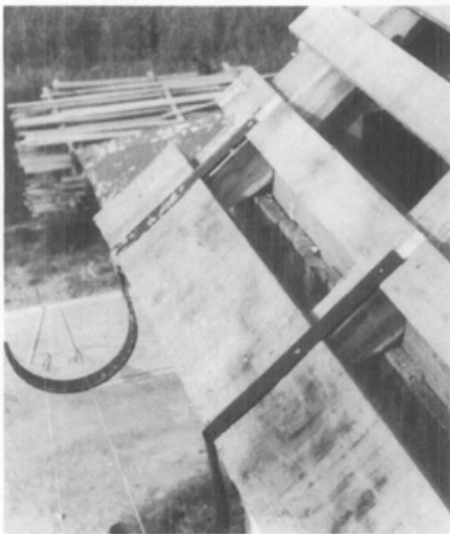
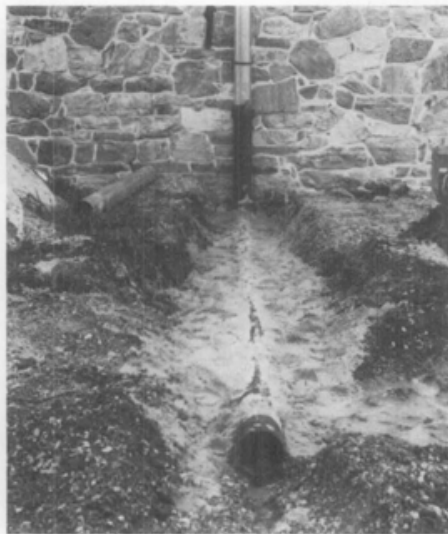
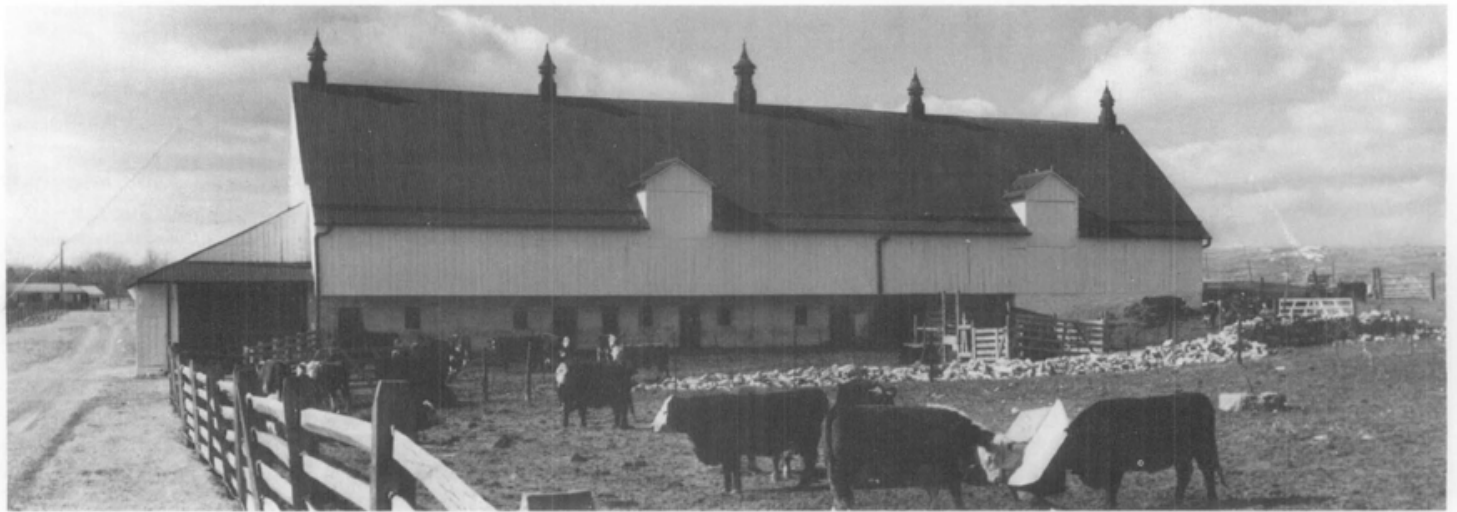
Fig. 7. Now part of Antietam National Battlefield, this bank barn (built in the 1820s and enlarged in 1898 and 1914) looks out over fields and hills where Union and Confederate armies fought on the bloodiest day in American history. Owned by the National Park Service, the barn underwent major repairs: (a) the foundation was regraded for better drainage; (b) the deteriorated metal roof was removed; (c) removal of the metal roof disclosed the rotten wall plate and roof rafters; (d) these elements were replaced, and collars to hold a new gutter system were added; (e) new downspouts and drain pipes were installed to carry water off the roof and away from the foundation; (f) damaged structural members were strengthened with new sections; (g) new roof and other work finished, the barn remains a working farm structure. Photos: (a-f), Courtesy, Williamsport Preservation Training Center, NPS; (g), Jack E. Boucher, HABS.

Many historic barns require more serious repairs than those normally classed as "routine maintenance" (see Fig. 7). Damaged or deteriorated features should be repaired rather than replaced wherever possible. If replacement is necessary, the new material should match the historic material in design, color, texture, and other visual qualities and, where possible, material. The design of replacements for missing features (for example, cupolas and dormers) should be based on historic, physical, or pictorial evidence.

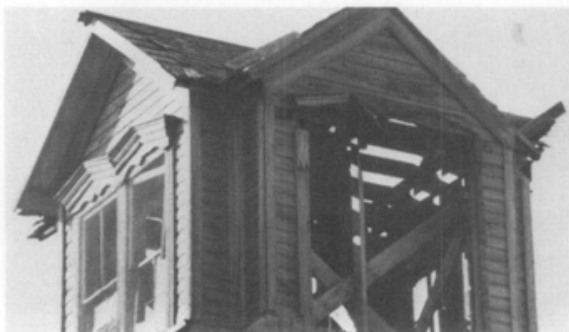
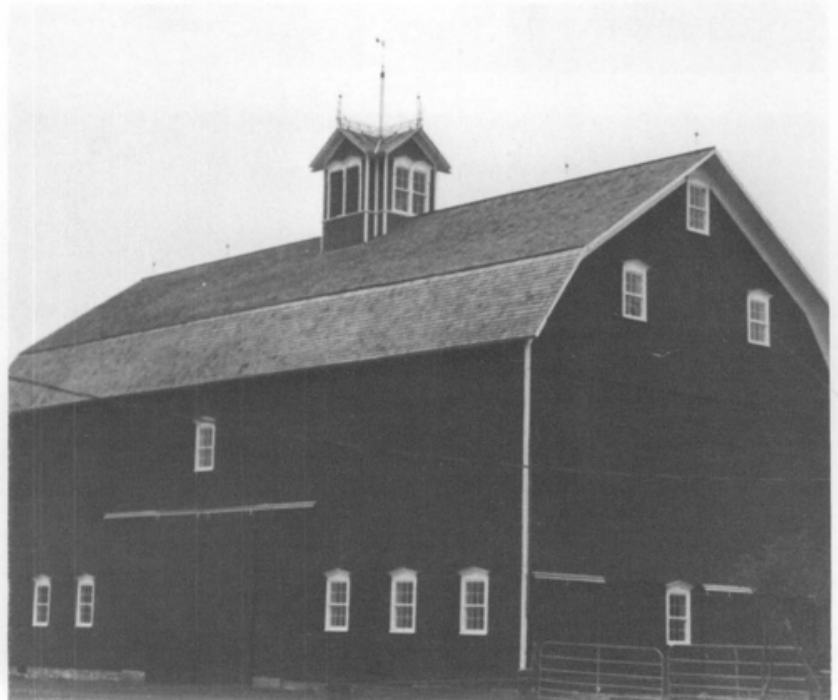
Fig. 8. Built in the Gothic Revival style in the 1890s, this four-story Indiana barn had fallen into disuse, and was deteriorating. In the process of returning it to use, the owner installed a new roof that matches the wooden shingles found beneath the deteriorating asphalt shingle roof; removed the modern asbestos shingle siding; repaired the windows, and reconstructed the cupola (including its lightning rod and weathervane). (Before and after views are of opposite sides of barn.) Photos: Before, Courtesy, Gary Post-Tribune; After, Courtesy, Kankakee Valley News.

Some barns have served the same uses for generations, and need only periodic repairs and routine maintenance. Others have become obsolete and need extensive updating for modern farming methods. (To house livestock, for example, a barn may need new feeding, watering, waste removal, electrical, plumbing and ventilation systems.) Similarly, barns that can no longer be used for agriculture at all normally require changes to adapt them for commercial, office, or residential use. In such cases barns need more extensive work than the maintenance and repair treatments outlined above. However, when rehabilitating a historic barn for a new farming operation or a new use entirely, care must be taken to preserve its historic character while making needed changes (see Figs. 8, 9 and 10).

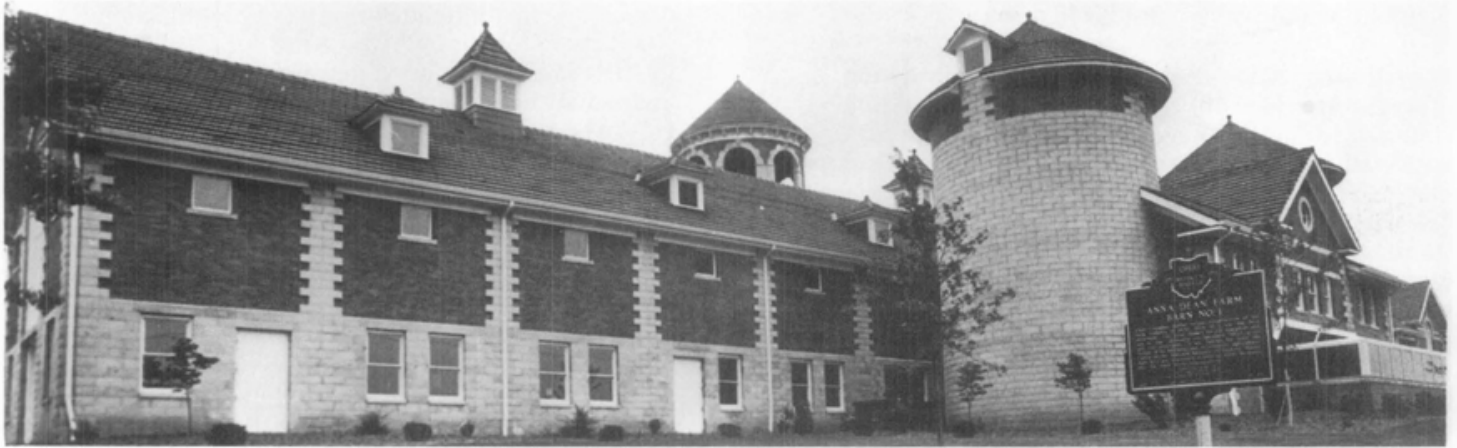
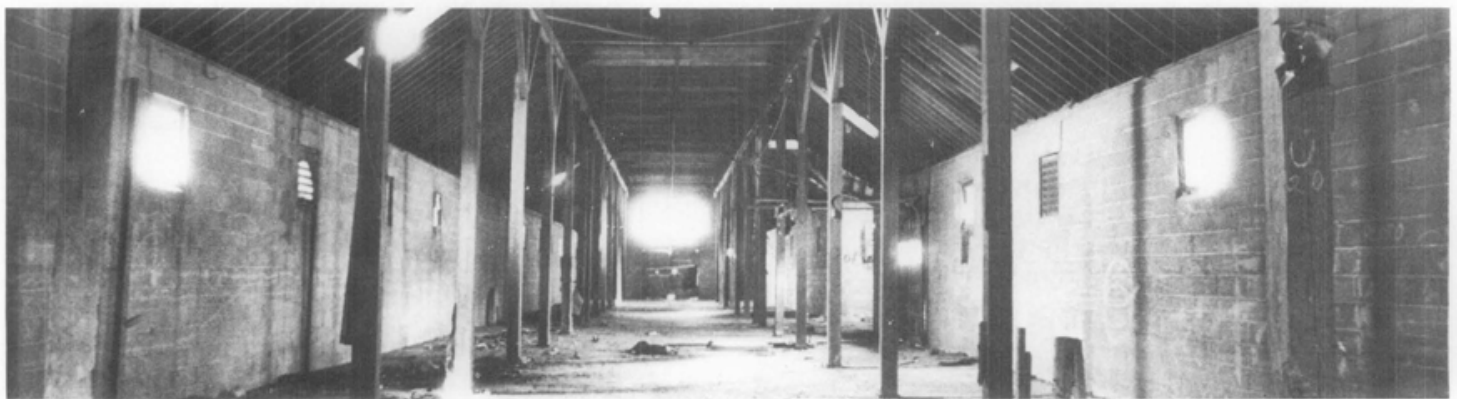
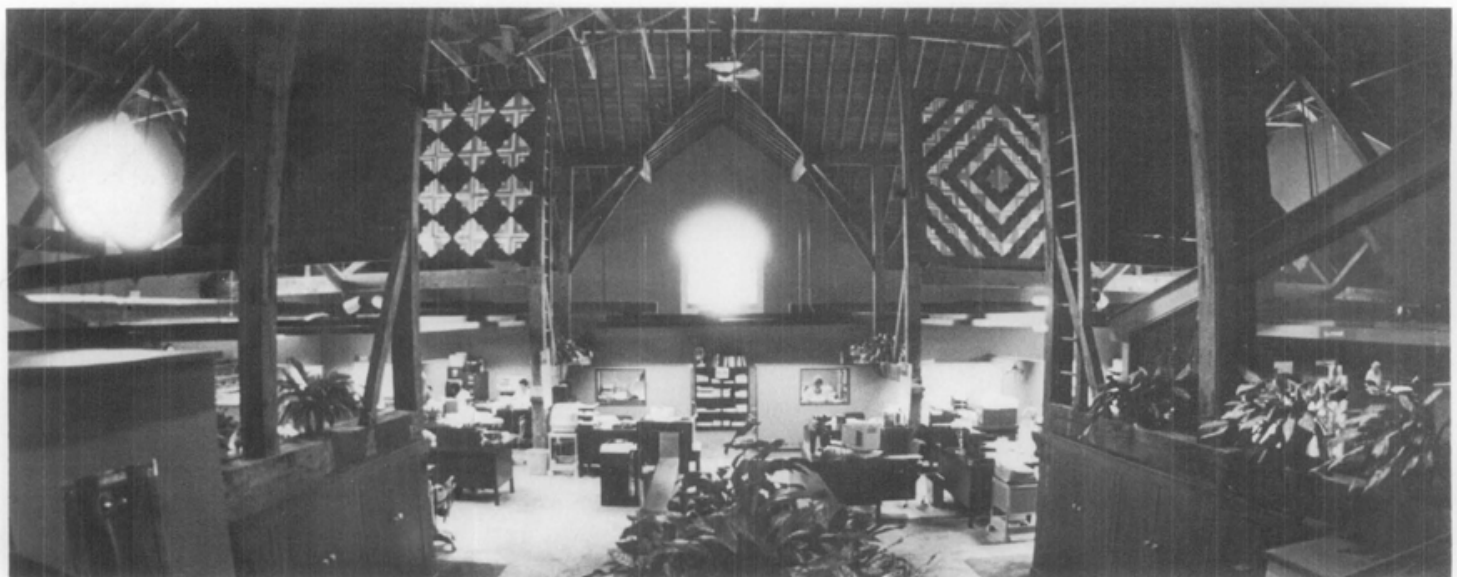
Fig. 9. This enormous Ohio barn (285 feet by 125) was built between 1909 and 1912. It was one of 102 structures on "America's Finest Farm." (Other buildings included the world's largest greenhouse and the world's largest barn—nearly 800 feet long). The barn seen here was rehabilitated for use as headquarters for an international agricultural firm. Although the use has changed, comparison of the interior photographs shows that the barn has retained its historic character. (After view, interior, is taken from a cross axis; distortion is from fish-eye lens.) Photos: Exterior and interior, after: Ron Kuntz, UPI; Interior, before: Courtesy, Barberton (Ohio) Historical Society.

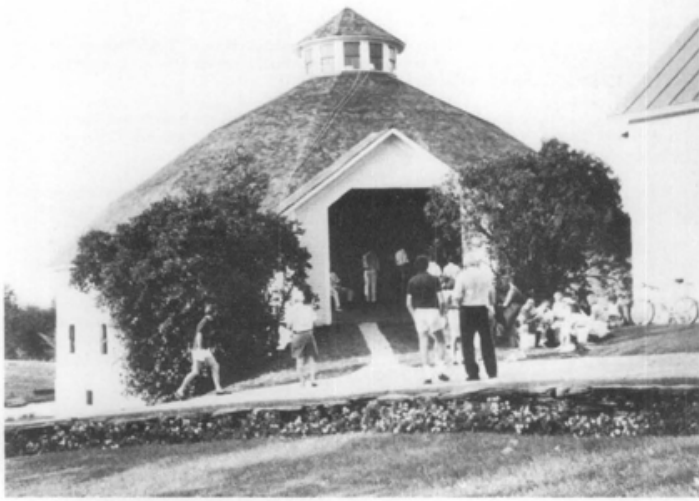
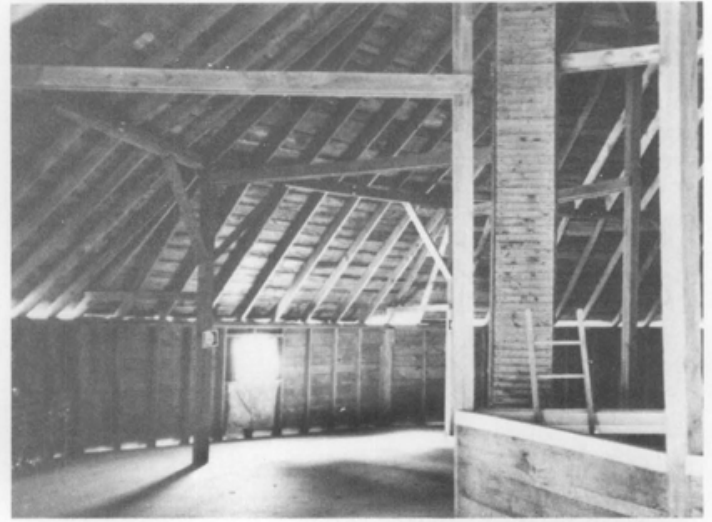
Fig. 10. This 1910 Vermont round barn is 80 feet in diameter. Disused and decaying, the building was converted to a community center, with artists' studios and spaces for weddings, parties and conferences. The barn underwent extensive structural repair and other work. Careful selection of new use permitted the building to be rehabilitated while retaining its principal spaces and features—and its historic character—intact. Photos: Jay White.
