23 PRESERVATION BRIEFS

Preserving Historic Ornamental Plaster

David Flaharty

U.S. Department of the Interior
National Park Service
Cultural Resources
Heritage Preservation Services

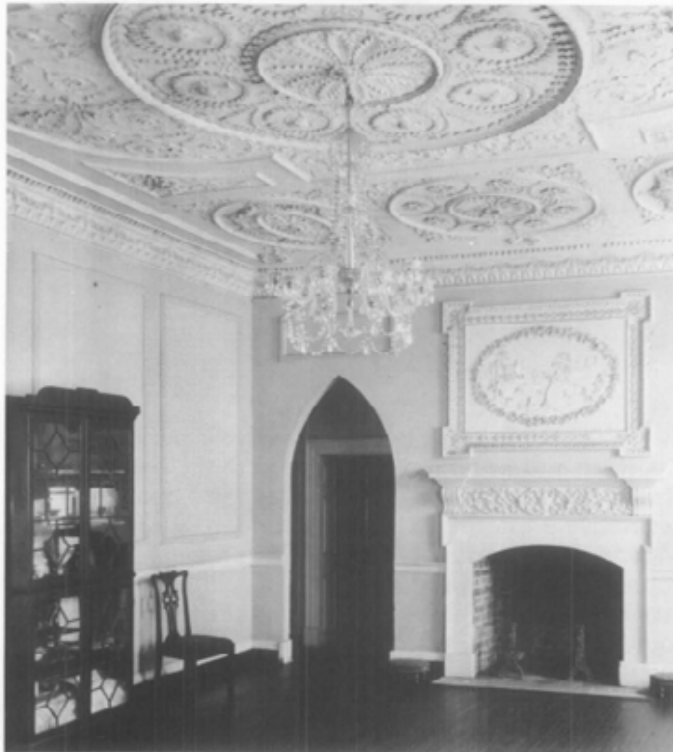
(a) **Kenmore, Fredericksburg, Virginia, c. 1752.** Georgian in style with ornamental ceilings based on Batty Langley's 1739 English style book, the plasterwork was executed by a Frenchman in the mid-1770s. This house was built by Col. Fielding Lewis and has the most elaborate ornamentation of any in the period. *Photo: Historic American Buildings Survey Collection.*

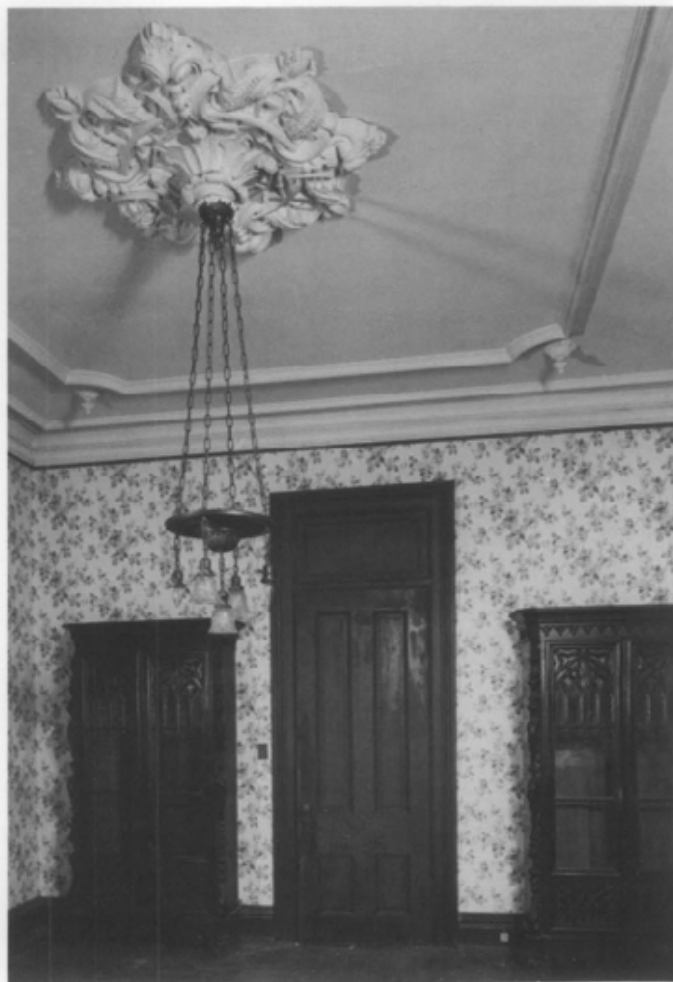
Fig. 2. This parlor medallion and pendant drops shown in a mid-19th century row house in Annapolis, Maryland were originally ordered from a catalog. A local plasterer ran the plain cornice and band ribbon, the curved corners of which were bench run, set with plaster adhesive and pointed at the joints. Photo: M. E. Warren.

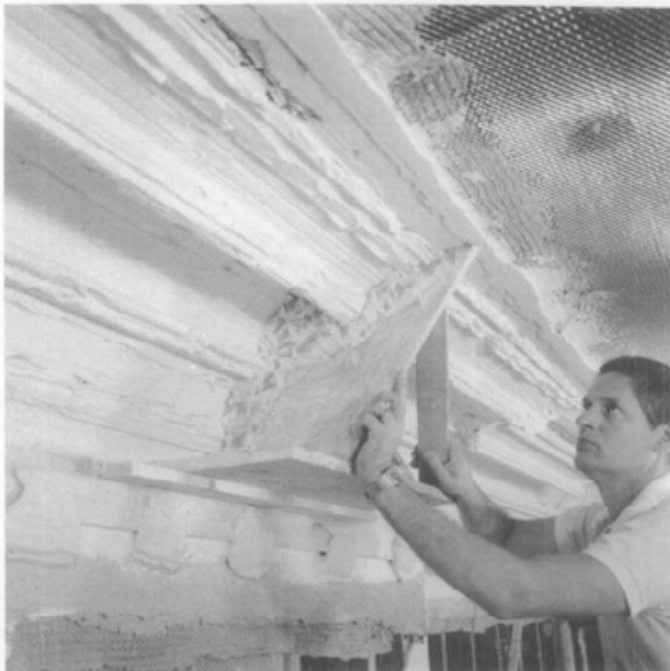
Fig. 4. Running a Cornice. The historic method of producing a cornice is unchanged today. A running mold or template is pushed along a lattice strip nailed to the wall. Base coat plaster is gypsum and sand; finishing plaster is added with small tools and stuffed wearing rubber gloves because lime burns the skin. As many as 20 passes are required to complete a smooth run; this particular cornice was formed in two stages, top and bottom, because it was so large. Cornices this size also have to be blocked and lathed to minimize the amount of applied material. Photo: Old-House Journal.

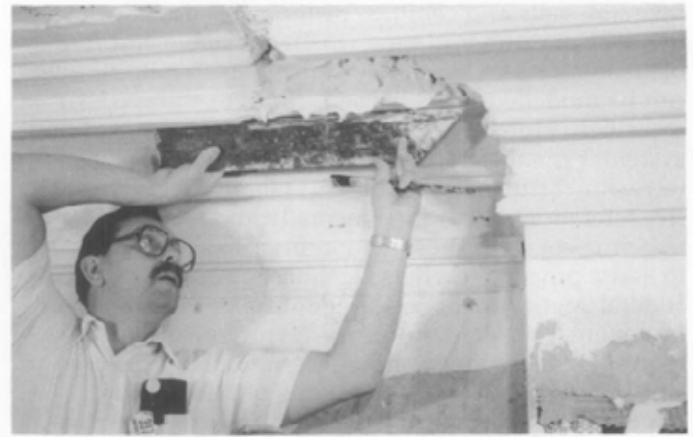
Fig. 5. Mitering a Plain-Run Cornice. Mitering requires great dexterity using the miter rod. In this case, a return at a chimney breast is tooled using an infill of gypsum and lime. Internal and external miters are required with the internal being the most difficult. Another method is to run a length of cornice (using the same blade) on a bench and set it in place, later to point the joints. Photo: Old-House Journal.

Short lengths of new cornice are best run on a bench using gypsum and lime; the reproduction molding should be somewhat longer than the required length (see Fig 18). The new footage is cut and fit in place to match the existing cornice, then securely countersunk-screwed to studs, joists and/or blocking. The resulting joints are pointed with flat mitering rods, flush with adjacent members (see Fig. 5, above).

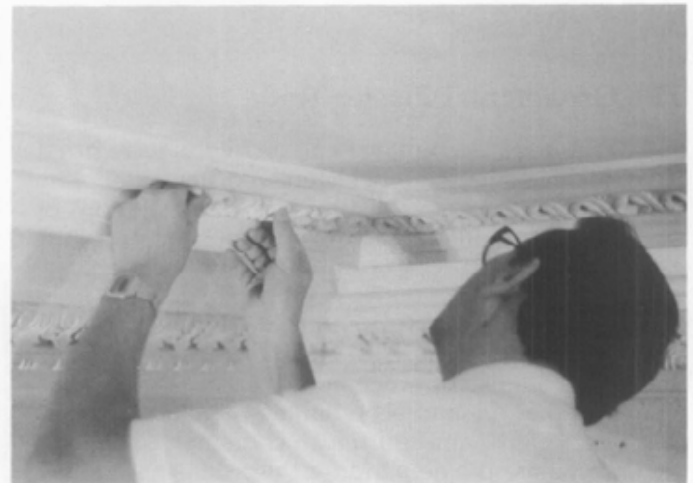
Fig. 6. Enriching a Plain-Run Cornice. After a cornice is run and mitered, cast enrichments are stuck in recessed sinkages planned to receive the casts. Ornamental models are made to engage with one another, resulting in unbroken lines or courses. A shop-cast ornament is soaked in water until saturated and pressed into its sinkage using wet plaster as an adhesive. Once the casts have been installed, they are carefully pointed at the joints and at the miters so that they appear as a continuous, repetitive design. Photo: Old-House Journal.

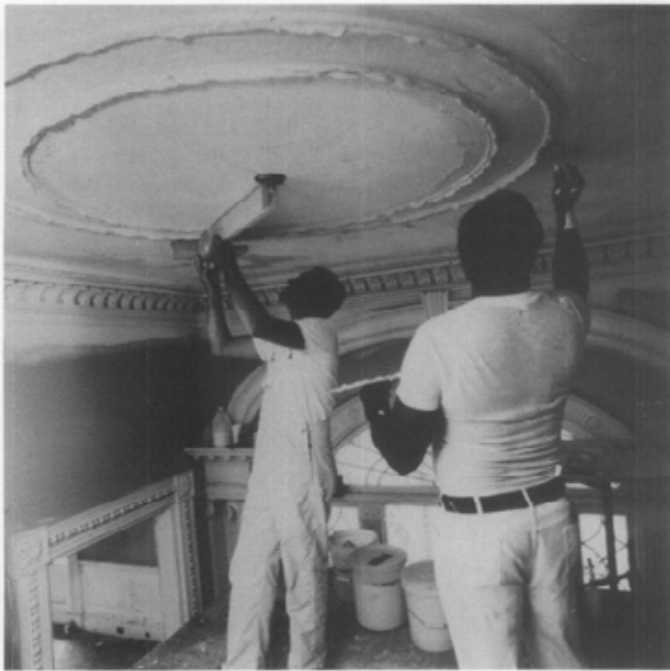
Fig. 7. Running and Enriching a Ceiling Medallion. The method of running and enriching a ceiling medallion remains the same today. (a) First, a plain-run surround is spun from a pivot point centered in the ceiling field. (b) Ornament layout is determined using plane geometric principles; segmented locations are deeply scratched to provide a rough surface for adequate bonding using plaster as an adhesive. Historically, cast enrichments could be bought from local suppliers and set individually, allowing architects to compose medallions to suit room dimensions and period motifs. Photos: Peter Sanders.

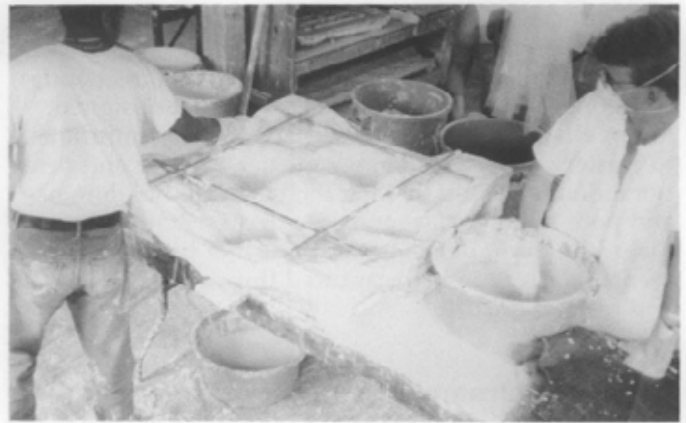
Fig. 8. Casting a Coffering Unit. Ceiling coffers are made the same way today except, historically, a hide glue mold was poured over an ornamental model whereas today urethane molding rubber is used. Now, as then, the plaster casts are made with steel channel irons embedded on the back of each panel. The coffers are hung from carrying irons fixed to the ceiling above by means of twisting wires to level each coffer to its neighbor. Afterward, the panels are fastened together and the joints pointed with plaster. Photo: David Flaharty.

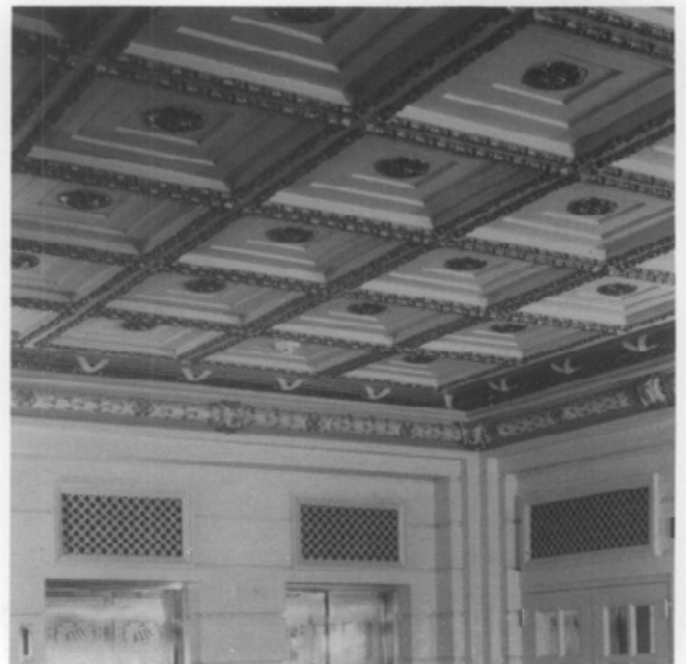
Fig. 9. The elaborate coffered ceiling was designed for the Willard Hotel in Washington, D.C. (1902–04) by Henry Janeway Hardenbergh. The coffered ceiling was restored as part of a rehabilitation project in the 1980s. Photo: Carol M. Highsmith.

identical in reflected plan; on domed or barrel ceilings, coffers differ from course to course so as to appear identical from various sight lines. The finish treatment of a coffered ceiling frequently exhibits the height of the painter's craft. Foremost examples of ceiling coffering include the United States Capitol, and Washington D. C.'s Union Station. As a popular decorative form with inherent acoustical benefits, the coffered ceiling is seen across the United States in many large public spaces such as theaters, courthouses, railroad stations, and hotels (see Fig. 9).

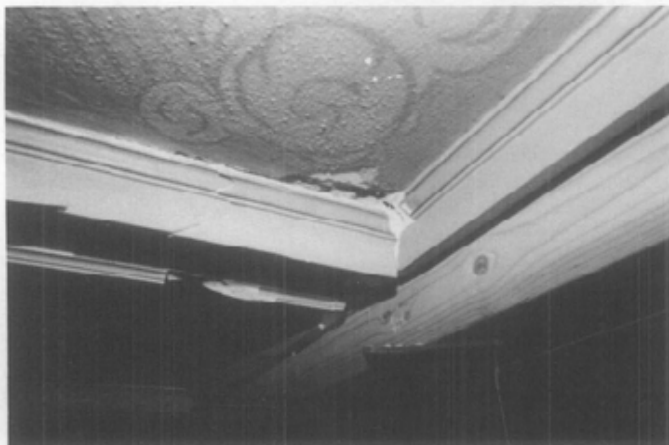
Fig. 10. Structural settling has caused this ceiling to deflect. Prior to restoring the damaged plaster and final repainting, a structural engineer experienced in historic preservation will be engaged to shore-up the ceiling from below and reattach the sagging ceiling plaster with the joists above (see also Fig. 17 under Immediate Action.) Photo: National Park Service files.

Signs of Failure. Failure of the substrate is more typical than failure of the plaster ornament itself. Among the reasons for deterioration, **structural movement** (see Fig. 10) and **water intrusion** (see Fig. 11) are the most deleterious. Buildings move and settle, causing deflection and delamination which result in stress cracking. These cracks often begin at the corners of windows and doors and extend upward at acute angles (see Fig. 12). Roof or plumbing leaks make finishes discolor and peel and cause efflorescence, especially on plain-run or enriched cornices. Unheated buildings with water intrusion are subject to **freeze-thaw cycles** which ultimately result in base coat and ornamental plaster failure (see Fig. 13).

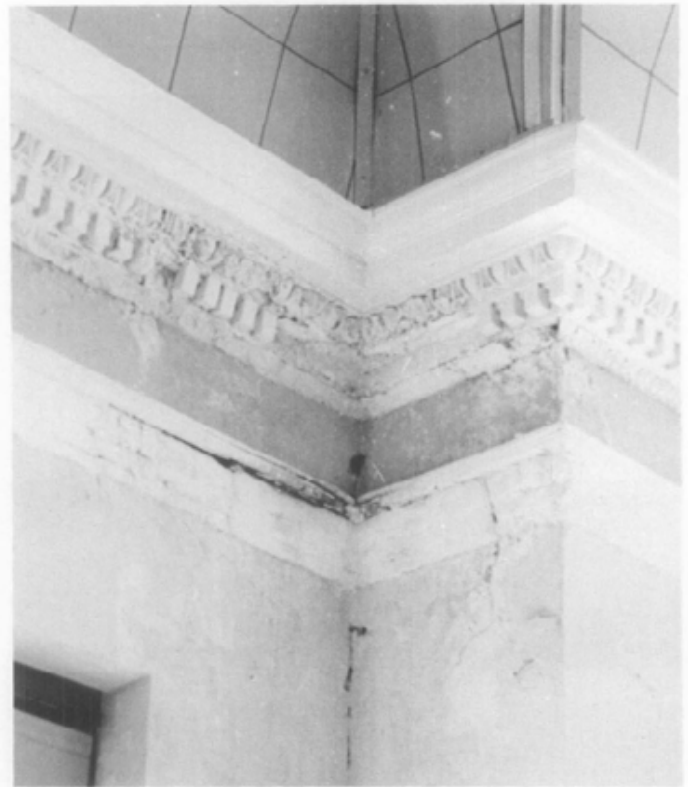
Fig. 11. The cornice of an Iowa courthouse has been severely damaged from a roof leak. In order to repair the ornamental plaster, a thixotropic rubber impression will be taken (with the paint build-up undisturbed). The efflorescence will be removed and fresh plaster casts installed so that egg and dart, dentil and leaf molding are perfectly aligned. Photo: National Park Service files.

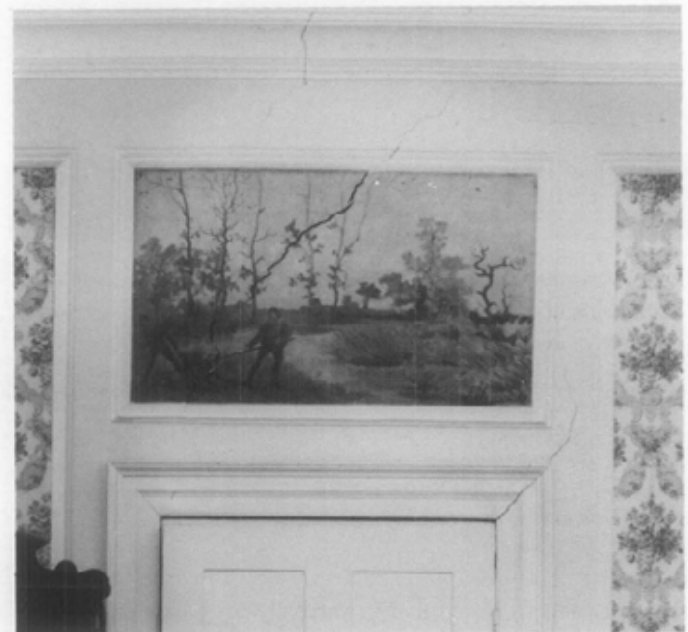
Fig. 12. Settlement caused stress cracking through both flat wall and ornamental plaster. Repairs to the cornice molding involve chamfering the stress cracks to a "V groove" and patching with a mixture of gypsum and lime. The cornice can be countersunk-screwed to its substrate to prevent further movement. Screw heads are then plastered over. The crack running through the painting will need to be filled carefully, and the painting restored by a trained conservator. Photo: Jack E. Boucher, Historic American Buildings Survey.

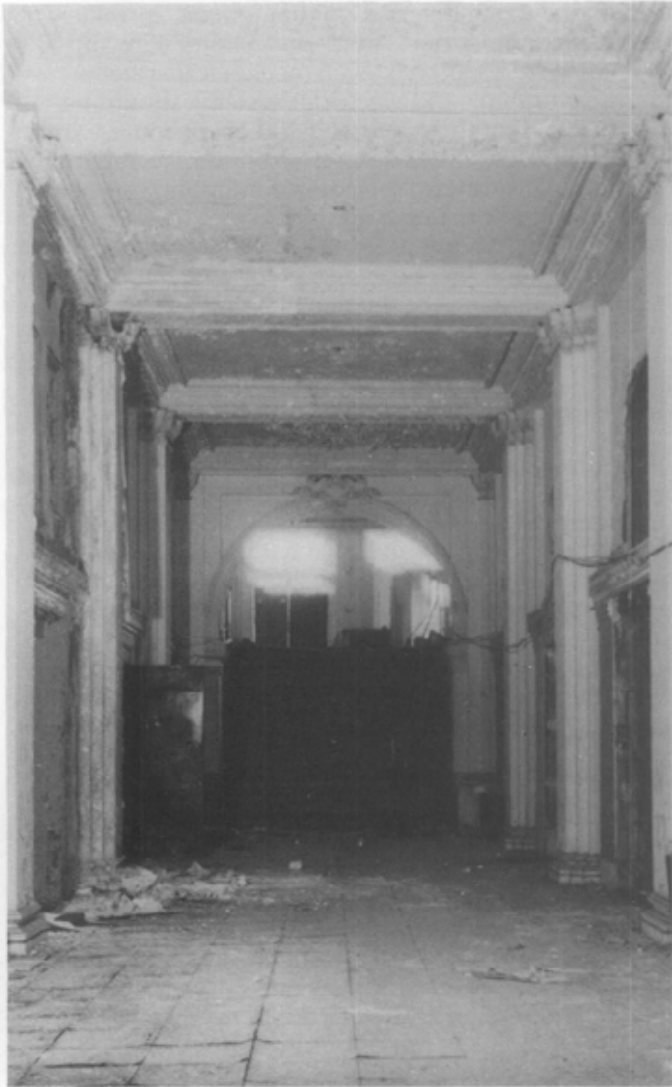
Fig. 13. Water intrusion and freeze/thaw cycles caused extensive efflorescence and ornamental plaster failure. The plaster needed almost total replacement within the rehabilitation project. Photo: Commercial Photographics.

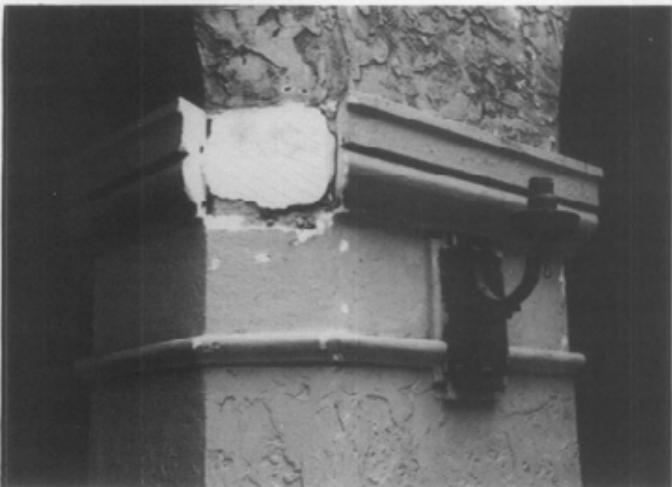
Fig. 14. A mitered portion of this impost capital abacus has fallen, revealing the plaster adhesive material. Repairs are made by obtaining a section through the abacus, making a bench-run length, cutting, fitting, and readhering the missing piece. Finally, the joints are pointed. Photo: Lee H. Nelson, FAIA.

In addition, keying and adhesive properties may be further jeopardized by **weak original mixes** (see Fig. 14) that were improperly applied. Substrate failure typically results from **faulty lathing or rusty lath nails**, causing ceilings to fall. In the 20th century, **vibration** from heavy vehicular traffic, nearby blasting, and even repeated sonic booms may contribute to damaging ornamental plaster. **Inadequate support** in an original design may also be to blame when particularly heavy units have simply broken off over time (Fig. 15). Finally, new mechanical systems, suspended ceilings and partition walls insensitively installed in adaptive use projects, show little regard for the inspired decorations of earlier periods (see Fig. 16).

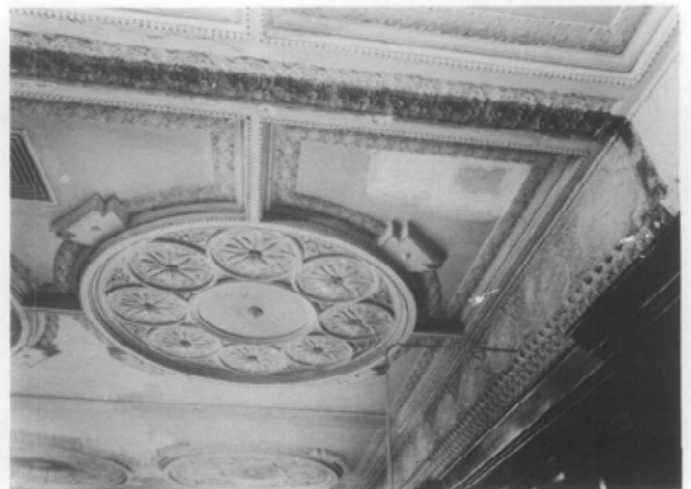
Fig. 16. The Auditorium Building, Chicago, Illinois, 1889, by Louis Sullivan. Earlier insensitive alterations were removed prior to restoration of the room. In the photo, a partition wall has already been removed; the electrical conduit and a ventilation grille followed. Plaster patching and painting were the final steps of restoration work. Photo: National Park Service files.

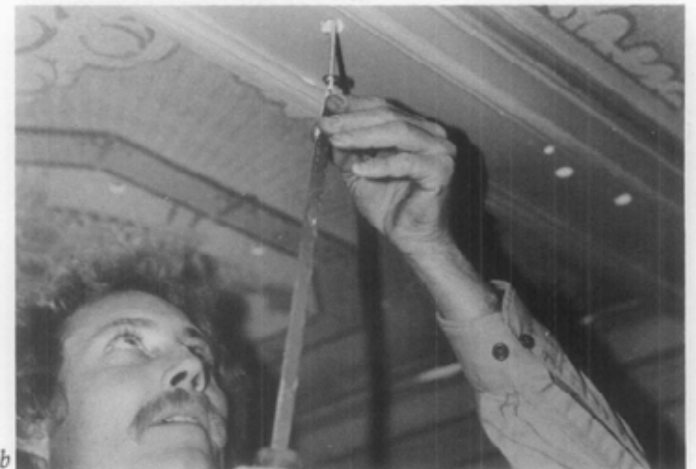
Fig. 17 (a) Where this ceiling was suffering from structural failure, the first step was to shore it up from below. (b) Toggle bolts were used to reattach the plaster molding to the ceiling joists. The ceiling was then patched with gypsum and lime, prior to restoring the significant paint finishes. Photos: National Park Service files.

First, roof or plumbing leaks must be repaired to eliminate the problem of water intrusion. General structural repairs should be undertaken to arrest building movement, which weakens the base coat plasters to which the ornamental enrichments are attached. Ornamental plaster deflection should be corrected by shoring from below followed by re-anchoring (see Fig. 17).

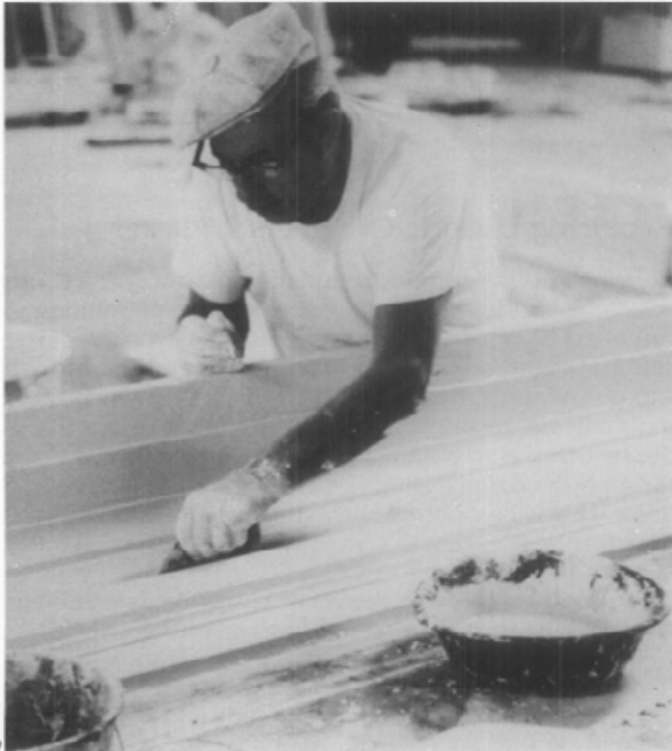
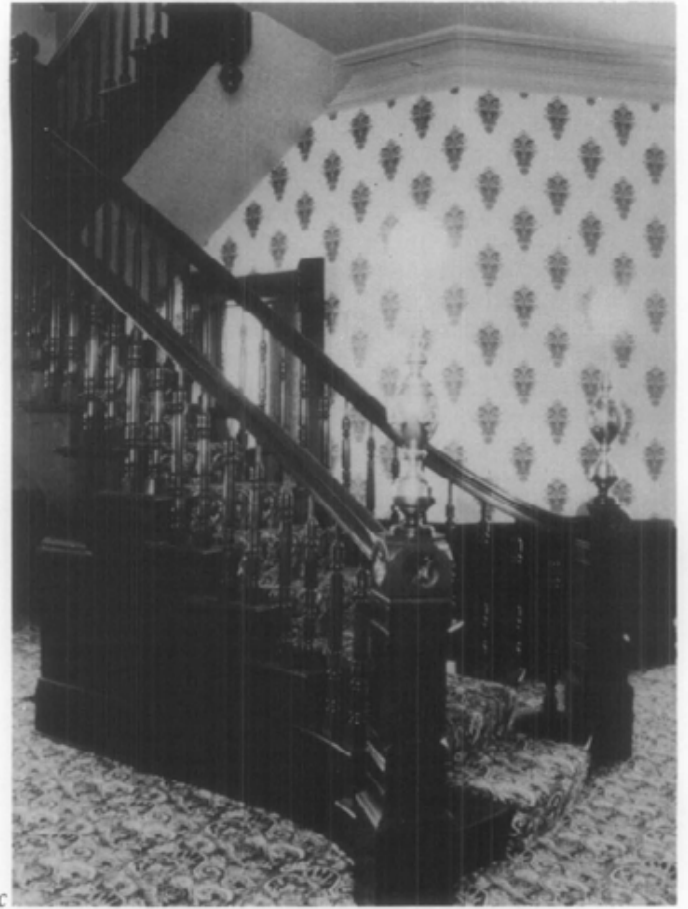
Fig. 18. Repairing a Cornice. (a) In the restoration of the Henry Hirshfeld House, a 19th century residence in Austin, Texas, removal of a tin ceiling revealed a damaged plain-run cornice. Photo: John Volz, AIA. (b) A section through the molding was taken, a template blade cut, horsed-up, and run on a bench using gypsum and lime. Photo: Charles E. Fisher. (c) The new cornice was then cut, fitted, and applied to new blocking between wall and ceiling. The external miter and returns were pointed using the miter rod. After the ceiling restoration was complete, other finishes, such as wallpaper, were applied. Photo: Candace Volz.

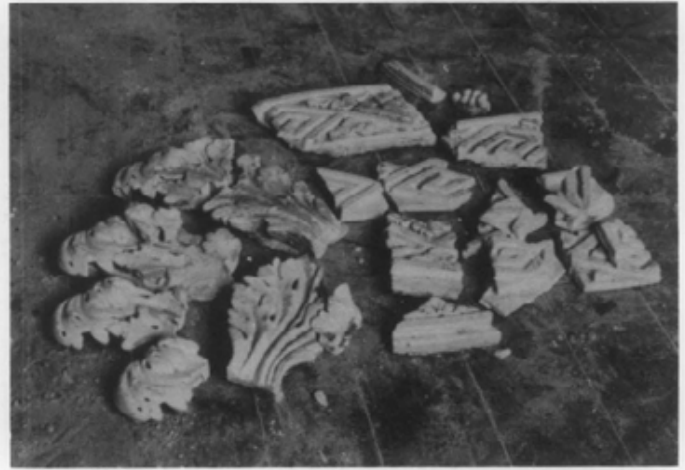
Fig. 19. Ceiling medallions may need repair or replacement. The ornamental plasterer takes impressions of the existing plaster, then casts new plaster elements. Adhesive plaster is used to reattach the new pieces. Left: Damaged elliptical medallion from Rockland, Fairmount Park, Philadelphia, Pennsylvania. Photo: David Flaharty. Right: Fragments of a medallion from the Bennett House, Charleston, South Carolina. The fragments serve as documentation for the replacement medallion. Photo: Peter Sanders.

Damaged ceiling medallions (see Fig. 19a) can be repaired by carefully removing representative plaster ornamentation, molding and recasting in the shop (see Fig. 20) and replacing the new enrichments so that they align perfectly with the original pattern. Polyvinyl acetate bonding agents are applied to the background and ornament so that the adhesive plaster grips tightly. Alternatively, a severely damaged medallion (see 19b) can be replaced using the fragments as physical documentation to cast a visually accurate replacement.

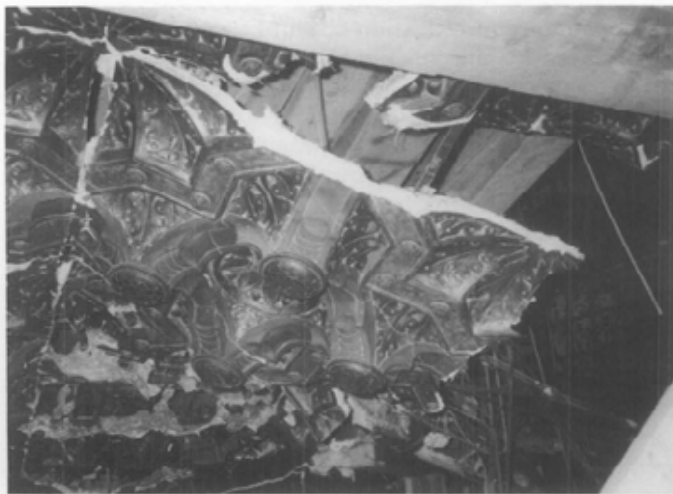
Fig. 21. The Yiddish Arts Theater, New York City, c. 1920s. The concrete roof of this building collapsed, damaging portions of the existing Moorish style coffered ceiling. The square coffer unit was easily identifiable and was removed to a casting shop for reproduction. Photo: David Flaharty.

Coffered Ceiling. Like cornices and medallions, coffered ceilings suffer from poor maintenance practices and structural problems; however, these individually cast ceiling units are particularly vulnerable when a building is being rehabilitated and great care is not taken in executing the work. In the most serious of cases, portions of a roof can collapse, dropping heavy debris through the hanging coffering panels, and demolishing large portions of the ornamentation (see Fig. 21).

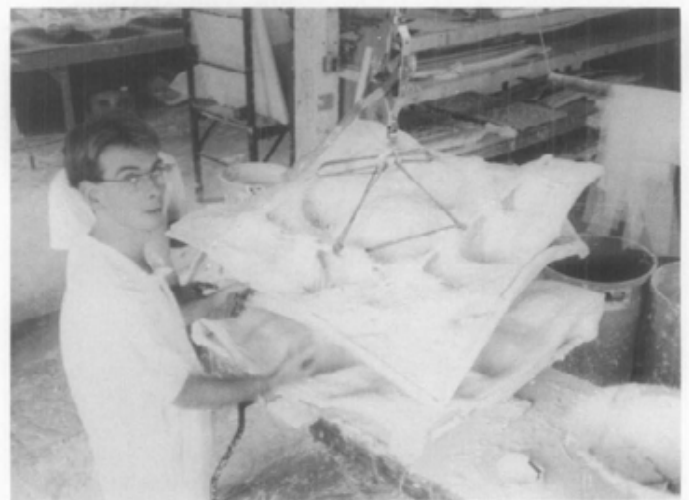
Fig. 22. Repairing a Coffered Ceiling. As part of the theater rehabilitation, the coffered ceiling panels are being reproduced in urethane rubber molds and reinforced with open weave burlap and wood fiber. Steel channel irons can be seen, attached to the backs of the casts. Later, these irons are used to hang the panels from a superstructure at the site. Photo: David Flaharty.

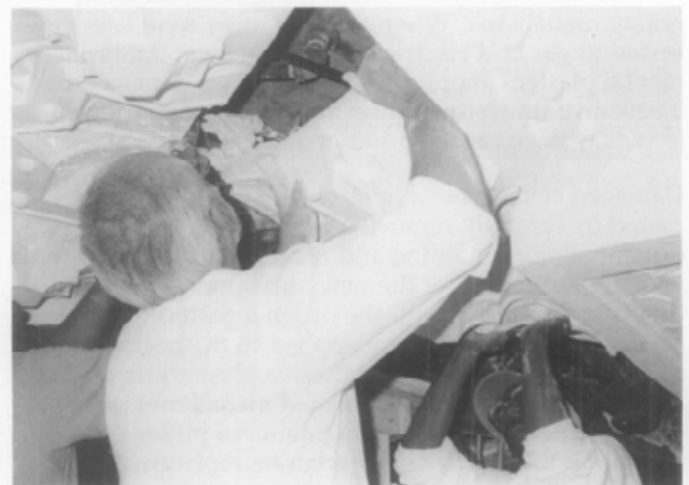
Fig. 23. A pre-cast coffer is lifted into place to abut adjacent panels. Tie wire will be fastened to the channel irons and the superstructure above, twisted to level, and finally wadded with wood fiber soaked in plaster to prevent the wire from stretching. Photo: David Flaharty.

and deflection. New channel iron is used to stabilize the existing coffers and ties reinforced, as necessary. An intact coffering unit is then identified and carefully removed to a casting shop for molding and casting (see Fig. 22). When re-hung, the units are painted to match the historic coffering (see Fig. 23).

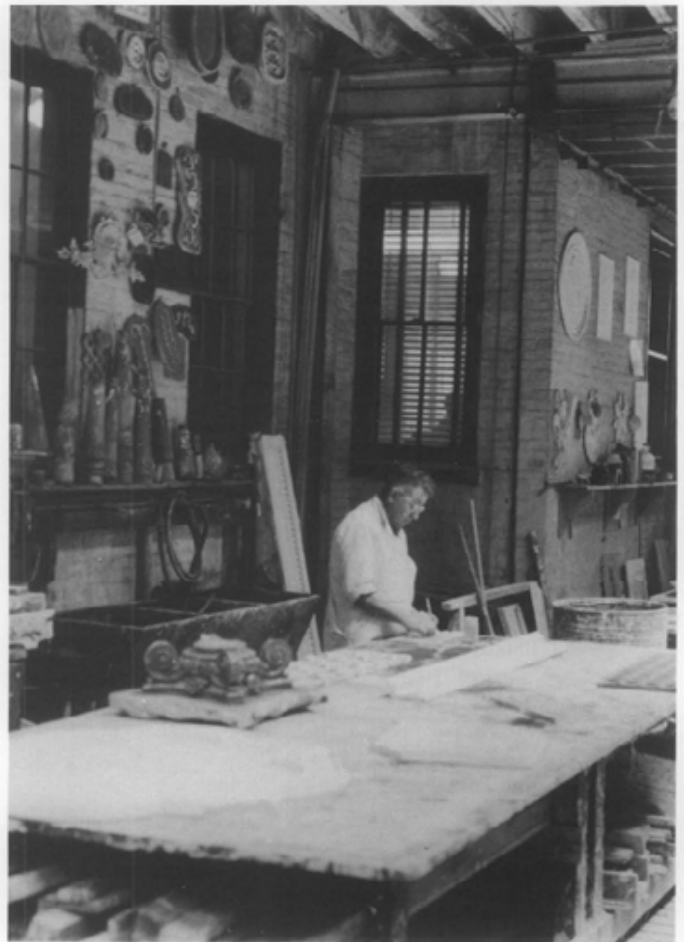
Fig. 24. This plaster studio is well organized, with ample work space. Note the plaster casts hanging neatly on the wall. Photo: Berry and Homer, Philadelphia.

or developer should secure the services of a reputable restoration contractor before proceeding further. It is clear as more and more projects are undertaken, that there is a wide disparity of skills within the trade today. This is partly due to the introduction of gypsum board as a substitute for traditional plastering. As gypsum board became popular after World War II, plasterers saw the demand for their skills decline. Plastering techniques were forgotten because they were often not passed down within shops and families. However, ornamental plaster studios have seen a resurgence in demand for their services in the last decade, particularly as more historic buildings are rehabilitated (see Fig. 24).
