# 27 PRESERVATION BRIEFS

## The Maintenance and Repair of Architectural Cast Iron

John G. Waite, AIA

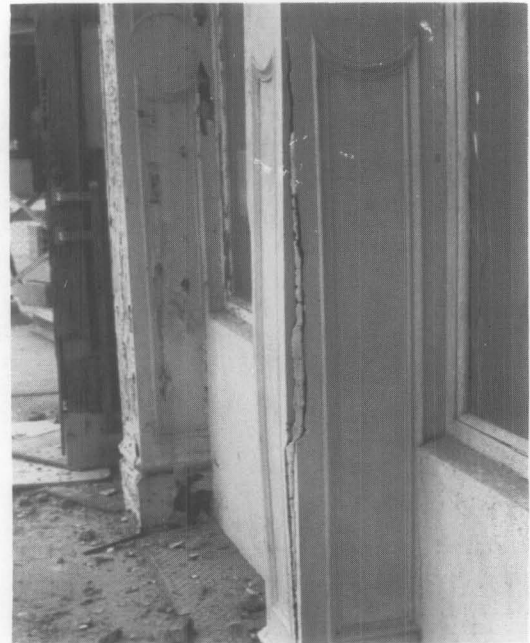
Fig. 11. Major cracks in the piers of this cast-iron storefront in Galveston, Texas resulted from the transfer of load onto the iron from internal brick piers eroded by rising damp. This crack was inappropriately filled with concrete, which trapped moisture and accelerated internal corrosion, pushing the iron further apart. Photo: Ford, Powell & Carson.

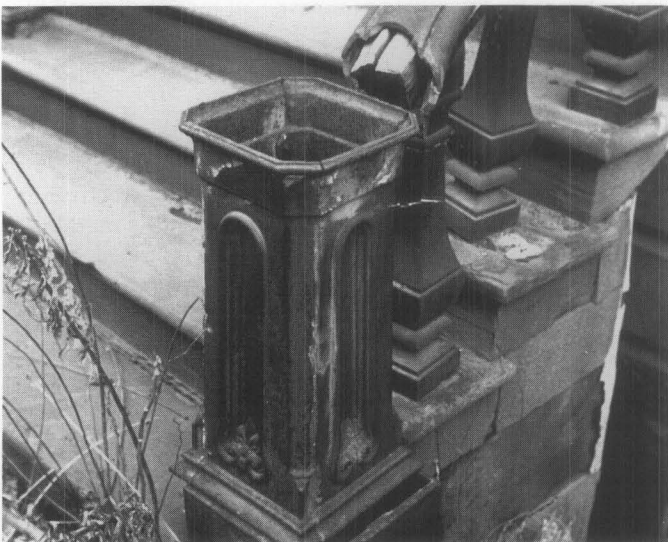
Fig. 15. In an effort to repair this stair railing, concrete was poured around the wood spacer inside the railing casting. Water penetrated the railing and reacted with the concrete to accelerate the corrosion of the iron. Photo: John G. Waite.

The internal voids of balusters, newel posts, statuary, and other elements should not be filled with concrete; it is an inappropriate treatment that causes further problems (Fig. 15). As the concrete cures, it shrinks, leaving a space between the concrete and cast iron. Water penetrating this space does not evaporate quickly, thus promoting further rusting. The corrosion of the iron is further accelerated by the alkaline nature of concrete. Where cast-iron elements have been previously filled with concrete, they need to be taken apart, the concrete and rust removed, and the interior surfaces primed and painted before the elements are reassembled.

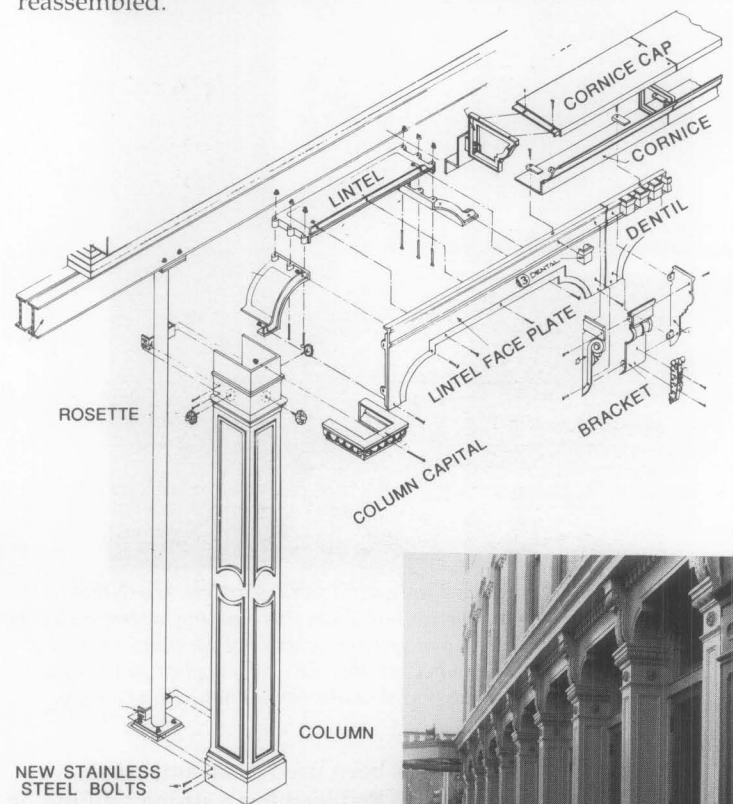
Fig. 16. Architectural cast iron is made of many small components bolted and screwed together. (a) This exploded view of a storefront illustrates the variety of elements, including brackets, fasteners, and holes for bolts. (b) The storefront was replicated in cast iron because of the extensive damage and structural failure, a detail of which is shown in Fig. 11. Drawing and photo: Historical Arts & Casting, Inc.

Most architectural cast iron is made of many small castings assembled by bolts or screws (Fig. 16a). Joints between pieces were caulked to prevent water from seeping in and causing rusting from the inside out. Historically, the seams were often caulked with white lead paste and sometimes backed with cotton or hemp rope; even the bolt and screw heads were caulked to protect them from the elements and to hide them from view. Although old caulking is sometimes found in good condition, it is typically crumbled from weathering, cracked from the structural settlement, or destroyed by mechanical cleaning. It is essential to replace deteriorated caulking to prevent water penetration. For good adhesion and performance, an architectural-grade polyurethane sealant or traditional white lead paste is preferred.

The replacement of cast-iron components is often the only practical solution when such features are missing, severely corroded, or damaged beyond repair, or where repairs would be only marginally useful in extending the functional life of an iron element (Fig. 16).

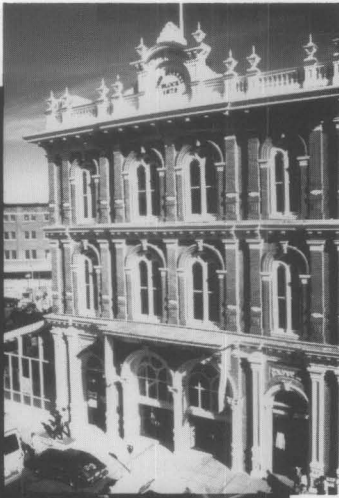
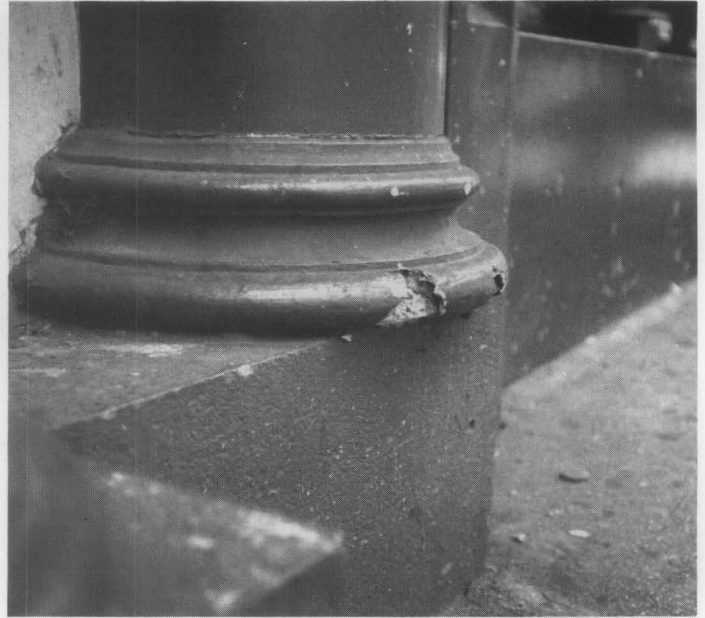
Fig. 20. The location of the feature must be taken into account if a substitute replacement material is being considered. This lightweight fiberglass column at street level sustained damage from impact within a few years of installation. The great strength of cast iron makes it ideal for storefronts and elements that must withstand heavy use. Photo: Building Conservation Associates.

corrosive, but is susceptible to ultraviolet degradation. Because of its rather flimsy nature, it cannot be used as a substitute for structural elements, cannot be assembled like cast iron and usually requires a separate anchorage system. It is unsuitable for locations where it is susceptible to damage by impact (Fig. 20), and is also flammable.
