31 PRESERVATION BRIEFS

Mothballing Historic Buildings

Sharon C. Park, AIA

U.S. Department of the Interior
National Park Service
Cultural Resources
Heritage Preservation Services

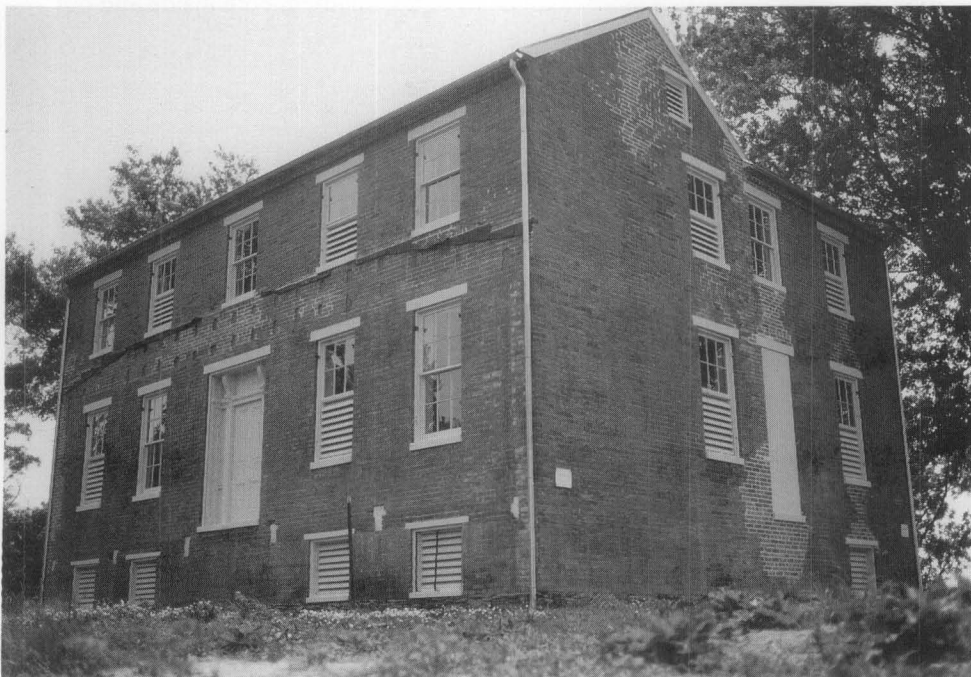
Figure 1. Proper mothballing treatment: This building has been successfully mothballed for 10 years because the roof and walls were repaired and structurally stabilized, ventilation louvers were added, and the property is maintained. Photo: Charles E. Fisher, NPS.

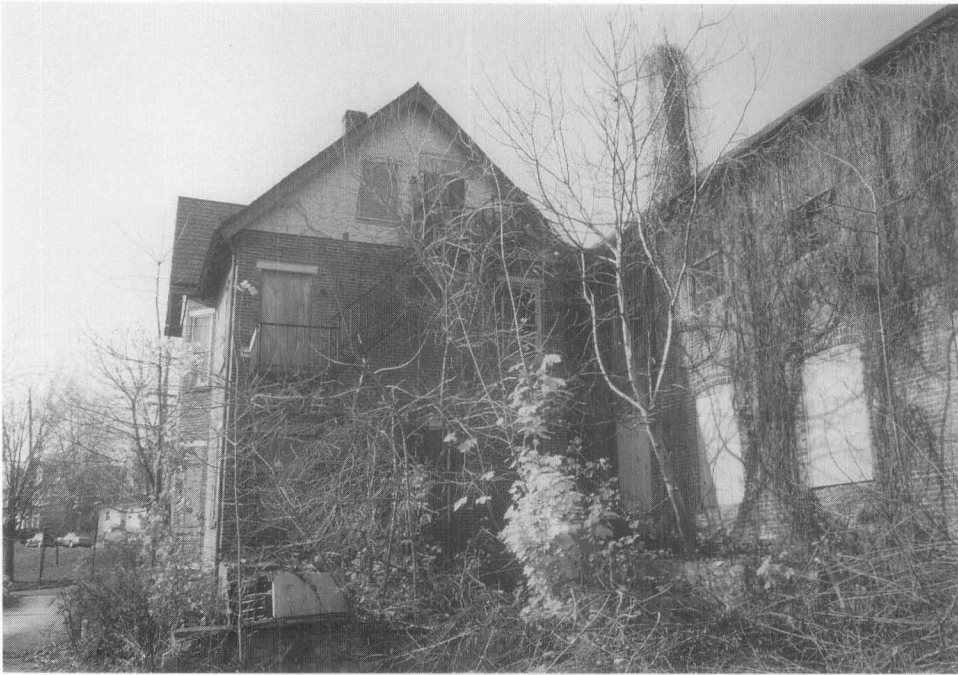
Figure 2. Improper treatment: Boarding up without adequate ventilation, lack of maintenance, and neglect of this property have accelerated deterioration. Photo; NPS file.

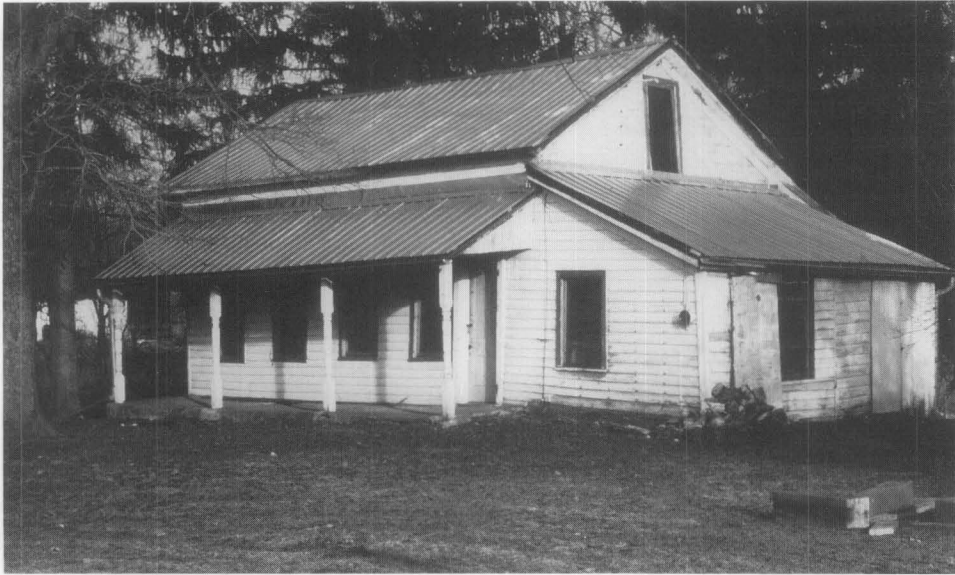
Figure 7. Non-historic materials are appropriate for mothballing projects when they are used to protect historic evidence remaining for future preservation. This lightweight aluminum channel frame and roofing covers the historic wooden shingle roof. Galvanized mesh panels secure the window openings from intrusion by raccoons and other unwanted guests. Photo: Williamsport Preservation Training Center, NPS.

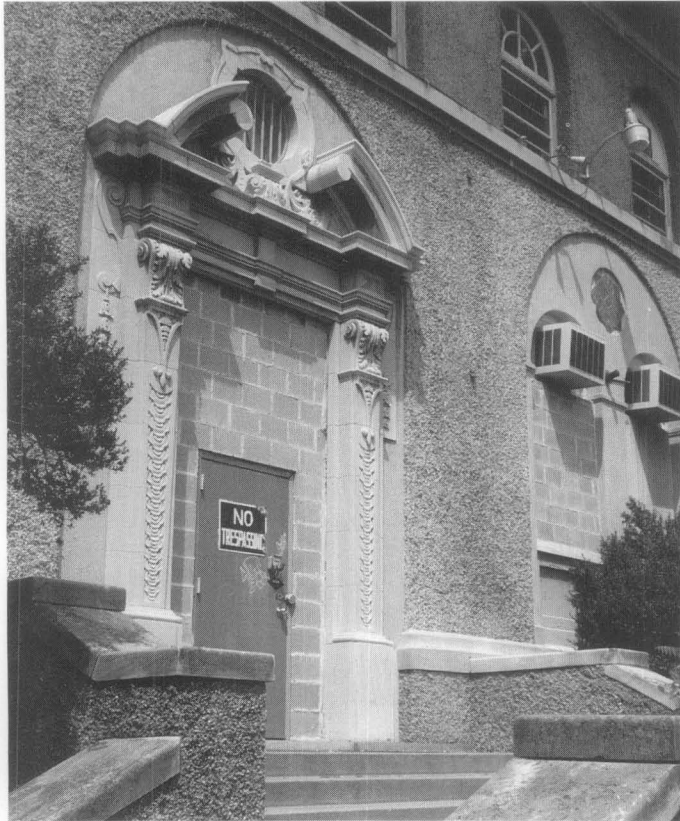
Figure 12. First floor openings have been filled with cinderblocks and doors, window sash and frames have been removed for safe keeping. Note the security light over the windows and the use of a security metal door with heavy duty locks. Photo: H. Ward Jandl, NPS.

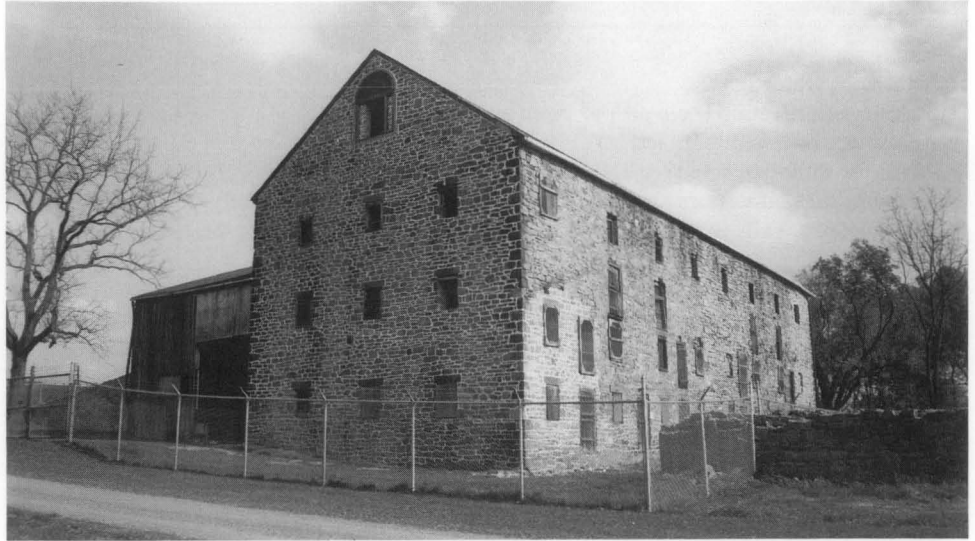
Figure 24. Once mothballed, a property must still be monitored and maintained. The openings in this historic barn has been modified with a combination of wood louvers and metal mesh panels which require little maintenance. The grounds are regularly mowed, even inside the chain link security fence. Photo: Williamsport Preservation Training Center, NPS.

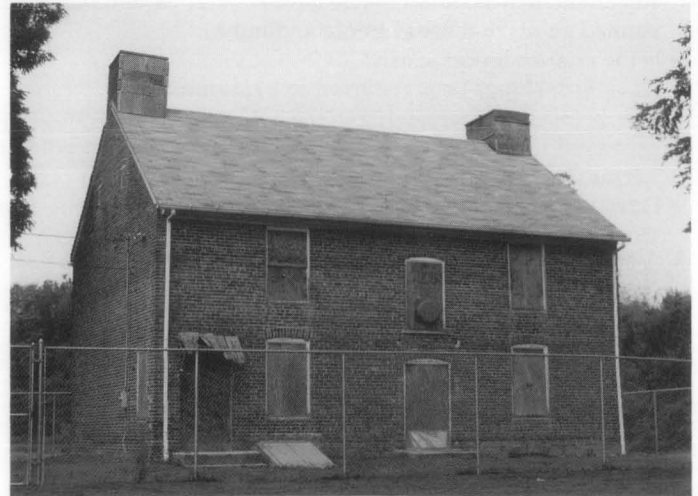
Figure 25. Above is a summary of the tasks that were necessary in order to protect this significant property while restoration funds are raised. Photographs: Michael Mills; Ford Farewell Mills Gatsch Architects.

a. A view showing the exterior of the house in its mothballed condition.

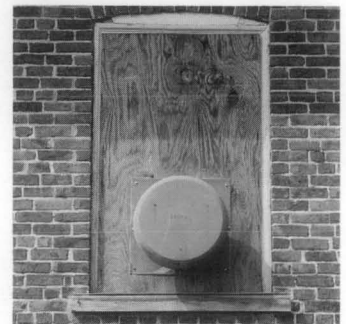
c. The exhaust fan has tamper-proof housing.
