45 PRESERVATION BRIEFS

Preserving Historic Wood Porches

Aleca Sullivan and John Leeke

National Park Service
U.S. Department of the Interior
Heritage Preservation Services

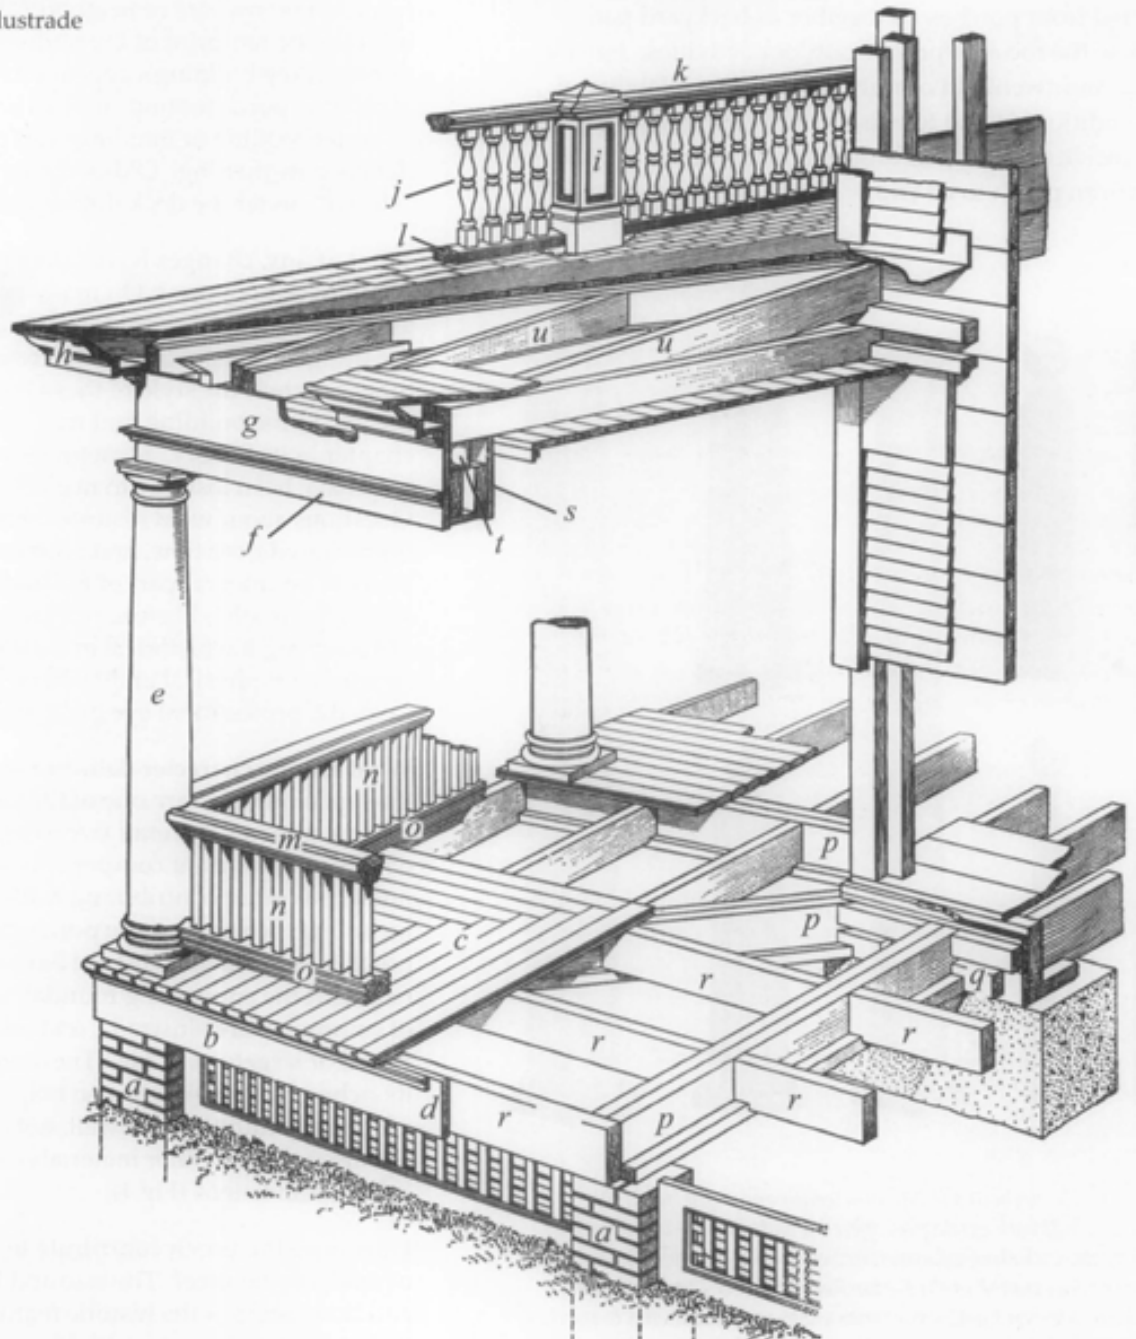
Drawing courtesy of Thomson Education Direct.

Roof Structural System (s, t, u)

- s - Beams inside the entablature span from column to column, support plate
- t - Plate of the entablature rests on beams, supports roof rafters and ceiling beams
- u - Rafter of the roof structural system

The open qualities are one of the key features of most historic porches. Overall size, shape and design are obviously important components as well. There are numerous other contributing features which may exist, including the shape of the porch roof, the way a large porch is divided into distinct bays as with columns, the nature of the supporting foundation, the style and size of columns and balustrade, and whether the porch is raised or largely at grade. The simplicity of a porch or its richness in detail will also help define it. Materials are usually important as well, not just the wood features, but also whether other materials exist such as masonry columns and steps (Fig 4).

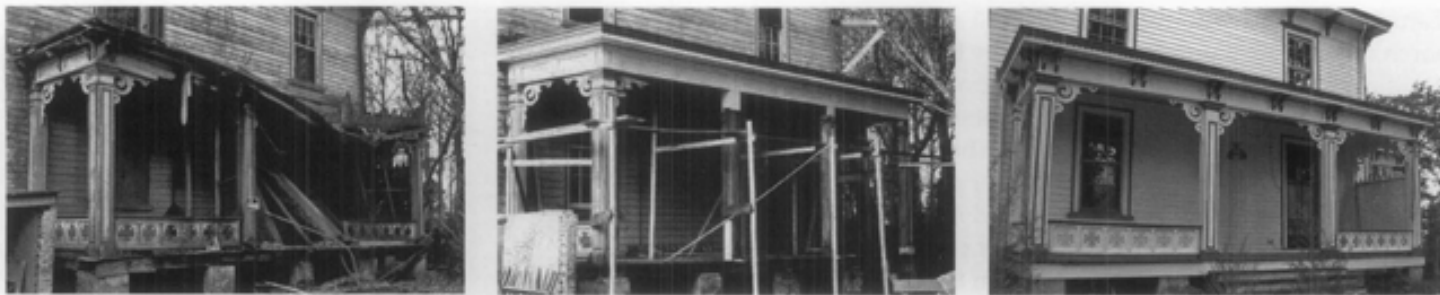
Figure 5. Even historic porches that appear to be in total disrepair may be repairable. While the roof needed replacement, much of this porch was repaired, including such features as the decorative columns, ornamental brackets, and balustrade. Photos: John Leeke.

engineer or building contractor familiar with old buildings. For an adequate assessment, it may be necessary to remove facing boards to check for potential decay in the structural sill behind (Fig 5).

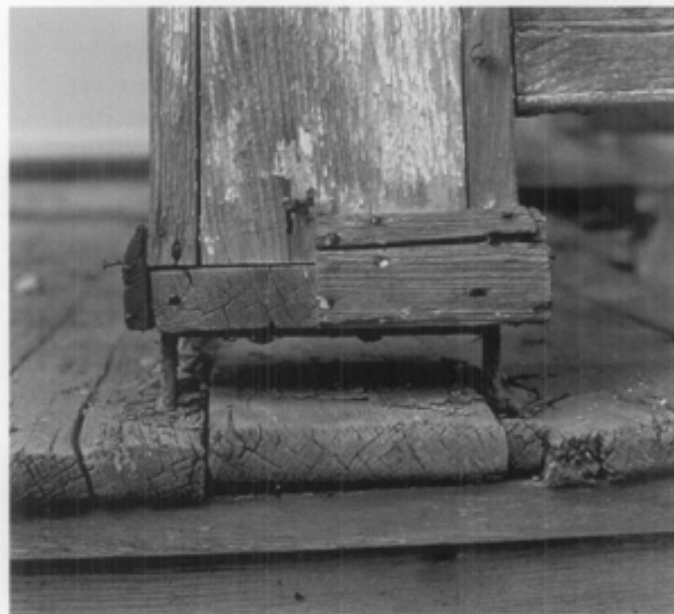
Figure 6. A traditional way to extend the life of porch posts was to place posts on metal feet, thereby providing a separation between the wood post and wood deck. This helped to prevent the wood post from rotting at the base. Early post feet were simple iron bars bent unto a stirrup shape. By the late nineteenth century manufactured cast-iron feet were common, consisting of a pair of disks separated by a short pipe. Post feet are still available today. Courtesy of Old-House Journal/Brian McNeil.

are made of and how they are constructed will aid in understanding how they function and may deteriorate over time (Fig.6). Although the posts on a wood porch are commonly made of wood, they may be of masonry or metal or a combination of materials. Large round columns usually are made of wood staves similar to the way barrels are constructed; smaller diameter columns may be solid. A sag in the deck below or a faltering foundation can impact the supporting role of a column or post above. Wood columns and posts are prone to water seeping into open joints, particularly in the base and the lower end of the shaft. It is not uncommon to find that older columns have had patches and replacement bases.

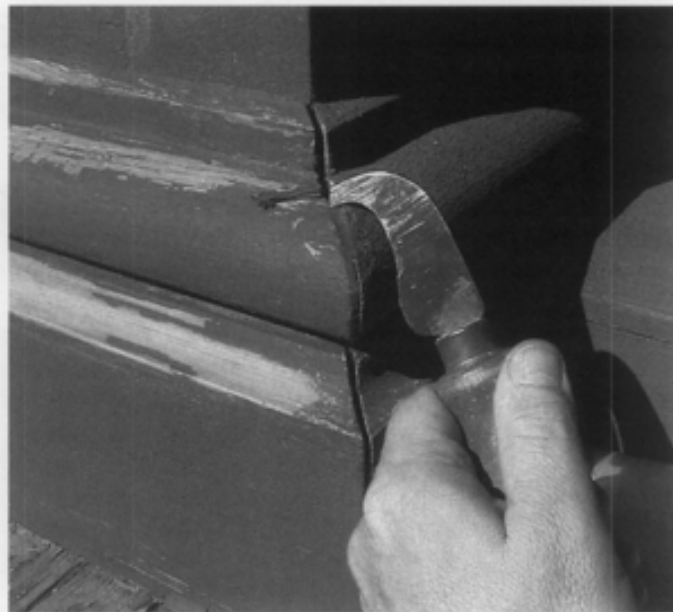
Figure 7. Common problems with porches that can contribute to serious wood decay include cracks in woodwork and joints that have opened up. Both provide an easy path for water seepage. Trapped moisture can foster peeling paint, wood decay and insect infestation. Open joints and cracks should be checked for evidence of more serious decay and marked for caulking or repair. Photo: John Leeke.

Tightly sealed connections keep water out. Where individual boards come together, cracks in woodwork and joints can eventually become a major problem (Fig.7). Cracks are primarily caused by movement and water penetration. Movement of structural members beneath the finished woodwork can shift the position of individual boards and trim, breaking open the thin coating of paint over joints. This condition is common on porches with shallow foundations that are subject either to annual winter frost heaving or where soil conditions undergo major seasonal changes in moisture content. Changes in the moisture content of the wood itself due to repeated wetting and drying or changes in seasonal humidity can also cause noticeable expansion and shrinkage across the width of a board. This provides opportunities for water to penetrate unprotected areas.

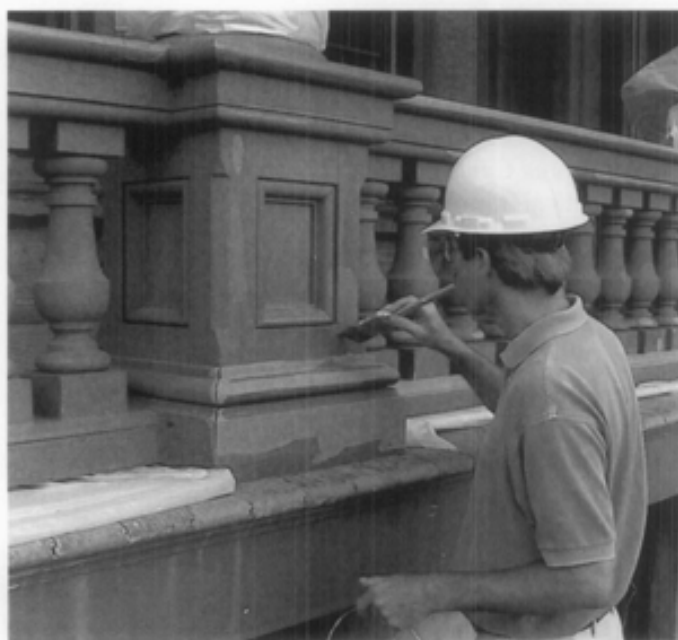
Figure 8. Decay can start when wood is left exposed to the weather or where joints open up. An inexpensive way to extend the life of the existing porch paint without jeopardizing the historic material is spot paint and caulk where needed every year or two. This cost-effective procedure is particularly effective in maintaining wood porches where the exposure to weathering is high. Photo: John Leeke.

Spot painting and resealing of open joints should be undertaken at least every other year (Fig. 8). Heavily used stair treads may require more frequent paint touchup. When peeling paint or bare wood is evident, inspect to ensure it is not signaling deeper problems, such as decay. With sound wood, scrape off the loose paint, sand, prime, and repaint the area. Where lead paint is present, appropriate lead hazard precautions and procedures apply. Only top-quality exterior primers and paints are recommended, selecting for the deck and stairs specially formulated paints. Where wood porch steps are exposed to moisture, grit added to the wet paint during application will help improve safety.

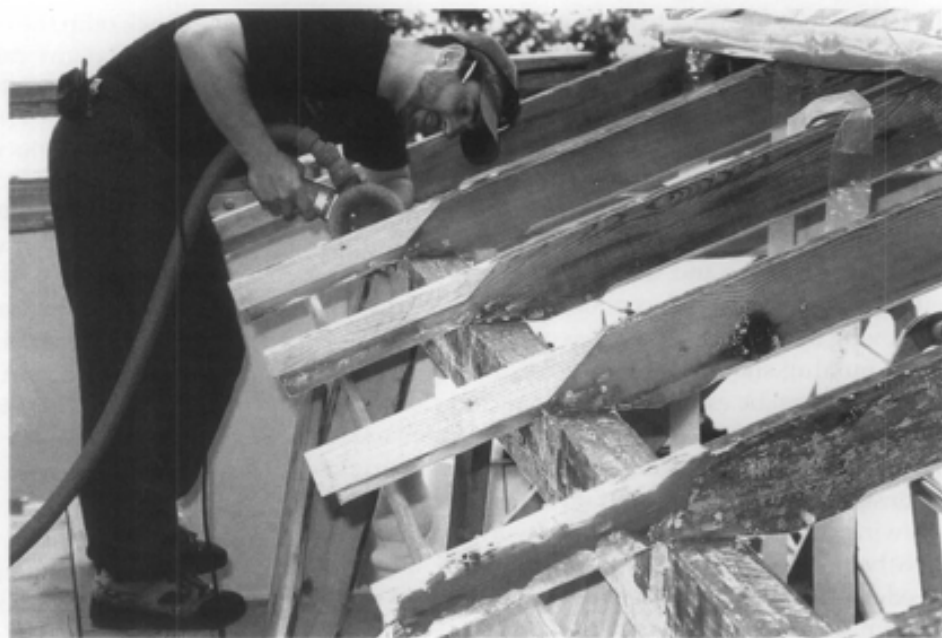
Figure 9. The ends of porch roof rafters are often susceptible to moisture decay. When concealed by a soffit or ceiling, rafters can be repaired by adding new sister boards. Where roof rafter ends are exposed, splicing new wood onto the old (dutchman repair) and use of epoxy consolidants and fillers both preserve sound historic fabric while retaining the historic appearance.

This traditional technique is often used to repair localized cases of decayed wood and, when undertaken with skill and care, will serve as a permanent repair (Fig. 9). If the damaged area has a structural function, temporary bracing or other support will be necessary. Otherwise the first step after removing any paint around the damaged area is to chisel or mechanically remove the decayed wood. It is best to use the same type of wood being replaced and the new or recycled wood should be seasoned to avoid shrinkage. The repair procedure involves cutting a piece of wood, called a *dutchman*, slightly larger than the area of damage that has been cut out. The dutchman then is laid over the damaged area and an outline scribed into the original wood surface below. Next, a chisel or router is used to follow the scribed line to form an opening in the existing wood for the new piece.

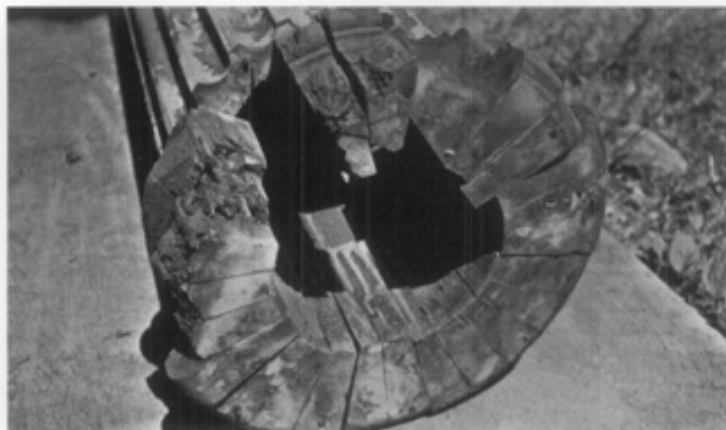
Figure 10. This nineteenth century porch column is made of wood staves, similar to the way a wood barrel is put together. After replacing the torus and making dutchman repairs to the apophyge along the base, the column and pedestal are ready to be reinstalled on the porch. Photos: NPS files.

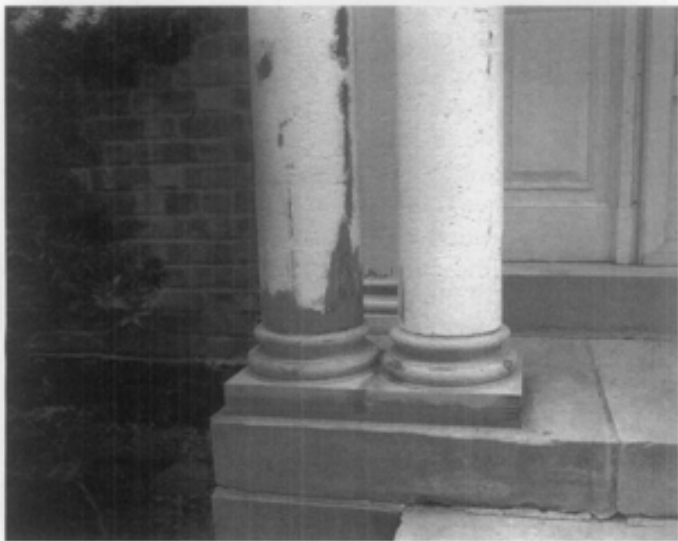
Figure 11. The lower shaft of the porch columns had decayed as water wicked up through the end grain (top). The column shafts were repaired in place by cutting out the deteriorated wood and making repairs using epoxy consolidants and fillers. (bottom). The column bases were replaced. Photos: Paul Marlowe, Marlowe Restorations.

When plinths and bases are deteriorated beyond repair, they can be replaced without replacing the column shaft, which may still be in good condition or require only minor repairs at the bottom. Such replacement will involve temporary shoring for the roof. One-story columns and shafts are often more easily removed during this work, while taller columns are sometimes supported in place. If only a few plinths or bases are deteriorated, it is often economical to have new ones made of wood to match. If numerous plinths and bases are deteriorated, replacing with bases made of rot-resistant materials can make economic sense; however, care must be taken to ensure that all the visual qualities including design, size, shape, color and texture of the historic part are matched (Fig. 11).

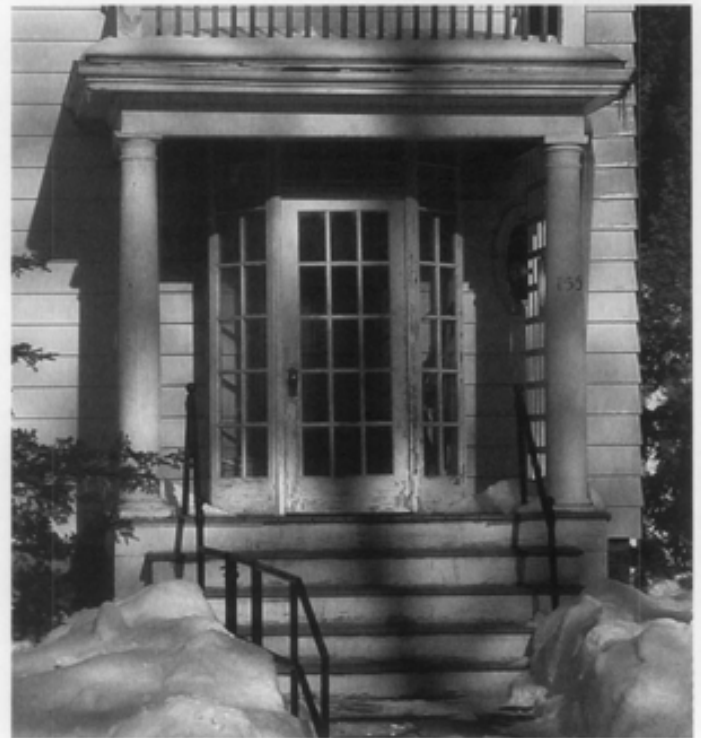
Figure 13. Particularly in New England, there is a cold weather tradition of installing temporary glass and wood panels at entrance doors, thereby creating an enclosed vestibule. These enclosures with their small divided lights were generally removed in the spring.

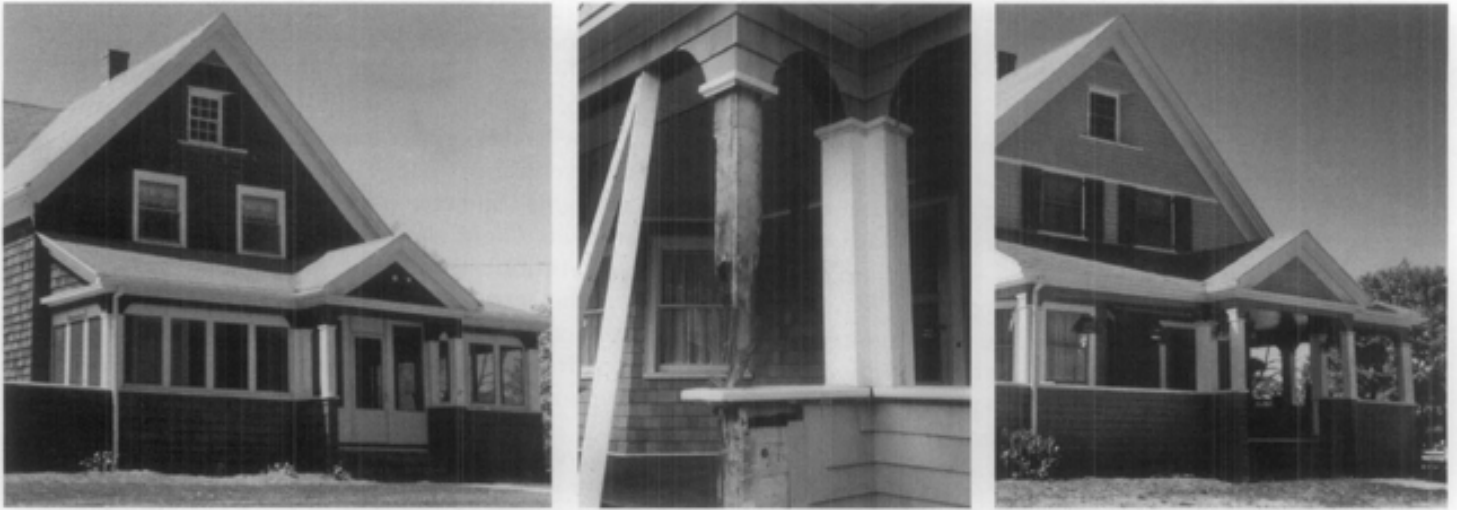
Figure 14. The enclosure of a prominent porch can dramatically change the historic character of a building. The L-shaped porch on this 1896 Shingle-style New England residence was later enclosed with aluminum windows and screens. Recent owners elected to reopen the historic porch. Among the other work, it was necessary to correct structural damage, as with this post, where beneath the wood casing carpenter ants had done serious damage. In reopening the porch, the historic character of the residence has been brought back and the traditional use of the porch is once again enjoyed. Photos: Mark Landry, Landmark Services.

Is the enclosure necessary? An enclosure will undoubtedly change the porch as a historic feature and may result in damage or loss of historic materials. Depending on the significance of the porch and the nature of the building, a new porch enclosure may also change the historic character of the building. Consideration should be given to alternate solutions such as recapturing underutilized space in an attic or basement (Fig 14).

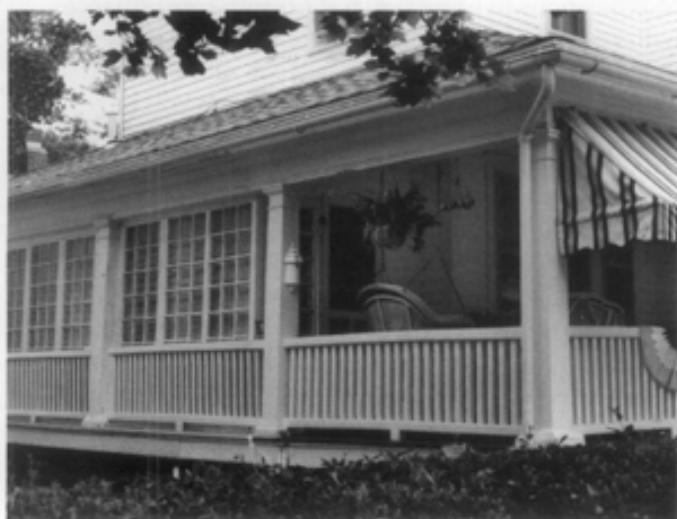
Figure 15. A traditional technique of porch enclosures still used today involves the insertion in each column bay of one or more glass enclosures set in wood frames. This enclosure is properly set back an entire porch bay from the front of the house and utilizes traditional light divisions and wood frames. The balustrade, added here for illustration purposes, shows the importance of retaining this linear feature within the enclosed bays. Photo: Charles Fisher.

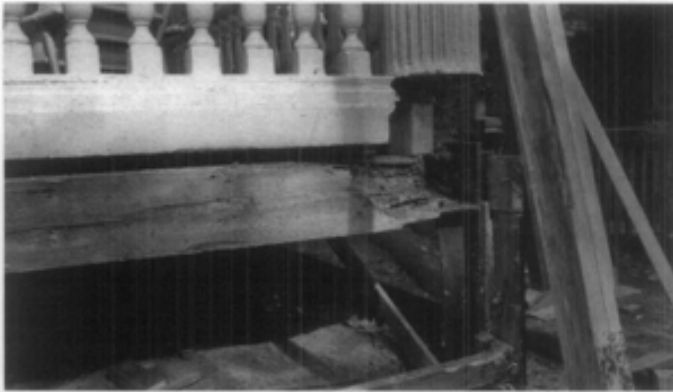
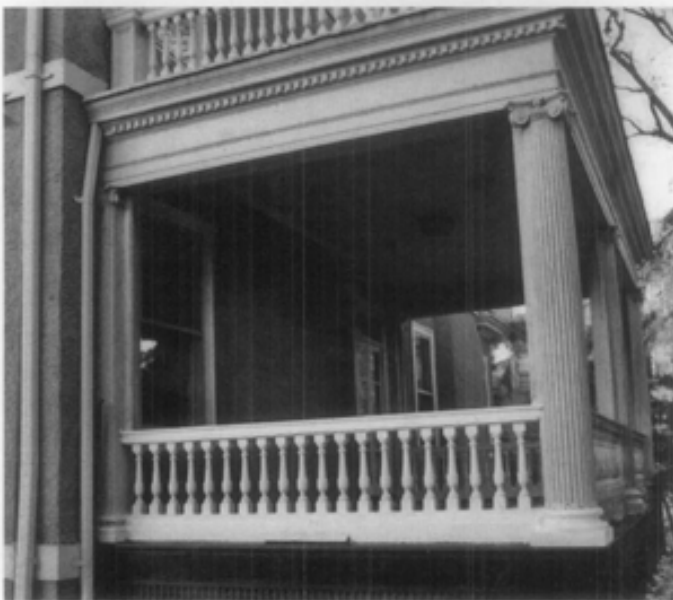
Figure 17. The porch's structural system must be capable of supporting today's loads. In this case moisture led to the deterioration of the wood girder at the corner, creating a major structural deficiency (top). A new solid timber was installed to replace the girder (middle); alternatively a built-up girder could have been used since a fascia board would conceal it. The column base was repaired and portions replaced and the balustrade and column reset and secured (bottom). Photos: Paul Marlowe, Marlowe Restorations.

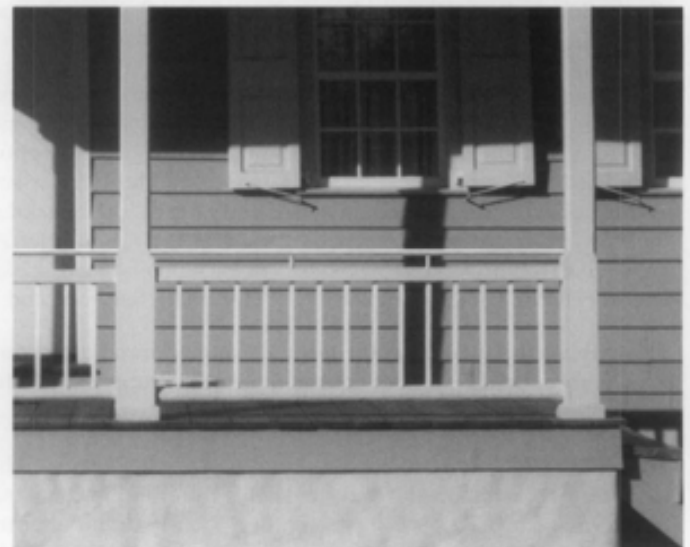
Figure 19. Historic porches generally have railings that measure 28 to 30 inches in height from the floor. When additional height is necessary for safety, a simple rail, added for illustration purposes in this photograph, can usually be installed above the historic railing. Not only does this treatment allow retention of the historic balustrade, but it also has a minimum impact to the appearance of the porch. Photo: Charles Fisher.
