THE SECRETARY
OF THE INTERIOR'S
STANDARDS FOR
REHABILITATION &

ILLUSTRATED
GUIDELINES ON
SUSTAINABILITY
FOR
REHABILITATING
HISTORIC
BUILDINGS

U.S. Department of the Interior
National Park Service
Technical Preservation Services

2011

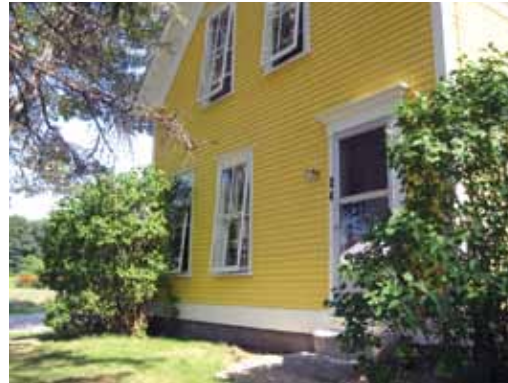
25

Not Recommended: [27] A broken sash cord can be repaired easily and does not justify replacement of the window.

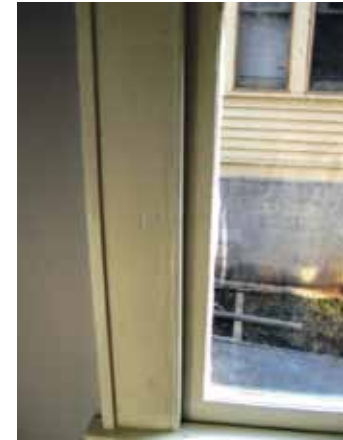
53

Recommended: [52-53] The original proportion and relationship of the wall to the windows and trim, which is important in defining the character of these historic interior spaces, has been retained here.

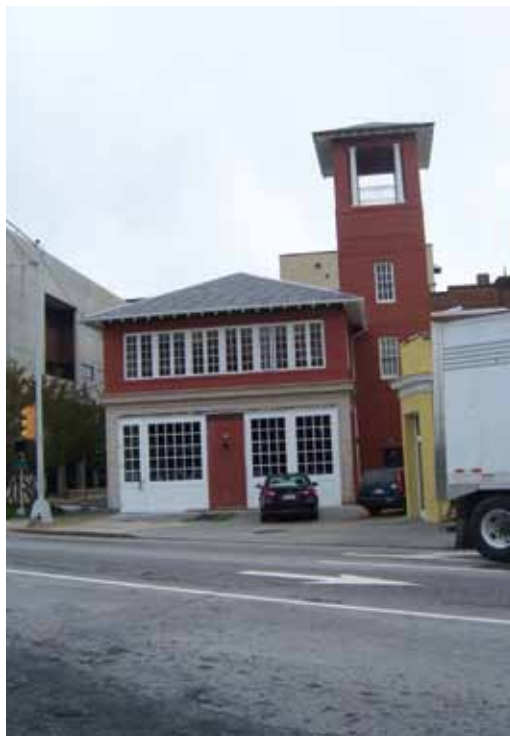
68

[68-69] A geothermal system, evidenced by a panel in the sidewalk, was installed on the site of this historic firehouse during rehabilitation.

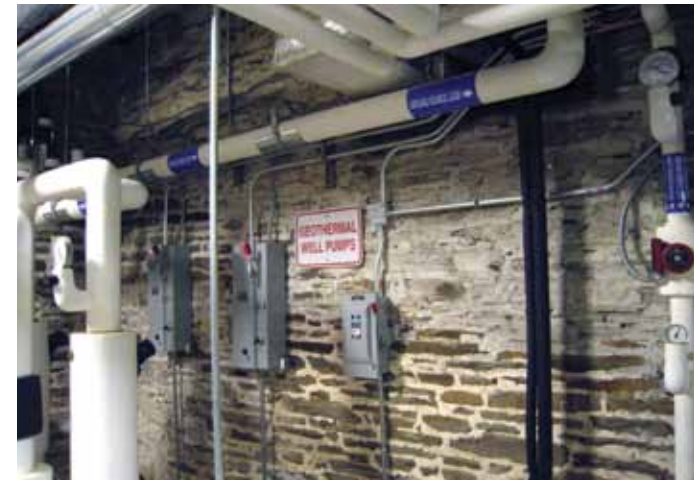
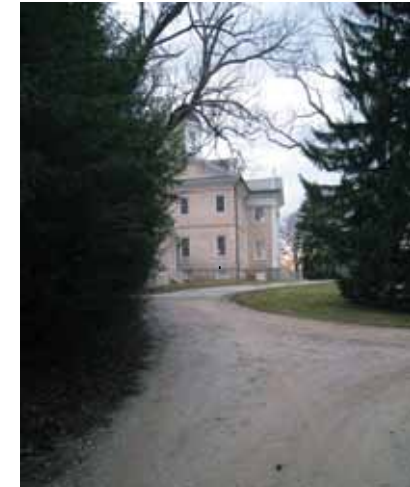
Recommended: [70-71] A geothermal system was installed on the property of this historic mansion, but only after an archeological investigation was conducted of the grounds.

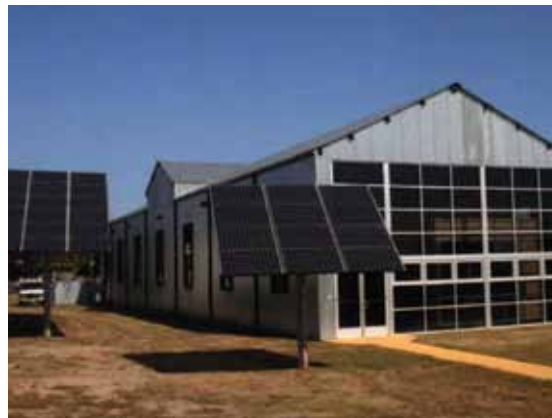
74

Recommended: [74] Free-standing solar panels have been installed here that are visible but appropriately located at the rear of the property and compatible with the character of this industrial site.

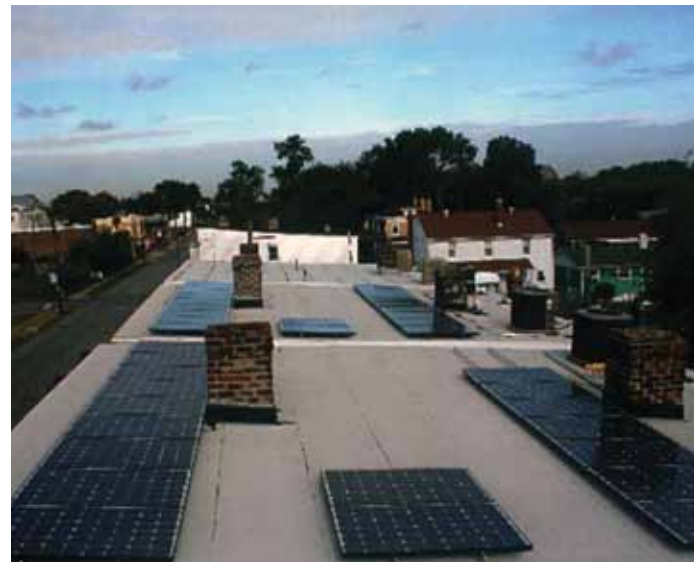
78

Recommended: [76-77] Solar panels, which also serve as awnings, were installed in secondary locations on the side and rear of this historic post office and cannot be seen from the front of the building. [78] Solar panels placed horizontally on the roof of this historic building are not visible from below.

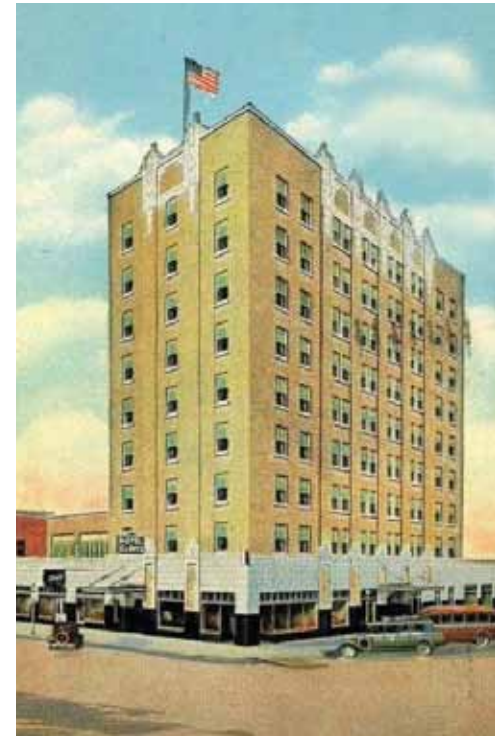
Not Recommended:
 [83-84] This historic hotel is a prominent and highly visible local landmark, and the wind turbines proposed to be added on the roof would negatively impact its historic character.

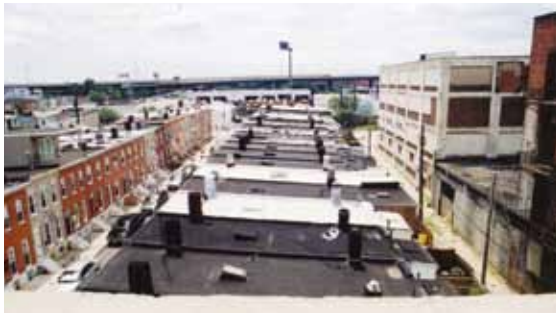
Recommended: [85-86] A cool or green roof is best installed on a flat roof where it cannot be seen from the public right of way and will not negatively impact the character of the historic building.

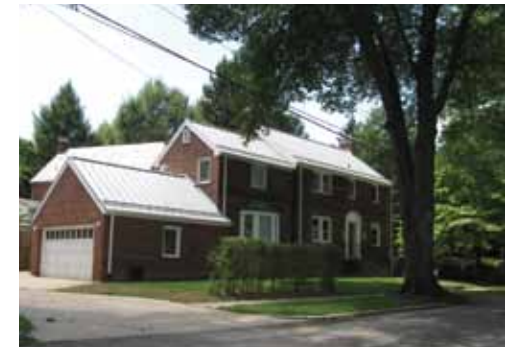
88

Not Recommended: [88] This new, cool white metal roof is not an appropriate material or color for this historic mid-20th century house.

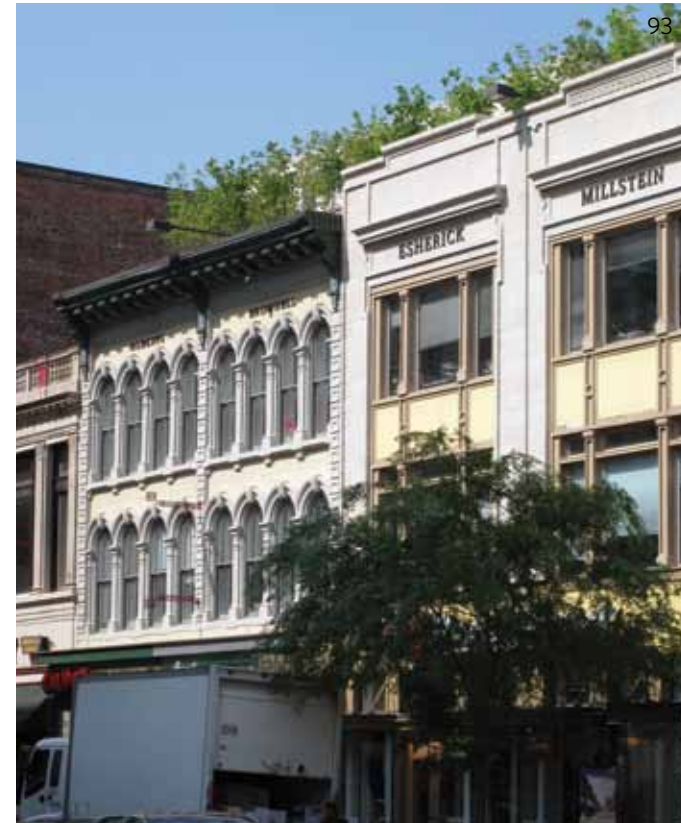
93

Not Recommended: [93] The vegetation on these green roofs has grown too tall and negatively impacts the character of these historic commercial buildings.

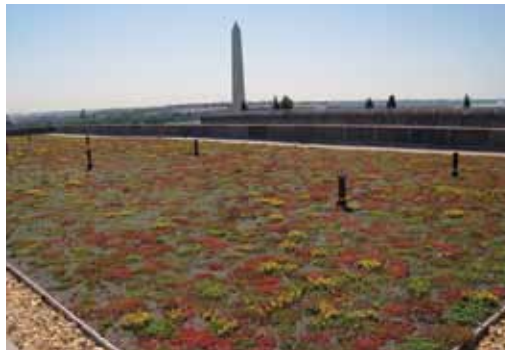
Recommended: [89-92] Low-scale and sustainable native plants are appropriate for these roof gardens on historic buildings.

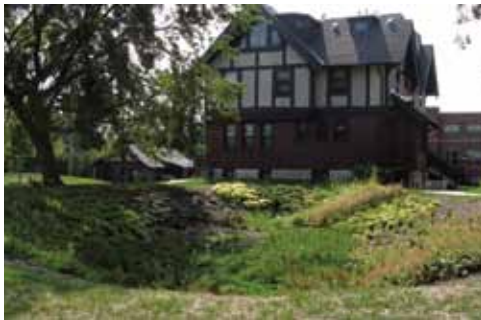
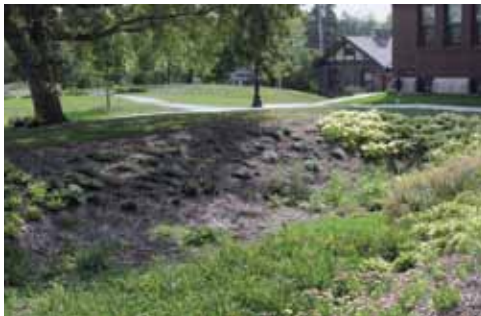
Recommended: [98-100] Rain gardens and rain-water collection tanks are features that may be added to a historic property to improve storm-water management and increase on-site water use.

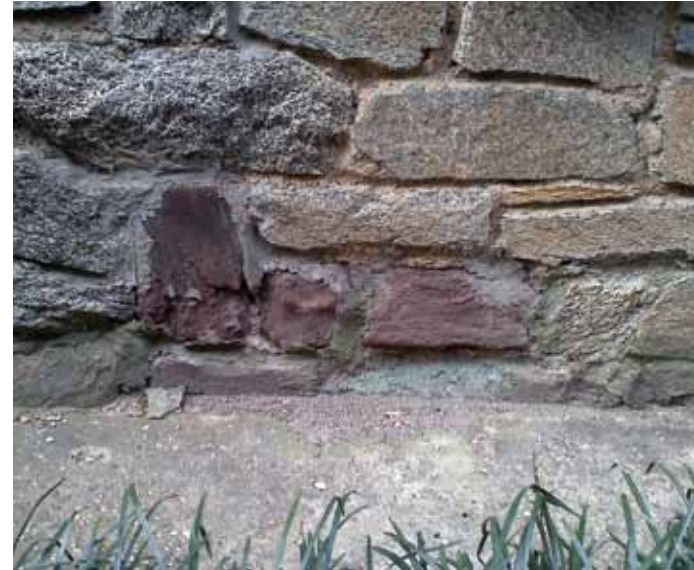
101

Not Recommended: [101] Splash back from the impermeable concrete paving next to the foundation is damaging these stones.
