Tech Notes

TEMPORARY PROTECTION

VILLARD HOUSES

Temporary Protection of Historic Stairways during Rehabilitation Work

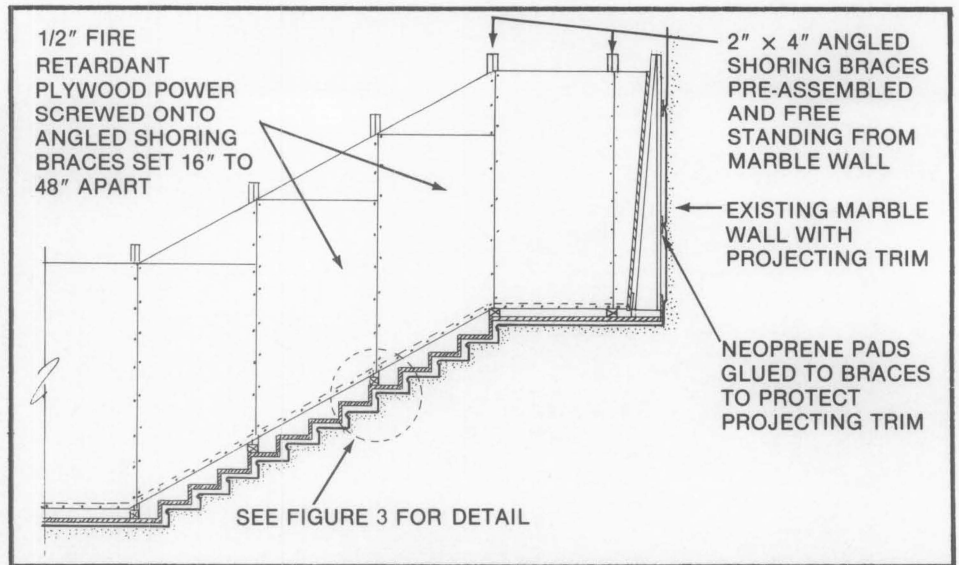
Figure 2. A system for protecting the decorative staircases was drawn and specified by the project architect. Drawing: Christina Henry.

The basic system consisted of using plywood and padding to cover the walls, steps and balustrade without using any anchoring devices that would damage historic material (see figure 2). Screws were used rather than nails in fastening the wooden temporary pieces together to lessen the chances of accidental damage to historic fabric and to facilitate disassembly.

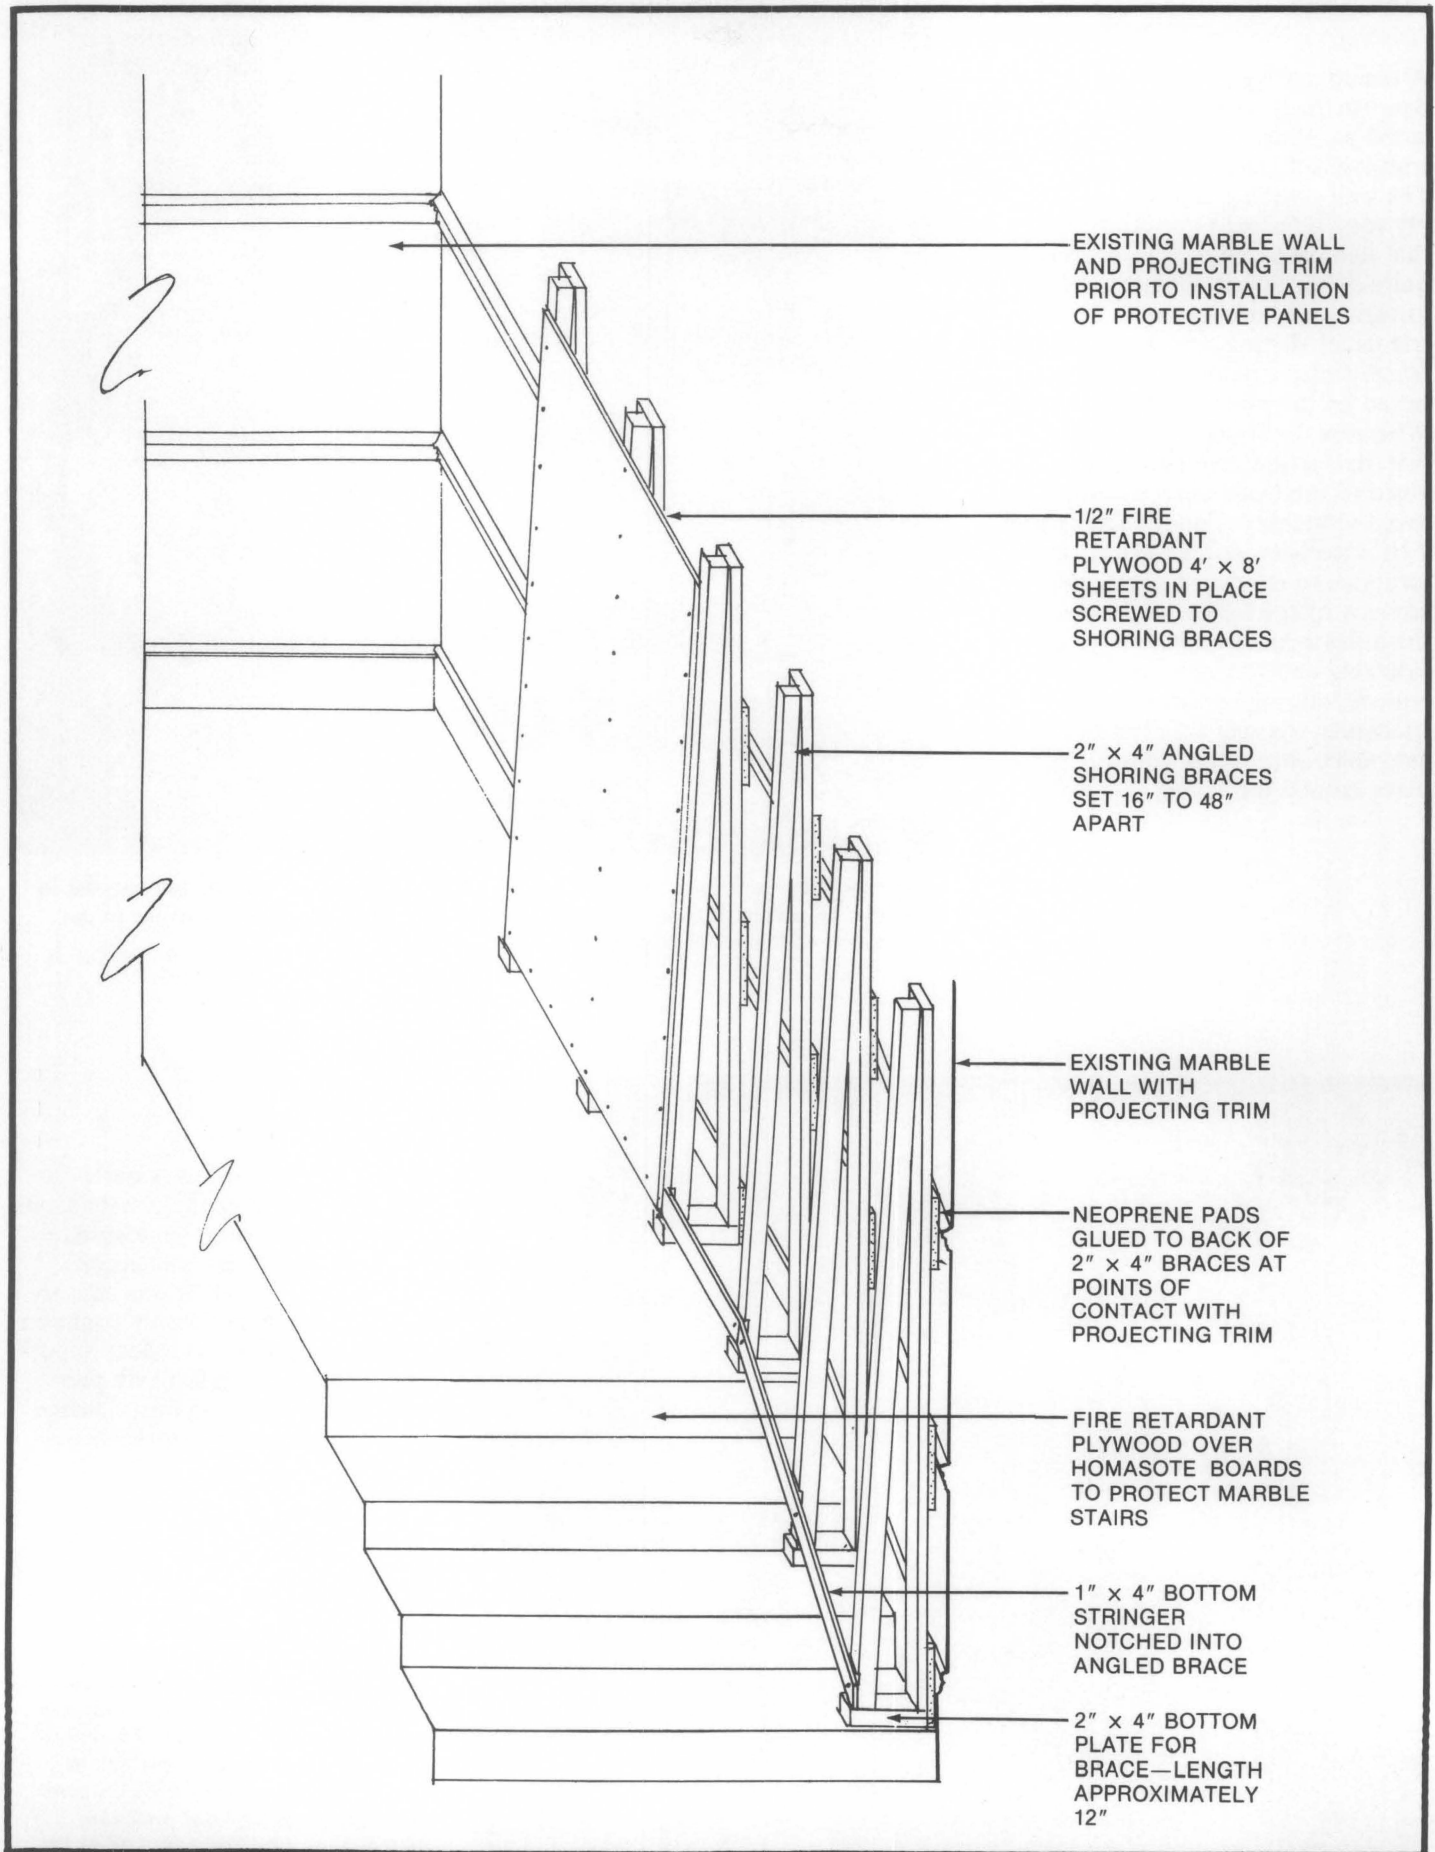
Figure 7. The temporary wall covering going up the stairs consisted of plywood mounted on a wooden frame. Neoprene padding was used where the frame abutted the historic walls. The method shown here requires no fasteners to be used, avoiding possible damage to the decorative walls. Drawing: Sharon Park, A.I.A.

A temporary eight foot high wall was constructed to protect the historic wood paneling, marble and decorative trim typically found along the stairs. The wall covering consisted of plywood attached to a wood frame that had been designed so as to require no anchor attachments to the historic walls (*see figure 7*). The triangular shaped sections of the frame which supported the plywood rested on the plywood floor covering. Wherever the frame abutted historic material, a thin neoprene pad was glued to the wood beforehand to avoid scratching. For greater rigidity, 2 by 4 sleepers were added in various locations to connect the triangular sections of the frame. In cases where the historic handrail protruded considerably and was not temporarily removed during construction, the triangular sections were not pre-assembled, but rather constructed in place around the railing.

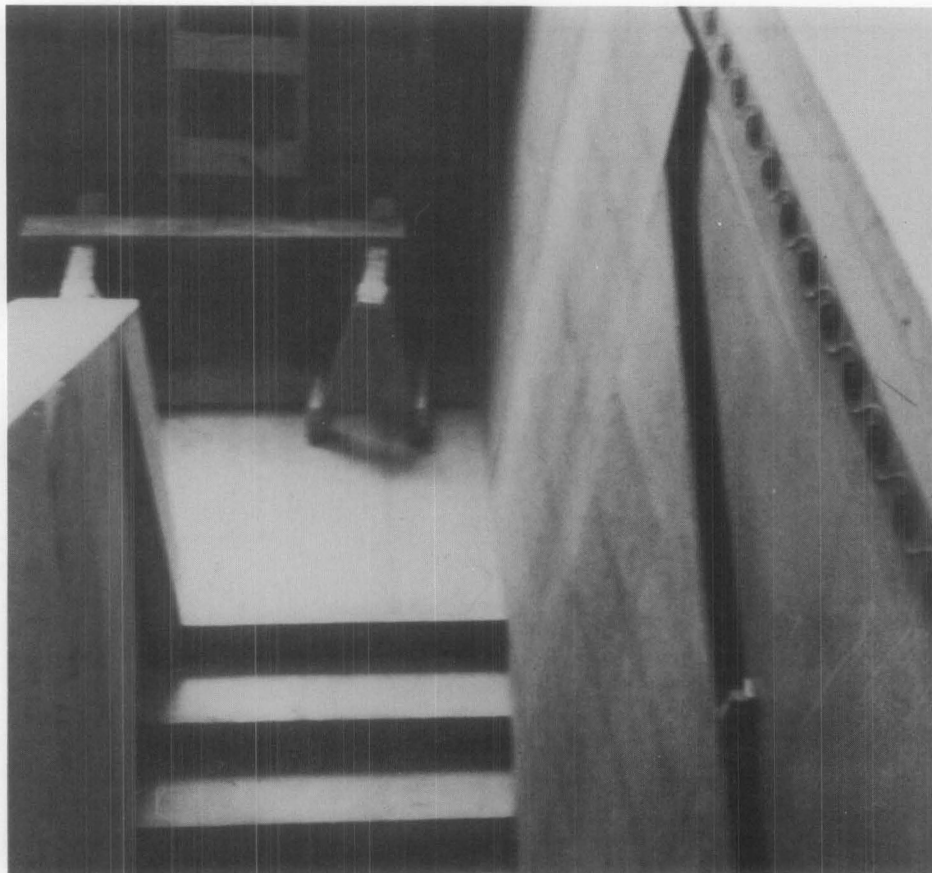
Figure 6. The balustrade on the left side of the photograph has been entirely encased in plywood to protect it from damage. Note that the kick-out at the end is due to the protrusion of the newel post. Photo: Charles Fisher.

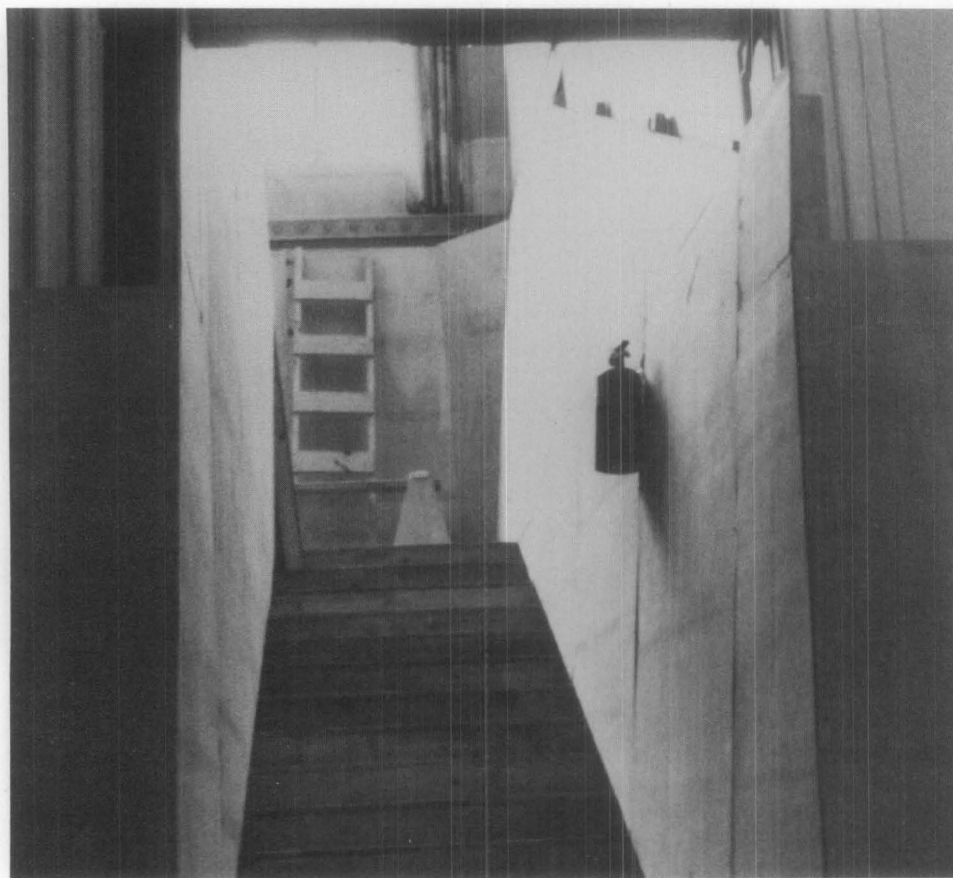
Figure 8. The entire historic staircase has been protected against possible damage during the renovation work. The balustrade on the left has been encased in plywood; the floors have been covered; and a temporary plywood wall constructed, shown on the right and at the landing. Note that the plywood wraps around the wall at the entranceway. Photo: Charles Fisher.

The cost of this work was quite modest and the protective system was sufficiently flexible to be adapted to staircases of different dimensions, designs and material. It was easy to construct and required only common fasteners and materials. Most importantly, this system effectively protected the staircases against damage during the renovation work (*see figure 8*).
