Chapter 7: Iron and Iron Alloys

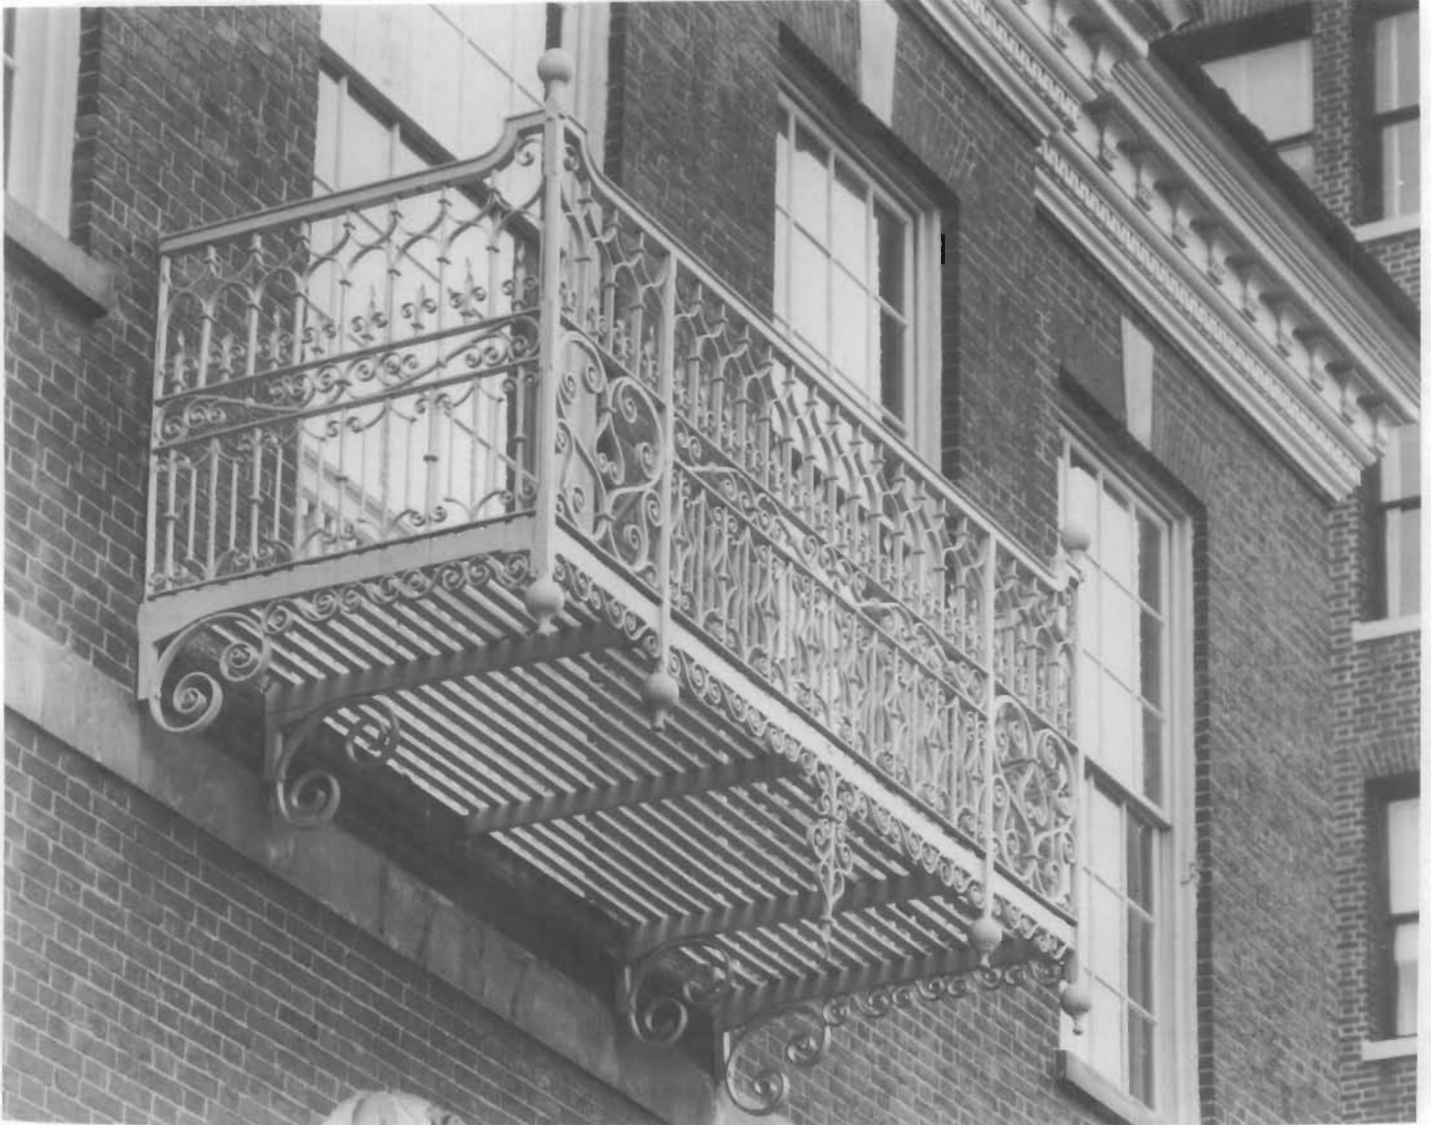
Figure 51. Wrought-iron Balcony, Samuel Wheeler, blacksmith; Congress Hall, 1787-1789, Chestnut Street at 6th Street, Independence National Historical Park, Philadelphia, Pennsylvania. Built as the Philadelphia County Court House, this building was used by the Federal Congress from 1790 to 1800. In 1961, the National Park Service removed many layers of paint from the balcony over the front door prior to its restoration. During the process, the name and date "S. Wheeler 1788" was discovered. The inscription was located on the inside of the balcony facing the window. Just a few layers of new paint have already obscured the marking. (Jack E. Boucher, NAER)

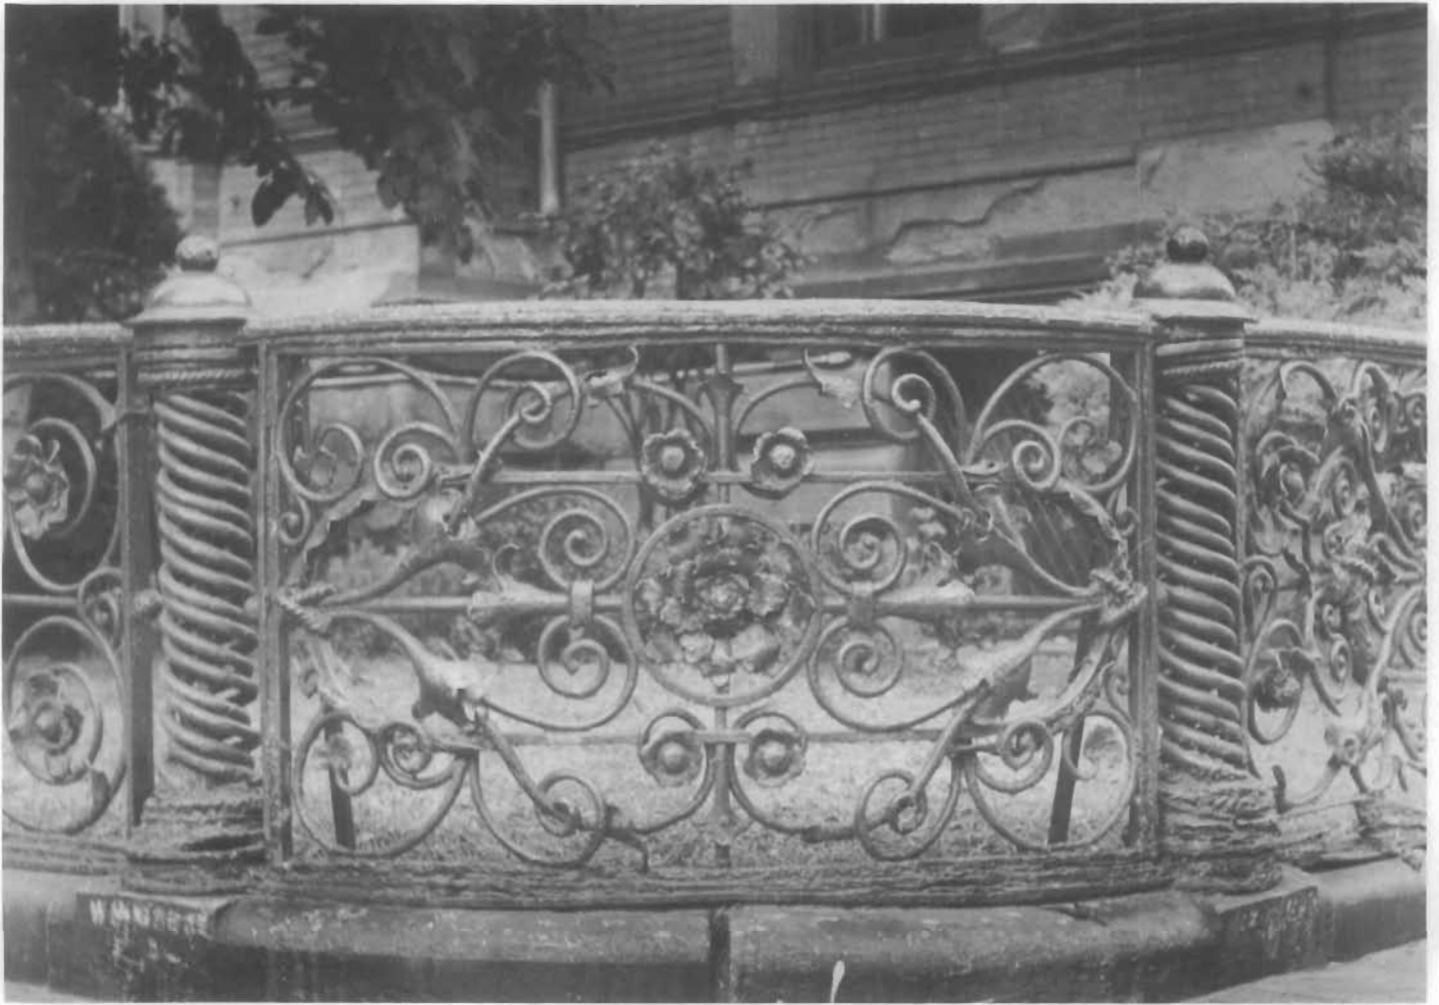
Figure 53. Wrought-iron Fence, Frederick Ames Mansion, 306 Dartmouth, Boston, Massachusetts, 1872; John Sturgis, architect. *This fence was fabricated by hand from iron bars; square and round sections were hot-worked into spirals, circles, and scrolls. Even the fence posts are compact spirals of strong rods shaped about a central support to make them rigid. (Esther Mipaas)*

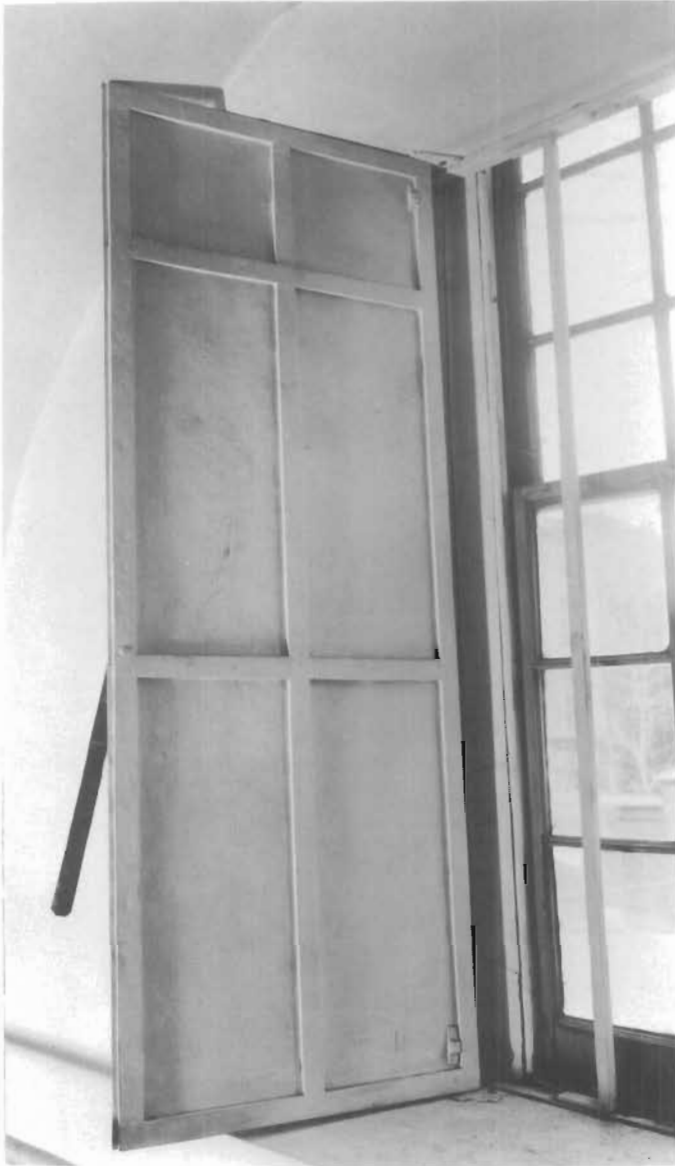
Figure 54. Wrought-iron Shutters, Arch Street Meeting House, 302-338 Arch Street, Philadelphia, Pennsylvania, 1803-1804; Owen Biddle, architect and master builder. The shutter is on the window of the "fireproof" vault used to store records. The iron shutter has a frame of hand-forged rectangular bars to which a series of rolled sheets was riveted. (George Eisenman)

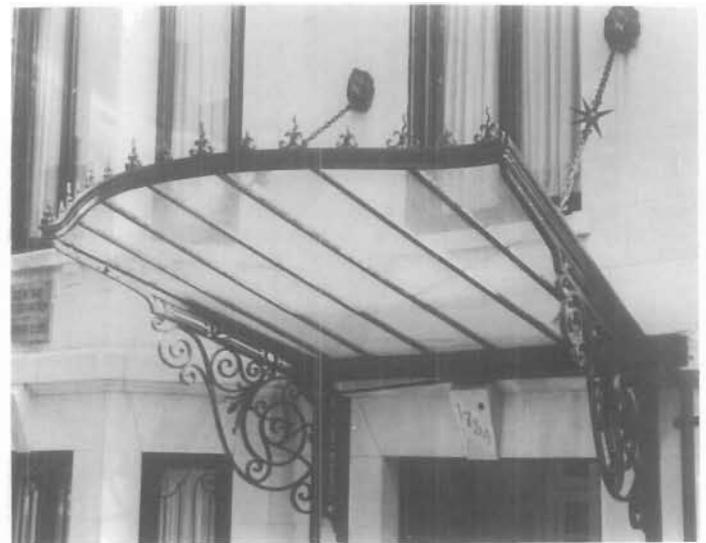
Figure 56. Wrought-iron and Glass Canopy, 1734 N Street, NW, Washington, D.C., ca. 1885. Iron is found in a variety of forms from strap hinges to fragile glass and iron combinations—such as the canopy protecting the entrance of this elegant townhouse. Glass panels were set in an iron frame with fleurs de lis on the front edge and flourishes as supporting brackets. (David W. Look)

Later 19th-century buildings display decorative wrought-iron and cast-iron stair railings, porches, balconies, verandas, roof cresting, lamps, grilles, fences, and canopies (figure 56).

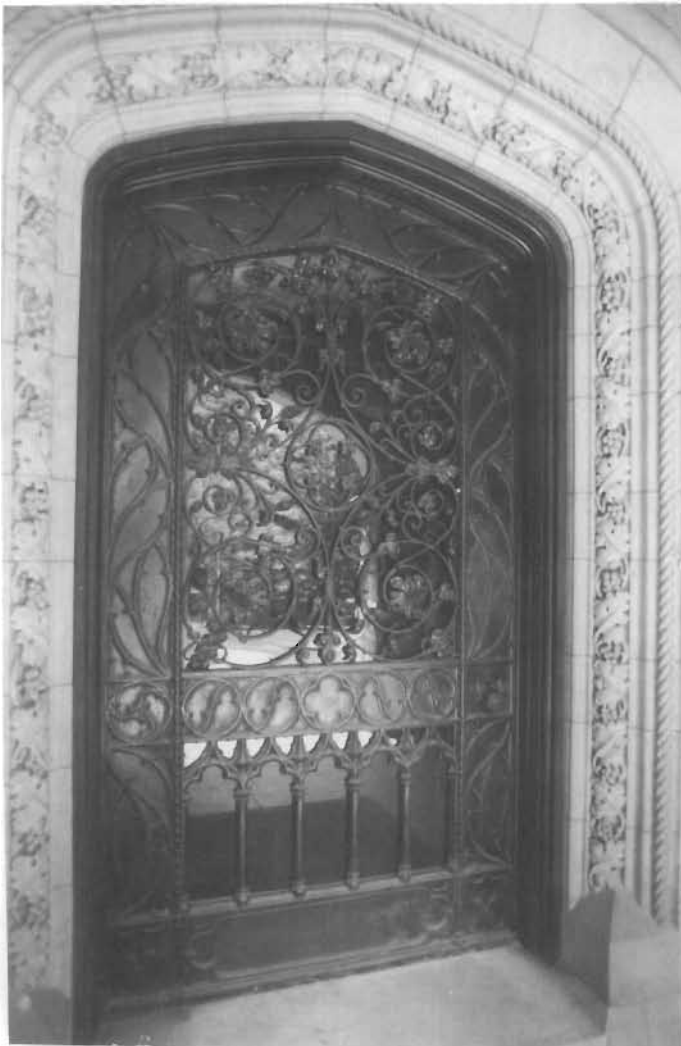
Figure 57. Wrought-iron Door, Joslyn Castle, 3902 Davenport Street, Omaha, Nebraska, 1902-1904; Winslow Bros., foundry, Omaha. The one-ton iron door to the entrance hall of this Scottish baronial-style mansion is precision balanced and swings easily. A hand-forged wrought-iron grille consisting of scroll and vine motifs is set in Gothic cast-iron framing. (Robert Peters)

At the end of the 19th and beginning of the 20th centuries, there was a rebirth of the crafts in America, of which ironworking was a part (figure 57). Fine artistic expressions were achieved in wrought iron by blacksmiths such as Samuel Yellin in and around the Philadelphia and Washington, D.C., areas (figure 58). Wrought iron was used on every type of building from residences, to Art Deco office buildings and stores. Although most blacksmiths used traditional methods, commercial ironworking firms began to use welding instead of rivets and collars and to use machines to bend and twist bars.

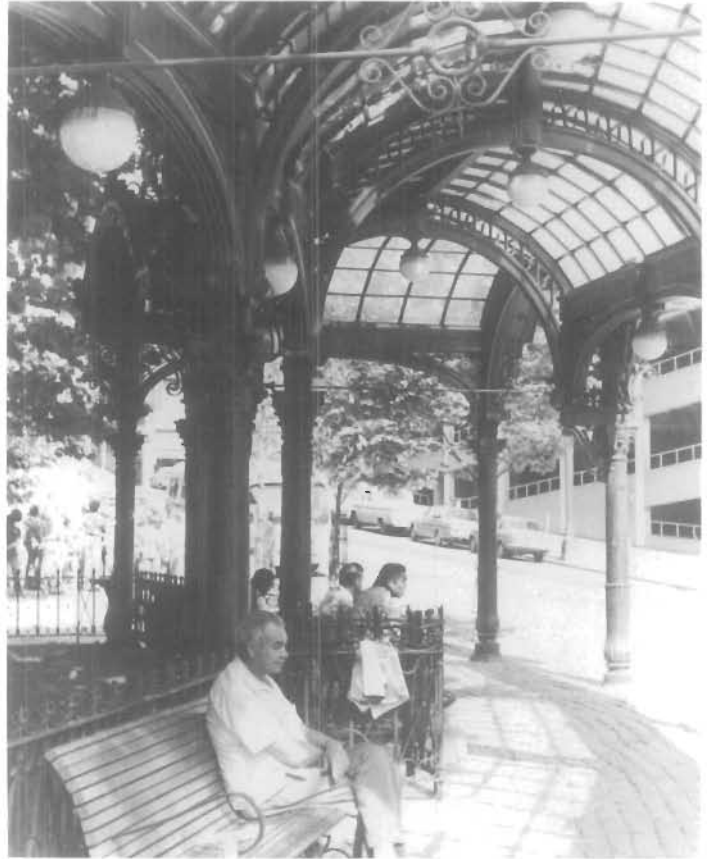
Figure 60. Iron and Glass Pergola, Trolley Station, Pioneer Square, Seattle, Washington, 1909. This station, which has become a symbol of the revival of the city's old commercial area, consists of glass panes held between ribs of wrought iron supported by cast-iron arches and columns, both of which are in compression. The wrought-iron tie rods (top of photo) take the outward thrust of the arches; thus, the rods are in tension. Iron members in tension had to be made of wrought iron because cast iron is suitable only for compressive loads. However, iron members in compression could be of either cast iron or wrought iron, whichever was more economical and convenient for the iron shop to fabricate. By the late 1960s, most of the glass in the pergola was broken and the iron was rusting. Preservationists, planners, and city officials worked together to rehabilitate Pioneer Square with the pergola as its centerpiece. Wooden patterns were carved from which sand molds were made to recast the lost and broken iron parts. With new lamps and fresh paint, the pergola was rededicated in 1973. (John Jochman, Seattle Office of Historic Preservation)

Often the hidden iron bars, straps, pins, U-shaped bridle-irons, and tie rods are revealed only at times of alteration or demolition. Star-shaped anchors on the exterior brick walls of old buildings mark the location of wrought-iron tie rods, sometimes called straps, which may be tied to wooden joists inside or may run through the structure to hold the wall in plumb. Often the anchors, which are of cast iron, take the form of stars, but they may be S-scrolls or fancier devices (figure 59). Occasionally tie rods are visible and are even ornamented, as in the Trolley Station in Seattle's Pioneer Square (figure 60).

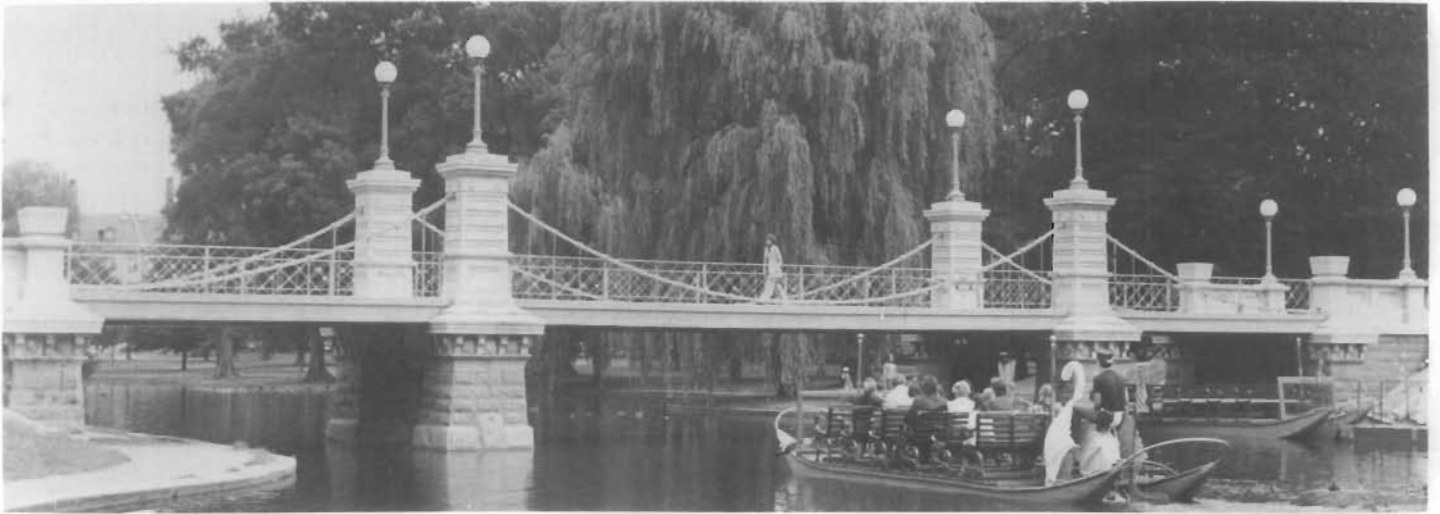
Figure 61. Suspension Bridge, Public Garden, Boston, Massachusetts, 1867; ELEMENS HERSCHEL and WILLIAM PRESTON, engineers. Popular among Bostonians, this small suspension bridge originally consisted of plank flooring hung from chains made of flat wrought-iron links. In 1921 the bridge's deteriorated wood was replaced with steel beams; the bridge was reinforced in 1975 with more steel and concrete. Although the deck has been replaced, the masonry piers and the chains hung between them are still largely original. (Carleton Knight, III)

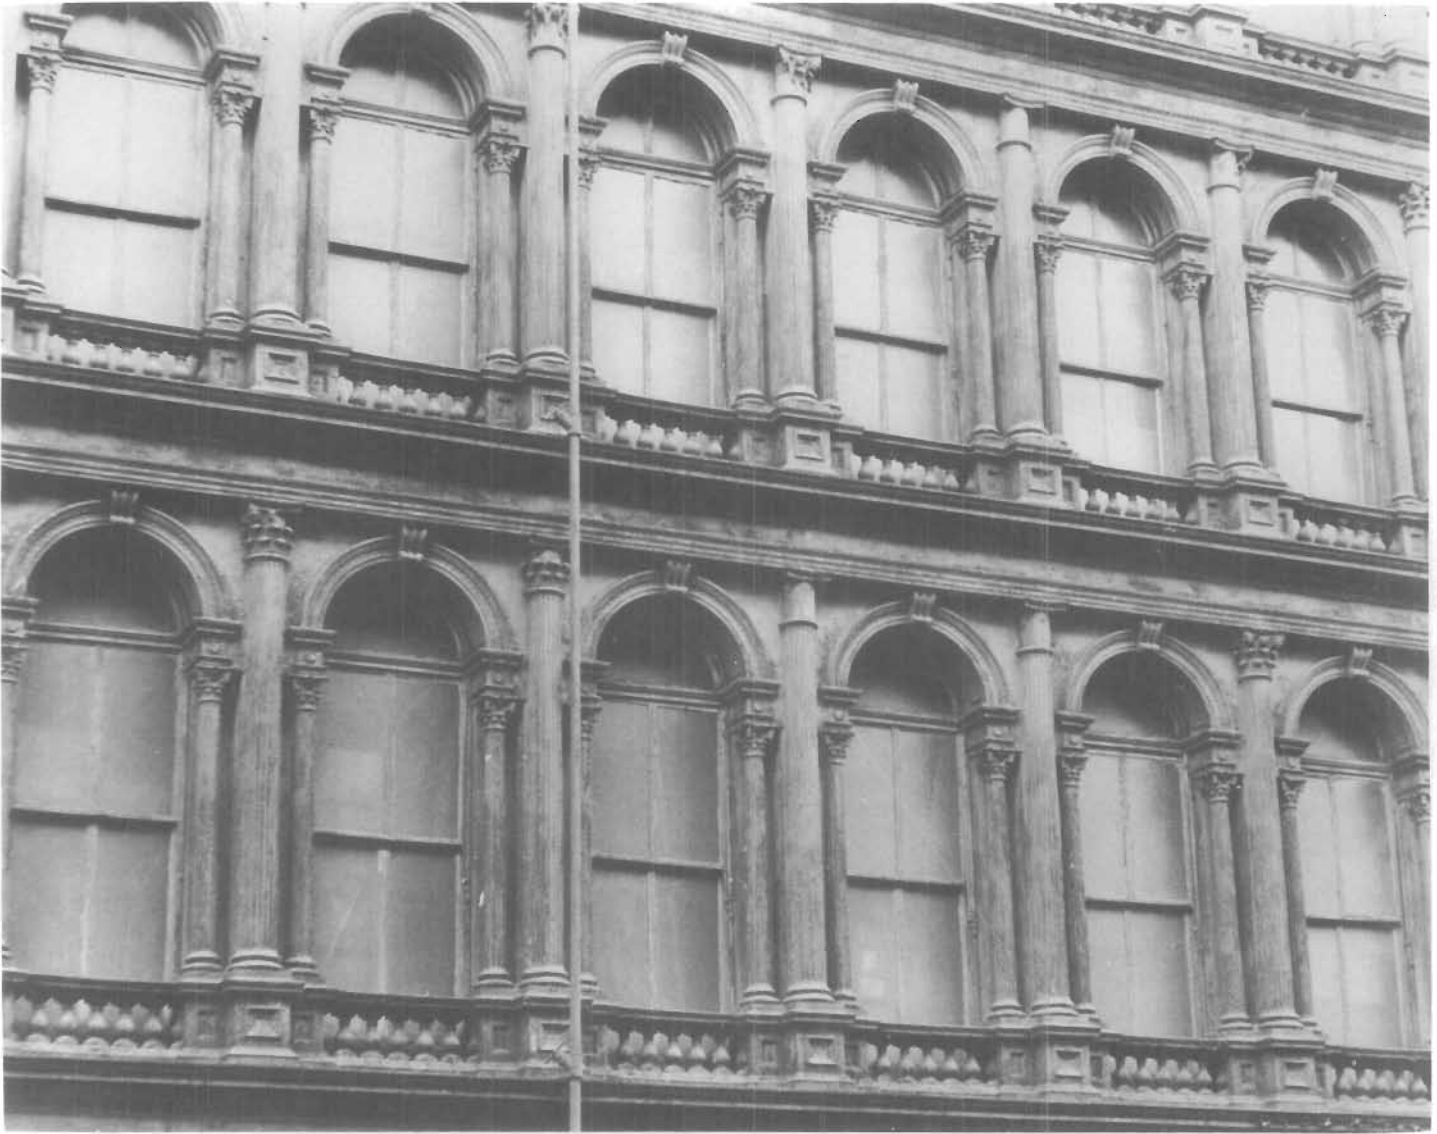
Figure 65. Cast-iron Haughwout Building, 490 Broadway, New York City, 1856; John P. Gaynor, architect; Daniel D. Badger's Architectural Iron Works of New York City. Some of the best iron front buildings stand in the SoHo area of the city. There are excellent examples of the quality and character of mass-produced 19th-century ironwork. Once foundry patterns were prepared, any number of like building fronts could be cast. The facade of the Haughwout Building consists of a single module, Palladian in character, repeated again and again. The result was an impressive design at a moderate cost. (Clover Vail)

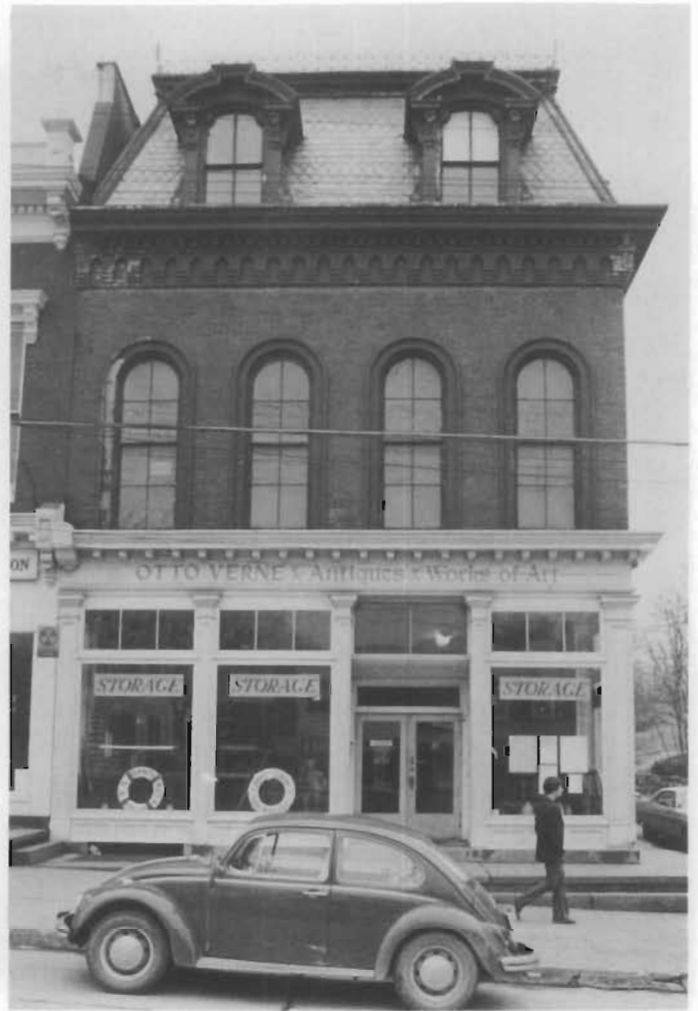
Figure 67. One-story Cast-iron Storefront, 75 Main Street, Cold Spring, New York. This modest facade is typical of cast-iron storefronts popular for decades after their introduction about 1825. Fabricated by both small local foundries and large nationally known companies, storefronts were available in a variety of styles and sizes, and could be ordered from catalogs. The slender piers and columns could support the weight of several stories, usually masonry, while providing the framework for broad expanses of glass. The open front was perfect for the display of merchandise. (Otto Verne)

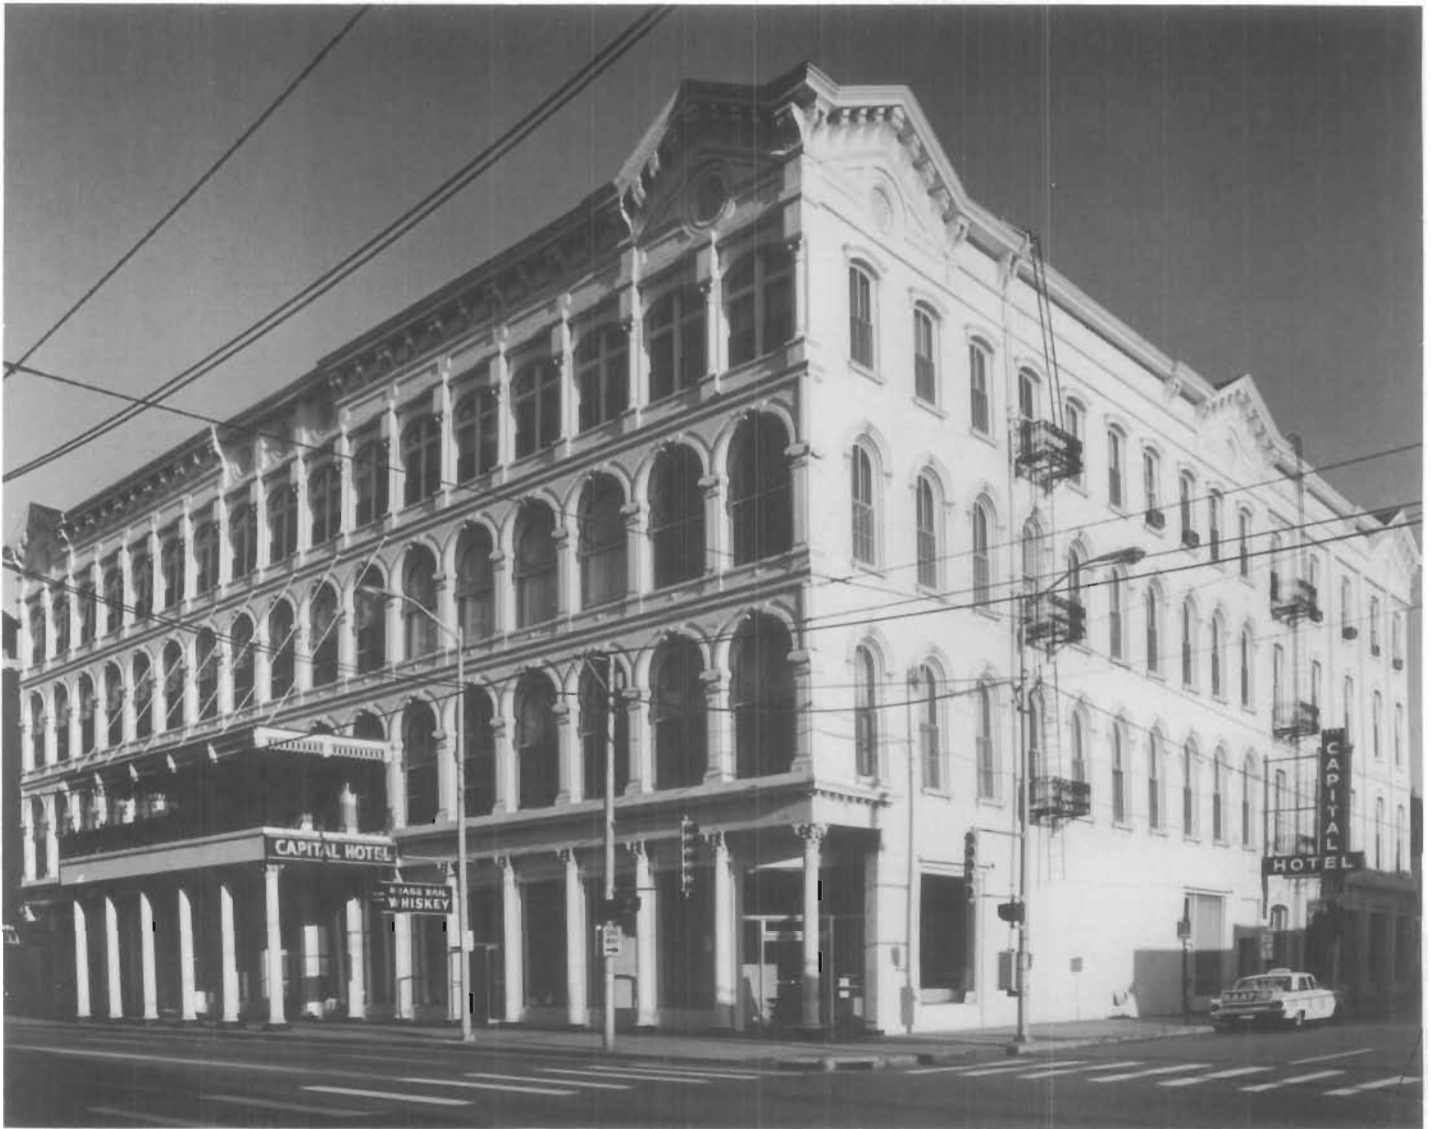
Figure 68. Cast-iron Facade, Capital Hotel (originally the Denkla Office Building), 117 West Markham Street, Little Rock, Arkansas, 1873. The Italianate office building was converted in 1877 into a hotel. Being located near the state capitol, it became popular with politicians and was often used as campaign headquarters. Note the difference in window size in the facade and the masonry sidewall. The larger windows of the cast-iron front provided a great deal of natural light, which the building's original use (offices) required. Although not apparent from a distance, the top story of the front facade and the cornice are pressed sheet metal, probably galvanized iron. (Earl Saunders)

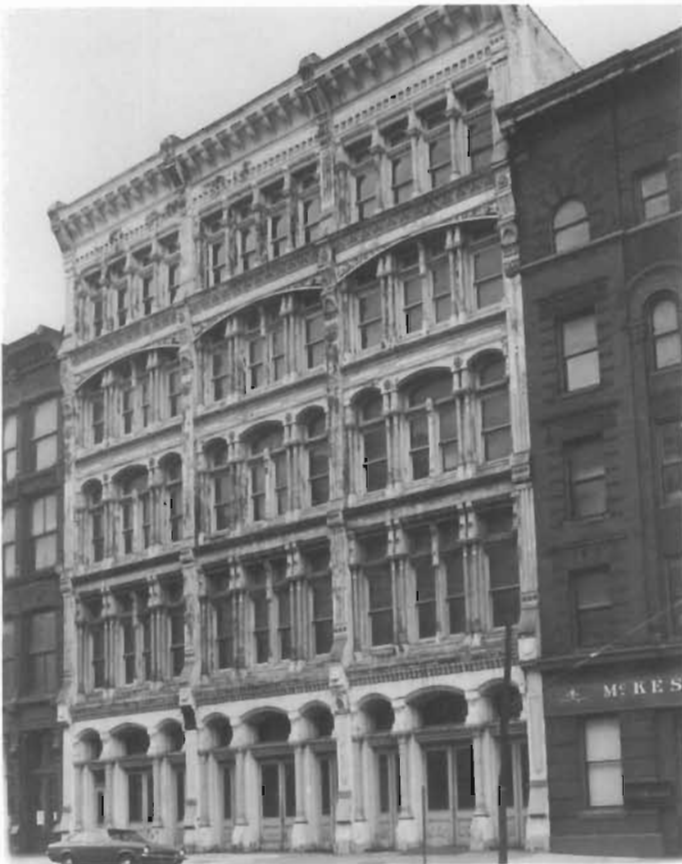
Figure 69. Iron Front Hildebrand Building, 730 Main West Street, Louisville, Kentucky, 1884; Charles D. Meyer, architect. The elaborate iron front of this five-story commercial building in the old downtown section exemplifies the advantages of cast-iron construction. The tall iron columns and colonettes between windows, slender as they are, take the weight of the materials, allowing large openings and light rooms. Iron manufacturers linked the technical requirements of their material with aesthetically appealing design, a fact which is evident even in this unrestored building. (John Albers and Preservation Alliance)

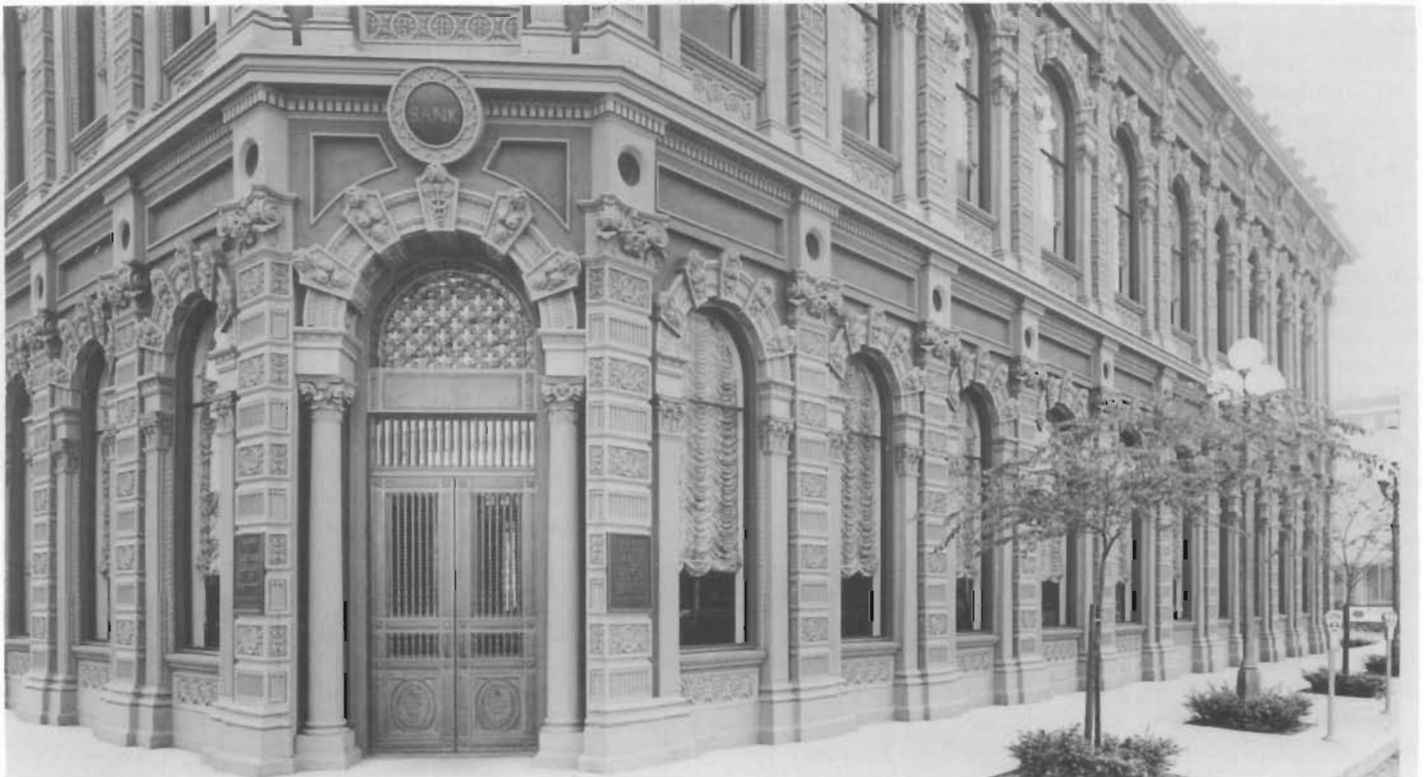
Figure 70. Ladd & Bush Bank (Branch of the U.S. National Bank of Oregon), 302 State Street, Salem, Oregon, 1869, Willamette Iron Works; addition by Skidmore, Owings and Merrill, 1967. The elaborate iron elements of this bank in Salem were a near twin to the Ladd and Tilton Bank in Portland, also cast by the Willamette Iron Works in 1868. When the latter was demolished, its iron facade was saved and later used for expansion of the Salem bank. Additional parts were cast as needed by the original foundry. Note the bronze doors which were added in 1912. (Donald Sipe)

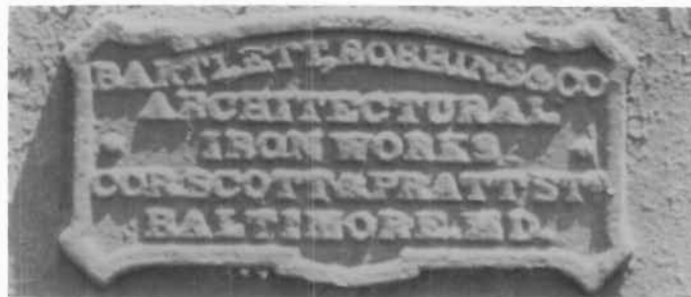
Figure 71. Foundry Label: "BARTLETT, ROBBINS & CO., ARCHITECTURAL IRON WORKS, COR. SCOTT & PRATT ST., BALTIMORE, MD." Foundries often attached labels to their work, a tradition started by bronze founders. A combination of pride and promotion, foundry labels can be found on architectural ironwork all over the country. This label appears on a building in downtown Baltimore. For some years the firm's name was Hayward, Bartlett and Co., under which it cast iron fronts for an attractive row of stores in Richmond, Virginia, recently restored as an office building. (David W. Look)

cast, polished, checked for fit and given a protective coat of paint in the iron foundry. Then they were shipped as separate pieces to the construction site and bolted together to form an entire facade of iron. Assembly of the prefabricated pieces was much faster than traditional construction methods allowed. Often the foundry cast its name on a facade element, usually on the base of a column, pilaster, or pier (figure 71).

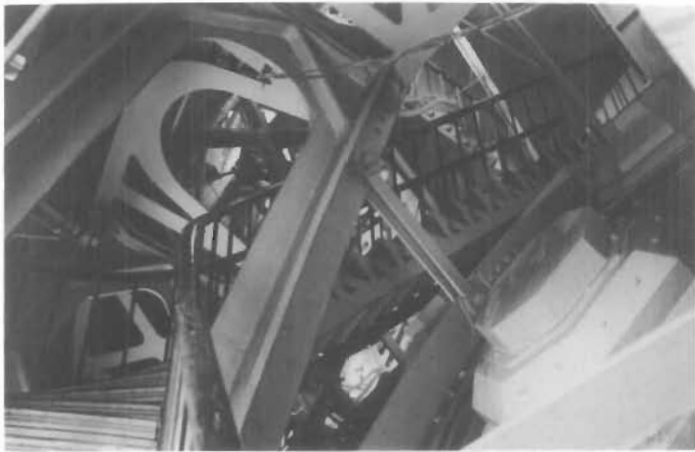
Figure 74. Stairs between the Inner and Outer Domes, U.S. Capitol, 1856–1865; Thomas U. Walter, Architect of the Capitol; Montgomery C. Meigs, engineer. The double shell dome construction is supported by 36 radiating, arched trusses. In this view of the stairs to the lantern, every element is cast iron except the wrought-iron tie rods and bolts. To the right is the back side of one of the cast-iron coffers of the inner dome. The center of the coffer can be unbolted for inspection and maintenance of the inner dome. (David W. Look)

The great dome of the U.S. Capitol, completed in 1865, is the most monumental example of cast-iron architecture in America. Thomas U. Walter, Architect of the Capitol, designed the Renaissance style dome and engineer Montgomery C. Meigs made erection of the dome technologically feasible and supervised its construction. Several iron foundries handled the casting work; innumerable iron pieces were bolted together—smaller assemblies at the foundry, larger ones at the site—to create the pie-shaped sections, curving from base to tip, that form the exterior “skin” of the big dome.

The highly decorated skin was laid over a daringly conceived armature of 36 main radial ribs, each an open-web truss made up of 10 iron sections. These massive trusses can withstand the driving force of winds and the expansion and contraction resulting from temperature changes. The dome of the Capitol stands on an iron drum which is ringed by a peristyle of iron columns cast in Baltimore. Except for the bronze statue of Freedom at its apex, all of the dome structure above the roof of the center pavilion, in both framing system and covering, is iron (figure 74). The influence of the U.S. Capitol's design can be seen in the many state capitols which display Renaissance style domes. Some are totally of iron, while others are sheathed with copper.

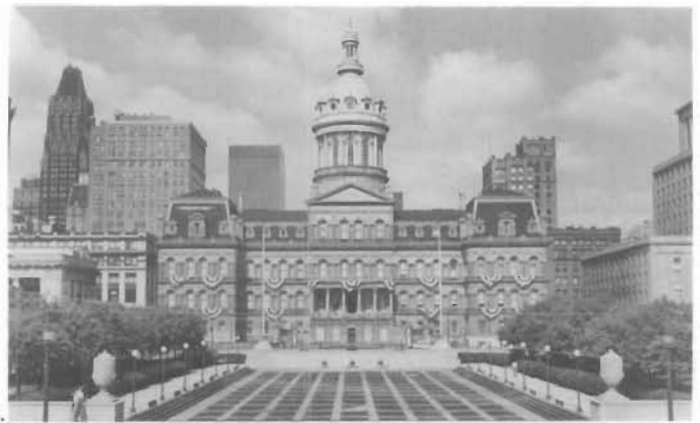
Figure 75. City Hall and the Restoration of the Dome, 100 North Holliday Street, Baltimore, Maryland; 1867–1875; George A. Frederick, architect; Wendel Bollman, engineer; restoration, 1975. (a) This Second Empire building was designed by Frederick, but the dome and lantern were designed by Bollman, inventor of the Bollman truss and sole proprietor of the Patapsco Bridge and Ironworks of Baltimore, Maryland. By 1970 the dome was in a seriously weakened condition. The sentiment of the townspeople and the mayor to keep the dome and rehabilitate the building was so strong that an \$8 million bond issue was approved for the project. (b) All parts of the dome pictured are cast iron. The outer plates were removed for strengthening the ribs. (Filip Sibley, Office of the Mayor, Baltimore; Robert M. Vogel)

Many city halls and county courthouses throughout America have cast-iron domes and cupolas. Built shortly after the U.S. Capitol dome and probably influenced by it, the Baltimore City Hall's cast-iron dome was recently restored (figure 75). The cupola of Brooklyn's Borough Hall burned in 1895; when it was rebuilt, the original wooden cupola was reconstructed in cast iron and sheet metal (figure 76).

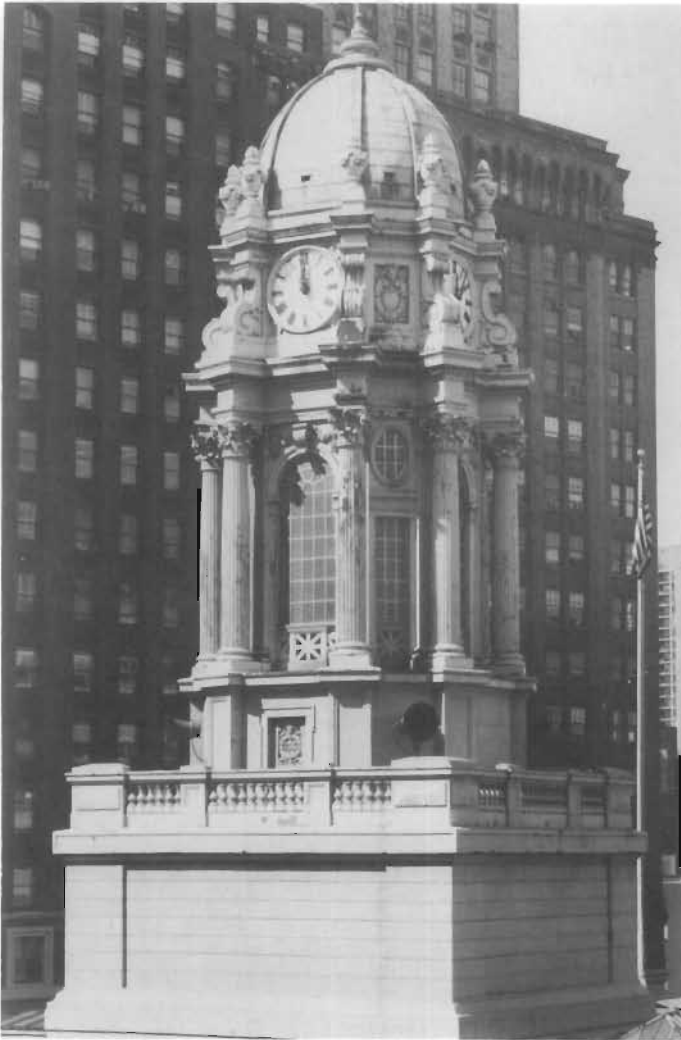
Figure 76. Cast-iron and Sheet-iron Cupola, Designed by C. W. and A. A. Houghton, architects, 1898; Hecla Ironworks; Borough Hall, 209 Joralemon Street, Brooklyn, New York, 1846-1851; Gamaliel King, architect. After the Old Brooklyn City Hall burned in 1895, it was rebuilt within the masonry shell, and a cast-iron and sheet-iron cupola replaced the wooden one that had been destroyed in the fire. It is typical of many such cupolas throughout America. (Esther Mipaas)

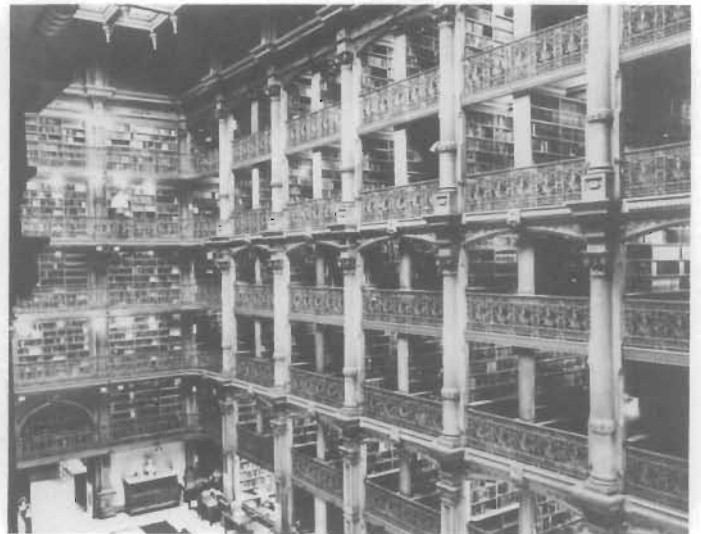
Figure 77. Cast-iron Interior, Peabody Institute Library, Mount Vernon Place, Baltimore, Maryland, 1857-1878; Edmund George Lind, architect; Bartlett, Robbins and Co., Architectural Iron Works, Baltimore. A gift from the philanthropist, George Peabody, who started his career in Baltimore, the Peabody Institute included a library which is virtually all cast iron and glass. Although the building's exterior is a traditional Renaissance design in stone, the most innovative materials of the time were used on the interior to safeguard the collection of books and manuscripts from fire. The central area of the library is surrounded by five floors of cast-iron galleries and is covered by one great skylight of glass set in an iron frame. The floors of the five decks are of iron inset with blocks of translucent glass. The decks are supported by cast-iron piers with applied two-story fluted pilasters rising in three tiers from floor to roof. (Peabody Library)

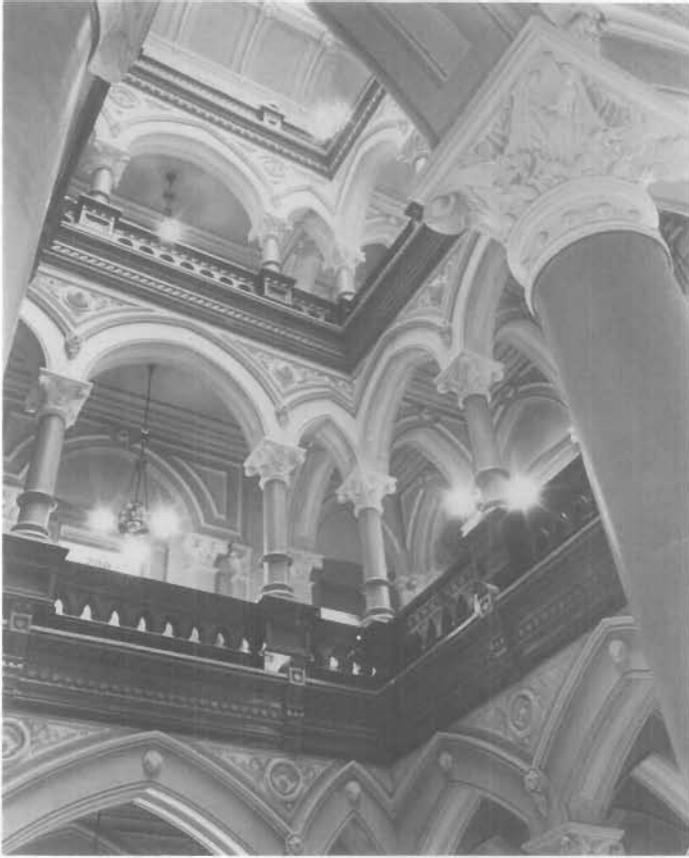
Figure 78. Cast-iron Light Court, Old City Hall, bounded by 10th, Broad, 11th, and Capitol Streets, Richmond, Virginia, 1886-1894; Elijah E. Myers, architect. The great central light court with its tiers of enriched cast-iron columns, spandrels, railings, and brass fixtures ranks as one of the most impressive municipal interiors in America. In imitation of stone, the cast iron has a massive, solid quality consistent with the character of the exterior masonry. (William Edwin Booth)

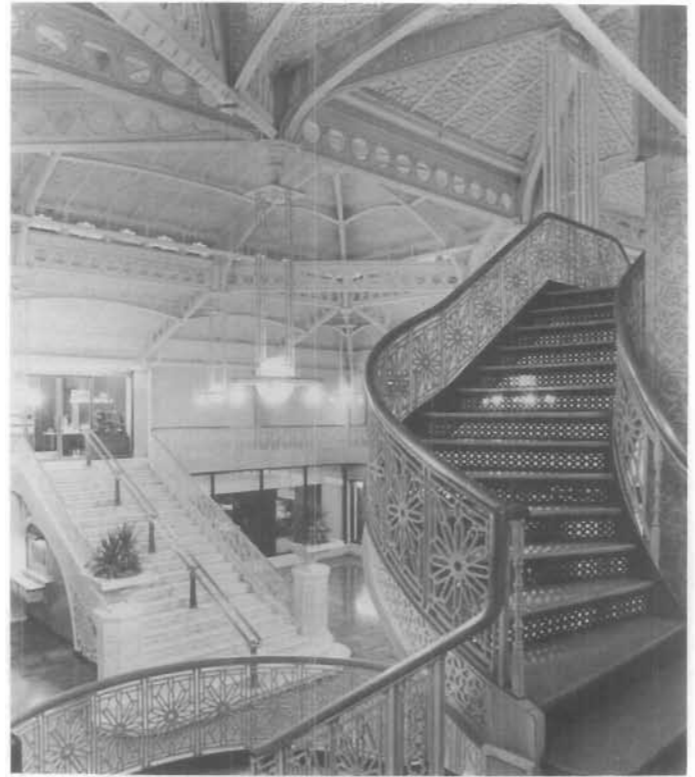
Figure 79. The Rookery, 209 South LaSalle Street, Chicago, Illinois, 1886; Burnham and Root, architects; Hecla Iron Works, Brooklyn, New York. The central foyer of this early 11-story skyscraper is a fine example of the integration of structural and decorative cast iron. The vaulting beams are perforated to reduce the dead load of the structural members without reducing the strength—the same principle as the truss. The chandeliers were designed by Frank Lloyd Wright in 1905. Unfortunately, the glass roof has been painted over. (Becket Logan)

In Burnham and Root's Rookery Building in Chicago, offices were wrapped around a large light court with an iron and glass skylight just above the foyer (figure 79). The upper floors surrounding the light court look onto an unroofed light well. Los Angeles' Bradbury Building is another instance of filigree cast-iron balustraded galleries (which serve as open corridors) and iron and marble stairs rising five stories. The entire light court is covered with an iron and glass roof (figure 80).

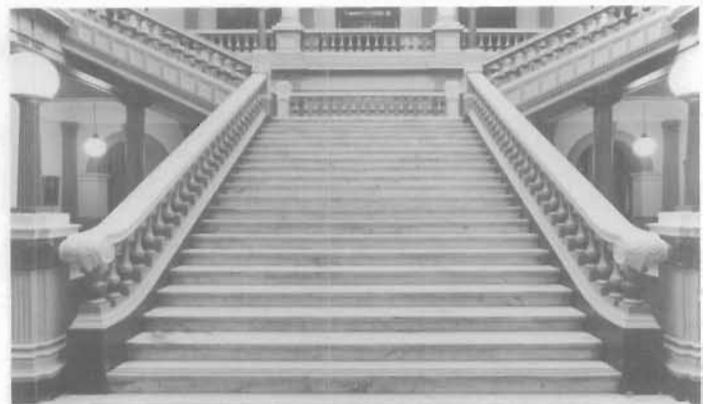
Figure 82. Grand Stairs and Detail of Cast-iron Railing, Georgia State Capitol, Capitol Square, Atlanta, Georgia, 1884–1889; Willoughby J. Edbrooke and Franklin P. Burnham, architects. Monumental stairs in public buildings were not only a means of vertical circulation but also a source of public pride and often the site of public ceremonies. (James R. Lockhart, Georgia Department of Natural Resources, Historic Preservation Section)

For the Federal Custom House in Wheeling, West Virginia, and many Federal structures, architects turned to cast iron because it was not combustible and because the repetitive nature of steps and railings allowed for the efficient use of molds. Ornate designs could be cast rather than carved, and parts of the stairs could be perforated to reduce the weight of the cast iron (figure 81). Iron staircases, sometimes monumental in size and design, often dominate the lobbies and rotundas of large public buildings (figure 82).

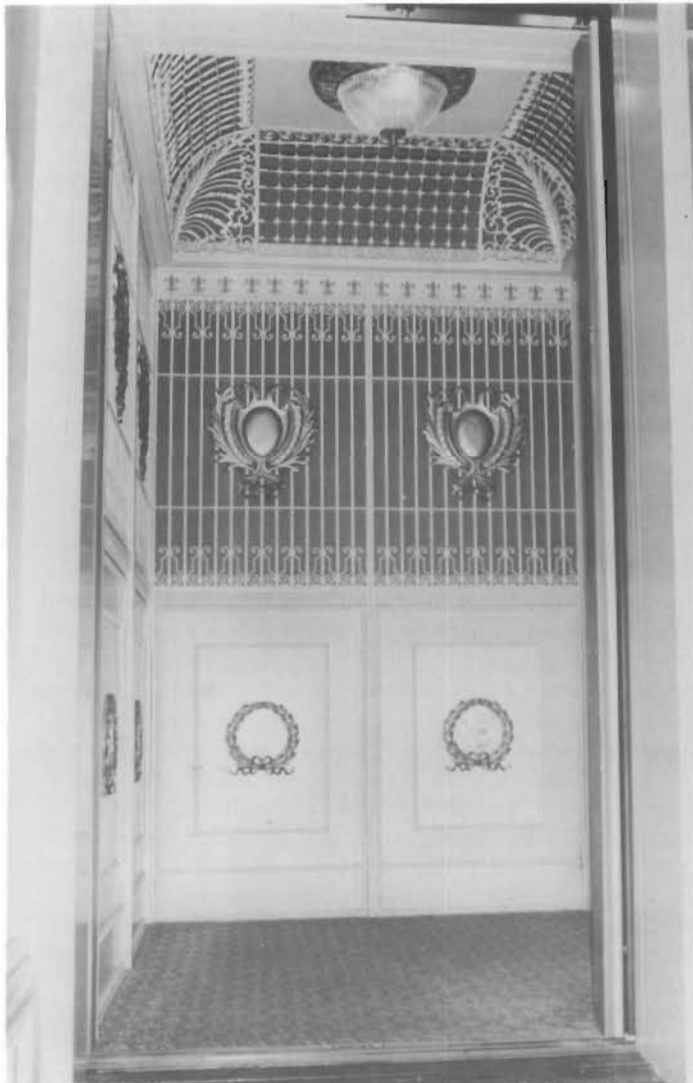
Figure 83. Cast-iron Elevator Cab, Otis Elevator Company, 1905; Pioneer Courthouse (U.S. Courthouse and Customhouse), 520 Southwest Morrison Street, Portland, Oregon, 1869-1873. To meet fire code requirements, restoration architects McMath and Hawkins installed a new fire wall inside the elevator shaft in 1973. To give the illusion of openness, the elevator grille and cab were painted a cream color, with gilt shields and wreaths; the fire wall was painted a dark gray, creating the effect of a silhouette. (Mike Henley)

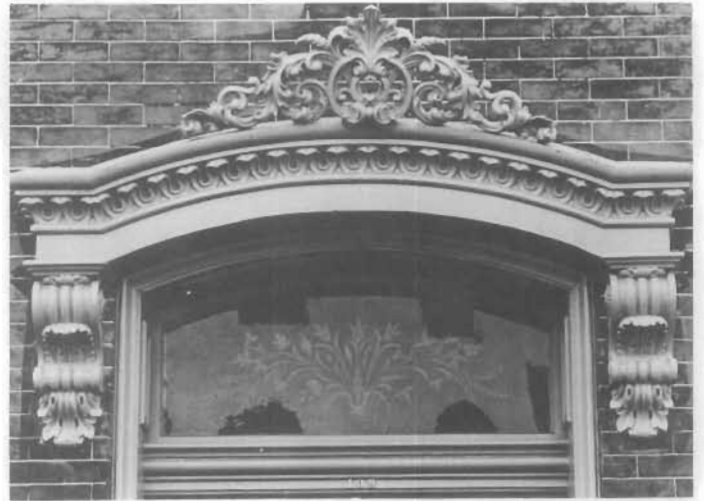
Figure 84. Cast-iron Lintel, Ben Whitmire House, 109 Jackson Street, Trenton, New Jersey, 1872. The scrollwork of the foliated lintel is clearly of cast metal; execution of such a design in stone would be almost impossible. This house also has window lintels and sills of iron, all of which were probably cast at Bottom and Tiffany's Foundry in Trenton. They were often painted stone colors with sand added for the correct texture. Residences, commercial buildings, institutions, and even industrial buildings incorporated ornate lintels and sills in their design. (Ben Whitmire)

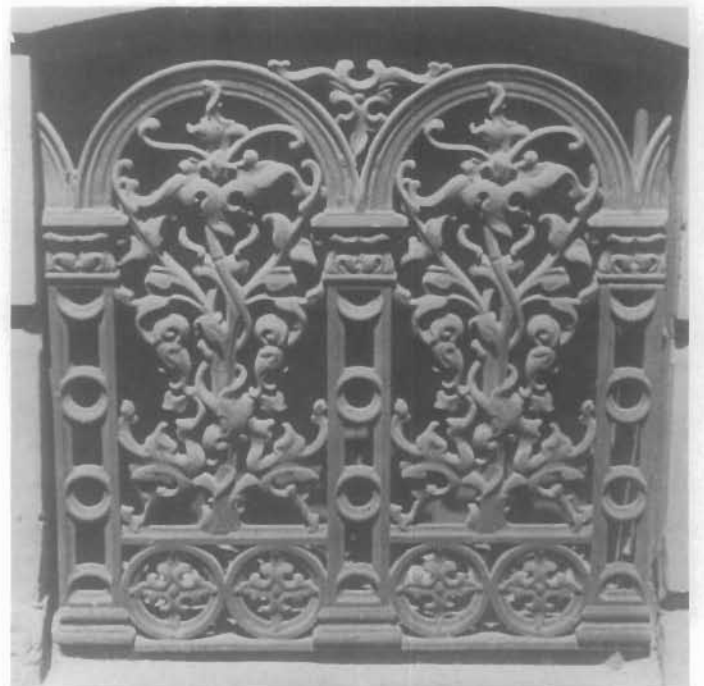
Figure 85. Cast-iron Cellar Window Grille, Matthew Quay House, northeast corner of Spruce and 11th streets, Philadelphia, Pennsylvania. Although little noticed, there is a seemingly endless variety of decorative cellar window grilles in Philadelphia. With the first-floor level several feet above grade and the sidewalks often extending right up to the facade, these articulated iron grilles were installed to protect exposed cellar windows while still allowing ventilation. The grille photographed here displays a motif of cast-iron vines set in a pair of arched panels. (Harley J. McKee, FAIA)

the day. Cast-iron window grilles were widely used on houses or public buildings for street-level or below-grade windows that had to be secured, yet where ventilation was desired. Philadelphia abounds in varied cellar window grilles of both cast and wrought iron (figure 85). The glass lights in exterior doors were often covered with custom-fitted ornamental cast-iron security grilles that were both effective and attractive. Many buildings built after 1840 used lacy ventilating grilles set under the eaves. These grilles could be ordered from catalogs, as could cast-iron hot-air registers (figure 86), grating, and panels for use under shop windows.
