Chapter 7: Iron and Iron Alloys

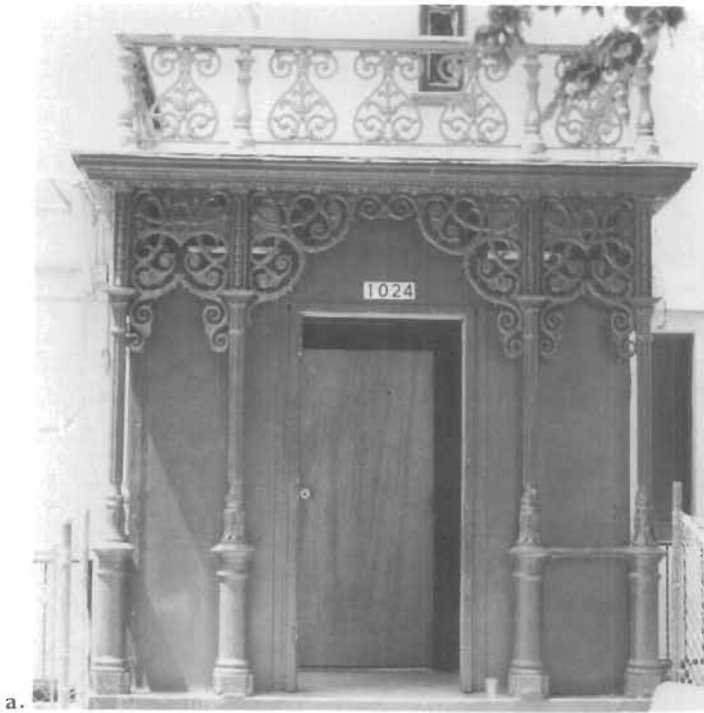
Figure 88. Cast-iron Veranda, Zephaniah Jones House, 1024 10th Street, NW, Washington, D.C.; Janes, Kirtland and Co., foundry. (a) It is a rewarding experience to see an advertisement for an architectural feature in a foundry catalog, then to discover the original model is still extant. **(b)** This veranda appears in Janes, Kirtland and Company's 1870 catalog of ornamental ironwork. The caption reads, "Verandah made to order for Z. Jones, Esq. of Washington, D.C." The veranda, in need of repair, remains on the Jones House over 100 years after its installation. (David W. Look)

Cast-iron verandas and balconies are almost universally identified with the streets and courtyards of New Orleans and with other Southern cities such as Savannah and Mobile (figure 87); but they are also found in many other localities (figure 88). If kept painted, these balconies and verandas can be preserved indefinitely. Sections may deteriorate or get broken, but they can be recast and inserted.

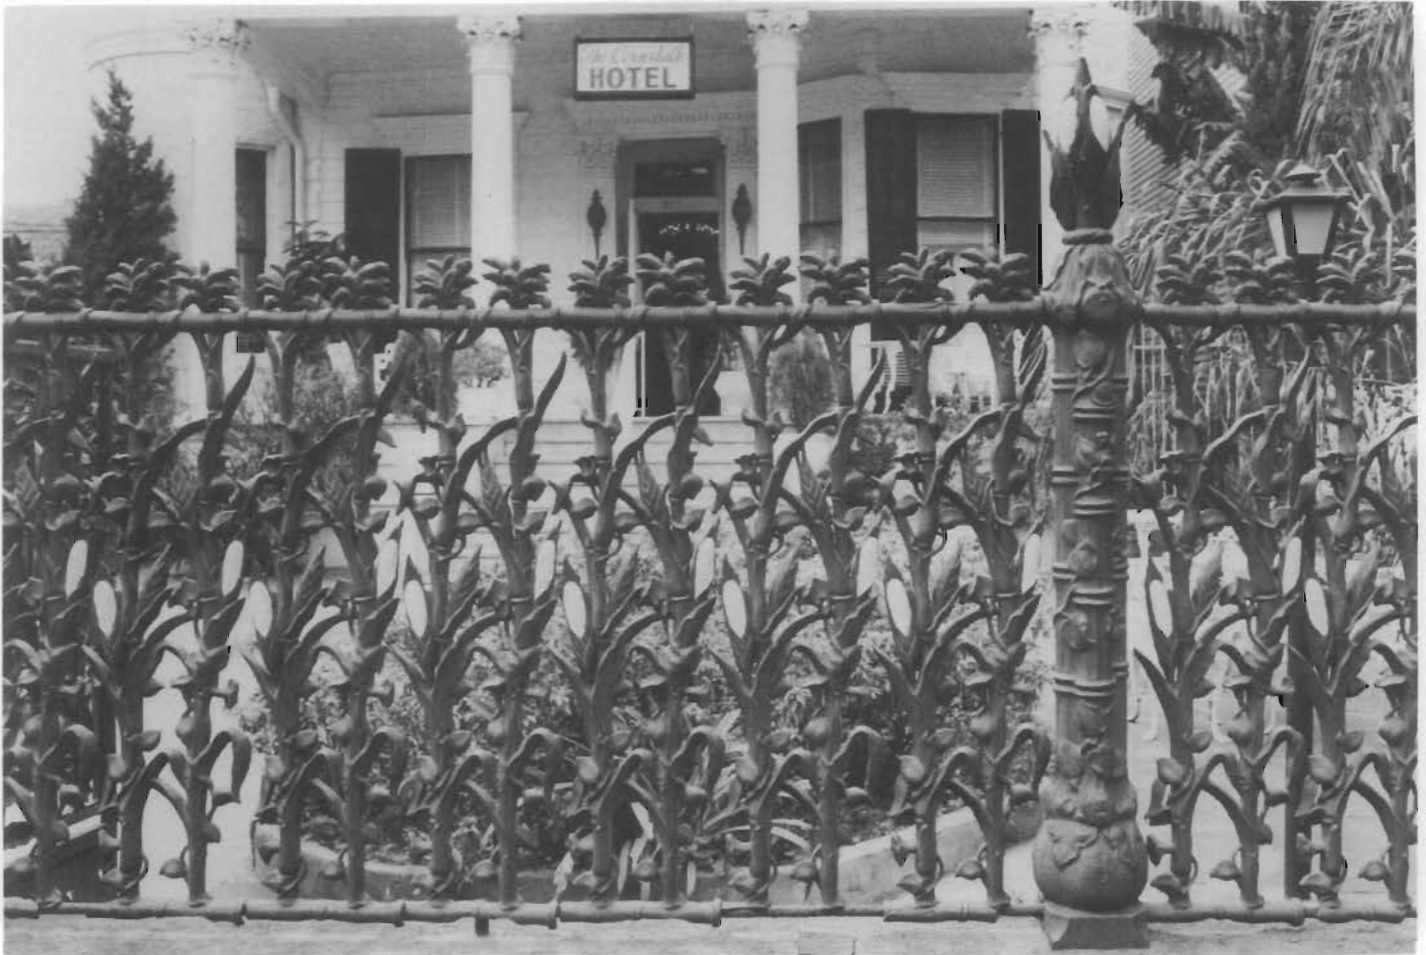
Figure 89. Cast-iron Fence, Cornstalk Hotel, 915 Rue Royale, New Orleans, Louisiana, ca. 1855; Wood and Perot, foundry, Philadelphia. *In the 1850s, Dr. Joseph Biamonti brought his bride to this New Orleans house, later converted to a hotel. In an effort to keep her from feeling homesick for her native Iowa, the doctor commissioned this cornstalk fence from the well-known Philadelphia foundry. Representing a field ready for harvest, the green and yellow fence sports ripe cast-iron ears of corn on their stalks. Pumpkin vines entwine the stalks and climb up the ironposts to the bundle of corn ears which make up the finials. Once a foundry made patterns, it would usually advertise the new design in its catalog and reuse the molds as orders were received; a rendering of this fence appeared in the 1858 Wood and Perot catalog. In 1859 another cornstalk fence was erected by Wood and Miltenberger, the New Orleans branch of Wood and Perot, at the Short-Favrot House in New Orleans Garden District. (Becket Logan)*

Closely related to railings in style and composition were the cast-iron fences and cresting. Molten iron could be cast in so many different shapes from simple to elaborate that designers and patternmakers had free rein. They made grapevine fences and fences resembling rows of swords thrust into the ground; there were also fences with Greek key designs for Greek Revival style houses. Railings, fences, and gates done in Gothic tracery were favored for churches, and a favorite cemetery gate motif shows lambs lying beneath a weeping willow tree. Other fences were made to look like a row of corn stalks (figure 89). Many custom designed fences carried symbols related to the structures with which they were associated.

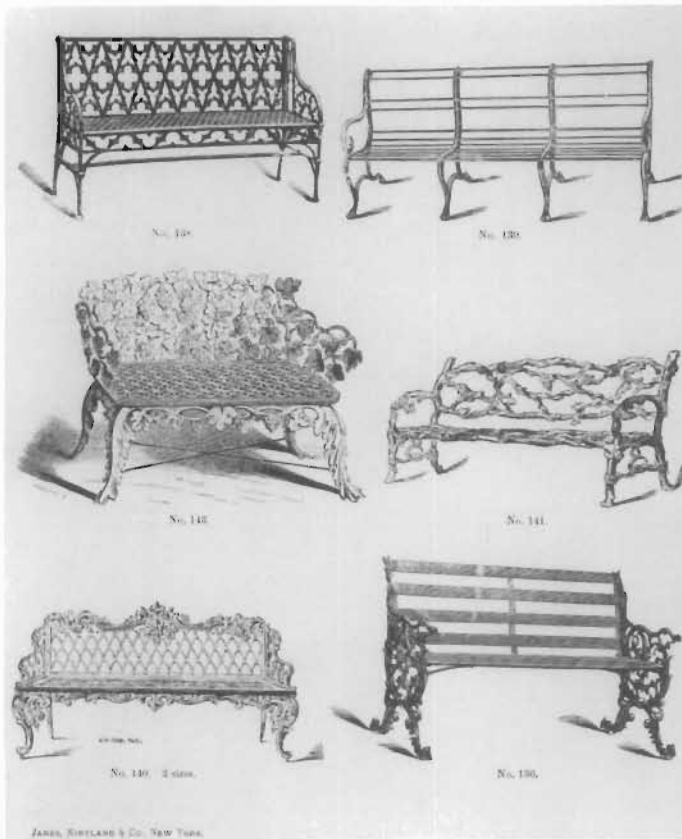
Figure 91. Cast-iron Benches, Illustrated Catalogue of Ornamental Iron Works, Janes, Kirtland & Co., 1870. Cast-iron furniture for both indoor and outdoor use enjoyed great popularity with the Victorians, especially for furnishing conservatories, porches, lawns, gardens, parks, public squares, and cemeteries. Benches such as these were cast in 10 or 12 sections, which were assembled and bolted together. After the rough edges were filed away to protect the user's clothing, the benches were painted several times to prevent rust from forming. This page of the catalog illustrates designs in the Gothic, grapevine, Rococo, and rustic styles. (Library of Congress)

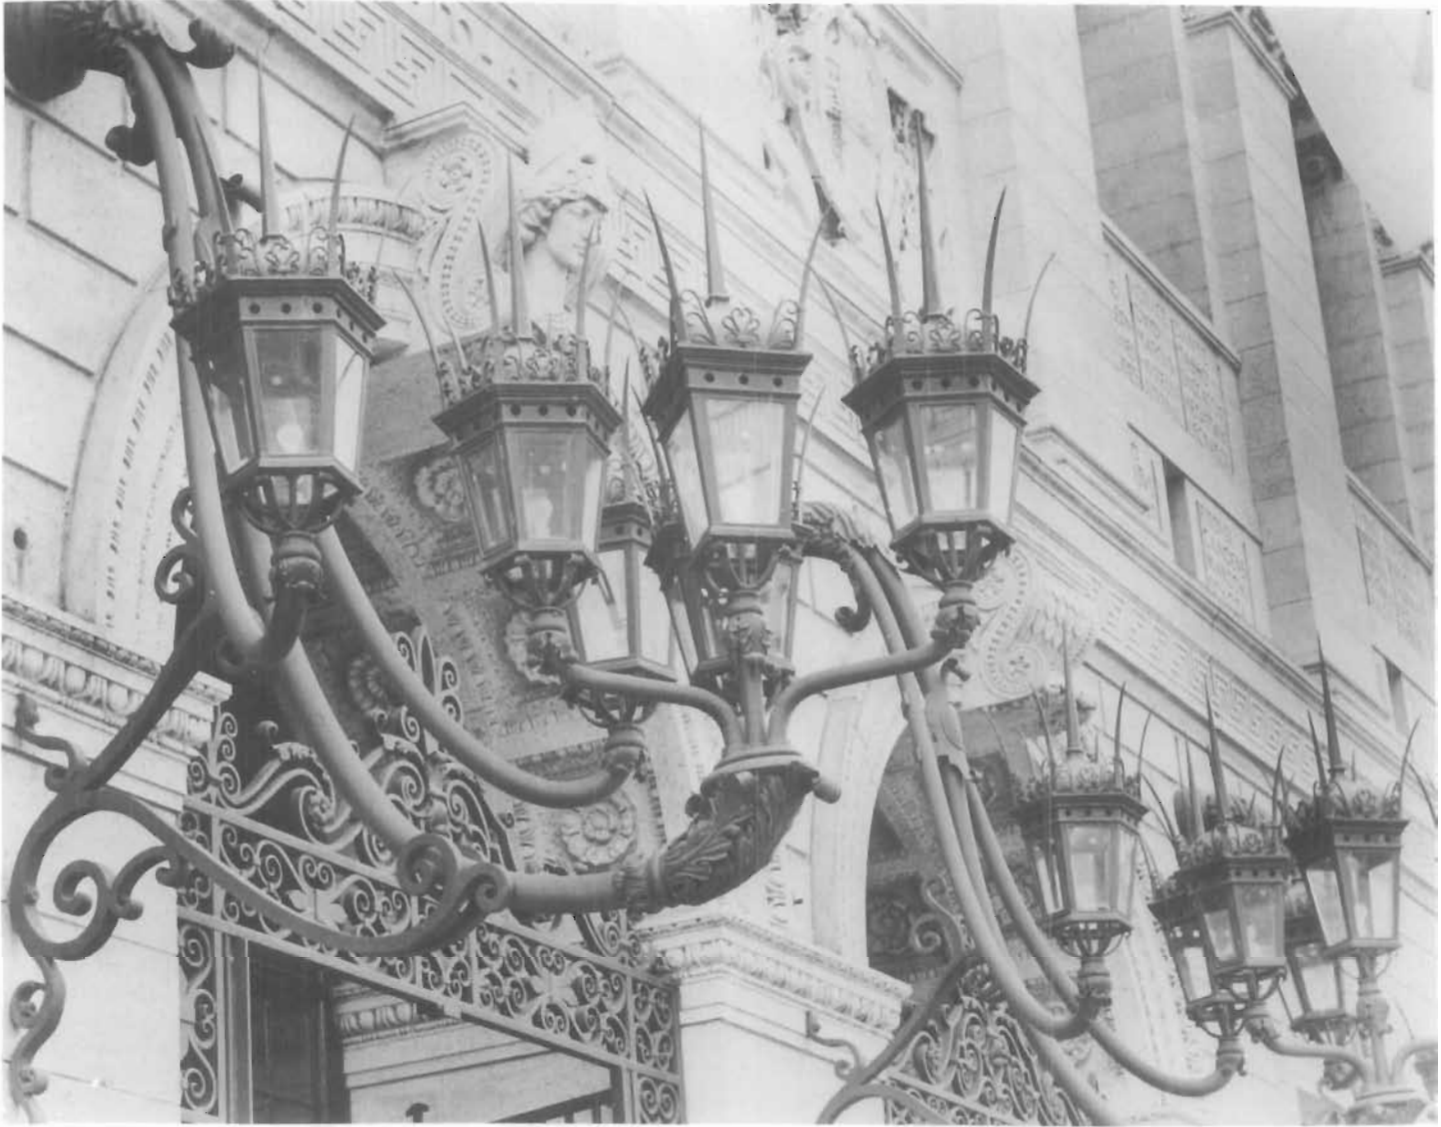
Figure 93. Iron Lamps, Boston Public Library, Copley Square, Boston, Massachusetts, 1895; Charles Follen McKim, architect. *The Boston Public Library contains many forms of metal ornamentation: bronze doors by Daniel Chester French, wrought-iron gates and grilles, and Strozzi-type wrought- and cast-iron lamps which flank the three entryways. Repeated casting from the same molds made ornamentation worthy of a Renaissance palace affordable in the 19th century. (Esther Mipaas)*

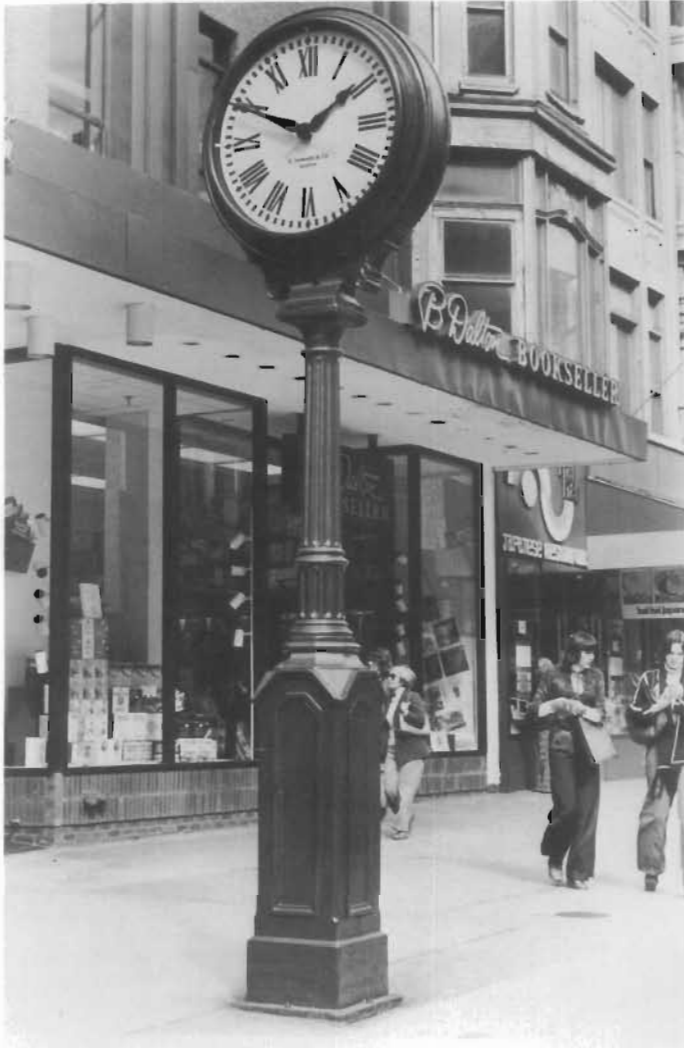
Figure 94. Cast-iron Post Clock, Boylston Street, near the corner of Berkley, Boston, Massachusetts, ca. 1900; E. Howard Clock Co. The iron post clock was a familiar item of street furniture for over a century, and was used nationwide as a form of advertising for merchants, especially jewelers, and for banks. This clock in the Boylston Street shopping area was manufactured by the noted New England clockmaker Edward Howard, whose company also made street clocks, steeple clocks, and watches long after his death in 1904. Other examples of such clocks can be found in Milwaukee, St. Louis, Salt Lake City, and Portland, Oregon. However, the post clock is a vanishing amenity, its useful life shortened by street widenings, abandonment of inner cities, and the ravages of the automobile. (Esther Mipaas)

Tall cast-iron street clocks were popular at the turn of the century, especially as picturesque advertisements for banks and jewelry shops. But they also rendered a public service (figure 94). Many still exist, and several cities, including Milwaukee, San Francisco, and Portland, Oregon, have designated them official landmarks.

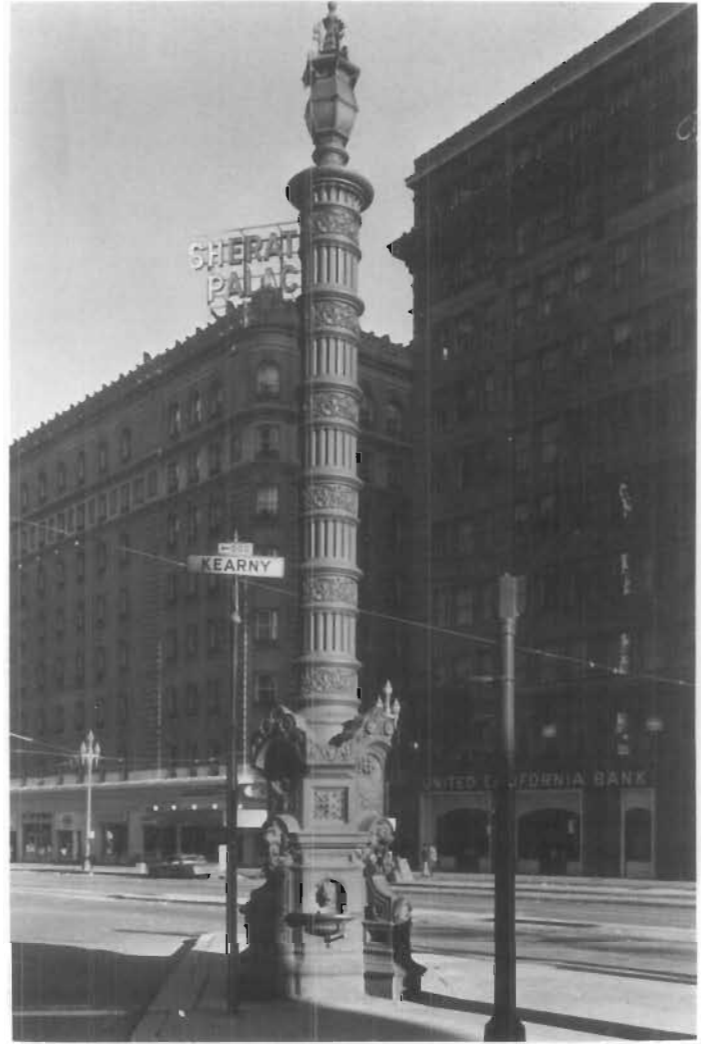
Figure 96. Cast-iron Drinking Fountain, intersection of Market, Kearny, and Geary streets, San Francisco, California, 1875. Cast iron took many shapes in the 19th-century urban landscape. One of the more interesting is this public drinking fountain given to the city by Lotta Crabtree, a grateful citizen who had acquired fame and fortune there as an actress. The fountain was restored and rededicated on its 100th birthday in 1975. (Becket Logan)

Some Victorian cast-iron fountains were both utilitarian and ornamental. Such is the case with Lotta's Fountain in San Francisco (figure 96). This sentimental 1876 gift to the city from the famous actress Lotta Crabtree incorporates four spigots for drinking water along with a tall decorated column with a light on top. Its base is heavily ornamented with cast-iron medallions depicting gold miners and sailing ships.

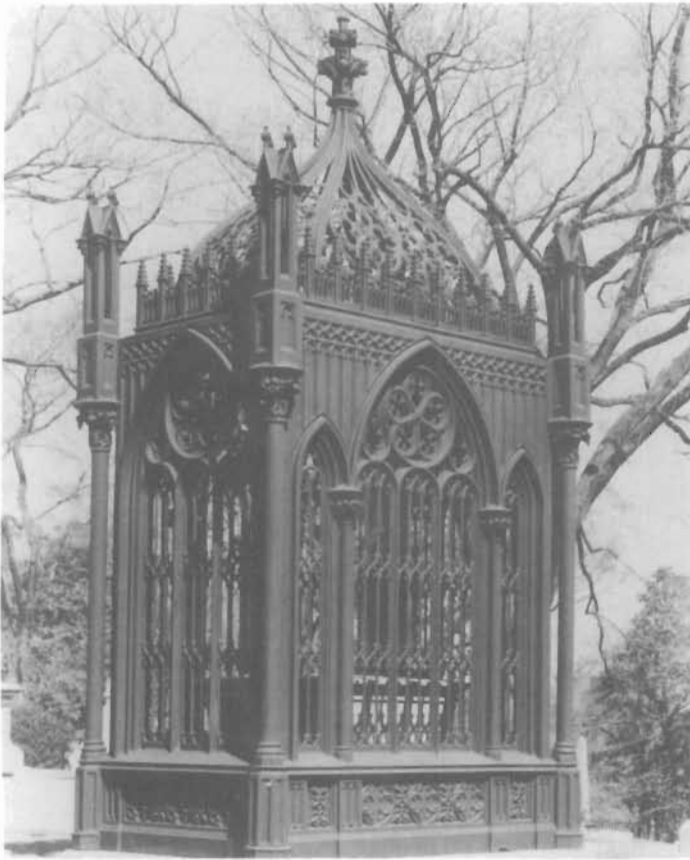
Figure 97. Cast-iron Tomb Enclosure, Grave of President James Monroe, Hollywood Cemetery, Richmond, Virginia, 1859; Albert Lybrock, architect; Wood and Perot, foundry, Philadelphia. *The ceremonial enclosure of the tomb of James Monroe is a particularly fine example of cast-iron design and craftsmanship. In the 1850s the state of Virginia took steps to move Monroe's resting place from New York to his native state. The Gothic Revival design chosen for the tomb was that of German-born Richmond architect Albert Lybrock. Perhaps more important was the selection of Wood and Perot, manufacturers of ornamental iron, to prepare the patterns, make the molds, and cast the separate parts that would compose this work of art. The words "Robert Wood, Maker" can be found at the edge of the enclosure. In later years, Wood and Perot presented sketches of the tomb cover in its sales catalog. It measures 7 feet wide by 10 feet long, with a perforated canopy rising 20 feet to a finial of crockets. Four miniature corner towers enclose side panels filled with Gothic arches and trefoil patterns. (F. Heite, Library of Congress)*

One of the finest examples of the founder's sculptural art is the 1859 iron tomb marking the grave of President James Monroe. In Richmond, Virginia's, Hollywood Cemetery on a prominence overlooking the James River, this Gothic style cast-iron masterpiece was designed by German-born Richmond architect Albert Lybrock and cast in the foundry of Wood and Perot in Philadelphia (figure 97). "Cast iron Mausoleums of beautiful design and finish" were advertised by Wood, Miltenberger and Co., the New Orleans branch of Wood and Perot. Several splendid iron tombs exist in New Orleans' historic cemeteries, while others, apparently stock designs, can be seen in Mobile, Alabama. Examples of modest-scale cast-iron architecture, these elegant little buildings were made of parts separately cast and bolted together by the same methods employed for iron front warehouses, hotels, and stores. Like their commercial counterparts, some tombs were individually designed and others could be ordered from catalogues.

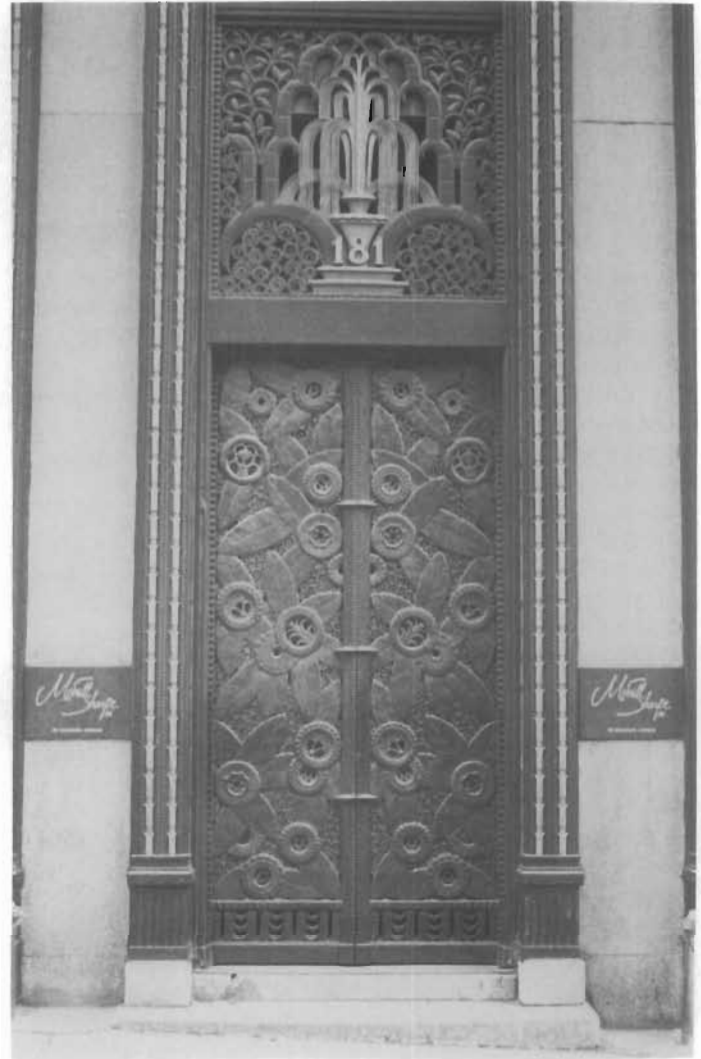
Figure 98. Cheney Brothers Silk Store (now Merrill Sharpe, Inc.), 181 Madison Avenue, New York City, 1925; Howard Greenley, designer; Ferrobrant, foundry. *Originally fabricated under the direction of Jules Bouy for Cheney Brothers Silk Store. These doors were later moved in 1928 to their present location, the Madison Belmont Building. Edgar Brant of Ferrobrant fabricated the additional metalwork for the new building. Note that the parts of the frame and transom painted gold (the lighter color in the photo) are actually cast bronze, recently restored and polished. (David W. Look)*

Other uses of cast iron continued uninterrupted until new styles eliminated their use or they could be more economically made of new materials. Two late examples are the Charles Scribner's Sons Bookstore on Fifth Avenue in New York City, which has an iron and glass storefront built in 1913, and the doors of the Cheney Brothers Silk Store, which were cast in iron in 1925 (figure 98). Cast iron was even used in the Art Deco period, when many new metals were becoming available.

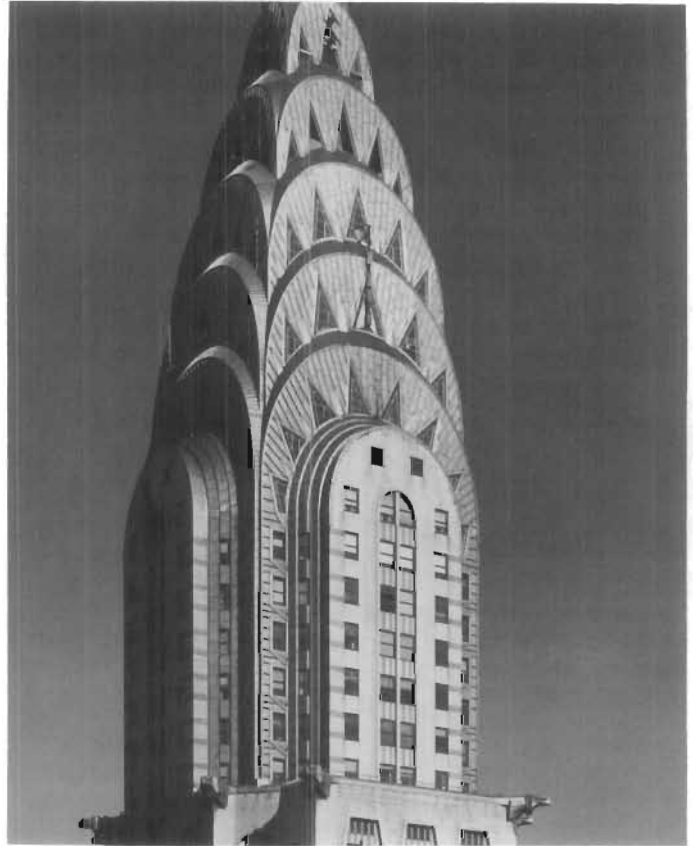
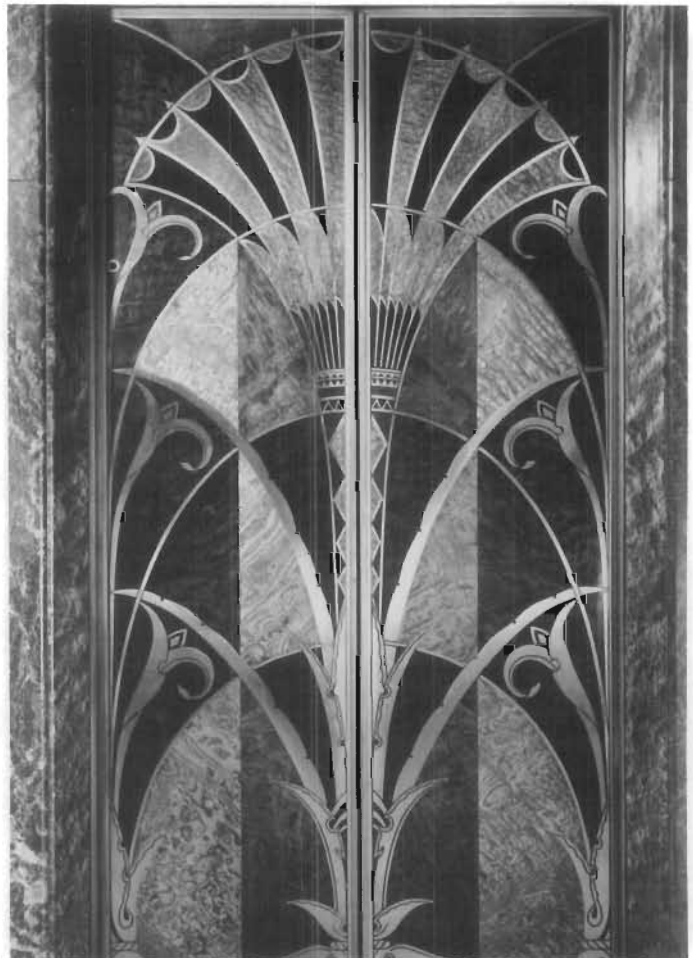
Figure 105. Stainless Steel Dome, Gargoyles, and Elevator Doors, Chrysler Building, 405 Lexington Avenue, New York City, 1928-1929; William Van Alen, architect. (a) *The Chrysler Building was the first extensive use in America of chromium-nickel steel, now commonly called stainless steel, as an exterior finish on a large commercial structure. There are many types of stainless steel with different properties; the type used here was Nirosta, K.A.2 (Krupp's formula), installed by the sheet metal contractor, Benjamin Riesner, Inc. According to the architect, "The sheet metal covering for the needle or upper third of the spire (not shown) was attached directly to the structural steel frame. A base of "nailing" concrete was provided for the sheet metal work, completely covering that portion of the dome and spire below the needle, and extended down on both sides of the circular-head dormers to the 59th floor level. The sheet metal ribs were fastened to fireproofed wood nailing strips placed on top of the concrete and fastened to the structural steel frame. Standing or lock seams, made without solder, were used throughout, except where they were impossible or undesirable, where soldered seams were used. The radial ribs on the fronts of the metal-covered dormers of the dome and similar ribbed construction are formed by sheet metal-covered wooden battens. Contact between dissimilar metals was avoided by using Nirosta steel nails, screws, bolts, nuts, and rivets for fastening the sheet steel in position."* (b) *Influenced by the discovery of the King Tut's tomb, these stainless steel elevator doors are inlaid with rare woods in a stylized Egyptian design featuring a lotus blossom at the top.* (Cervin Robinson)

Stainless steel sheets have been used for roofing, flashing, gutters, leader heads, downspouts, and cladding. One of the most extensive early uses of stainless steel was in the Chrysler Building in New York City. Architect William Van Alen originally intended to use aluminum to clad the building's Art Deco pinnacle (figure 105a), but finally decided in favor of stainless steel. The gargoyles were cast of stainless steel; the main entrance and storefronts are fabricated of rolled sheets and extruded sections of the same material. The elevator doors are stainless steel inlaid with wood (see figure

105b). Also in the Chrysler Building is a branch of Manufacturers Hanover Trust which is a *tour de force* of cast stainless steel (figure 106).

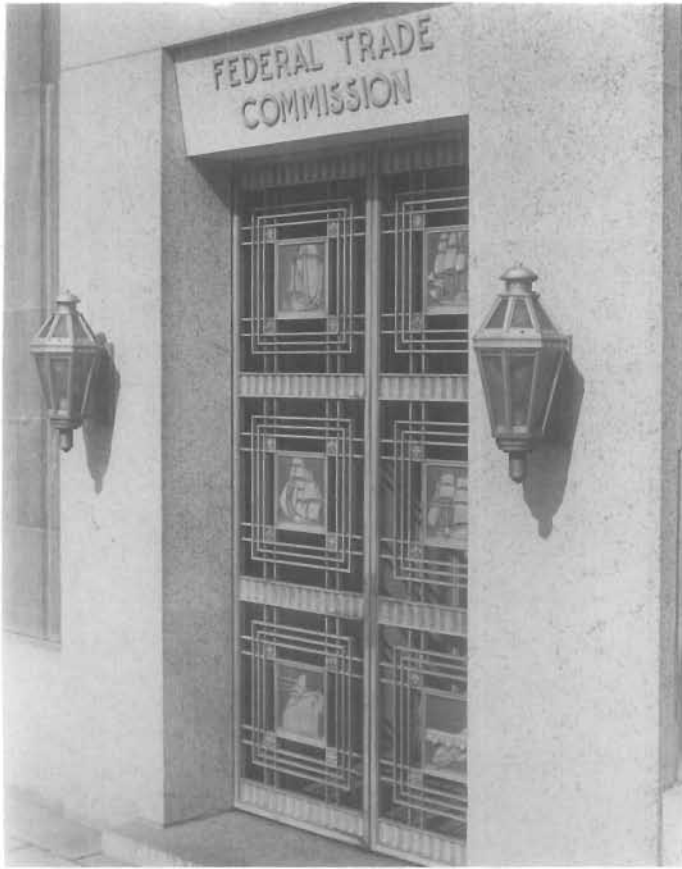
Figure 108. Stainless Steel Gates, Lamps, and Lettering, Federal Trade Commission, Sixth and Constitution Avenue, NW, Washington, D.C., 1937; Bennett, Parsons, Frost, architects; William McVey, sculptor. During the 1930s stainless steel was frequently used for monumental doors and ornamental gates on government buildings. Noted sculptors were employed to design custom ornamental metalwork. The lamps, lettering, and window grilles (not shown) are all stainless steel. (David W. Look)

In the late 1920s and 1930s, the use of white metals increased with the rise of Art Deco, Depression Modern, Streamline Modern, and the International styles. Mirror finish chromium-plated metalwork was frequently used, but the plating often wore through to the base metal in high traffic areas such as entrances and lobbies. Since stainless steel is very hard, can be highly polished, and requires little maintenance other than periodic washings, it was a good choice for doors and storefronts. Some designs for stainless steel doors that became standard stock models can be found on several buildings, including the Versailles Apartment Building in Brooklyn (figure 107). Others were custom designed such as the stainless steel gates on the Federal Trade Commission Building in Washington, D.C., modeled by sculptor William McVey (figure 108).

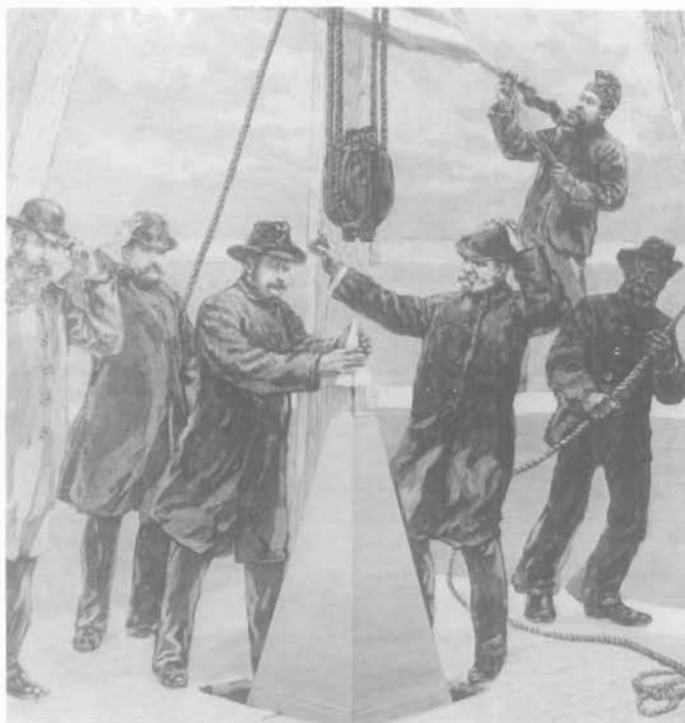
Figure 111. The Setting of the Aluminum Tip on the Washington Monument, Washington, D.C. The first architectural use of aluminum was the small pyramidal cap of the Washington Monument, which was set in place on December 6, 1884. At that time, aluminum was still considered a precious metal. (Engraving in Harper's Weekly, December 20, 1884; Martin Luther King Library)

In 1855 at the Paris Exposition aluminum was introduced to the public. Napoleon III had pocket watches and a table service designed of it, and during the American Civil War, General Ulysses S. Grant received an aluminum medal from the U.S. Congress. One hundred ounces of the rare metal were cast to form the small pyramidal cap of the Washington Monument in Washington, D.C. Before ceremonial positioning of the cap atop the monument on December 6, 1884 (figure 111), it was displayed in Tiffany's window in New York City. The monument cap was the first American architectural use of aluminum.

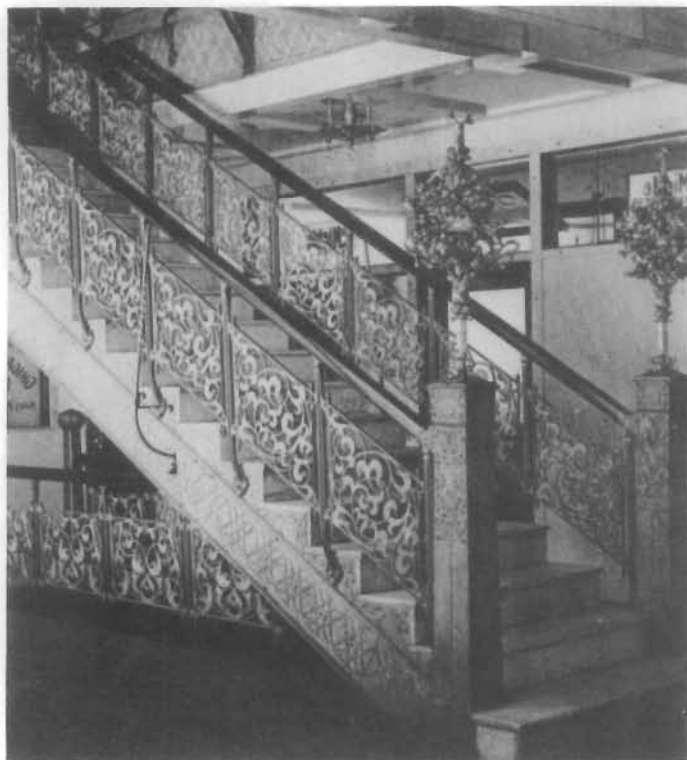
Figure 112. Cast Aluminum Staircase, Monadnock Building, 53 West Jackson Boulevard, Chicago, Illinois; Burham and Root, architects; Winslow, Brothers, Co., foundry. Although the Monadnock Building is widely known as the last skyscraper with load bearing walls, few people know that it contains the second known architectural use of cast aluminum in America. The first story staircase, including the newell posts, electroliers, balustrade railing, facias, and stringers, are all cast of aluminum. The lamps have been removed. Aluminum ventilation grilles near the exterior doors are also illustrated, but have also been removed. (plate 4, Collection of Photographs of Ornamental Iron Executed by Winslow Bros., 1893, Library of Congress)

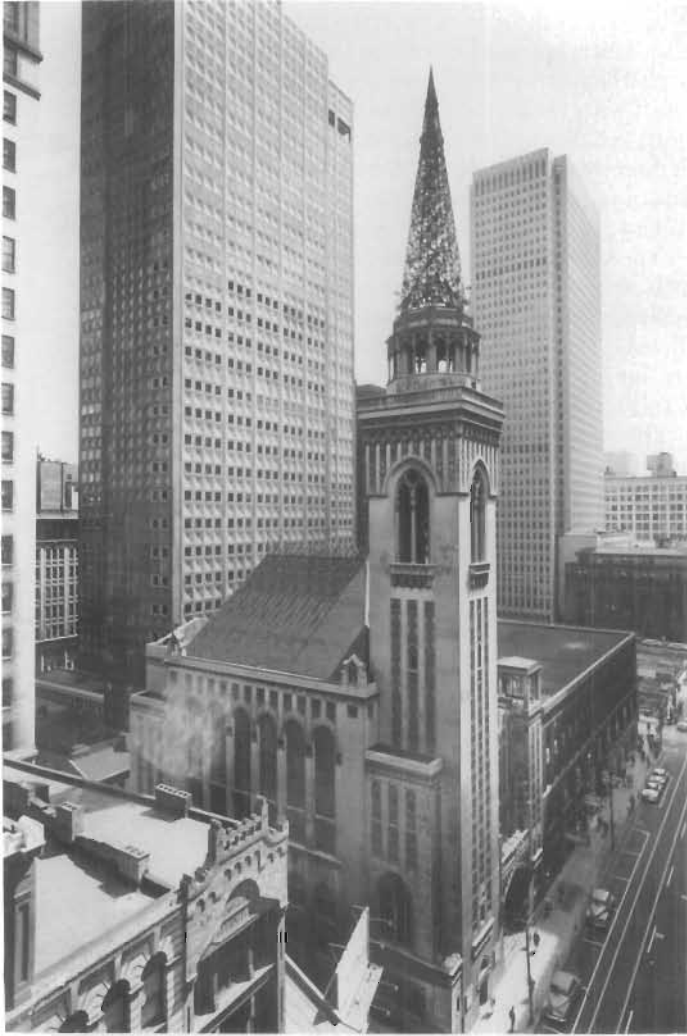
Figure 113. Cast Aluminum Spire, German Evangelical Protestant Church, Pittsburgh, Pennsylvania, 1926; Henry Hornbostel, architect. Also Alcoa Building (background, left), Golden Triangle, 1952; Harrison and Abramovitz, architects.

The perforated spire of the German Evangelical Protestant Church, now the Smithfield Street Congregational Church, consists of 22 filigree aluminum castings. The Alcoa Building is the first multistory structure with an aluminum curtain wall. The other tall building (right) is the United States Steel-Mellon Building. (Carnegie Library of Pittsburgh)

The perforated Gothic spire of the Smithfield Street Congregational Church was cast in Pittsburgh and affixed to the church in 1926 (figure 112). Another exterior use of aluminum was in the 1929 Springfield, Illinois, Post Office where decorative aluminum panels are set into the walls, and bold stylized anthemions stand along the roofline.

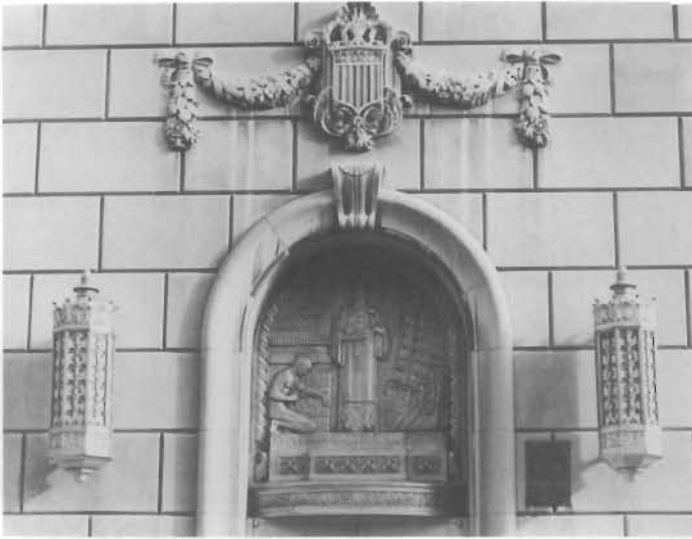
Figure 114. Aluminum Bas-Relief Sculpture in Tympanum and Lamps, U.S. Customhouse, bounded by Chestnut, Second, and Third streets, Philadelphia, Pennsylvania, 1933; Ritter and Shay, architects; Edward Ardolino, sculptor. In the 1920s and 1930s, architects frequently chose one of the white or silvery metals for their buildings; those designing in the Art Moderne, now called Art Deco style, especially considered gold or bronze colored metals "old-fashioned." The highly stylized bas-relief mural in the tympanum is flanked by cast aluminum and glass lamps. (Esther Mipaa)

In 1933 almost 65,000 pounds of aluminum sheets were used to roof the Union Terminal in Cincinnati. That same year the architectural firm of Ritter & Shay, designed the U.S. Custom House on Chestnut at Second Street in Philadelphia, which had aluminum light standards and sculptural bas-relief figures in tympanum panels over the doors (figure 113). In Washington, D.C., sculptor Carl Paul Jennewein modeled the aluminum work for the Department of Justice Building (figure 114).

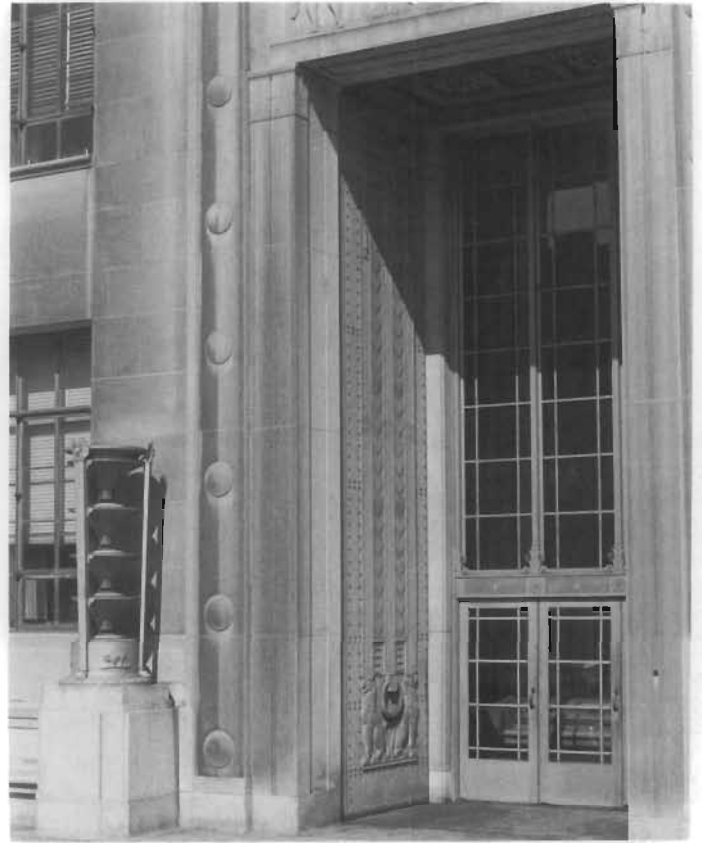
Figure 115. Aluminum Doors and Lamps, U.S. Department of Justice, Ninth and Constitution Avenue, NW, Washington, D.C., 1934; Zantzinger, Boris, Medary, architects; Carl Paul Jennewein, sculptor. The monumental doors, fabricated of cast lions and rolled sections of aluminum riveted together, are opened back into pockets of the walls of the entrance showing the inner set of aluminum and glass doors and transom. Flanking the entrance are cast aluminum lamps with stylized eagles, buffaloes, and dolphins. The work was executed by Anthony D. Lorenzo. (David W. Look)
