Subject: Treatment of Interiors in Industrial Buildings

Applicable Standards: 2. Retention of Historic Character
5. Preservation of Distinctive Features, Finishes and Craftsmanship

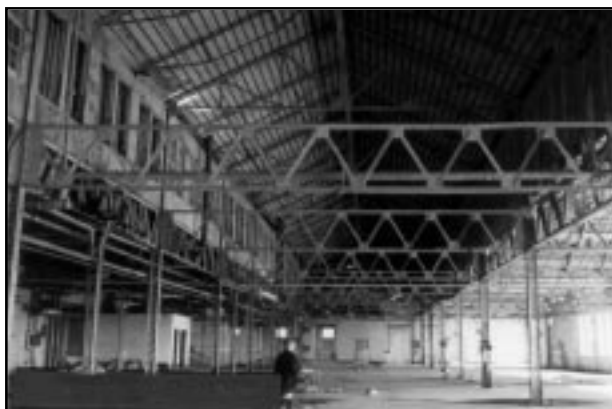
Second and third floor truss system before rehabilitation.

Application 1 (Compatible Treatment): This 1895, three-story brick warehouse with its stepped gable façade, corrugated metal monitor roof and distinctive ventilators was originally built as a tin can manufacturing plant. The long vacant building was recently rehabilitated for use as research and office space for the world headquarters of a major manufacturing company. The creative design used in the rehabilitation for the interior underscored the building's industrial character by using materials, such as corrugated metal walls, steel beams and exposed wooden columns. Any required partitions were constructed to retain an open view of the character-defining latticed I-beams and metal trusses. The windows in the roof monitor over the center aisle were reopened and restored. The result is an open, contemporary office space that successfully retains the character of this utilitarian building.

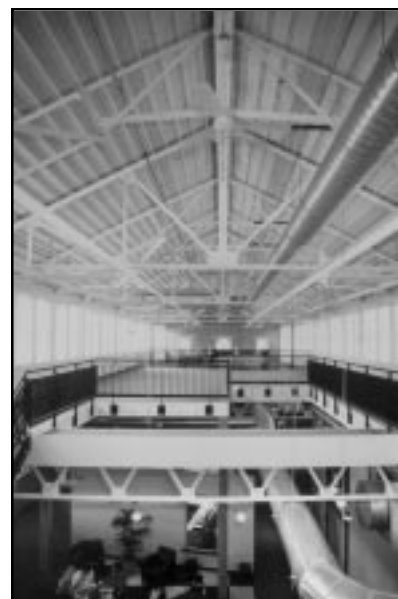
Interior following rehabilitation showing exposed latticed I-beams and metal trusses.

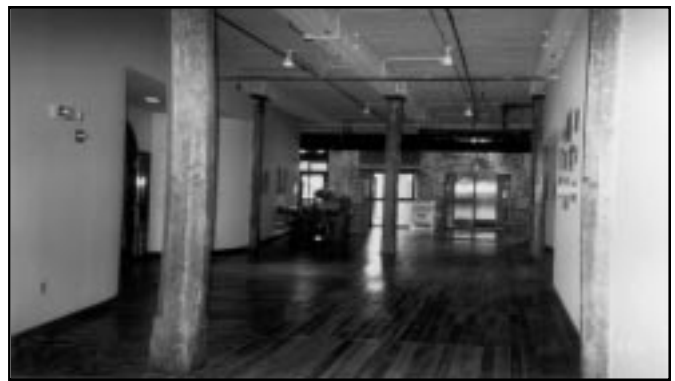
Interior after rehabilitation retains the exposed structure and finishes characteristic of the mill building with subdivision of the space for the new use.

This monumental, three-story mill building with its prominent four-story, mansard roofed stair towers is more than 400 feet in length. Constructed from 1878 to 1881, this building serves as the entry to a former flour/cotton mill complex. Recently, this mill building was rehabilitated as part of a mixed-use residential and commercial complex. While the exterior of this imposing building is highly ornamented, the interior was historically utilitarian manufacturing space characterized by exposed brick walls, wooden-chamfered posts, beams and planking, void of any decorative detail. The rehabilitation retained these character-defining features while accommodating the necessary subdivision of the large expanses of space for the new use. The large number of columns were retained by leaving some free standing in hallways and public spaces, while many remain visible engaged as part of partitions. The exposed beams, original flooring and exposed brick also preserves the industrial character of the mill's interior in the new use.
