12 PRESERVATION BRIEFS

The Preservation of Historic Pigmented Structural Glass

(Vitrolite and Carrara Glass)

U.S. Department of the Interior, National Park Service
Rocky Mountain Regional Office, Cultural Resources Division

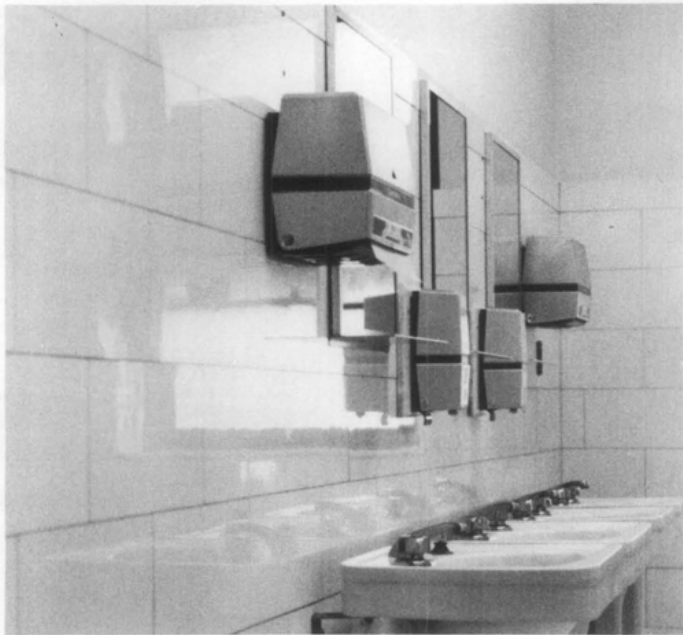
Fig. 4. White pigmented structural glass was used in this remodeling of the U.S. Custom House, Denver, Colorado. Photo: Gregory D. Kendrick.

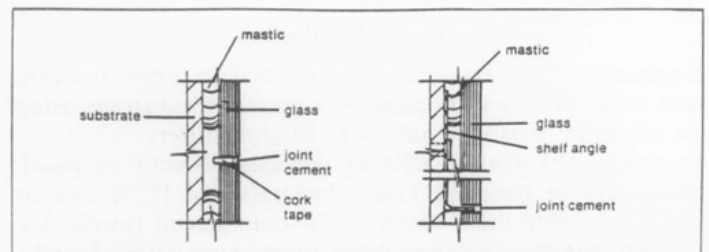
Basic exterior construction details (Dwgs: D. Beals for Building Conservation Technology)

Fig. 7. In the installation process, hot asphaltic mastic was applied to the ribbed or textured back of each glass panel. The panel was then pressed against a masonry wall and supported by metal shelf angles which were usually bolted to the masonry substrate on 3-foot centers. The joints between the panels were filled with cork tape or joint cement. The end result was a modular veneer of clean, uniform glass panels. Courtesy, *Bulletin for the Association for Preservation Technology*, 13 (1981).

The key to proper preservation and repair of both interior and exterior pigmented structural glass is a thorough understanding of the original material specifications and detailed installation techniques. Fortunately, these specifications and techniques remain virtually unchanged from their first early 20th century application (see fig. 7).

Essentially, the glass veneer was applied to a dry, smooth, and solid masonry or plaster-on-masonry substrate using an asphaltic masonry adhesive. Manufacturers recommended against affixing the glass directly to wood, either lath or paneling. Glass thicknesses of 11/32 inch or 7/16 inch were most common for commercial storefronts.

Shelf angles—18-gauge brass or stainless steel, 3 inch square with a 1/2 inch leg fastened directly to the masonry substrate—were used to provide additional support. Inserted along the bottom edge of the panels, they supported every second course of glass and were thus spaced not more than 3 feet apart. Horizontally, the angles were spaced approximately one every 18 inches with at least two used for any piece.

The next step in the installation procedure was to push the glass panel onto the masonry substrate. Every horizontal seam and abutment was separated by a 1/16 inch thick adhesive cork tape recessed from the front surface by 1/8 inch. Vertical edges were kept apart at a uniform 1/32 inch. In either case, the joint opening was then buttered with a joint cement which was colored to match the surrounding glass.

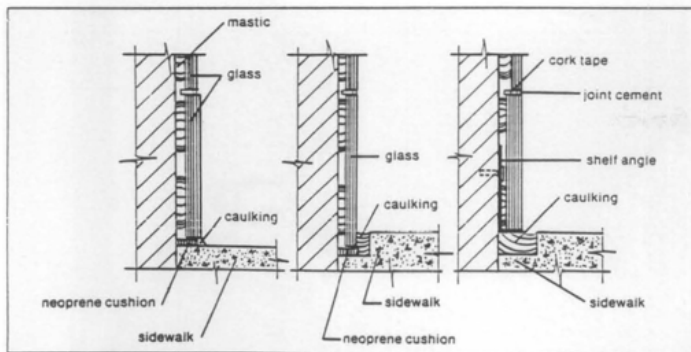
Sections at sidewalk level.

Fig. 8. Courtesy, *Bulletin for the Association for Preservation Technology*, 13 (1981).

Proper detailing at the edges of the veneer could prolong the life of the pigmented structural glass. For example, to prevent possible chipping and cracking of the glass where it met the sidewalk, a cushion of neoprene or leather was provided and the exposed surface then caulked (see fig. 8). The side edges of the glass were detailed in a variety of methods or the glass simply terminated at the desired location with the ends ground smooth (see fig. 9). In either case, the edge was secured to the substrate with a mastic and the joints or void filled with joint cement or caulking compound. Where the edge of the glass abutted another material, such as the brickwork of a neighboring storefront, the glass was held back 1/8 inch to 1/4 inch from the adjacent material. The gap was usually filled with pliable caulk to permit expansion and to prevent moisture migration (see figs. 10 and 11).

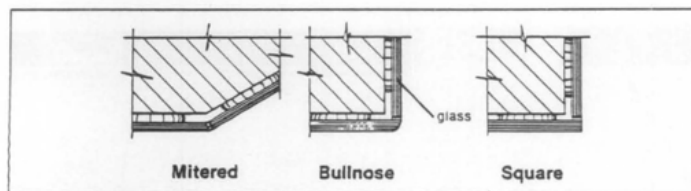
Exterior corners.

Fig. 9. Courtesy, *Bulletin for the Association for Preservation Technology*, 13 (1981).

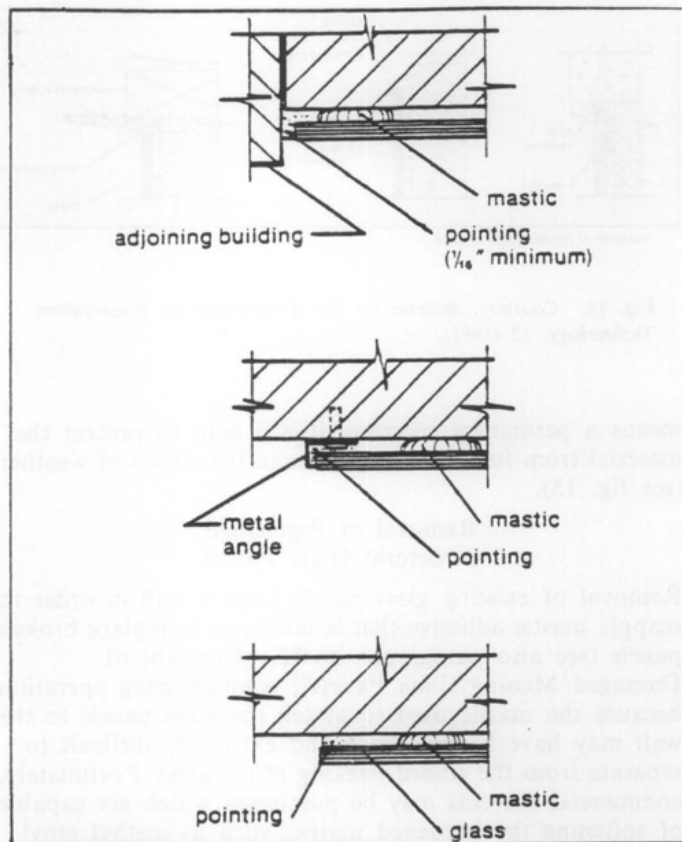
Termination details.

Fig. 10. Courtesy, *Bulletin for the Association for Preservation Technology*, 13 (1981).

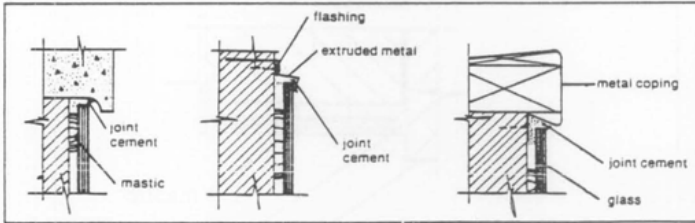
Methods of finishing tops of glass.

Fig. 11. Courtesy, *Bulletin for the Association for Preservation Technology*, 13 (1981).

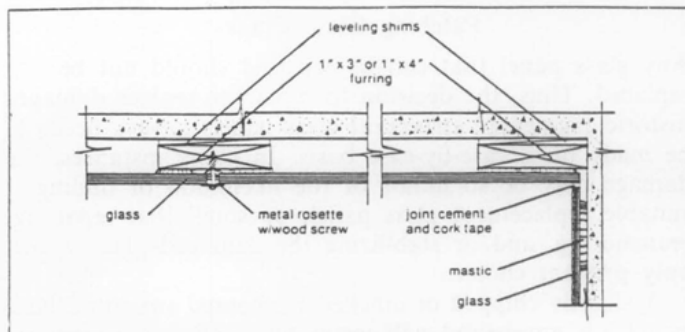
Ceiling construction.

Fig. 12. Courtesy, *Bulletin for the Association for Preservation Technology*, 13 (1981).

Ceiling slabs 11/32 inch in thickness were attached to 1 inch x 4 inch wood furring strips with mastic (a full 4 inch width coverage was recommended around the edge of the panels). Brass wood screws and small rosettes, protected with felt exterior covers, provided additional support (see fig. 12).

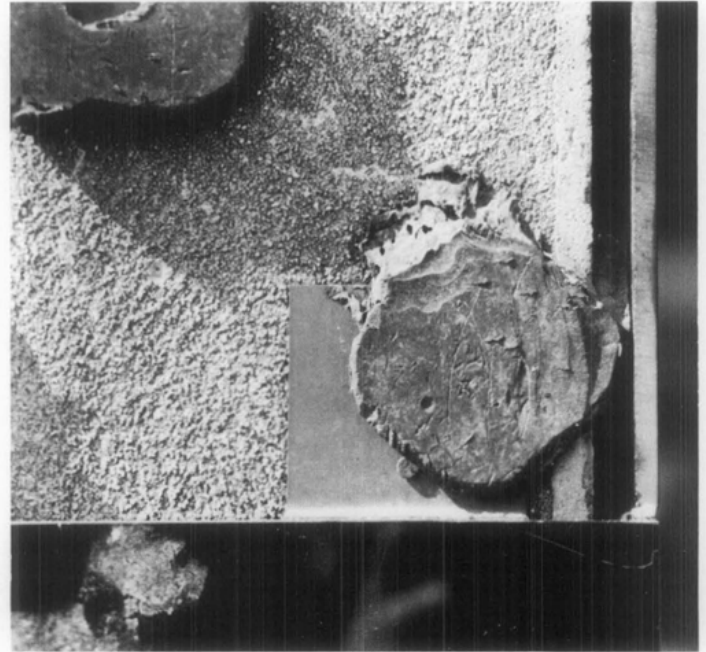
Fig. 13. The pigmented structural glass panel has separated and fallen, exposing the substrate and hardened, brittle daubs of mastic. Photo: Douglas A. Yorke, Jr., AIA.

Failure due to long-term hardening of the original mastic adhesive has accounted for a substantial loss of pigmented structural glass panels. The petroleum-based mastics normally possessed a 30 to 40 year lifespan. Once flexibility of the adhesive is lost, the glass panels become vulnerable to slippage and eventual destruction (see fig. 13).

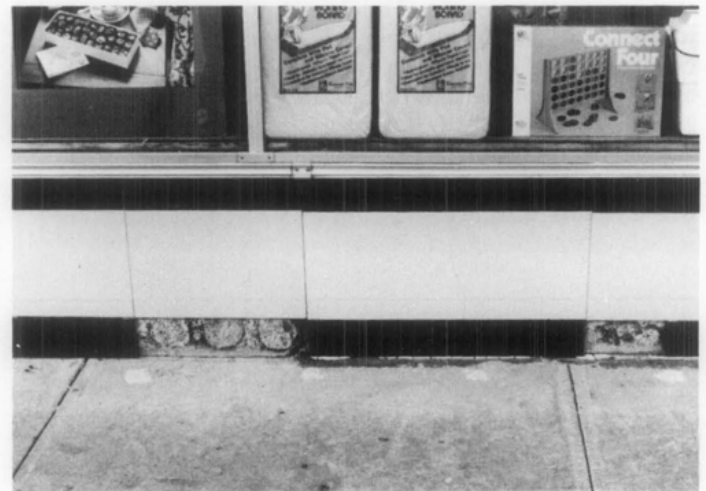
Fig. 14. The vast majority of damaged pigmented structural glass panels are found at ground level, the result of vandalism or improper caulking between the glass panel and the concrete sidewalk. Photo: Thomas Keohan.

Glass breakage through impact is virtually impossible to prevent. The material is, by its nature, vulnerable to loss through vandalism or accident (see fig. 14).

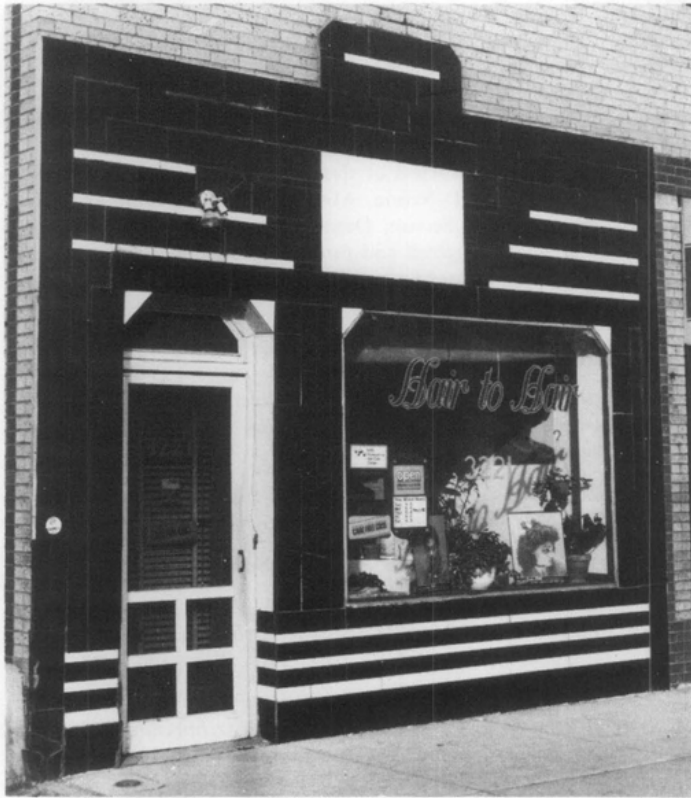
Fig. 15. Owners of this small barber shop, Denver, Colorado, have successfully preserved the historic character of their pigmented structural glass storefront by patching the cracked panels with a dark caulking compound. Photo: Gregory D. Kendrick.

A slightly chipped or cracked pigmented structural glass panel left unrepaired will inevitably become a source of water infiltration. Careful patching of those cracks with an appropriately colored, flexible caulk will deter moisture penetration while still allowing expansion and contraction with temperature fluctuations. Although patching is by no

means a permanent solution, it will help to protect the material from further damage due to the effects of weather (see fig. 15).

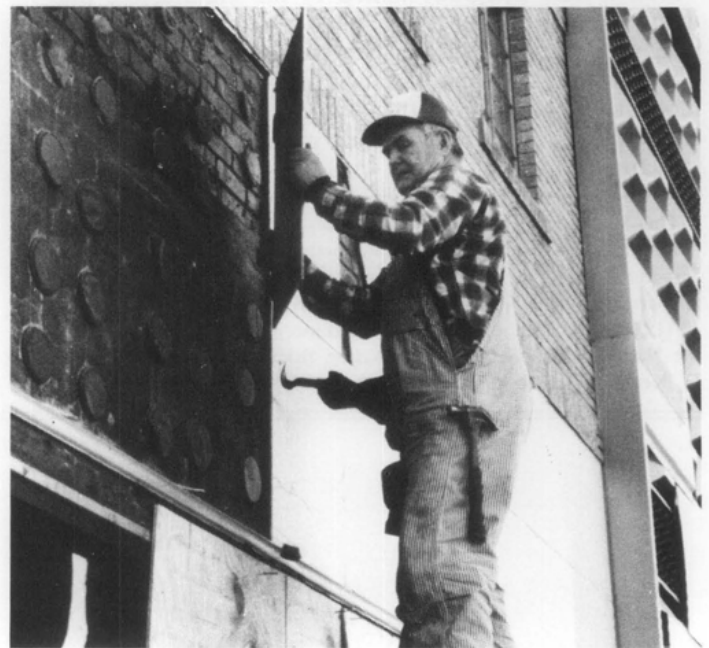
Fig. 16. A worker carefully removes a large glass panel by placing a small piece of wood between a flat prying bar and the glass, then exerting steady pressure. The majority of panels were removed without damage using this procedure. Photo: Thomas Keohan.

If time is a concern, a fast, simple removal method is to carefully pry the panels off with a broad flat tool such as a nail puller. A small piece of wood placed between the flat tool and glass will minimize splintering of the edges. Stubborn pieces can be removed by squirting the mastic with a solvent (as described above), then letting it set

several minutes. This procedure softens the mastic, making it more pliable. The piano wire/sawing method may be useful in removing the topmost glass panels of a continuous face where no edges occur. The wire can be effectively worked into the joints and will cut through the mastic. With care, a high percentage of the glass panels can be salvaged using this method (see fig. 16).
