## TOTEM POLES

# Tech Notes

## EXTERIOR WOODWORK

### Protecting Woodwork Against Decay Using Borate Preservatives

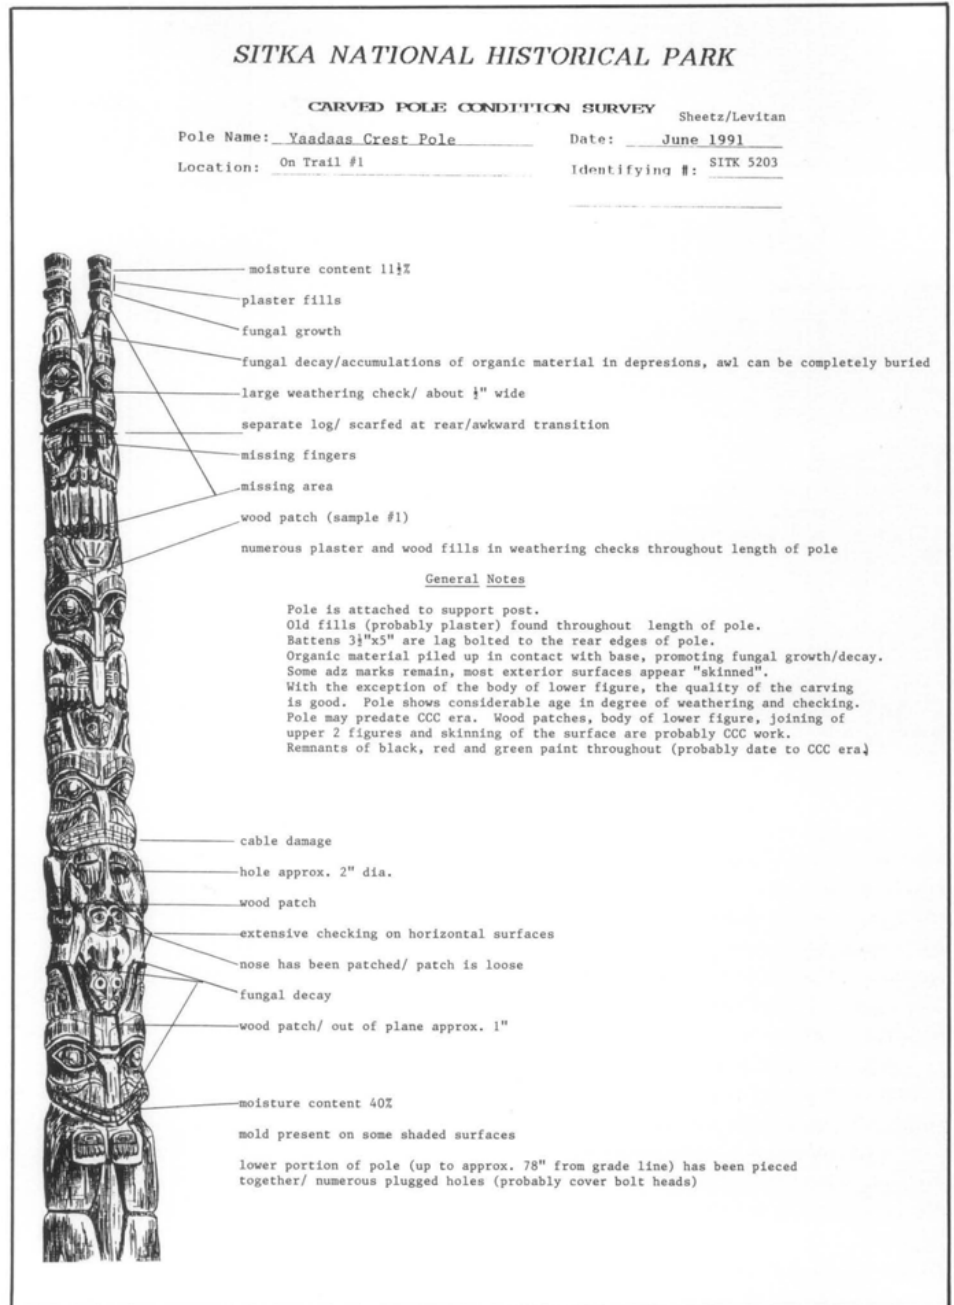
Figure 3. A condition survey of each of the 7 totem poles identified a variety of problems, including fungal decay, cracks and splits, and high moisture levels.

In 1991, a 3-day Totem Preservation Conference was held in Sitka to evaluate preservation approaches and a condition survey made of the collection. The survey included 30 carved poles and carved house poles at the park; some were on display and others were in storage (see figure 3).

The 7 poles determined to be in the most advanced state of decay shared several characteristics. They were all displayed outside and, in consequence, their bases were decayed. In several cases, the moisture content of the wood to 6" above ground was as high as 47% and fungal decay on the surface was clearly evident. Damage to the bases had occurred directly above ground and below grade to a depth of 18".

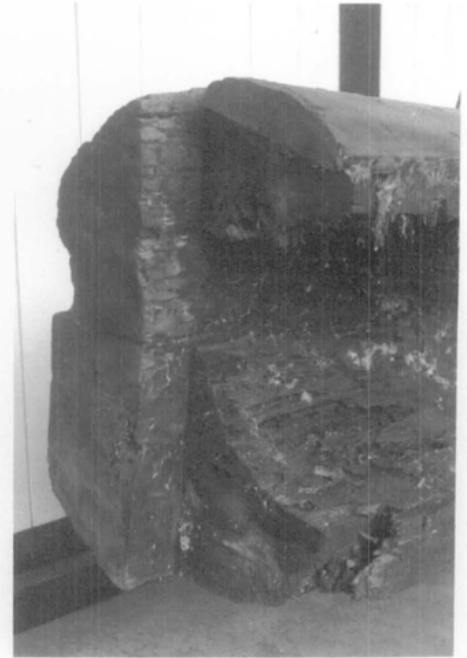
Figure 5. Deterioration occurred between the support post and the hollowed back of the totem. Coal tar had been applied in the past to the hollowed back of this totem to deter fungal decay.

Although less serious than the damage to the bases, fungal decay also had occurred at other locations. At the top of the poles, the open end grain and cracks in the wood created perfect conditions for water retention (see figure 4). Some of the poles were flat at the top, permitting water ponding. Fungal decay also was evident on the horizontal surfaces of the carvings throughout the length of the poles, in crevices created by carvings, and in the cracks and splits in the wood where organic debris tended to accumulate and retain moisture. One pole had an 8 foot-long vertical split at the base. Finally, decay was evident in the concave backs of the poles that abutted supporting posts (see figure 5).

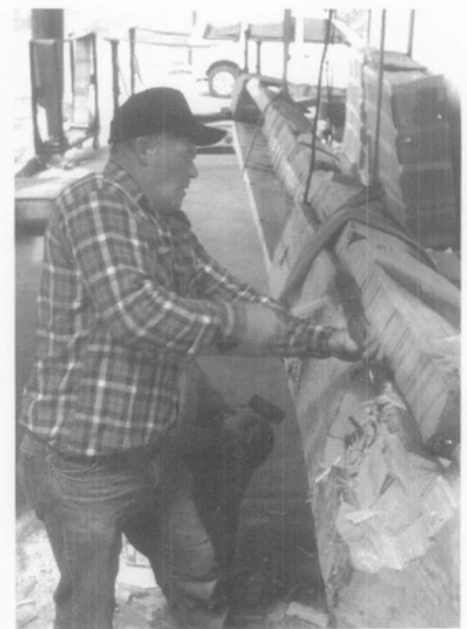
Figure 6. Three of the 7 totems had support posts. The steel bolts connecting the support posts to the totem had rusted and often needed to be chiseled out of the support post. Note the hollowed back of the totem which extended nearly the entire length while the support post extended only about half way.

base. Support posts were detached by removing the 1/2" all-thread steel rods that had connected the posts to the carved poles (see figure 6). The totem poles then were cleaned with water using natural bristle brushes and a garden hose with a spray attachment. Since the red cedar poles had

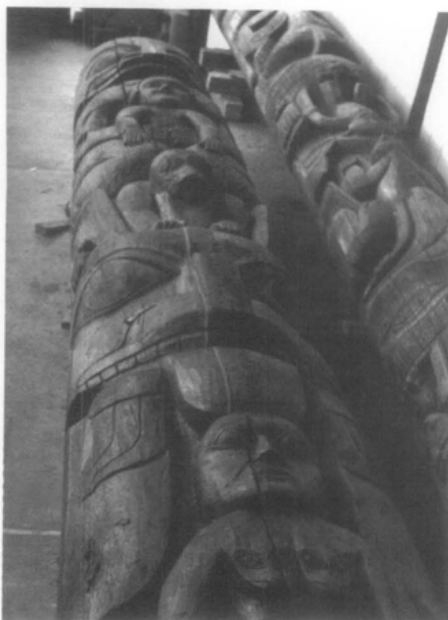
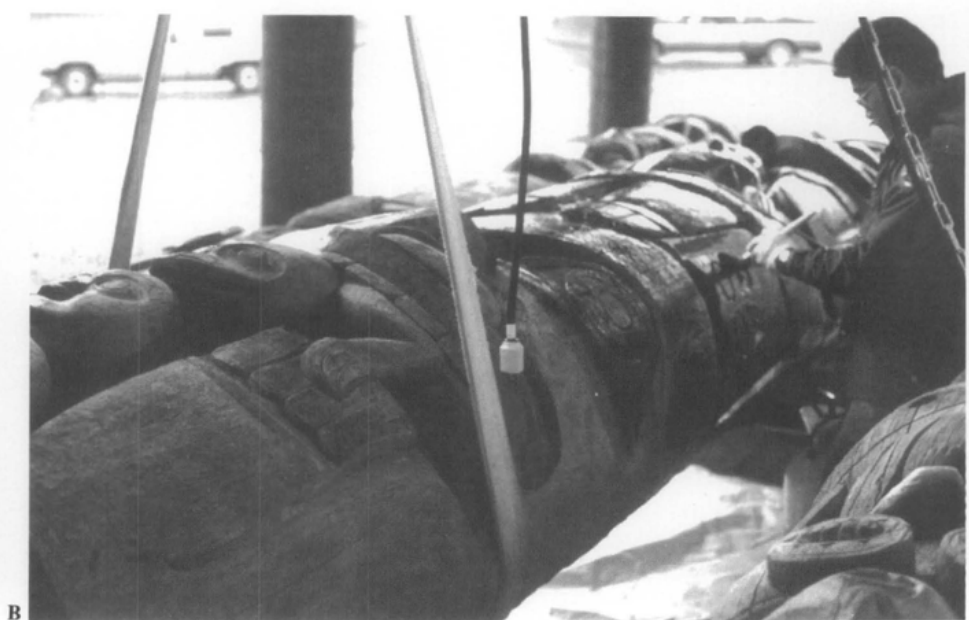
Figure 7. Borates were applied to the totem using a garden sprayer and brushes. This was followed by an application of a water repellent with mildewcide. Photo A is during application and photo B shows totems while drying.

Following repairs, the poles were first treated with a commercially available borate preservative. It was purchased as a concentrate and diluted with warm water in a 1:1 mixture in accordance with label instructions. With the pole on its back, supported by cribbing and padding, the ends were treated with a brush application of the preservative as well as with any end grain exposed by carvings. The preservative was then sprayed onto the rest of the pole using a 2-gallon garden sprayer (see figure 7). This was followed by a second coat, spraying slowly to ensure all cracks and crevices received ample coverage. The poles were sprayed until thoroughly wet and rotated with a chain hoist as needed. Near the surface, where wood was oversaturated with the preservatives, boron salts fluoresced on the surface after the glycol and water evaporated. The fluorescence was removed by wiping with a wet brush. After waiting several days for the surface to dry from the application of the wood preservative, the water repellent and mildewcide mix then was sprayed onto the pole, again using a garden sprayer to apply the mix and a brush to spread it.

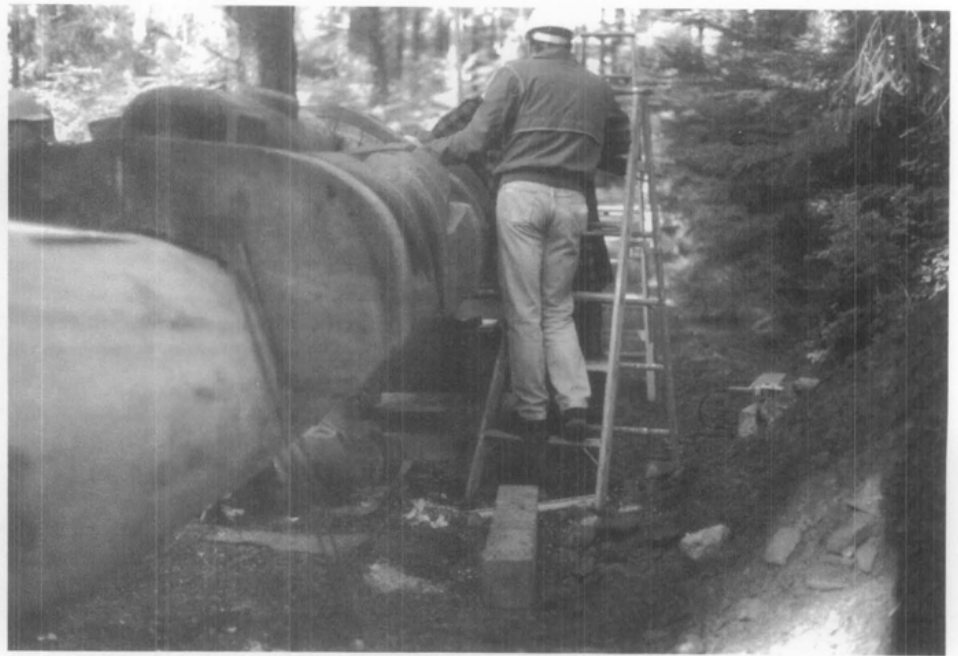
Figure 8. Due to the heavy weight of the totems, they were usually attached to their fitted support post and re-erected at the site.

Upon securing the support post to the totem, the entire unit was re-erected (see figure 8). The prepared bandage was fastened to the support post before the last 20" of fill dirt was added (see figure 9).

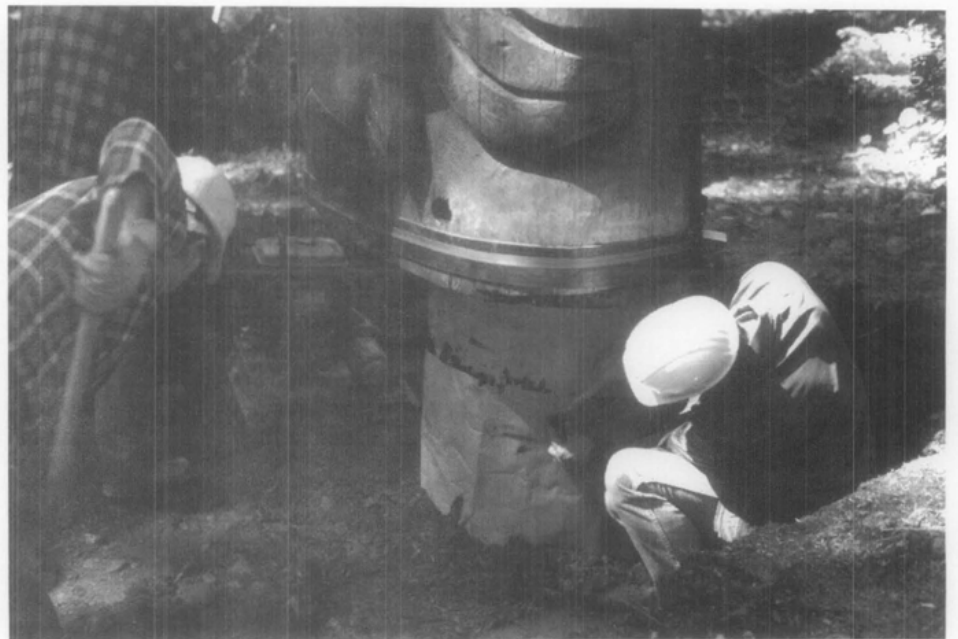
Figure 9. After securing the support post in the ground, a wood preservative in a "bandage" form was attached to the support post before dirt was filled to grade level.

mold and mildew. The utilization of a wrap or bandage was considered the most effective application method and, in addition, it would retard the borate from leaching out of the wood. It is anticipated that the wraps will be inspected in 10 years to assess their condition and possible replacement. (This would only require removal of the dirt around the bases to a depth of approximately 20" so that a new wrap could be applied, if needed.)
