Tech Notes

NUMBER 1

Process-Printing Decals as a Substitute for Hand-Stencilled Ceiling Medallions

NATIONAL ARCHIVES Washington, DC.

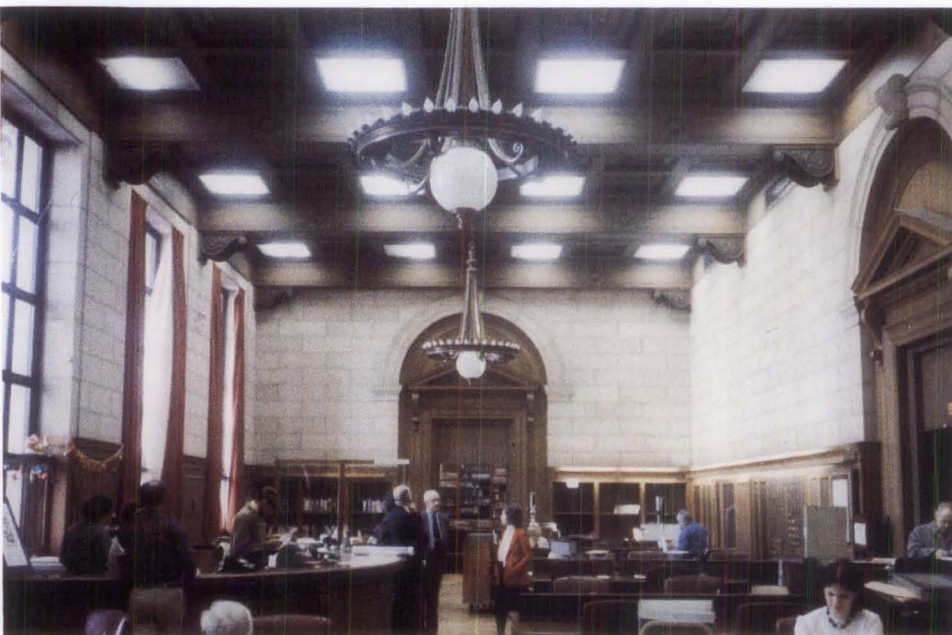
The coffered ceiling had been badly damaged in 1962 with the installation

of fluorescent light fixtures (see figure 2). Forty of the coffers had been drilled with large holes to attach the light fixtures and the central medallions had been removed (see figure 3). In 1988, the General Services Administration (GSA) authorized a new sprinkler system in the Central Search Room. As part of the sprinkler project, the 1962 intrusive fluorescent lights were proposed for removal, with attendant enhancement of the desk level lighting. The two historic chandeliers were to be retained.

2. The 40 large visually obtrusive fluorescent lights, installed in 1962, damaged the coffered ceiling in the Central Search Room. Photo: Dell Corporation.

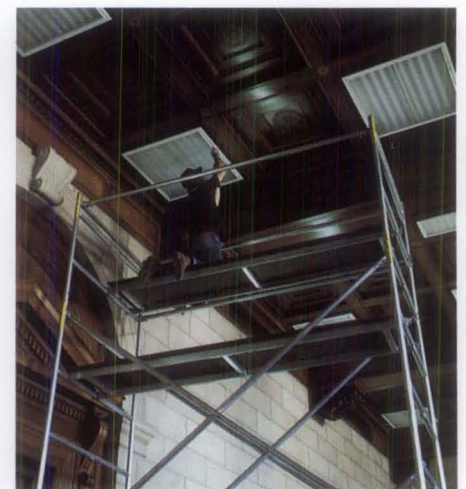
3. The light fixtures were carefully removed to permit installation of a sprinkler system behind the coffered ceiling and to restore the ceiling to its original appearance. It was necessary to reproduce 40 new panels for installation in the coffered ceiling, due to the damage resulting from the 1962 lighting work. Photo: Dell Corporation

Using the ceiling openings created by removal of the modern light fixtures, 2" diameter pipes were installed for the new sprinkler system. Because the intact historic panels were so tightly glued in place, it was difficult to remove them without damage. Therefore, the new sprinkler heads were located at the centers of the 40 replacement panels, which were evenly spaced across the ceiling. One historic panel was removed to serve as a model for the replacement panels.

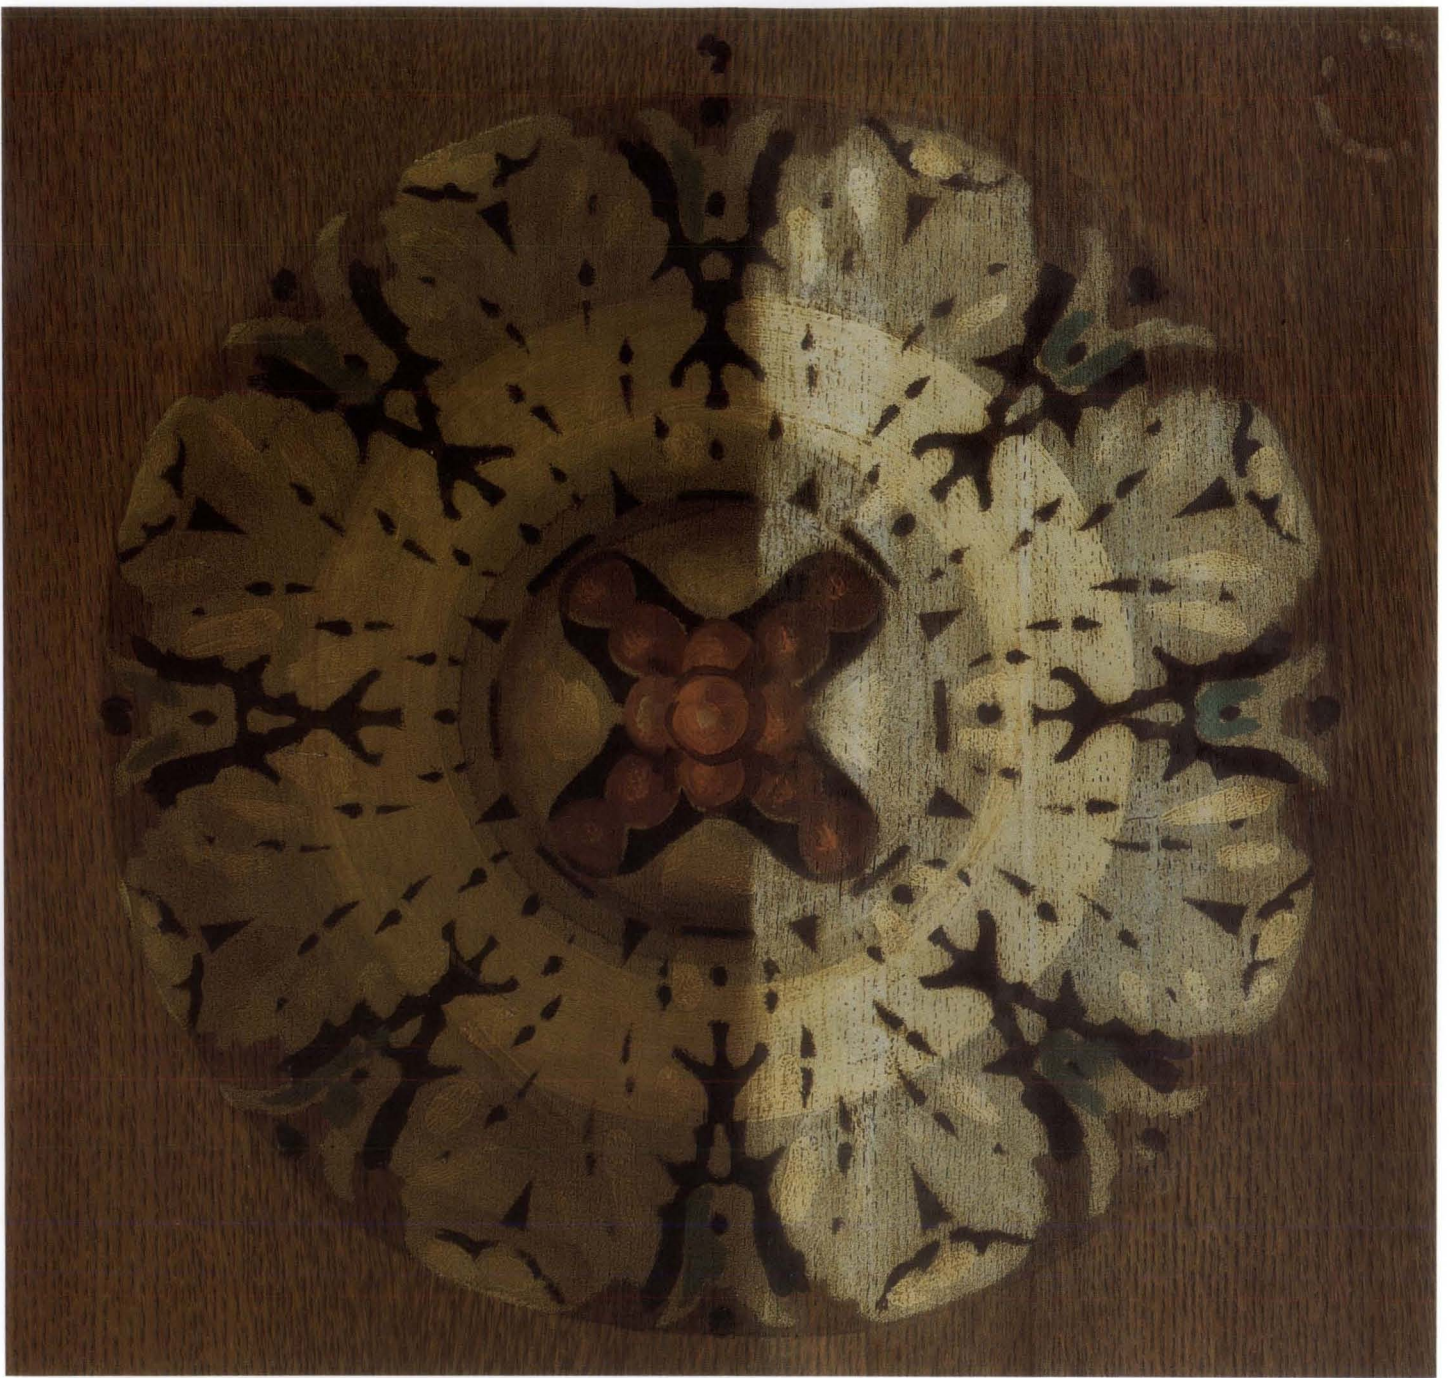
4. A historic stencilled panel was removed and cleaned in order to have a model for the replacement panels. In this view, only half of the panel has been cleaned, revealing the difference between the aged and original appearance of the ceiling. Since the ceiling was not scheduled to be cleaned, a decision was made to reproduce the original panel appearance and then artificially age the replacement panels to blend in with the existing ceiling. Photo: Dell Corporation.

Original medallions used as backing for access panels and shim pieces when the fluorescent lights were installed served as test panels for cleaning. Various chemicals were tested to find a treatment that would remove the old varnish without removing the paint. One entire undamaged panel was removed and cleaned, based on the test results, and served as the model for the replacement work. The varnish overcoat was removed using cotton swabs dipped in a solvent solution. It took 6 applications to carefully strip the varnish without removing the original brush marks. This was followed with up to 6 cleanings of the paint and highlights using a

commercial stripper of toluene, acetone, and butyl-acetate. The result was that the original lighter tones of the white oak background were also revealed along with the bright colors of the original painted medallions (see figure 4).

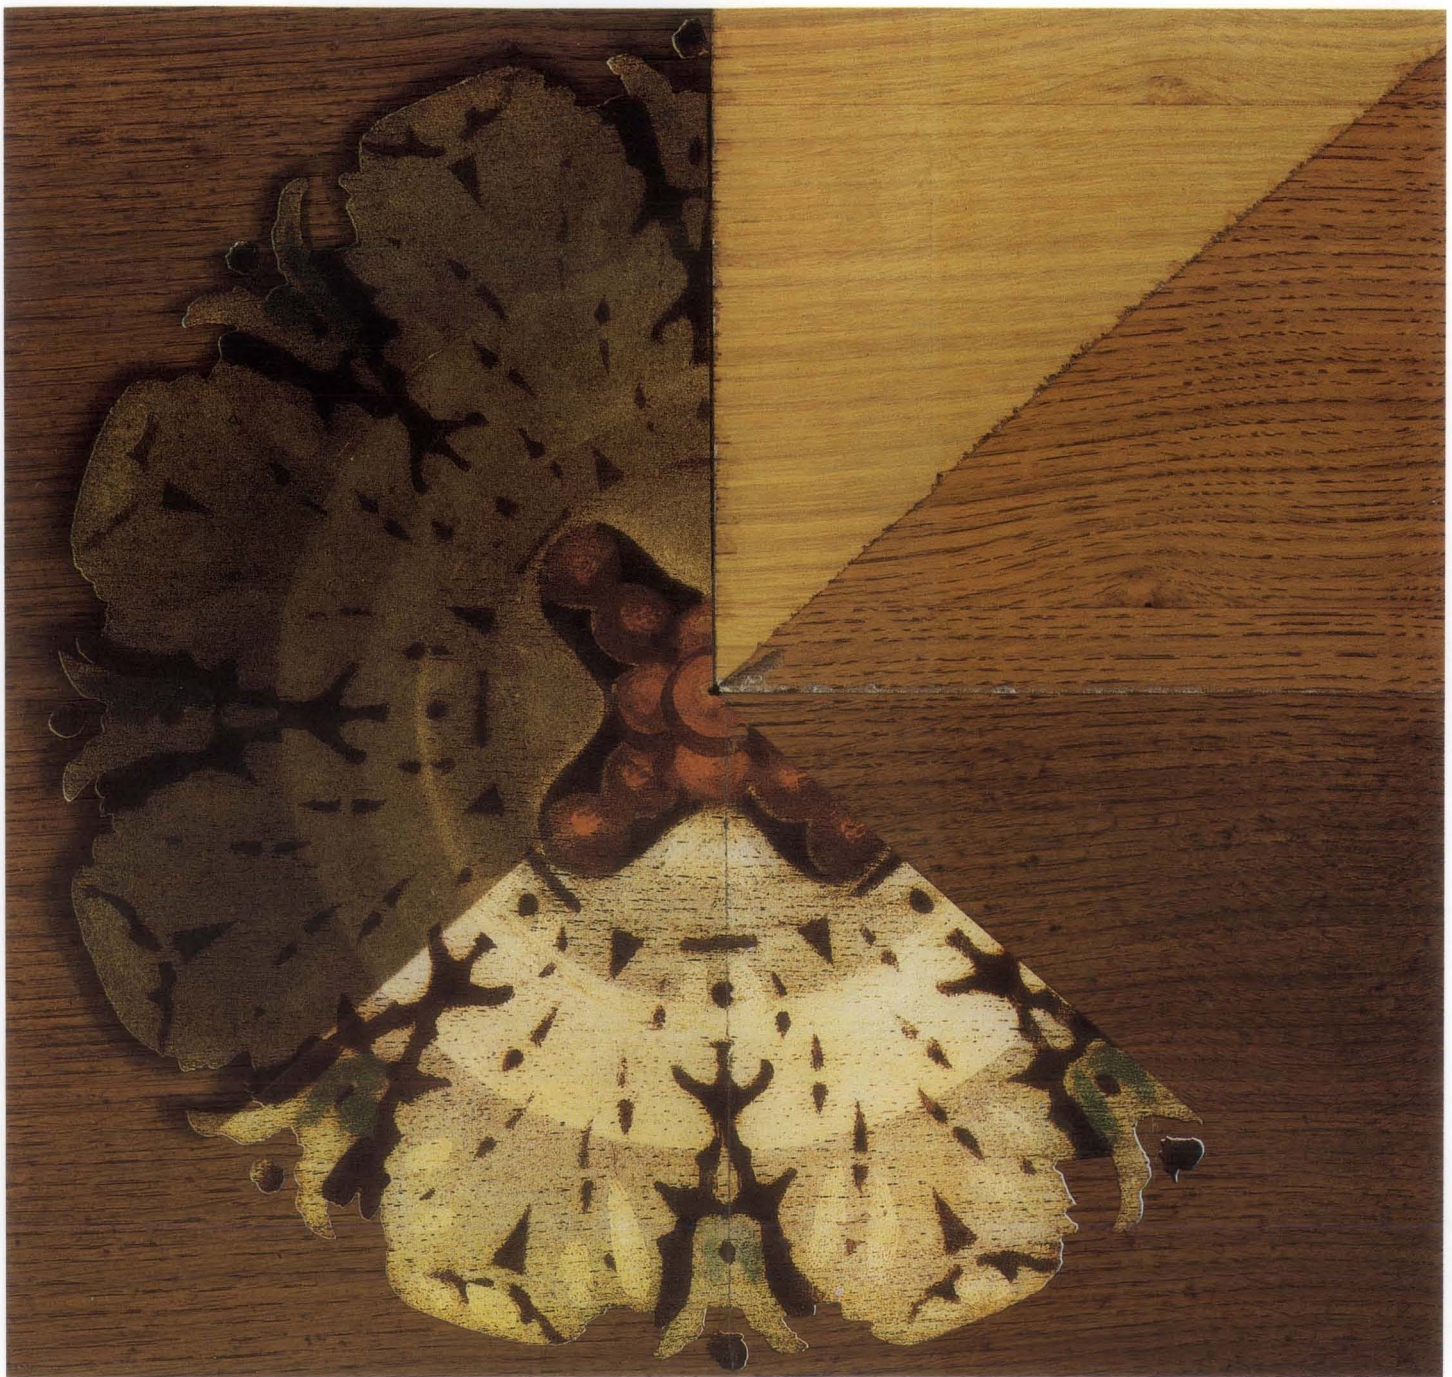
5. This demonstration model shows the various stages involved in finishing the ceiling panel. Starting with the raw wood panel in the upper right corner (1) and moving clockwise, a penetrating stain was applied (2) that matched the historic stain. A tinted varnish, or sealer, (3) was then applied to ready the backing panel to receive the decal (4). Two coats of acrylic sealer were used to protect this "cleaned" condition. The next 3 steps (5, 6, 7) produced the "aged" appearance with tinted varnish layers sprayed on using cardboard masks to produce the proper tones. A top coat of clear varnish (8) provided the final protective layer. Photo: Dell Corporation.

Because the original panels were not to be cleaned at this time, the replacement panels were artificially aged to match the current appearance of the historic panels. To give an individual appearance to each medallion with a minimum amount of hand work, highlighting was done by rubbing a solvent soaked cotton swab over the tinted overcoats, removing some of the topcoat varnish in selected areas. A clear coat was sprayed over the tinted coat to provide a final protective layer (*see figure 5*).

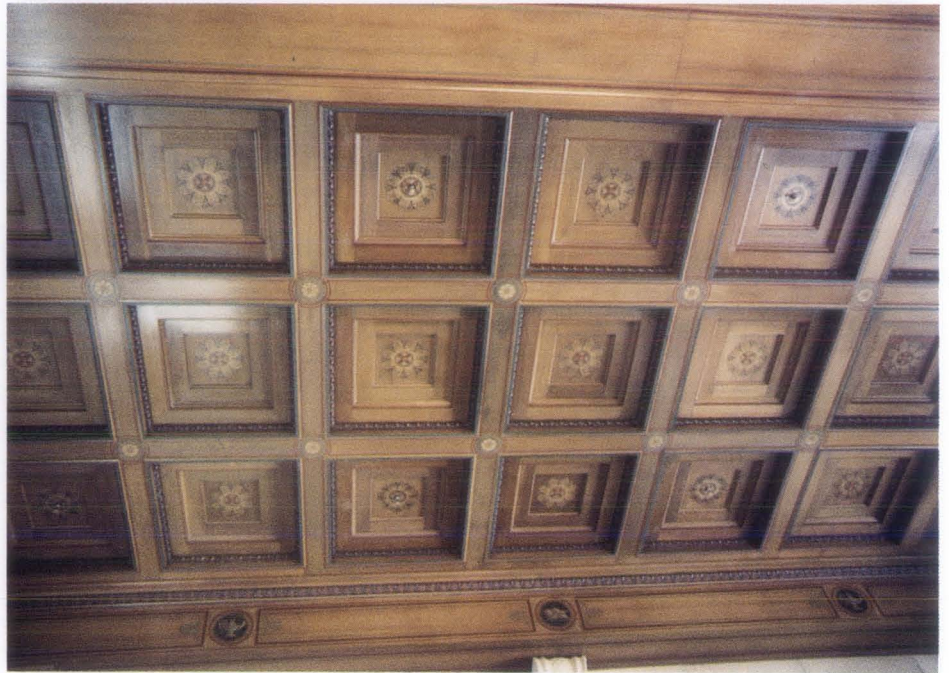
7. Following the work, the difference between the decal replacements and the historic stencilled panels is not discernible from the floor of the Central Search Room. Photo: Dell Corporation.
