# Architectural Documentation & the Treatment of Historic Structures

## Historic Preservation Training Center, Bucks County Community College

# Brawner Farmhouse

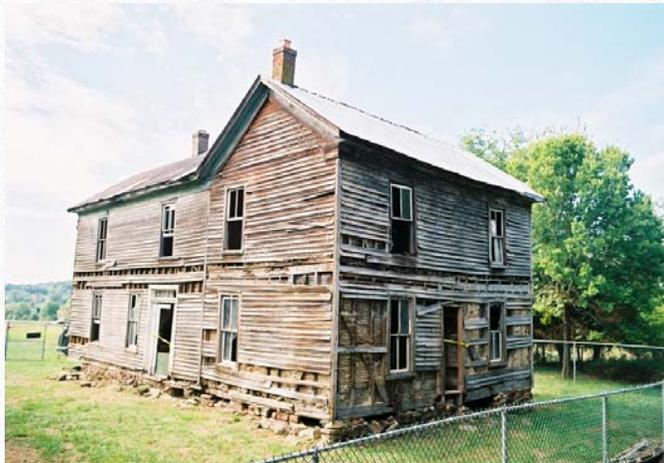
A two story "L" shaped vernacular frame house with modest Victorian finishes stands on a ridge north of the Lee Highway, formerly Warrenton Turnpike. Historical research suggests that the antebellum house known as Bachelor's Hall was built ca. 1820 by George Tennille, when the house first appears on the tax records. Tennille had been residing on the property since the late 18<sup>th</sup> century. The ownership of the farm passed to Tennille's grandson George A. Douglas ca. 1846 and subsequently to Mrs. Augusta Douglas during the war. The footprint of a three or four bay wide, two pile deep frame house with paired exterior chimneys on the gable ends was uncovered

(kitchen) was reversed from an earlier entrance from the east parlor near the original south entrance door.

The actual appearance of the Douglas Hall is still speculative. It may have been the full 2 1/2 story, two pile house that was being built in the area c1820 (Pater, Stephen, "No Maneuvering and Very Little Tactics, Archaeology and the Battle of Brawner Farm" NPS, 2001). It could also be a 1 1/2 to 2 1/2 story, one pile house with a full one story shed lean-to across the north rear. There is an outside possibility that a 1 1/2 story 18<sup>th</sup> century house was enlarged ca. 1820 to a 2 1/2 story house and then diminished after the Civil War to the extant 1 1/2 story framing. War damage may have been enhanced by neglect and/or natural disaster to contribute to the smaller rebuild. There was no evidence of a fire comprehensive enough to cause Douglas Hall to burn to the ground, although some blackened scarring on second floor joists suggests a small fire was extinguished.

The Davis family undertook the 1904 remodeling and enlarging of the earlier house adding formal spaces to the house and changing the orientation of the entrance door. All 1904 construction is circular sawn balloon framing, except for heavy sill plates. Full two story diagonal braces are used on the south gable and two story studs carry a ledger or ribbon board to support the second floor joists. A small basement was dug under the entrance hall, entered from a bulkhead on the west side. The concrete walls have "E. P. D. 1916" etched in the east wall.

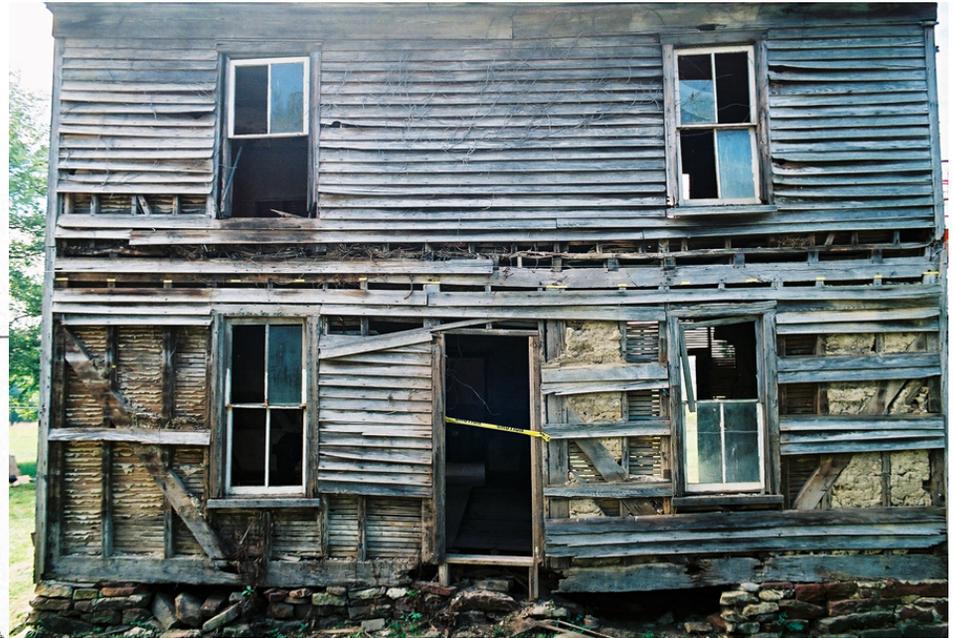
NORTH ELEVATION

CIRCULAR SAWN
- KEY TO METHOD OF JOINING & SQUARING TIMBERS

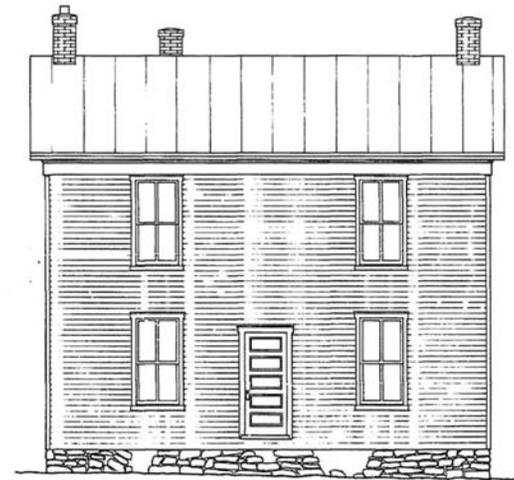
HISTORIC AMERICAN  
BUILDINGS SURVEY  
SHEET 4 OF 9 SHEETS

### ELEVATIONS

FEET 1/4" = 1'  
METERS 1:48

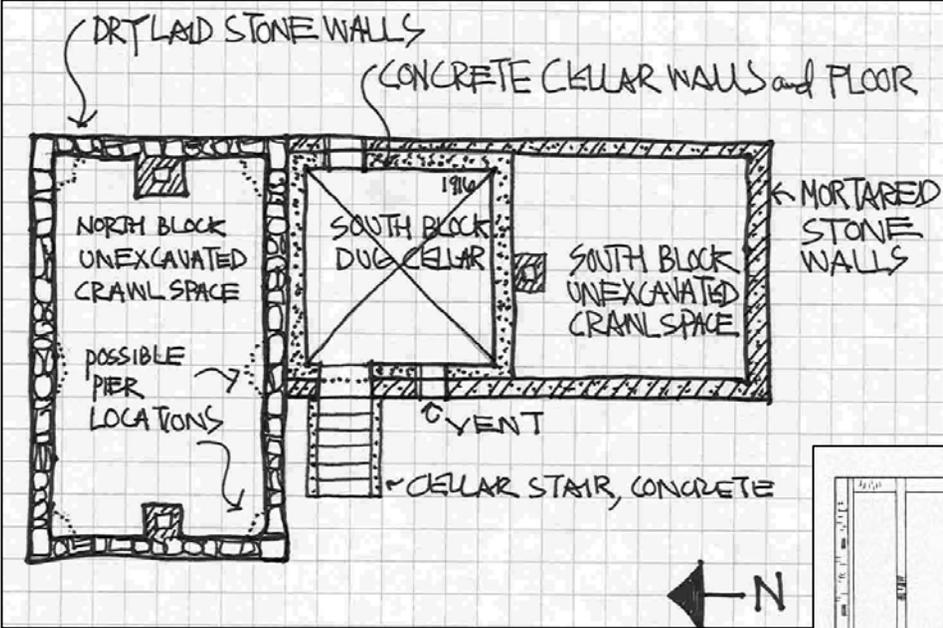
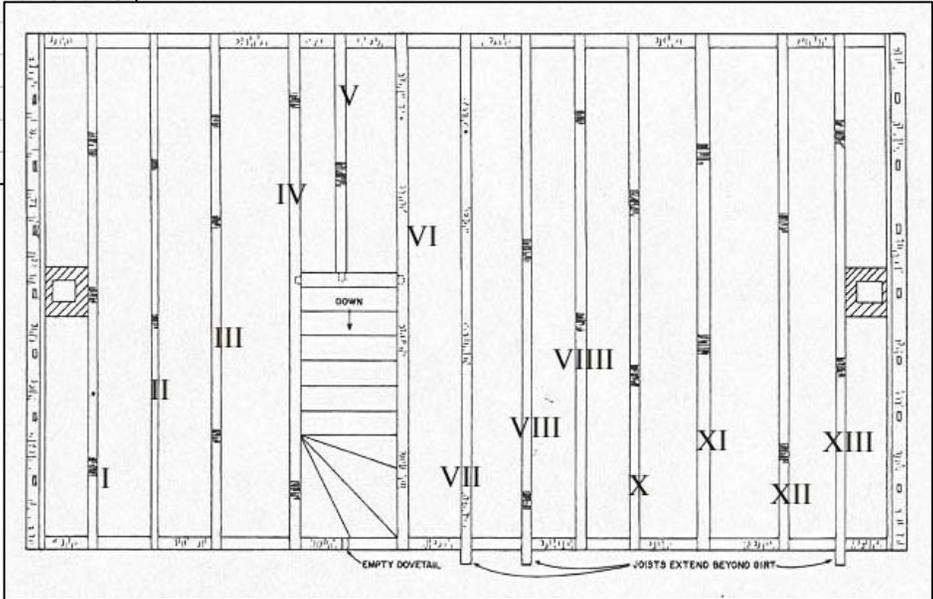
HSR illustrations derived from documentation project

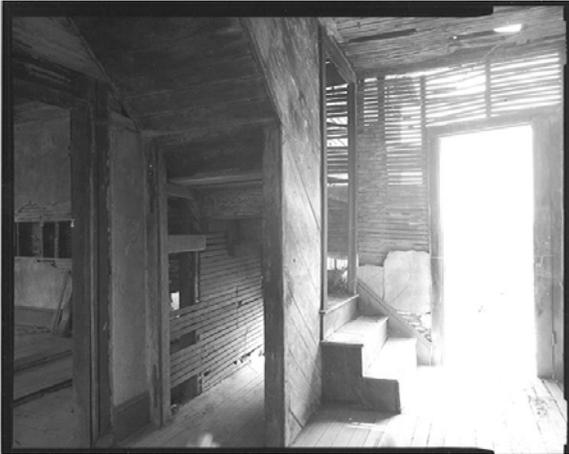
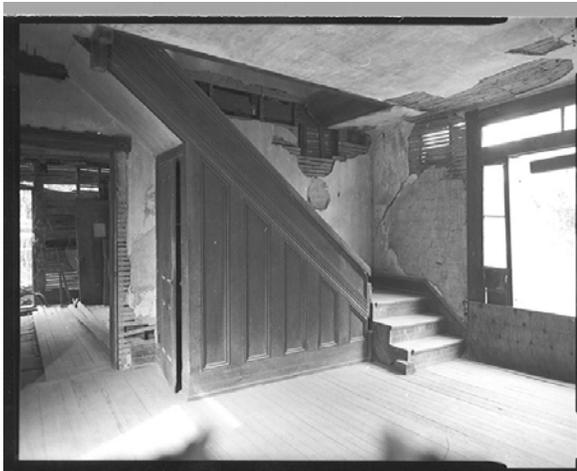
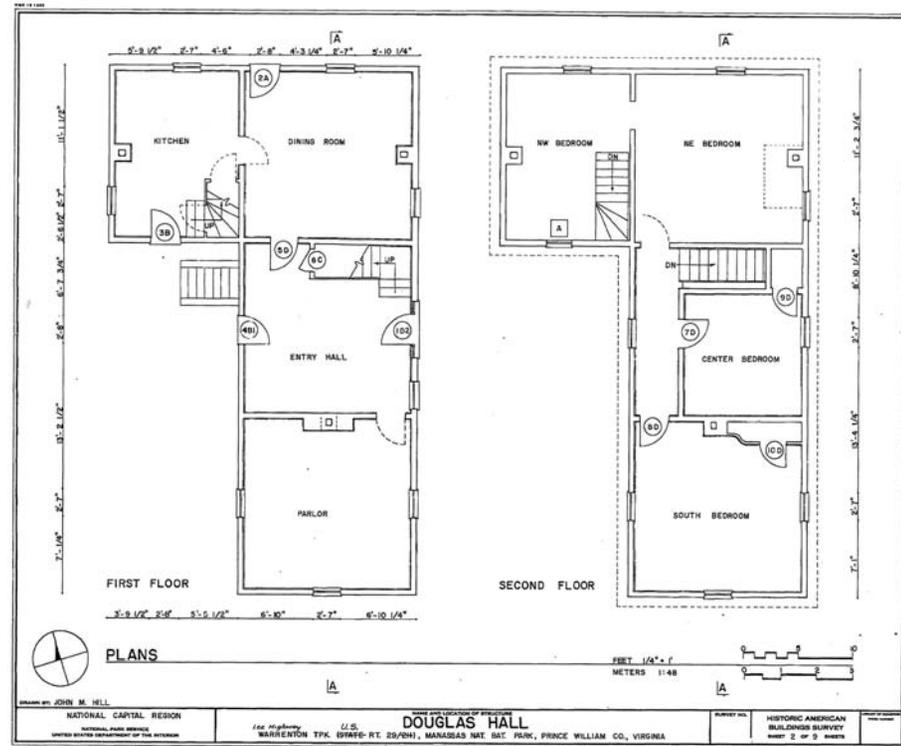
2002 HABS interior photos  
& 1985 floor plan

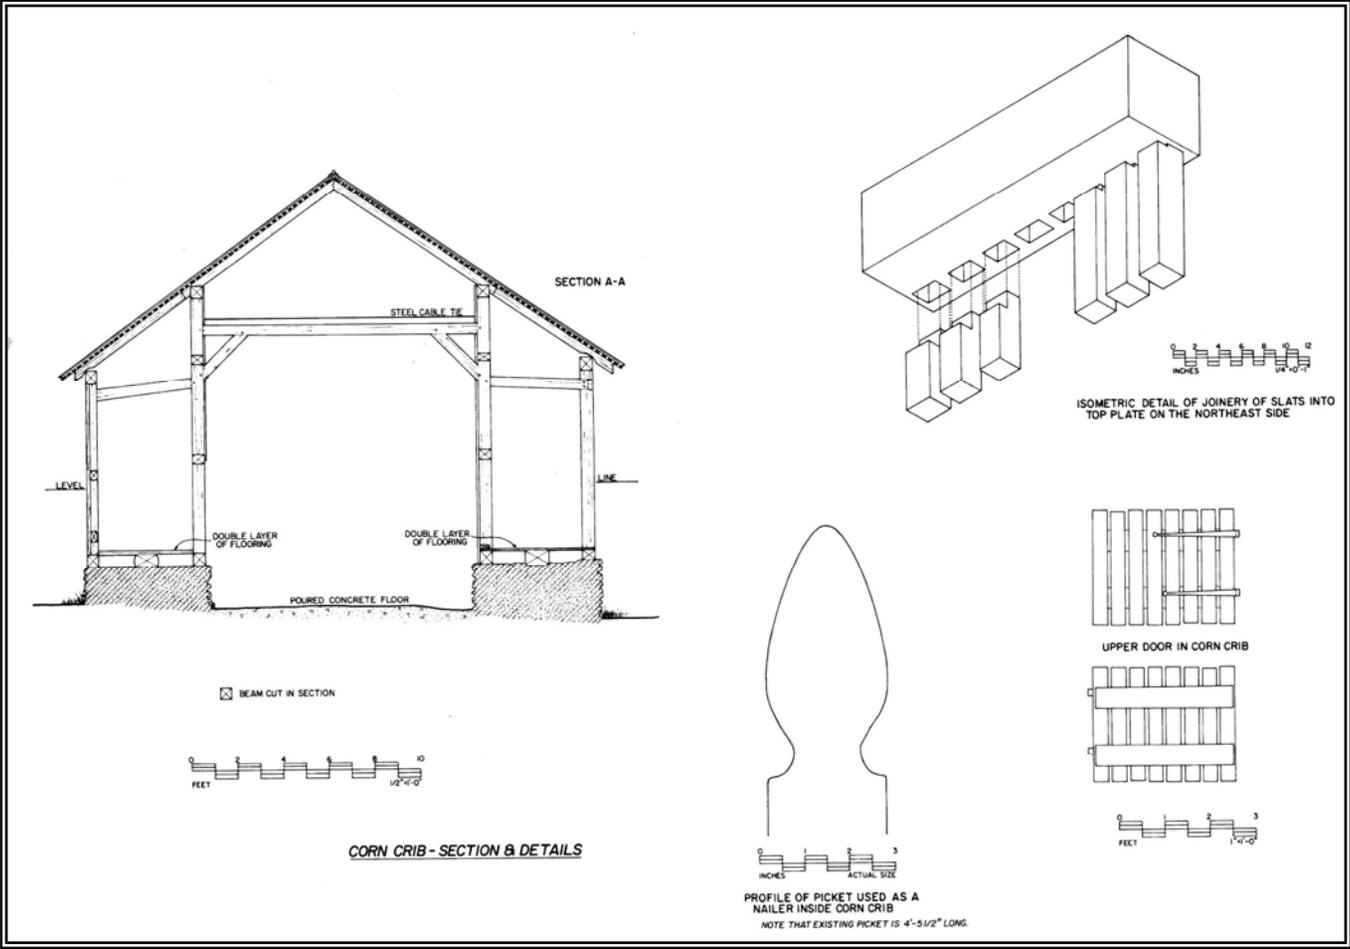
Details from HABS drawings, Corn Crib @ Thomas Farm by BCCC, 2004

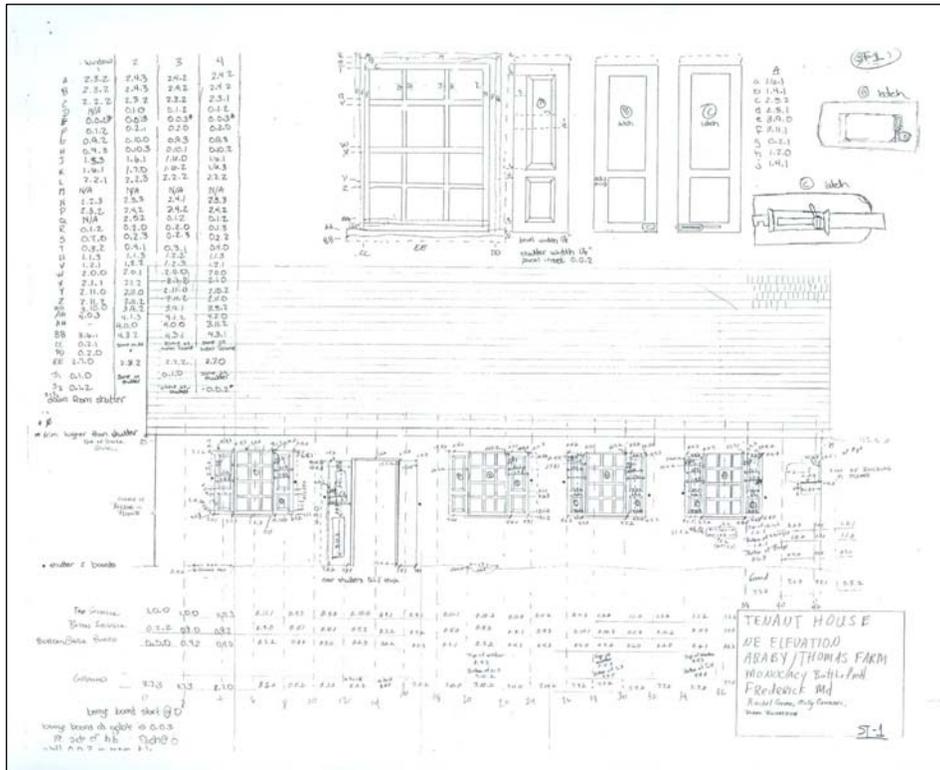
Stone Tenant House  
 Field Documentation  
 Thomas Farm, MONO NB (2005)

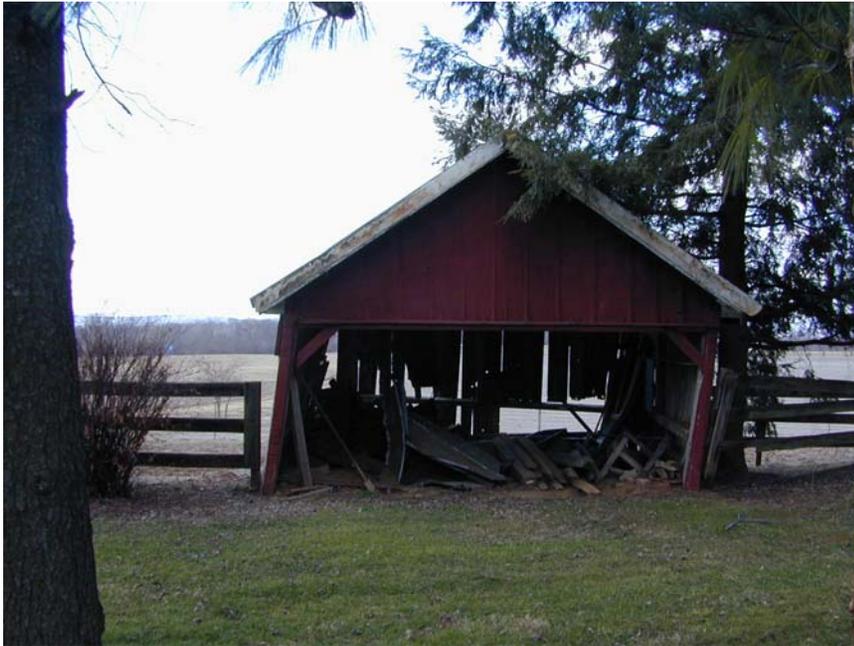
Wood (Implement) Shed  
Field Documentation  
Thomas Farm, MONO NB (2005)
