# PERMEATING CHALLENGES

### CENTER FOR URBAN ECOLOGY

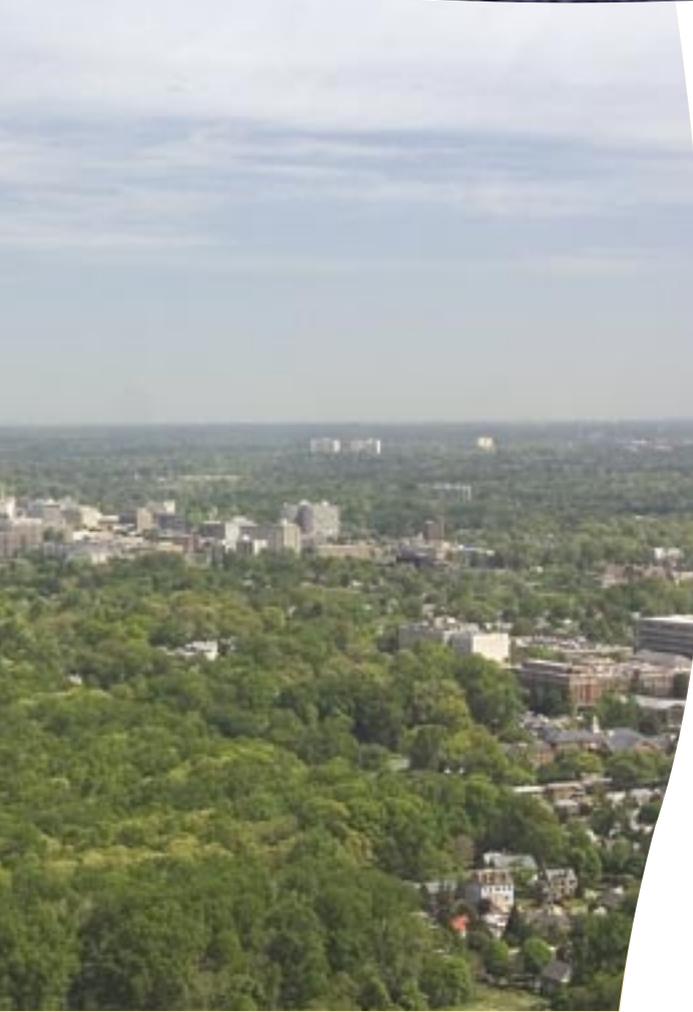
Figure 1 (above)

Rock Creek Park (dark green center), located in the Washington, D.C. metro area, is a forested island surrounded by a sea of impervious surfaces created by residential and commercial development.

The challenge for the National Park Service is to protect resources threatened by development and to mitigate and restore resources already impacted. This is particularly difficult when threats and impacts to the resources within the parks originate outside the park boundaries. For example, three of our parks are long, skinny ribbons with large perimeter areas. One of these, the Chesapeake and Ohio Canal National Historical Park, is 184 miles (296 km) long and includes over 109 streams that are potentially affected by pollution from the surrounding developed lands in Maryland and the District of Columbia. Seven other parks are either entirely inside cities or abutting development from one or more directions. Rock Creek Park is an island of green forest within a sea of impervious surfaces (Figure 1).

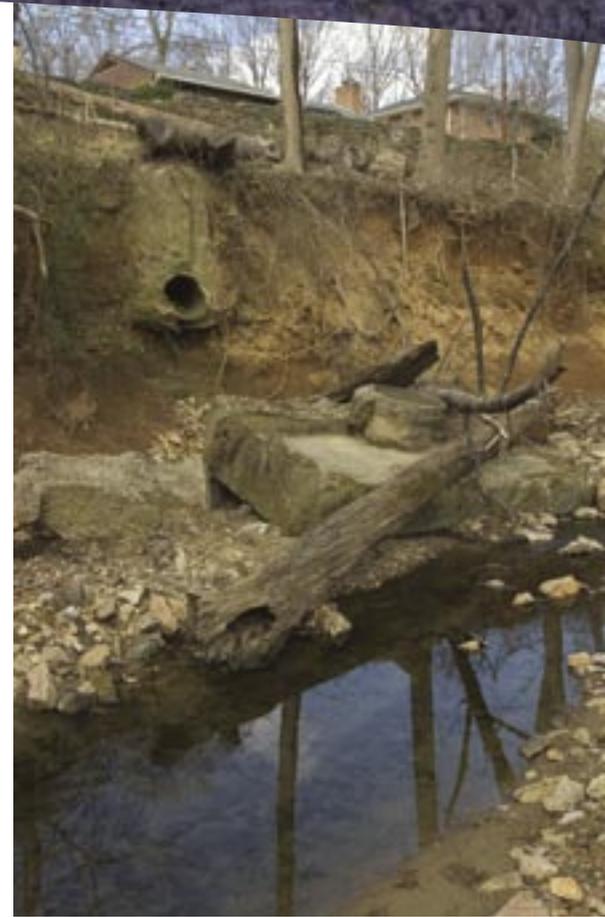
Figure 3  
Storm water flowing into an unprotected gully causes massive erosion.

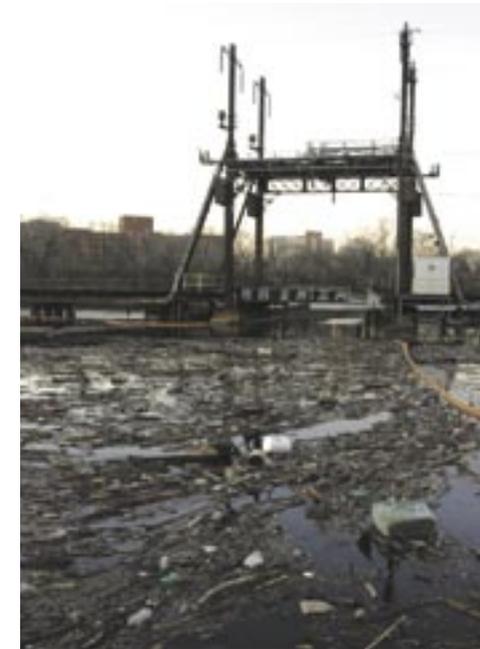
The Anacostia River receives trash and contaminants from urban streams in the Washington, D.C. metro area, some of which flow through National Parks.
