Archeological Investigation  
of the Carriage House  
James A. Garfield National Historic Site,  
Mentor, Ohio

Midwest Archeological Center  
Technical Report No. 62

United States Department of Interior  
National Park Service  
Midwest Archeological Center  
Lincoln, Nebraska

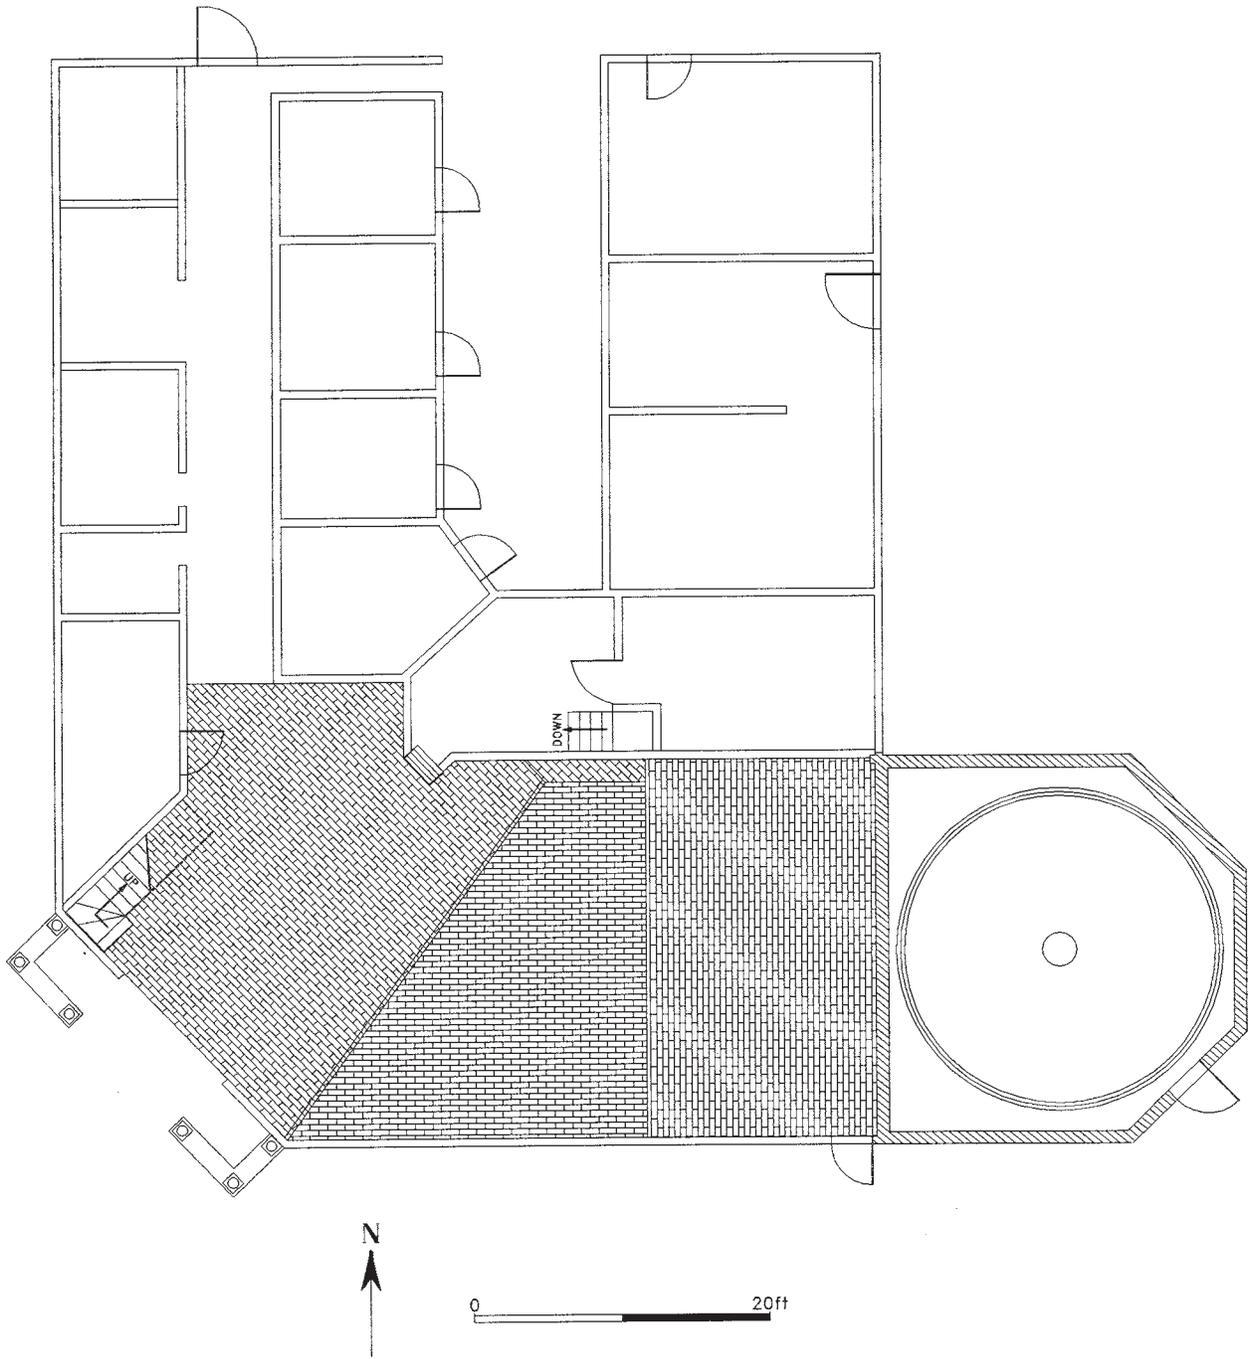
Figure 4. Carriage House/Gas Holder first-floor plan.

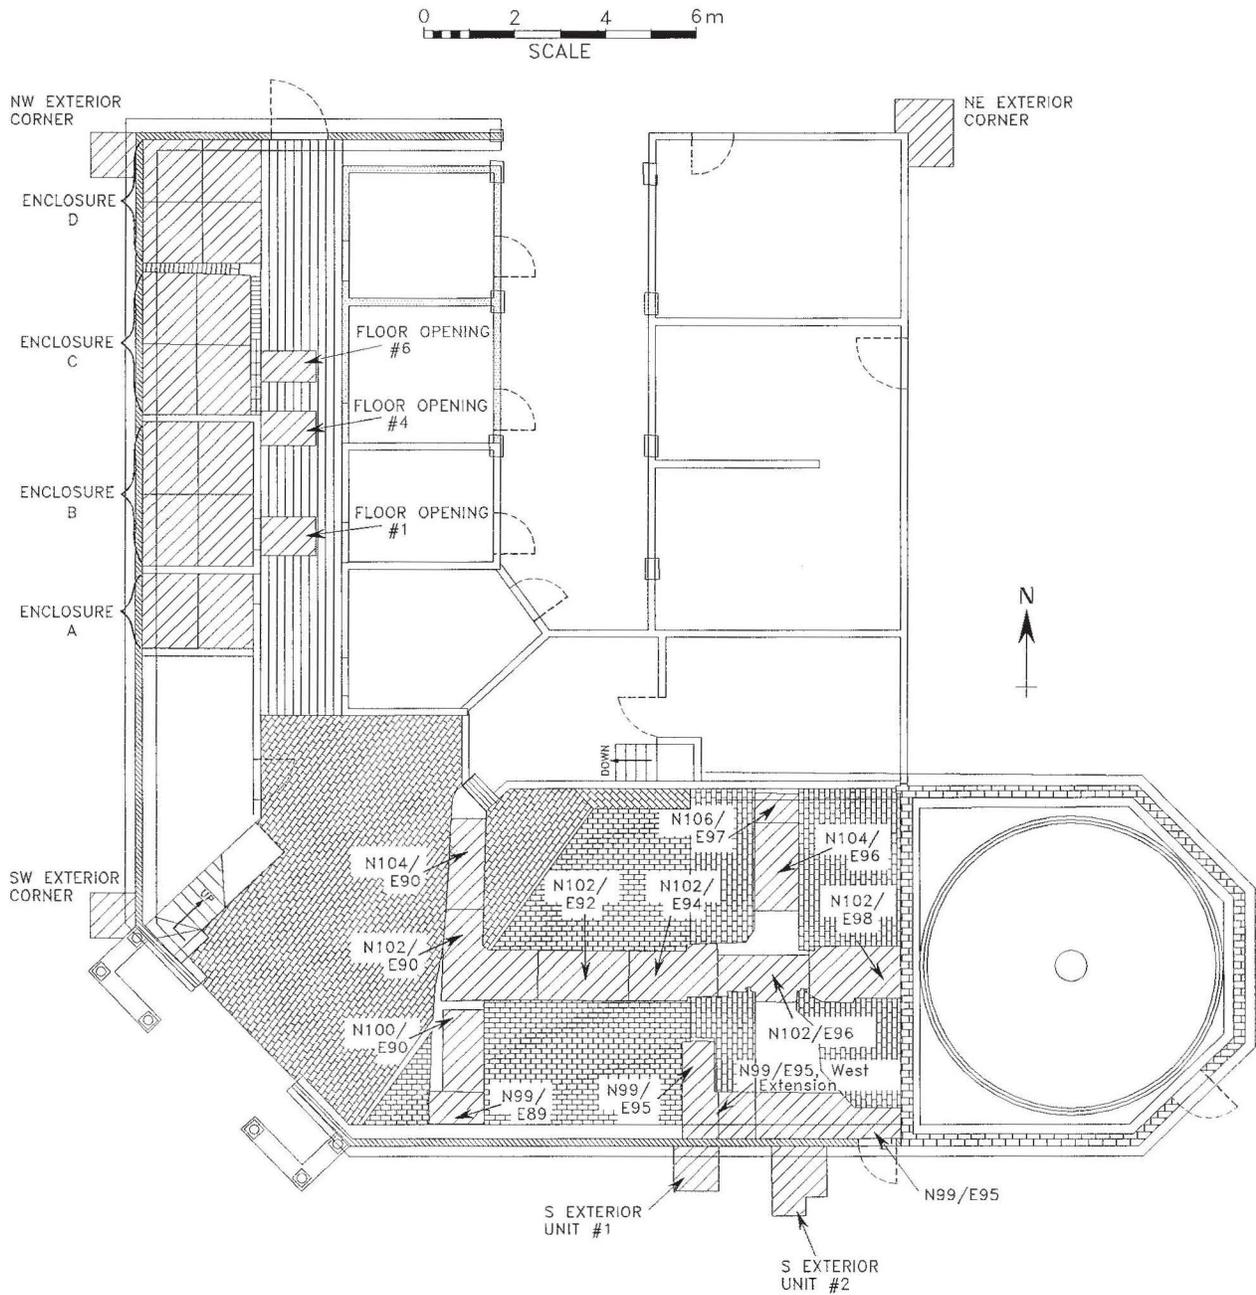
Figure 5. Tested and excavated areas in and around the Carriage House.

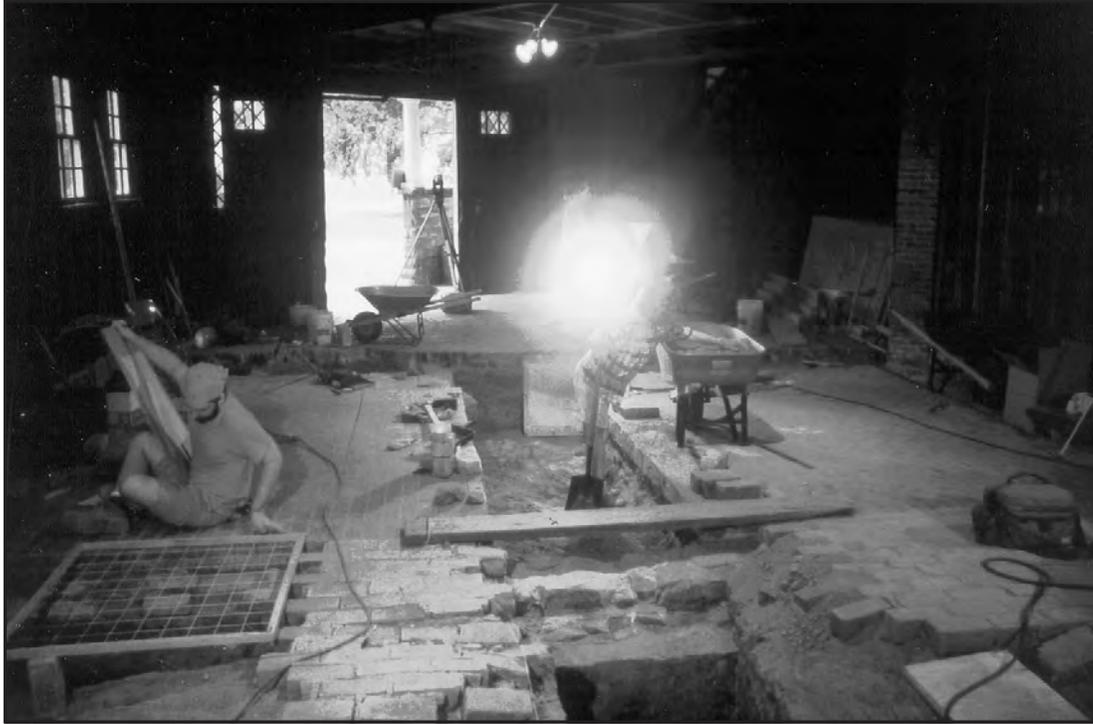
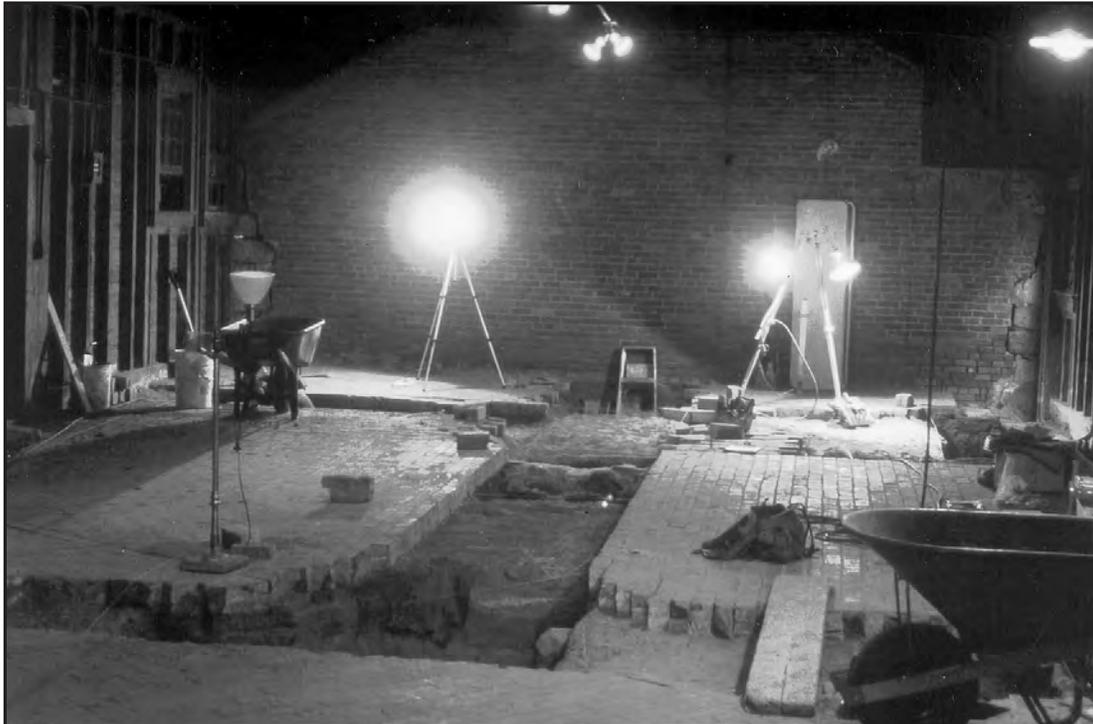
Figure 6. South Room excavations; view to east from near the South (Carriage) Room door (top), and view to west from near the common wall with the Gas Holder (bottom).

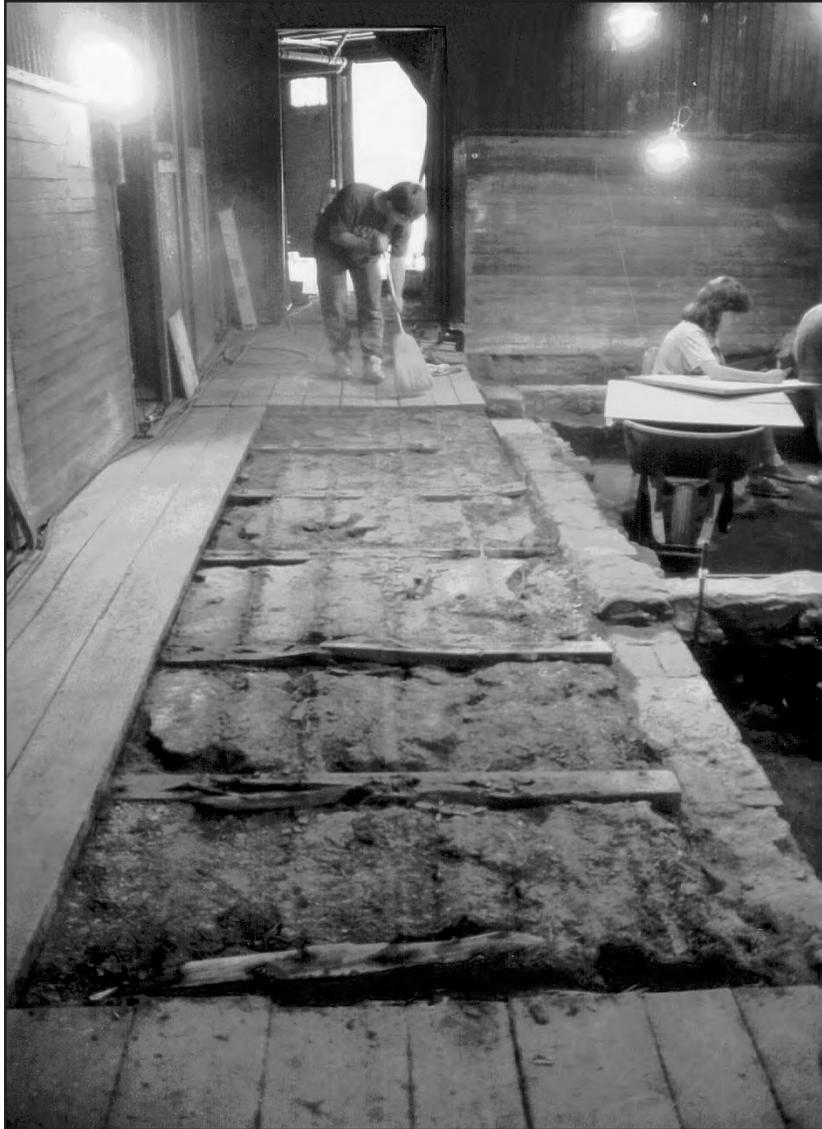
Figure 7. Excavated areas within the North (Stable) Room looking south across the floor openings. Enclosures A-C are to the right.

The North Room differed physically from the South Room in that it was broken up into distinct units of space by visible architectural features. These included a series of foundations on the west side of the room, a plank floor at its center, and a number of horse stalls on the east side. Knowing that the structure had a relatively brief history, it was decided to use these architecturally bound spaces as investigative units (Figure 5). The spaces enclosed by foundations were tackled first, as their dirt floors were most accessible to excavators. Once the foundation-enclosed areas were completed, sections of planks were taken up at the middle of the floor, with spaces between the floor joists defined as excavation units. The stables on the east side were never investigated other than by some subsurface probing in the southernmost stall. This was the only stall with a dirt floor. The remaining stalls had concrete or plank flooring that prevented easy access, and by the time the investigation of other areas in the North Room were completed, no time remained for testing these locations.

*Enclosures A–D.* The west side of the North Room was divided into four spaces by foundations of various construction. Three of these were virtually of the same size, with the southernmost space being about half the size of the others. The remaining portions of the latter space appeared to lie under the concrete floor of a storage room built between the stairwell and the North Room. For convenience, these four foundation-bound spaces were termed “Enclosures” and designated A to D from south to north (Figure 5). Each was further divided into quarters labeled NE, NW, SE, and SW, with each quarter excavated separately from the others. Enclosure A, being about half the size of the other enclosures, was divided into north and south units.<sup>1</sup> The southeast and northwest quarters of each enclosure were removed in arbitrary 10-cm units. This allowed continuous north–south and east–west stratigraphic cross sections of each enclosure to be drawn. As vertical stratigraphic profiles were visible on two faces of the southwest and northeast quarters, they were removed using SUs.

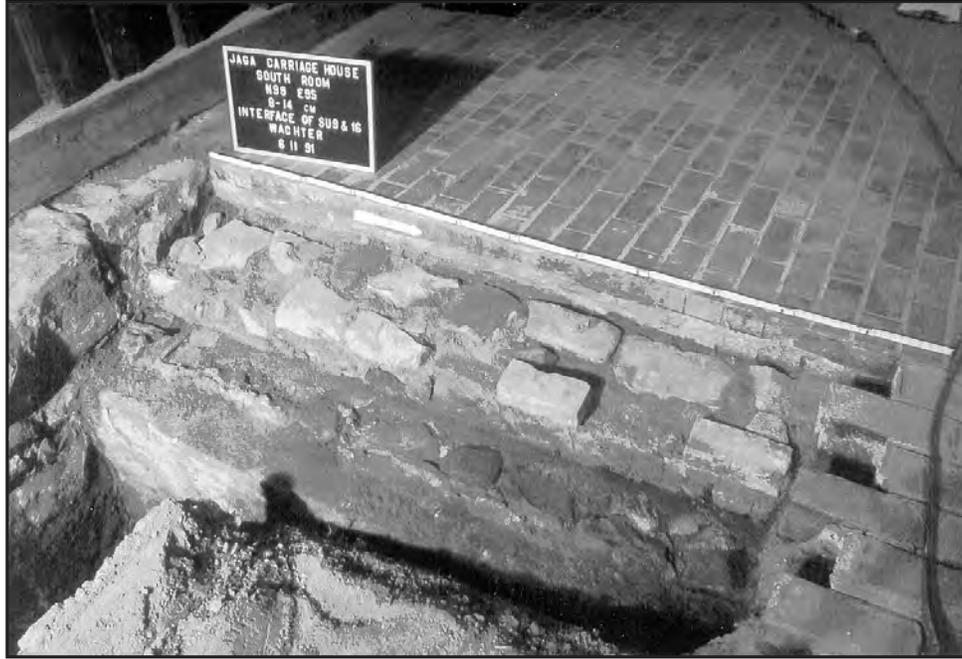
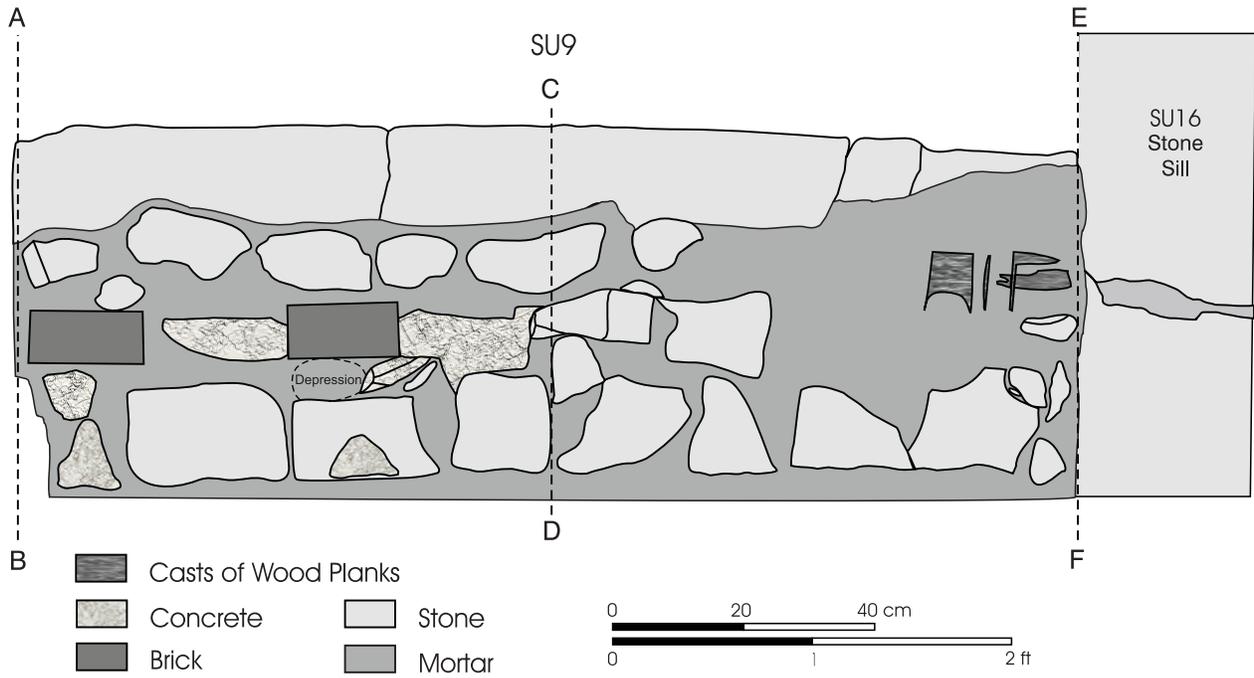
Figure 11. Upper margins of the Gas Holder basement's west foundation; view of exposed segment at juncture with south wall (top), and plan view showing construction materials (bottom).

In cross section, the upper surface of the foundation appears as a series of four “ledges” (Figure 11). The lowest ledge (A) is composed of neatly mortared sandstone block and actually represents the upper, unmodified element of the foundation. It lies 15–23 cm (9.0 in) below the inside corner of the top of the foundation and is about 18 cm (7.1 in) wide. Lying immediately on top of this is Ledge B, a thin (4 cm/1.6 in) layer of mortar and thin, flat stones. The upper margins of this ledge are 20 cm (7.9 in) wide and retain fragments of wood. The north–south orientation of the fragments’ grain suggests that an 8-in-wide wooden sill once rested here. Ledge C, lying immediately west of B, is composed of plaster. It has a squared, 7 cm (2.76 in) high face and a flat, 16–18 cm (6.3–7.1 in) wide upper surface. The vertical face of the plaster retains wood fragments and impressions of wood, reinforcing the belief that a wooden sill had been placed against it. It also suggests that the upper walls of the Gas Holder building’s west room may have been plastered. The uppermost portion of the foundation (Ledge D) rises 4–5 cm (1.5–2.0 in) above the plaster. Here, the foundation is composed of irregularly shaped sandstone and a hard mortar, with small, flat stones placed across the top to level its upper surface. The builder’s trench on the exterior face was filled with cobbles, mortar chunks, and shaped fragments of stone. This portion of the wall is crude in appearance but would not have been observed by a visitor to the Gas Holder, as it lay underground.

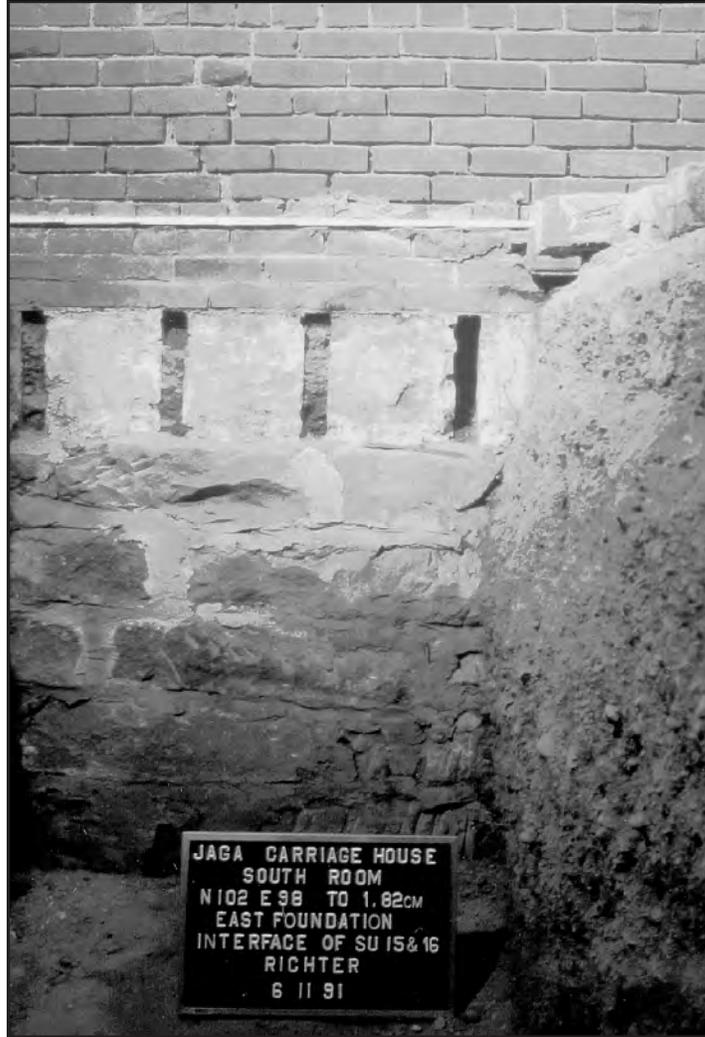
Figure 12. Juncture of basement foundation and brick wall separating Carriage House from the Gas Holder.

*East Foundation (SU 9E).* The east foundation (Figure 12) was exposed in only one excavation unit (N102-E98), which was dug to a depth of 1.28 m (4.2 ft) below the upper surfaces of the brick floor (SU 7). The Historic Structure Report (HSR) for the Carriage House states that “the foundation to the wall separating the Gas Holder from the Carriage Area is brick” (Mack 1991:12). However, excavations revealed that the foundation here is actually composed of courses of large, rectangular-shaped sandstone block surmounted by a short segment (about 4 courses) of plastered-over brick. Both brick and stone are bound with a concrete mortar. The top of this brick segment is parallel with the base of the brick floor. Above this segment is the brick wall dividing the South Room from the Gas Holder.

Five courses of the stone foundation were exposed. Each block incorporated into this structure is of a unique size, individual specimens varying in width from 12 to 16 cm (4.7–6.3 in) and in length from 8 to 65 cm (3.15–25.6 in). Foundation stones are bound together with thick layers of hard mortar which was somewhat carelessly applied during its application, with significant portions of the individual stone faces obscured.

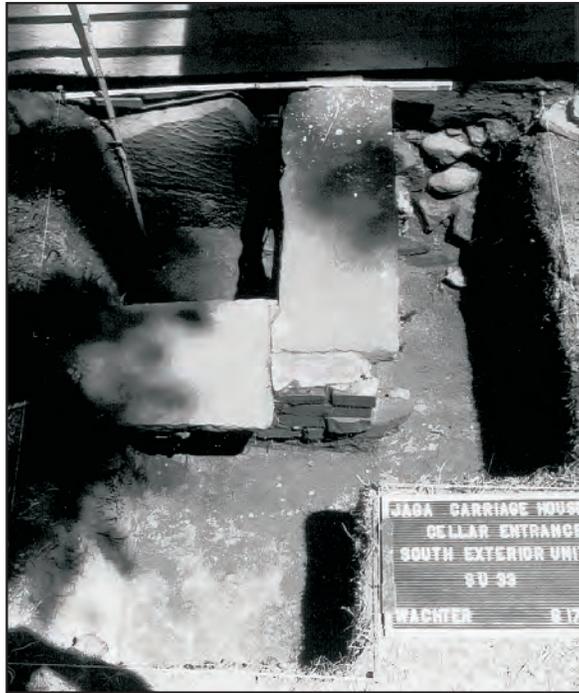
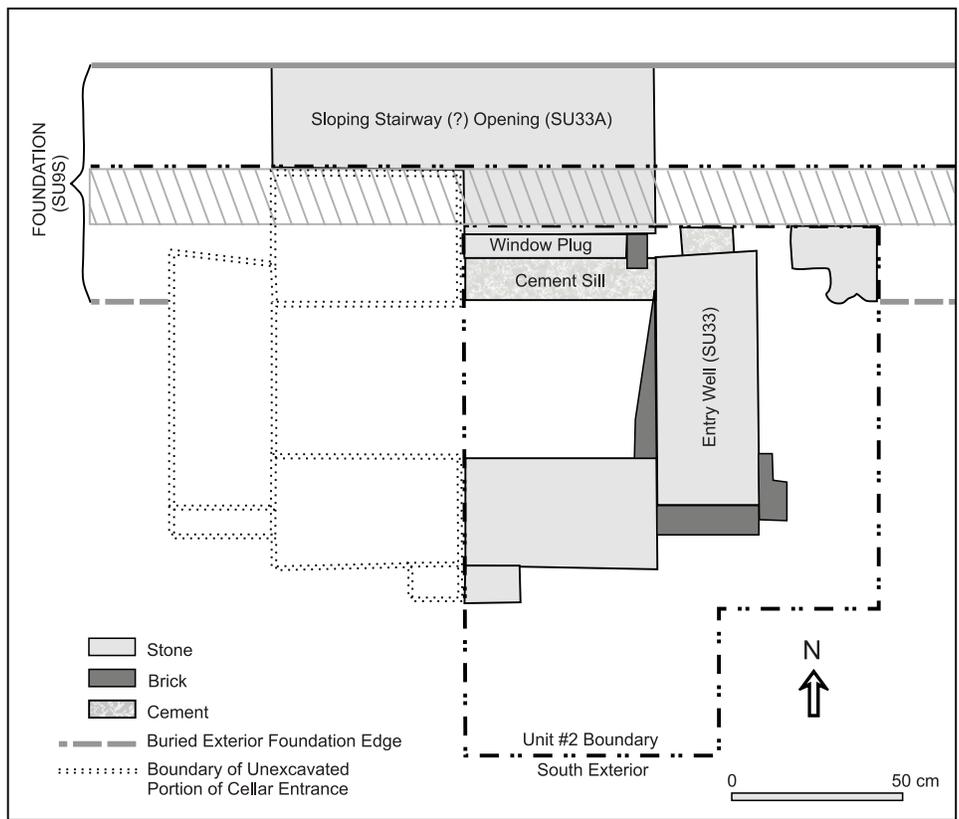
Figure 13. Stairwell or window well in Gas Holder basement's south wall. Note stone slab sealing the opening photograph.

Access to the basement may have been through an opening in the foundation (SU 33A) near the southeast corner of the building (Figure 13). A groundhog burrow through the upper portion was visible on the outside of the building prior to excavation, a situation which may have led to its identification as a crawl space in the HSR (Mack 1991:13). The east margin of the opening is situated at N99-E98.3 about 1.7 m (10.5 ft) west of the South Room’s east wall. It is rectangular in shape, about 75 cm (30 in) high by 94 cm (37 in) wide. The east and west margins of the opening are of stone, with roughly squared faces. The lower sill is manufactured of a sandstone slab shaped with a stone mason’s chisel. The upper surface of this stone slants downward toward the basement floor. The size and shape of the opening suggest a stairway at this location, with the stair’s stringers supported by the sloping stone sill.

The exterior elements of this entry were exposed in Exterior Unit 2 (Figure 13). The outside of the entry had been blocked with a large slab of sandstone, brick, and cobbles. It is enclosed by a small rectangular foundation (SU 33B) or entry well of brick and sandstone slab construction. A narrow builder’s trench (SU 34) of loose, root-filled, dark fill was noted in conjunction with this structure. The outside dimension of the well foundation, from front (south side) to back (north side), is 91 cm (3 ft). Though only the east half of this foundation was excavated, it is estimated to have an overall width of about 1.7 m (5 1/2 ft). It encloses a rectangular space 59 cm (23.2 in) deep and estimated to be about 1.12 m (3.7 ft) wide. Its various elements have been put together so that its upper surfaces demonstrate a 15-degree tilt from front to back (Figure 14).

The entry well is actually U-shaped in that it is composed of three brick walls, each capped by rectangular slabs of stone. The capstones are shaped much in the same manner as the sill of the foundation opening. Each wall is made of a four courses of soft red brick. The front (south) wall is 33 cm (13 in) high and 24 cm (9.4 in) thick. The sandstone cap is 32 cm (12.6 in) wide and cut such that the upper surface slants downward toward the south; i.e., in cross section it is 6 cm thick on its south (exterior) edge and 10 cm thick on its north (interior) edge. The east–west length of the capstone is estimated to be 1.12 m (3.7 ft) wide.

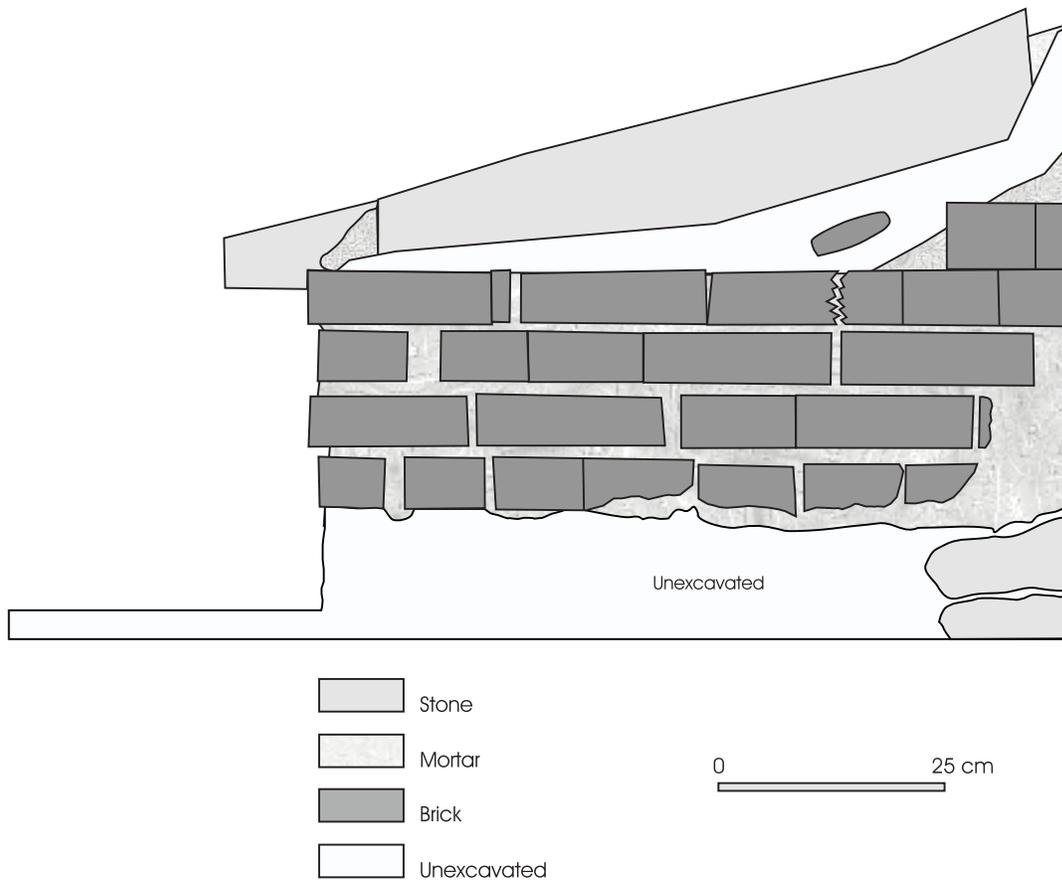
Figure 14. Profile of stairwell's (SU33) east wall.

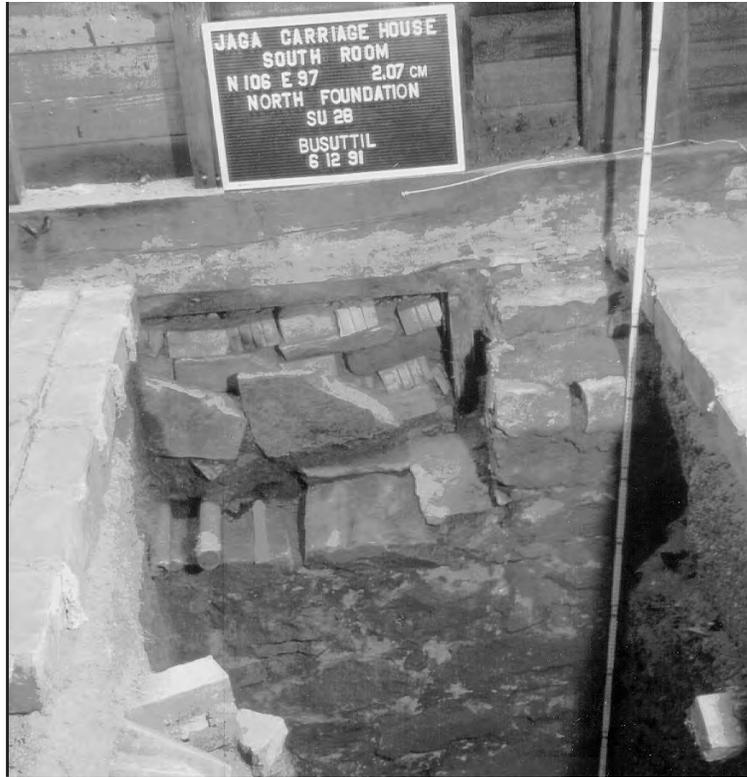
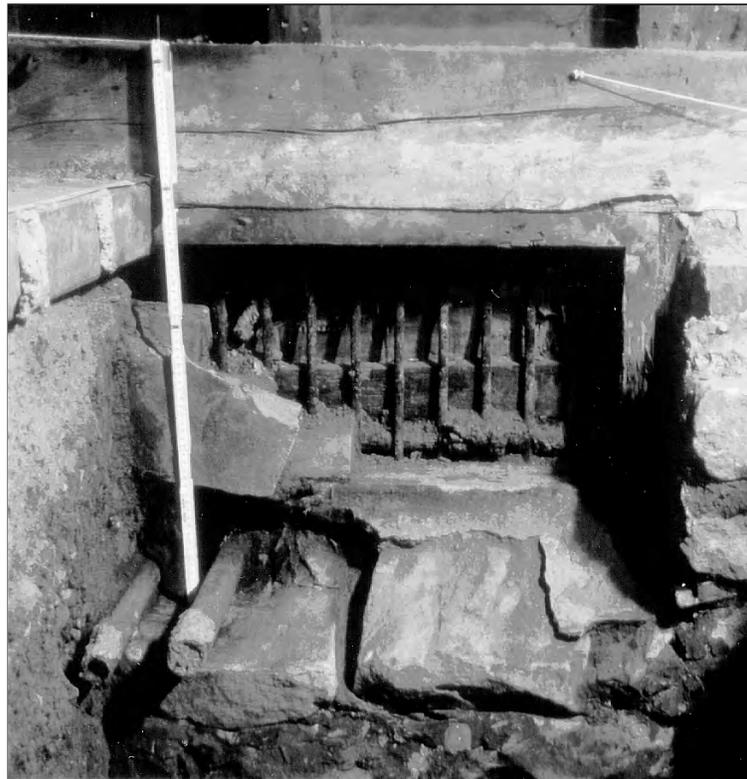
Figure 15. Window in Gas Holder basement's north wall with blockage in place (top) and after blockage was cleared (bottom).

*North Foundation (SU 9N).* A 1-m (3.3-ft) wide section of this foundation was exposed at N106-E96 (Figure 15). Its construction appeared to be generally the same as that described for the other foundation elements, with the exception that this portion is pierced with a barred opening (SU 28A). The opening is partially visible in the south wall of the sloped access (Room 109 in the HSR) to the boiler pit and is illustrated in the HSR with the caption "Ventilator to Area Below Room 102 [Carriage Storage]. This vent indicates that the east portion of the carriage storage area had some type of open area below the east end of the floor, perhaps related to the Gas Holder" (Mack 1991:82).

Several pipes from the steam room protrude from between the bars. The intrusive presence of these pipes and the opening's partial obstruction by the concrete wall of the boiler pit suggest that it was in place before construction of the boiler pit and its sloped access (sometime after the Carriage House construction in 1893). At the time the basement was abandoned and filled, the opening was blocked up with flat slabs, brick, and cobbles similar to that previously noted for the entry in the south foundation.

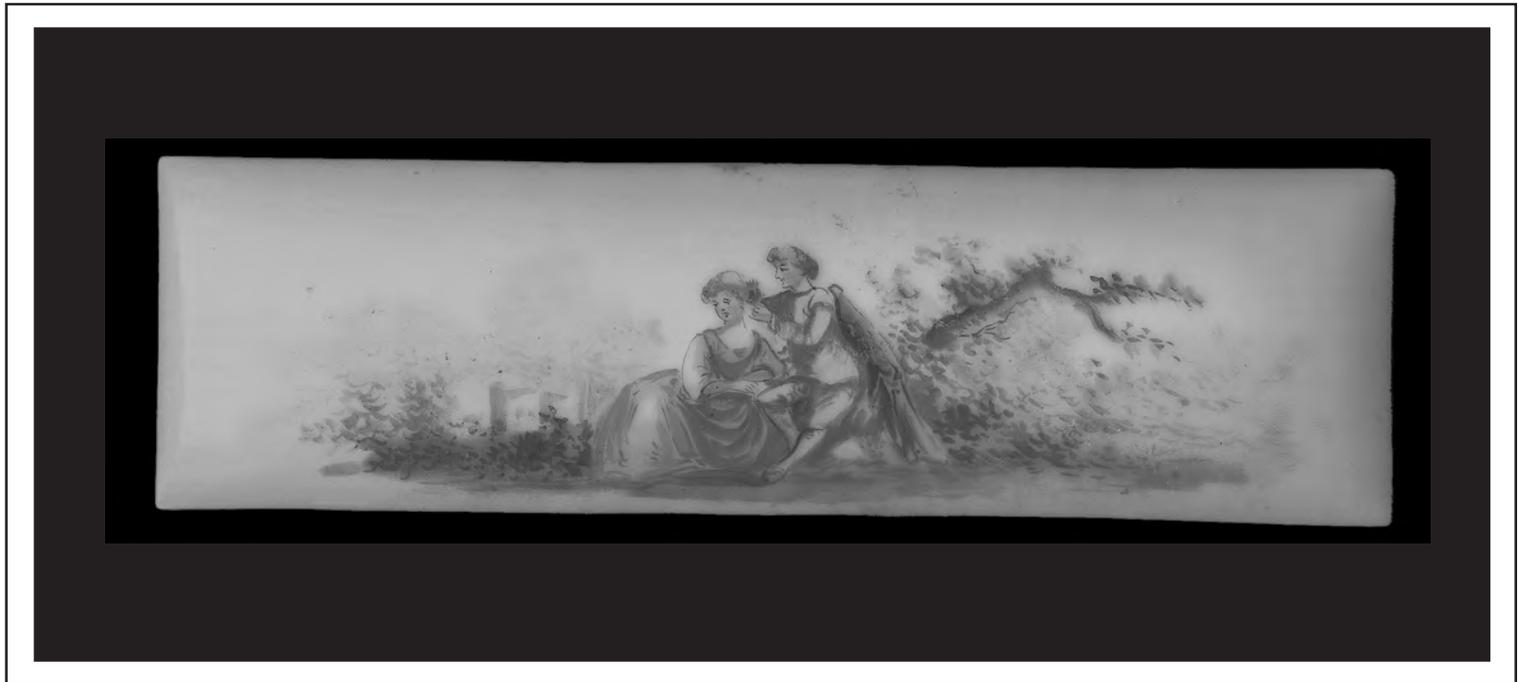
Figure 20. Ceramic plaque (field cat. #24) from the South Room.

Provenience	Level (cm) or Stratum	Cat. No.	Identification	Period	Description, Comment
<u>Furnishings</u>					
<i>Furniture</i>					
N99-E95	SU 4	24	Ceramic plaque	?	Rectangular (1.87 in x 6.48 in) with decalcomania romantic scene under clear glaze on exterior (Figure 20); unglazed back impressed with "406"; suggested date of circa 1860-1900 (personal communication, 1992, Dean Zimmerman, Curator, Western Reserve Historical Society, Cleveland); groundhog disturbed
N106-E96	SU 28	56	Butt hinge	IV	Ferrous; 2.43 in long x 1.75 in wide; 6 mounting holes; 5 wood screws, 1 cupric repair screw; used in "cabinet work, china closets and doors" (Montgomery Ward 1969a:598)
<i>Decorative</i>					
N100-E90	10-20 cm	40	Flower pot	IV-V	2 unglazed redware fragments. Rim = 2.5 in diameter; base = 2 in diameter
<u>Food and Drink</u>					
N99-E95	0-20 cm	35	Crown cap	?	Carbonated beverage closure; corrugations (n=21), granulated composition cork liner, and skirt height (0.26 in) suggest date of post-1920 to pre-1956 (Bender 1986:22, 24-5); groundhog disturbed

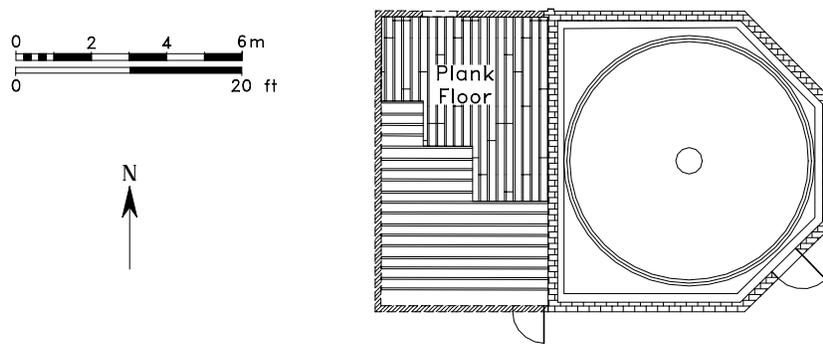
Figure 21. The Gas Holder floor plan as it may have existed in Period II (circa 1885-1893).

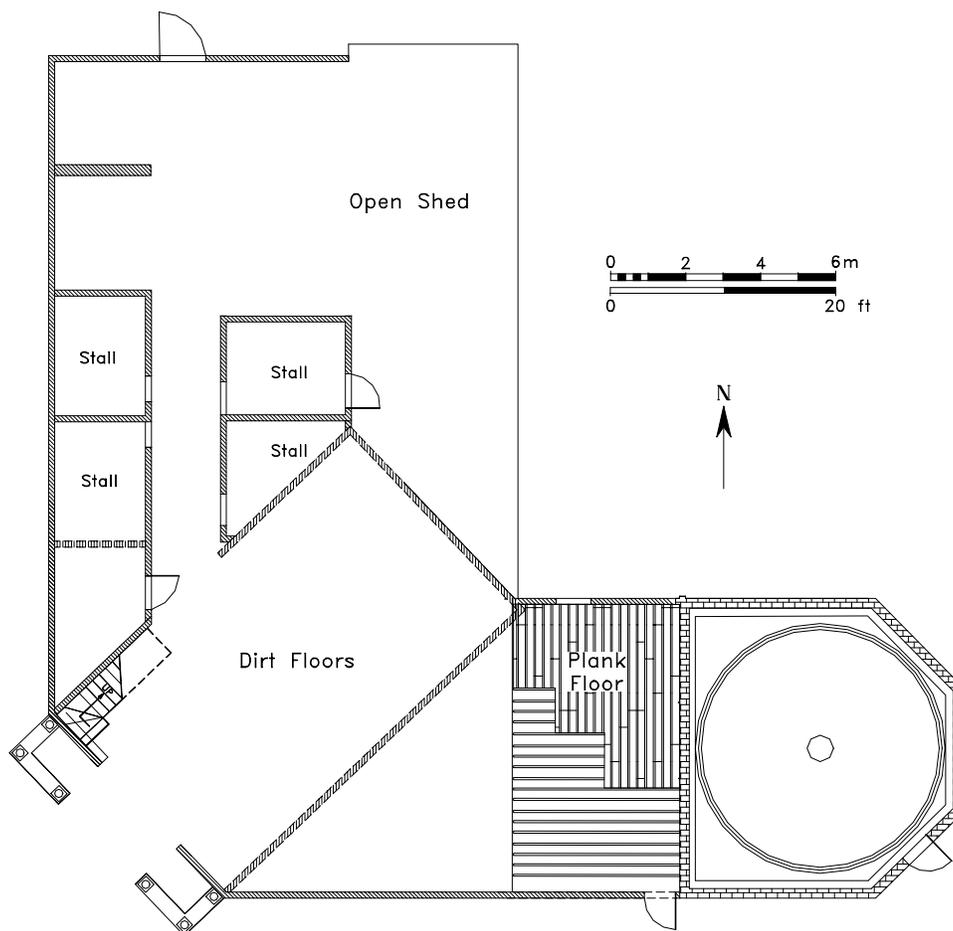
Figure 22. The Gas Holder/Carriage House floor plan during Period III (1893 to circa 1905).

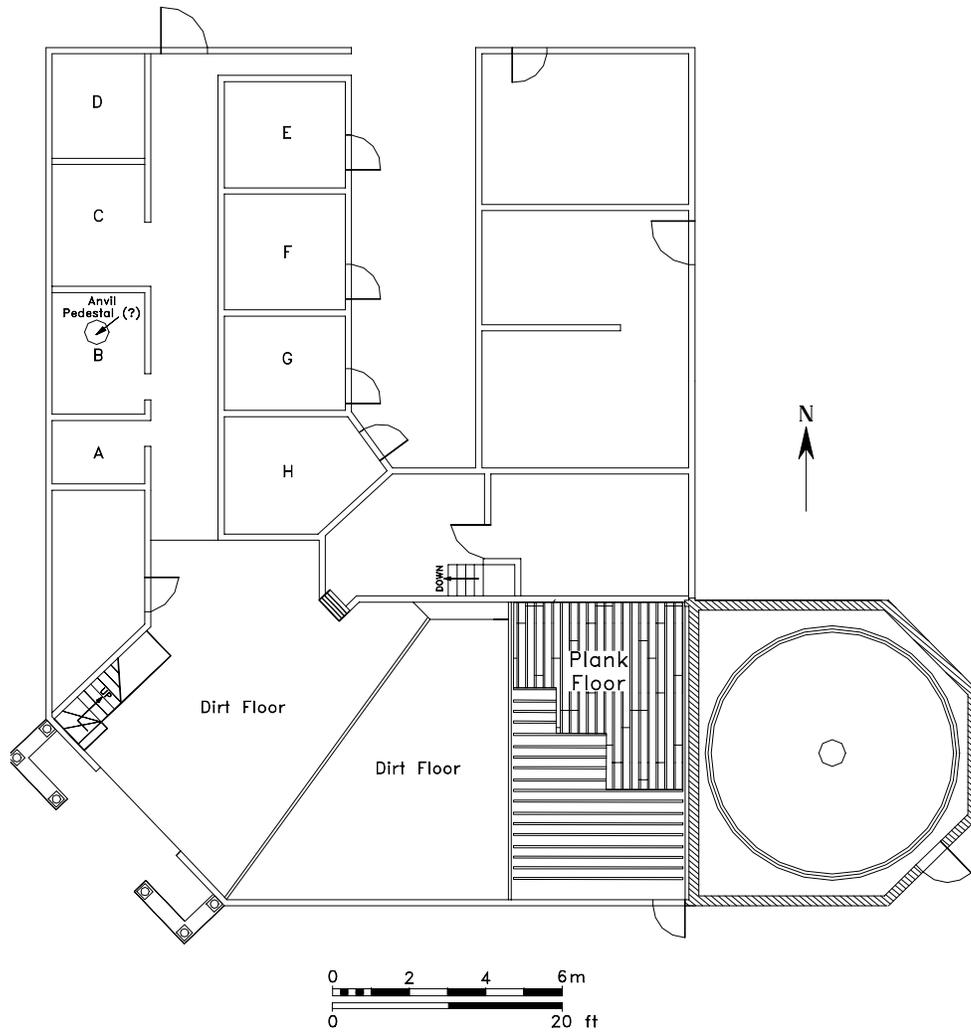
Figure 23. The Gas Holder/Carriage House floor plan during Period IV (circa 1900 to circa 1930).
