Exceptional Places

Volume 3

Fall 2008

Common Problems with Brick Masonry

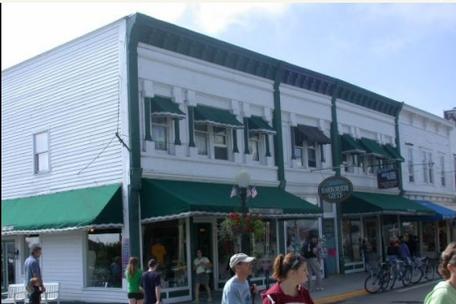
The William G. Preston building, included in the Mackinac Island NHL District, in Mackinac Island, Michigan, serves as an example of the testimonials used by both companies to boost catalog sales. Although altered, today it still resembles a drawing featured in the 1904 catalog of George L. Mesker & Co. Catalog image courtesy of the Illinois Historic Preservation Agency.

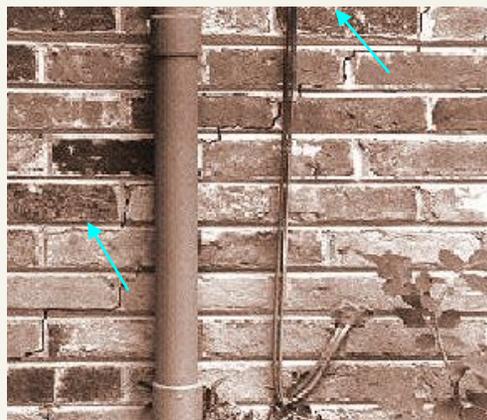
Figure 1 - Example of a common wall crack which follows the brick in a stair-step pattern. This type of movement was probably caused by thermal or moisture expansion.

Such cracks (Figure 1) are normally cyclical and will open and close with the season. They will grow wider in cold weather and narrower in hot weather. If possible, monitor such cracks over a period of time to see if they're active. Active cracks should be sealed with a flexible sealant; inactive cracks may be pointed.

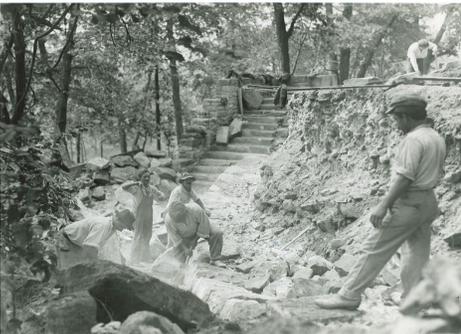
Original wall construction at Stan Hywet Hall, 1920s. (Historic photo courtesy of Stan Hywet Hall archives)

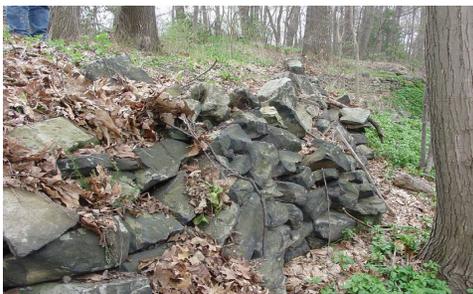
Original wall in deteriorated condition, April 2007. (Photo courtesy of Dry Stone Conservancy [http://www.drystone.org/gallery /album22](http://www.drystone.org/gallery/album22))

been incorporated into the fabric of the wall died and collapsed, leading to severe deterioration and loss of structural integrity.

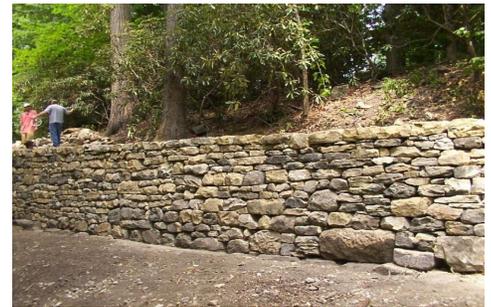
Retaining wall after restoration, July/ August 2007. (Photo courtesy of Dry Stone Conservancy: <http://www.drystone.org/gallery/album22>)

A team of DSC dry stone craftsmen, led by Master Stonemason and project supervisor Neil Rippingale, successfully restored a 300-foot section of this wall in July/August of 2007. Fortunately, the team salvaged approximately two thirds of the historic rock from the downhill slope, where it had gradually slid over time. In addition, the team made use of broken and fragmented stone as packing in the core of the wall. Additional stone was cut and brought in from an off-site location. For the critical top structural layer of the wall (cover course), DSC used all new cut stone. Castellation or parapet stone—which is stone placed in a vertical position along the wall at the edge of the road—was restored as well. This particular dry stone feature is frequently found in Olmsted/Manning designs.

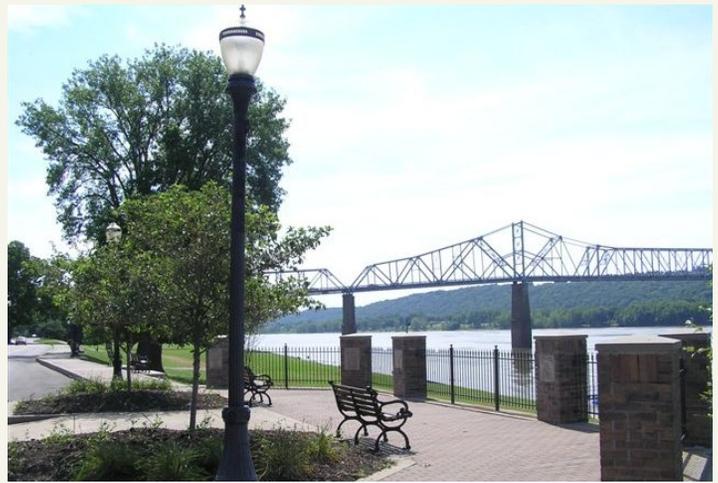
Initially constructed in 1928/29, the cantilevered through truss bridge is one of the oldest remaining bridges over the Ohio River. Along with the age and condition of the bridge, increased traffic necessitates the replacement of the bridge. The current two-lane bridge

Milton-Madison Bridge, U.S. Highway 421, Ohio River. Photo courtesy of John Stacier, HMI, Inc.

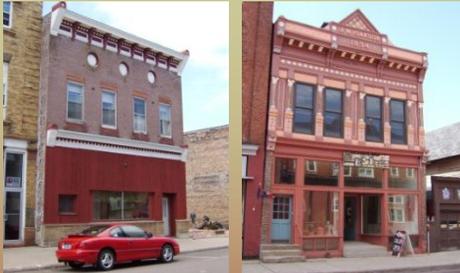
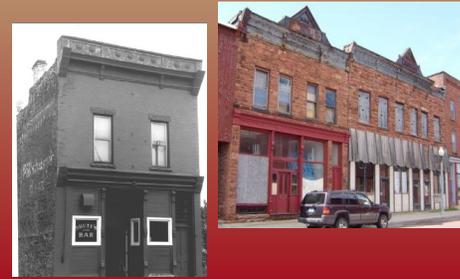
Calumet NHL District
Calumet, MI

While these Meskers have all been identified and verified, there could be additional examples in your National Historic Landmark. If you think you have a Mesker in your community, please let us know.

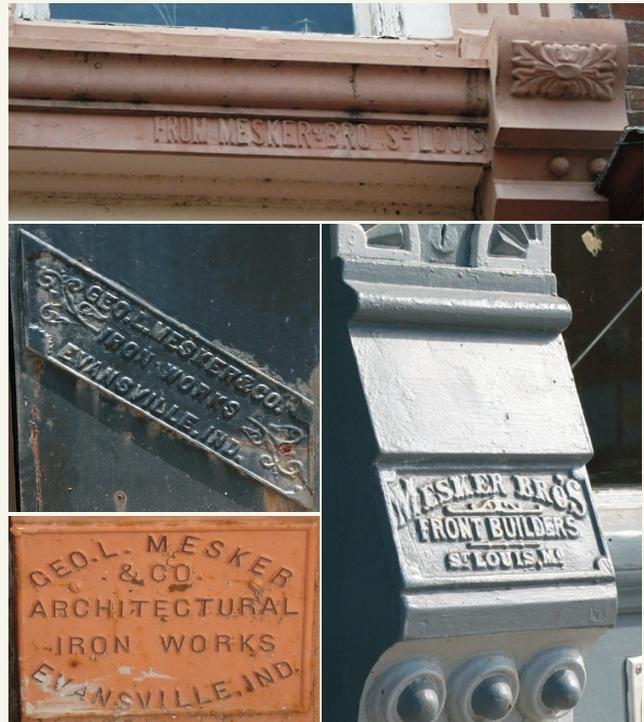
Nameplates like these help to easily identify a Mesker storefront. Images courtesy of the Illinois Historic Preservation Agency.

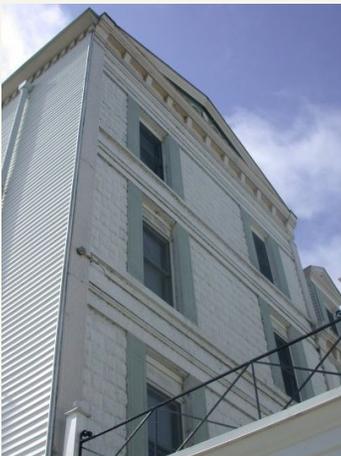
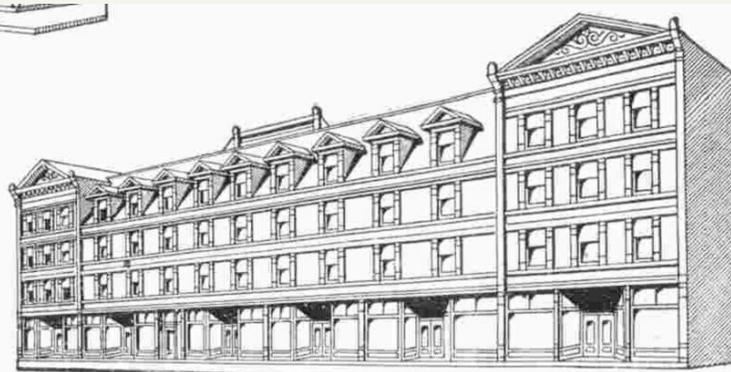
GEO. T. ARNOLD'S BUILDING,
MACKINAC ISLAND, MICH.

The Chippewa Hotel, in the Mackinac Island NHL District, is still in use today. It is a great example of a Mesker storefront featuring recessed entryways, ornate pressed metal cornices, and pressed sheet metal siding resembling stone. A drawing of this building also appeared in the 1904 George L. Mesker Catalog. Catalog image courtesy of the Illinois Historic Preservation

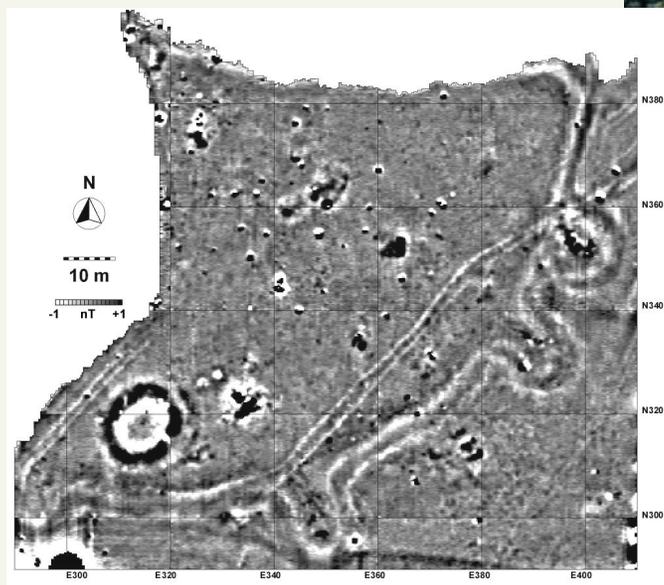
Magnetic gradiometry map of Menoken Indian Village Site NHL.

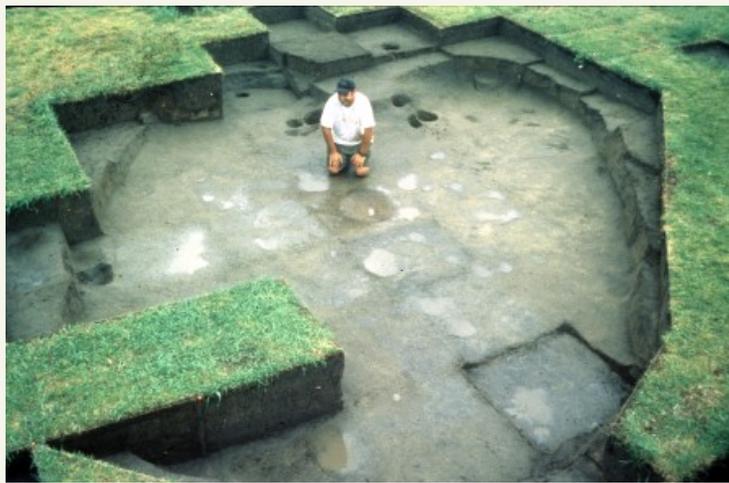
Excavation of a prehistoric house feature at Menoken.

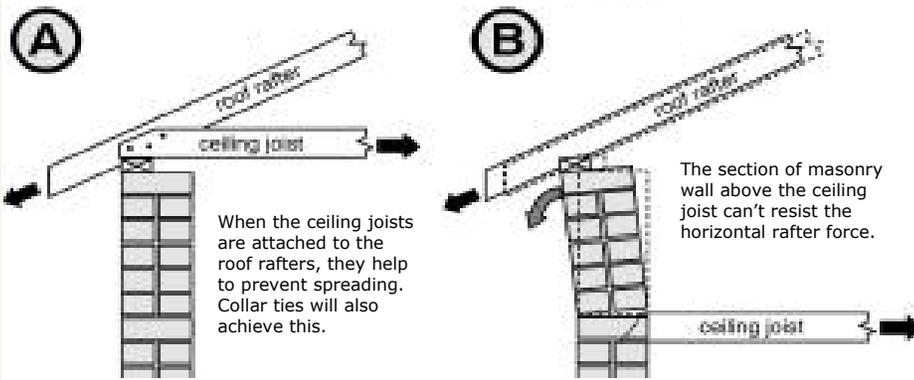
Figure 2 – Example of masonry failure due to unrestrained roof rafters. Image: Housing & Urban Development, *Residential Rehabilitation Inspection Guide*.

The roof may be leaking as well. When this occurs, examine the roof structure carefully to ascertain whether there has been a failure due to the incorrect placement of ceiling rafters and/or the lack of rafter ties. If so, additional horizontal ties or tension members will have to be added and, if possible, the roof pulled back into place. The damaged masonry can then be repaired.

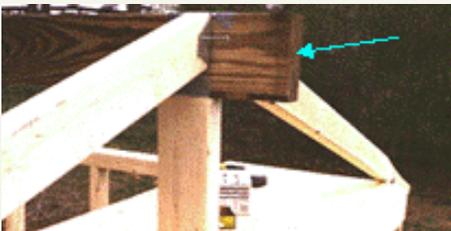
Figure 3 – Ridge rafter (also, ridge beam, or ridge board). Image: www.lowes.com. Accessed June 30, 2008.

An examination of the attic over the main portion of a building should disclose the presence (or absence) of a ridge rafter (Figure 3) and collar ties (Figure 4). It is likely that snow loads might overstress the roof causing the masonry walls to start to buckle outward, causing structural cracking.

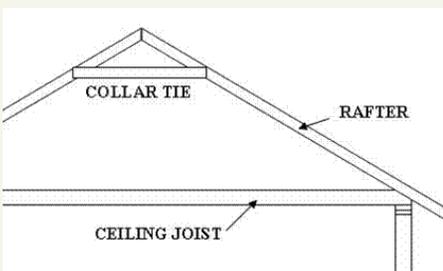
Figure 4 – Typical roof framing. Image: www.diychatroom.com. Accessed June 30,

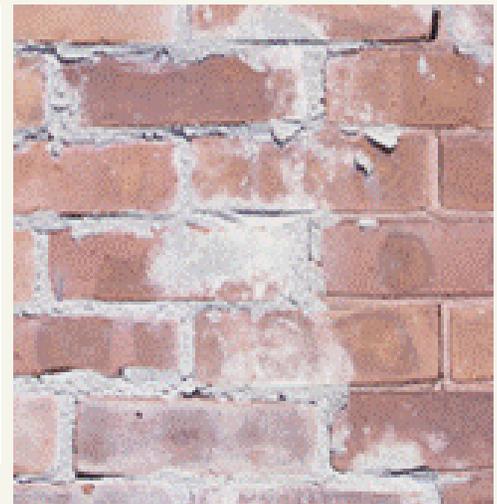
Figure 5 – Example of poor pointing technique. Not only was a portland cement used (the dark grey color is its giveaway), but the preparation and application were poor. The color, width, and tooling of the original mortar was not matched. Further, cleanup is absent: the mortar was allowed to run over the brick surfaces and dry.

Once the nature and source of cracks has been determined, the next step is repair. Structural repairs precede minor or cosmetic repairs. Repointing mortar joints is often required, however, this action requires care and is best done with professionals familiar with historic masonry techniques. All too often, more damage is done to historic brick buildings with improper pointing than most any other treatments. And the damage is not only cosmetic. Care must be taken to match the properties (color, hardness, permeability) of the existing mortar. Hard mortars (those with high concentrations of portland cement) are less permeable than surrounding brick, and with both differential movement and differences in moisture permeability, will often cause the surrounding masonry to deteriorate or deteriorate faster. The application must also be carefully controlled. Width of joints and tooling should match the historic appearance, and care must be taken in application and cleanup to ensure that mortar does not extend past the joints of individual units and onto the surface of bricks. From a distance this latter action is most bothersome – the wall changes from a uniform to a mottled appearance. National Park Service (NPS) *Preservation Brief No. 2: Repointing Mortar Joints in Historic Masonry Buildings* is an excellent guide for this work: <http://www.nps.gov/history/hps/TPS/briefs/brief02.htm>

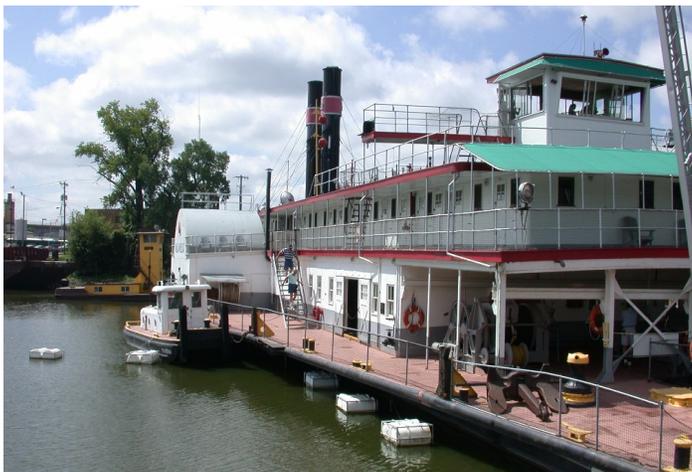
The *William M. Black*, part of the National Mississippi River Museum & Aquarium in Dubuque, Iowa.

and preservation of the steamboat *William M. Black*. Built in 1934 and operating until 1973 the *Black* is 277 feet long and 85 feet wide. The *Save America's Treasures* grant is being used for preservation and in-kind replacement of the canvas decking, repairs to steel smokestacks, and repairs to the pilot house.

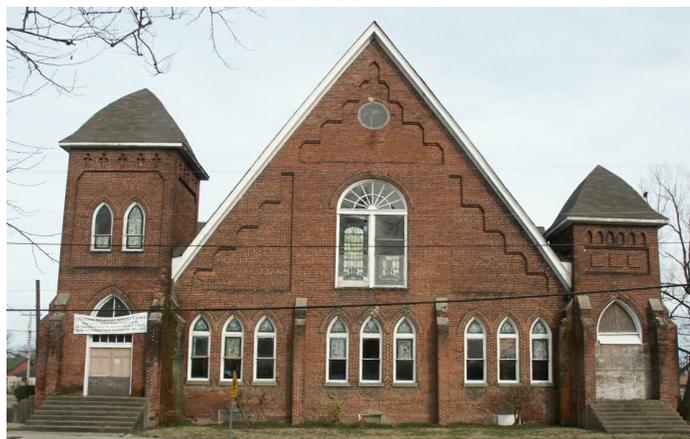
Centennial Baptist Church, façade (north wall), in Helena, Arkansas.

Centennial Baptist Church in Helena, Arkansas, was the home base for Reverend Dr. Elias Camp Morris from the dedication of the church in 1905 until his death in 1922. While serving as pastor, Dr. Morris was president (1895-1922) of the National Baptist Convention, the largest African-American organization in the United States at the end of the 19th century. Morris brought attention to the right of African Americans to establish independent religious associations. The E.C. Morris Foundation received a grant for stabilization of the church's very elaborate but dangerously under-engineered roof system in 2006.
