16 PRESERVATION BRIEFS

The Use of Substitute Materials on Historic Building Exteriors

Sharon C. Park, AIA

U.S. Department of the Interior
National Park Service
Cultural Resources
Heritage Preservation Services

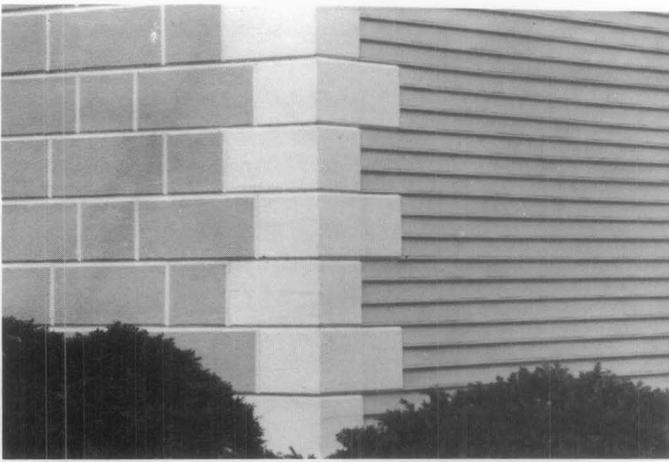
Illus. 1. An early 18th-century technique for imitating carved or quarried stone was the use of sand-impregnated paint applied to wood. The facade stones and quoins are of wood. The Lindens (1754), Washington, D.C. Photo: Sharon C. Park, AIA.

The tradition of using cheaper and more common materials in imitation of more expensive and less available materials is a long one. George Washington, for example, used wood painted with sand-impregnated paint at Mount Vernon to imitate cut ashlar stone. This technique along with scoring stucco into block patterns was fairly common in colonial America to imitate stone (see illus. 1, 2).

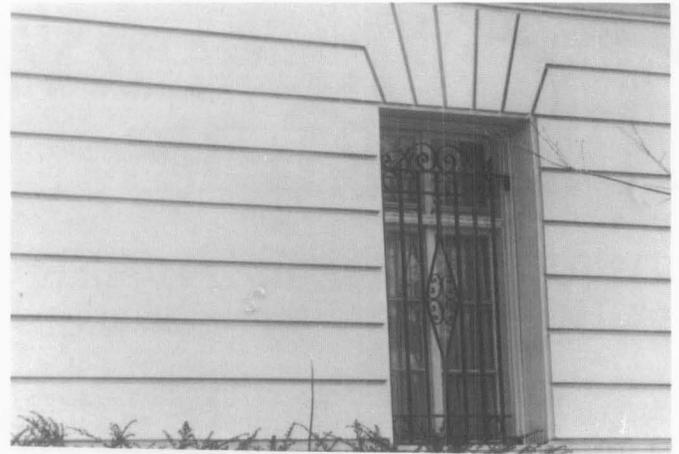
Illus. 2. Stucco has for many centuries represented a number of building materials. Seen here is the ground floor of a Beaux Arts mansion, circa 1900, which represents a finely laid stone foundation wall executed in scored stucco. Photo: Sharon C. Park, AIA.

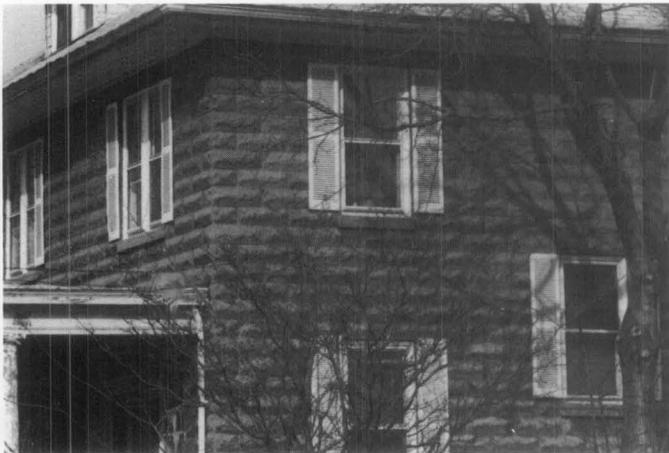
Illus. 3. Casting concrete to represent quarried stone was a popular late 19th-century technique seen in this circa 1910 mail-order house. While most components were delivered by rail, the foundations and exterior masonry were completed by local craftsmen. Photo: Sharon C. Park, AIA.

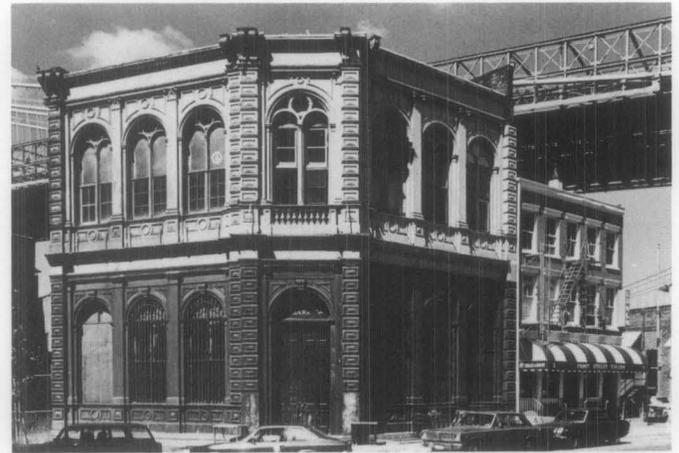
Illus. 4. The 19th-century also produced a variety of metal products used in imitation of other materials. In this case, the entire exterior of the Long Island Safety Deposit Company is cast-iron representing stone. Photo: Becket Logan, Friends of Cast Iron Architecture.

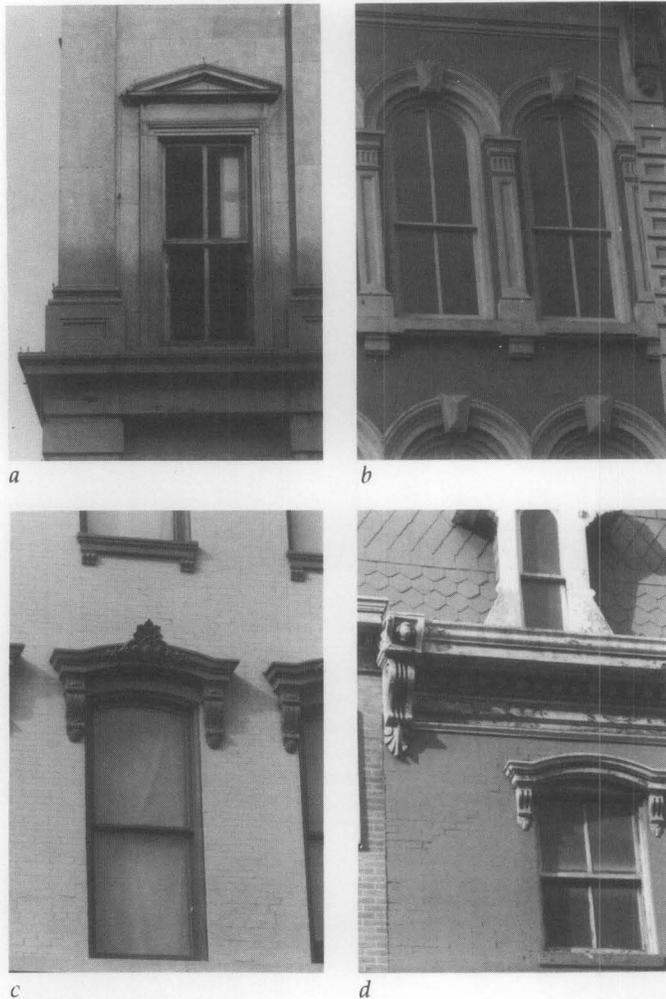
Illus. 5. The four historic examples of various window hoods shown are: (a) stone; (b) cast stone; (c) cast-iron; and (d) sheet metal. The criteria for selecting substitute materials today (availability, quality, delivery dates, cost) are not much different from the past. Photo: Sharon C. Park, AIA.

production at the same time and were selected on the basis of the availability of materials and local craftsmanship, as well as durability and cost (see illus. 5). The criteria for selection today are not much different.

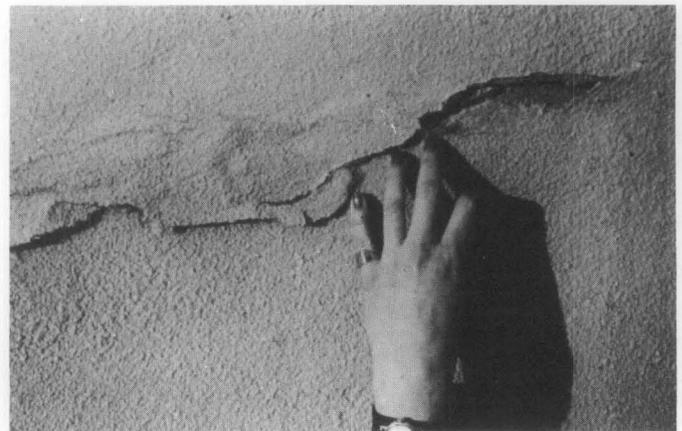
Illus. 6. Substitute materials should never be considered as a cosmetic cover-up for they can cause great physical damage and can alter the appearance of historic buildings. For example, a fiberglass coating was used at Ranchos de Taos, NM, in place of the historic adobe coating which had deteriorated. The waterproof coating sealed moisture in the walls and caused the spalling shown. It was subsequently removed and the walls were properly repaired with adobe. Photo: Lee H. Nelson, FAIA.

Because the overzealous use of substitute materials can greatly impair the historic character of a historic structure, all preservation options should be explored thoroughly before substitute materials are used. It is important to remember that the purpose of repairing damaged features and of replacing lost and irreparably damaged ones is both to match visually what was there and to cause no further deterioration. For these reasons it is not appropriate to cover up historic materials with synthetic materials that will alter the appearance, proportions and details of a historic building and that will conceal future deterioration (see illus. 6).

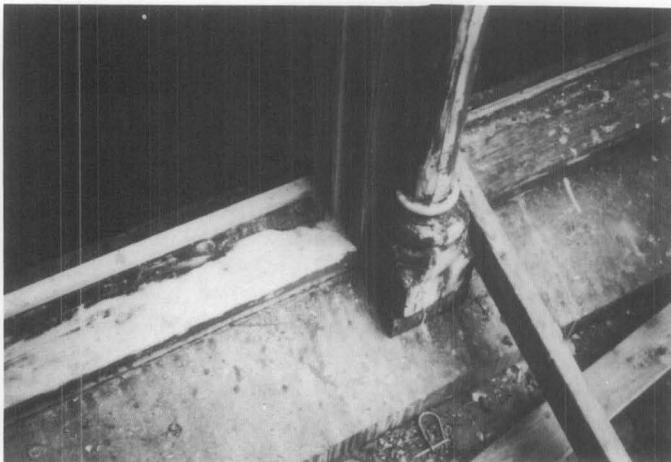
Illus. 7. Whenever possible, historic materials should be repaired rather than replaced. Epoxy, a synthetic resin, has been used to repair the wood window frame and sill at the Auditors Building (1878) Washington, DC. The cured resin is white in this photo and will be primed and painted. Photo: Lee H. Nelson, FAIA.

Some materials have been used successfully for the repair of damaged features such as epoxies for wood infilling, cementitious patching for sandstone repairs, or plastic stone for masonry repairs. Repairs are preferable to replacement whether or not the repairs are in kind or with a synthetic substitute material (see illus. 7).

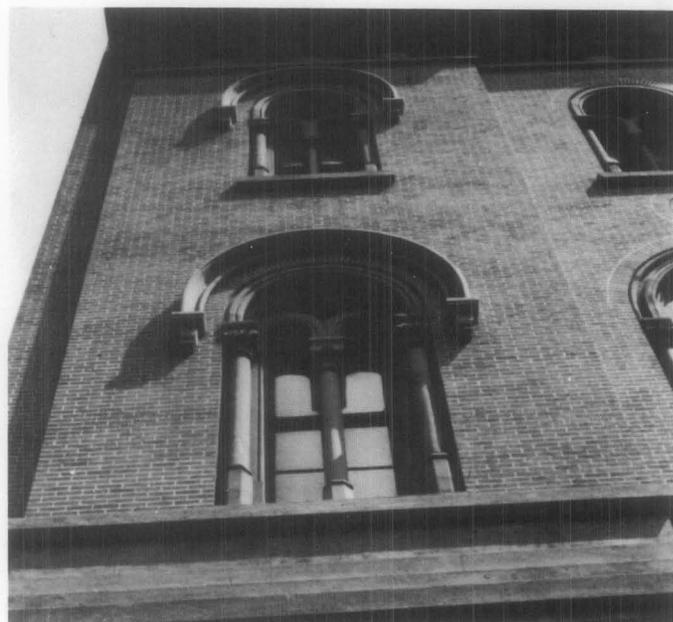
Illus. 8. Even when materials are not locally available, it may be possible and cost effective to find sources elsewhere. For example, the local sandstone was no longer available for the restoration of the New York Shakespeare Festival Public Theater. The deteriorated sandstone window hoods, were replaced with stone from Germany that closely matched the color and texture of the historic sandstone. Photo: John G. Waite.

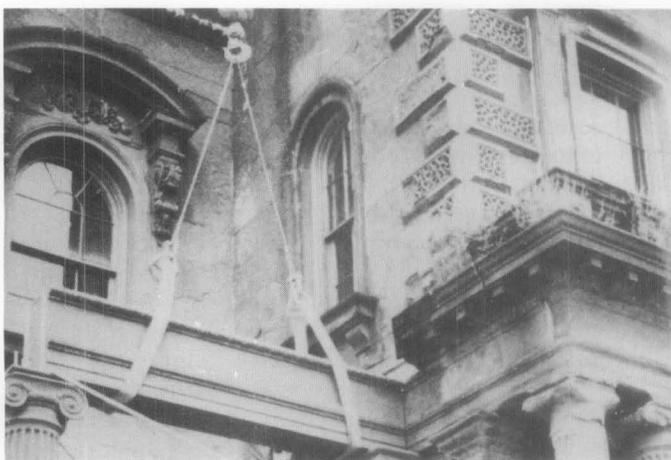
Illus. 9. Simple solutions should not be overlooked when materials are no longer available. In the case of the Morse-Libby Mansion (1859), Portland, ME, the deteriorated brownstone porch beam was replaced with a carved wooden beam painted with sand impregnated paint. Photo: Stephen Sewall.

as a replacement section, achieved using readily available traditional materials, conventional tools and work skills. (see illus. 9). Simple solutions should not be overlooked.

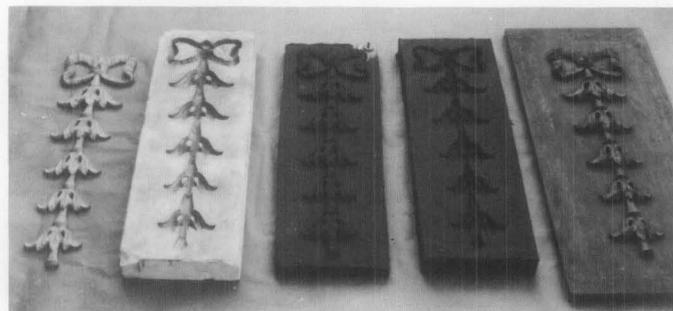
Illus. 10. The use of substitute materials is not necessarily cheaper or easier than using the original materials. The complex process of fabricating the polyester bronze reproduction pieces of the gilded wood molding for the clockcase at Independence Hall required talented artisans and substantial mold-making time. From left to right is the final molded polyester bronze detail; the plaster casting mold; the positive and negative interim neoprene rubber molds; and the expertly carved wooden master. Photo: Courtesy of Independence National Historical Park.

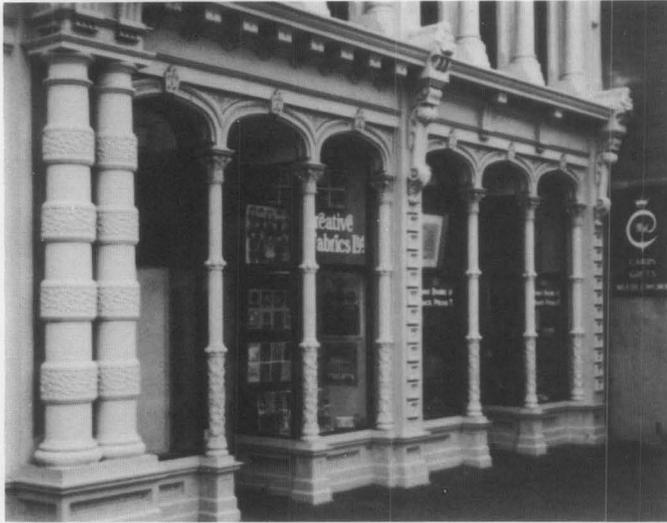
Illus. 11. The unavailability of historic craft techniques is another reason to consider substitute materials. The original first floor cast iron front of the Grand Opera House, Wilmington, DE, was missing; the expeditious reproduction in cast aluminum was possible because artisans working in this medium were available. Photo: John G. Waite.

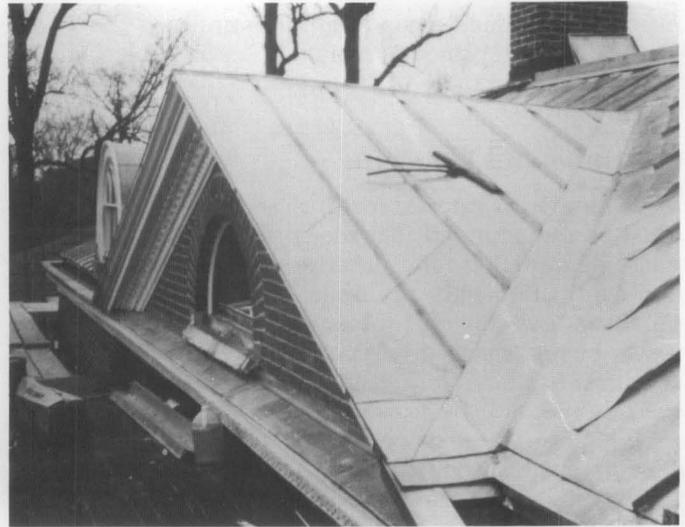
Illus. 12. Substitute materials may be considered when the original materials have not performed well. For example, early sheet metals used for roofing, such as tinplate, were reasonably durable, but the modern equivalent, terne-coated steel, is subject to corrosion once the thin tin plating is damaged. Terne-coated stainless steel or lead-coated copper (shown here) are now used as substitutes. Photo: John G. Waite.

3. Poor original building materials. Some historic building materials were of inherently poor quality or their modern counterparts are inferior. In addition, some materials were naturally incompatible with other materials on the building, causing staining or galvanic corrosion. Examples of poor quality materials were the very soft sandstones which eroded quickly. An example of poor quality modern replacement material is the tin coated steel roofing which is much less durable than the historic tin or terne iron which is no longer available. In some cases, more durable natural stones or precast concrete might be available as substitutes for the soft stones and modern terne-coated stainless steel or lead-coated copper might produce a more durable yet visually compatible replacement roofing (see illus. 12).

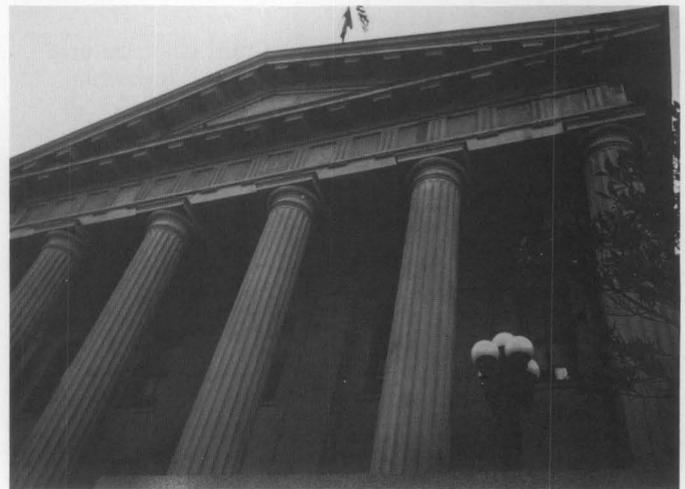
Illus. 13. Code-related changes are of concern in historic preservation projects because the integrity of the historic resource may be irretrievably affected. In the case of the Old San Francisco Mint, the fiberglass cornice was used to bring the building into seismic conformance. The original cornice was deteriorated, and the replacement (1982) was limited to the projecting pediment. The historic stone fascia was retained as were the stone columns. The limited replacement of deteriorated material did not jeopardize the integrity of the building. Photo: Walter M. Sontheimer.

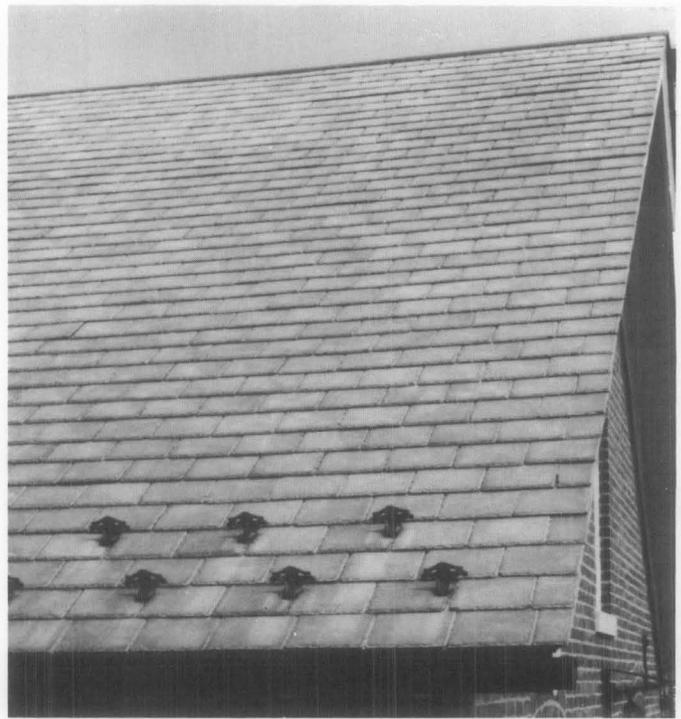
Illus. 14. The visual qualities of the historic feature must be matched when using substitute materials. In this illustration, the lighter weight mineral fiber cement shingles used to replace the deteriorated historic slate roof were detailed to match the color, size, shape and pattern of the original roofing and the historic snow birds were reattached. Photo: Sharon C. Park, AIA.

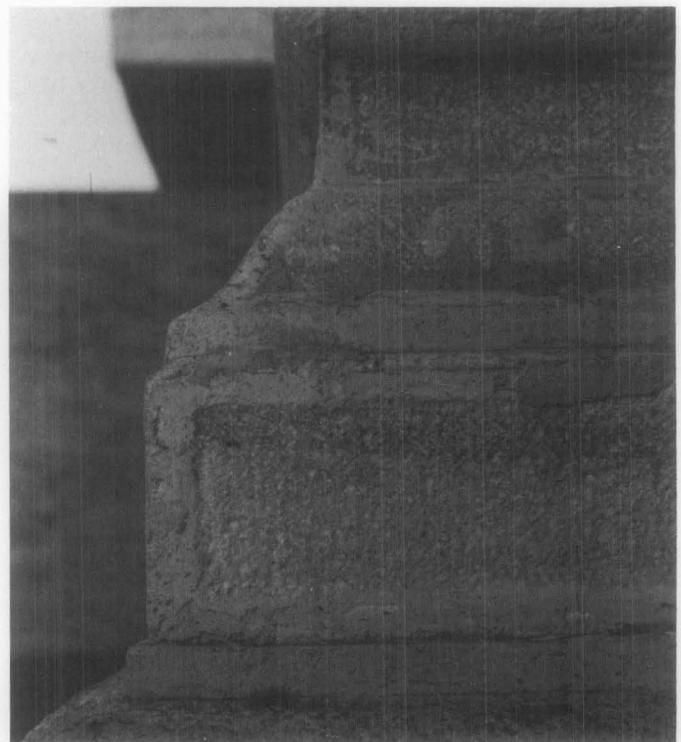
Illus. 15. Poor quality workmanship can be avoided. In this example, the crudely cast concrete entrance pier (shown) did not match the visual qualities of the remaining historic sandstone (not shown). The aggregate is too large and exposed; the casting is not crisp; the banded tooling edges are not articulated; and the color is too pale. Photo: Sharon C. Park, AIA.

Fabricators should supply a sufficient number of samples to permit on-site comparison of color, texture, detailing, and other critical qualities (see illus. 15, 16). In situations where there are subtle variations in color and texture within the original materials, the

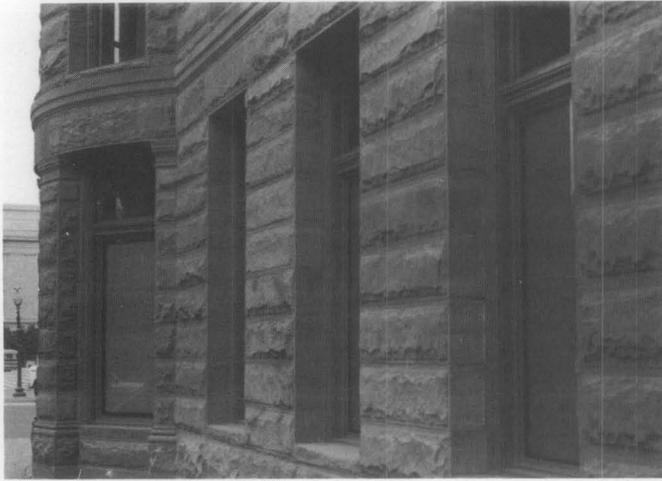
Illus. 16. The good quality substitute materials shown here do match the historic sandstone in color, texture, tooling and surface details. Dry-tamp cast stone was used to match the red sandstone that was no longer available. The reconstructed first floor incorporated both historic and substitute materials. Sufficient molds were made to avoid the problem of detecting the substitutes by their uniformity. Photo: Sharon C. Park, AIA.

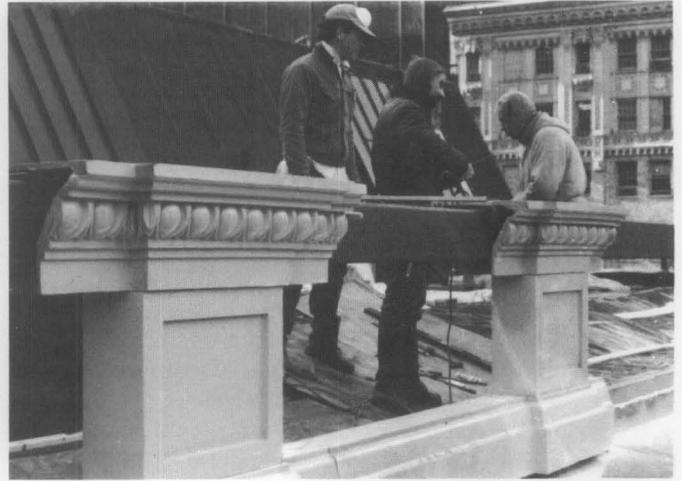
Illus. 18. Substitute materials must be properly installed to allow for expansion, contraction, and structural security. The new balustrade (a polymer concrete modified with glass fibers) at Carnegie Hall, New York City, was installed with steel structural supports to allow window-washing equipment to be suspended securely. In addition, the formulation of this predominantly epoxy material allowed for the natural expansion and contraction within the predesigned joints. Photo: Courtesy of MJM Studios.

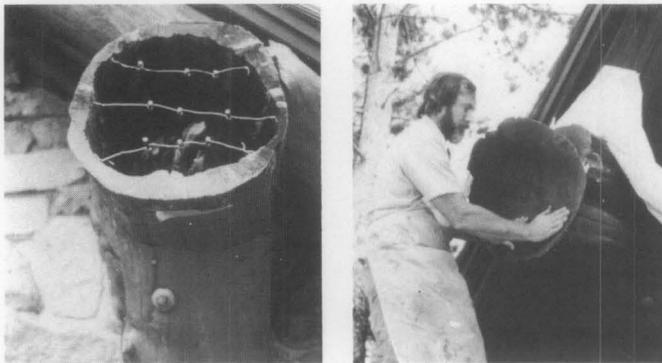
Illus. 17. Care must be taken to ensure that the replacement materials will work within a predesigned system. At the Norris Museum, Yellowstone National Park, the 12-inch diameter log rafters, part of an intricate truss system, had rotted at the inner core from the exposed ends back to a depth of 48 inches. The exterior wooden shells remained intact. Fiberglass rods (left photo) and specially formulated structural epoxy were used to fill the cleaned out cores and a cast epoxy wafer end with all the detail of the original wood graining was laminated onto the log end (right photo). This treatment preserved the original feature with a combination of repair and replacement using substitute materials as part of a well thought out system. Photos: Courtesy of Harrison Goodall.

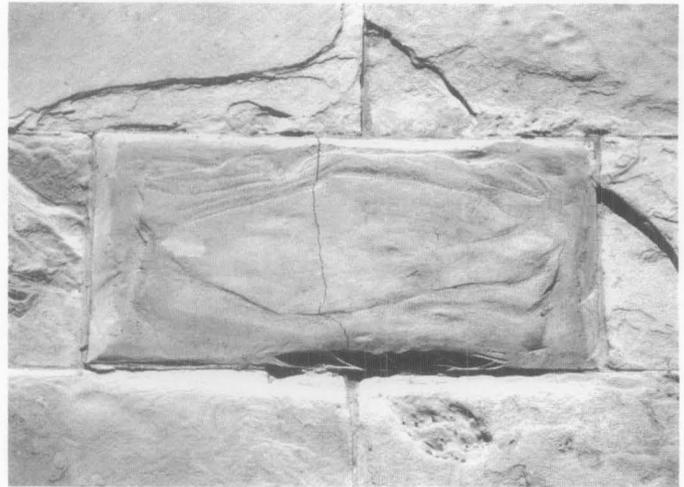
Illus. 19. When the physical properties are not matched, particularly thermal expansion and contraction properties, great damage can occur. In this case, an extremely rigid epoxy replacement unit was installed in a historic masonry wall. Because the epoxy was not modified with fillers, it did not expand or contract systematically with the natural stones in the wall surrounding it. Pressure built up resulting in a vertical crack at the center of the unit, and spalled edges to every historic stone that was adjacent to the rigid unit. Photo: Walter M. Sontheimer.

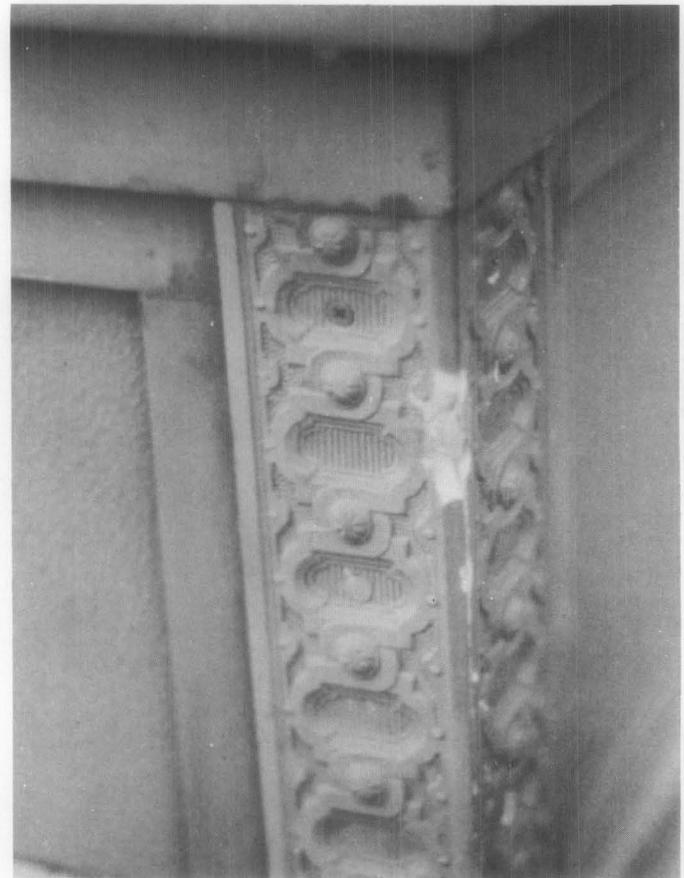
Illus. 20. Long-term performance can be affected by where the substitute material is located. In this case, fiberglass was used as part of a storefront at street level. Due to the brittle nature of the material and the frequency of impact likely to occur at this location, an unsightly chip has resulted. Photo: Sharon C. Park, AIA.

While a substitute material may appear to be acceptable at the time of installation, both its appearance and its performance may deteriorate rapidly. Some materials are so new that industry standards are not available, thus making it difficult to specify quality control in fabrication, or to predict maintenance requirements and long term performance. Where possible, projects involving substitute materials in similar circumstances should be examined. Material specifications outlining stability of color and texture; compressive or tensile strengths if appropriate; the acceptable range of thermal coefficients, and the durability of coatings and finishes should be included in the contract documents. Without these written documents, the owner may be left with little recourse if failure occurs (see illus. 20, 21).

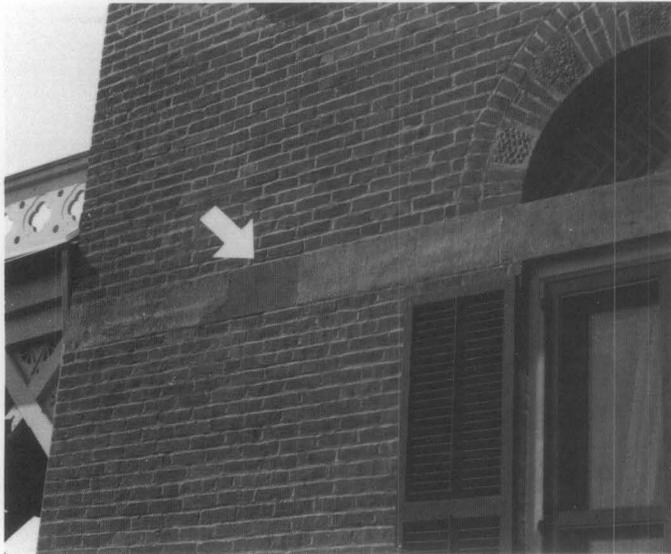
Illus. 21. Change of color over time is one of the greatest problems of synthetic substitute materials used outdoors. Ultra-violet light can cause materials to change color over time; some will lighten and others will darken. In this photograph, the synthetic patching material to the sandstone banding to the left of the window has aged to a darker color. Photos: Sharon C. Park, AIA.

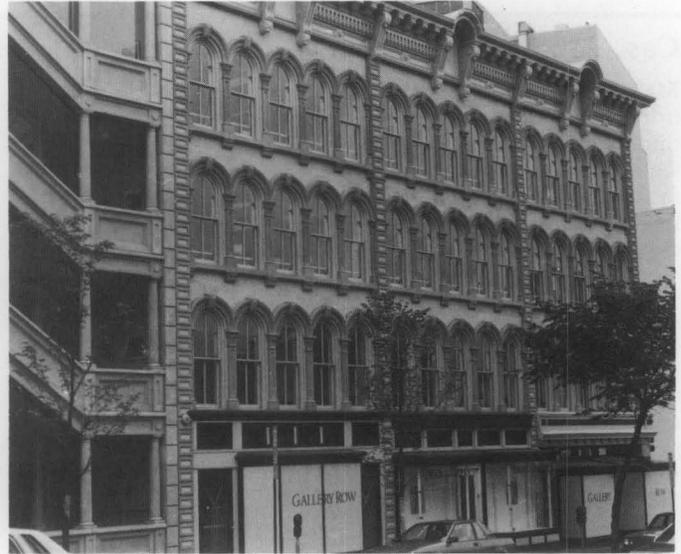
Illus. 22. A fiber reinforced polymer (fiberglass) cornice and precast concrete elements replaced deteriorated features on the 19th-century exterior. Photo: Sharon C. Park, AIA.

Once all reasonable options for repair or replacement in kind have been exhausted, the choice among a wide variety of substitute materials currently on the market must be made (see illus. 22). The charts at the end of this Brief describe a number of such materials, many of them in the family of modified concretes which are gaining greater use. The charts do not include wood, stamped metal, mineral fiber cement shingles and some other traditional imitative materials, since their properties and performance are better known. Nor do the charts include vinyls or molded urethanes which are sometimes used as cosmetic claddings or as substitutes for wooden millwork. Because millwork is still readily available, it should be replaced in kind.

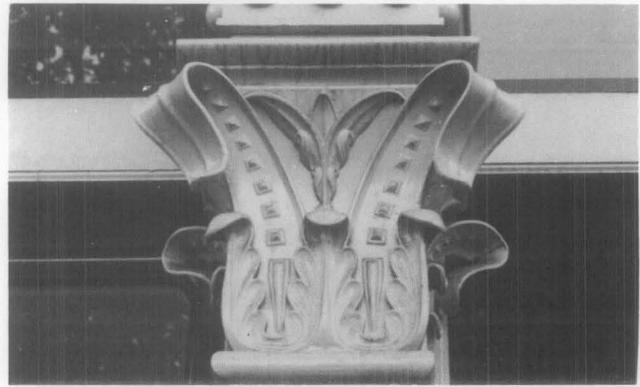
Close-up detail showing the crisp casting in aluminum of this 19th-century replica column and capital for a storefront. Photo: Sharon C. Park, AIA.

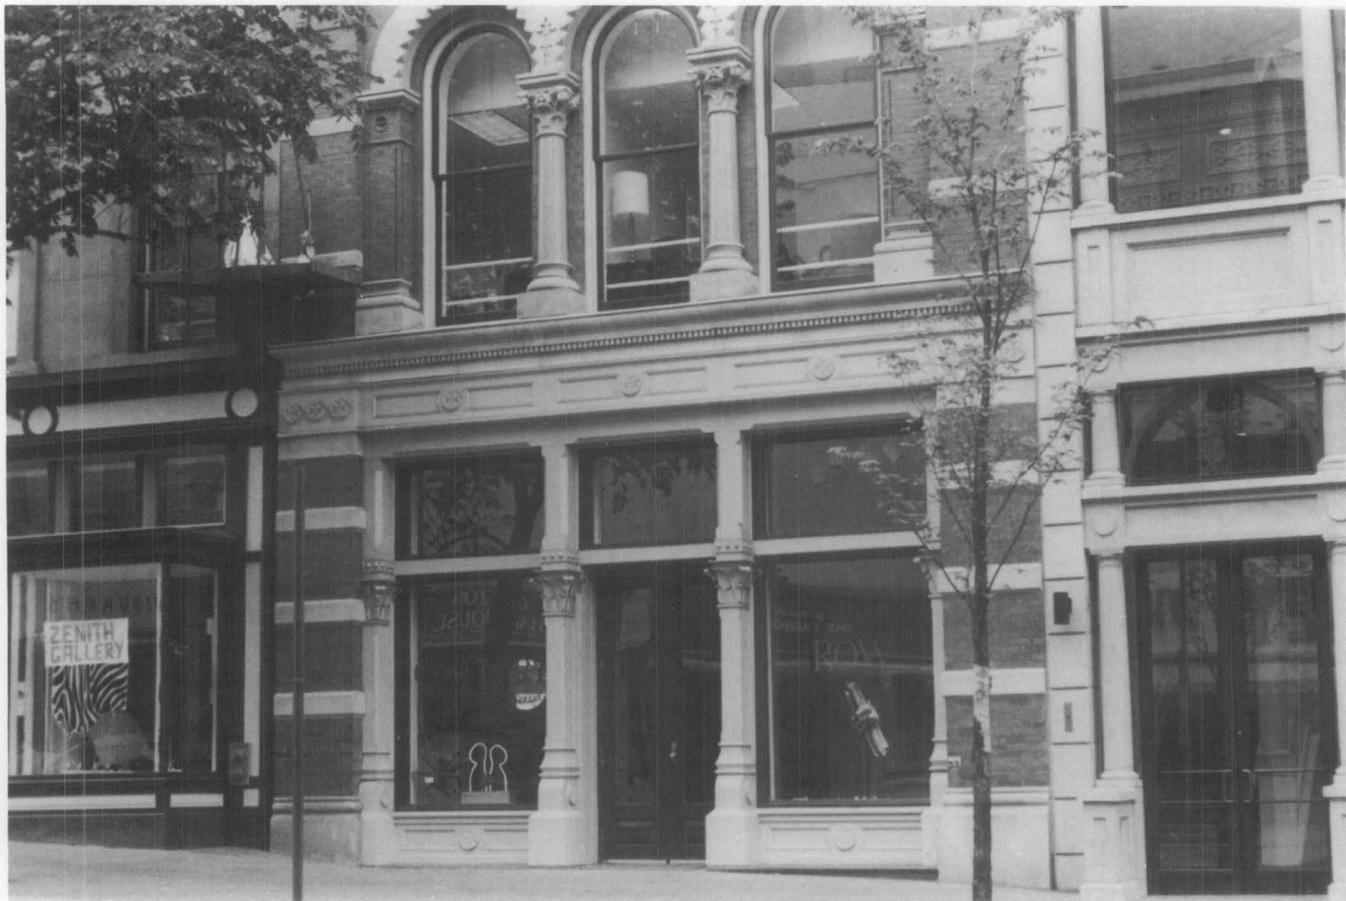
The new cast aluminum storefront replaced the lost 19th-century cast-iron original. Photo: Sharon C. Park, AIA.

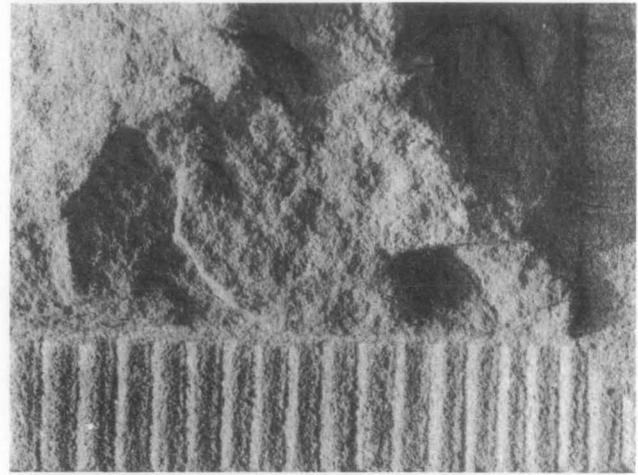
Dry-tamped cast stone can reproduce the sandy texture of some natural stones. Photo: Sharon C. Park, AIA.

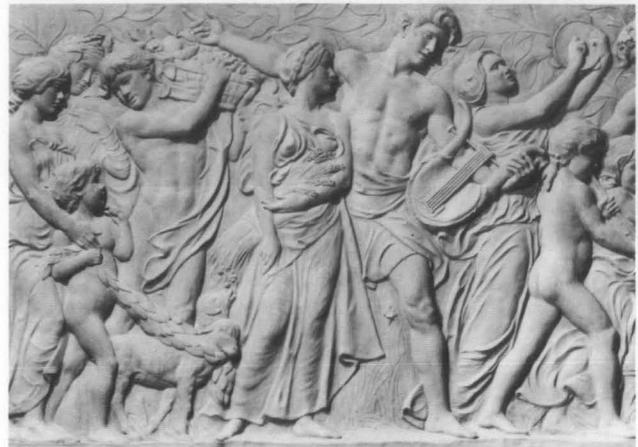
This glass fiber reinforced concrete sculptural wall panel will replace the seriously damaged resin and plaster original. A finely textured surface was achieved by spraying the GFRC mix into molds that were created from the historic panel and resculpted based on historic photographs. Photo: Courtesy of MJM Studios.

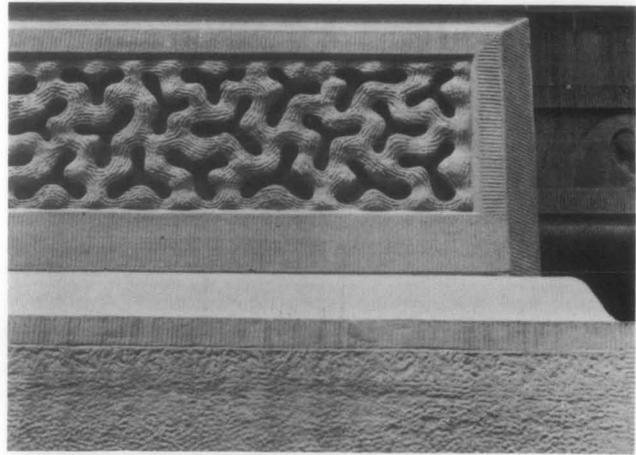
Textured molds can produce a variety of high quality carved, quarried, and tooled surfaces in concrete.

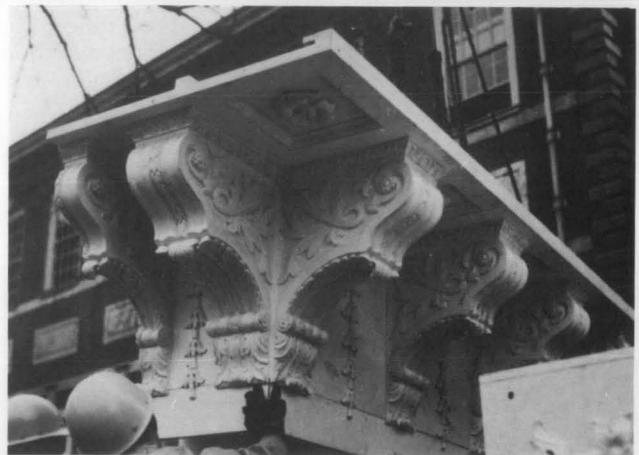
A fiberglass cornice for the reconstruction of an 18th-century wooden clockcase is being lifted in pre-fabricated sections. The level of detail is intricate and of high quality. Photo: Courtesy of Independence National Historical Park.

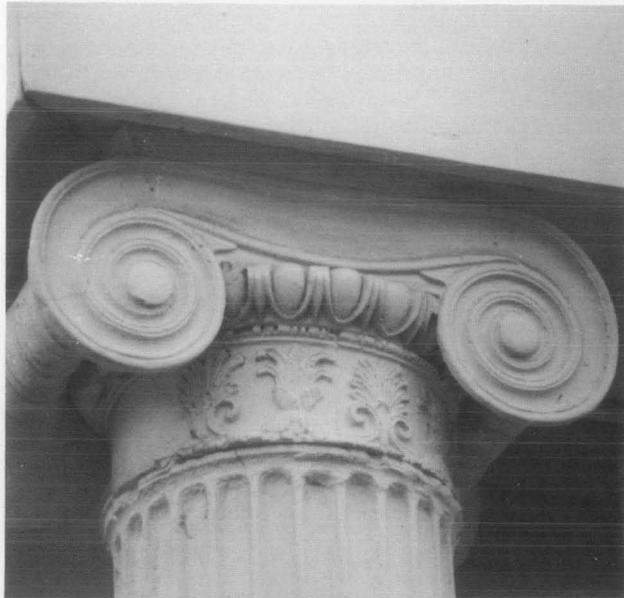
This replica column capital was made using epoxy resins poured into a mold taken from the building. The historic wooden column shaft was repaired during the restoration. Photo: Courtesy Dell Corporation.

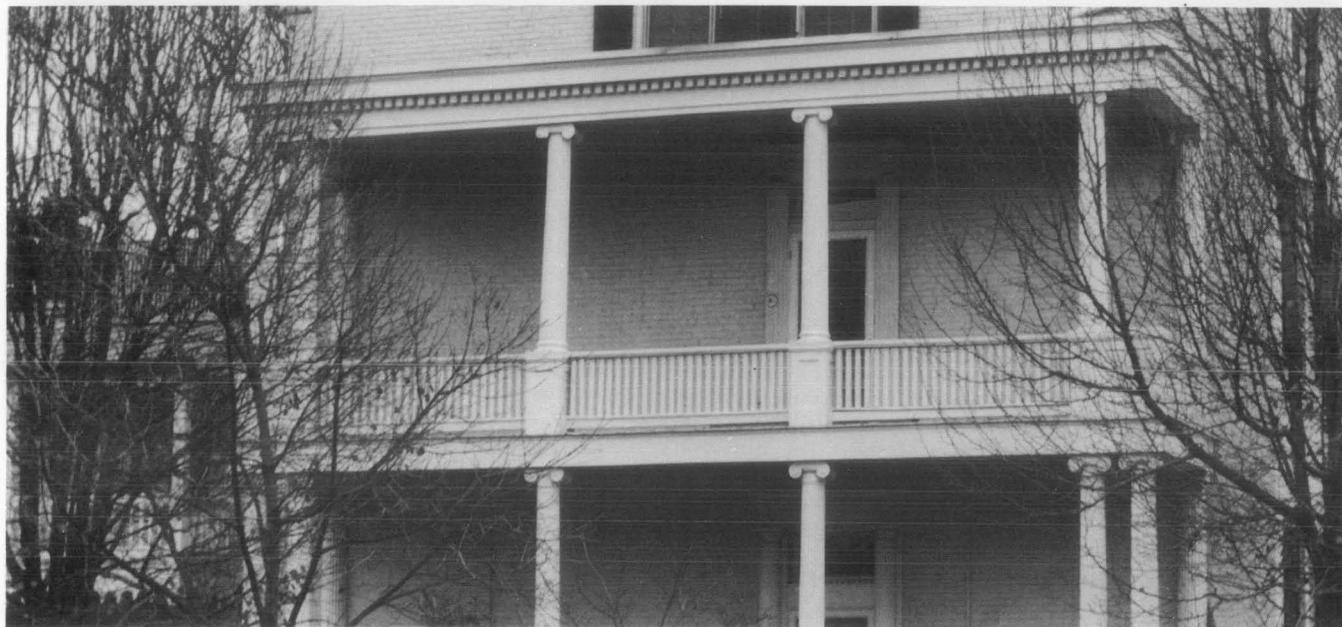
Columns were repaired and a capital was replaced in epoxy on this 19th-century 2-story porch. Photo: Dell Corporation
