Vanishing Treasures Program

Year-End Report for
Fiscal Year 2007 and
Proposed 2008 Activities

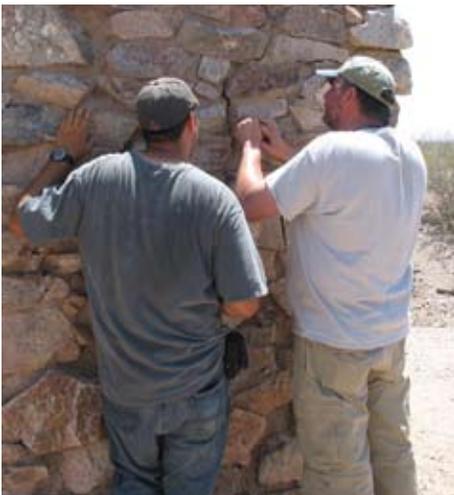
VT Structural Engineer Preston Fisher attaches a crack monitor to a stone structure at Victoria Mine, Organ Pipe Cactus National Monument.

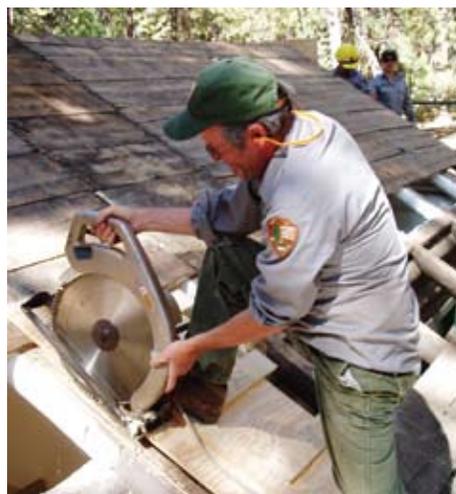
VT Materials Conservator Jake Barrow cuts a slot in a broken rafter in preparation for the installation of a reinforcing spline, Grand Canyon National Park.

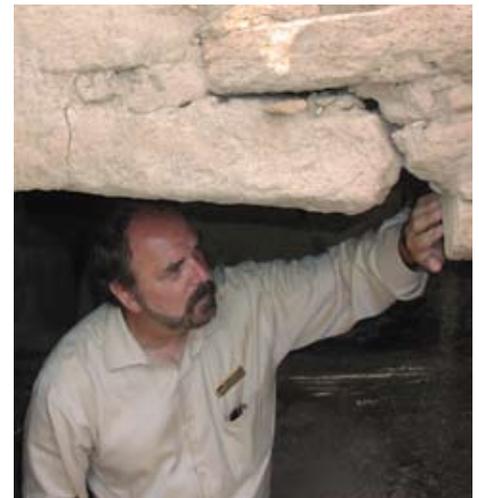
VT Historical Architect Randy Skeirik examining a failing lintel in a cavate at Puye, an ancestral Santa Clara pueblo near Bandelier NM, Santa Clara Pueblo.

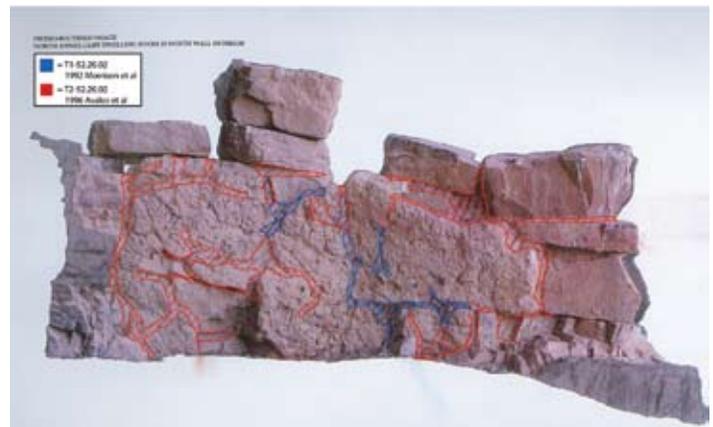
52.20.02, North Interior wall

Figure 2: Annotated photo of stabilization events occurring at a wall in the North Annex Cliff Dwelling.

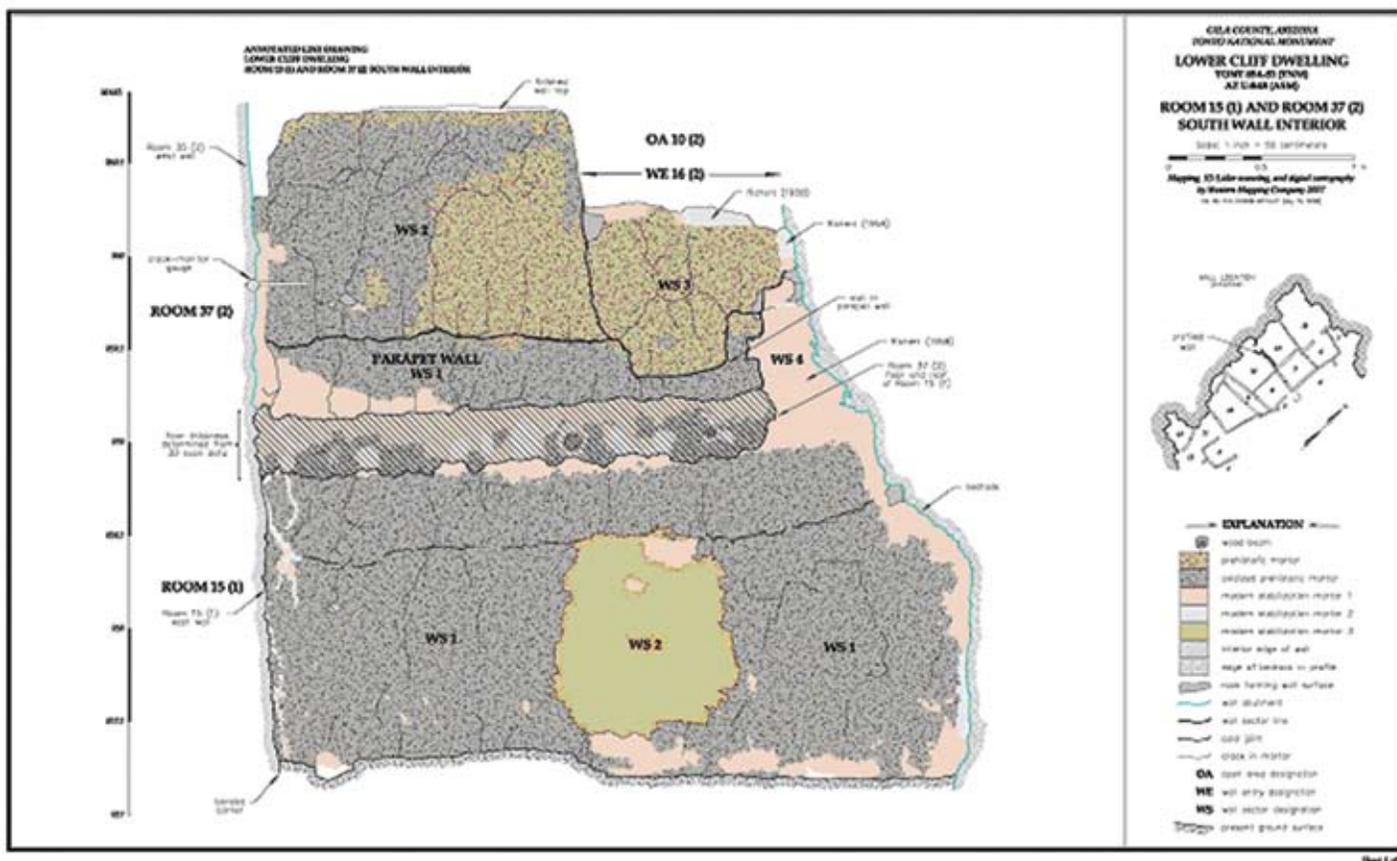
Figure 3: Architectural sheet created by Western Mapping Company and Larry Nordby, depicting construction sequences, repair events, and, most importantly, the anthropological information that tells us behavioral details about the prehistoric inhabitants. Image: Courtesy, Tonto National Monument

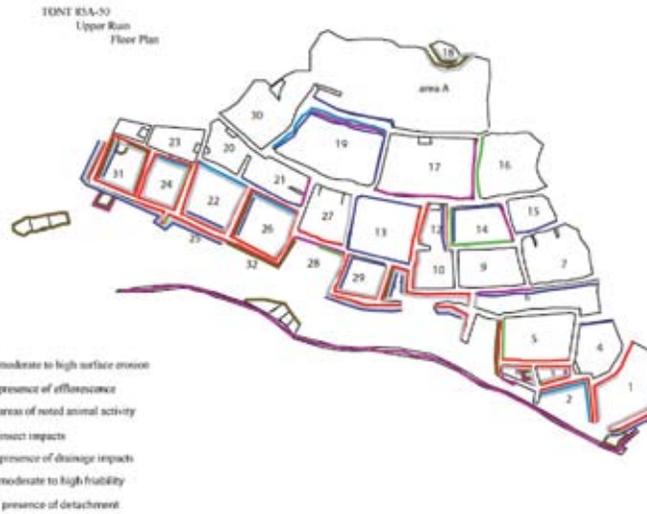
Figure 4: Site-level condition assessment map created by Matt Guebard, depicting numerous impacts throughout the Upper Cliff Dwelling.

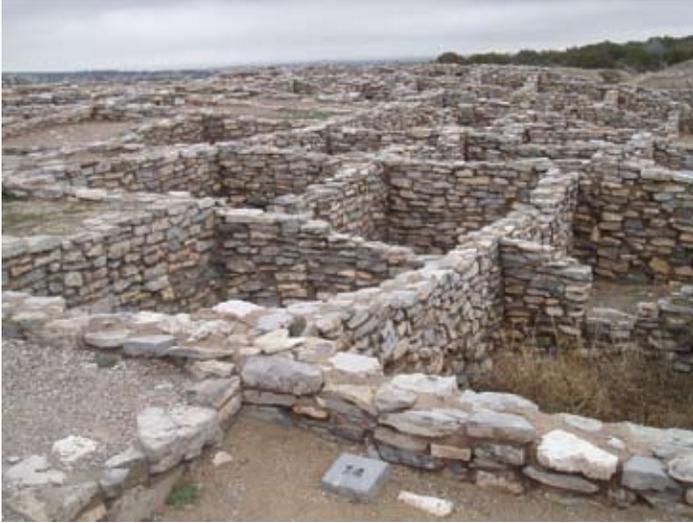
Figure 2: This example of selective backfilling at Salinas Pueblo Missions National Monument shows how pueblo sites can be protected by backfilling while still retaining their interpretive value.
Photo: Randall Skeirik

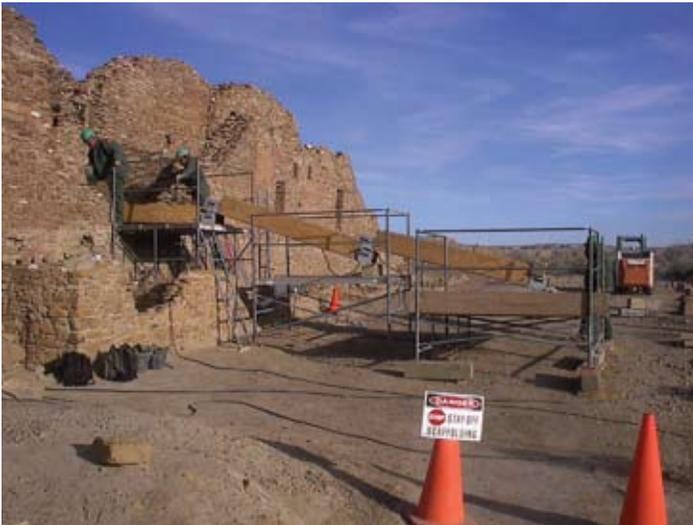
Figure 3: Conveyor system used for backfilling the south room area at Pueblo del Arroyo.
Photo: Courtesy, Chaco culture National Historical Park

mechanically, either using conveyors (Figure 3) or directly using a front-end loader. Fill dirt is spread through the area by hand using shovels and rakes, then tamped after each foot-thick lift (Figure 4). Aztec has used geo-webbing to help control movement of backfill soil where unequal fill levels cannot be avoided.

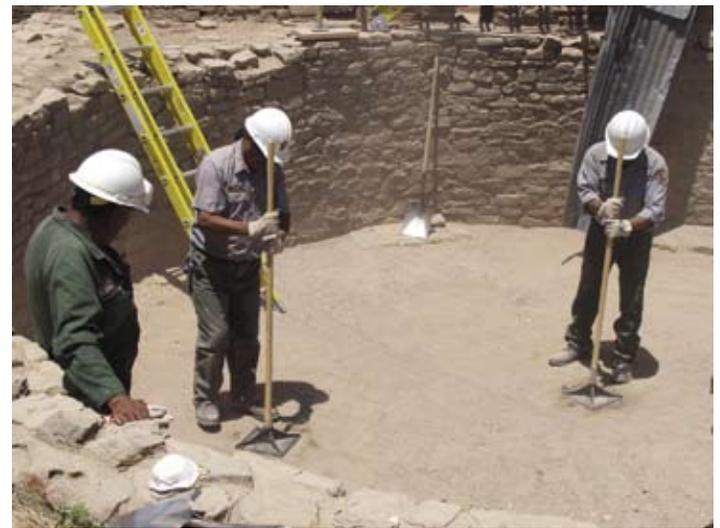
Figure 4: Backfill crew tamping sandy loam prior to deposition of another layer at West Ruin, Aztec Ruins National Monument.
Photo: Courtesy, Aztec Ruins National Monument

The current backfilling programs include the use of sandy loam and clayey sandy loam soils for most of the filling, with a thick cap of clay to impede saturation of subsoils and to assist in directing surface runoff toward the evaporative basins or PVC drain inlets. A geotextile horizon marker is always laid down first to assist in any future re-excavation and modification of the backfill situation. Fill dirt is generally transported into rooms

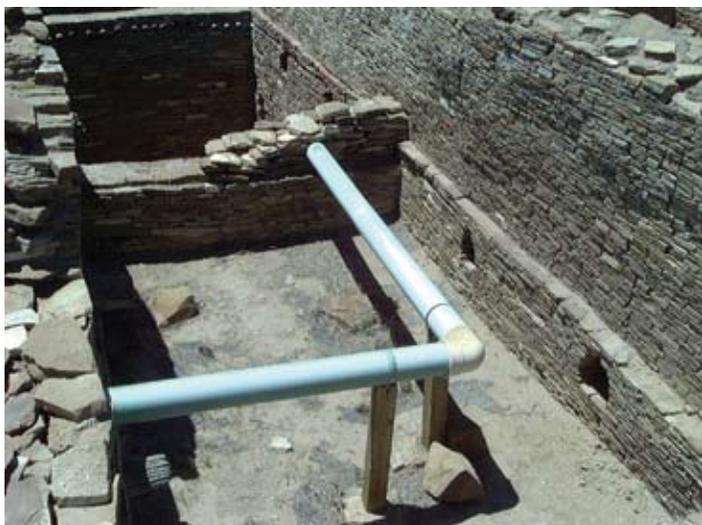
Figure 5: Drainage system in the back wall row of rooms at Pueblo del Arroyo before backfilling.

Different drainage systems have been tested and used at Chaco and Aztec, but two main design types are dominant: a subsurface PVC system of drain pipes (Figure 5), and collection of surface water into evaporative basins (Figure 6). The PVC drain system allows water to be moved from a room or group of rooms to a basin or off-site location. The pipes are usually set relatively high in the backfill and move from rooms or outer walls by passing through doorways, vents, or existing breaches in walls. This has been the preferred drainage method when architectural and elevation constraints allow; but wall perforations are sometimes necessary, especially in order to route drain pipes through exterior walls to off-site locations. Slope gradients of approximately ¼ inch per foot are maintained.

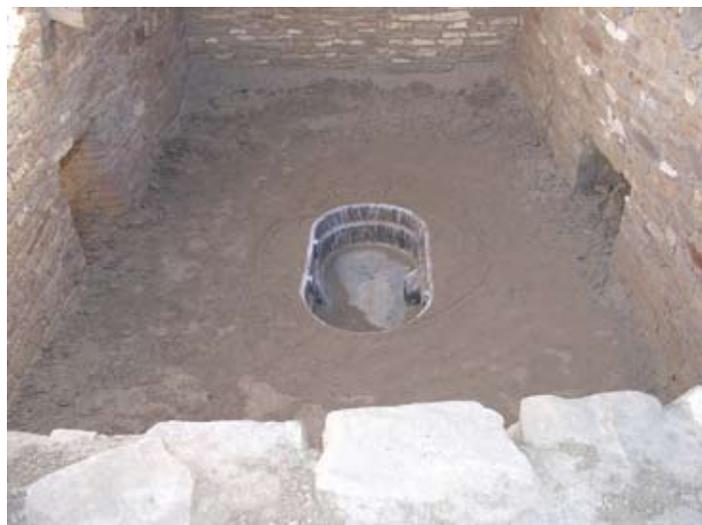
Figure 6: Central evaporative basin in a room with shallow backfill at Pueblo del Arroyo.

Several types of collection basin systems have been tried at Chaco. Both plastic and metal basins with 40-70 gallon capacities have been used, with some round and some oblong. Aztec has consistently used stainless steel basins that are either 4 feet or 6 feet in diameter. They are acquired from oil/gas well suppliers, who use the basins to cap tanks on local well pads, or from feed stores. Basin depth ranges from one to two feet into the new backfill. Basins have been used mostly in areas where a pipe system is not feasible or would require an unacceptable intrusion through masonry walls (e.g., kivas) or in unexcavated fill. The surface of rooms and kivas is graded to direct runoff into the basin which is typically located in the center.

When basins were first used, it was hoped that all moisture collected would evaporate into the air. This concept works when the room is relatively open to wind and the amount of rain or snow at any one precipitation event is very low. With the types of monsoon showers that often occur in the Southwest, basins often fill to within 80% or more of their capacity and need to be emptied. Basins are usually in places that cannot be drained. Instead, water is usually pumped out of the basins with an electric or gasoline-powered water pump connected to a hose so that water

is moved to a location outside the structure. Winter snow and ice can also build up and require removal. Monitoring of the basins after installation is important because some basins fail, allowing water to collect down the outside into surrounding fill. This is usually corrected by re-tamping the backfill dirt and modifying the interface between the soil and the basin or modifying the lip of the basin.

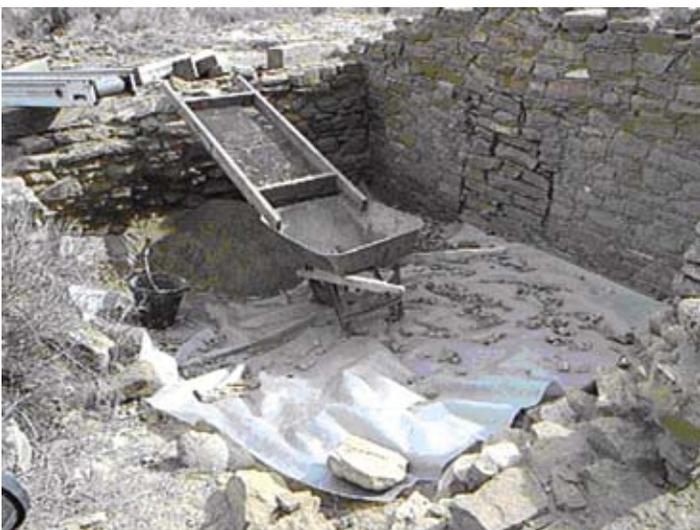
Figure 7: Typical shallow backfill project.
Photo: Courtesy, Aztec Ruins National Monument

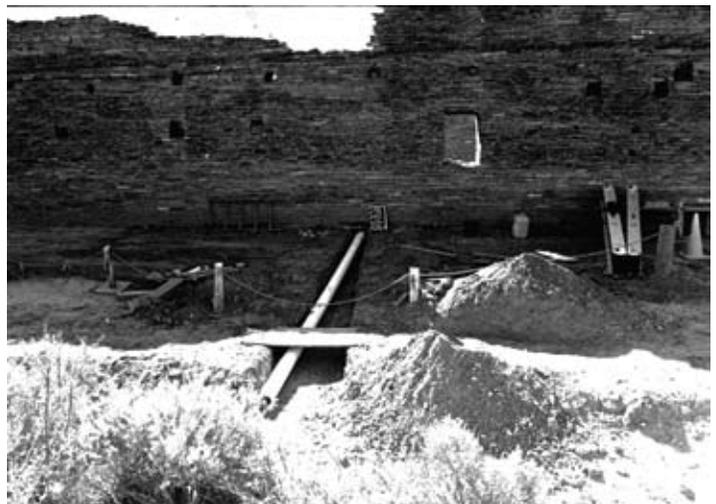
Figure 8: Drain from the back row of rooms at Chetro Ketl to a ditch outside the pueblo.
Photo: Dave Six, 2003

The 1994 backfill areas were monitored for several years to determine the effectiveness of the program. By 1998, the park was ready to begin a second round of backfilling at Chaco. The initial backfilling results and their assessment were also instrumental in designing the West Ruin backfilling program at Aztec. Preparation for these projects included architectural documentation and condition assessments, stabilization treatment of structures to be backfilled, and writing scopes-of-work that included designing drainage systems and backfill contouring. In 1999, the east wing room block of Chetro Ketl was backfilled. Because no wood beams extended out into the rooms to be backfilled, no geomembrane was placed near the top of the fill. Several PVC drainage systems were placed, but they proved challenging since they had to run up to 70 feet outside the ruin to an arroyo in order to provide effective drainage.

The emergency work at Chetro Ketl in 2003 was precipitated by the discovery that moisture was beginning to accumulate in the lower fill areas. Exposure of the geomembrane showed that it had leaked in several areas, especially around places where monitor and drain pipes passed through it. The fill was removed and wood examined. A new plan was used to provide protection for the wood. Better geomembrane and geotextile materials were now available as well as manufactured welded pipe sleeves, so we were able to correct the problem. Monitoring continues to test the effectiveness of this new system.

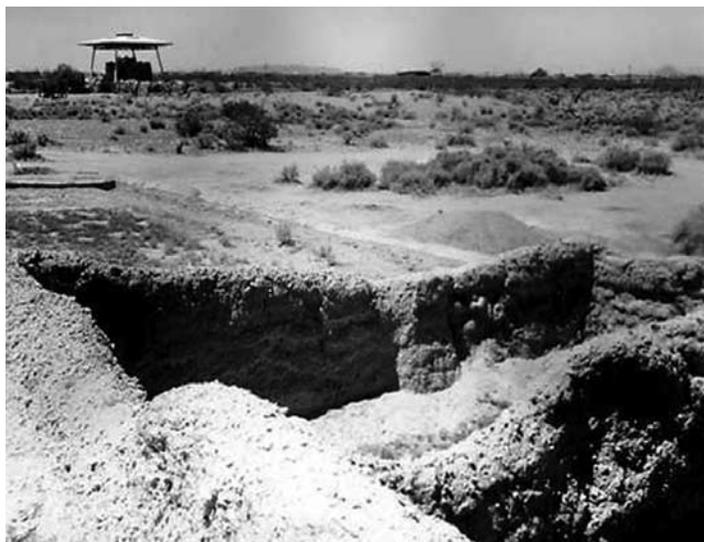
Figure 4a: The original caption for this 1958 photo states, "These walls in Compound 'B' have been uncovered, restored to some degree and recovered to protect them from erosion."

ways led to new experimentation (*Figures 4a and 4b*). The move toward the use of scientific methods in ruins preservation has remained in a state of continuing development, yielding substantial and beneficial results. Many of the findings are subtle, since no magic formula or treatment has ever emerged. It is unlikely that one ever will. Rather, the history of our preservation efforts has been a process of experimentation, empirical learning, and trial and error. Ultimately, scientific endeavors, coupled with planning and analysis, will better focus limited resources toward regular maintenance cycles. In the 1990s, graduate preservation programs in universities began joining the NPS in research activities, the pursuit of solutions, and training. This process mirrors the early 1900s University involvement with excavation and stabilization as well as mid-century field schools that were devoted to training archeologists. Cooperative Ecosystems Studies Units (CESUs), which are the mechanism through which most universities now participate, have further invigorated the use of scientific methods and have augmented NPS capabilities.

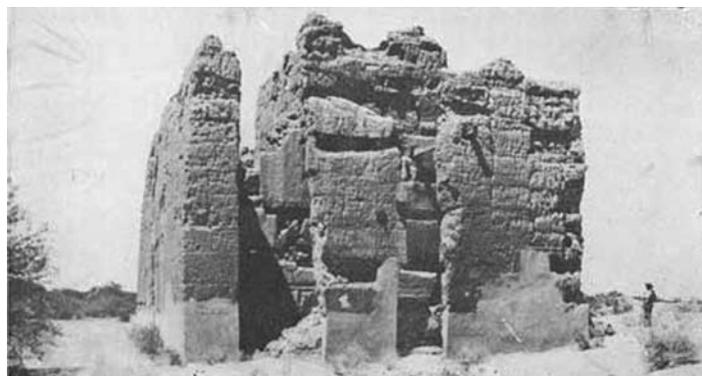
Figure 3: Casa Grande seen from southwest about 1892. Repairs to areas with basal erosion are clearly evident even in this early photo.

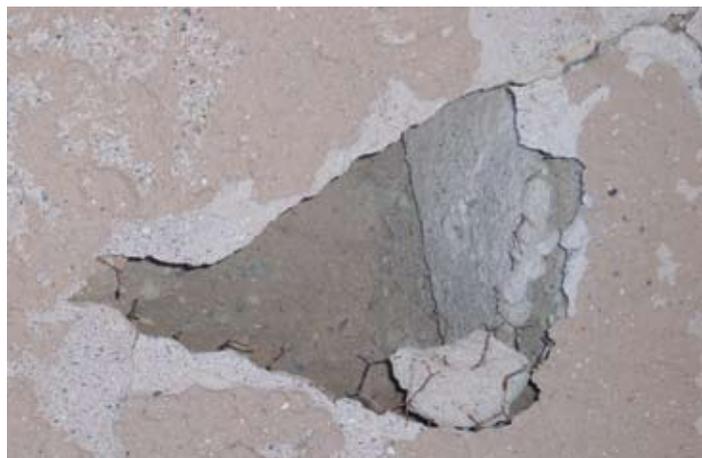
Figure 4b: This photo, taken in 2005, shows one of the walls in Compound "B" with its 1950s protective coating. The use of portland cement for the protective coat has caused the original material beneath to deteriorate. This is illustrated by the gap between the protective coat and the current surface of the wall. Nearly two inches of historic material have been lost in less than 50 years.

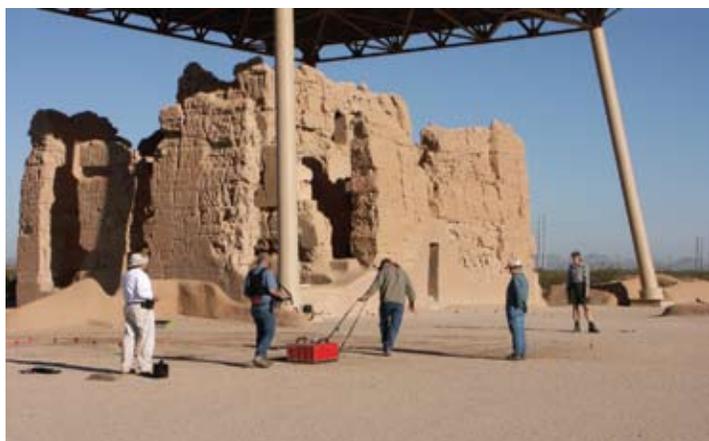
Ground penetrating radar being used to locate previously undocumented subsurface archeological features in Compound A at Casa Grande Ruins National Monument.

In coordination with the United States Department of Agriculture (USDA) Soil Service, a survey was conducted to determine the effectiveness of Ground Penetrating Radar (GPR) and Electromagnetic

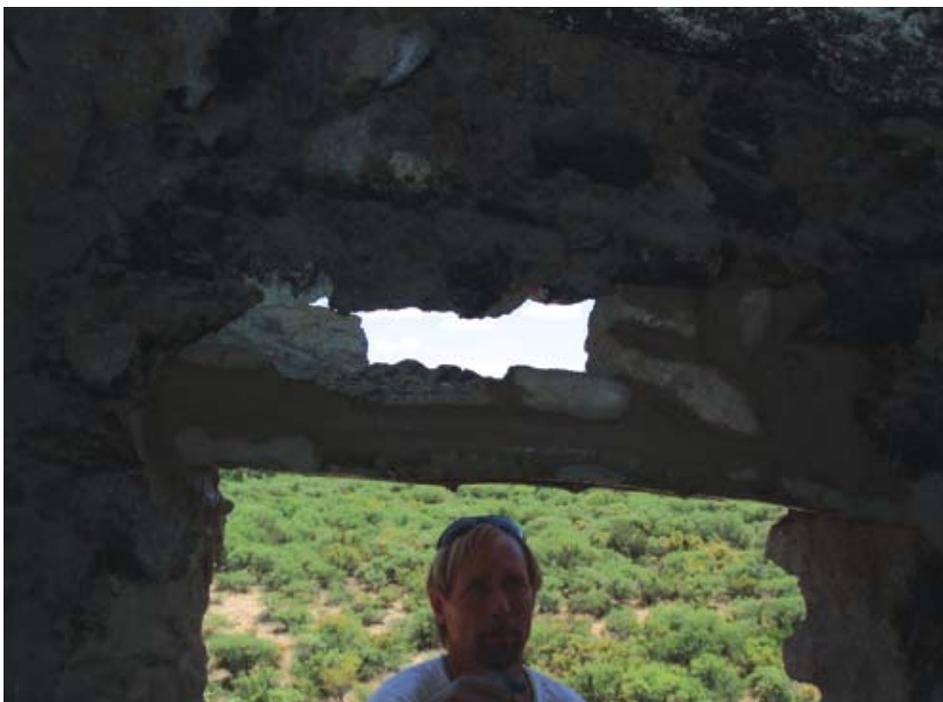
High above Beaver Creek, preservation mason Stefan Sloper repairs the stonework above a lintel in the entrance to a cavate near Montezuma Castle. Photo: Courtesy, Montezuma Castle National Monument

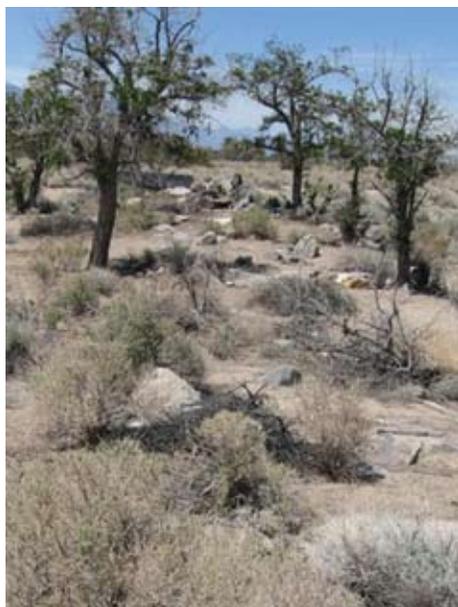
The Block 9 mess hall garden before excavation.

Project Summary: In 2007, the Block 9 Mess Hall Garden at Manzanar was documented and stabilized. This feature, which had been partially buried by sediment and overgrown with vegetation, had been determined to be important for telling the story of how Manzanar’s Japanese American internees adapted to the confinement and tedium of their imprisonment. Mr. Ryozo Kado, a Methodist landscaper interned in Block 34, constructed the garden to revive the morale of the Buddhist fishermen from Terminal Island who lived in Block 9. The garden had been identified during previous archeological survey work; but its extent was unknown and no historic photographs of the feature have been found.

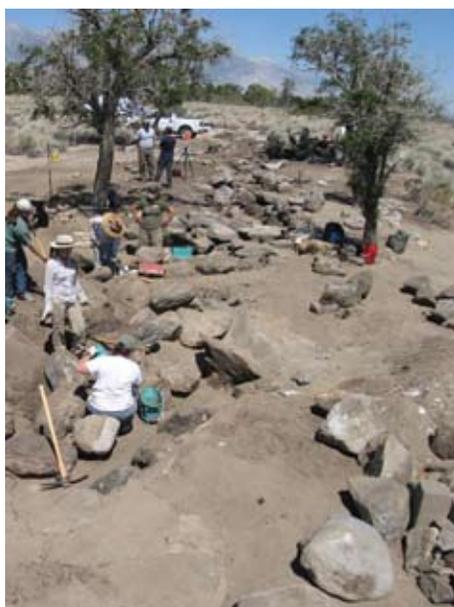
Above: The Block 9 mess hall garden during restoration. Below: Garden plan. Photos: Courtesy, Manzanar National Historical Site

The excavation also provided evidence about the relocation center abandonment. When the relocation center was closed, building debris and left-behind artifacts were dumped into the pond and burned. This disposal, evidently done with heavy machinery, pushed in some of the rocks of the garden and damaged other features. Over 400 artifacts, including buttons, a ring, toys, a toothbrush, jars, a spoon, and food remains, were collected from the pond fill.

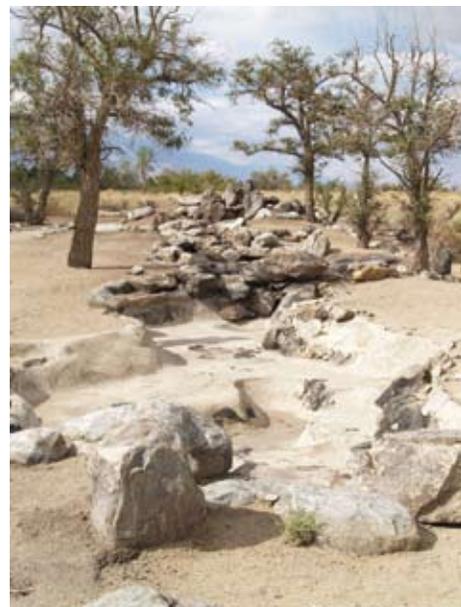
The Block 9 mess hall garden after restoration.

Stabilization work included re-fitting of boulders that had been displaced, restoration of an earthen mound, and patching of concrete. One faux wood log, a hallmark of Mr. Kado’s work, which had been damaged during abandonment, was repaired. Mapping and photography, including overhead views, and documentation of the stages of excavation and stabilization. Artifact analyses and a detailed archeological report are in progress. Techniques initiated and developed for the Block 9 garden project will facilitate a much larger project at Merritt Park, Manzanar’s community garden that is scheduled for 2008.

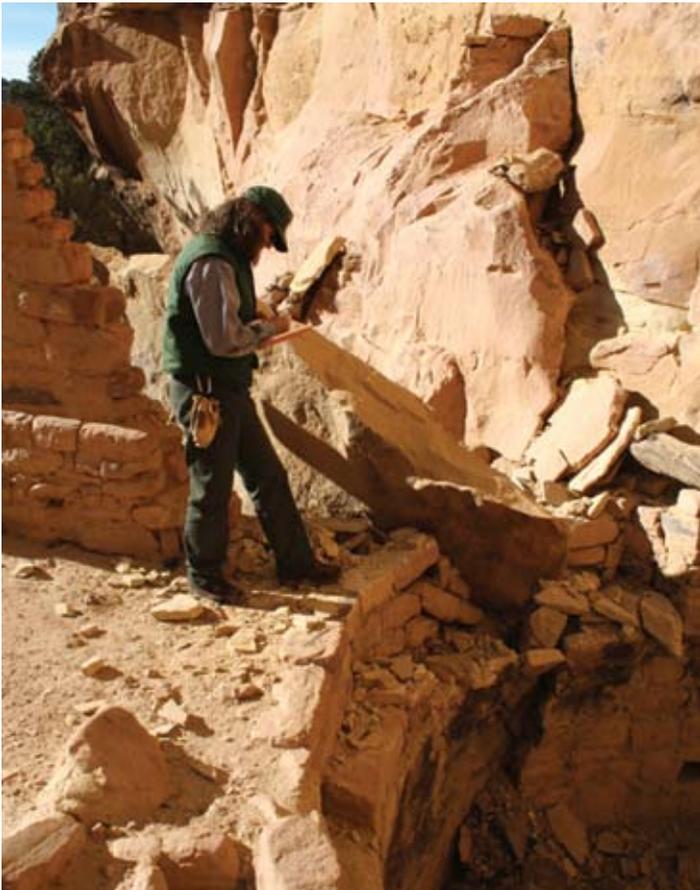
*Archeologist Julie Bell documenting damage from a rock fall at Square Tower House, Mesa Verde National Park.
Photo: Courtesy, Mesa Verde National Park*

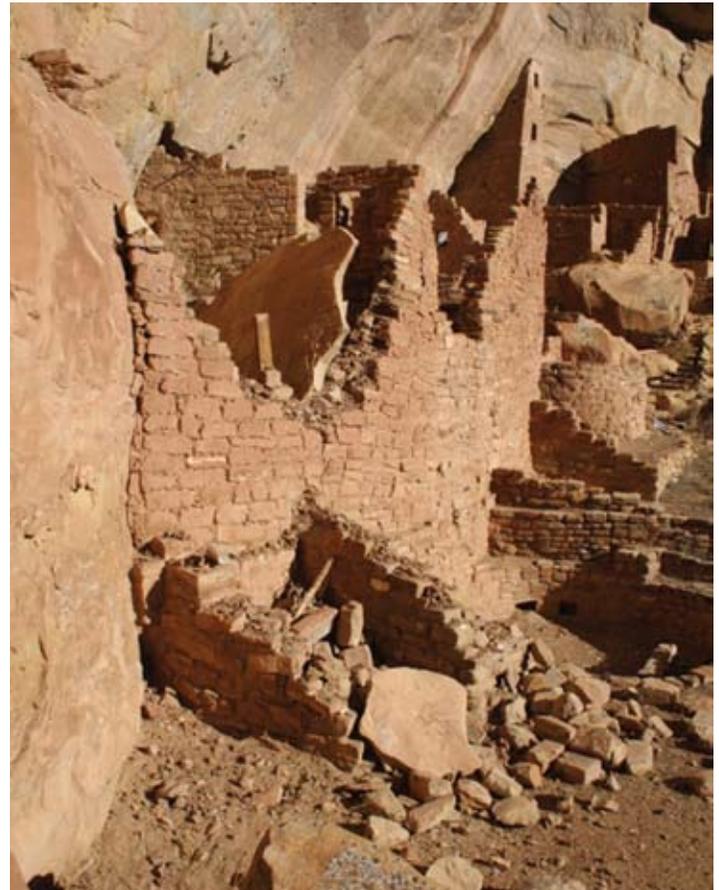
*Damage from rock fall to standing walls at Square Tower House, Mesa Verde National Park.
Photo: Courtesy, Mesa Verde National Park*

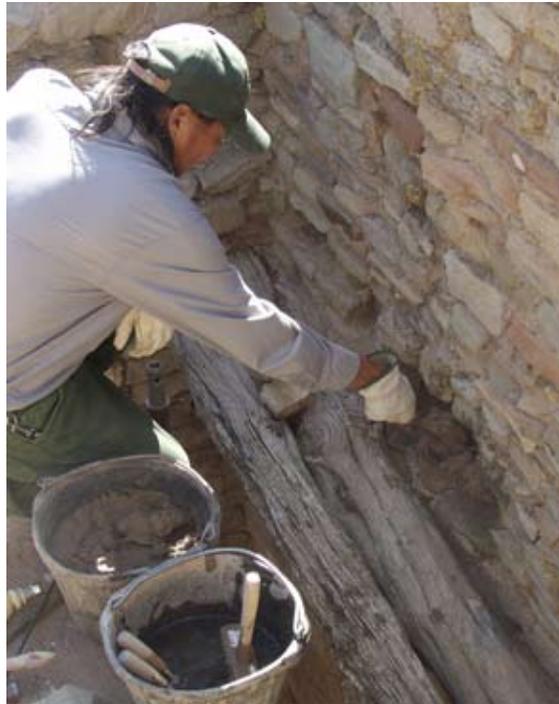
VT Masonry Worker Carl Jim executing masonry replacement on deteriorated Chacoan walls at West Ruin, Aztec Ruins National Monument.
Photo: Cheryl Paddock

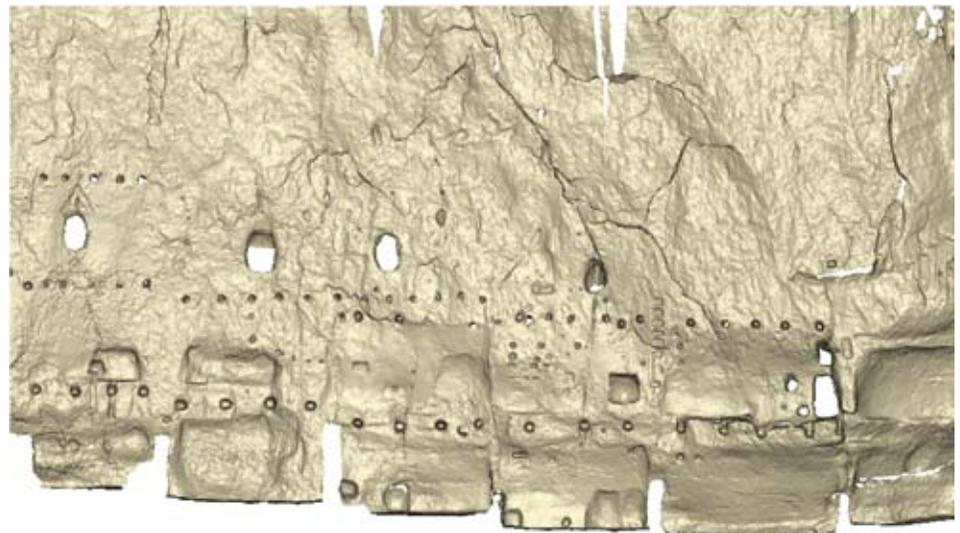
Elevational representation of the 3-dimensional data of a cliff face collected through the use of high-resolution laser scanning. The horizontal series of circles show viga sockets that once supported floor or roof structures for rooms built in front of the cliff face.

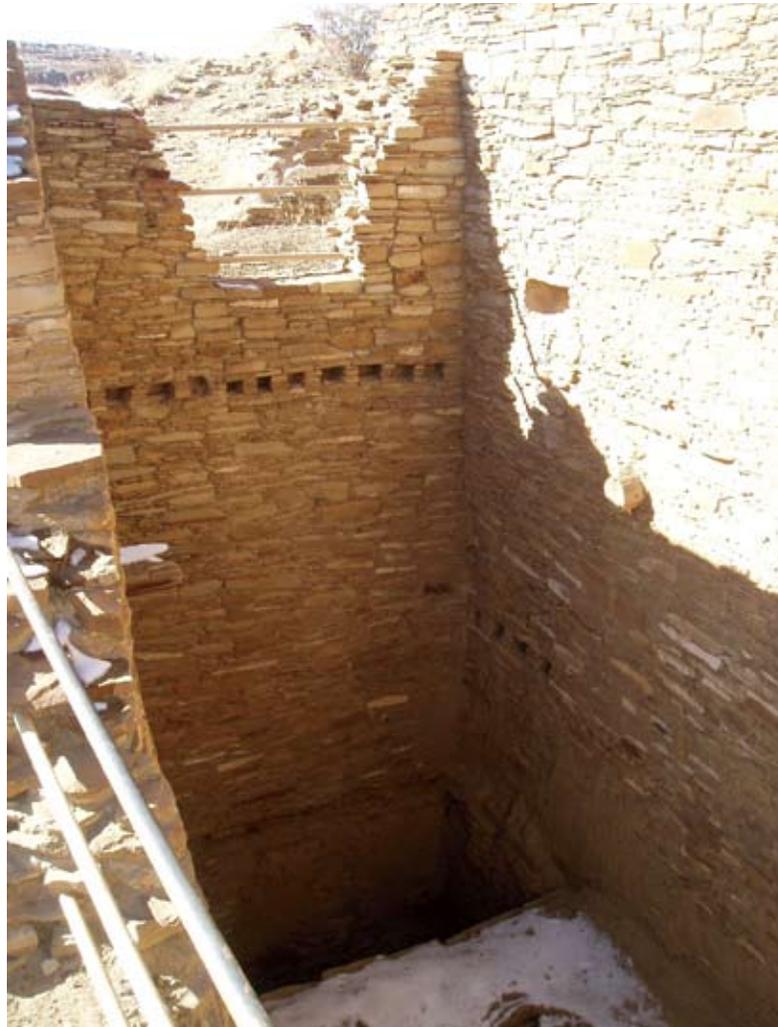
This deeply excavated room block illustrates the problem of differential fill as well as the need for good site drainage. The weight of the soil on the back side of these walls will eventually cause them to collapse, while the water that collects in the bottom of the excavated room will accelerate the deterioration of the masonry. Additionally, good drainage of the soil outside these rooms will decrease hydrostatic pressure, reducing the forces acting to push the walls over.

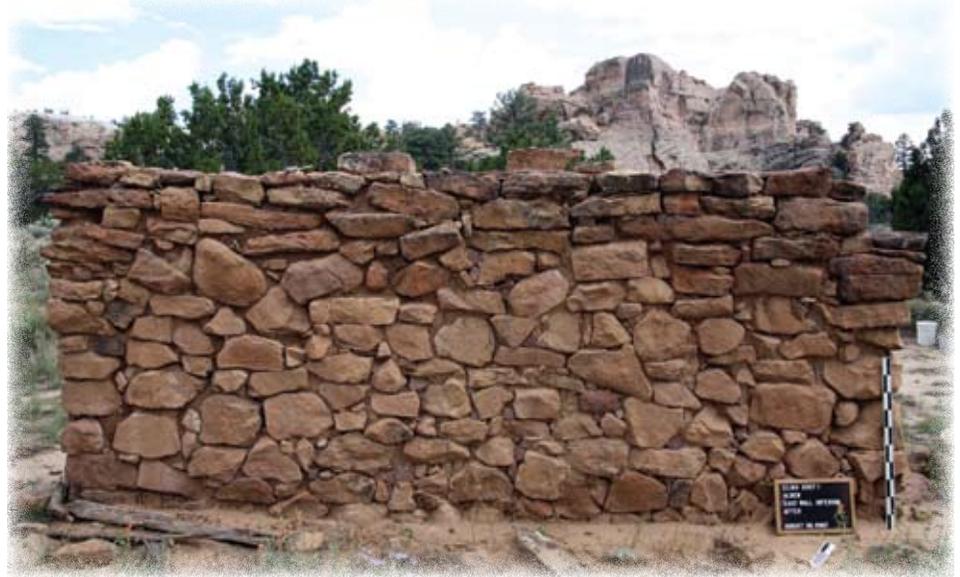
*East Wall of the Alben Homestead after preservation, El Malpais National Monument.
Photo: Courtesy, El Malpais National Monument*

Jim managed multiple Vanishing Treasures projects at both El Malpais and El Morro National Monuments during FY 2007. At El Malpais, the VT program conducted routine preservation treatments on the Alben Homestead. This work included repointing eroded mortar joints and photo-documenting the current condition of this turn-of-the-20th century homestead. At El Morro, the VT program conducted preservation treatments that included both vegetation management, to clear weeds from rooms and drainage systems, and structural maintenance to repair the pilasters within the pueblo's rectangular

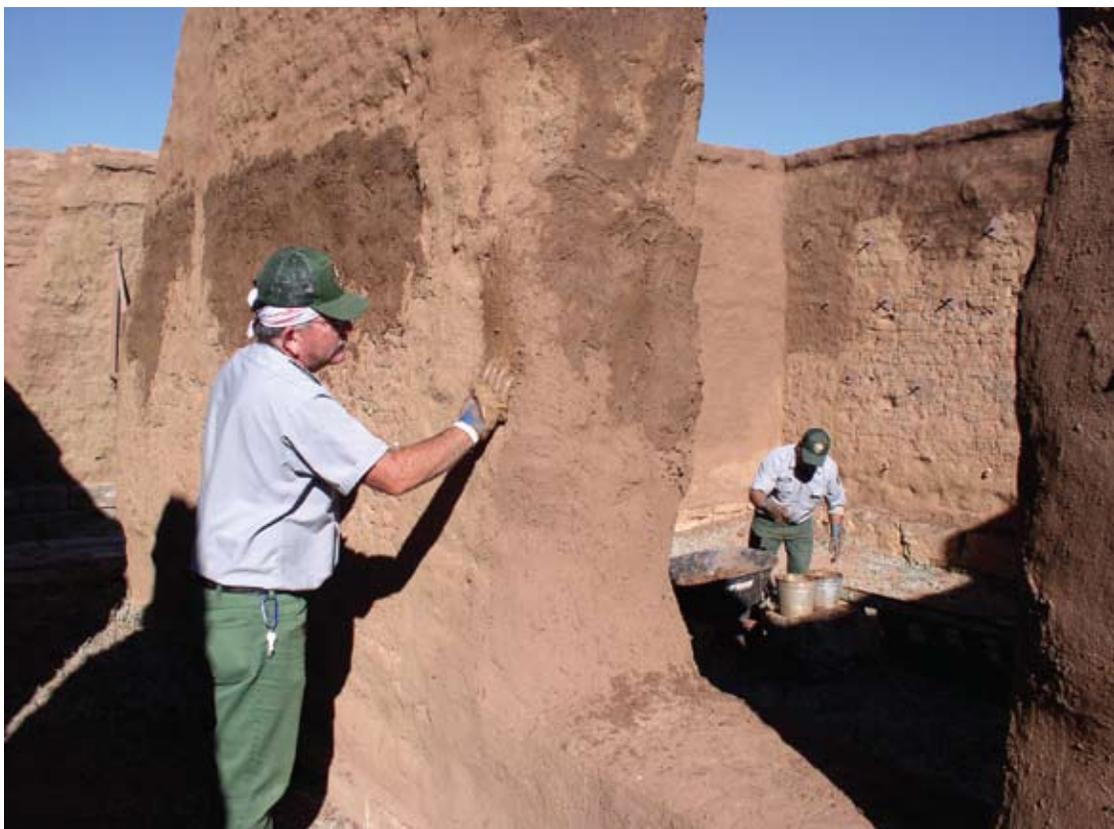
The Fort Union preservation crew applies a shelter coat to the adobe walls, Fort Union National Monument.

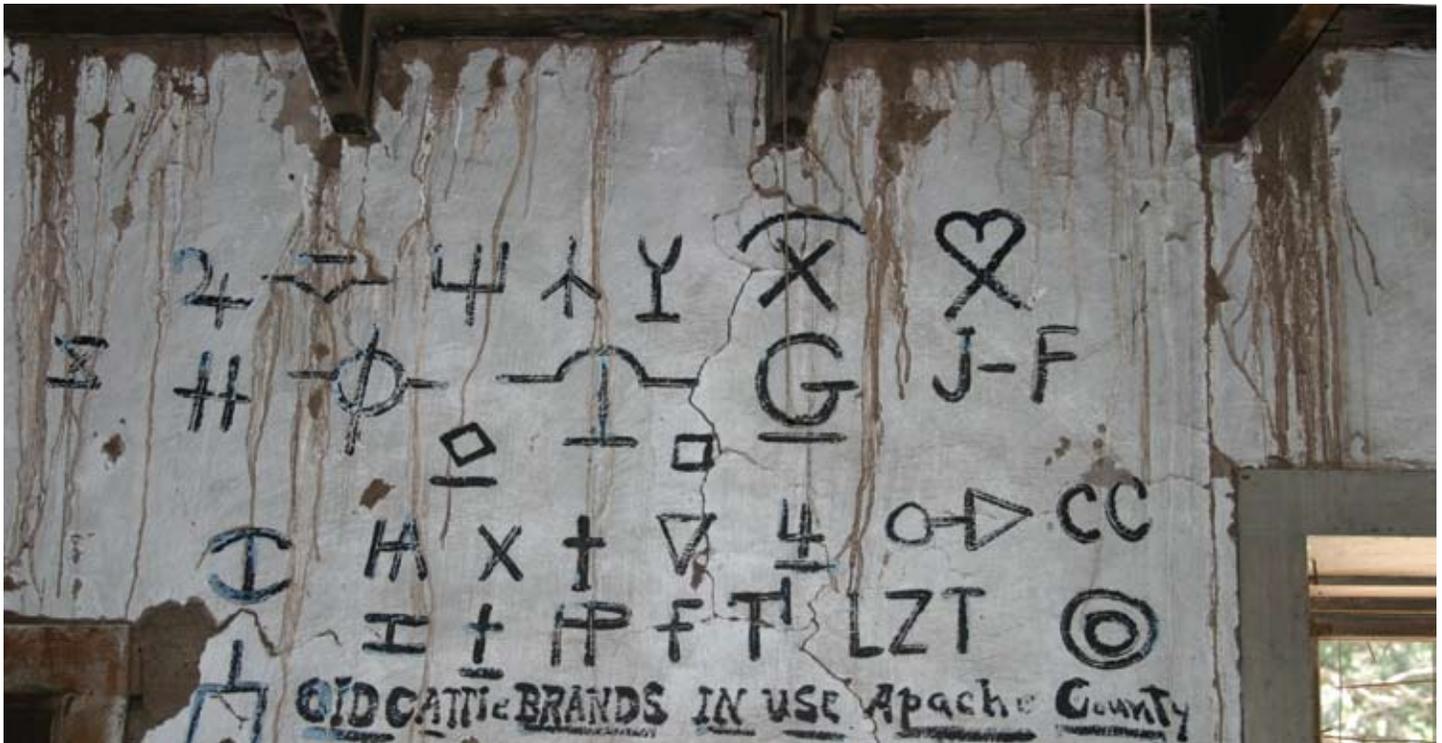
This interior view of Pigeon's Ranch shows a historic inscription written on the interior plaster finish. Deteriorating adobe beneath the plaster was causing the plaster to crack and delaminate. In addition, a failing roof was allowing water penetration that was washing dissolved adobe down the face of the wall partially obscuring the inscription, Pecos National Historical Park.

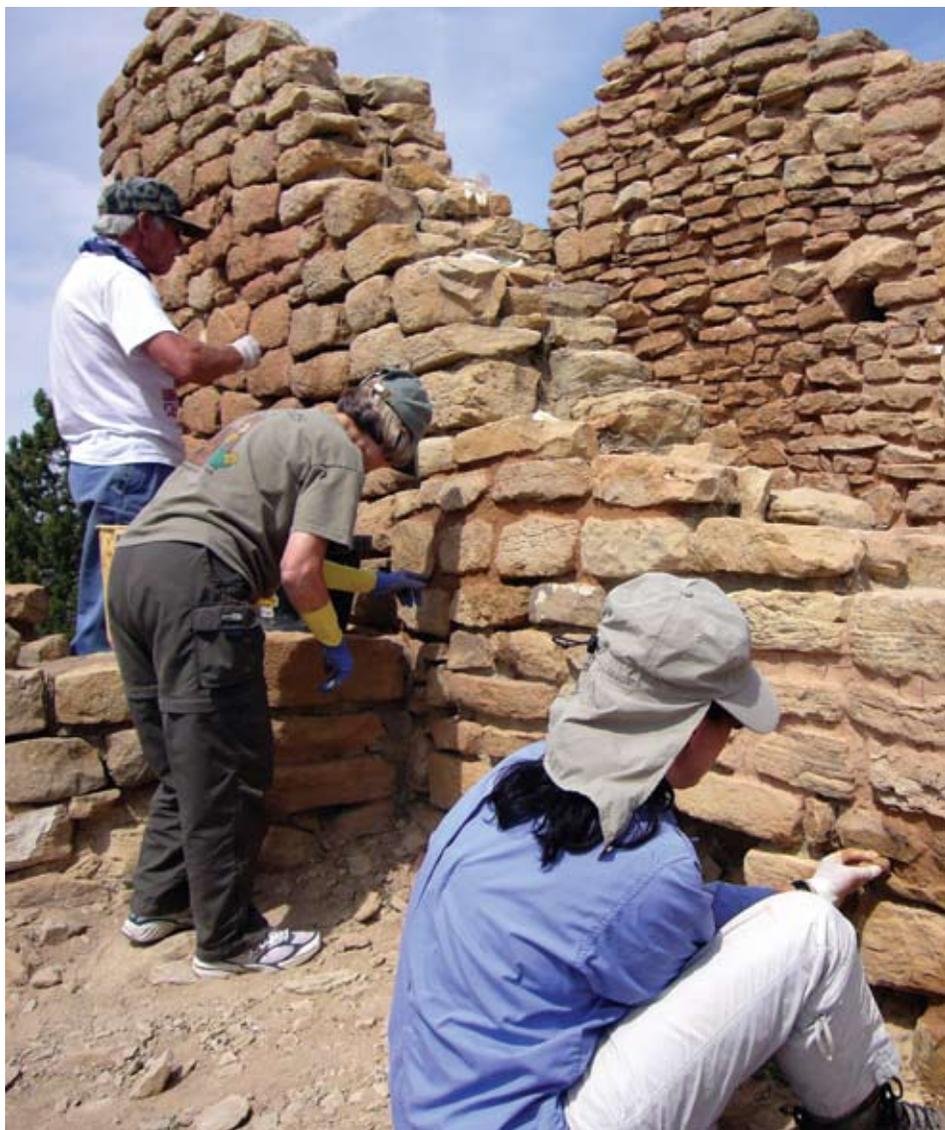
Sierra Club volunteers Ron and Jean Wise and Ellen Davis repoint portions of Cajon House at Hovenweep National Monument in April, 2007.

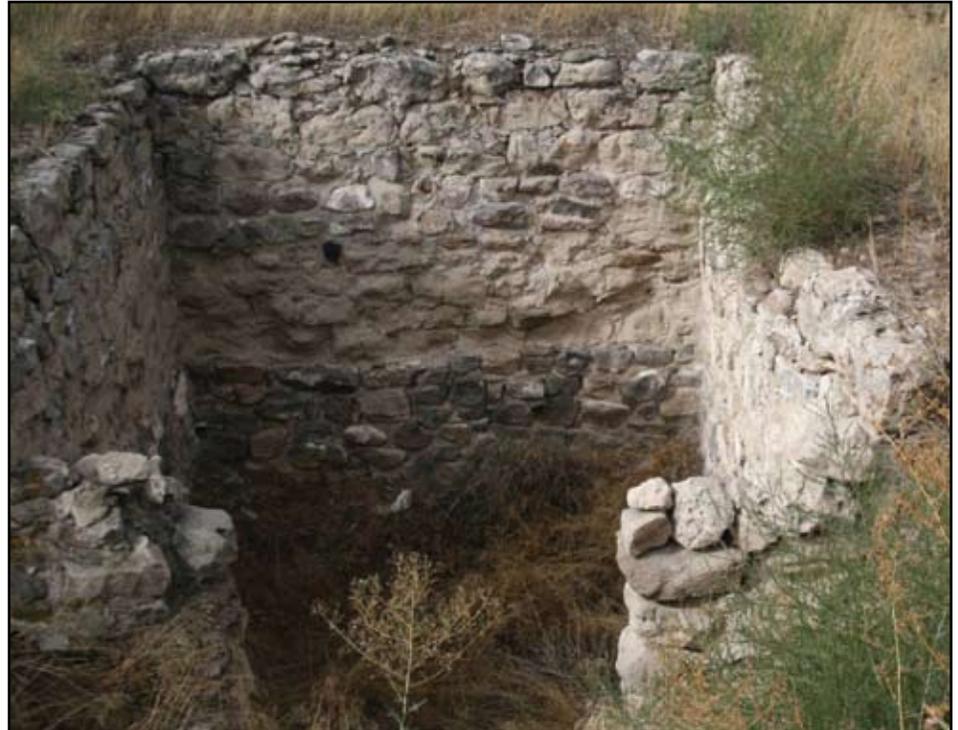
The Ice House, before the bracing was installed, showing the bowed walls and collapsing walls near doorway.

A significant accomplishment of preservation staff this year was the stabilization of the historic ice house ruin. The ruin, located below grade, was in danger of collapse as the earth surrounding it was pushing on the stone masonry walls, forcing them inwards. Using money from VT, the staff fabricated a temporary shoring system that will prevent further movement of the walls until a permanent method of stabilization can be devised. This may require
