Technical Brief 18: Protecting Archeological Sites on Eroding Shorelines: A Hay Bales Approach

Robert M. Thorne, Pickering Environmental Consultants, Inc., Jackson, MS

Published by the DOI Departmental Consulting Archeologist/NPS Archeology Program, National Park Service, Washington, DC, July 2004.

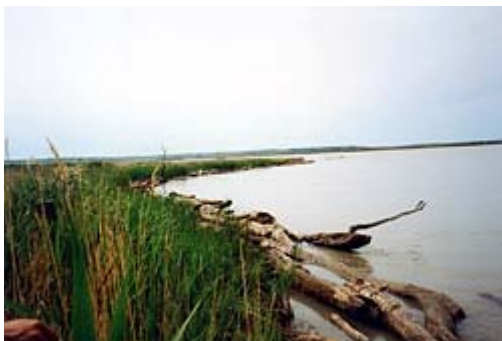
Figure 1. An Army Corps (WES) stabilization project using logs cabled in place and revegetation planted on bankline. Lake Sharpe, South Dakota, June 1994.

The revegetation effort at the lake—designed and directed by Hollis Allen—had already proved successful, alone and in combination with driftwood trees (Figure 1). The use of bales, which was untried previously, also proved effective. But the test setting—a relatively well protected bank sloping gently to the water’s edge—was not representative of conditions at Lake Sharpe (Figure 2). The revegetation techniques were common (e.g., Thorne 1990); their efficiency was really never in doubt. The primary purpose was to test the bales in actual conditions.

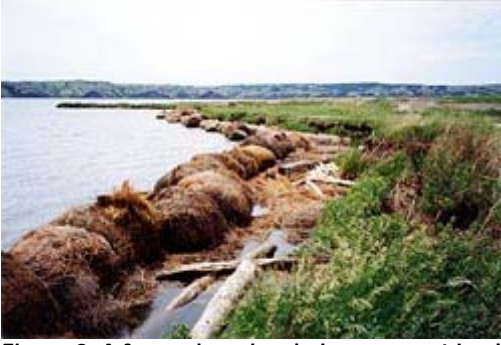
Figure 3. A farm where hay bales were put in place Sept/Oct of 1993. Note the height of the vertical cutbanks in the background, which are common to the entire lake. Lake Sharpe, South Dakota, June, 1994.

Most of the bales at Lake Sharpe were placed slightly opposite vertical banks, up to six feet high (Figure 3). Because of the near constant water level—and the lack of ebb and flow—there were few beaches to use as staging areas. Initially, the bales were lifted from the top of the banks by a crane or a dragline fitted with a clamshell bucket or specially designed clamp (Figure 4).

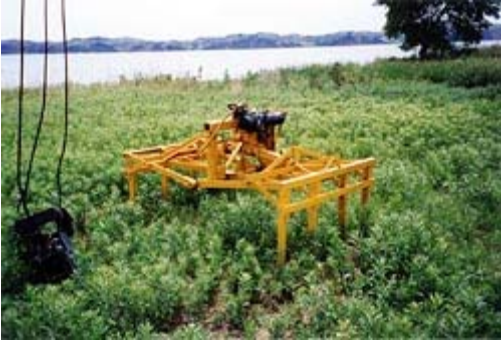
Figure 4. Commercially manufactured hay bale tongs for a crane. Were these actually attached to a crane, they would be hydraulically operated from inside the cab. Lake Sharpe, South Dakota, June, 1994.

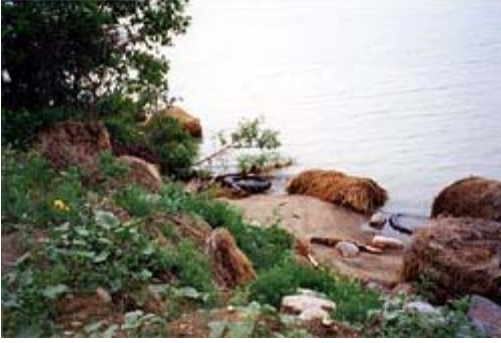
Figure 6. A stabilization at the Fort George Game & Fish Commission (with no Army Corps involvement) attempted to use tractor tires and hay bales. Note the sand buildup behind the center bale. Lake Sharpe, South Dakota, June, 1994.

As is the case with all stabilization techniques (Figure 6), no one approach is appropriate for every setting. This technique was not suited to the entire shoreline; in some places the bank was too high, in others the water too deep. Normally, the harsh environment may have disqualified this approach. In this case, however, it provided an excellent testing ground for developing and refining the technique. Winter temperatures are well below freezing, and the lake freezes to a depth of over three feet. This is not particularly destructive in and of itself, but during spring strong winds drive broken pieces of ice into the bales. At the least they could be pushed out of alignment; at the worst destroyed.

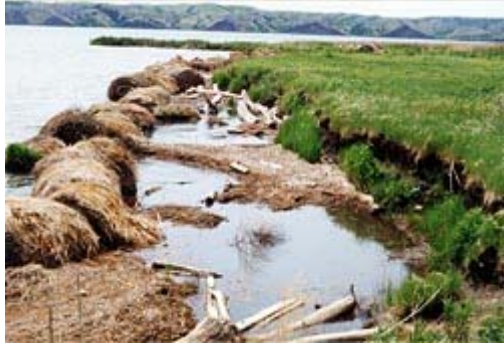
Figure 7. A south-by-southwest view of the farm. Lake Sharpe, South Dakota, June, 1994.

There have been no complaints that the barriers are unsightly, nor have any been vandalized. Less than a year later, fish were spawning in the basins; a mallard and her hatchlings were using one as a refuge (Figure 7). Even though some slumping continued, grass was growing in large patches. The benefit to the environment cannot be overemphasized.
