East Harbor Vegetation Restoration

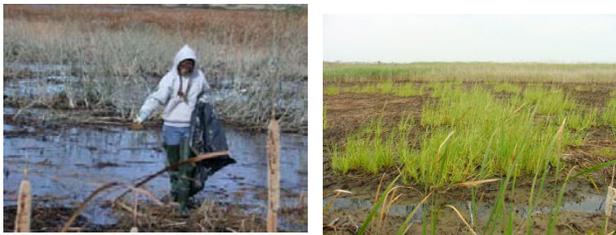
AmeriCorps member hand-seeding a salt-killed cattail area with seeds of native salt marsh species (left) and an example of the results (right) – a vigorous stand of cordgrass (*Spartina alterniflora*) in 2005. This species dominates pristine marshes elsewhere in the Seashore.

In 2004, seeds of native salt marsh plant taxa were collected from a nearby pristine marsh, bagged and transported to East Harbor where they were scattered into areas of salt-killed vegetation. The seeds germinated and produced numerous stands of salt marsh vegetation, which are now a source of seed inputs themselves. Subsequent expansion through clonal growth has resulted in rapid expansion of salt marsh vegetation throughout the system.

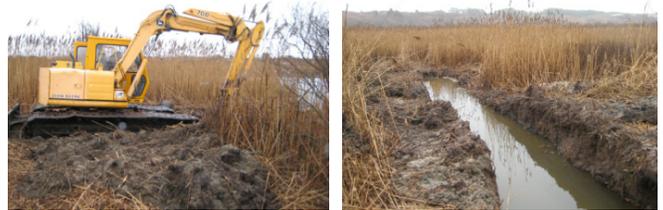
Cape Cod Mosquito Control constructing channels through a berm.

In 2008, seven openings were created in old earthen berms in the southeastern marsh area of East Harbor (known as Moon Pond). With the help of Cape Cod Mosquito Control and their heavy machinery, channels were dug through the berms to allow for the free flow of water into marsh areas behind them.
