Portsmouth Village Cultural Landscape Report

Portsmouth Village

Cape Lookout National Seashore
Carteret County, North Carolina

Cultural Landscape Report

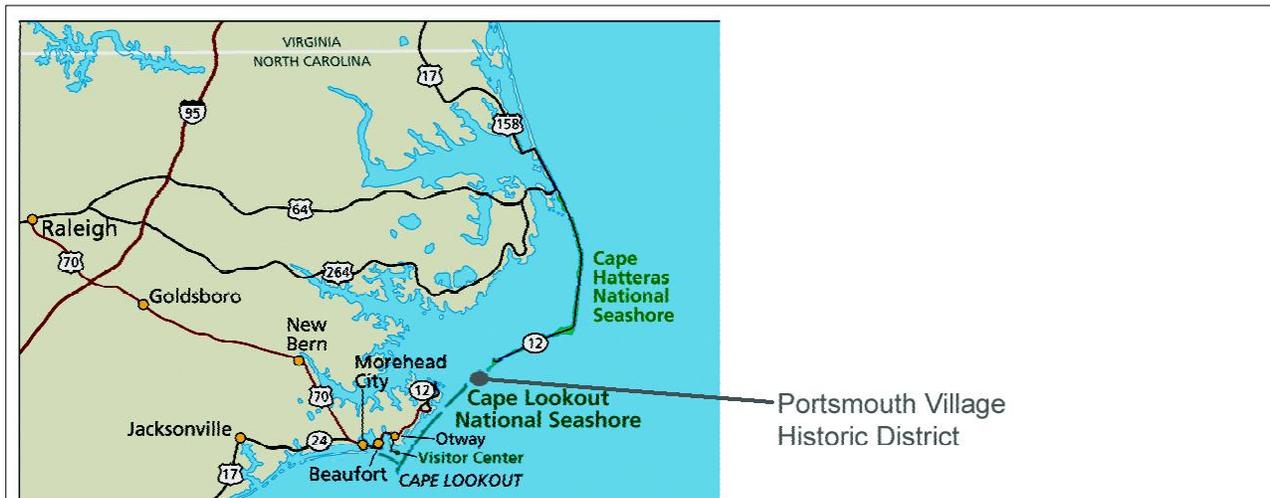
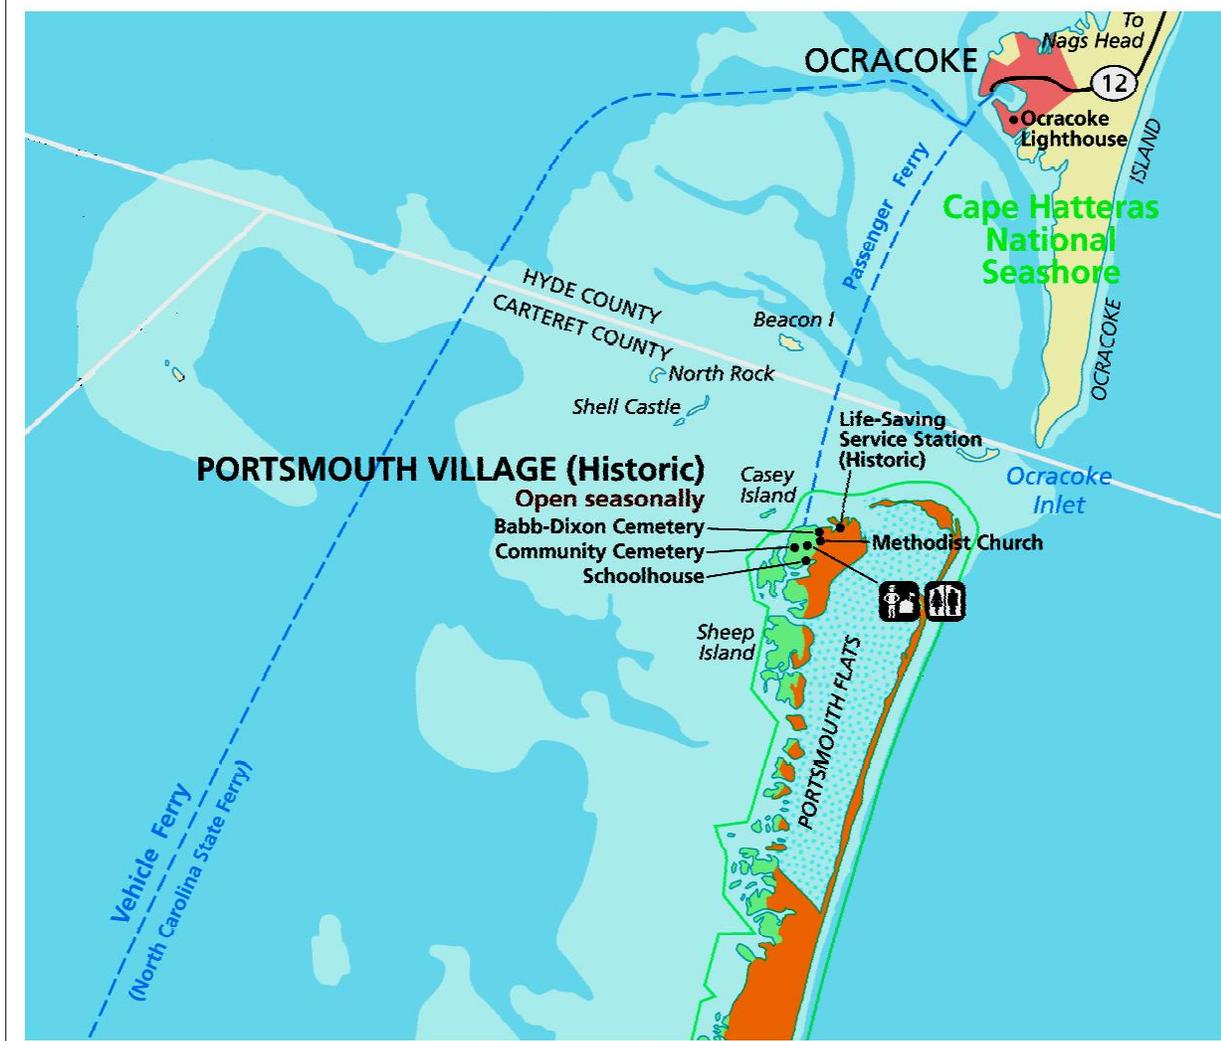
See Fig. 1, Site Location and Context Map. Cape Lookout National Seashore forms a portion of North Carolina's Outer Banks in the easternmost portion of the state. To the east lies the Atlantic Ocean. Leeward are a series of named sounds, including Pamlico Sound, Core Sound, and Back Sound. The park's Visitor Center is located at the eastern tip of Harkers Island, reached via bridge from a peninsula located north of Beaufort, North Carolina. The park includes North and South Core Banks, with Portsmouth Village located at its northern end and Cape Lookout at its southern end. Also included within the park is Shackleford Banks, an island that extends west of Cape Lookout Lighthouse and edges Back Sound to the south of Harkers Island.

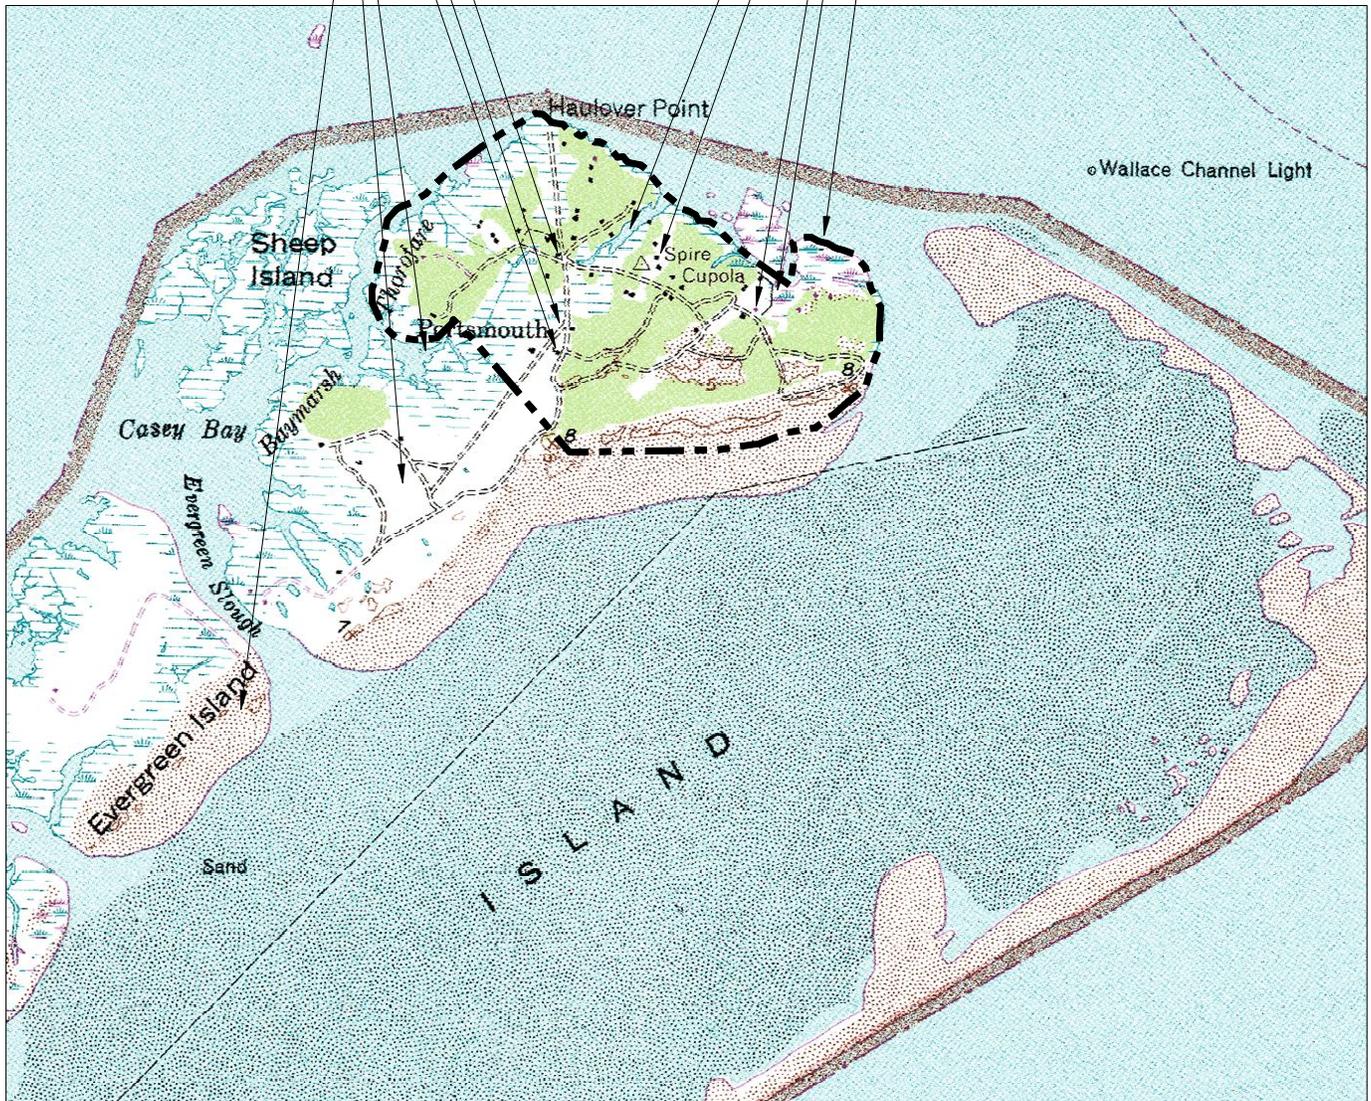
Not to scale.

- Post Office and General Store
- Old Straight Road
- Portsmouth Schoolhouse
- Warren Creek
- Former Middle Community
- Former Sheep Island community
- Doctor's Creek
- Portsmouth Methodist Church
- Portsmouth Life-Saving Station
- Coast Guard Creek
- Portsmouth Village Historic District Boundary
