Date: December 20, 2012	Project #: 10042
Attention: Tracy Stakely 404.507.5791	
RE: Cravens House CLR

### Cravens House

The CLR is intended to provide the park with an assessment of the character-defining landscape features of the Cravens House. It will document historic and existing conditions, and provide specific treatment recommendations to protect this historic resource.

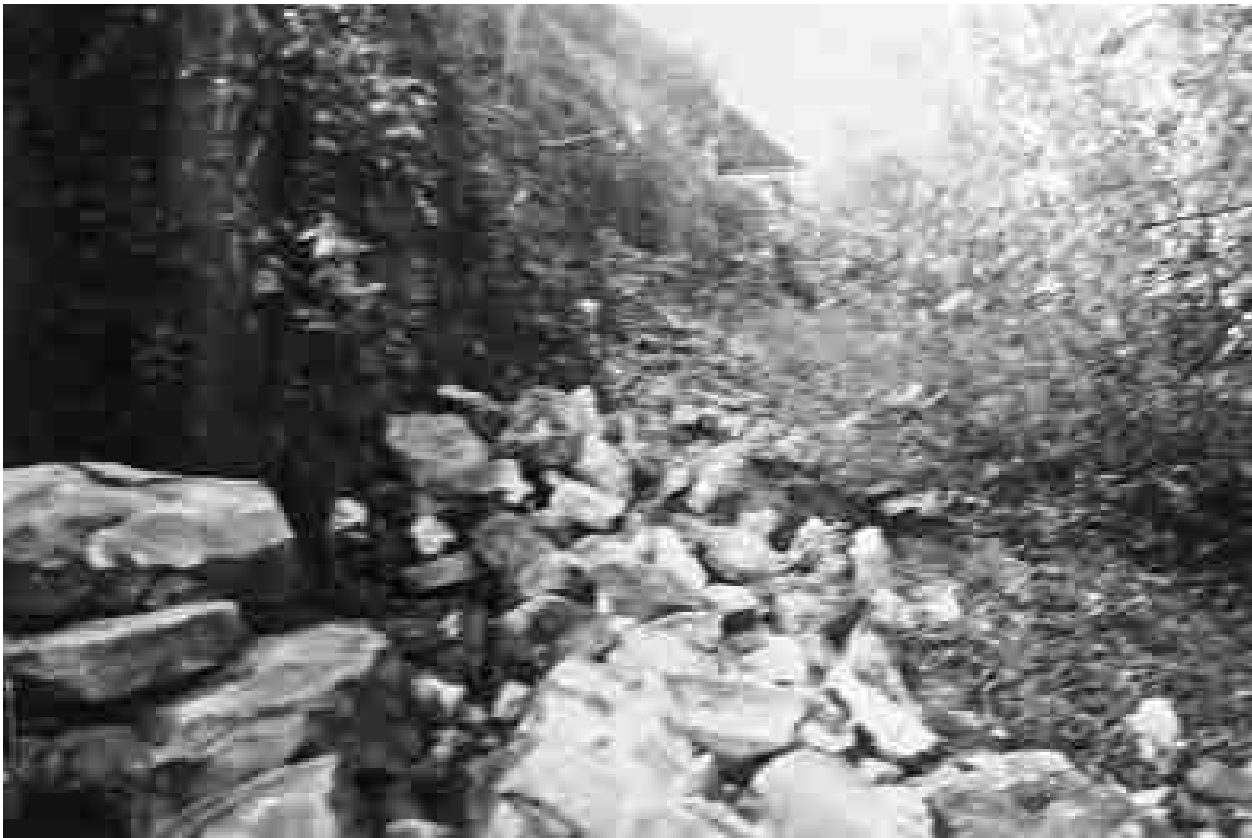
**Figure 2.23:** "Cravens Reservation, Lookout Mountain. Before Retaining Wall Constructed," 1937. (CHCH Archives)

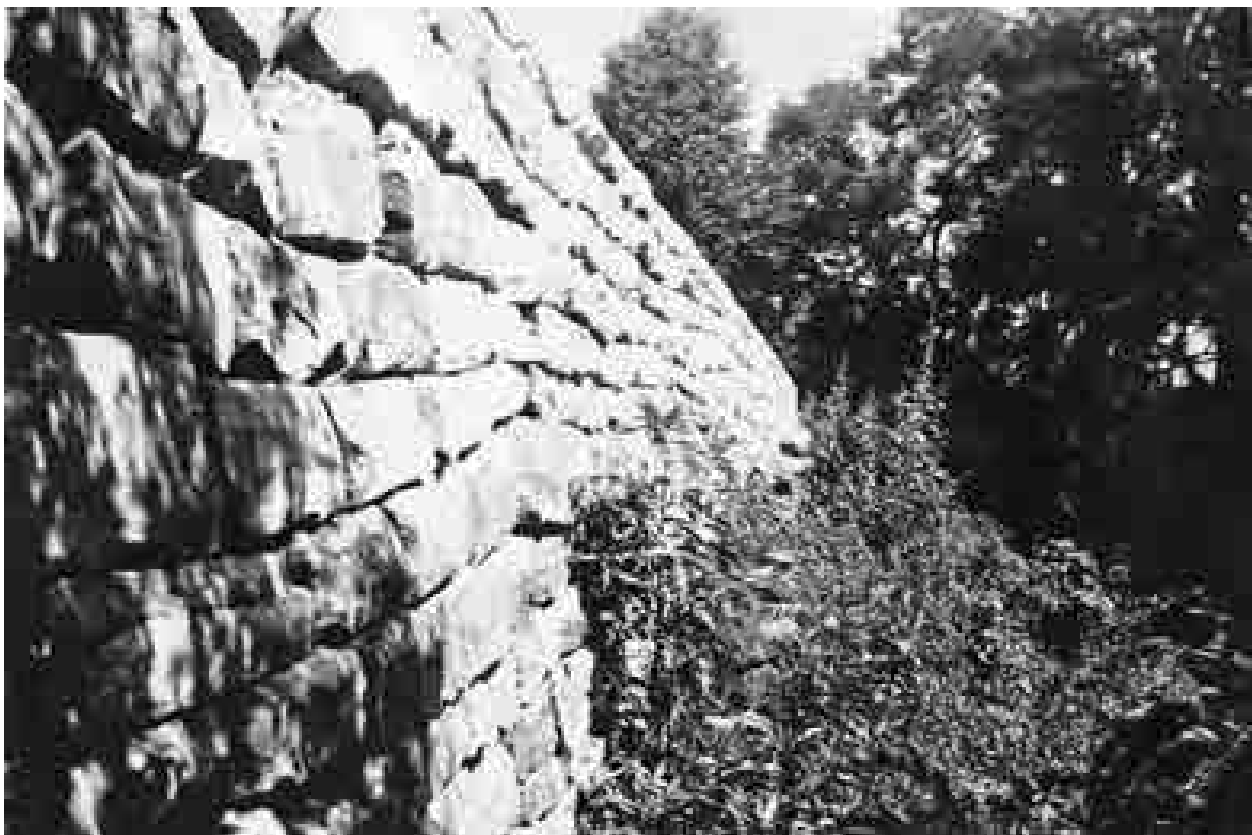
**Figure 2.24:** "Cravens Reservation, Lookout Mountain. After Retaining Wall was Constructed," 1937. (CHCH Archives)

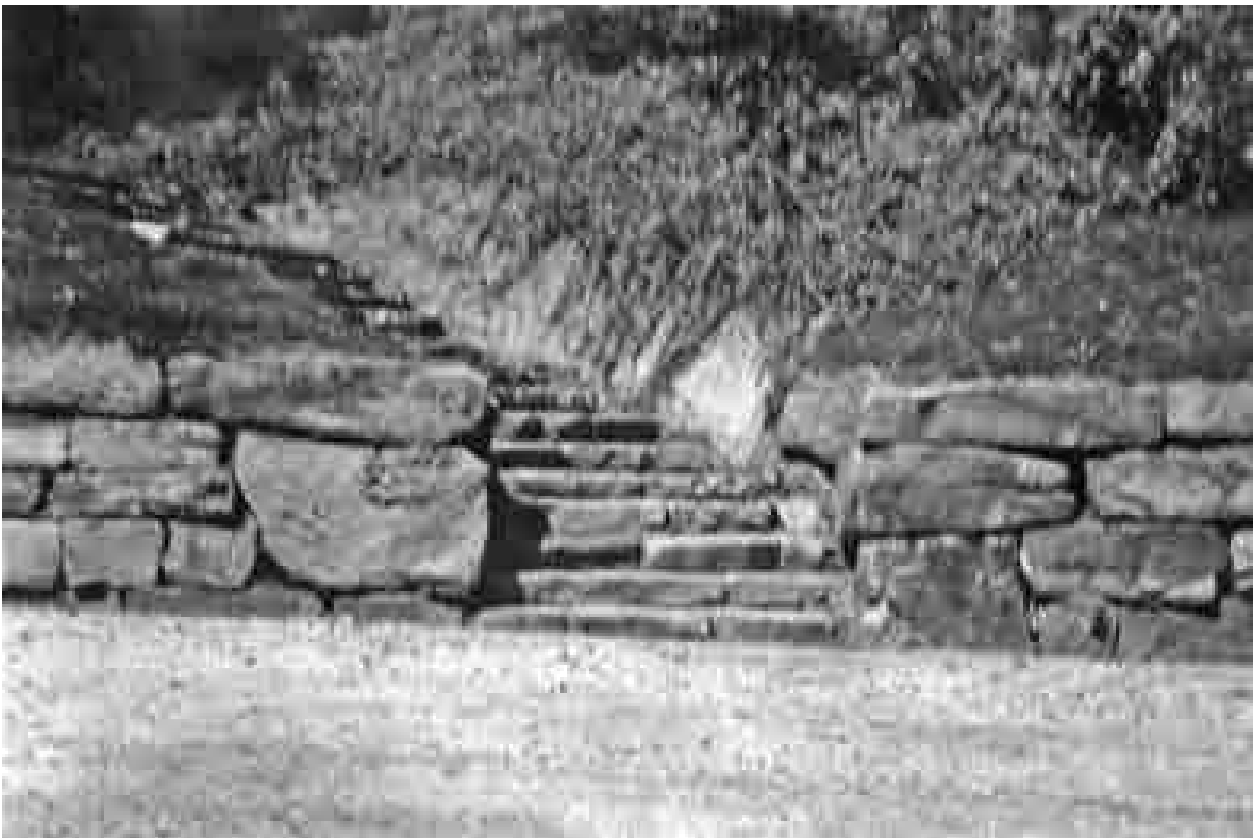
**Figure 2.26:** "View, showing section of parking area at Cravens. After stone wall and steps were constructed," 1937. (CHCH Archives)

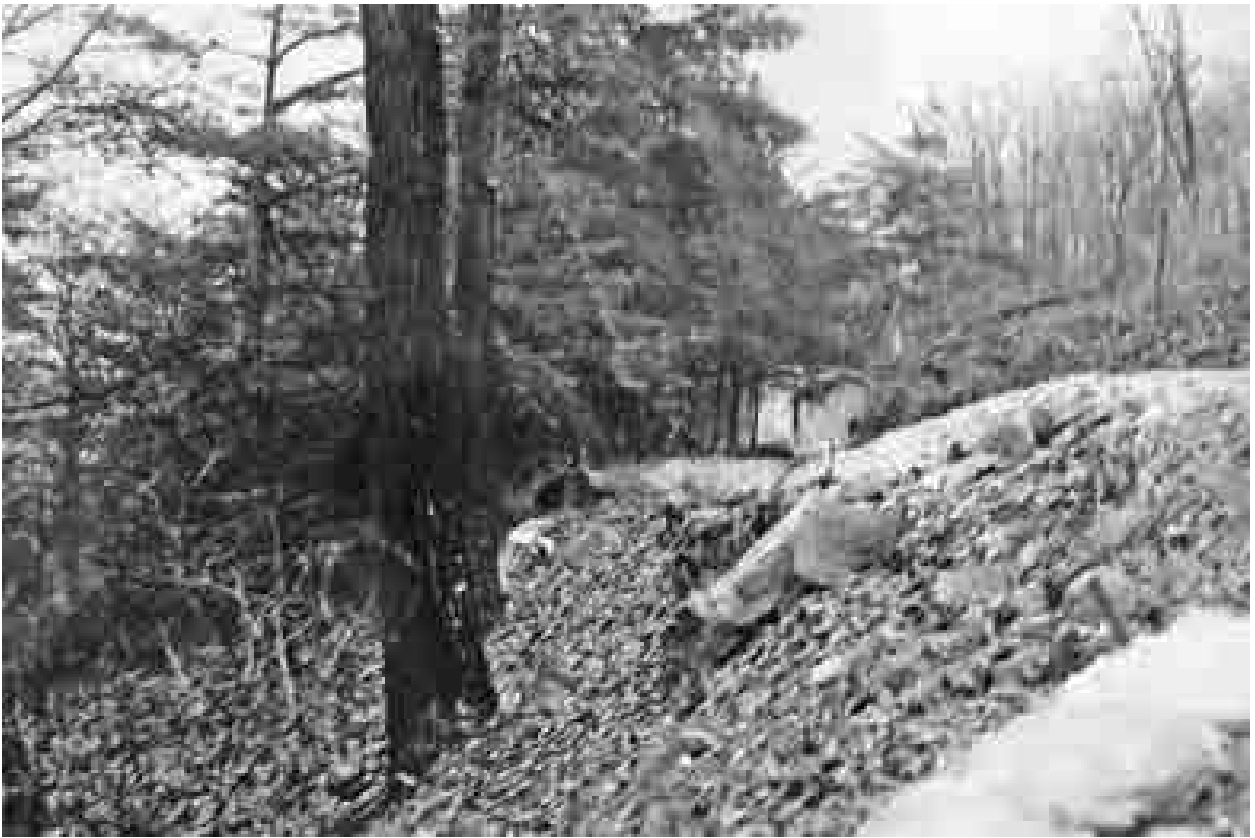
**Figure 2.29:** “Old Cravens Road - Stone Wall and Guard Rail - Before,” circa 1937. (CHCH Archives)

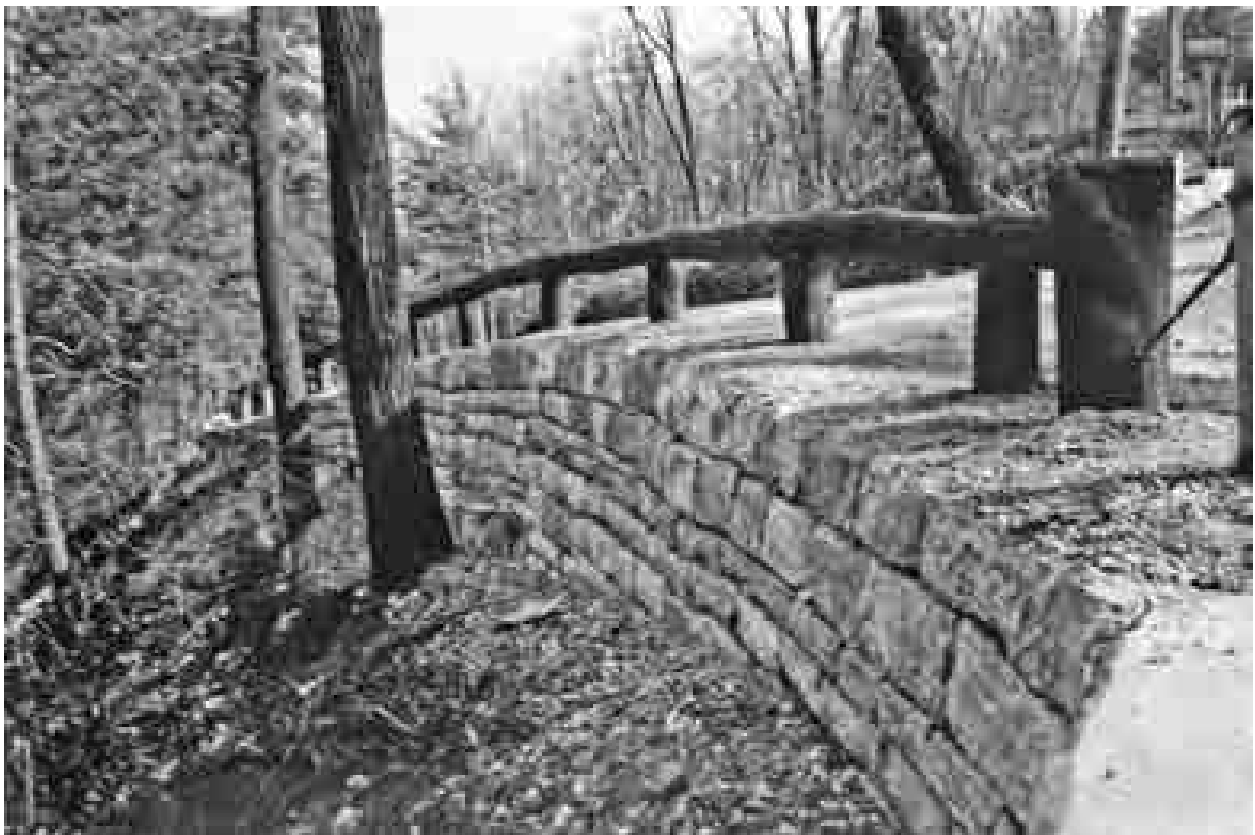
**Figure 2.30:** “Old Cravens Road - Stone Wall and Guard Rail - After,” 1937. (CHCH Archives)

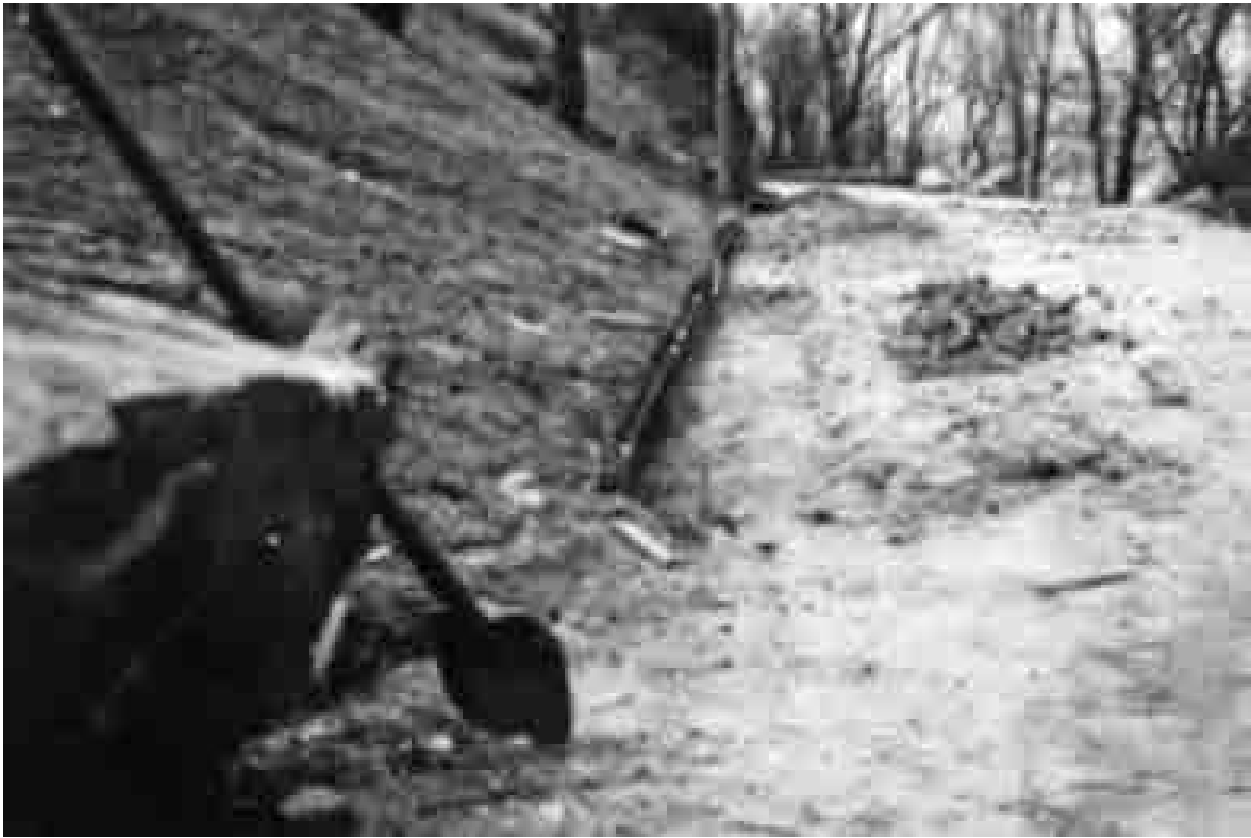
**Figure 2.31:** "Rip Rap Paving - Cravens House - Sodding - Before," circa 1937. (CHCH Archives)

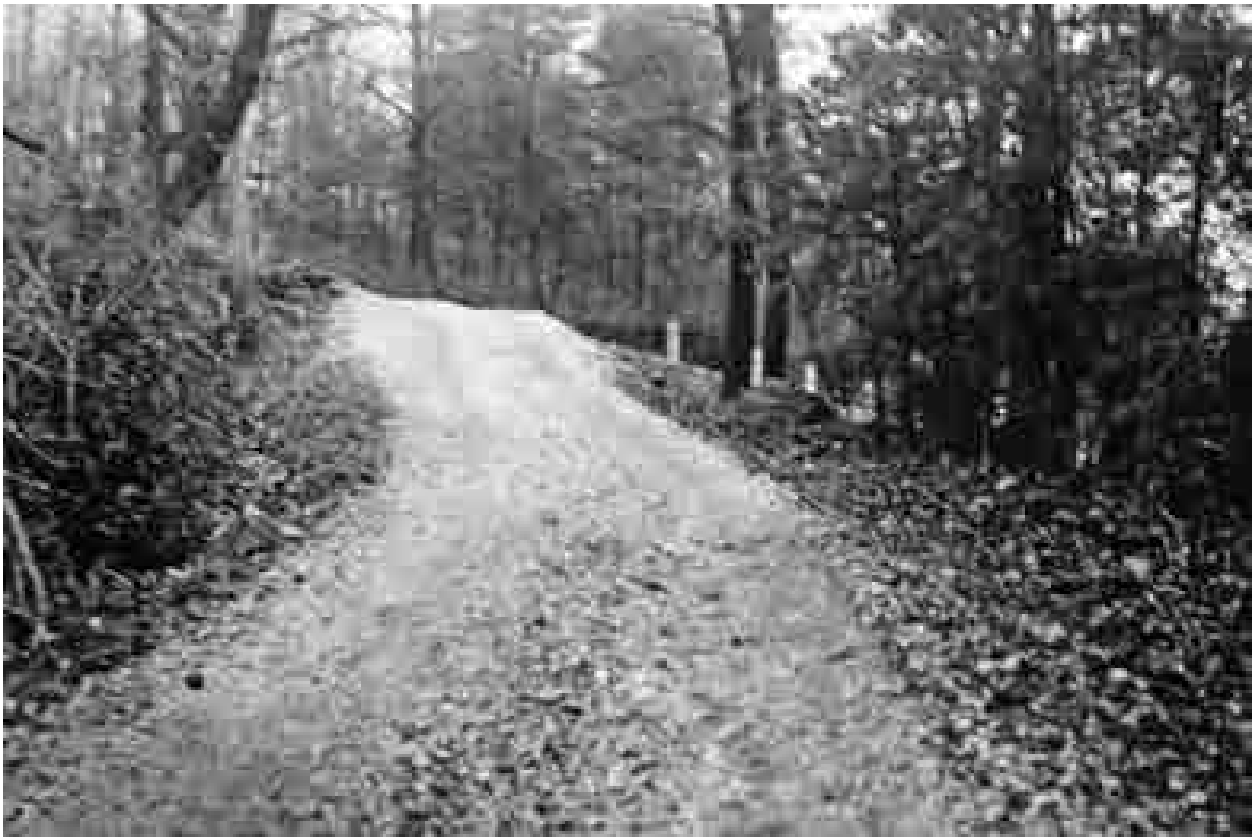
**Figure 2.33:** "Old Cravens Road - Fine Grading and Rip Rap - Before," circa 1937. (CHCH Archives)

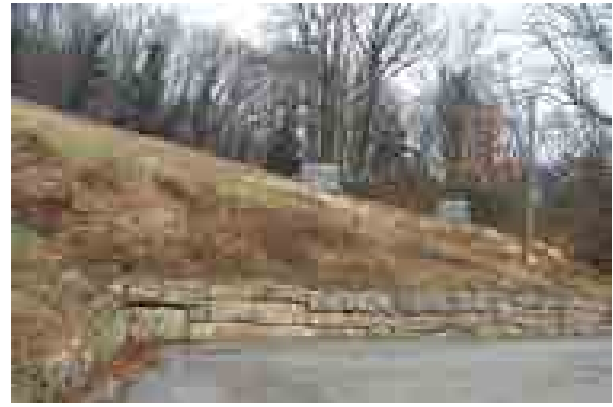
In 1937, NPS added a parking area off this road below Cravens House. The parking area features a retaining wall comprised of large, stacked limestone blocks with steps set into the landscape. It is highly likely that there is a retaining wall in the hillside adjacent to the steps, as this wall appears in the photograph illustrating the finished project

**Figure 3.6:** View of the CCC-era parking area along Cravens Terrace Road. (The Jaeger Company, January 2011)

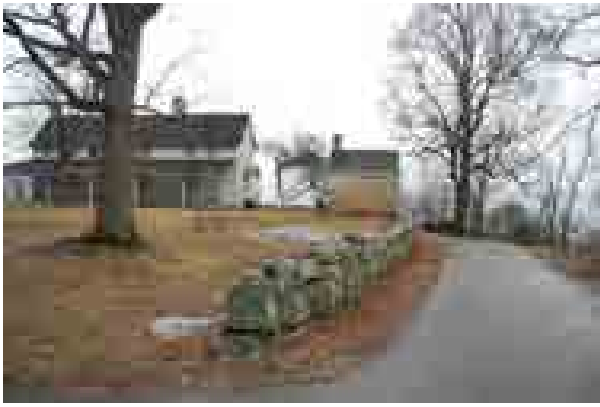
**Figure 3.7:** Cravens House Drive with adjacent stone wall. (The Jaeger Company, January 2011)

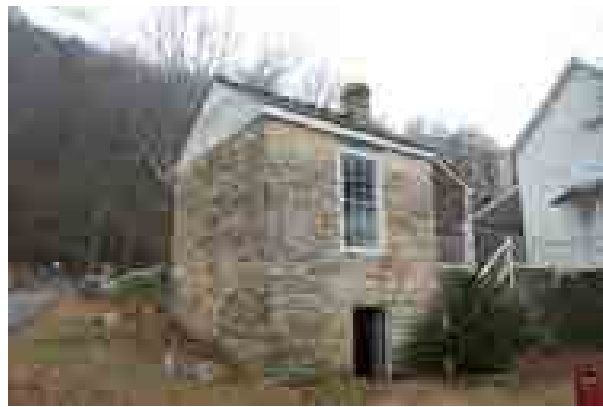
This circa 1861-1863 random ashlar masonry building is approximately 10 feet by 15 feet with

**Figure 3.15:** Oblique view of the Kitchen/Dairy Outbuilding showing access to basement. (The Jaeger Company, January 2011)

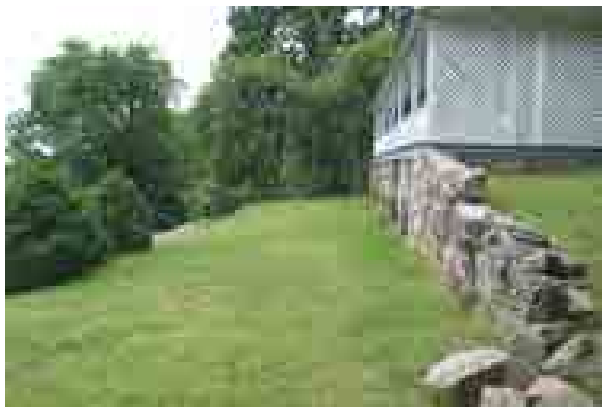
**Figure 3.21:** Terrace Wall on northeast corner of Cravens House. (The Jaeger Company, May 2011)

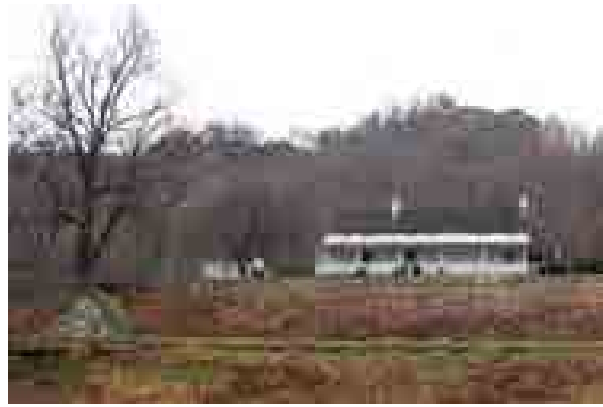
**Figure 3.20:** View of stone retaining wall along Cravens Terrace Road, in foreground, and view of stone retaining wall at Cravens House. (The Jaeger Company, January 2011)
