HISTORIC STRUCTURE REPORT
THE CATOCTIN AQUEDUCT

HISTORICAL DATA

CHESAPEAKE AND OHIO CANAL NATIONAL HISTORICAL PARK

March 1976

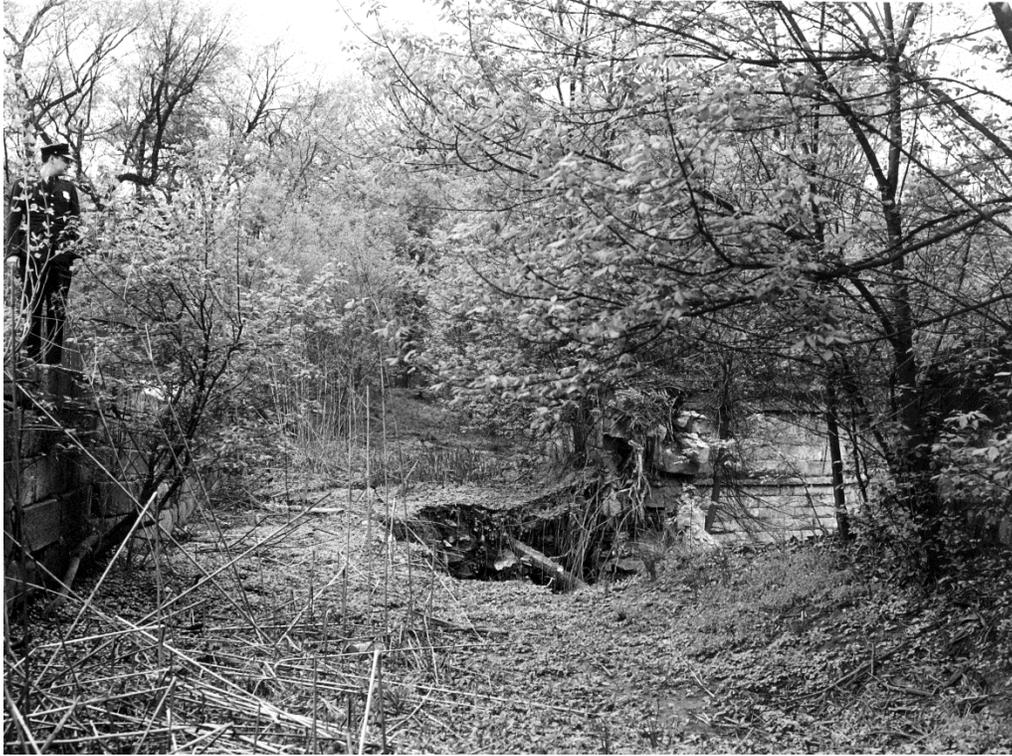
3. Aqueduct trunk showing the effects of the partial collapse of the center arch, upstream side, 1945.

In 1950 a field survey was made of Paw Paw Tunnel and of the aqueducts, culverts, and overpasses on the canal by Engineer C. D. Geisler. He observed that the center span of Aqueduct No. 3 had “developed a sag and is near collapse.” The “upstream spandrel with underlying section of arch barrel” had fallen away, and all three spans would “require complete reconstruction.”⁶⁸

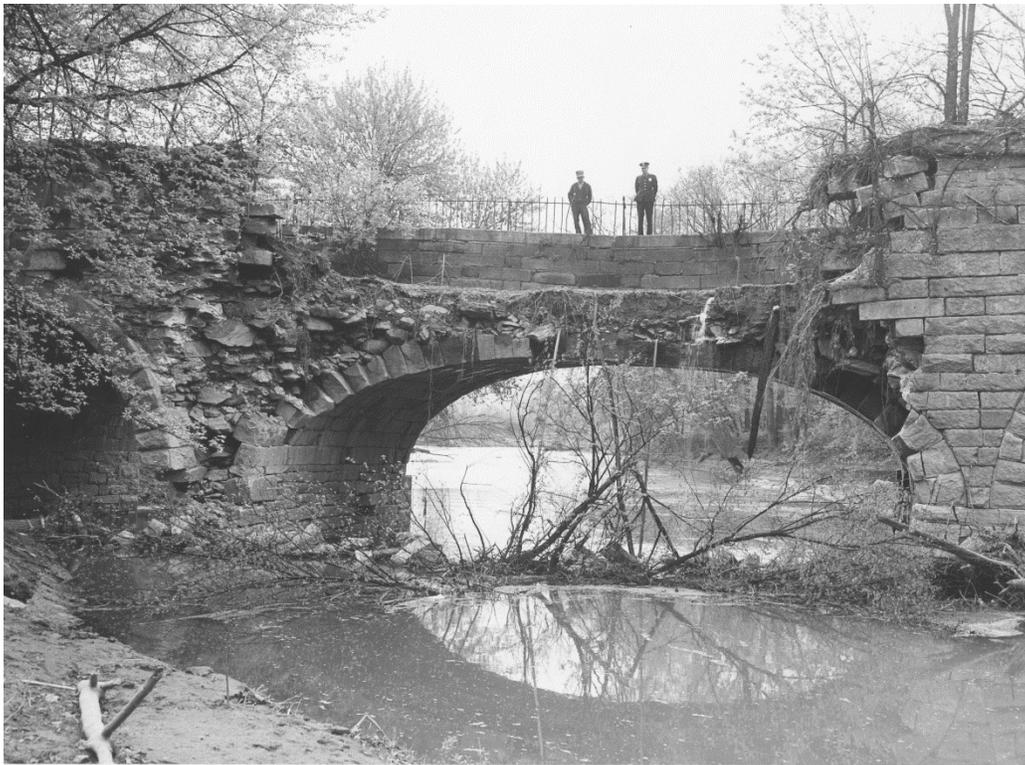
4. Partial collapse of the center arch, upstream side. Photo dated April 4, 1945.

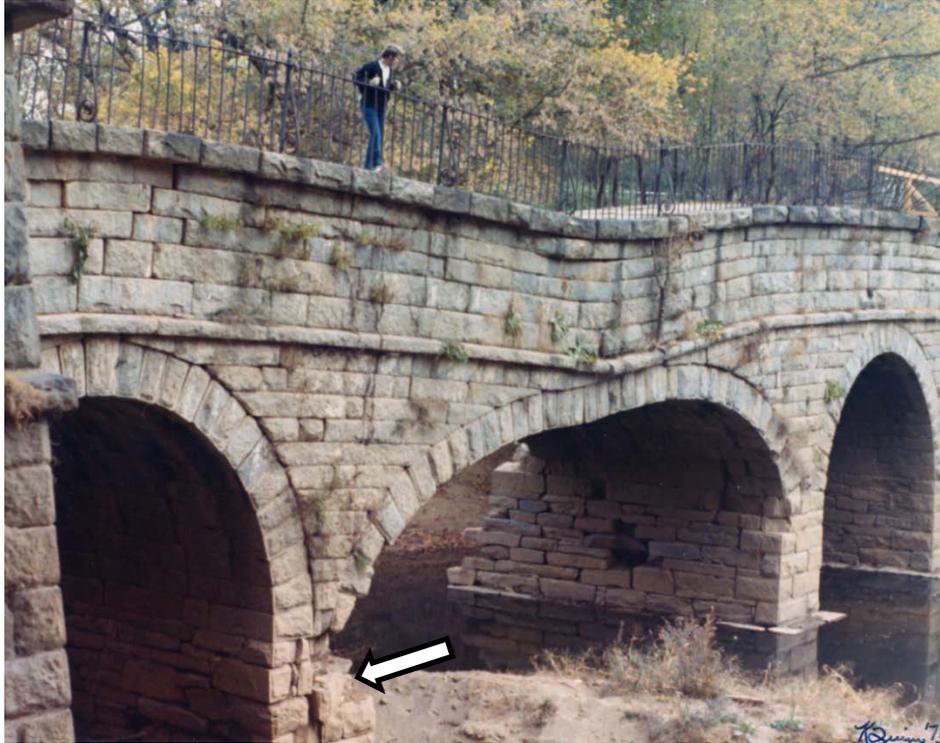
9. Catoctin Aqueduct prior to collapse, 1973. Photographer K. Quinn.
Note failure of the stone in the upstream pier of the center arch.

We find no reason to believe that any substantial failure of the piers or pier foundations occurred prior to the collapse of the two spans, however the loss of some of the key stones in the piers would have added to the tendency to collapse. The surprising thing about the structure is not that it collapsed, but that it stood so long prior to collapsing.

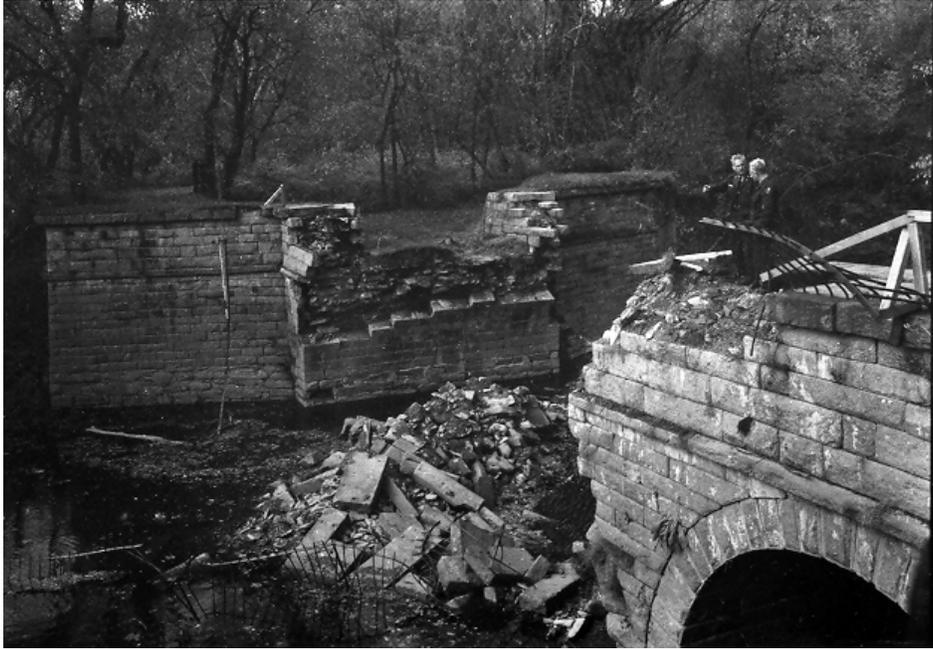
11. Catoctin Aqueduct after the October 30, 1973 collapse of the upstream and center arches.

On the morning of October 30, 1973, Aqueduct No. 3 collapsed, leaving only a remnant of its eastern arch standing. The remains of the structure's western pier and foundation can still be seen above the water surface of Catoctin Creek, and the damaged western abutment walls are still standing. The cost for its complete reconstruction has been estimated at nearly \$4 million.⁶⁹

By action of scour and age, the mortar between stones has disappeared, and in time the upstream parapet wall failed and collapsed into the stream. By the loss of the upstream parapet, the assumed loss of some of the downstream stones, and by action of the water, the final collapse of the middle span was predictable, and with it went one of the adjacent spans.

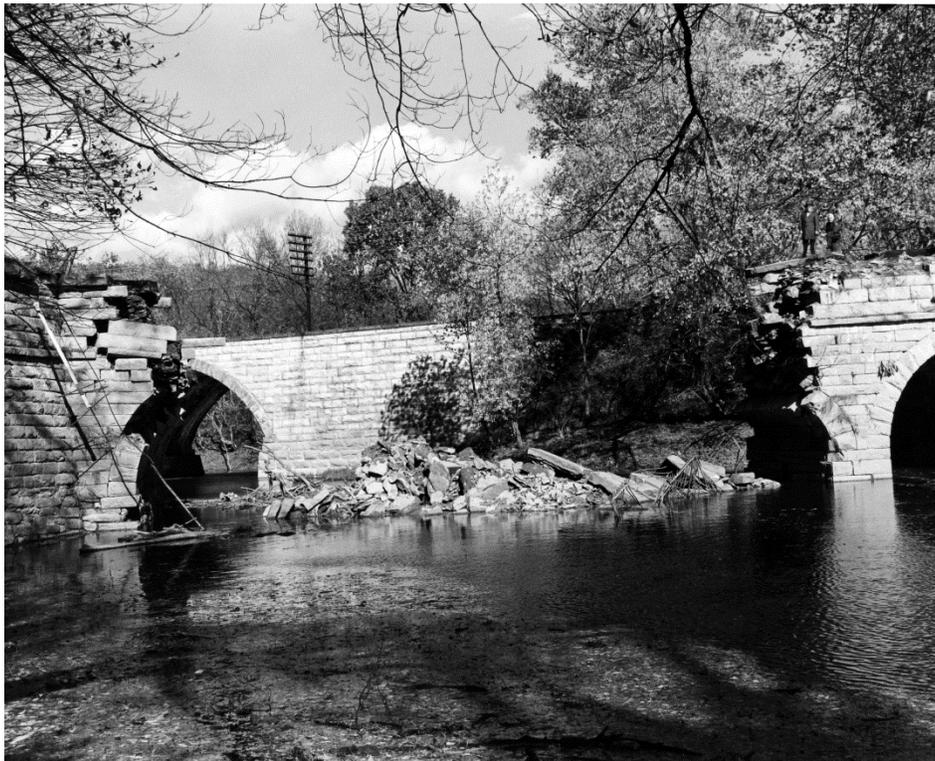
12. Catoctin Aqueduct after the October 30, 1973 collapse with the railroad viaduct in the background.

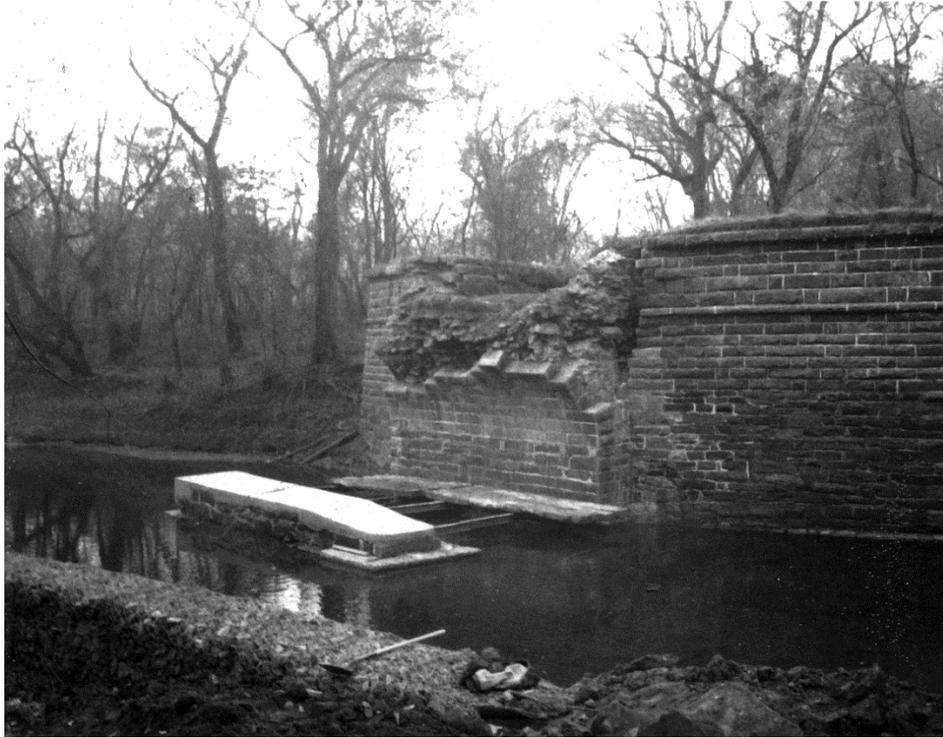
13. Catoclin Aqueduct, October 30, 1974 showing the upstream abutment and base of the upstream pier with concrete cap.

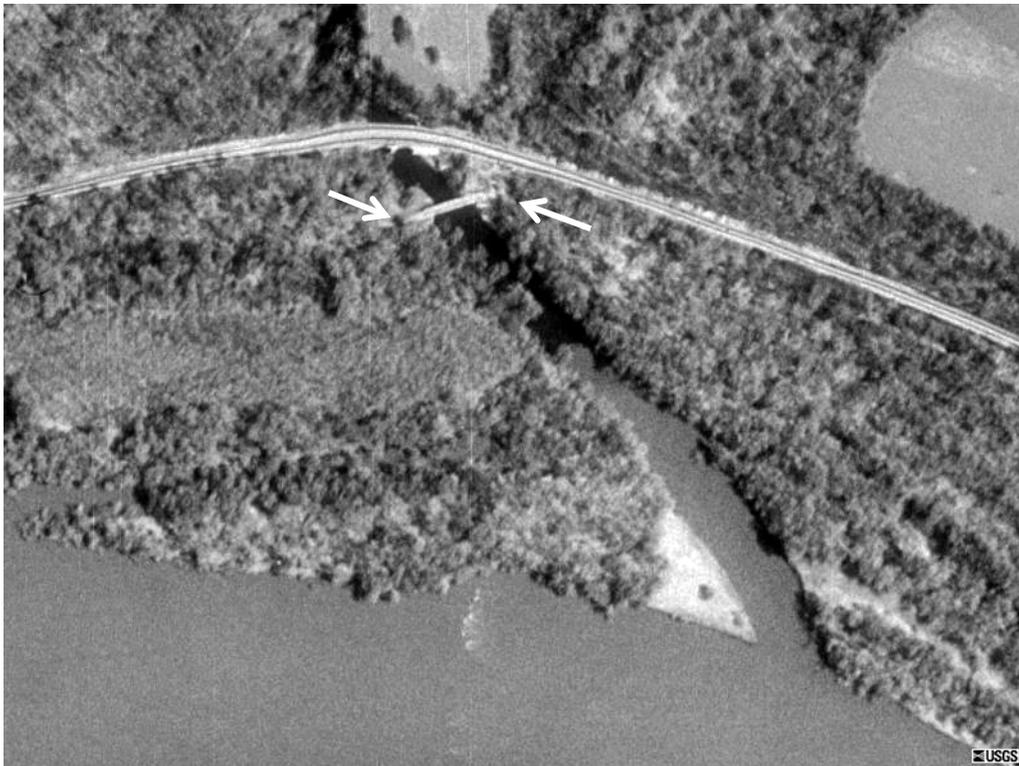
15. Aerial view of Catoctin Aqueduct and railroad line, with Potomac River At the bottom. Note the sharp turn of towpath on both approaches to aqueduct.

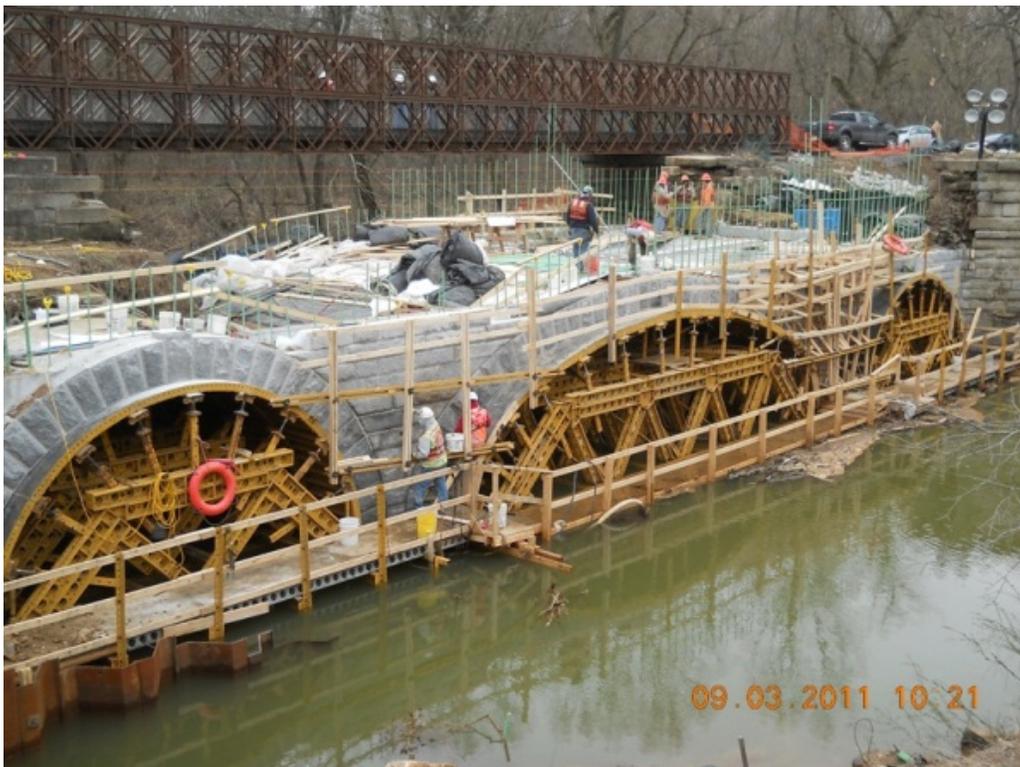
16. Reconstruction nearing completion, September 3, 2011.

- The severely deteriorated western pier and footing were removed and reconstructed.
- Scour around existing abutments and piers were repaired.
- The berm and towpath parapets were rebuilt and topped with original coping stones when possible.
- Railing compatible with the original railing was installed along the towpath, incorporating original railing when possible.
- A retaining wall was built as an extension to the upstream wingwall to prevent scouring.
