HISTORIC STRUCTURES REPORT
CONOCOCHEAGUE AQUEDUCT
CHESAPEAKE AND OHIO CANAL

Historic Data Section

John F. Luzader
Historian

Edited and Revised in 2011
For electronic publication

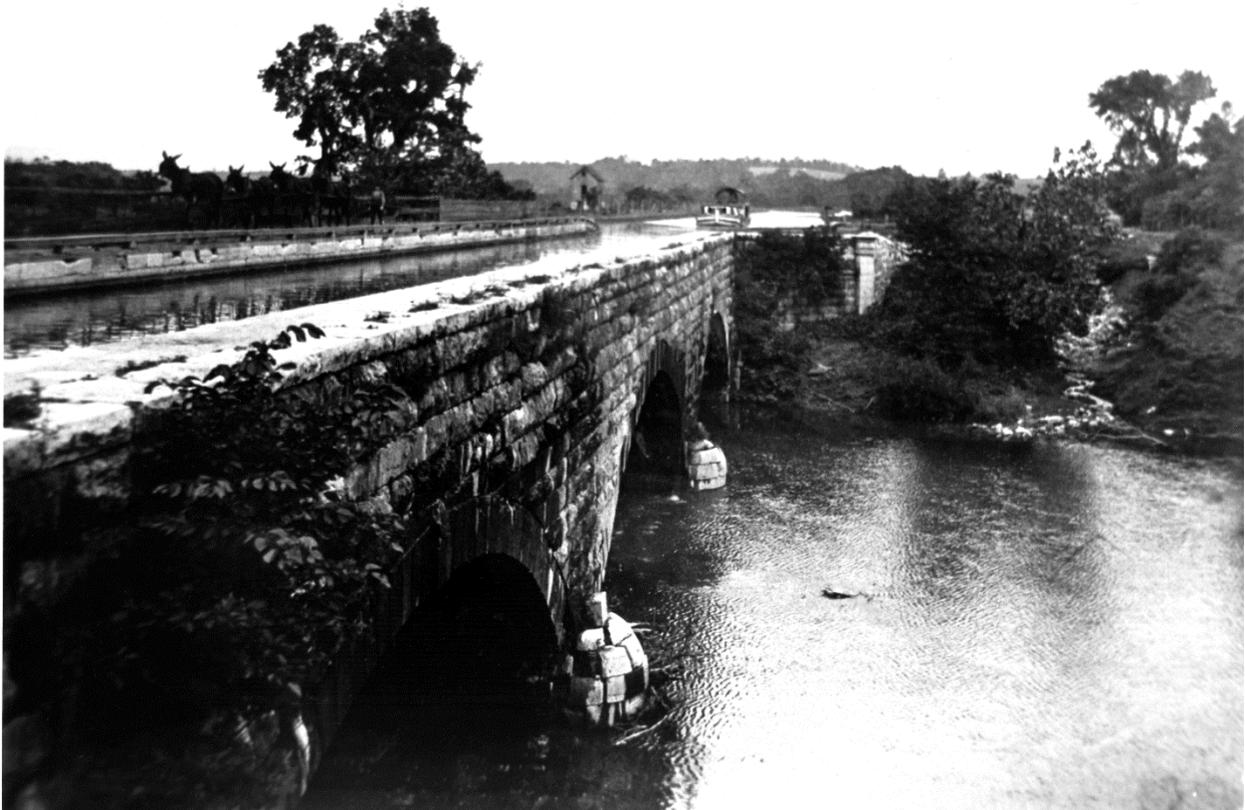
1. The aqueduct before the collapse of the upstream parapet in 1920.

Note the boat entering the aqueduct and that all four mules are on the towpath. When the boats were loaded or unloaded, no mules would be left in the stable on the boat and would be taken off the boat before it was taken to the wharf.

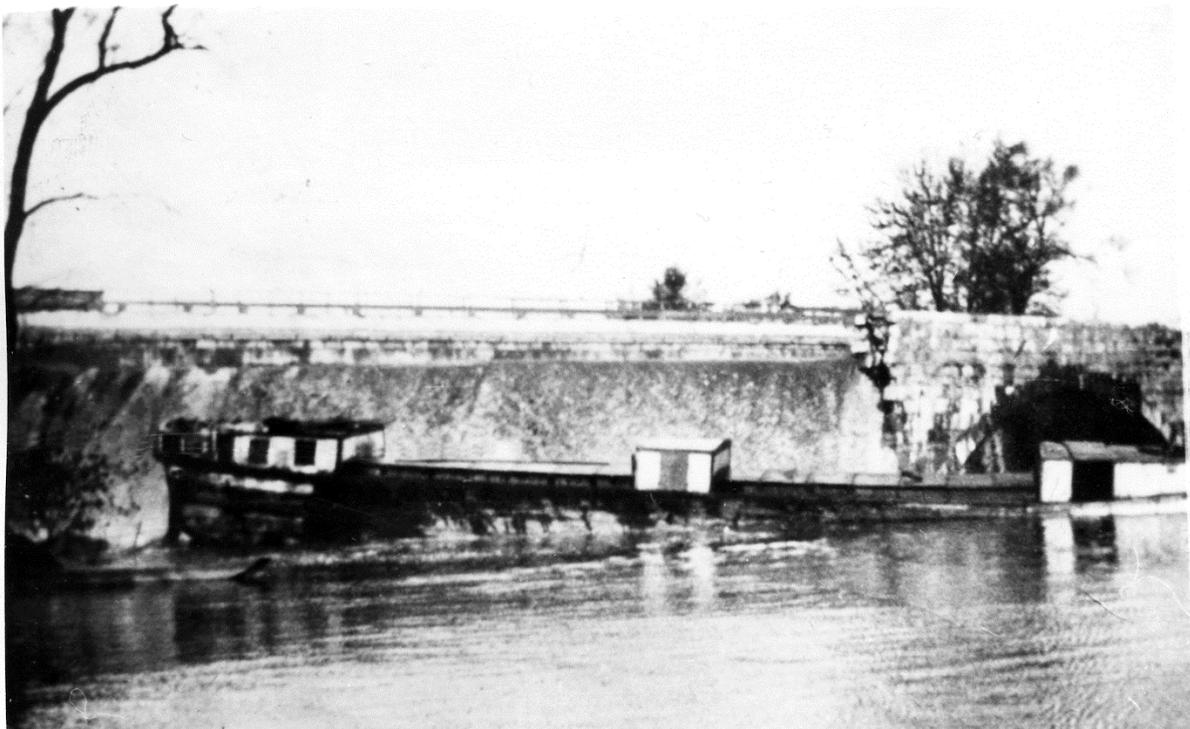
3. The upstream parapet wall collapsed about 5 a.m. on the morning of April 20, 1920.

Collapse of the Berm Parapet Wall

Canal Towage Company Boat No. 73, captained by Frank Myers of big Pool, was passing through the Aqueduct when the wall gave way. Captain Myers later said that he noticed the wall waver and called to his stepson, Joseph Davis, who was walking with the mules, to release them when from the towline, thereby preventing them from being pulled into the canal when the wall collapsed. Captain Myers was able to leap to the aqueduct's downstream wingwall on the berm side before the boat was carried into the Conococheague by the water draining from the canal.

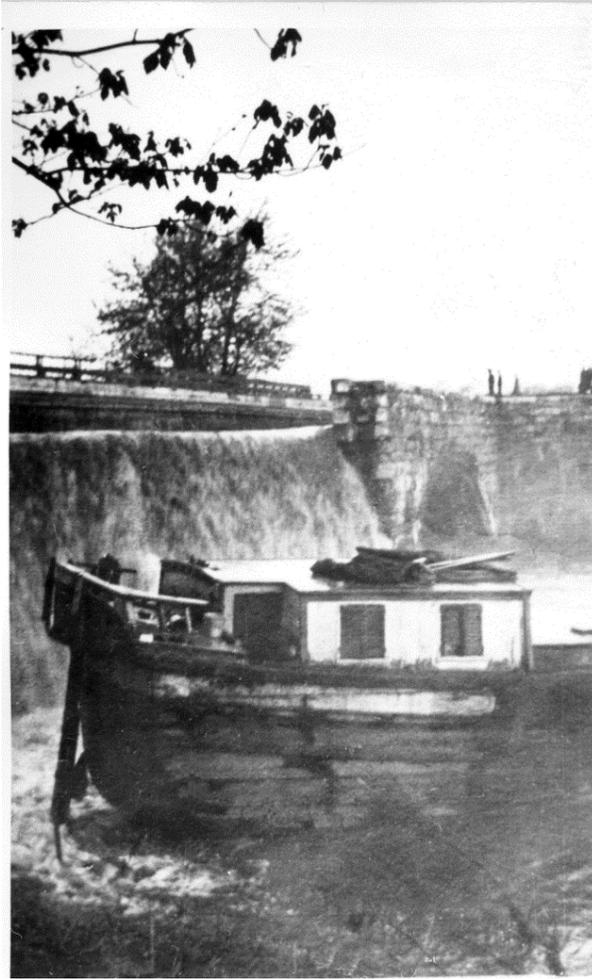
4. Boat and aqueduct with water pouring out.

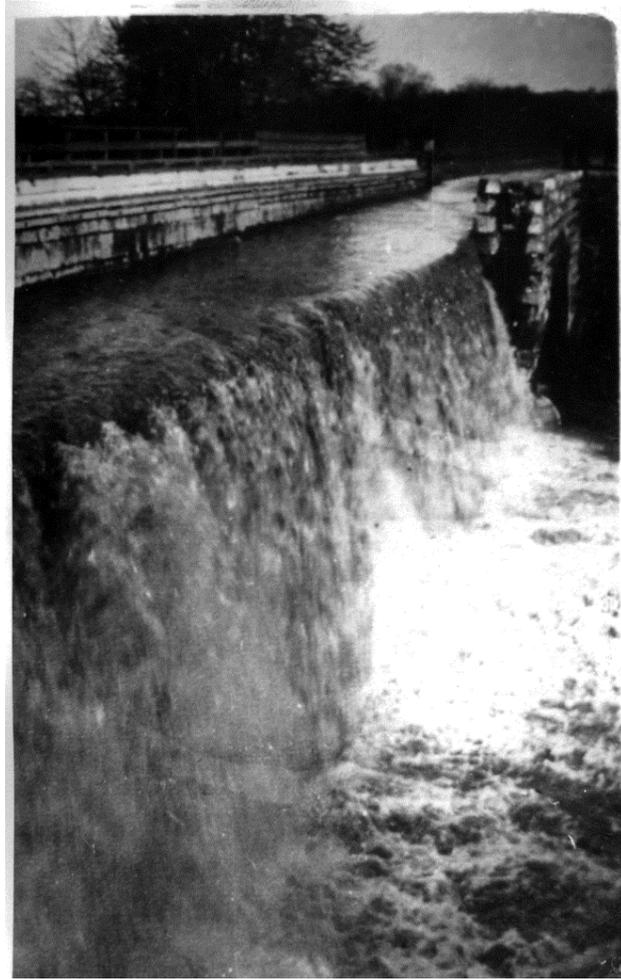
5. Water draining section between stop gates.

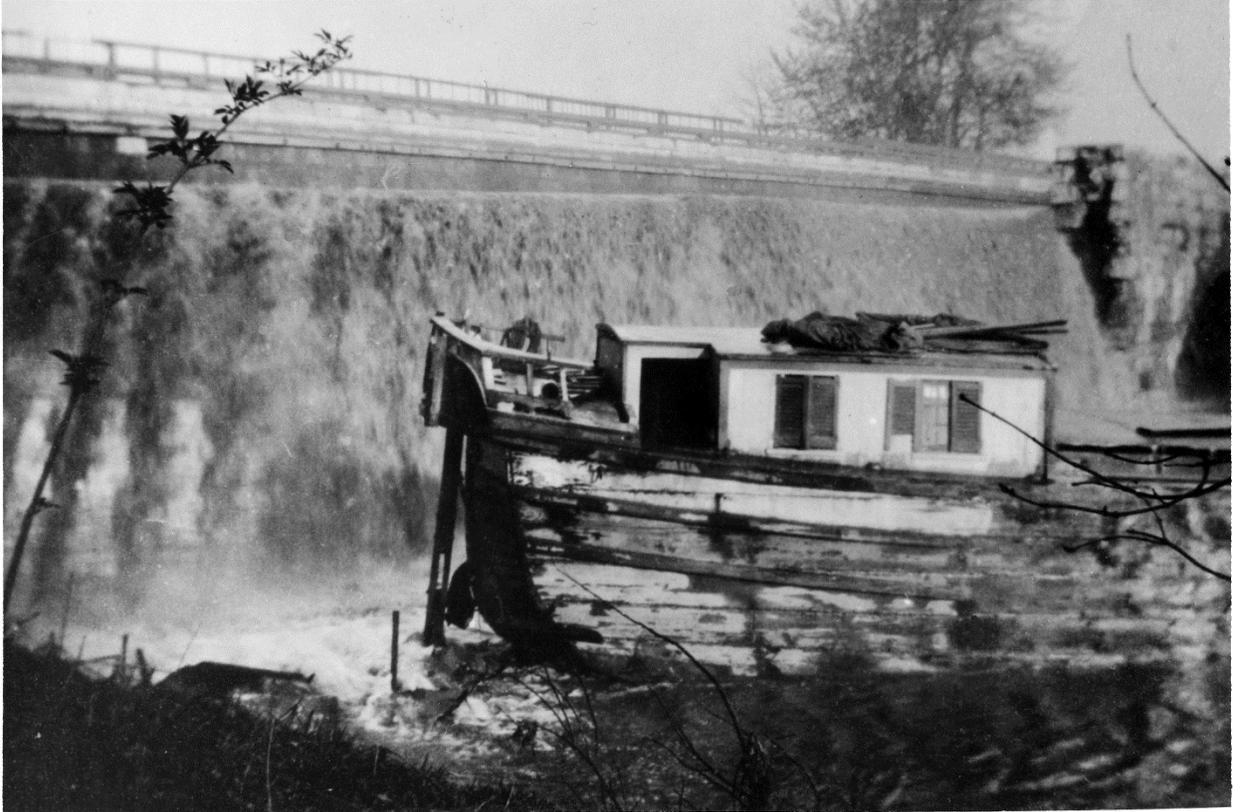
6. Canal Towage Company boat No. 73 in the Conococheague shortly after the collapse of the berm-side (upstream) parapet wall of the aqueduct collapsed into the Conococheague. The boat would remain in this location until the flood of 1936 washed it out into the Potomac, breaking it up and carrying the pieces downriver.

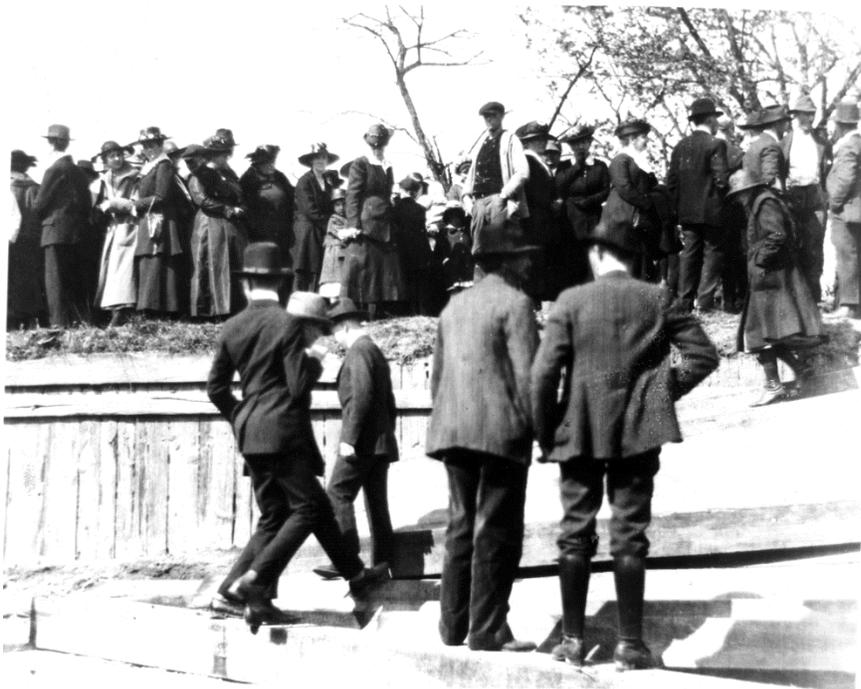
7. Crowd at the aqueduct. The collapse of the aqueduct wall was the subject of great local interest and for several weeks after the collapse many regional residents came to observe the damage and the boat in the Conococheague.

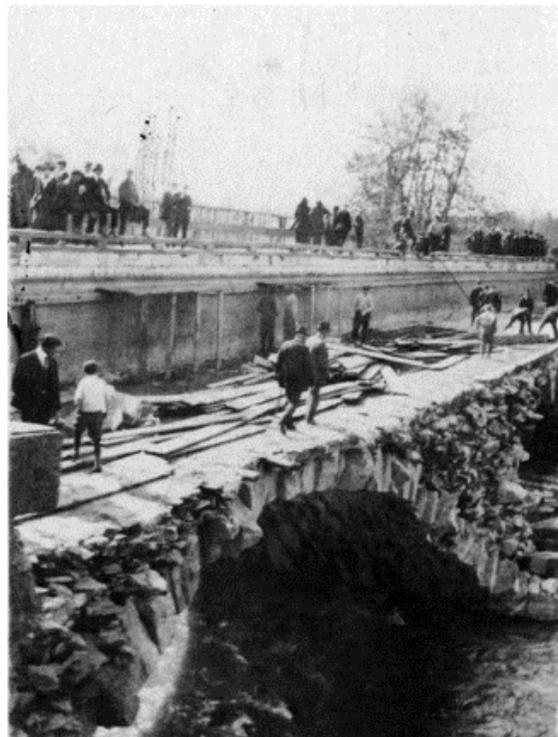
8. C. — May 2, 1920 crowds visiting the Aqueduct

The canal was closed and boats were idled until the aqueduct could be repaired. Along that part of the canal that drained through the aqueduct breach, boats settled onto the bottom and remained there until it was rewatered subsequent to the completion of the wood parapet.

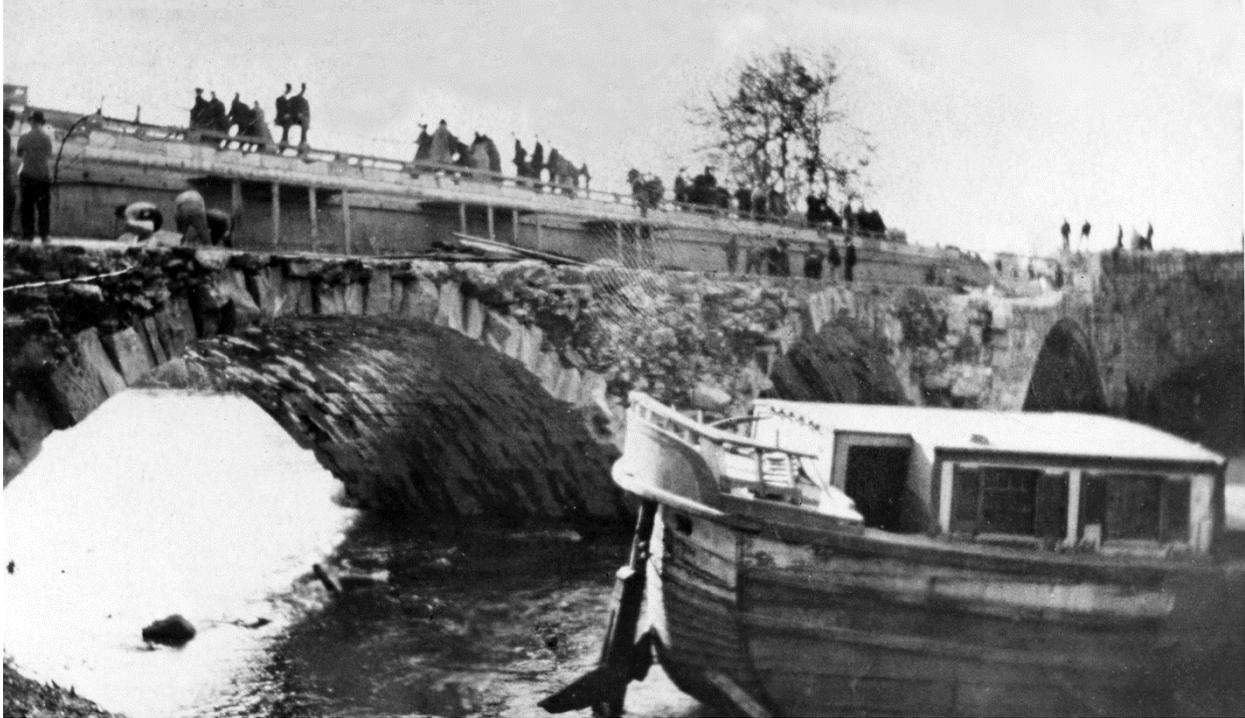
9. The aqueduct showing some of the first work being done.

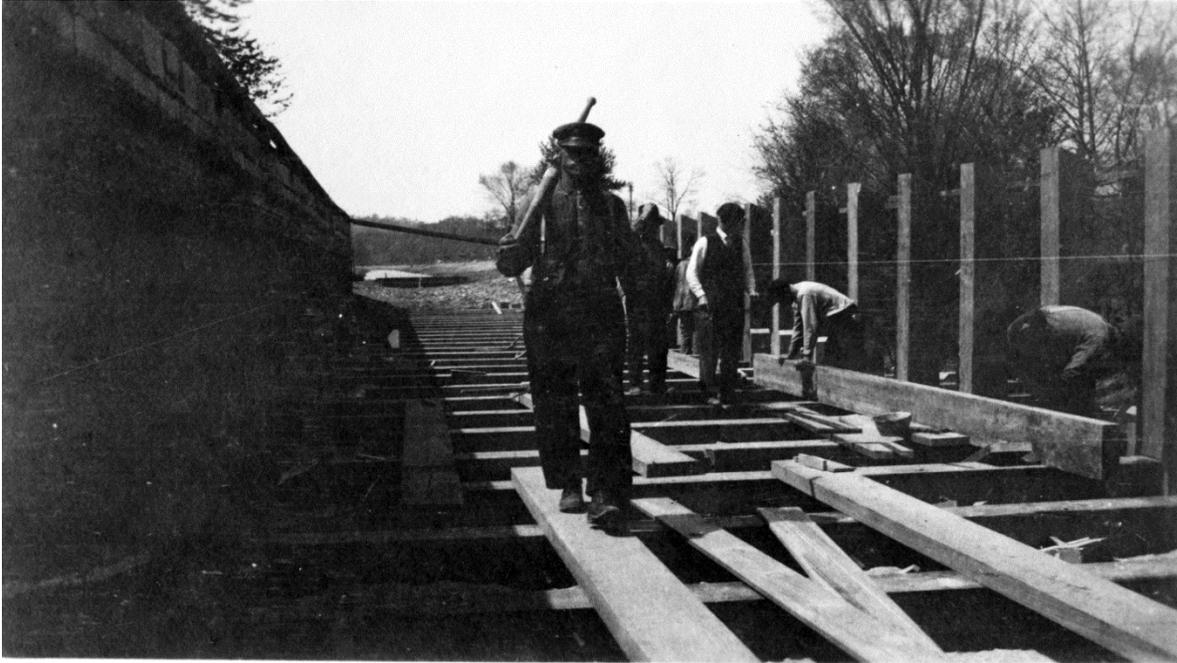
12. Workmen rebuilding the trunk and parapet wall with wood.

The berm parapet was replaced by a wooden wall, which remained in place until after the cessation of operations in 1924, after which it was destroyed, possibly by fire. Here again, Company records¹⁶ and news accounts seem to be silent.

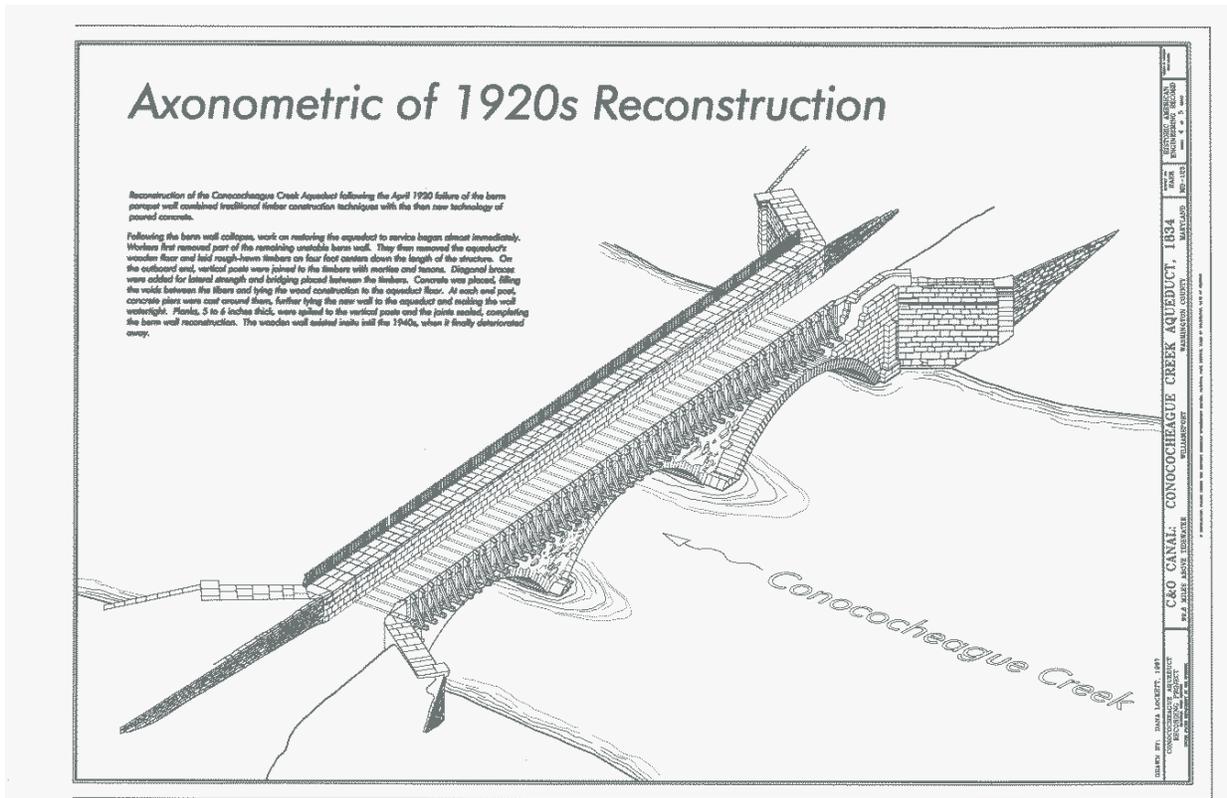
13. Historic American Engineering Record (HAER) Axonometric drawing. This HAER project done in 1997 documented the aqueduct and the wooden parapet that replaced the original masonry wall after the 1920 collapse. See: www.loc.gov/pictures/item/MD1492/

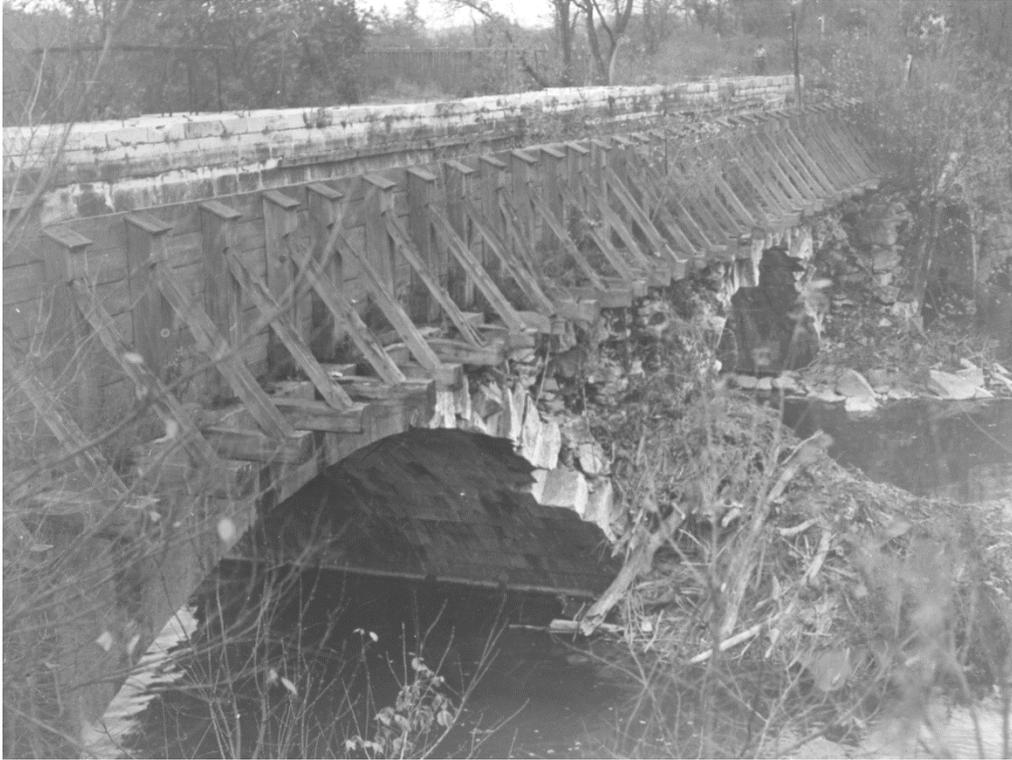
14. The aqueduct after the 1924 closure of the canal with the wooden parapet.

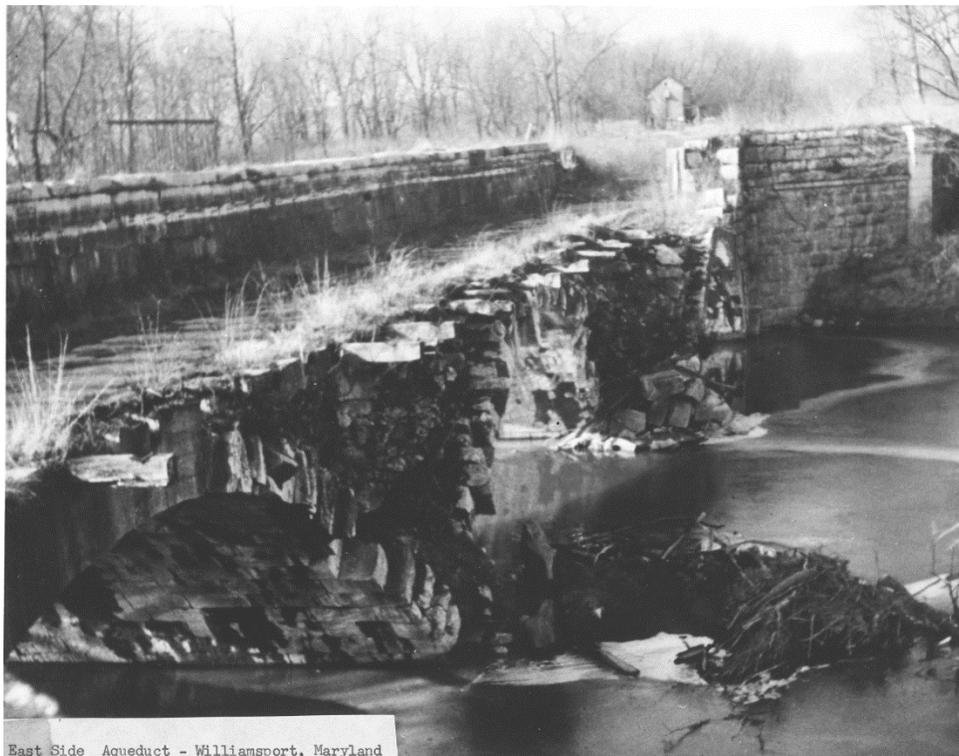
15. The aqueduct after the closure of the canal and with the parapet gone. The date is unknown but this photo appears to have been taken from the period prior to the canal becoming a National Historical Park in 1971.

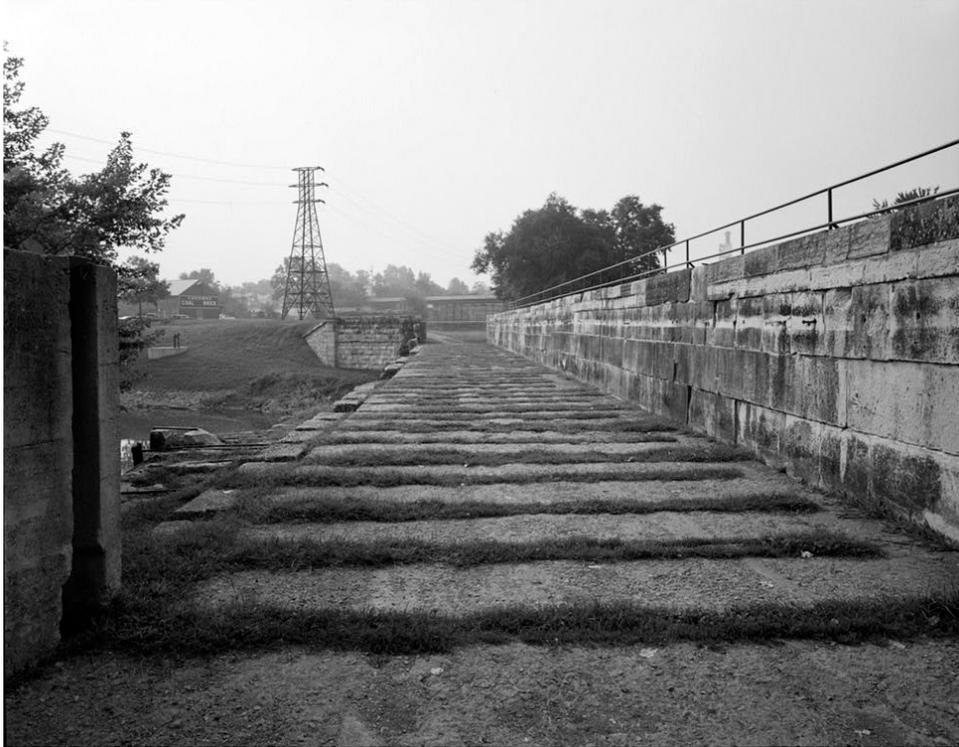
16. Looking downstream through the trunk of the aqueduct toward the Cushwa Basin. Note the missing parapet on the left and towpath wall on the right. HAER MD-22, WILPO.3-3 1997.

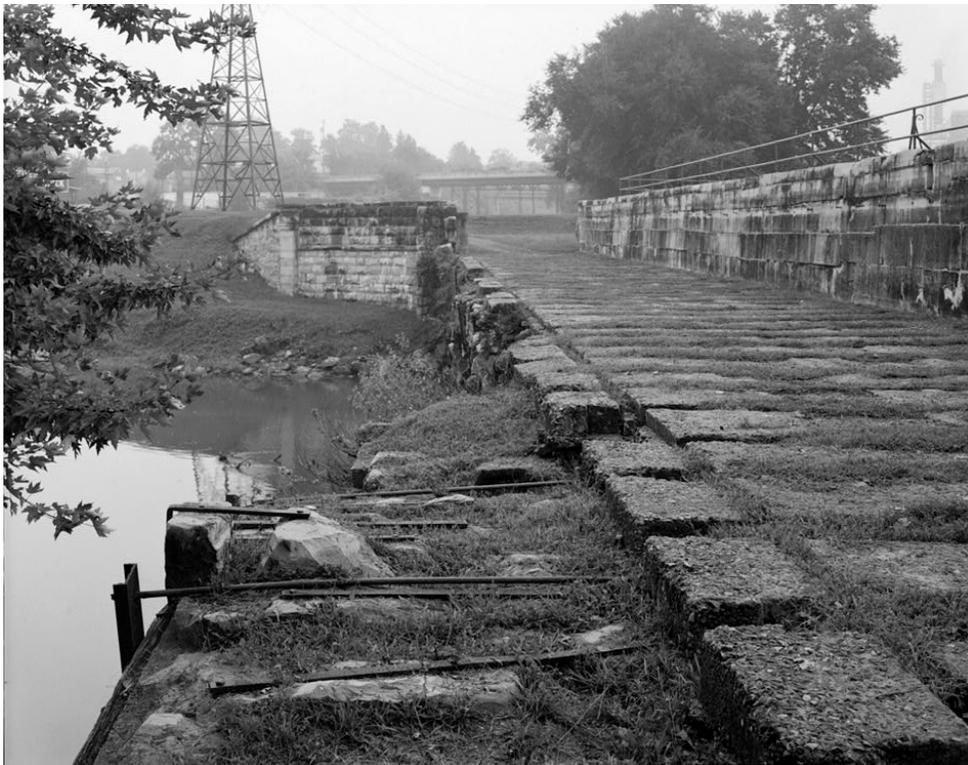
17. Looking downstream and showing short section of the masonry base for the upstream parapet in the foreground. HAER MD-22, WILPO.3-4 1997.

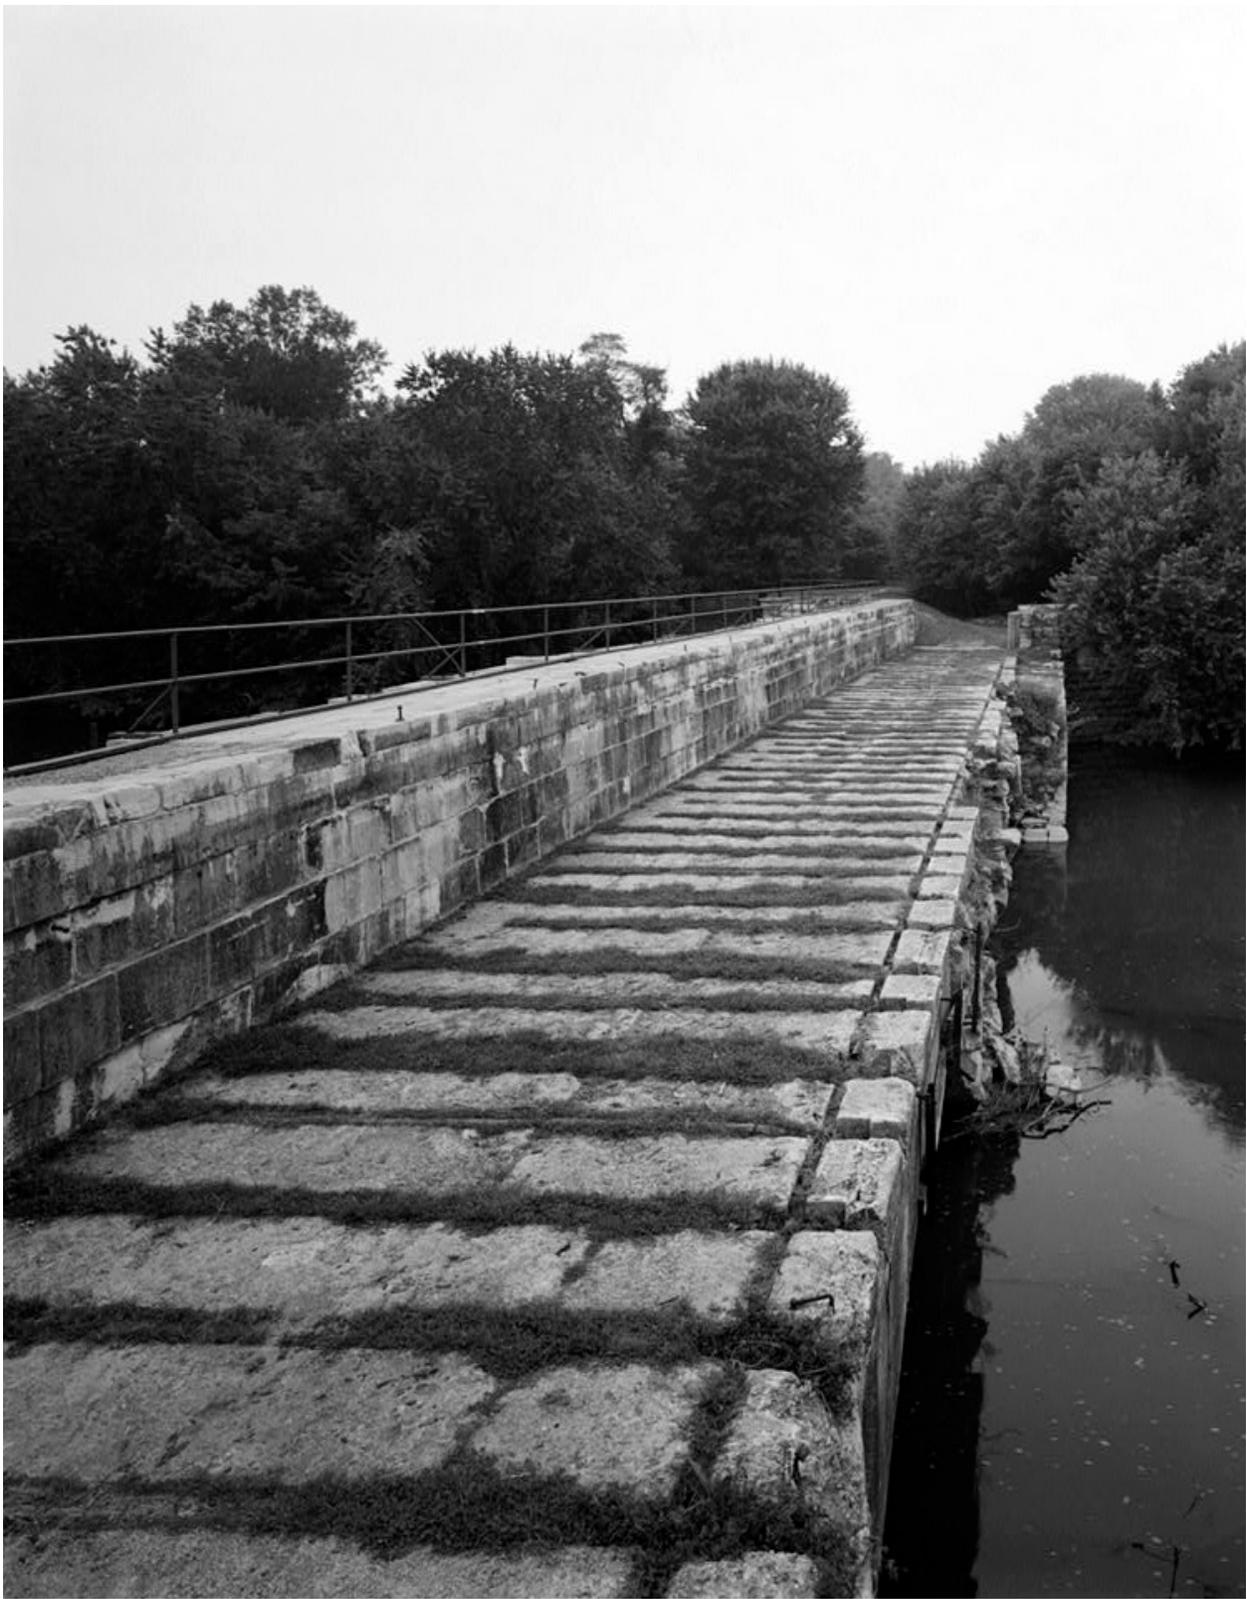
18. Looking upstream with the towpath parapet on the left and missing parapet on the right.
HAER MD-22, WILPO 3-5 1997.

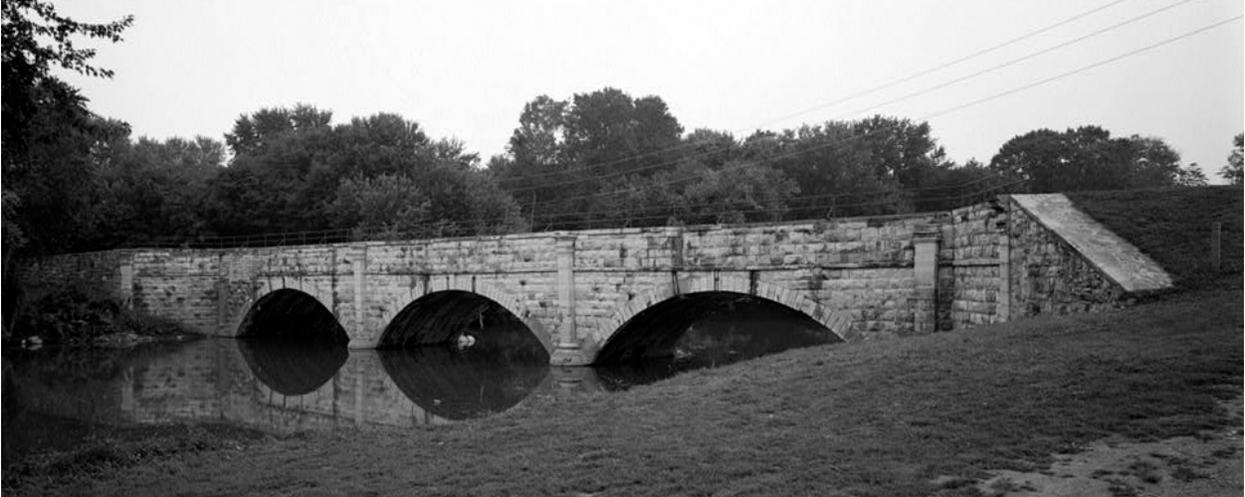
19. Downstream side of the Conococheague Aqueduct, 1997. HAER MD-22, WILPO 3-1, 1997.

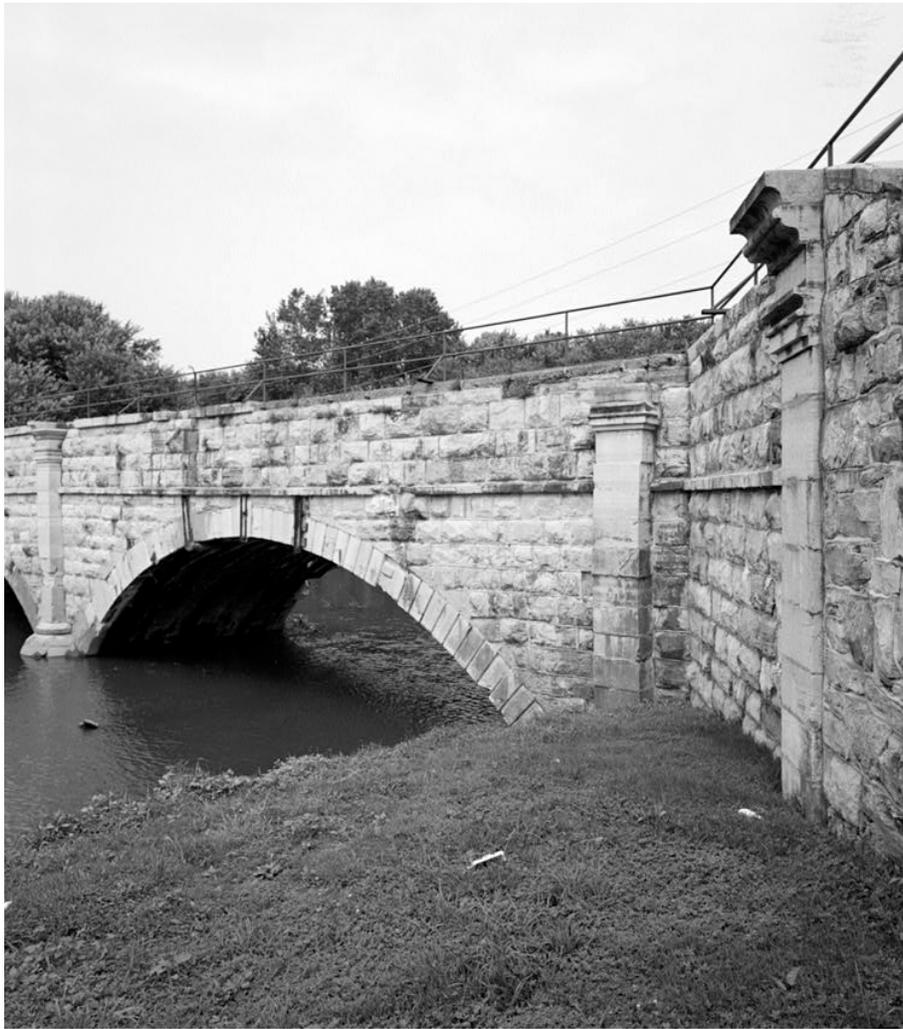
20. Looking northwest at the wingwall and downstream arch at the east end of the aqueduct. HAER MD-22, WILPO 3-10, 1997.

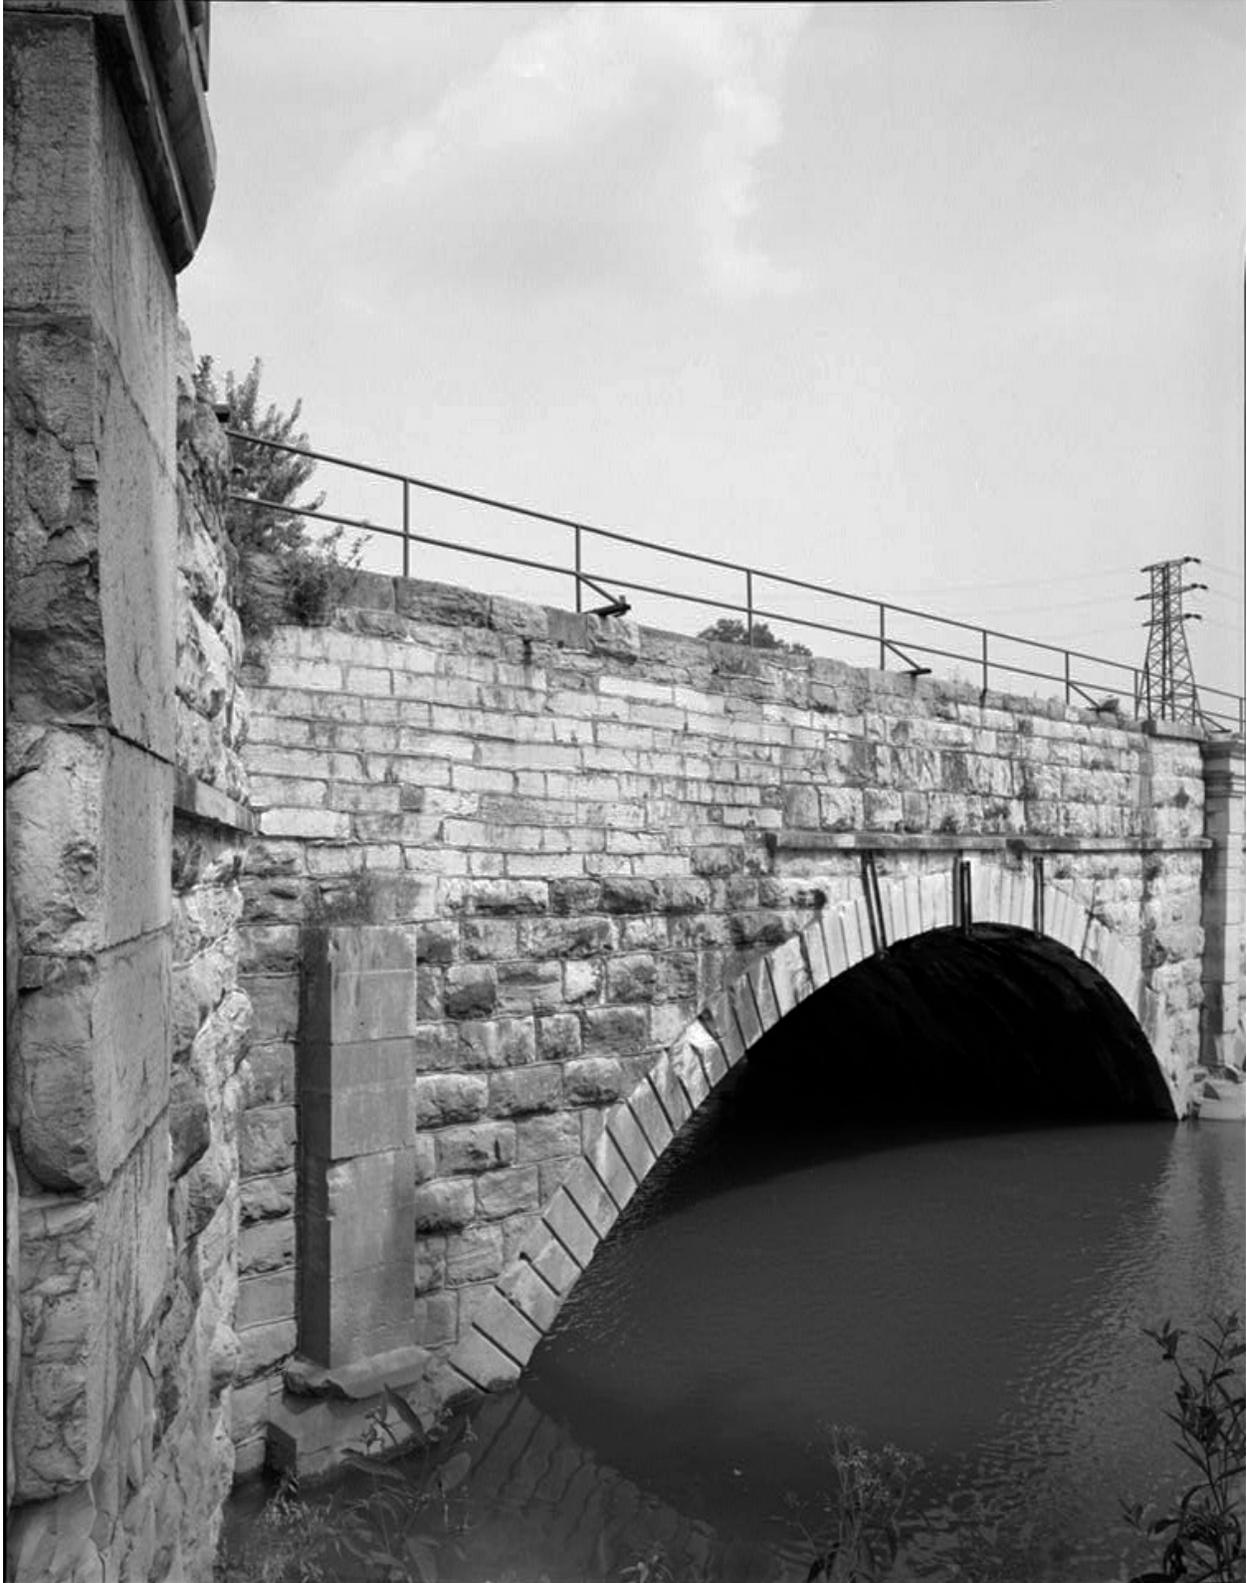
24. Upstream arch and wingwall (leftside) on the downstream side of the aqueduct. Note the repaired area above the incomplete pilaster, representing the repair done following after the damage done by a Confederate raid in August 1864. HAER MD-22, WILPO 3-11, 1997.
