HISTORIC STRUCTURE SURVEY

**BROAD RUN TRUNK**

CHESAPEAKE AND OHIO CANAL  
NATIONAL HISTORICAL PARK

September 1961

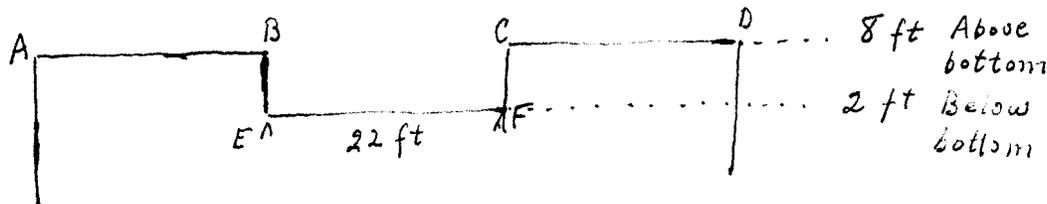
The rebuilding of the trunk was commenced within a few days. After clearing the site of the wreckage of the collapsed structure, the construction of the masonry was undertaken. The following “longitudinal vertical section” of the stone work was drafted by Chief Engineer Fisk:

AB and CD should be equal, say 31 feet each, making 86 feet in all.<sup>25</sup>

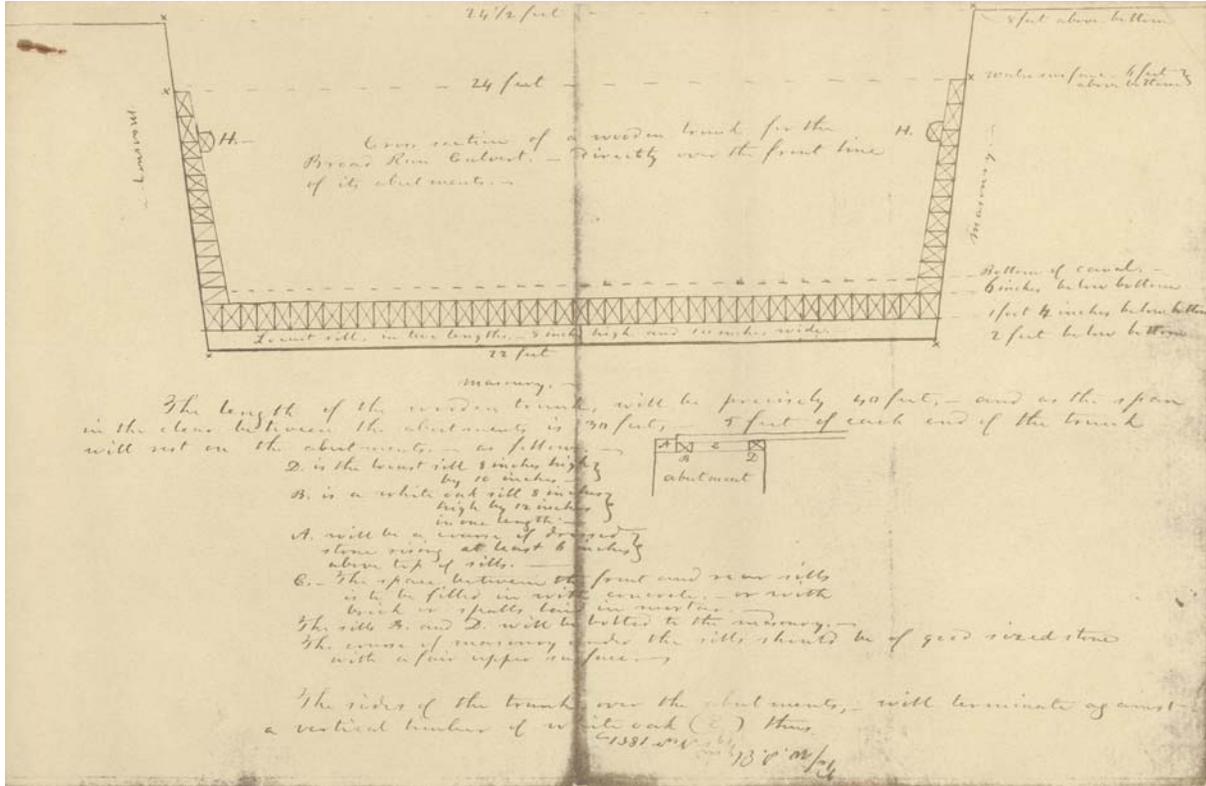
Sheet 1 of 4

By Charles M. Fisk, Chief Engineer, Nov. 19, 1851

A detailed plan was prepared by Fisk and sent to Elgin. This plan, which is reproduced and accompanies this report [see Appendix A], is the only one concerning the structure at Broad Run that has been located.<sup>27</sup>

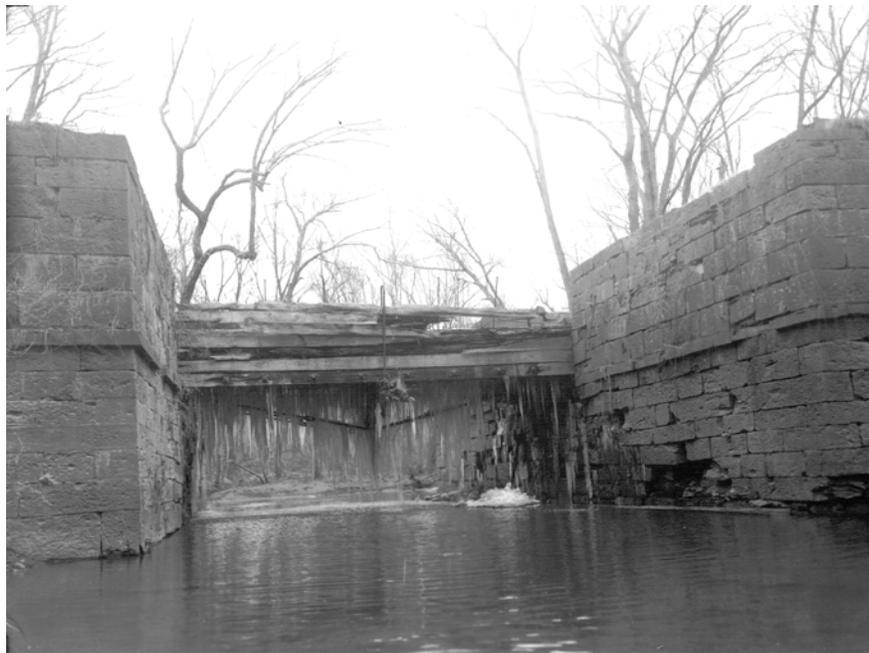
Photo #1: This photograph was taken from downstream of Broad Run, looking upstream at the towpath side of the trunk. The mule bridge spanned the stream on this side of the flume. Note the masonry, laid in 1857, and the inverted truss that supports the Trunk.

The trunk is now in a ruinous condition. Much of the flume is gone; and the mule bridge has disappeared. The accompanying photos will illustrate its current appearance and give some idea of its historic character [see Appendix B].

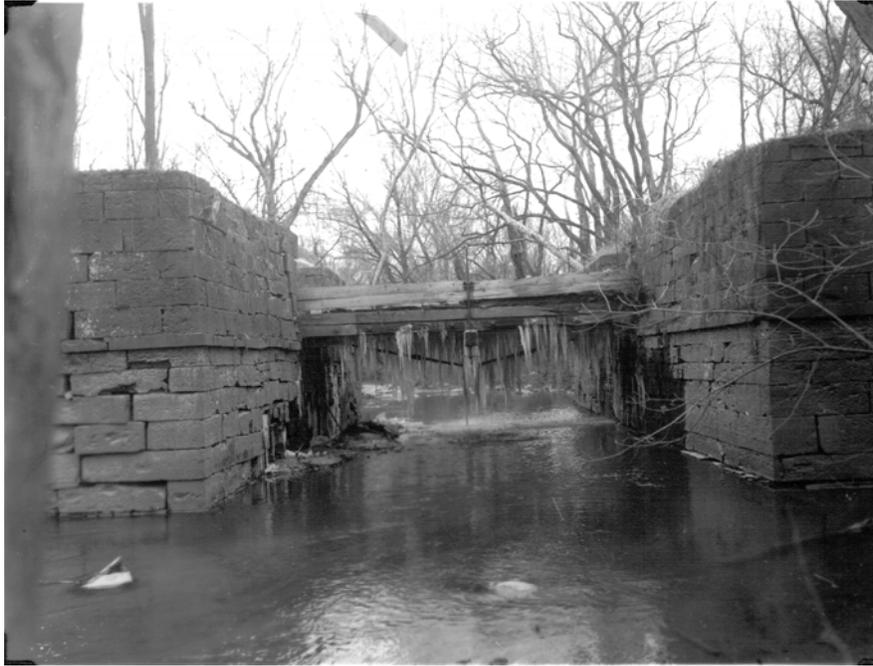
Photo #2: This photograph was taken from upstream of Broad Run, looking downstream at the berm side of the Trunk. Note, again, the masonry and the inverted truss.

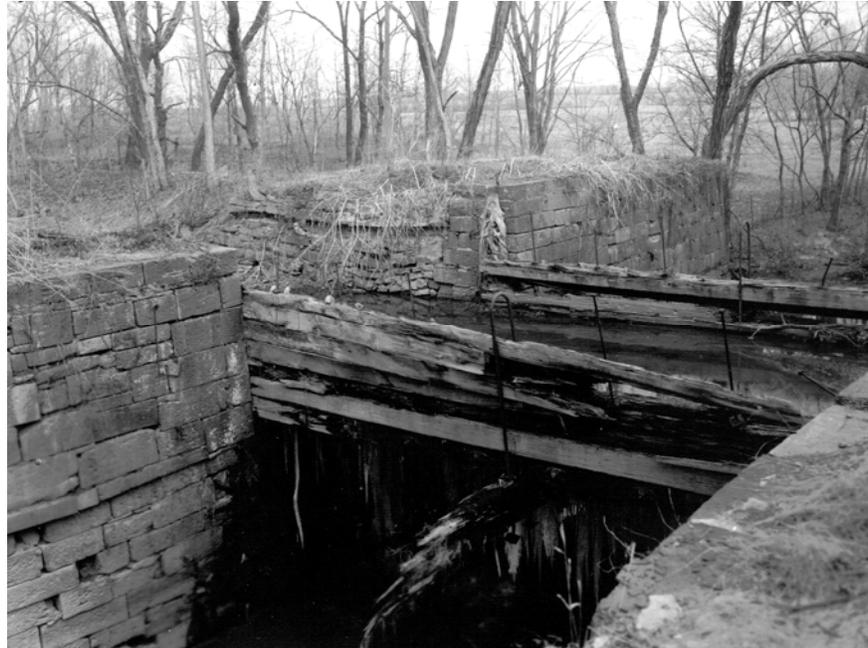
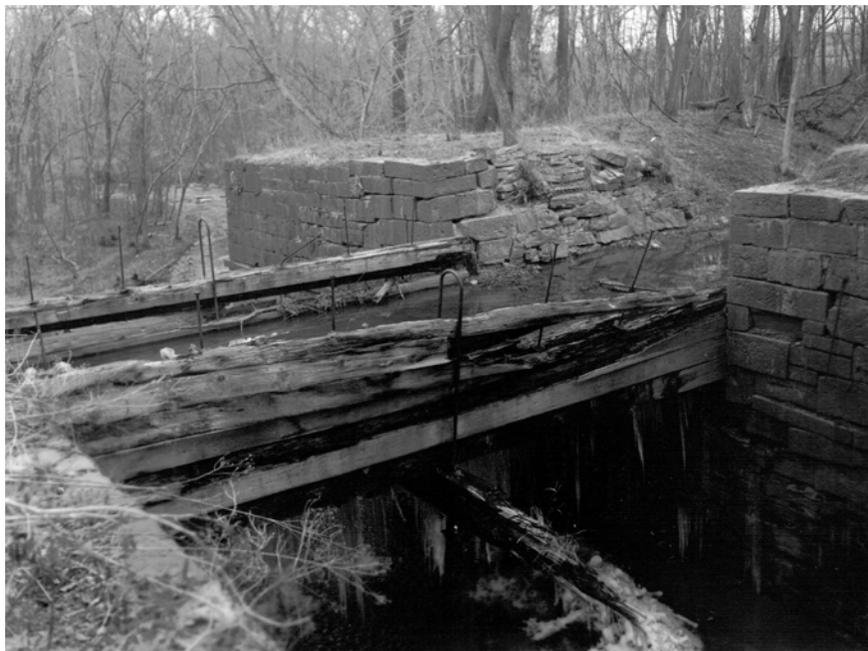
Photo #3 (above) and #4 (below): These are view showing the flume or Trunk from the towpath side. Note the metal work and the protruding center timber, to which the inverted truss of the mule bridge was tied.

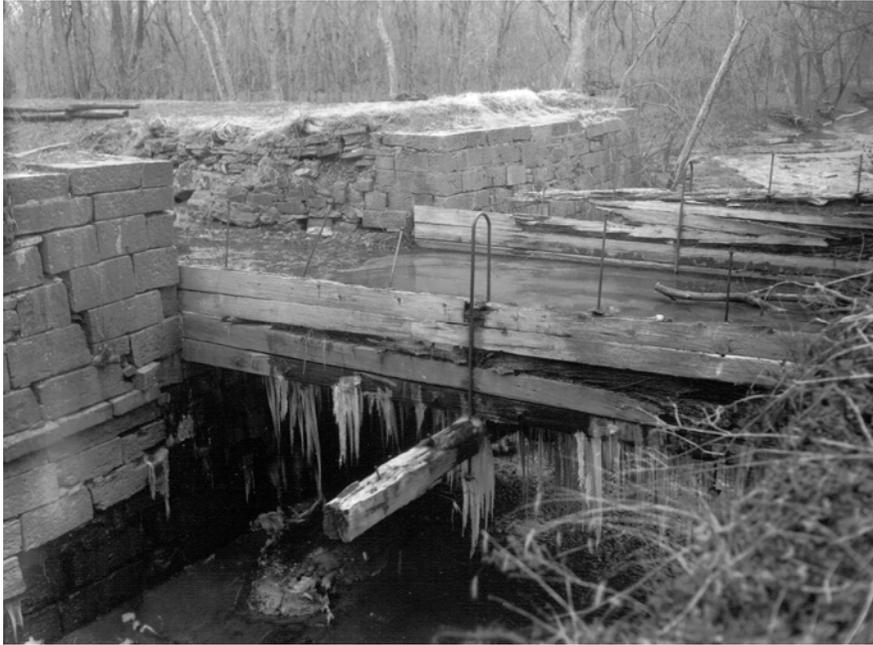
Photo #5: This scene shows the Trunk from the berm side. Note the center timber, one end of which protrudes on the towpath side, as seen in Photos #3 and 4.

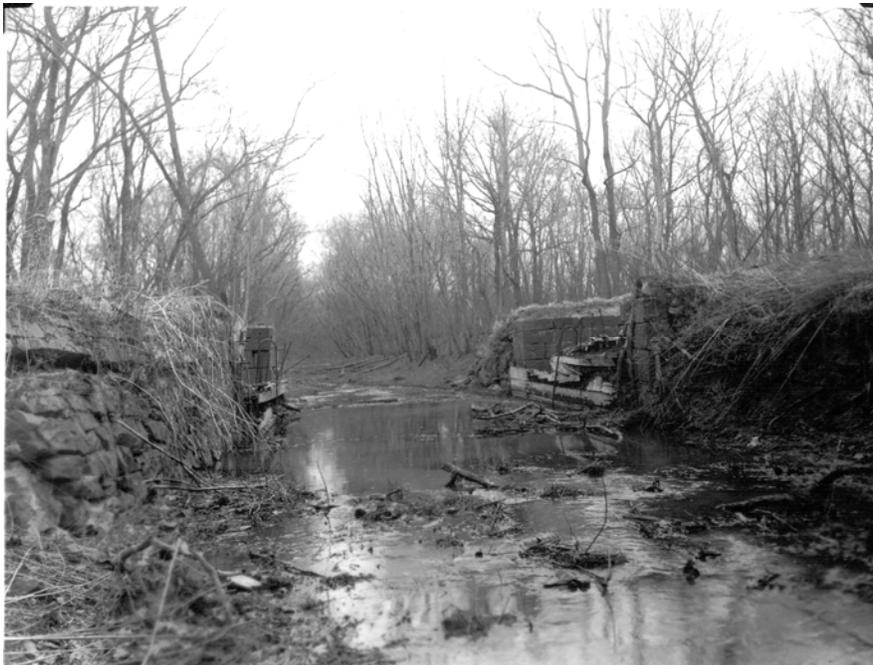
Photo #6: This view is looking downstream of the Canal, through the flume of the Trunk.

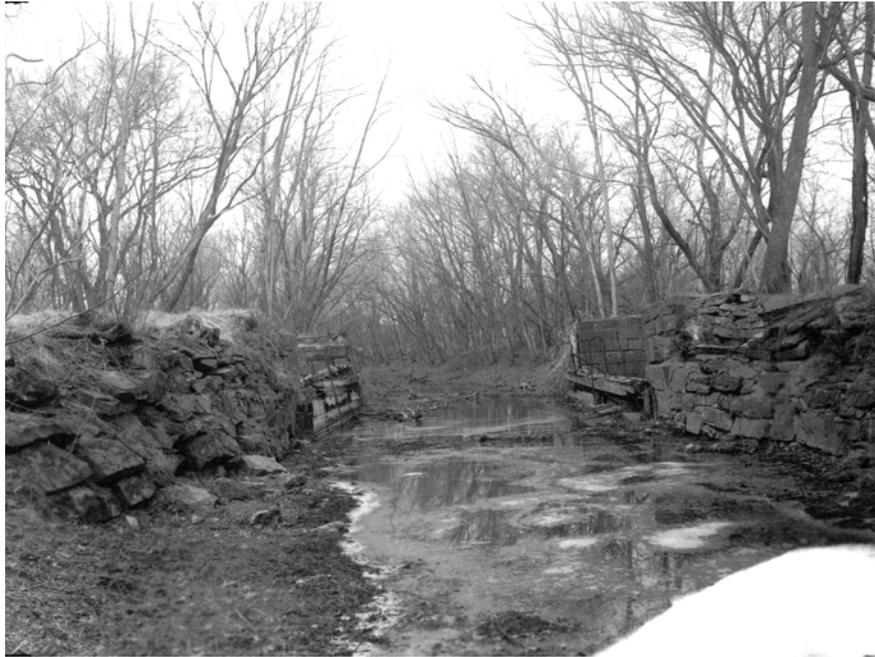
Photo #7: This view is looking upstream of the Canal, looking through the flume of the Trunk.

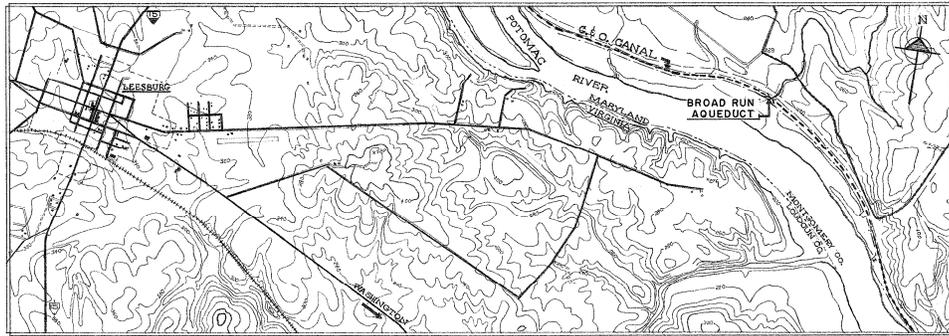
This Site Plan for the Broad Run Aqueduct was developed by Historic American Buildings Survey (HABS), August, 1961, Sheet 1 of 4.

THE PRESENT AQUEDUCT OVER BROAD RUN CREEK IS THE ONLY AQUEDUCT WITH A WOODEN FLUME STILL IN EXISTENCE ALONG THE CHESAPEAKE AND OHIO CANAL. THE EXISTING STRUCTURE WAS BUILT DURING THE WINTER MONTHS OF 1856-7 BY THE CANAL COMPANY, IT REPLACED AN EARLIER TEMPORARY FLUME. THE ORIGINAL TWO SPAN MASONRY AQUEDUCT WAS DESTROYED BY A FLOOD IN JULY OF 1846. THE AQUEDUCT SERVES TO ILLUSTRATE A STAGE IN THE CANAL'S DEVELOPMENT AND THE MEANS RESORTED TO IN THE REPAIR AND MAINTENANCE OF THE SYSTEM.

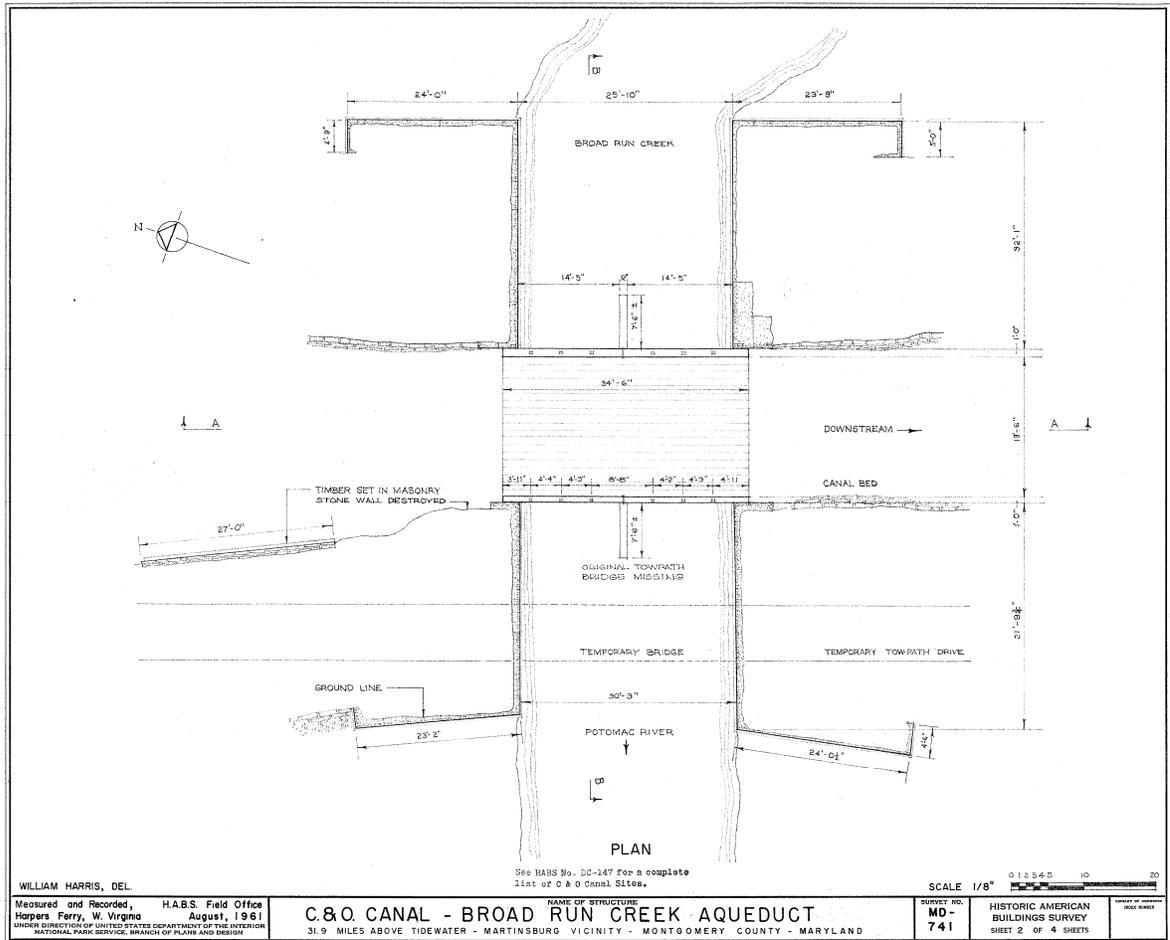
This HABS aerial view shows the Trunk and abutments, Sheet 2 of 4.

Photo # 6: This photograph is a detail of the canal wall north of the aqueduct, showing a timber set into the masonry. Look on the HABS drawing, Sheet 2 of 4, left hand side, about half way up, to locate this wall with relation to the Trunk.

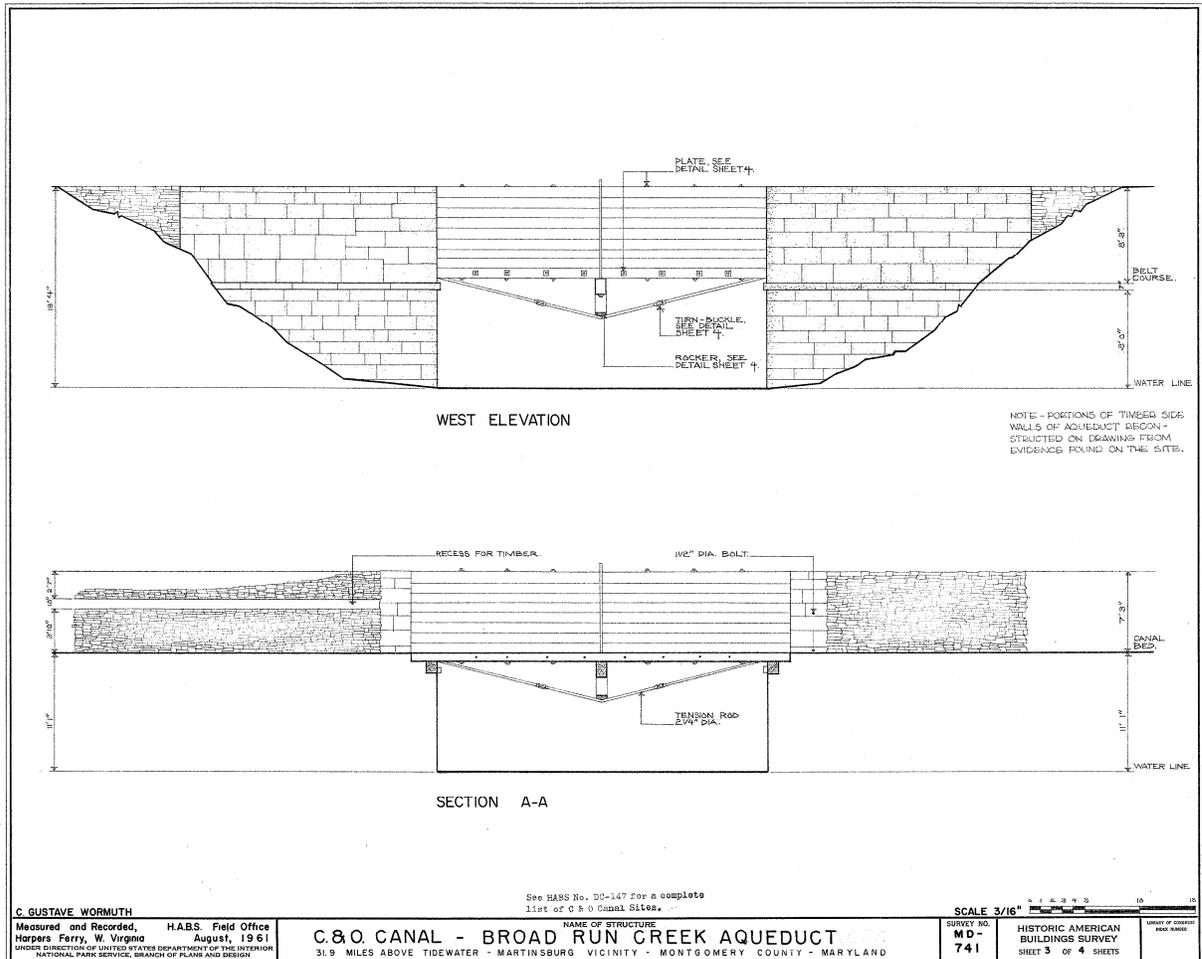
This drawing, HABS Sheet 3 of 4, shows an elevation from the towpath side and then a longitudinal sectional view of Broad Run Aqueduct.

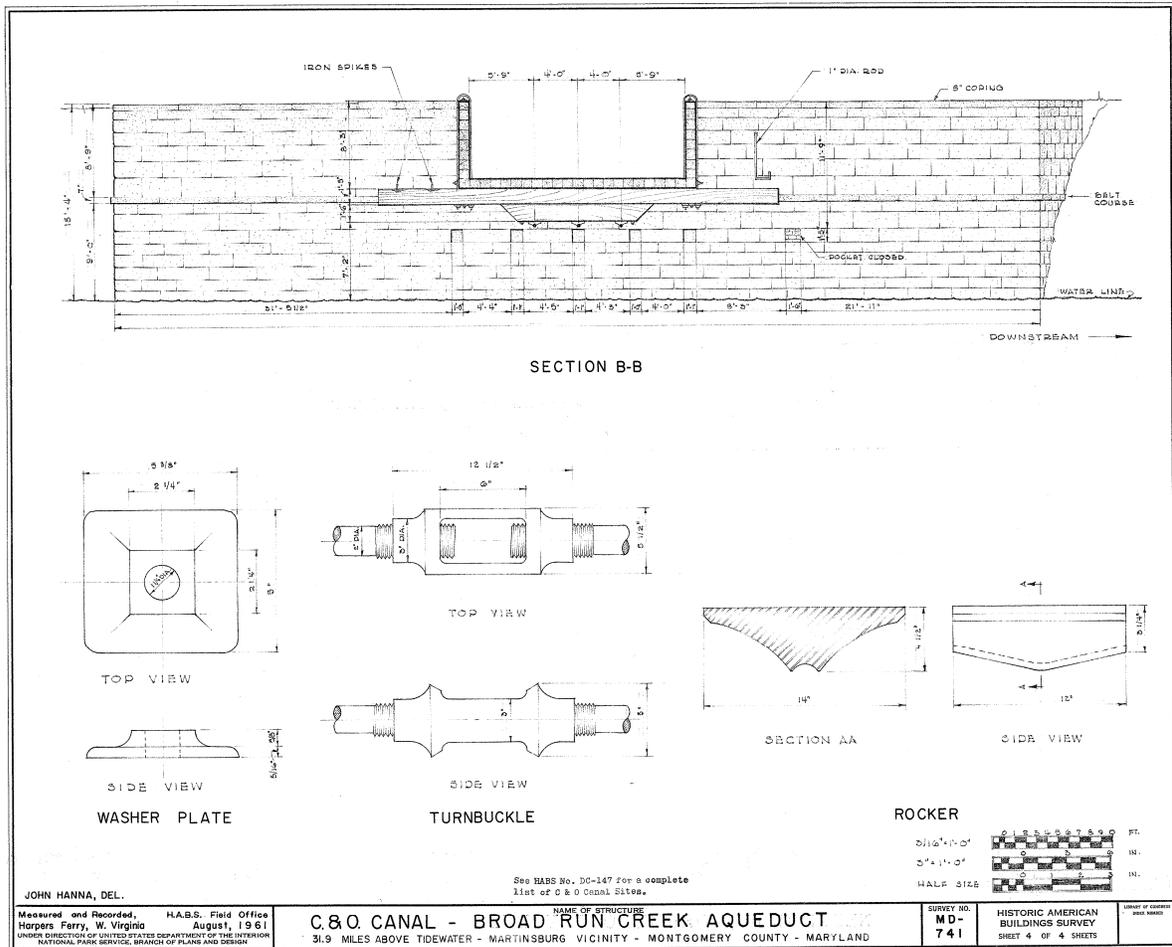
This drawing, HABS Sheet 4 of 4, shows a cross sectional view of Broad Run Aqueduct, and some of the iron parts.

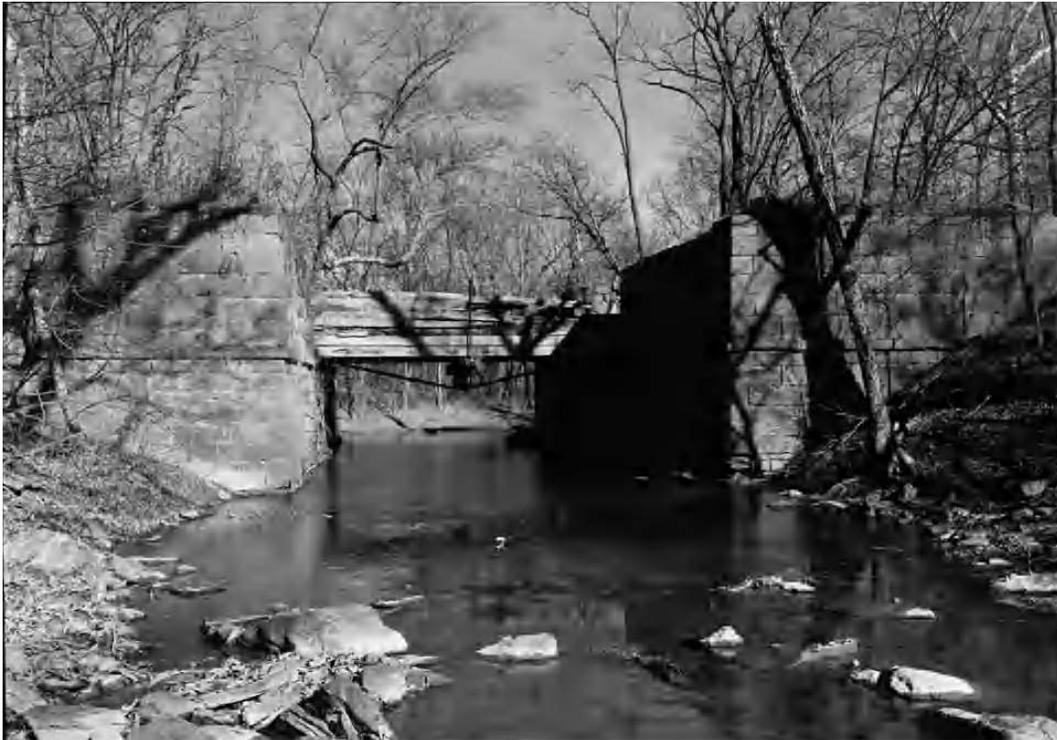
Photo #1: This is a view of the western wing walls.

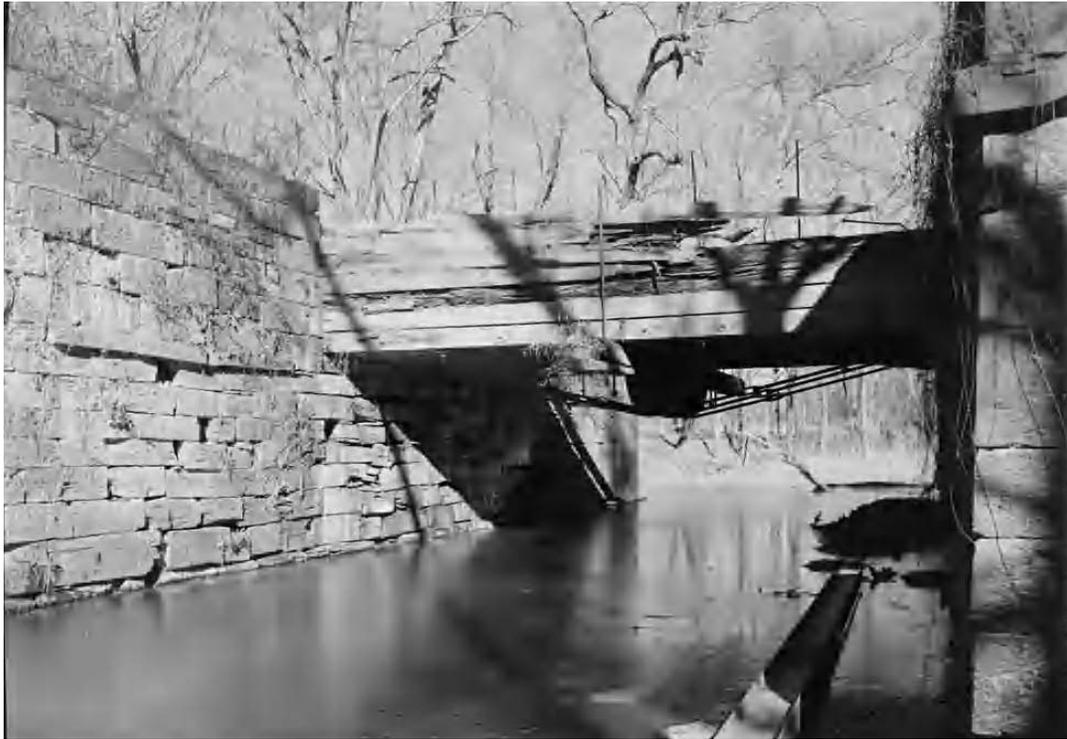
Photo #2: This is a view of the western wing walls and the western wall of the aqueduct.

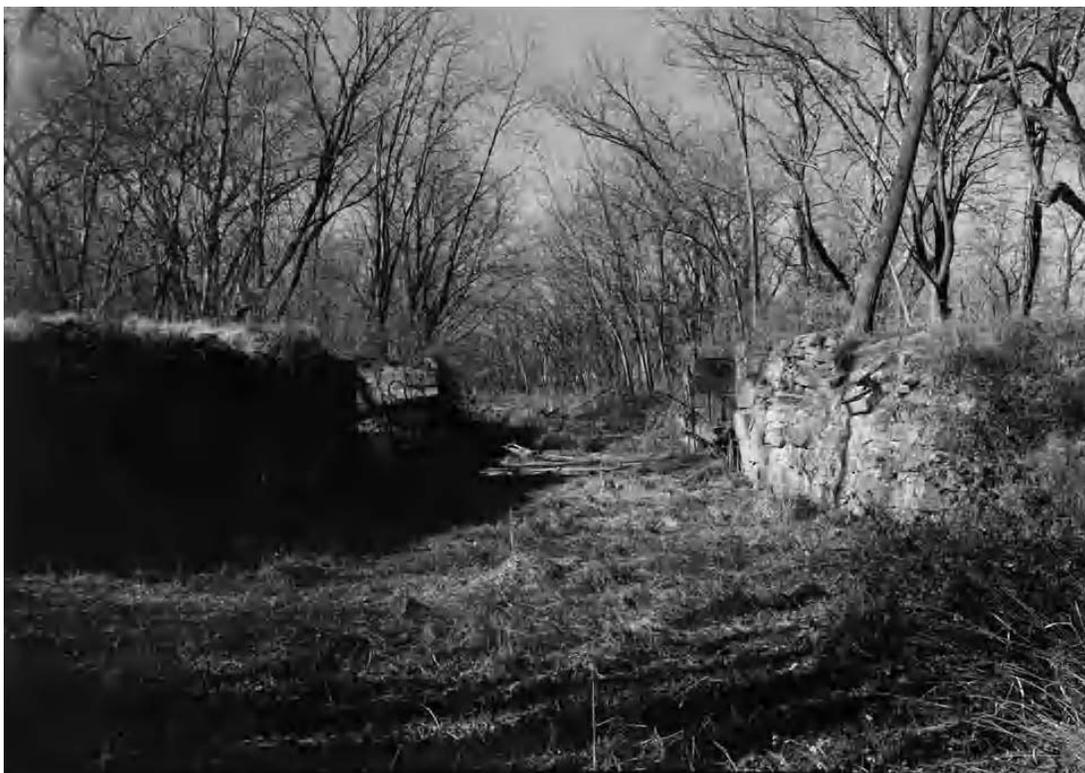
Photo #3: This is a general view of the canal [trunk] bed, looking north.

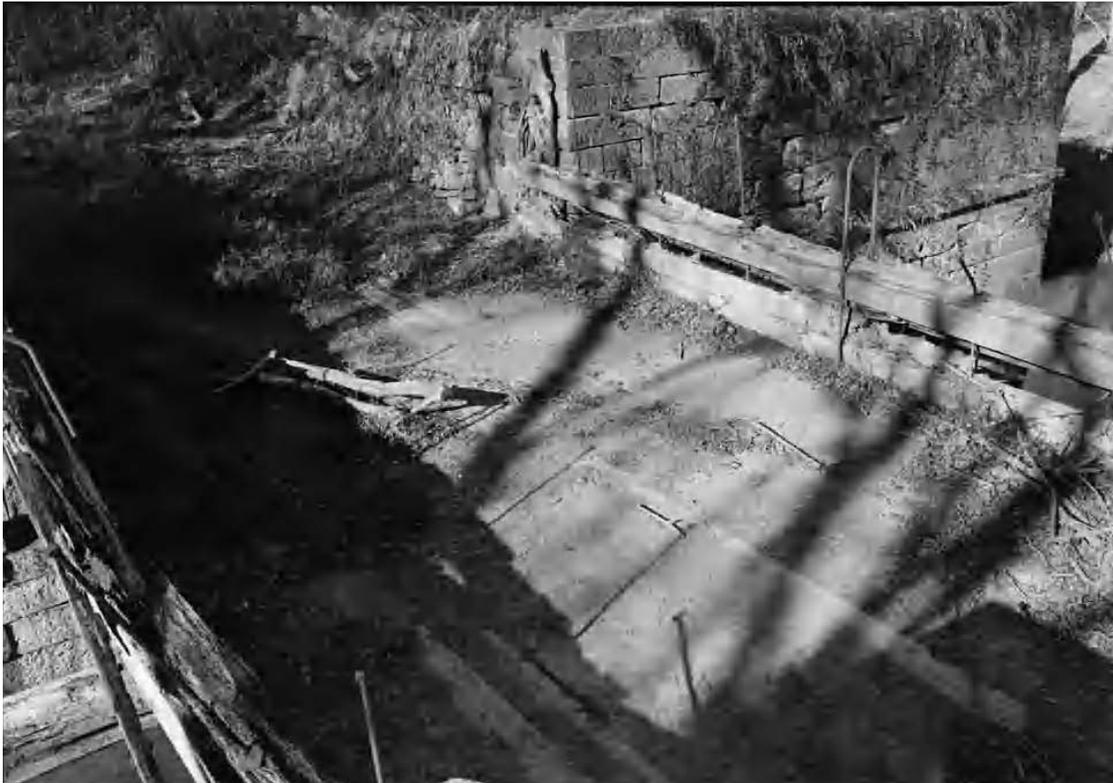
Photo #4: This is a view of the canal [trunk] bed, notice the detail of the wooden flooring.

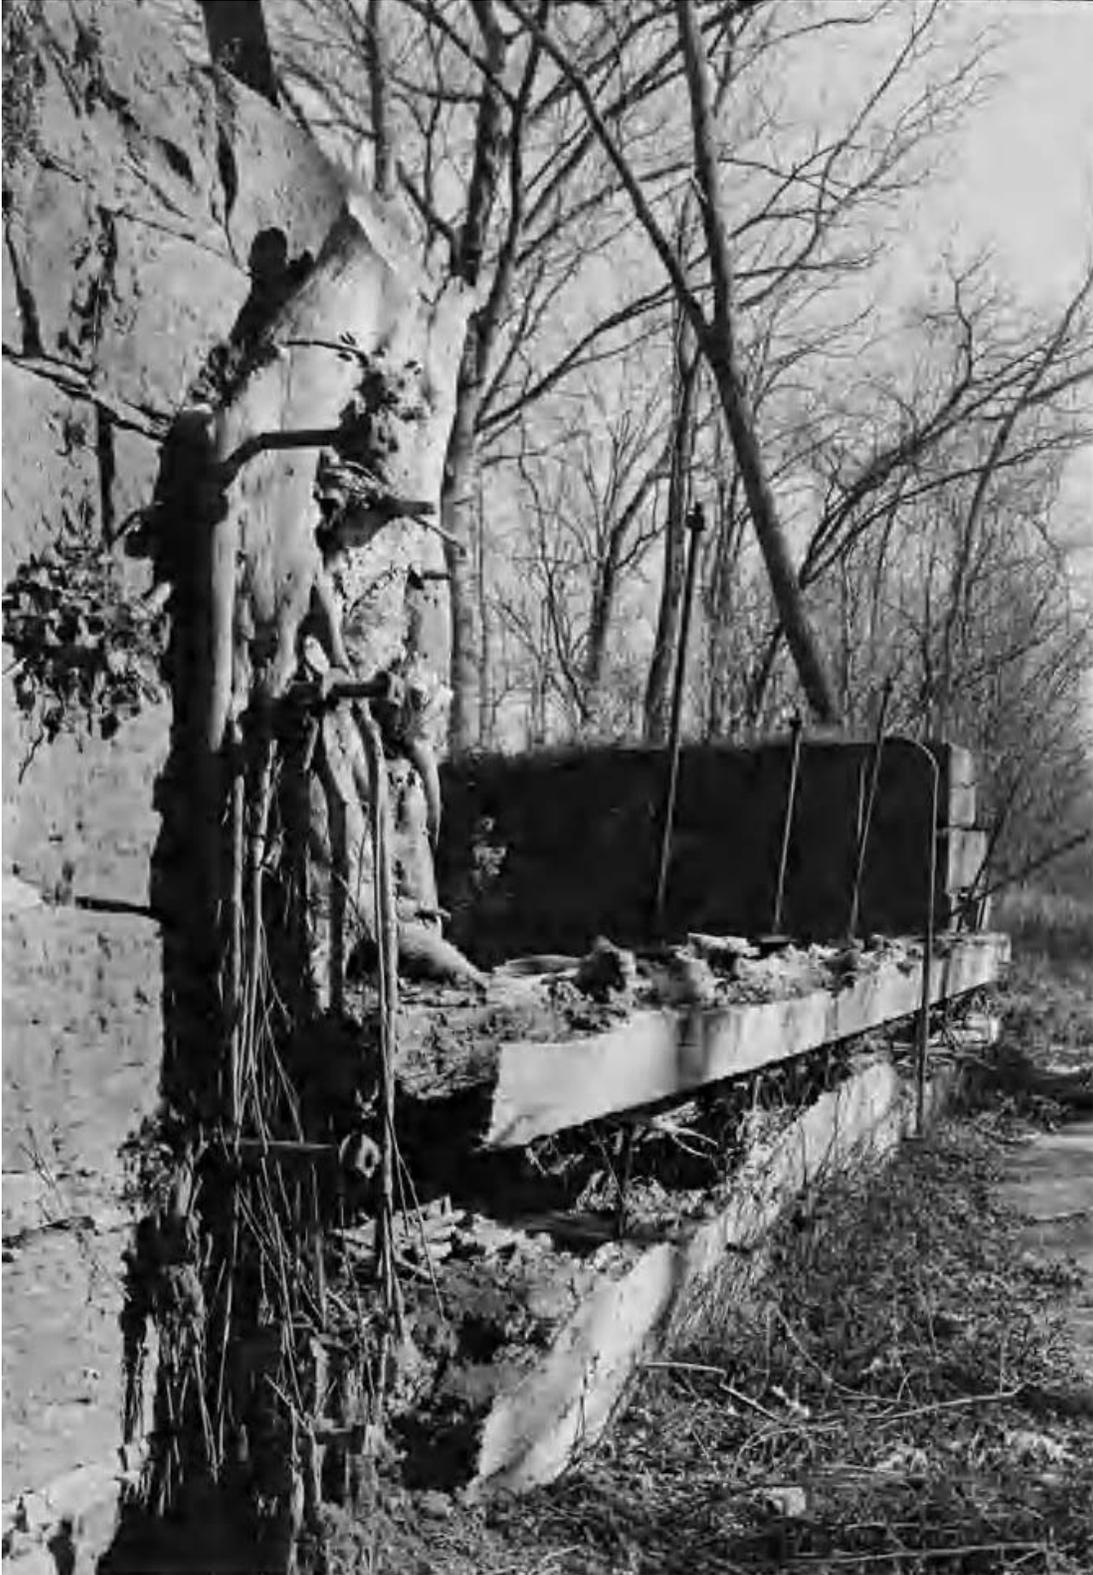
Photo #5: This is a view of the detail of the eastern wall of the aqueduct.
