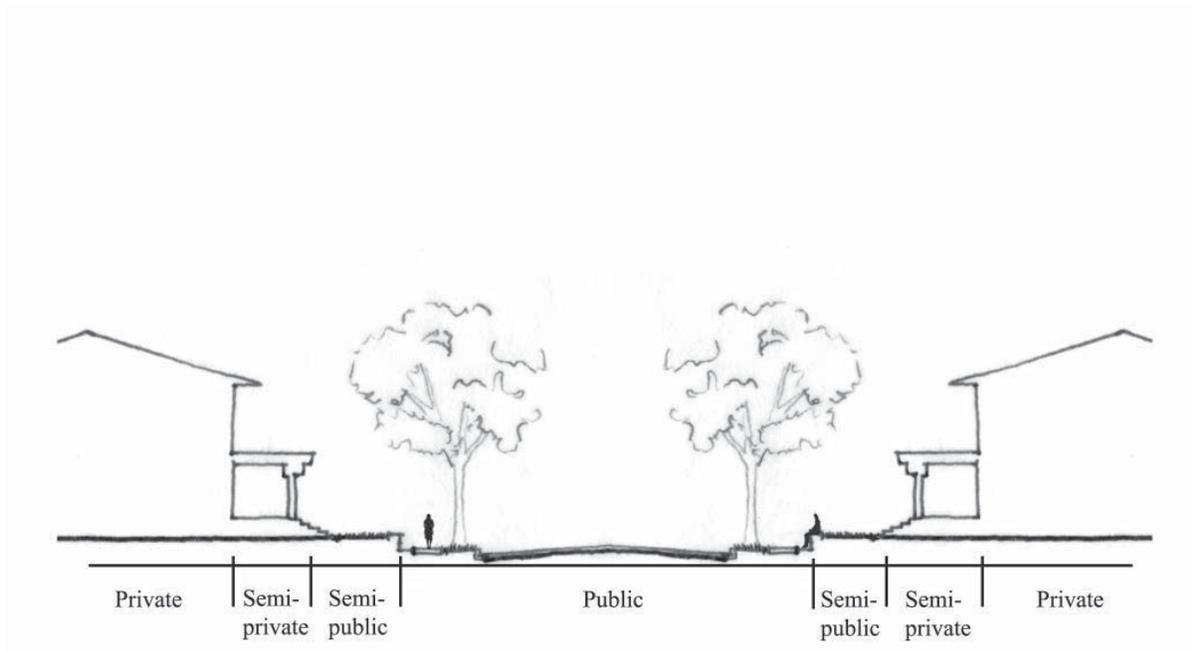
**Figure 2-31.** This section across a typical neighborhood street in the study area shows the linear spatial qualities of the streetscape. *Source: John Milner Associates, Inc., 2008.*

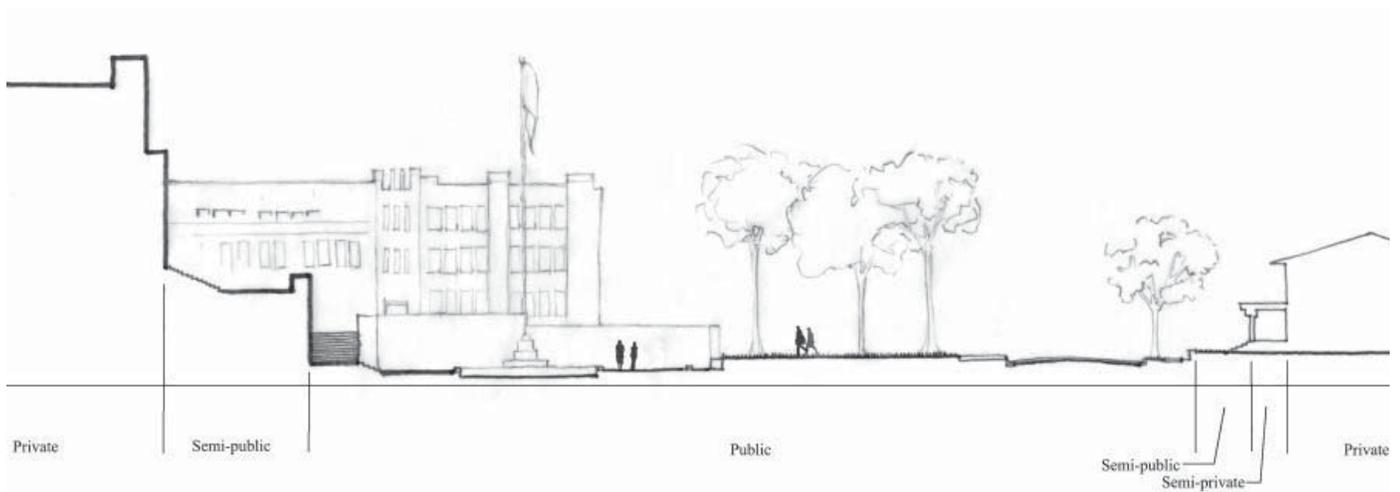
**Figure 2-32.** This section across S. Park Street shows the spatial relationship of the front space of the school as it contrasts with the more narrow spatial qualities of the neighborhood streets. *Source: John Milner Associates, Inc., 2008.*

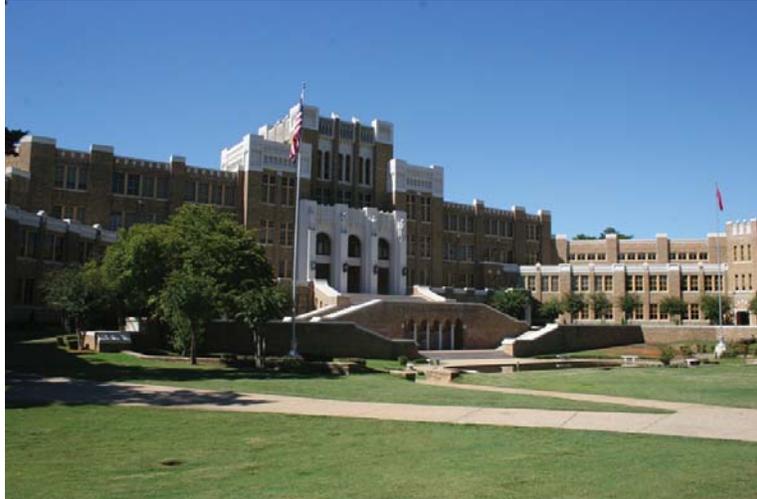
**Figure 2-33.** The front plaza of Central High School is the most significant feature of the Historic Scene character area (seen here looking northwest). *Source: John Milner Associates, Inc., 2007.*

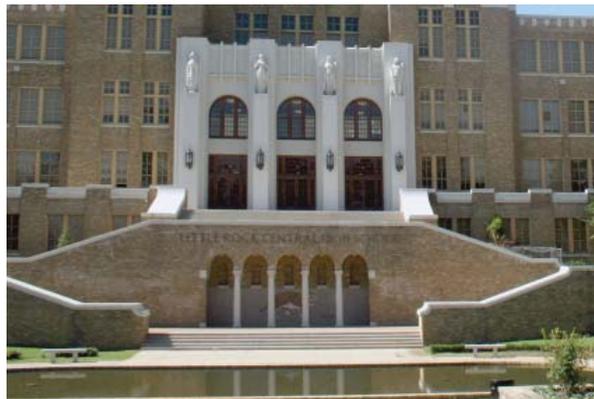
**Figure 2-34.** The front entrance to Central High School and the reflecting pool, which was restored in 2005. *Source: John Milner Associates, Inc., 2007.*

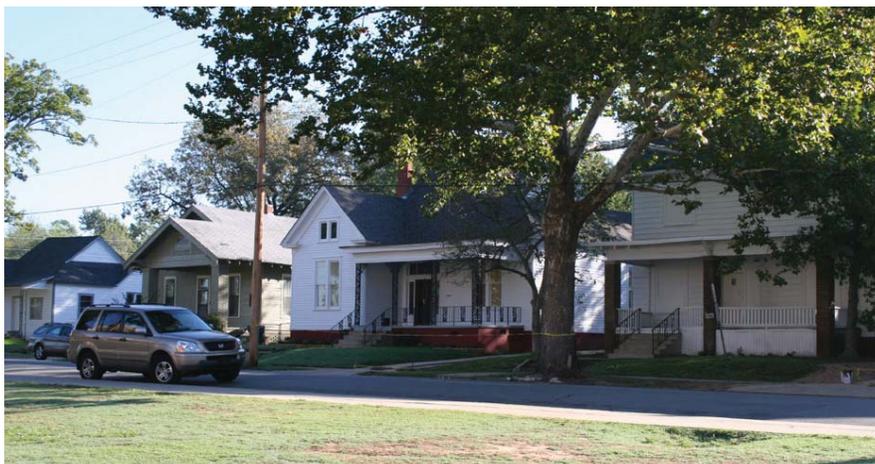
**Figure 2-35.** Four of the seven residences that remain facing the front entrance of the school on S. Park Street (seen here looking northeast). *Source: John Milner Associates, Inc., 2007.*

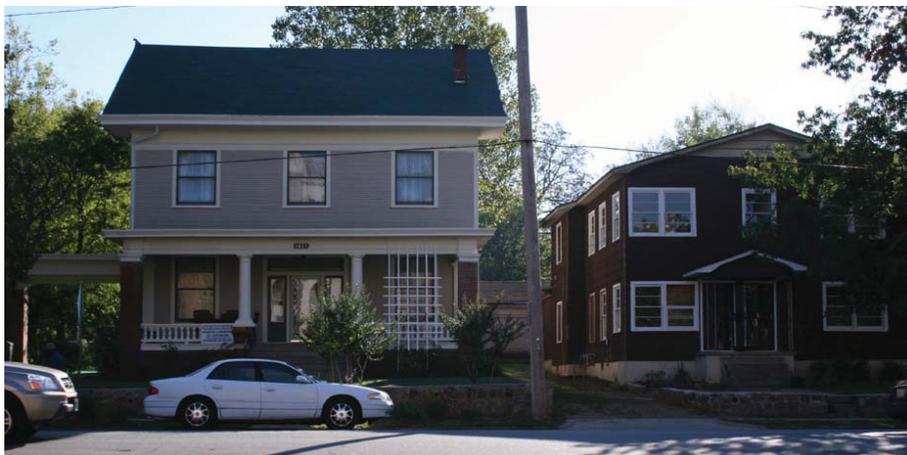
**Figure 2-36.** These residences area a critical component of the historic streetscape (looking east). *Source: John Milner Associates, Inc., 2007.*

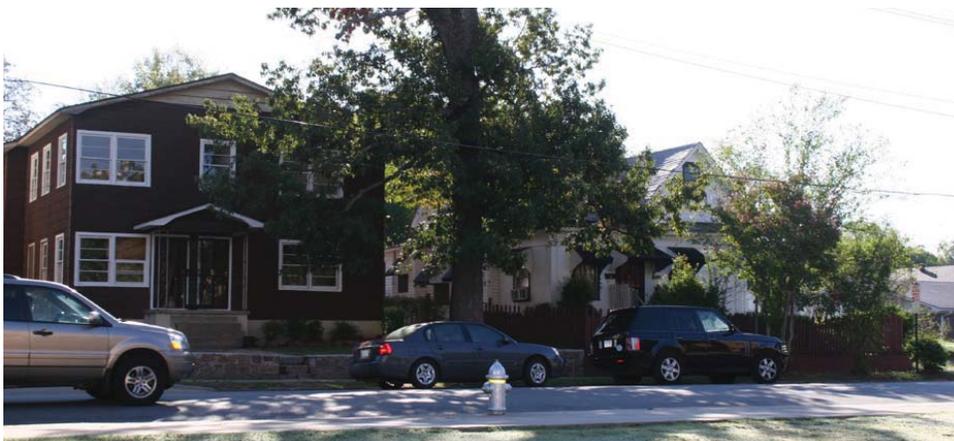
**Figure 2-37.** The last house facing the school is seen here (looking southeast), center, next to an open lot and garden between it and a church on the corner. *Source: John Milner Associates, Inc., 2007.*

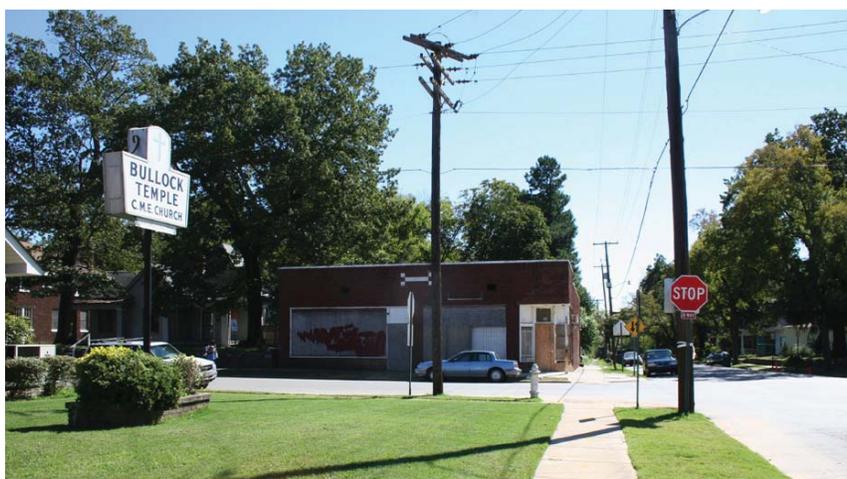
**Figure 2-38.** The south end of the S. Park Street block that faces the school. The sign on the left is for the Bullock Temple C.M.E. Church; the building across the street is the Capel Building (formerly Ponder's Drug Store).

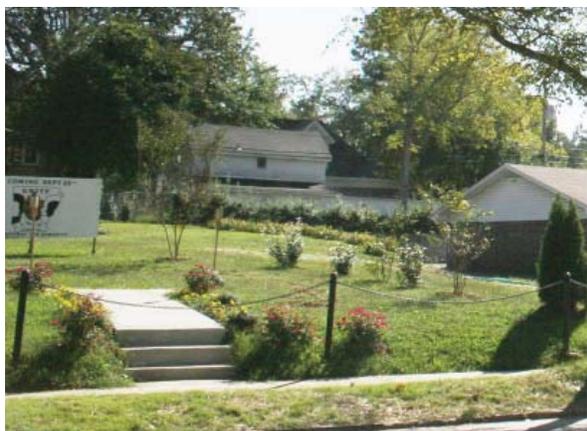
**Figure 2-39.** A small garden occupies site of a former residence on S. Park Street, adjacent to the north side of the church. *Source: John Milner Associates, Inc., 2007.*

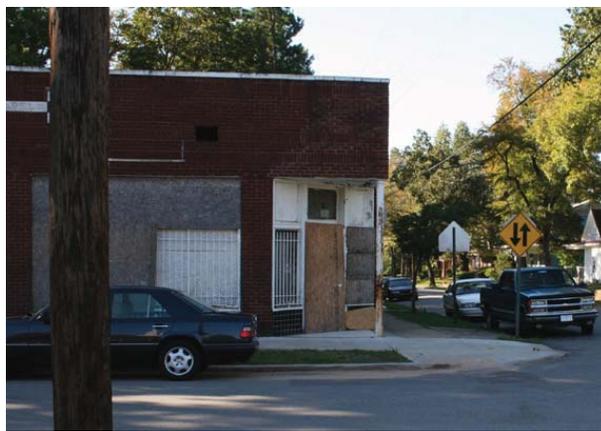
**Figure 2-40.** The Capel Building (formerly Ponder's Drug Store) is currently unoccupied. *Source: John Milner Associates, Inc., 2007.*

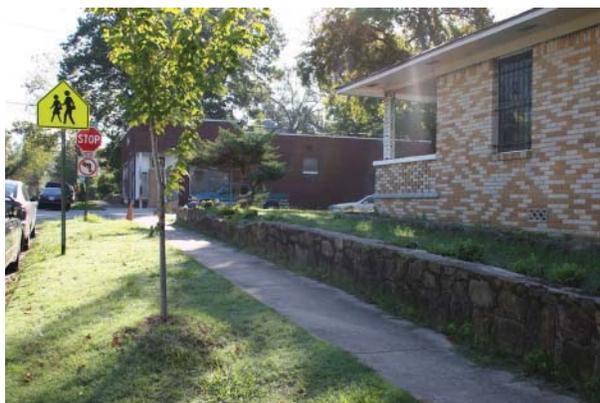
**Figure 2-41.** The brick house and mortared stone retaining wall across from the former Ponder's drug store is depicted in photographs from 1957. *Source: John Milner Associates, Inc., 2007.*

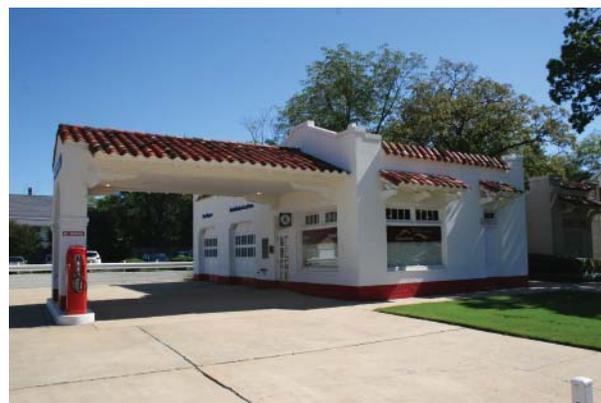
**Figure 2-42.** The Mobil Magnolia service station, where journalists phoned in their stories in 1957, was rehabilitated to its ca. 1950s appearance in 1997. *Source: John Milner Associates, Inc., 2007.*

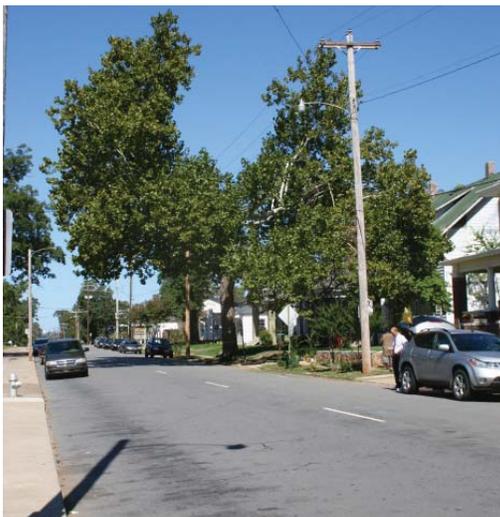
**Figure 2-43.** S. Park Street (looking north) is a one-way street headed south. *Source: John Milner Associates, Inc., 2007.*

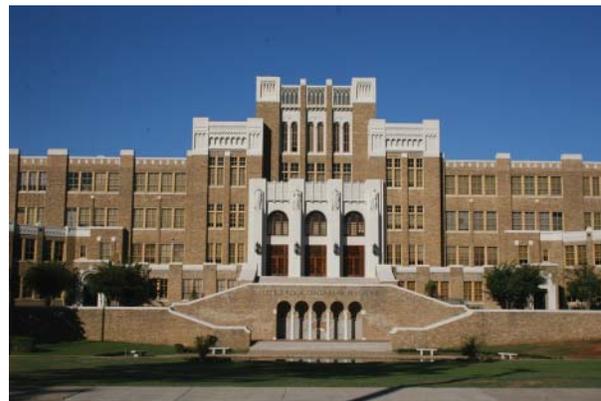
**Figure 2-44.** The front grounds of Central High School are organized symmetrically along a central axis leading from the front door. *Source: John Milner Associates, Inc., 2007.*

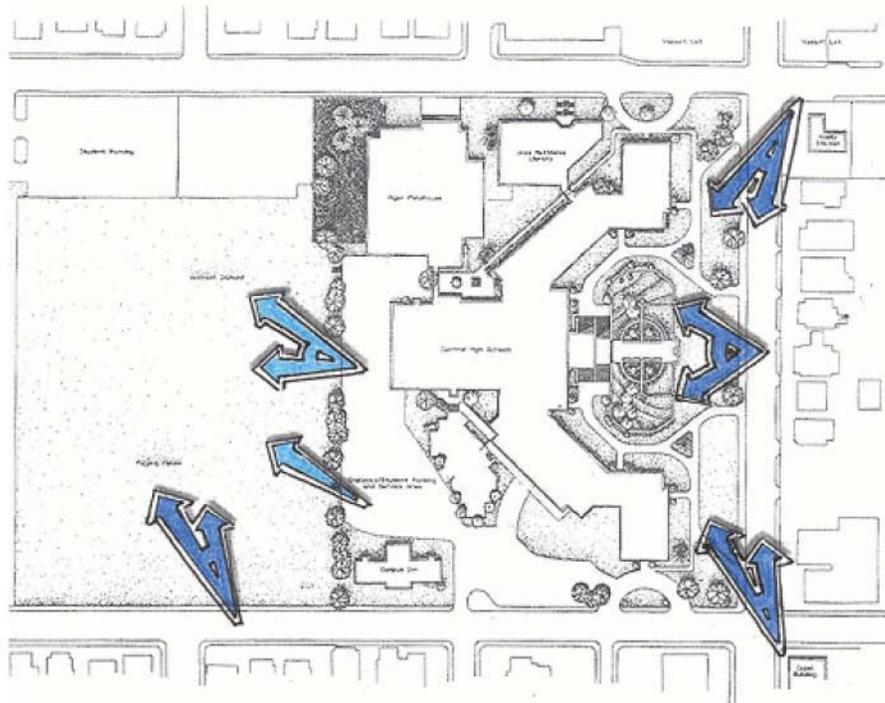
**Figure 2-45.** Views Around Central High School; Dark Blue=Historic Views (views from streets); Light Blue=General Views (interior views). *Source: "Little Rock Central High School, Little Rock Central High School National Historic Site," National Park Service Cultural Landscape Inventory (CLI), 2003, 53.*

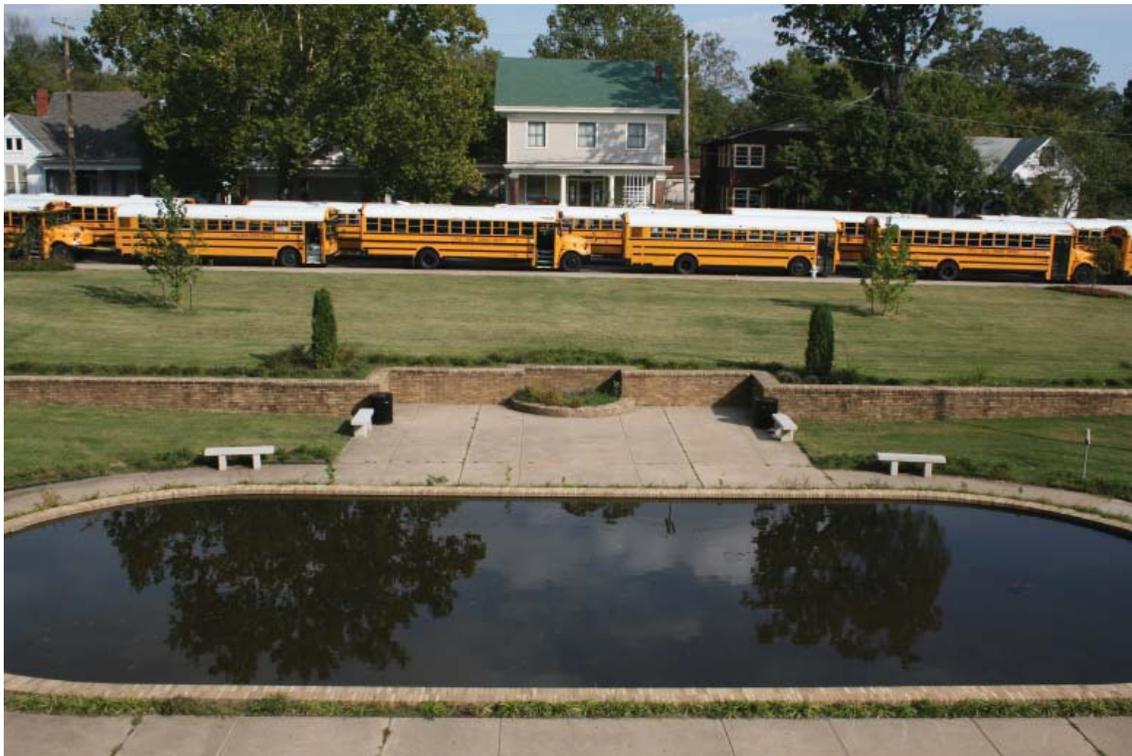
**Figure 2-46.** View from the entrance landing of Central High School, looking east across the front lawn towards S. Park Street. *Source: John Milner Associates, Inc., 2008.*

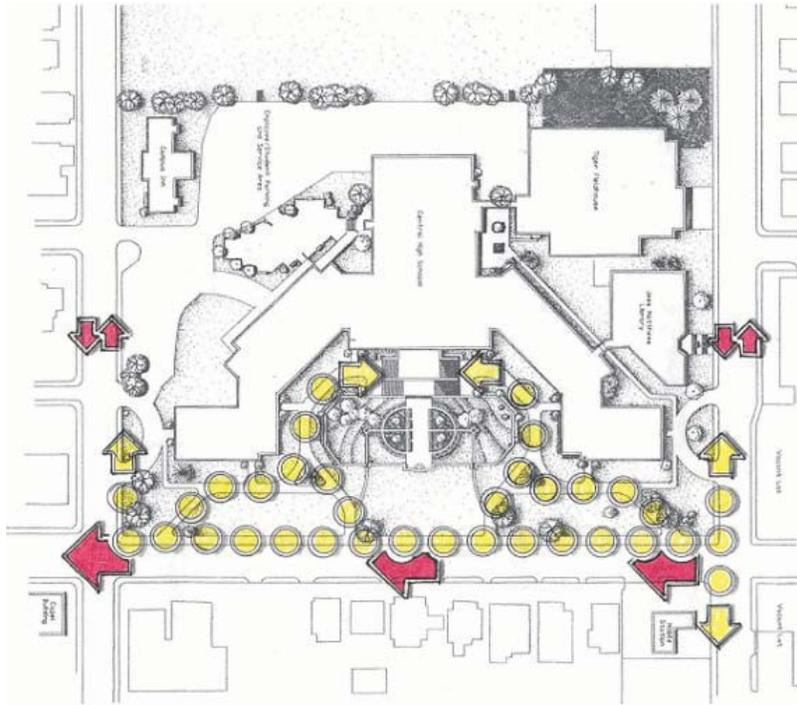
**Figure 2-47.** Vehicle and Pedestrian Traffic Circulation; Red=Vehicular (large arrows on streets); Yellow=Pedestrian (small arrows on sidewalks). Source: "Little Rock Central High School, Little Rock Central High School National Historic Site," *National Park Service Cultural Landscape Inventory (CLI)*, 2003, 49.

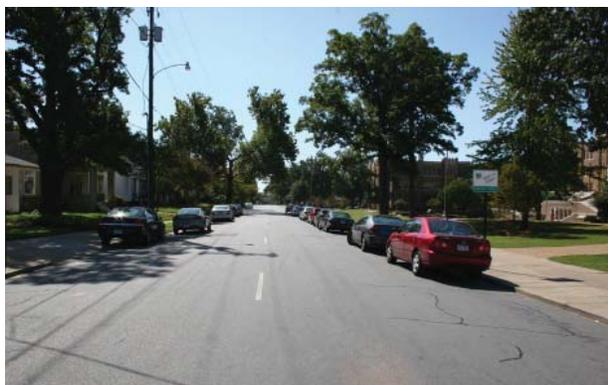
**Figure 2-48.** S. Park Street (looking south); the west side of the street is used for school bus drop-off and pick-up. *Source: John Milner Associates, Inc., 2007.*

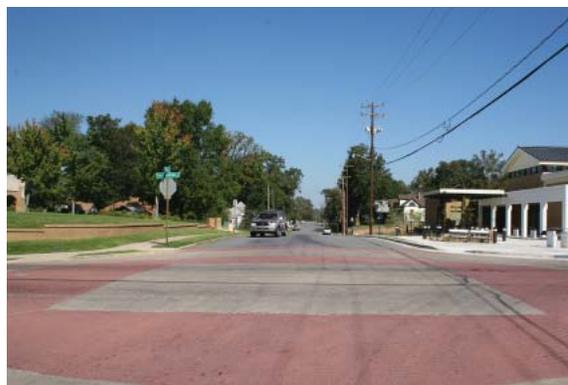
**Figure 2-49.** A scored and tinted concrete paving pattern has been recently installed at the intersection S. Park Street and Daisy Bates. *Source: John Miln Associates, Inc., 2007.*

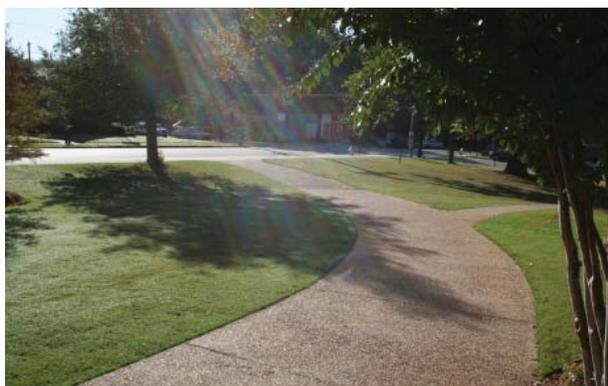
**Figure 2-50.** Curvilinear sidewalks within the school property have been recently re-surfaced with exposed aggregate. Today's material, as well as the walks' alignments, are consistent with the historic period's. *Source: John Milner Associates, Inc., 2007.*

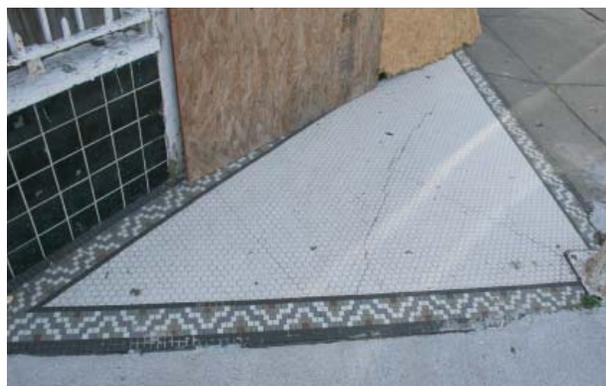
**Figure 2-51.** Ornamental ceramic tile at the threshold of the Capel Building (formerly Ponder's Drug Store). *Source: John Milner Associates, Inc., 2007.*

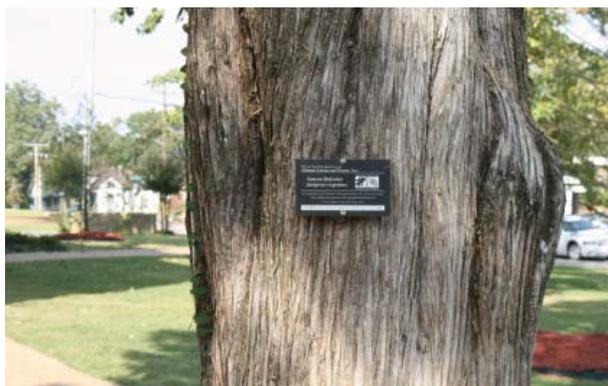
**Figure 2-52.** Plaques signify the 28 trees on the Central High School front lawn remaining from 1957-58, known as the "Little Rock Nine Witness Trees." *Source: John Milner Associates, Inc., 2007.*

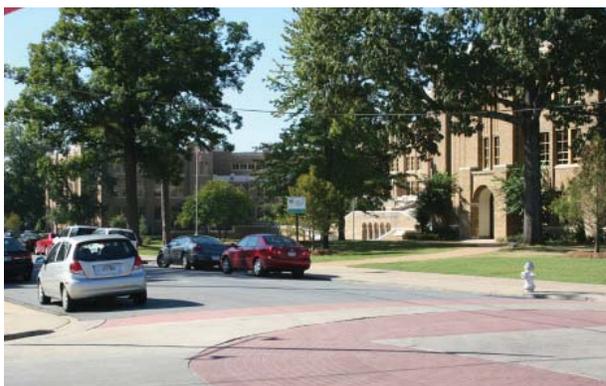
**Figure 2-53.** Vegetation within the historic scene including large shade trees and medium evergreen, small flowering trees, evergreen shrubs, ground covers and lawn. *Source: John Milner Associates, Inc., 2007.*

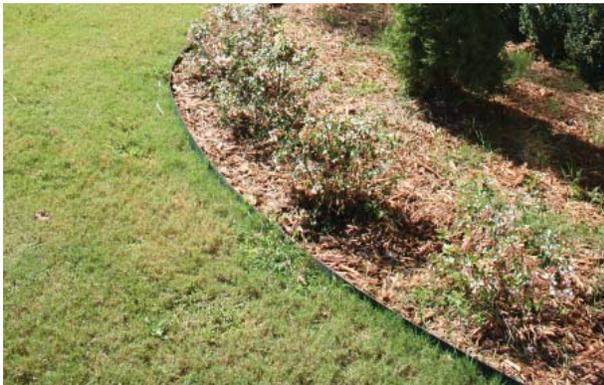
**Figure 2-54.** Metal edging inscribes curvilinear, mulched foundation plantings around the school. *Source: John Milner Associates, Inc., 2007.*

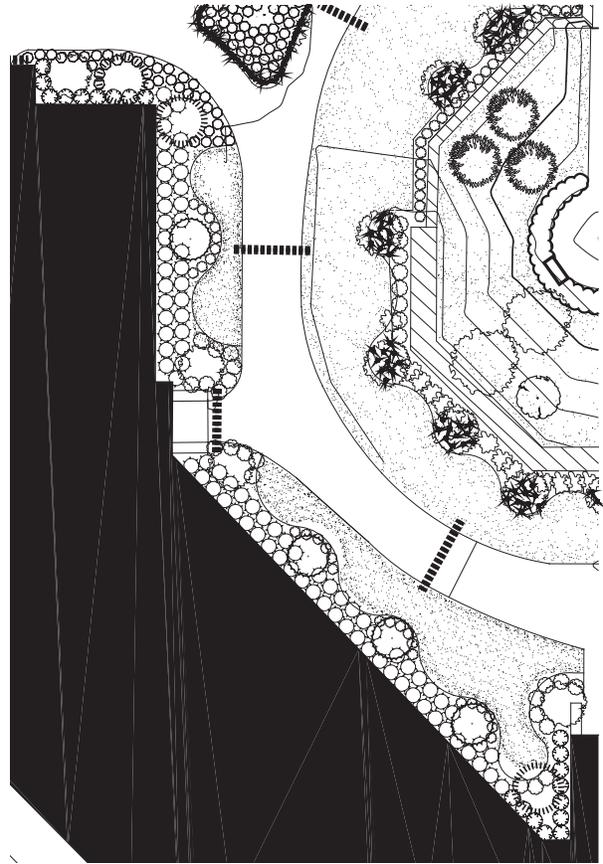
**Figure 2-55.** Detail of 2007 Landscape Plan. *Source: Frank R. Riggins, "Central High School Landscape," Phases 1-2. Crafton, Tull, and Associates, Inc. (now Crafton, Tull, Sparks and Associates, Inc.), Little Rock, Arkansas, 2007 (AutoCAD drawing).*

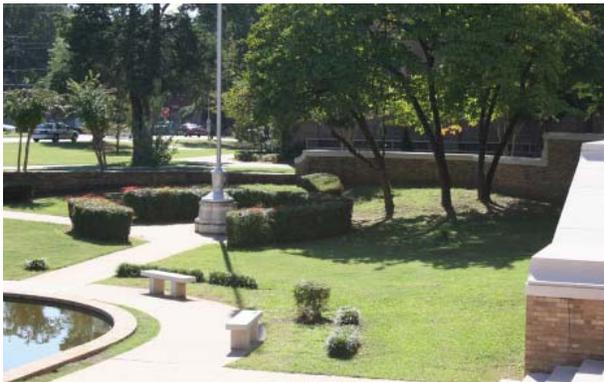
**Figure 2-56.** New and older plantings of dogwood trees, evergreen shrubs, perennials and annuals ornament the sunken plaza. *Source: John Milner Associates, Inc., 2007.*

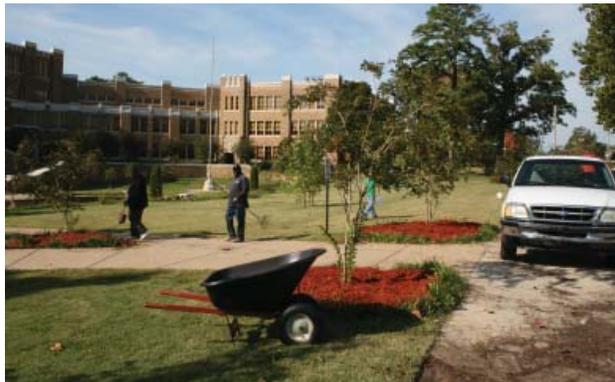
**Figure 2-57.** Redwood mulch around new plantings on the front lawn of Central High School is obtrusive. *Source: John Milner Associates, Inc., 2007.*

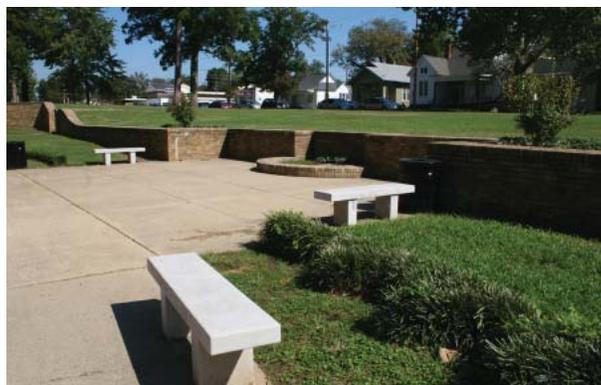
**Figure 2-58.** Ten concrete commemorative benches in the sunken plaza area are inscribed with the names of the “Little Rock Nine;” the tenth represents all past, present, and future students of the school. *Source: John Milner Associates, Inc., 2007.*

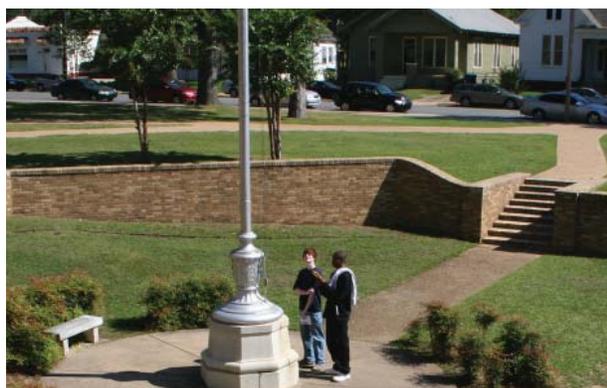
**Figure 2-59.** Two flagpoles in the sunken plaza are extant from 1927. *Source: John Milner Associates, Inc., 2007.*

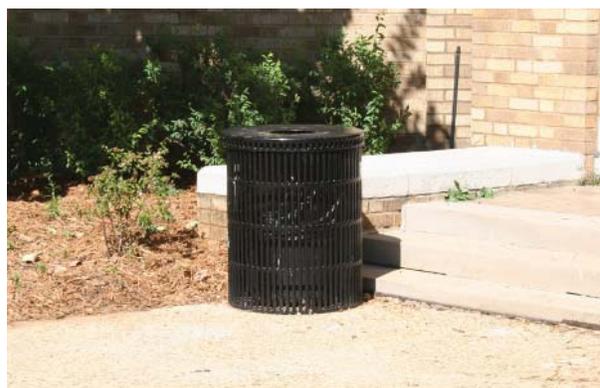
**Figure 2-60.** Painted steel trash cans are small-scale features in the front plaza and at school entrances today. *Source: John Milner Associates, Inc., 2007.*

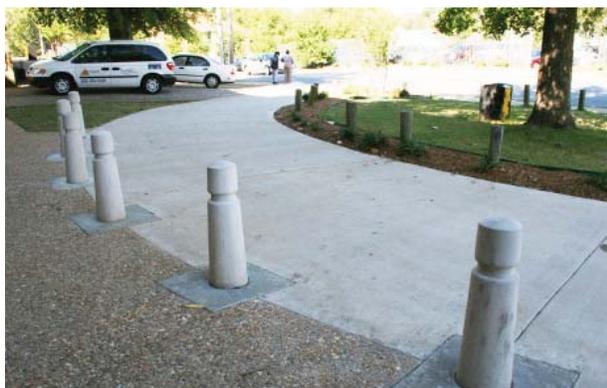
**Figure 2-61.** Concrete bollards, installed in 2007, at the east end entrance door. *Source: John Milner Associates, Inc., 2007.*

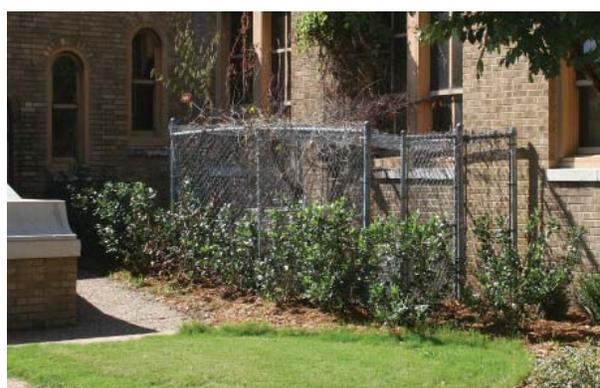
**Figure 2-62.** Chain link fencing and shrubs secure and partially conceal HVAC equipment near the front entrance of the school. *Source: John Milner Associates, Inc., 2007.*

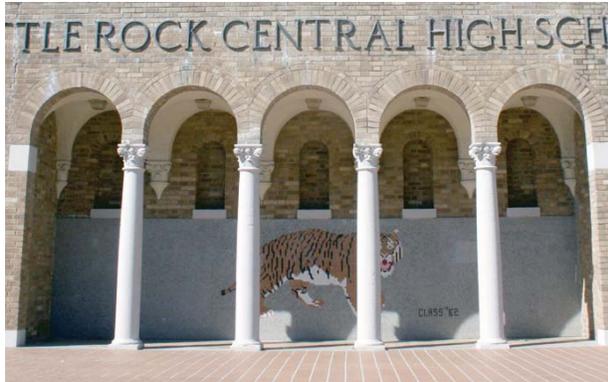
**Figure 2-63.** A ceramic tile tiger mosaic adjacent to the reflecting pool was a gift from the Class of 1962. *Source: John Milner Associates, Inc., 2007.*

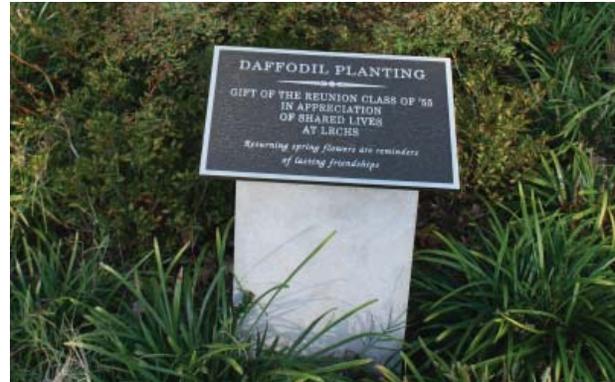
**Figure 2-64.** Plaques on the Central High School front lawn commemorate gifts from alumnus, such as the daffodil bed. *Source: John Milner Associates, Inc.,*

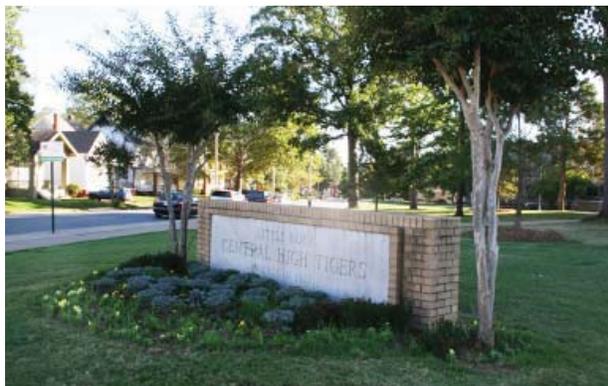
**Figure 2-65.** A monument sign on the northeast corner of the school property was a gift from the Class of 1972. *Source: John Milner Associates, Inc., 2007.*

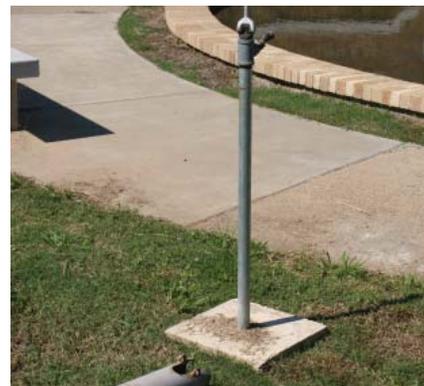
**Figure 2-66.** A water faucet is located near the reflecting pool. *Source: John Milner Associates, Inc., 2007.*

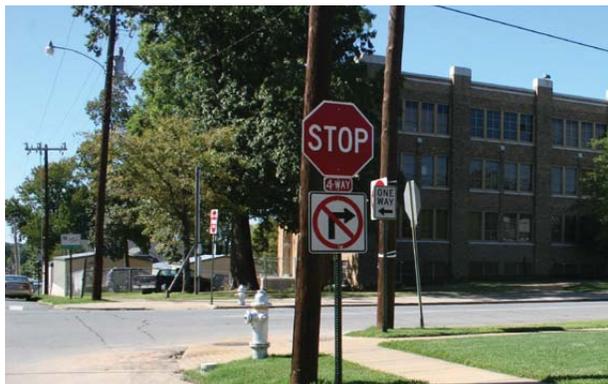
**Figure 2-67.** Typical signage along S. Park Street (seen here at the intersection of W. Sixteenth looking west). *Source: John Milner Associates, Inc., 2007.*

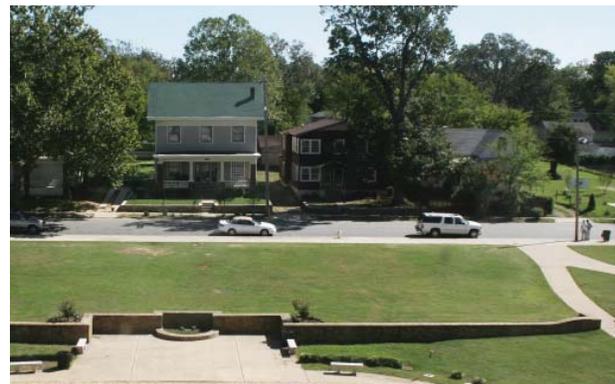
**Figure 2-68.** Utility poles that lined the west side of S. Park Street in 1957 are not present today (view from inside the high school library). *Source: John Milner Associates, Inc., 2007.*

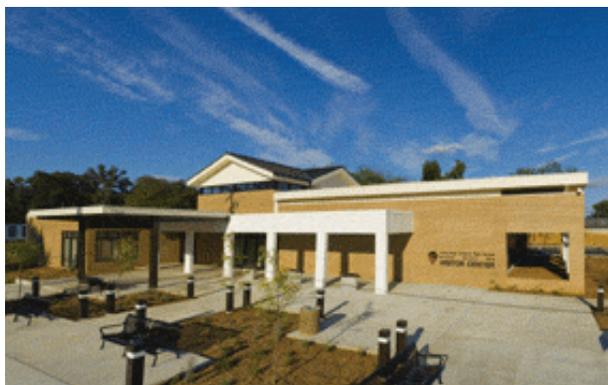
**Figure 2-69.** The Little Rock Central High School NHS Visitor Center opened in the fall of 2007.  
*Source: John Milner Associates, Inc., 2007.*

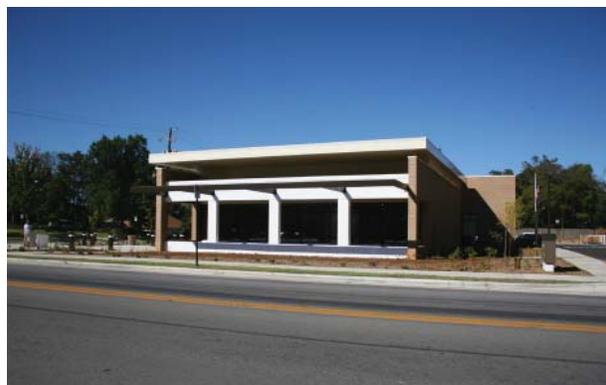
**Figure 2-70.** The south end of the Visitor Center features glass windows, such that a view of the school forms the backdrop of its interior interpretive exhibits.  
*Source: John Milner Associates, Inc., 2007.*

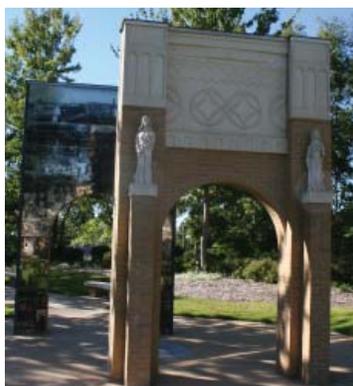
**Figure 2-71.** A sculptural installation is the centerpiece of the Commemorative Garden.  
*Source: John Milner Associates, Inc., 2007.*

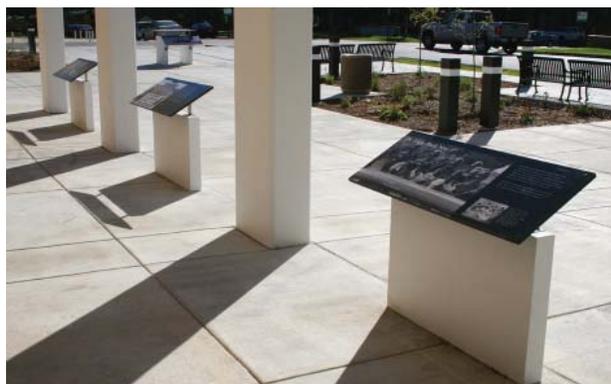
**Figure 2-72.** The seating plaza associated with the Visitor Center features interpretive displays.  
*Source: John Milner Associates, Inc., 2007.*

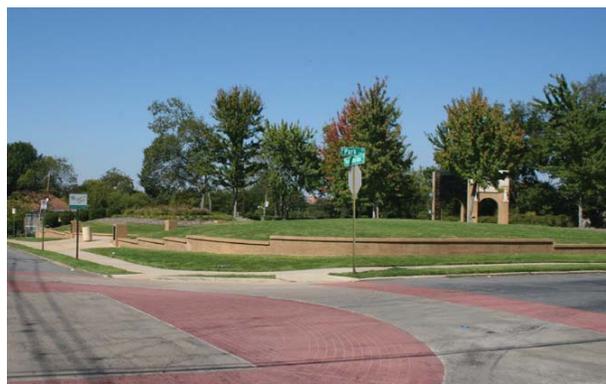
**Figure 2-73.** The southeastern corner of the Commemorative Garden is an open, grass knoll.  
*Source: John Milner Associates, Inc., 2007.*

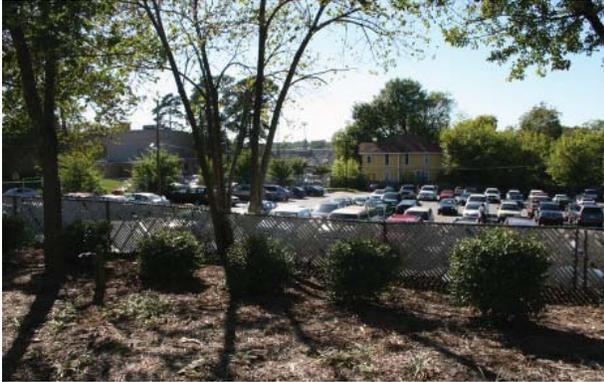
**Figure 2-74.** Vegetation and a fence partially screen the high school's north parking lot from the Commemorative Garden. *Source: John Milner Associates, Inc., 2007.*

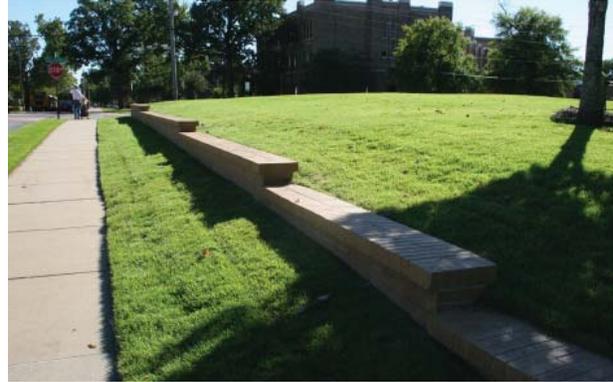
**Figure 2-75.** Concrete sidewalks edge both sides of S. Park Street, seen here looking south. *Source: John Milner Associates, Inc., 2007.*

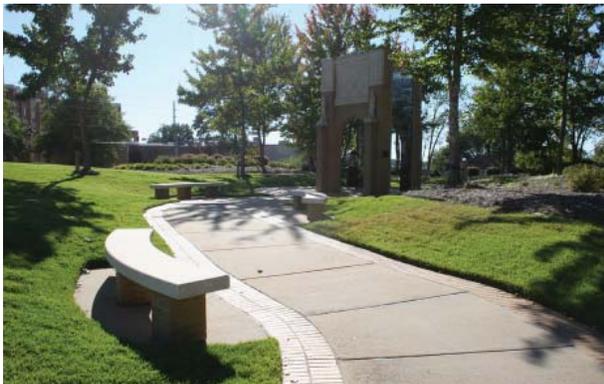
**Figure 2-76.** A curvilinear, brick-edged concrete sidewalk winds through the Commemorative Garden. *Source: John Milner Associates, Inc., 2007.*

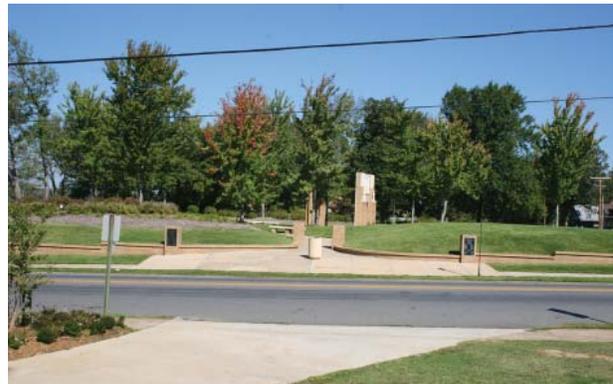
**Figure 2-77.** The entrance to the Commemorative Garden on Daisy Bates, looking north from the school grounds across the street. *Source: John Milner Associates, Inc., 2007.*

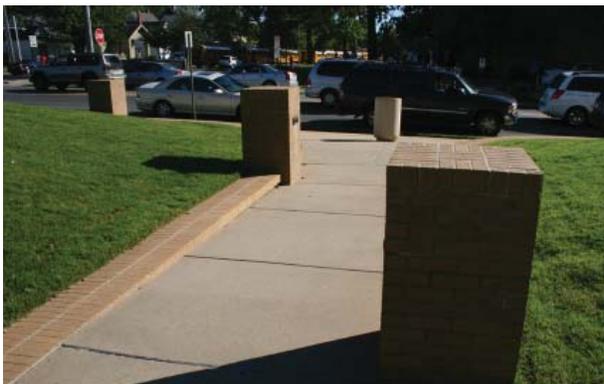
**Figure 2-84.** Brick bollards with inset path lights in the Commemorative Garden.  
*Source: John Milner Associates, Inc., 2007.*

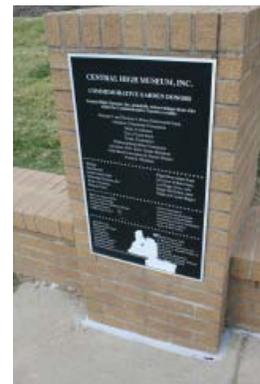
**Figure 2-85.** Square brick column with inset dedication plaque in the Commemorative Garden.  
*Source: John Milner Associates, Inc., 2007.*

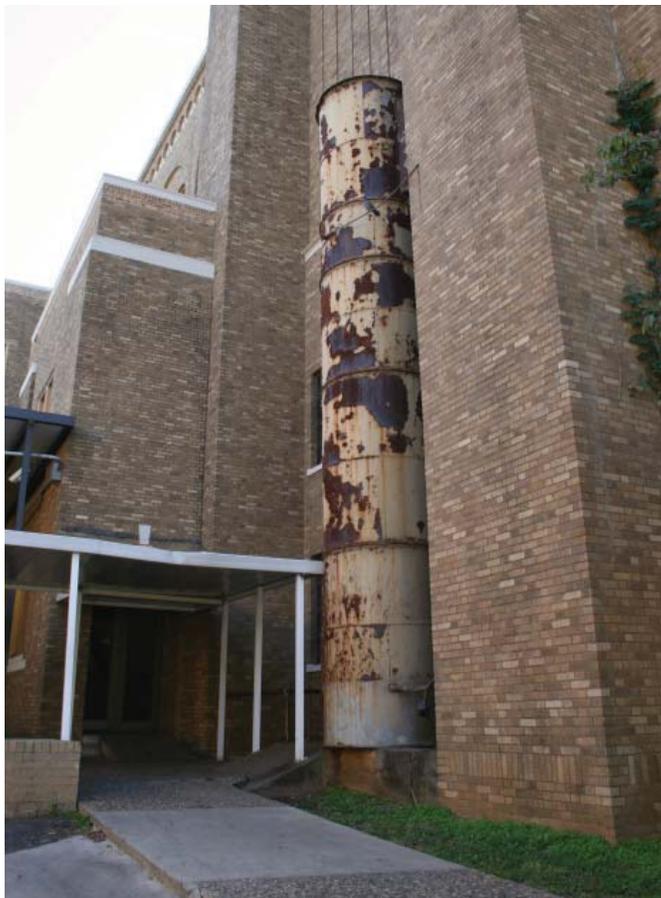
**Figure 2-86.** One of the features found at the back of the building is this spiral slide enclosed in metal sheeting, presumably original to the building. Its twin is located on the opposite corner on the same side of the building.  
*Source: John Milner Associates, Inc., 2007.*

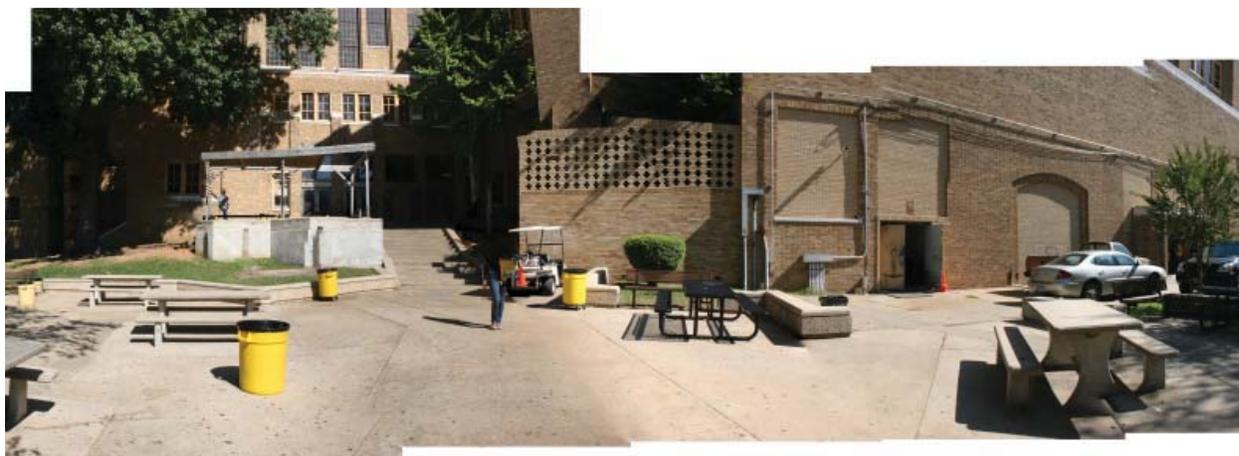
**Figure 2-87.** This panoramic photo-montage illustrates the complex rear facade of the high school building and the variety of uses hosted there. Access to the lower level is through the garage doors to the right.  
*Source: John Milner Associates, Inc., 2007.*

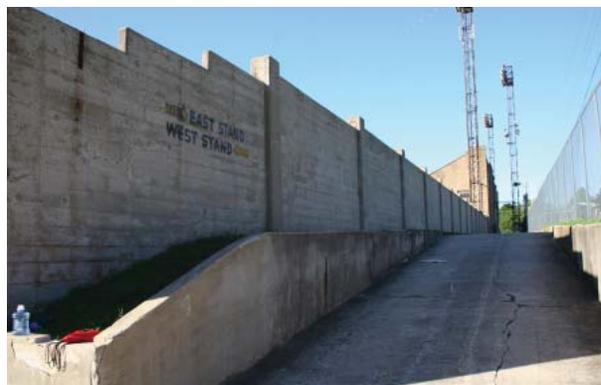
**Figure 2-89.** Looking north along the poured concrete wall surrounding Quigley Stadium. *Source: John Milner Associates, Inc., 2007.*

**Figure 2-115.** The poured concrete wall that surrounds Quigley Stadium. *Source: John Milner Associates, Inc., 2007.*

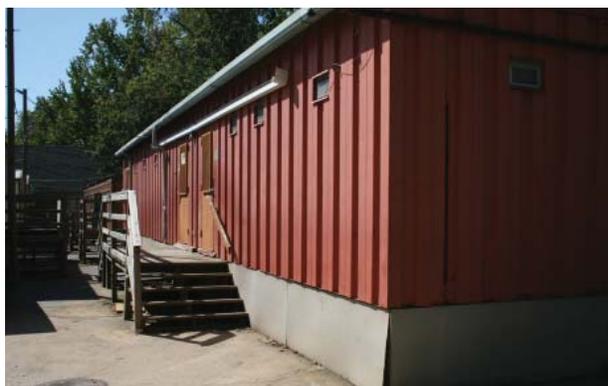
**Figure 2-100.** The portable classrooms are prefabricated structures of varying colors and styles. *Source: John Milner Associates, Inc., 2007.*

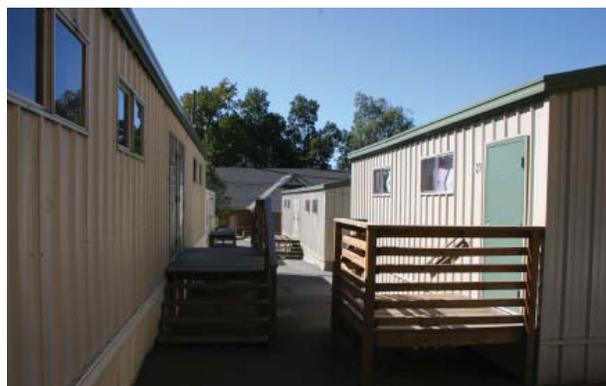
**Figure 2-101.** Wood stairs, handrails and landings access the portable classrooms. *Source: John Milner Associates, Inc., 2007.*

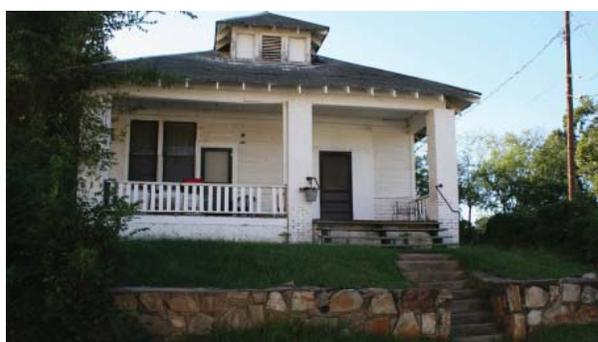
**Figure 2-108.** Craftsman house facing CHS on Jones Street; note stone retaining wall. *Source: John Milner Associates, Inc., 2007.*

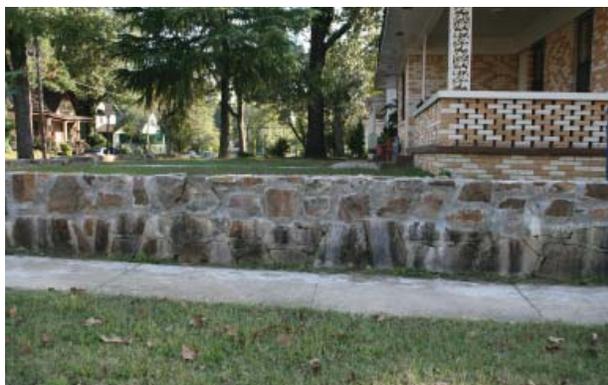
**Figure 2-111.** A retaining wall on the corner of S. Park and W. Sixteenth Streets. *Source: John Milner Associates, Inc., 2007.*

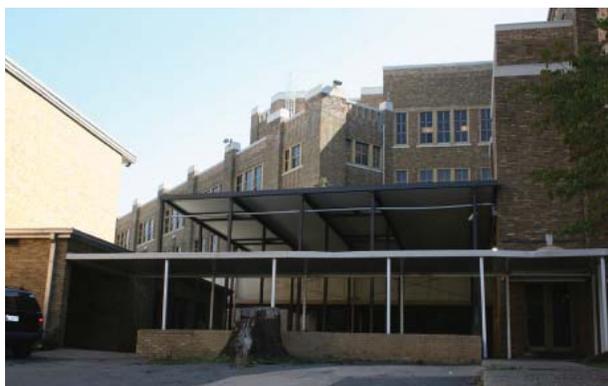
**Figure 2-113.** Overhead structures and passageways on the south side of the high school. *Source: John Milner Associates, Inc., 2007.*

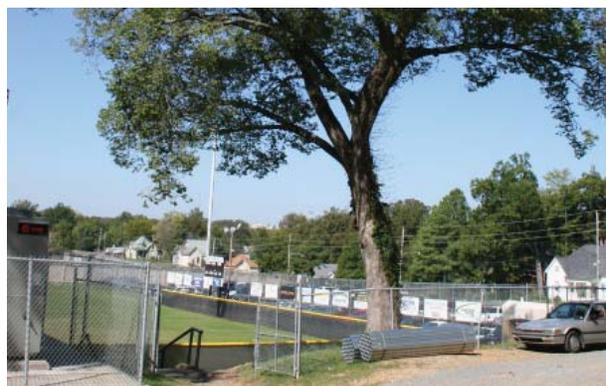
**Figure 2-114.** Chain link fence surrounds many areas within the school ground. *Source: John Milner Associates, Inc., 2007.*

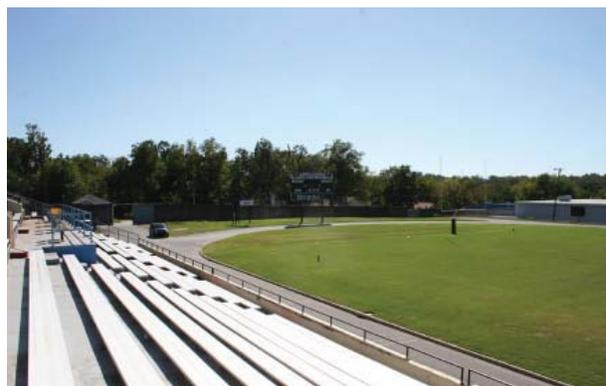
**Figure 2-116.** View of the surrounding wall from within the stadium. *Source: John Milner Associates, Inc., 2007.*

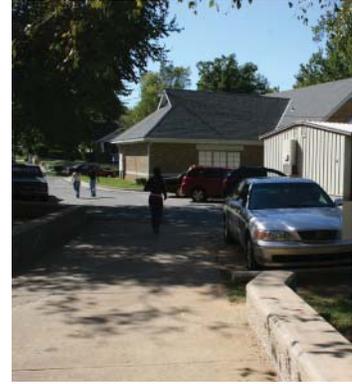
**Figure 2-119.** Views towards the neighborhood are also obstructed by the modular structures. *Source: John Milner Associates, Inc., 2007.*

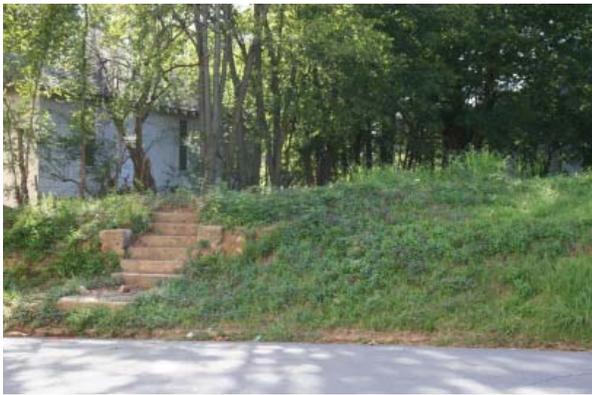
**Figure 2-120.** Site of demolished house on Jones Street, west of the high school. *Source: John Milner Associates, Inc., 2007.*

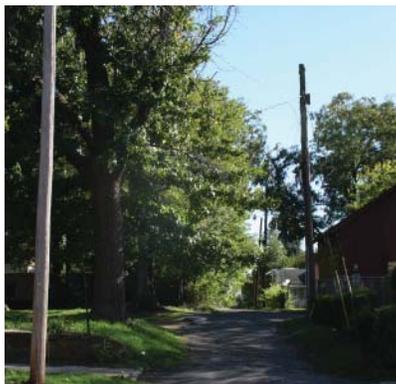
**Figure 2-122.** A tree-lined alley between S. Park Street and Denison Street. *Source: John Milner Associates, Inc., 2007.*

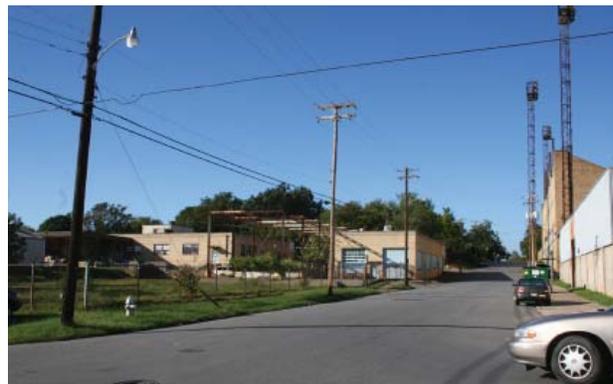
**Figure 2-123.** A warehouse west of Quigley Stadium is accessed from Jones Street. *Source: John Milner Associates, Inc., 2007.*

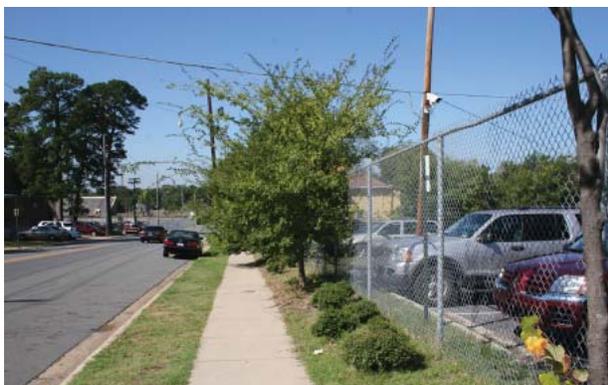
**Figure 2-124.** The parking lot on the north side of Daisy Bates, across from the high school. *Source: John Milner Associates, Inc., 2007.*

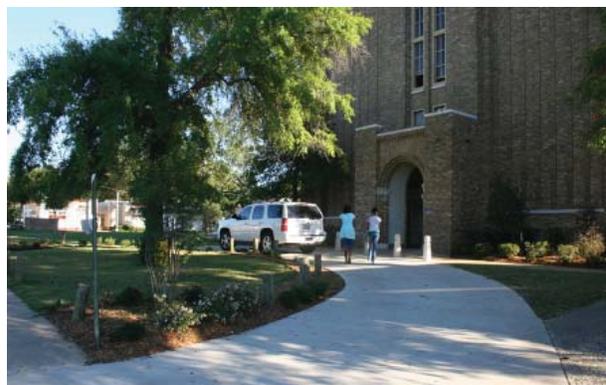
**Figure 2-125.** An accessible drop-off area, on the north side of the school. *Source: John Milner Associates Inc., 2007.*

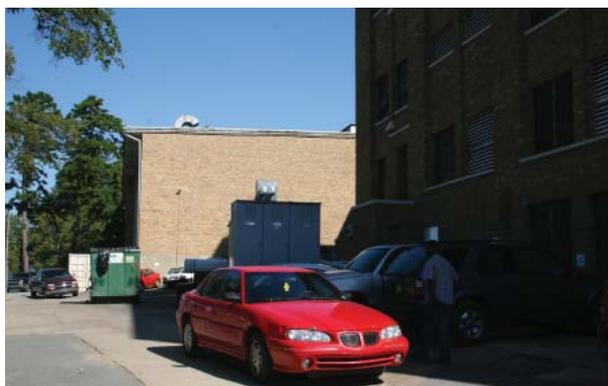
**Figure 2-126.** Cars parked in the unassigned areas behind the school. *Source: John Milner Associates Inc., 2007.*

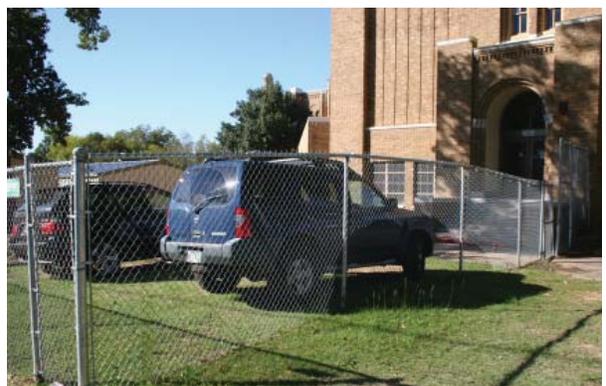
**Figure 2-127.** Cars parked behind a chain link fence on the south side of the school. *Source: John Milner Associates, Inc., 2007.*

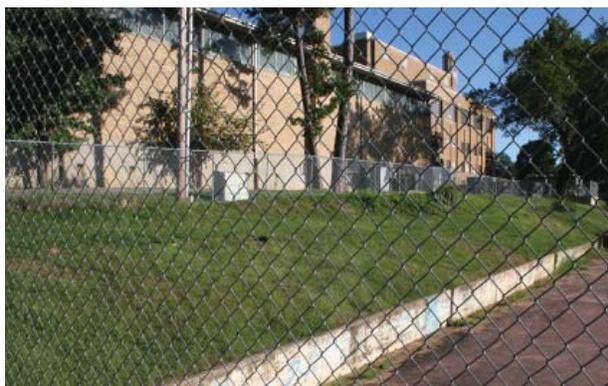
**Figure 2-128.** The parking lot west of the school and the surrounding chain-link fence. *Source: John Milner Associates, Inc., 2007.*
