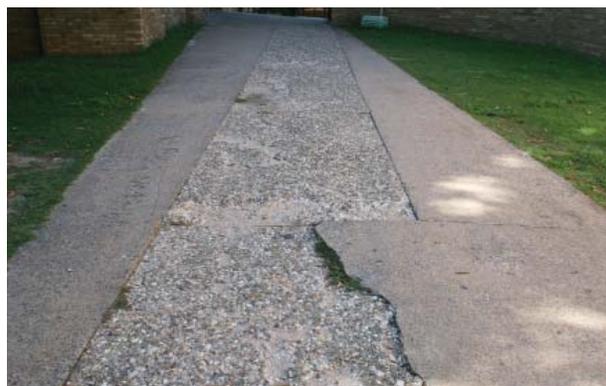
**Figure 2-129.** Paving in need of repair. *Source: John Milner Associates Inc., 2007.*

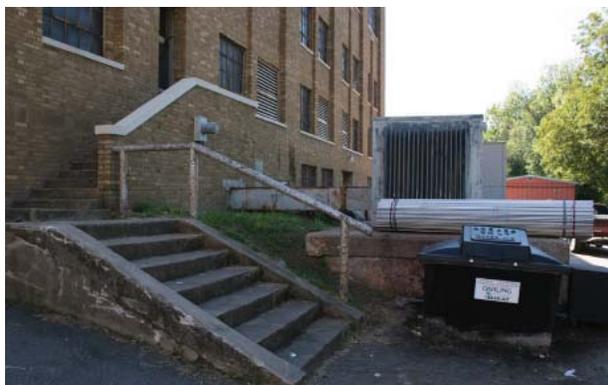
**Figure 2-130.** Damaged stair cheekwalls. *Source: John Milner Associates, Inc., 2007.*

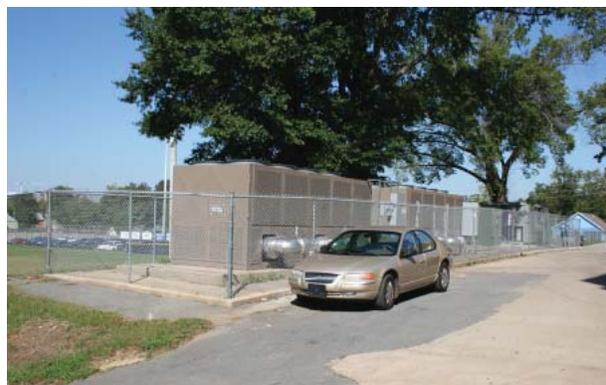
**Figure 2-131.** Pavement in drives is cracked and patched. *Source: John Milner Associates, Inc., 2007.*

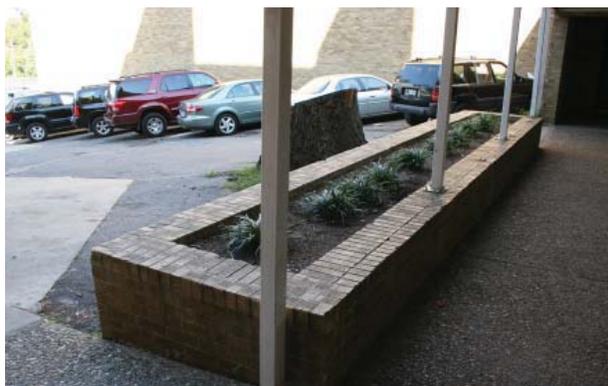
**Figure 2-134.** A raised planter near one of the overhead canopies on the west side of the school. *Source: John Milner Associates, Inc., 2007.*

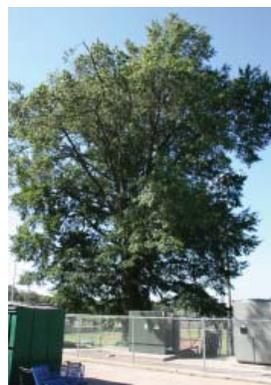
**Figure 2-137.** Large tree preserved on the slope west of the school. *Source: John Milner Associates, Inc., 2007.*

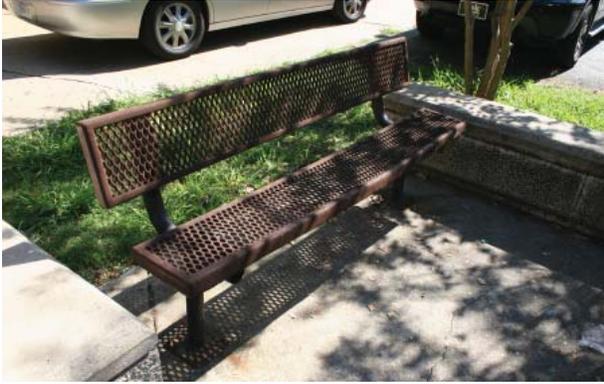
**Figure 2-141.** Brown-painted punched metal bench. *Source: John Milner Associates, Inc., 2007.*

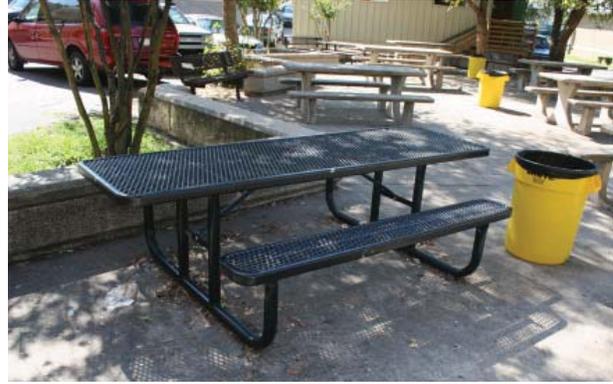
**Figure 2-142.** Black-painted punched metal bench. *Source: John Milner Associates, Inc., 2007.*

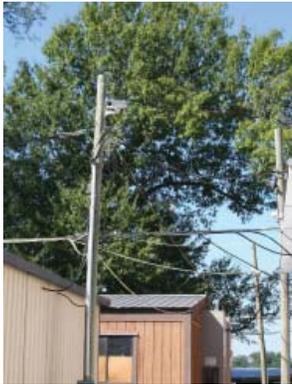
**Figure 2-143.** Utility poles between the modular structures on the southwest side of the school. *Source: John Milner Associates, Inc., 2007.*

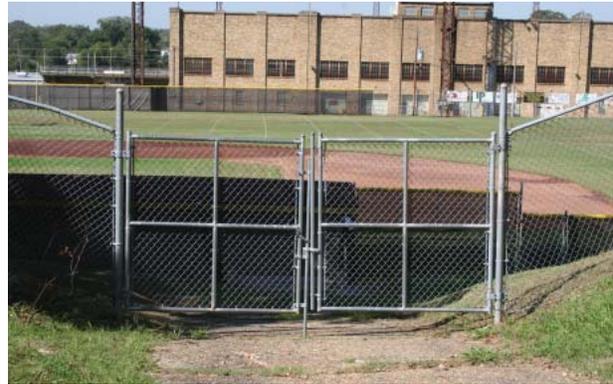
**Figure 2-144.** Chain-link fence and gate securing the playing fields. *Source: John Milner Associates, Inc., 2007.*

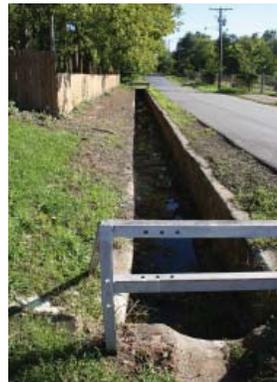
**Figure 2-145.** A drainage canal along Jones Street that begins at W. Sixteenth St. *Source: John Milner Associates, Inc., 2007.*
