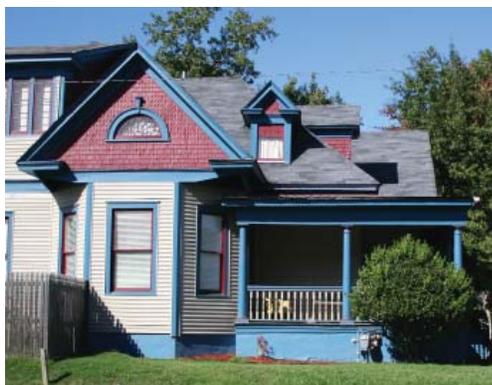
Figure 2-147. Example of an earlier version of Colonial Revival. *Source: John Milner Associates, Inc., 2007.*

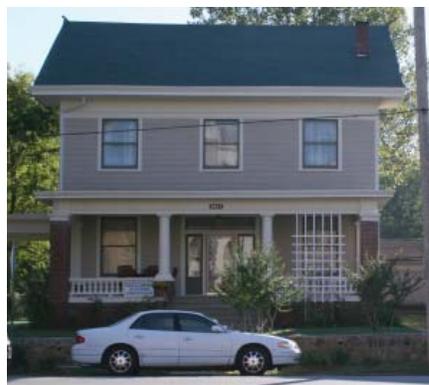
Figure 2-148. Example of a later type of Colonial Revival. *Source: John Milner Associates, Inc., 2007.*

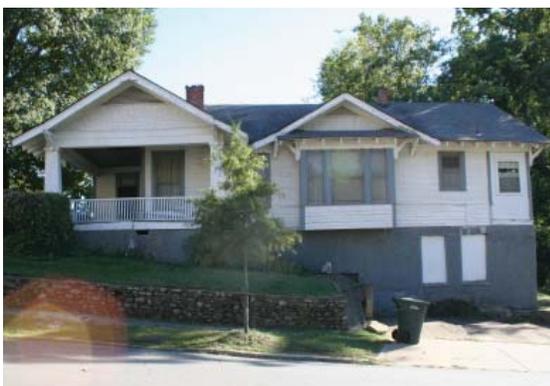
Figure 2-149. Example of a Craftsman Bungalow. *Source: John Milner Associates, Inc., 2007.*

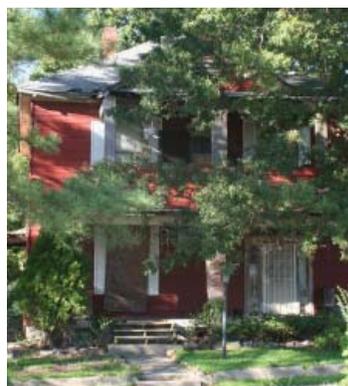
Figure 2-150. Example of a Greek Revival house. *Source: John Milner Associates, Inc., 2007.*

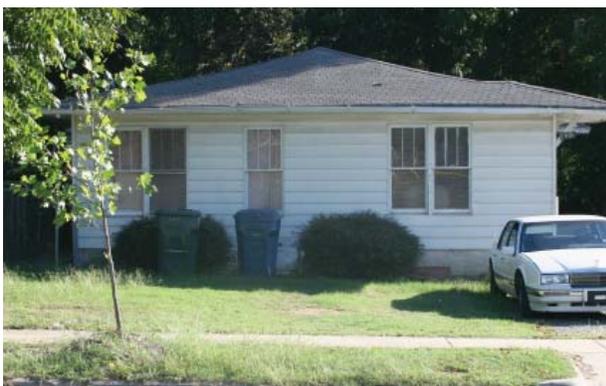
Figure 2-151. Typical mid-20th century Minimal Traditional house. *Source: John Milner Associates, Inc., 2007.*

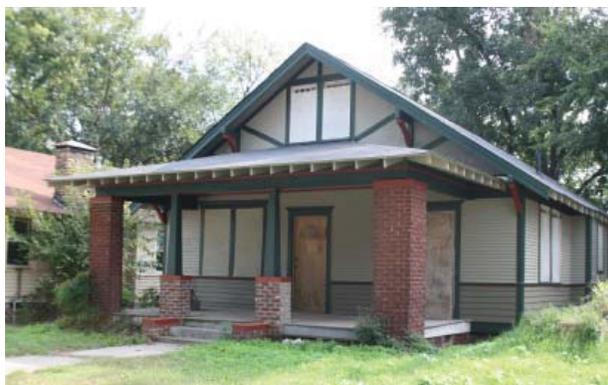
Figure 2-152. Brick porch columns. *Source: John Milner Associates, Inc., 2007.*

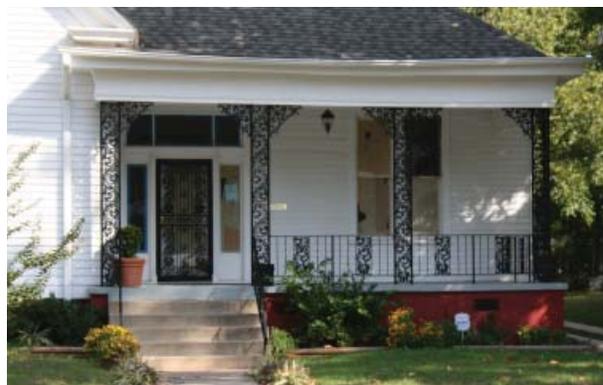
Figure 2-153. Ornamental metal porch columns. *Source: John Milner Associates, Inc., 2007.*

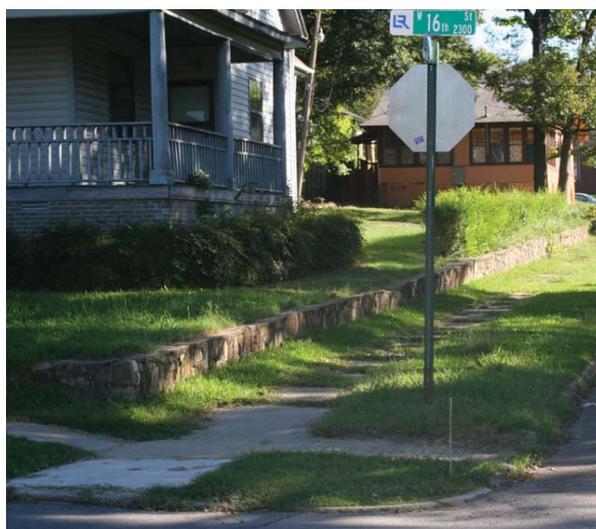
Figure 2-159. Raised lot supported by low retaining wall. *Source: John Milner Associates, Inc., 2007.*

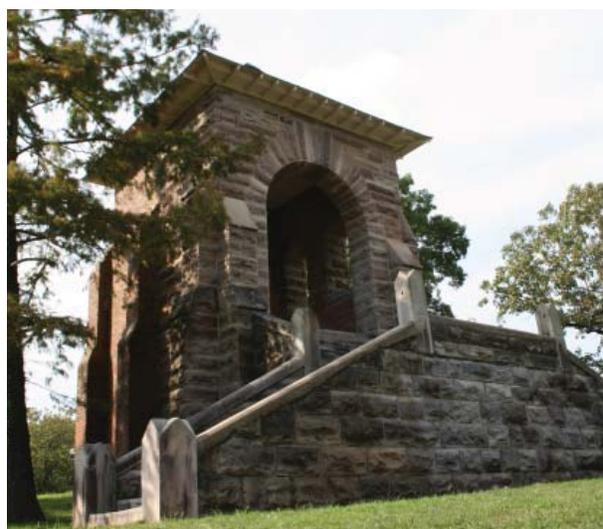
Figure 2-160. Remnant stone entrance to the former Centennial Elementary School. *Source: John Milner Associates, Inc., 2007.*

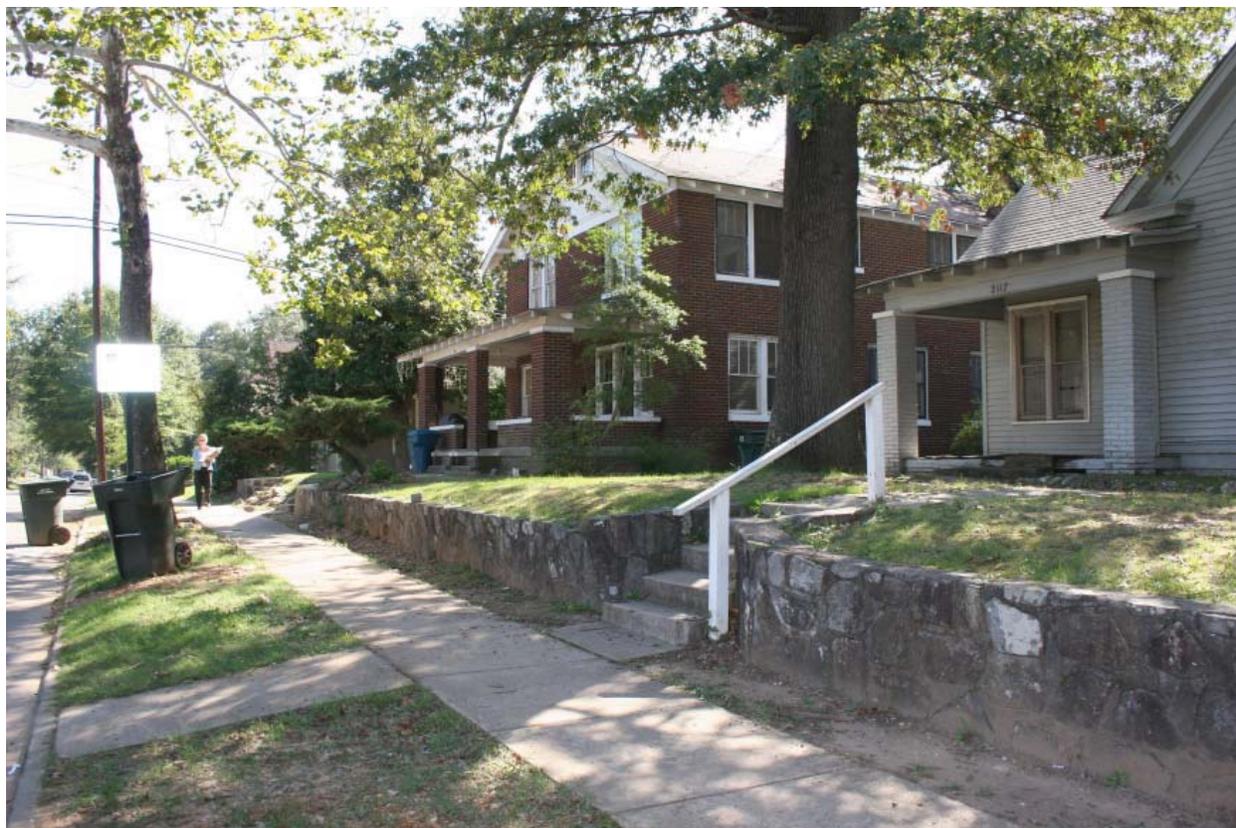
Figure 2-161. This photographs illustrates the hierarchy of public to private space typical of the streetscape of the neighborhood setting of Central High. *Source: John Milner Associates, Inc., 2007.*

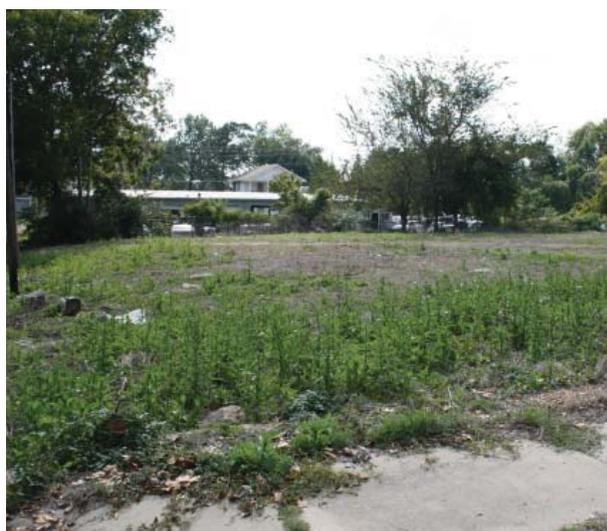
Figure 2-162. Gaps in the neighborhood fabric left by demolition interrupt the lineary qualities of the streetscape. *Source: John Milner Associates, Inc., 2007.*

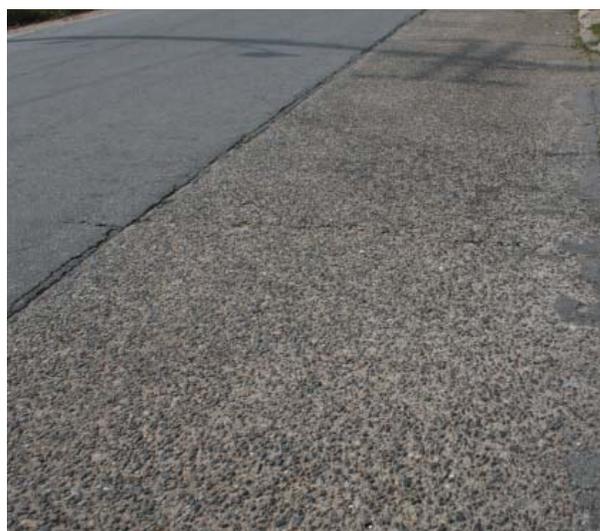
Figure 2-163. A broad exposed aggregate gutter or parking strip lines may of the streets. *Source: John Milner Associates, Inc., 2007.*

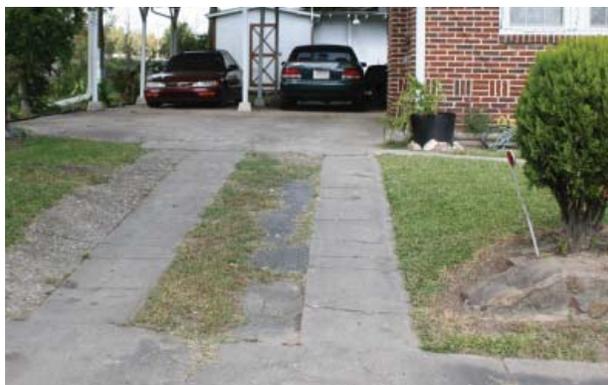
Figure 2-164. Residential driveways are frequently concrete two-tracks with a turf center. *Source: John Milner Associates, Inc., 2007.*

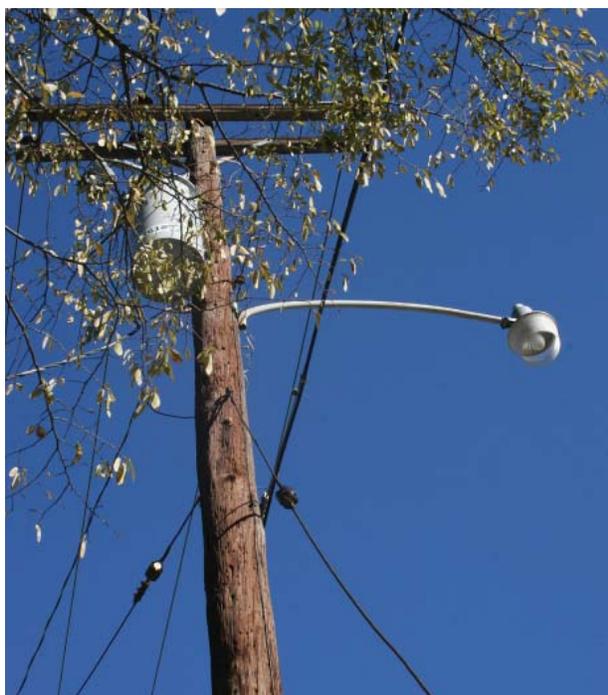
Figure 2-166. Street lighting attached to a utility pole. *Source: John Milner Associates, Inc., 2007.*

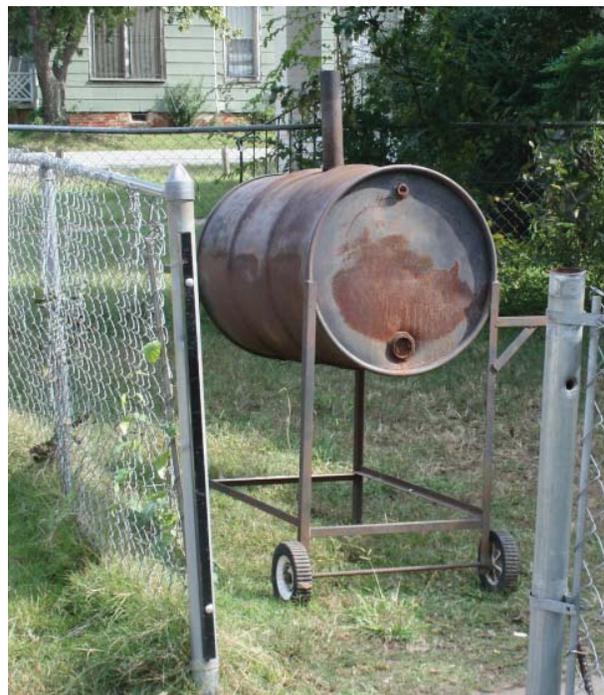
Figure 2-167. Backyard smoker fabricated from an oil drum. *Source: John Milner Associates, Inc., 2007.*

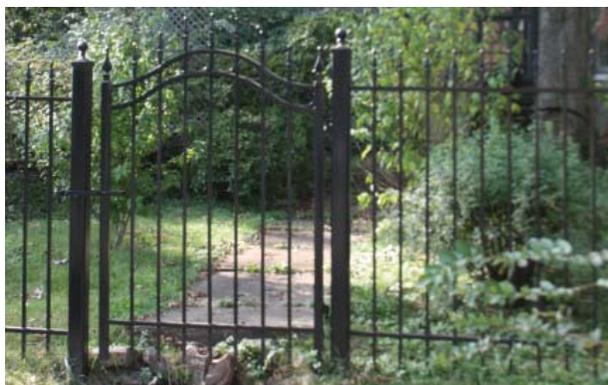
Figure 2-168. Metal fencing. *Source: John Milner Associates, Inc., 2007.*

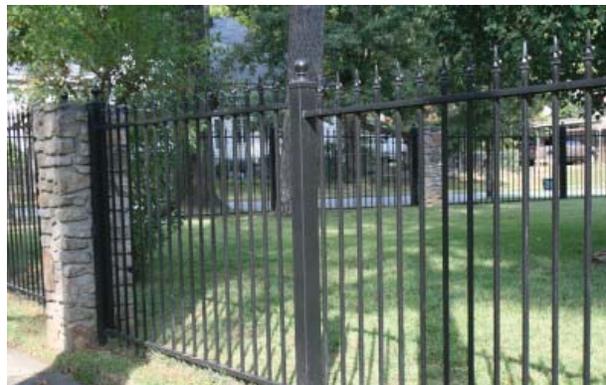
Figure 2-169. Metal fencing with stone columns. *Source: John Milner Associates, Inc., 2007.*

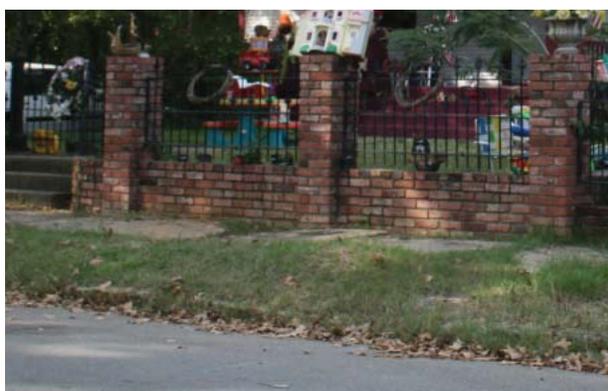
Figure 2-170. Metal fencing with brick columns. *Source: John Milner Associates, Inc., 2007.*

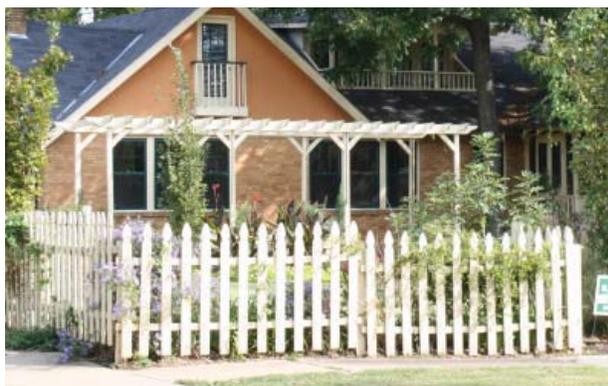
Figure 2-172. Wood picket fencing. *Source: John Milner Associates, Inc., 2007.*

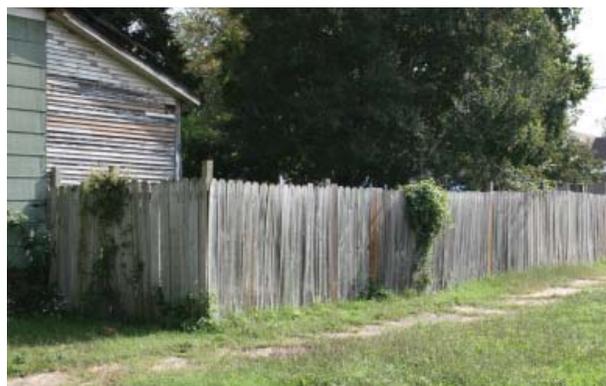
Figure 2-173. Wood board privacy fence. *Source: John Milner Associates, Inc., 2007.*

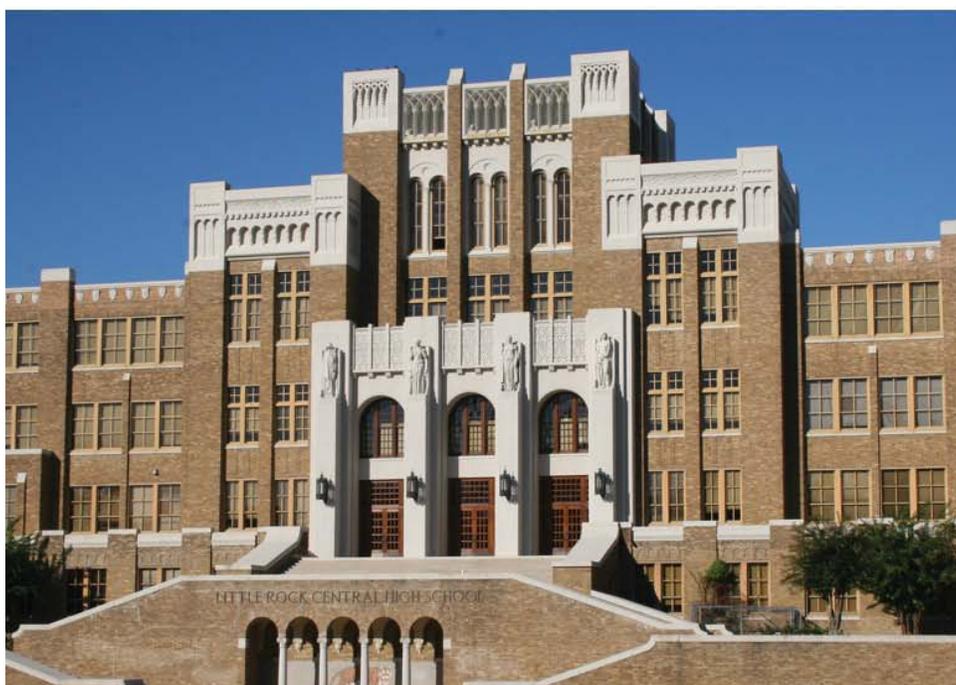
Figure 2-174b. These photographs show very little change to the facade of Central High School since the period of significance. However, two evergreen trees that flanked the main entrance are no longer extant. *Source: John Milner Associates, Inc., 2007.*

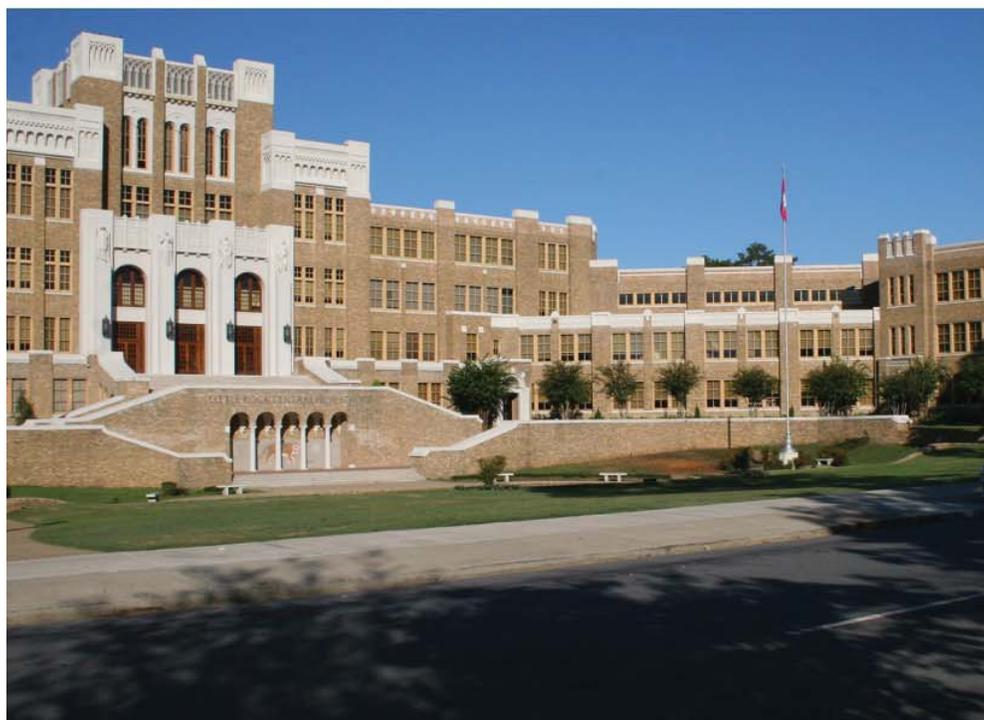
Figure 2-175b. In this recent view of the high school, many features are extant from the historic period. Missing, however, are the utility poles that once lined the west side of S. Park Street. *Source: John Milner Associates, Inc., 2007.*

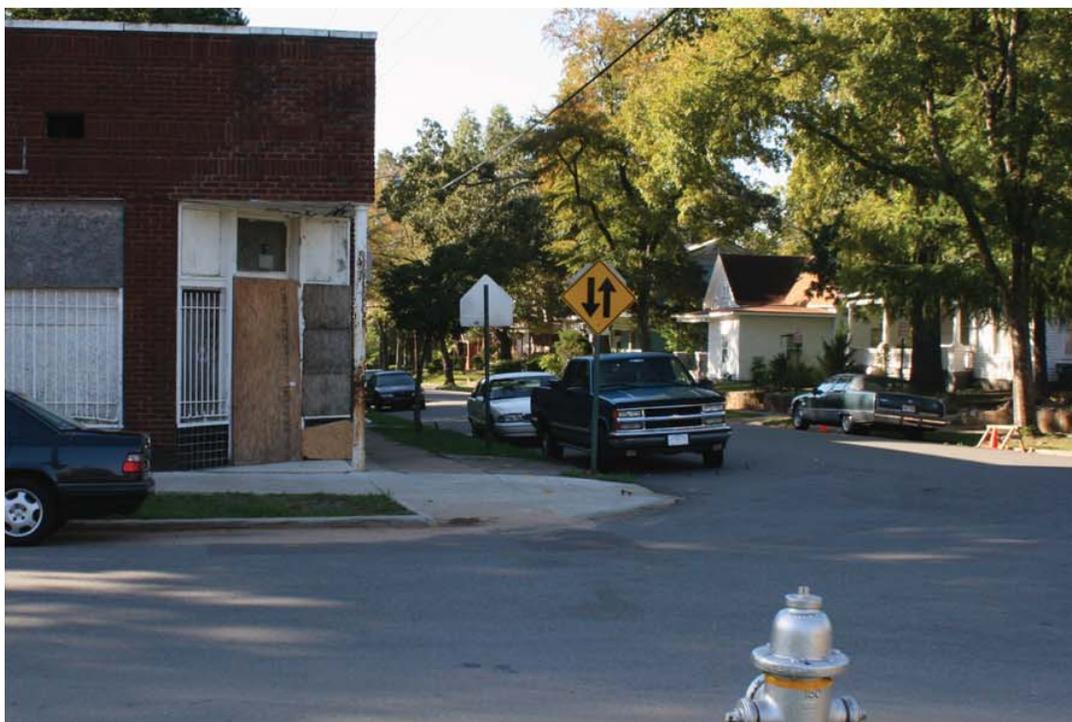
Figure 2-179b. Today, the building that housed Ponder's is vacant, signs removed, and windows boarded up. Some traffic signs have been added, the street sign bollard since removed and a fire hydrant installed. Residences that faced the street in the 1950s are still in place today. *Source: John Milner Associates, Inc., 2007.*

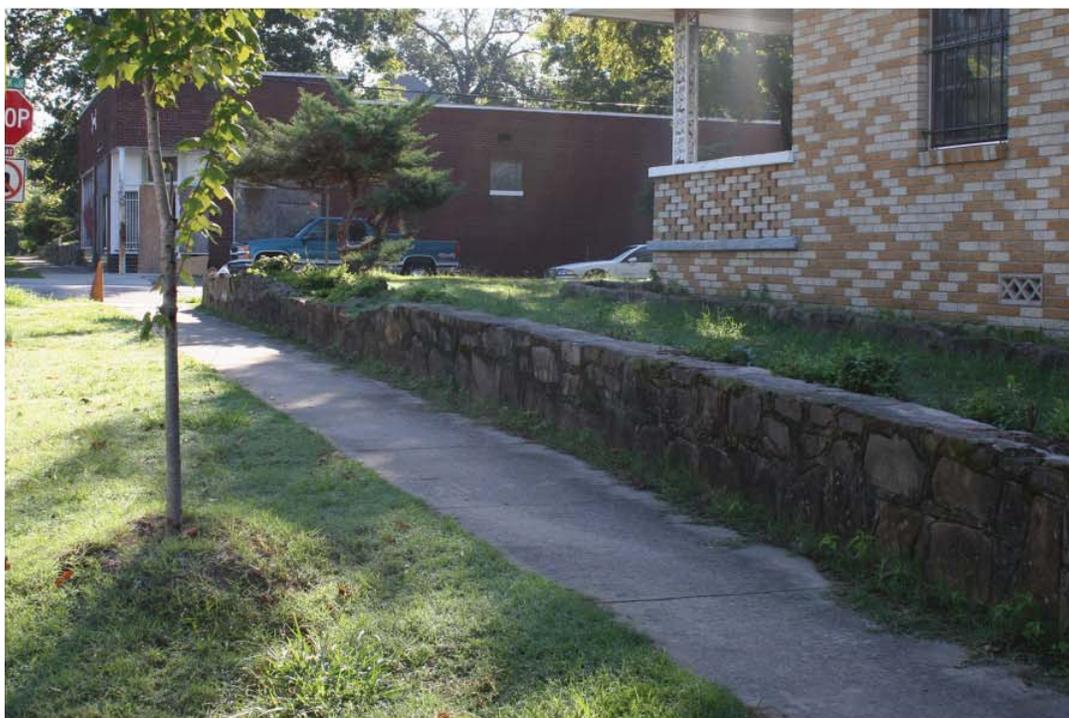
Figure 2-180b. Today, the house and stone wall appear to be in very much the same condition as they were in 1957-58. *Source: John Milner Associates, Inc., 2007.*

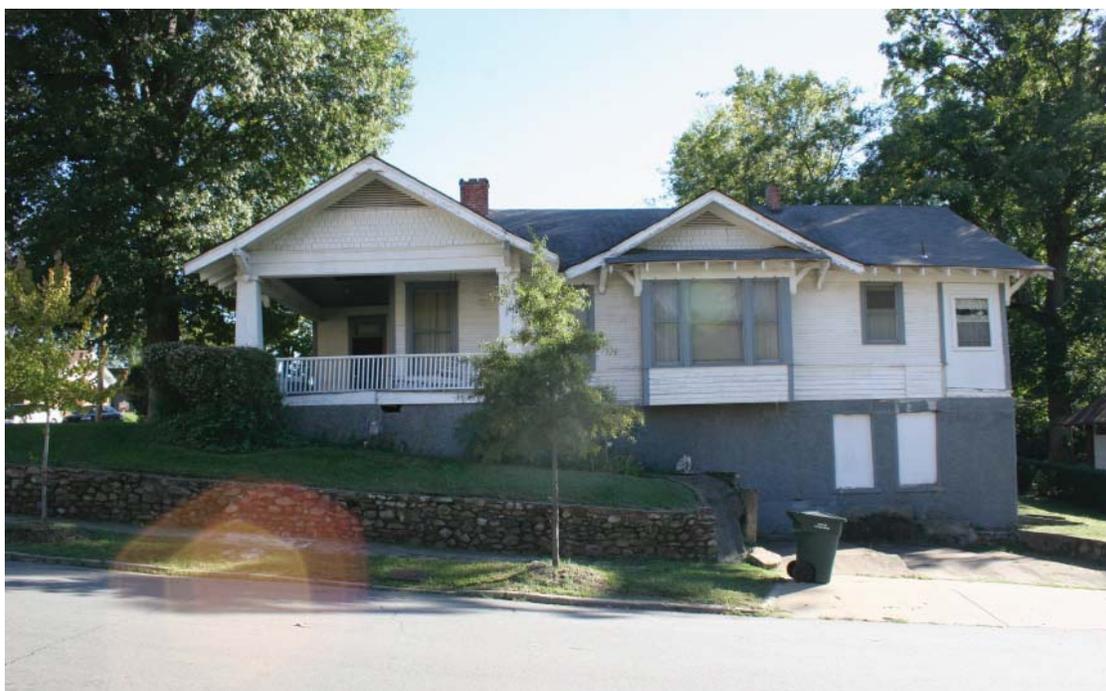
Figure 2-185b. The house and stone retaining wall at 1600 Dennison in 2007. *Source: JMA, 2007.*
