CRM

CULTURAL RESOURCE MANAGEMENT
Information for Parks, Federal Agencies,
Indian Tribes, States, Local Governments,
and the Private Sector

A Unity of Theory and Practice Bridging to the Past

The
University of
Pennsylvania
and the NPS

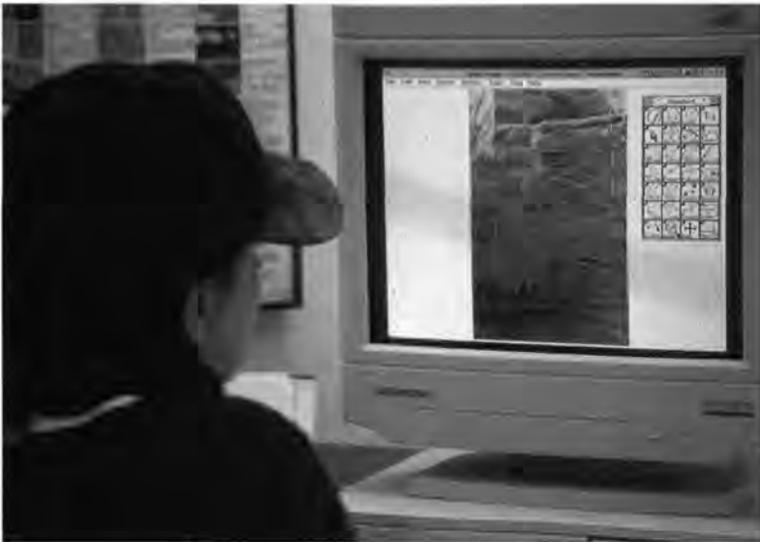
Recording conditions surveys on computer. Photo by Frank Matero.

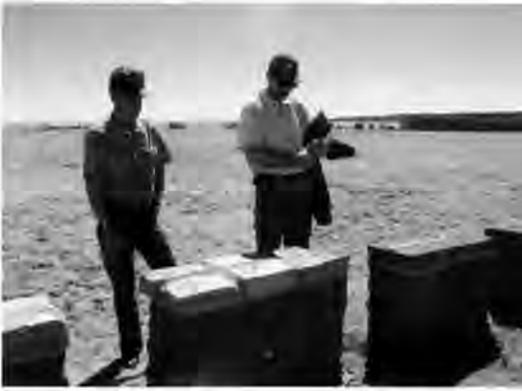
Facility Manager Albert Dominguez and architectural conservator Bob Hartzler evaluate 1996 test walls. Photo by Jake Barrow.

During the summer of 1996, a pilot implementation project was conducted at Fort Union to carry out the second and third recommendations of the Preservation Plan. In the spring, a range of lime-modified adobe caps had been tested at the Architectural Conservation Laboratory of the University of Pennsylvania by graduate students Mark Goodman and Elisa Del Bono. Based upon their recommendations, the most promising of these modified caps were manufactured, and installed on both test walls and historic walls at Fort Union, along with unmodified, cement-modified, hydraulic lime-modified, and acrylic-modified adobes. Potential shelter coats were also selected, manufactured and applied to adobe test walls.

In the spring of 1997, Bob Hartzler and Jake Barrow returned to Fort Union to analyze the results of the adobe monitoring system as well as the performance of the adobe test walls and the pilot caps and shelter coats. Based upon the analyses, recommendations for the material compositions and application procedures for new caps and shelter coats were made. Funding for a major capping project was secured by the Monument, and the work commenced at the beginning of the 1997 summer.

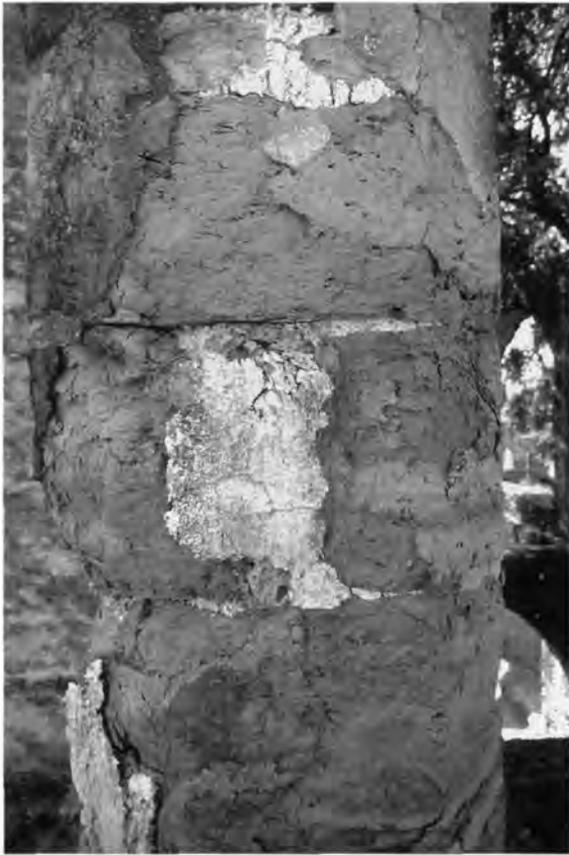
Column condition before restoration, detail, 1992.

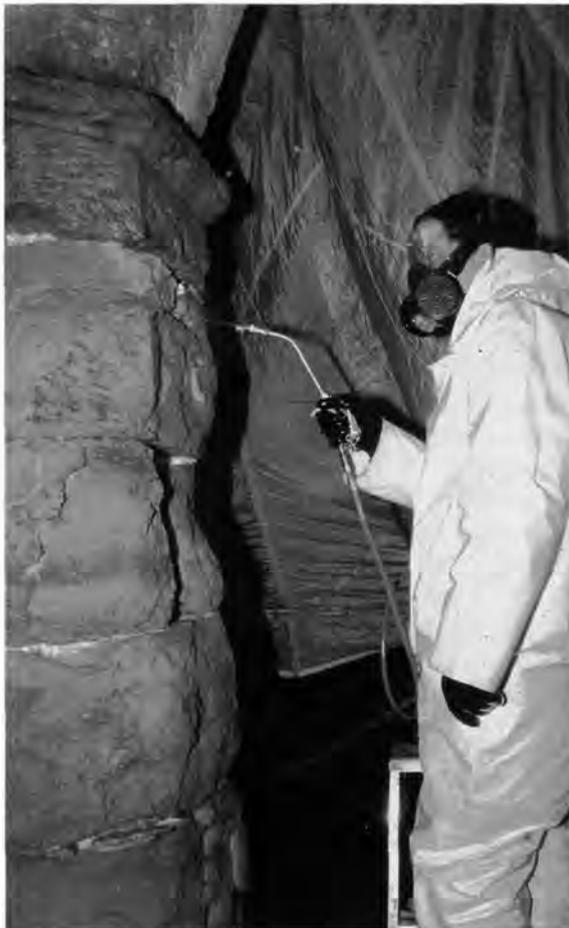
Applying consolidant to column surface. HS203A-North wall, 1993.

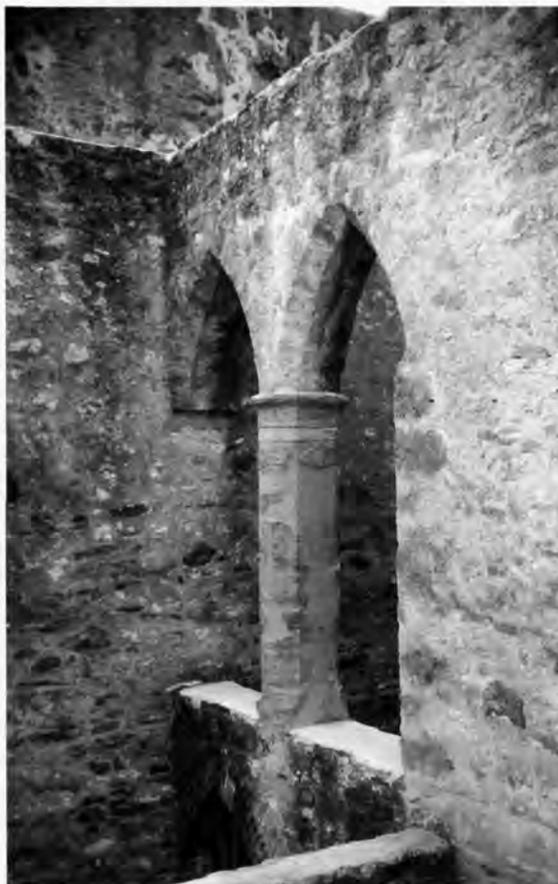
Column after conservation.

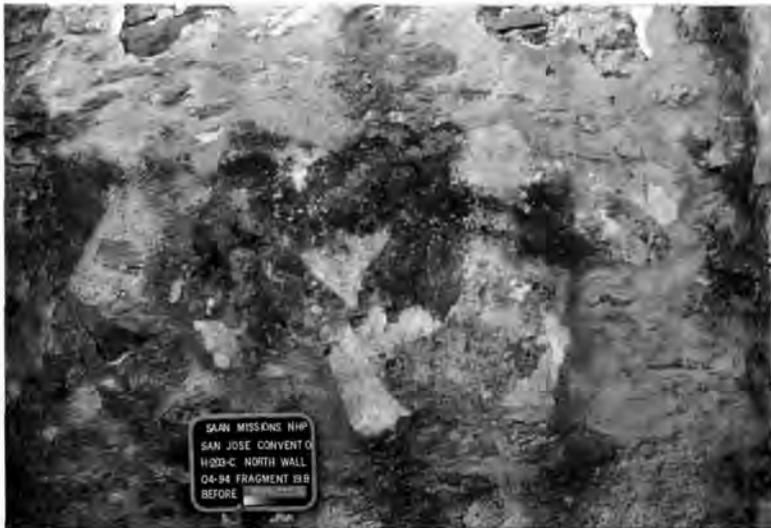
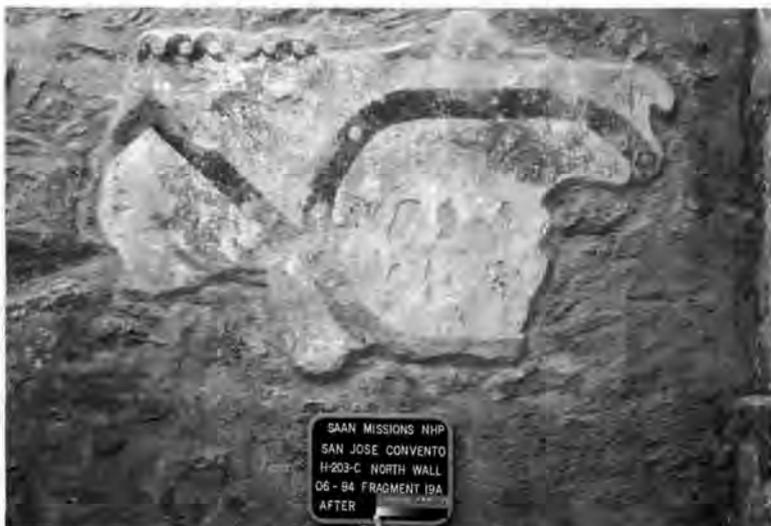
San Antonio
Missions NHP,
Mission San Jose
paint and plaster
conservation pro-
ject. Room
#HS203-C,
Fragments: 19B
before and after
treatment.

Following cleaning and stabilization, losses, cracks, and exposed edges were filled with a hydraulic lime mortar to protect them from water ingress. Surface losses within fragments were filled with the fine-grained mix. The fills were recessed slightly lower than the original surface, rendering them distinguishable. Edges were sculpted at a slight angle with a coarse grained mix to positively shed water away from the plaster surface.

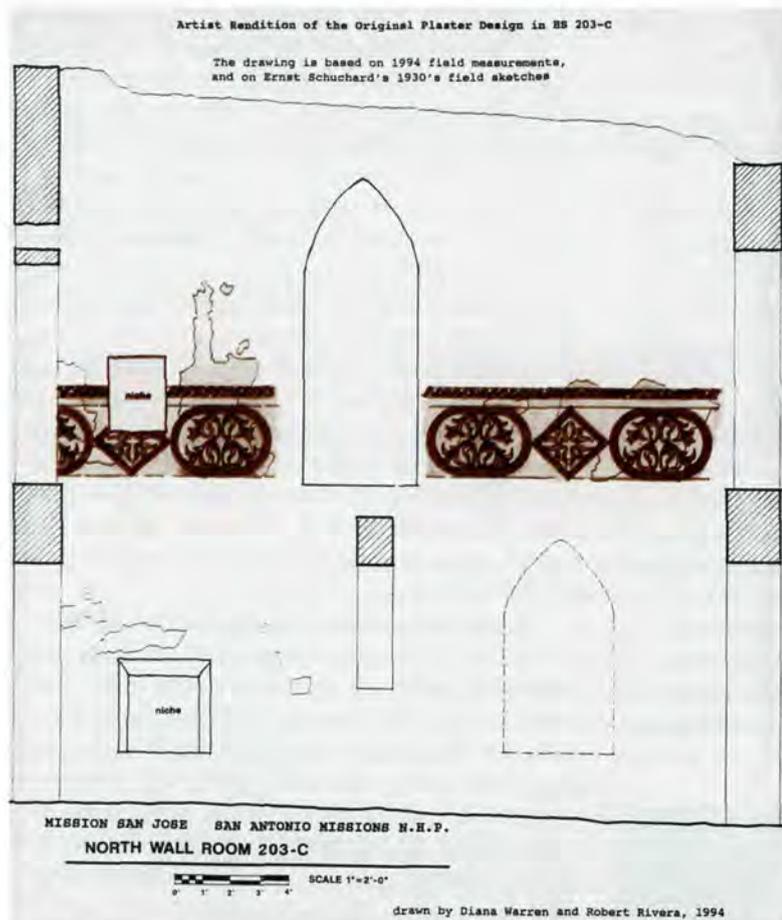
Mission San Jose, San Antonio Missions NHP. Artist's rendition of the original plaster design in HS 203-C. The drawing is based on 1994 field measurements, and on Ernst Schuchard's 1930s field sketches. Drawn by Diana Warren and Robert Rivera, 1994.

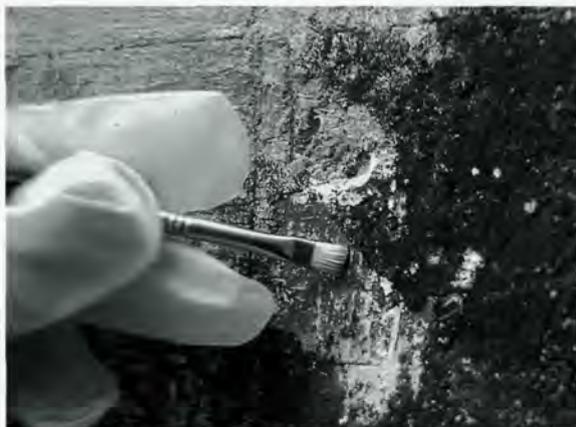
Dry cleaning lichen on painted plasters.

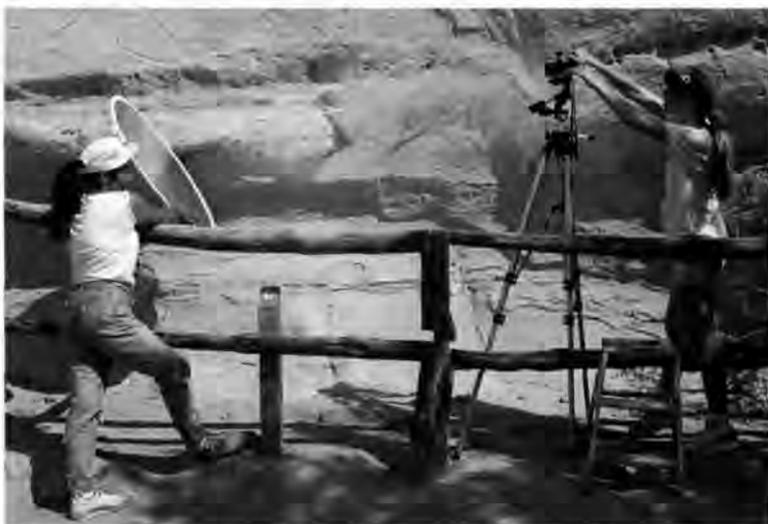
Documentation project using reflector to control light on the stone surface. Photo by Antoinette Padgett.

35mm film format was chosen over a 4" x 5" format. This compromise in film negative quality was balanced by the speed and agility of using a 35mm camera system. Color slides were also taken of each panel. A perspective control lens was used whenever possible to minimize distortion and enable more precise measurements to be taken directly from the photographs. A 5cm or 10cm scale was placed in each photo when logistically possible. A light reflector disk was used to augment or redirect sunlight when necessary. In areas of perpetual shade, flood lamps were used. Whenever possible, inscriptions were photographed with side-raking light, which was determined to be optimal lighting for highlighting incised inscriptions. Overview photos of sections were also taken. A corresponding Mylar overlay for each overview section photo was developed to show the location of each panel within that section. This information should help future site researchers locate even the most ephemeral panel. All photographs taken were recorded in a photographic log which contained the date, view, and subject for each exposure. An index which references each panel to its corresponding film roll and negative/slide number was also created.

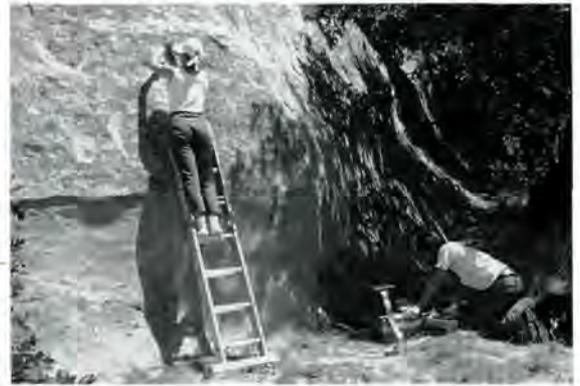
Marie Ennis and
Dennis Sack con-
ducting non-
destructive testing
at El Morro,
Inscription Rock.
Photo by Jake
Barrow.

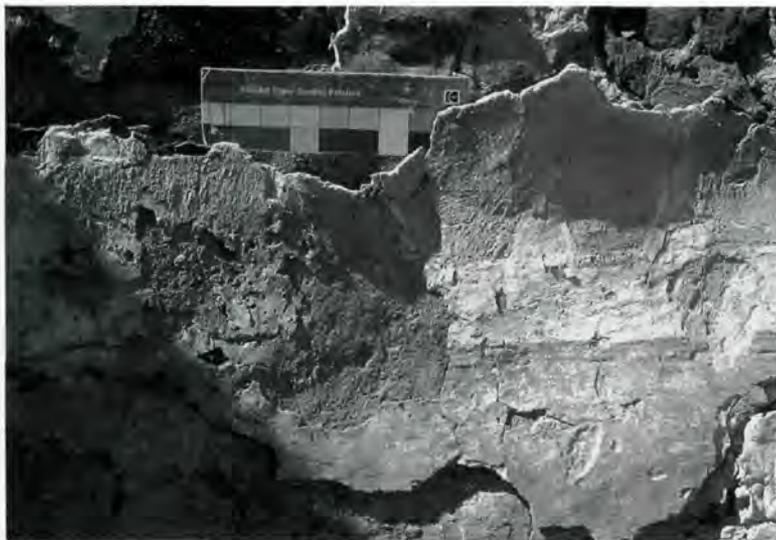
Detached and delaminating finishes in Kiva "C" Mug House. Photo by Frank Matero.

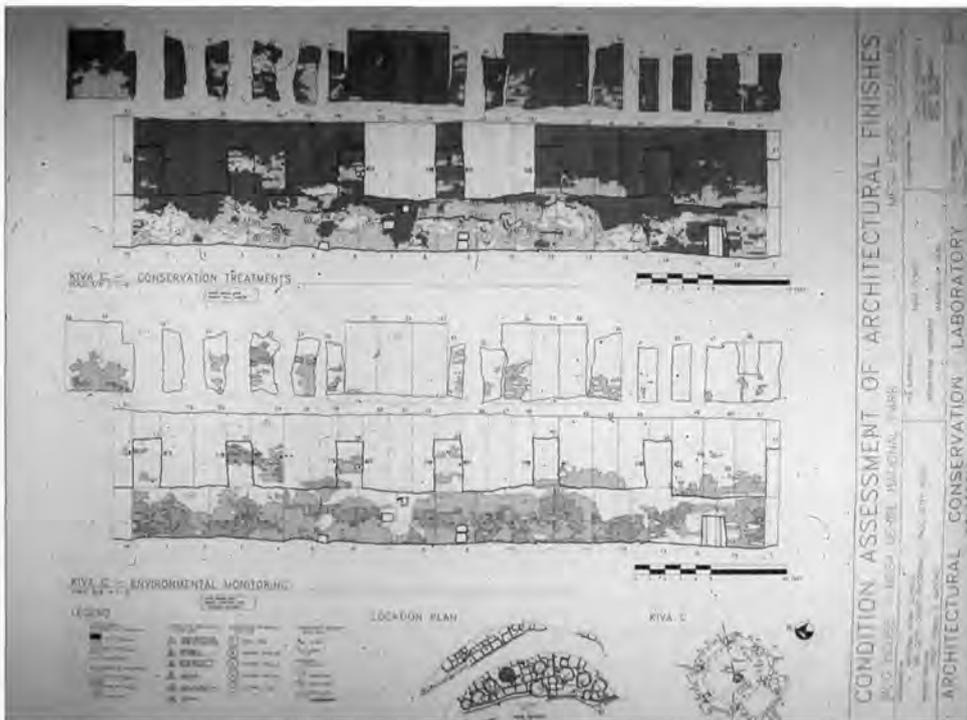
Condition assessment of architectural surface finishes, Kiva C, Mug House. UPenn, 1996.

Conditions Survey: The photographic documentation of surface finishes at the Mesa Verde site of Mug House was begun in the 1995 field season. Conditions were recorded on specially prepared architectural survey forms, and graphically documented on 35mm rectified photographs. All condition field notes were transcribed to a graphic-

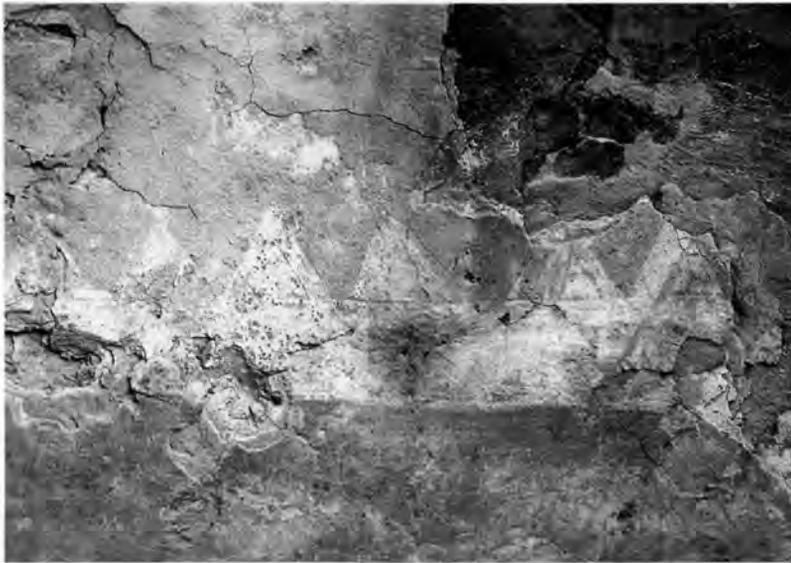
Kiva C painted plaster dado.

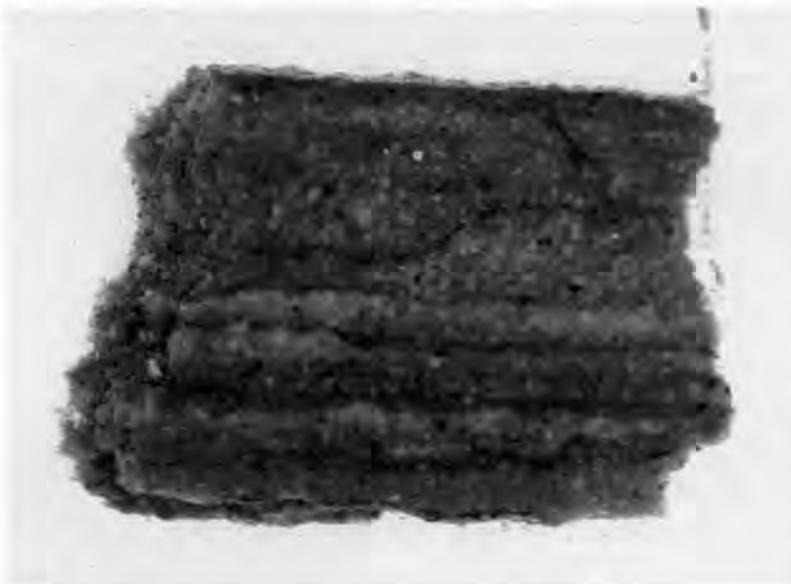
Cross-section of Kiva C layers, Mug House.

ter, indicating that the mortar is less dimensionally stable in the presence of water. X-ray diffraction analysis revealed the presence of gypsum, a non-clay mineral commonly found in southwestern soils, in the Kiva C plaster, but not in the mortar sample. The variations found were what one might expect, given the structural function of the mortar (knitting together the sandstone wall) versus the decorative and insulative function of the plaster. Other factors that could influence material selection are the importance of shrinkage resistance in the plaster (not quite as important in the mortar), and preparation at different times or by different people.

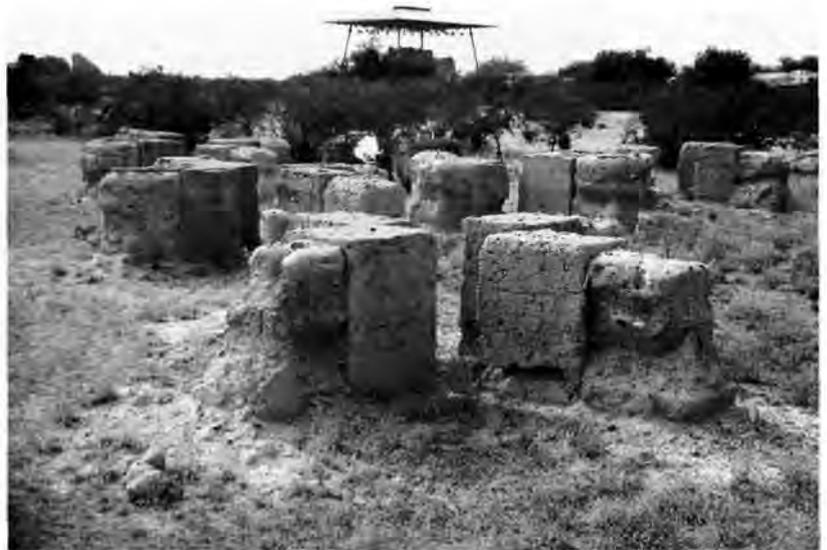
Takenaka Aqua-Reactive Chemical Soil Stabilization System—held promise, but failed.

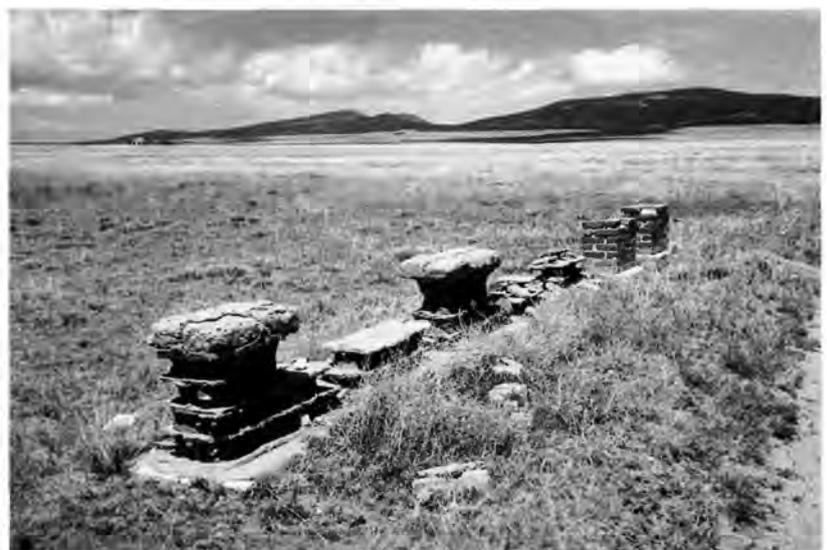
Fort Union test walls from 1959 as seen in 1996. Photo by Jake Barrow.

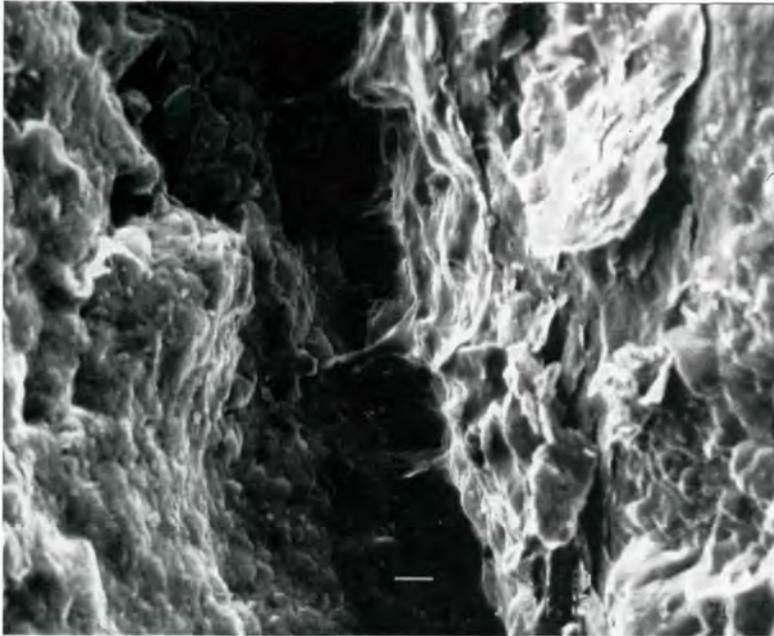
Rhoplex® strands in soil-mortar sample at 5,000X. Photo by Bob Hartzler.
