Cultural Resource Protection and Emergency Preparedness

Information for parks, federal agencies, Indian tribes, states, local governments, and the private sector that promotes and maintains high standards for preserving and managing cultural resources

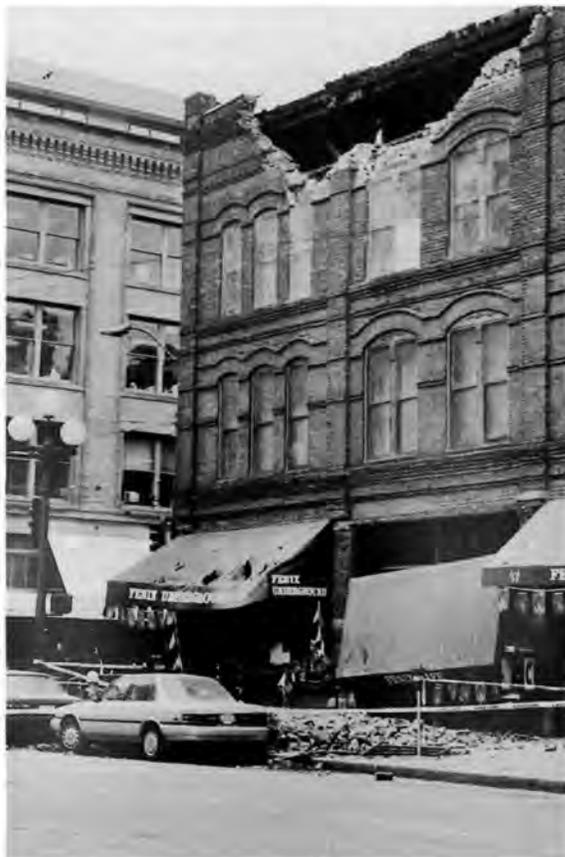
Cadillac Hotel, Seattle, Washington, March 1, 2001. The Cadillac Hotel is the most controversial building damaged in the Nisqually earthquake. Photo by the author.

Seattle's vital Pioneer Square Historic District, where the greatest dollar value damage was experienced, but the best assistance programs are available, several buildings are in jeopardy as a result of opportunistic interests looking for a higher use, among them the venerable Cadillac Hotel.

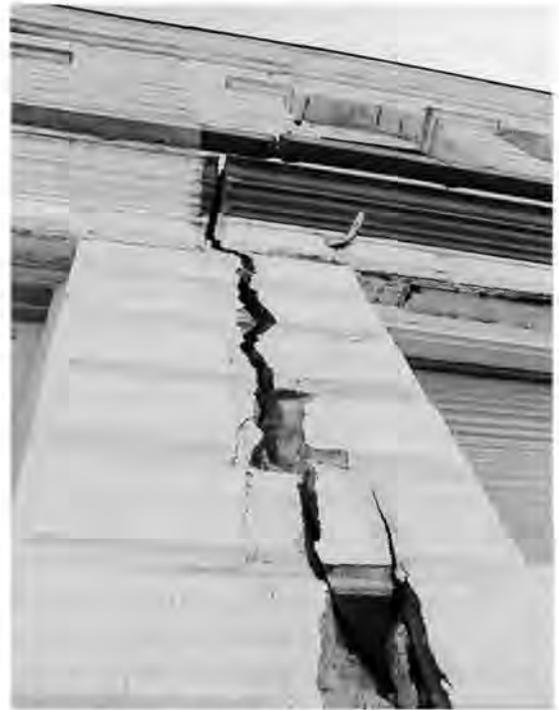
Vertical crack in façade pilaster on the Aberdeen Post Office building. Artifacts field photo.

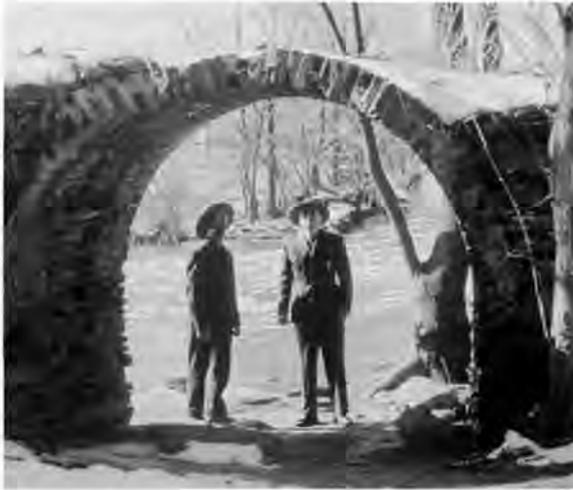
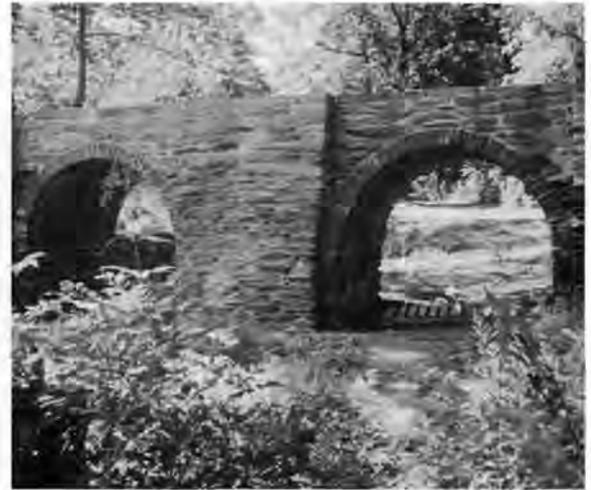
Left, Virginius Island water intake arch in jeopardy of collapse after losing its structural load, photo courtesy NPS. Right, same arch following stabilization work completed during 1996 flood recovery program, photo by the author.

The park's Virginius Island section presented some unique challenges following the 1996 floods. In the mid-19th century, Virginius Island had been the site of a small water-powered industrial community. During the past century and a half, the manufacturing concerns had gradually declined due to the transition to steam power, the devastation wrought by the Civil War, and the ravages of repeated flood episodes. Even before the 1996 floods, the built environment on Virginius Island had been reduced to a ruinous condition. The historic character of the island was in jeopardy of being completely lost as the area gradually returned to a "natural" state. The September 1996 flood was especially hard on the island and made it clear that intervention was required if the park hoped to continue interpreting this area's industrial heritage to the visiting public.

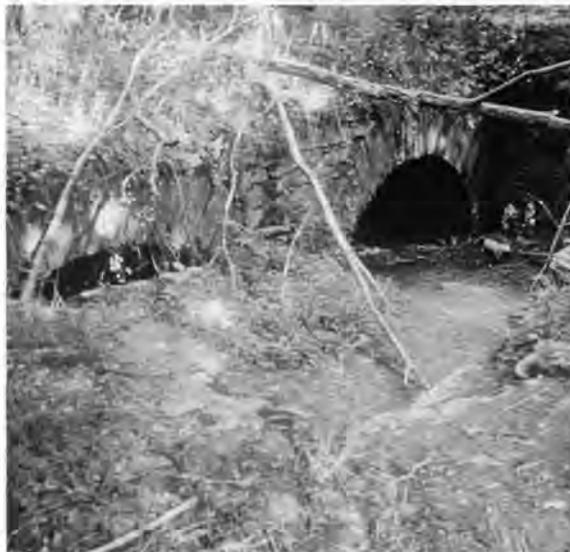
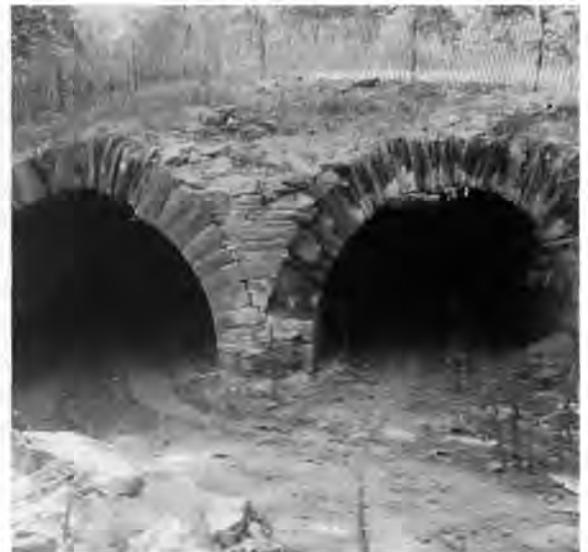
Left, water tunnels on Virginius Island nearly filled with flood debris, photo courtesy NPS. Right, same tunnels with debris removed as part of the 1996 flood recovery program, photo by the author.

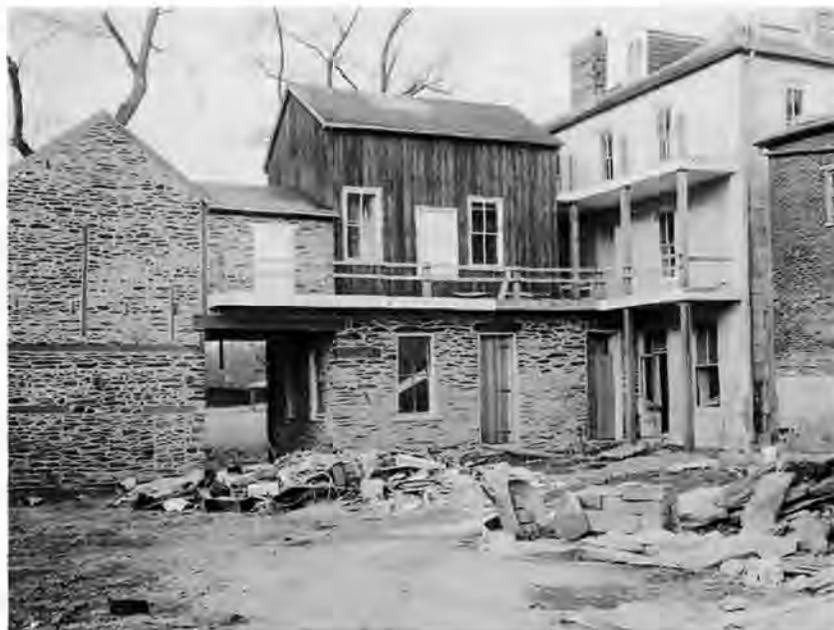
East elevation of buildings 32 and 33A following the January 1996 flood, looking west. Site debris was deposited as the water receded. The trees behind the buildings were lost.

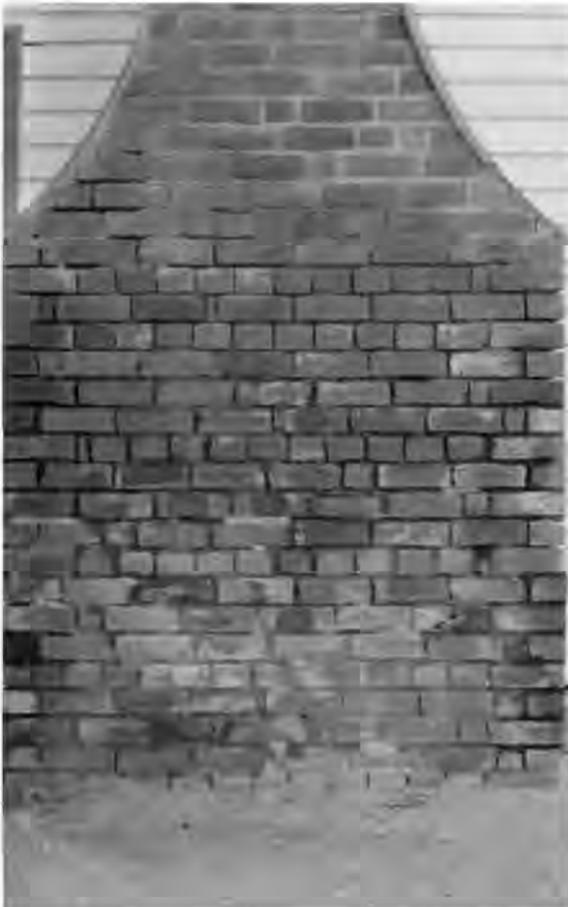
Rising damp and salt attack, chimney of cook house, Murray Downs Homestead, Swan Hill, NSW. Note the salt efflorescence at the bottom and the extent of the mortar loss. Photo by the author.

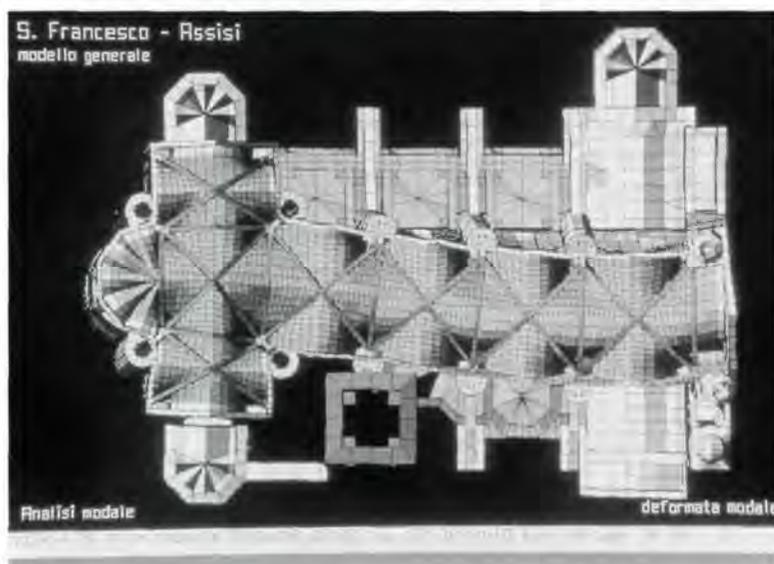
One of the modes of vibration of the global model.

clearly shows that high tensile stress is produced in the ribs and the curvature is reduced even in static conditions under the effect of dead loads. A preliminary step-by-step analysis with horizontal statically equivalent forces shows that when seismic forces reach approximately 0.18g, cracks and permanent deformation occurs, and that with forces between 0.25 and 0.30g the vault may collapse. These values of the seismic forces are comparable with the values induced by the earthquakes of September 1997. The values also explain the great damage everywhere and how the vaults near the façade and near the transept, which received the additional stress, collapsed.

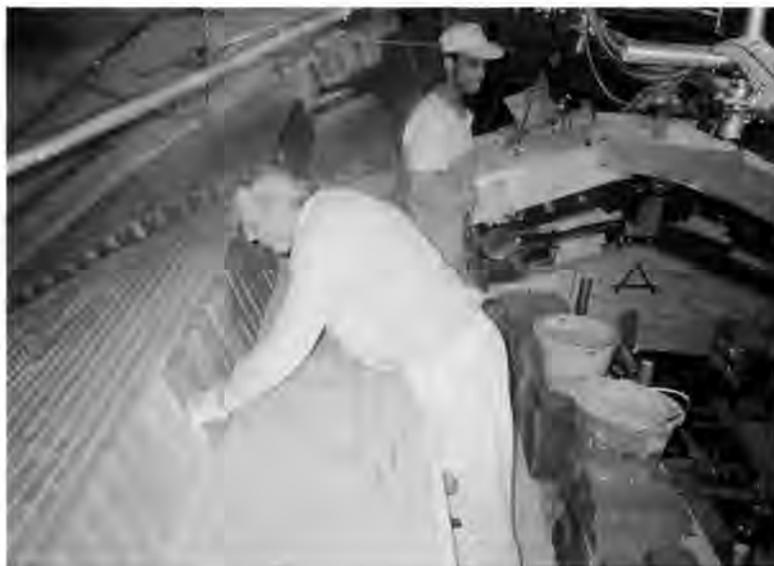
The reconstruction of the vault.

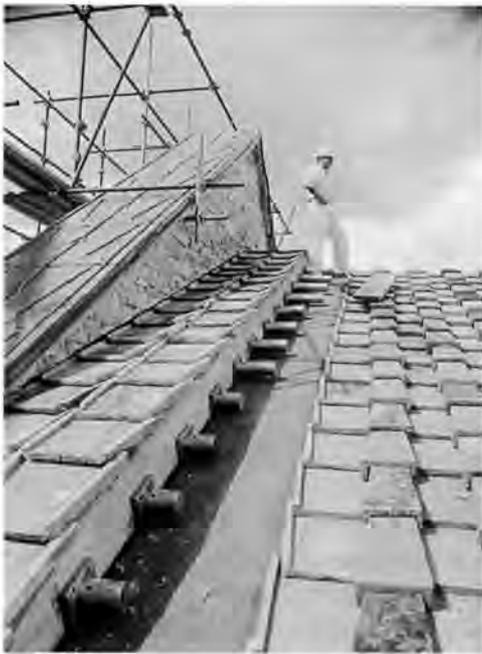
The cylinders that contain the special anchorages connecting the tympanum and the roof.

steel trussed beam has been placed over the cornice of the walls inside the basilica (immediately below the stained glass windows), to stiffen and strengthen the walls covered with Giotto's frescoes. The connection between this beam, which runs along the perimeter, and the walls has been created with special viscous devices which allow relative displacements due to thermal effects, but become rigid under dynamic

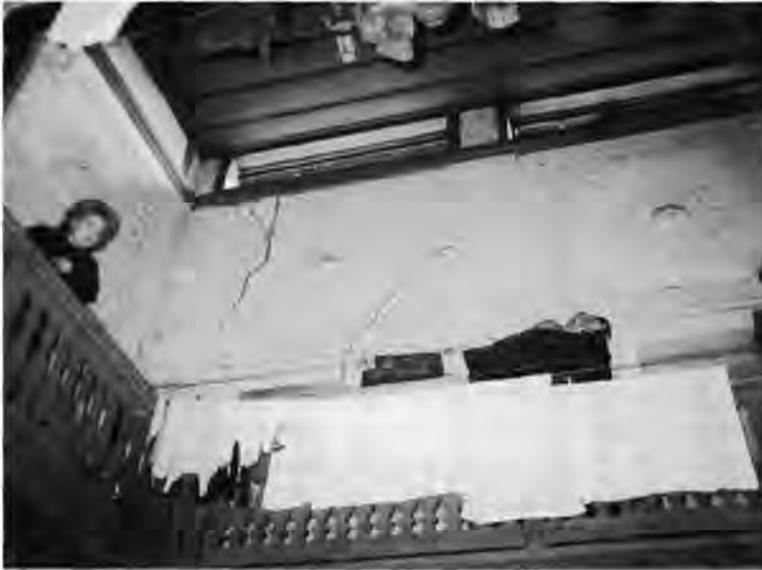
Tbilisi, Georgia, earthquake damage. Photo by the author.

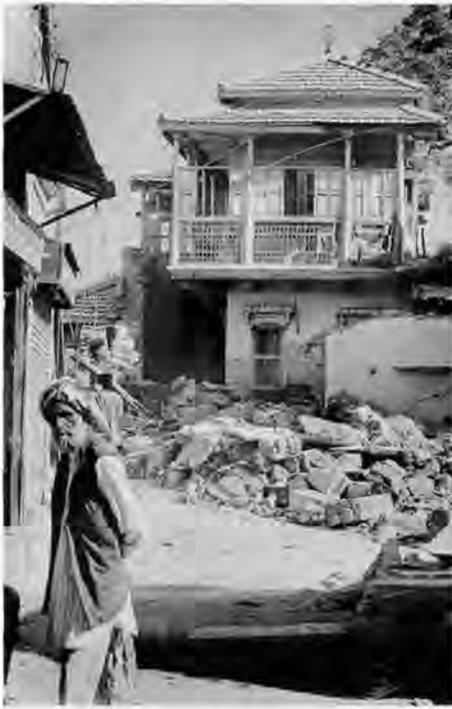
Surviving house, Anjar, India.
