CRM BULLETIN

A National Park Service
Technical Bulletin

Vol.4, No.1
March 1981

Twenty-Eight Coats of White House History

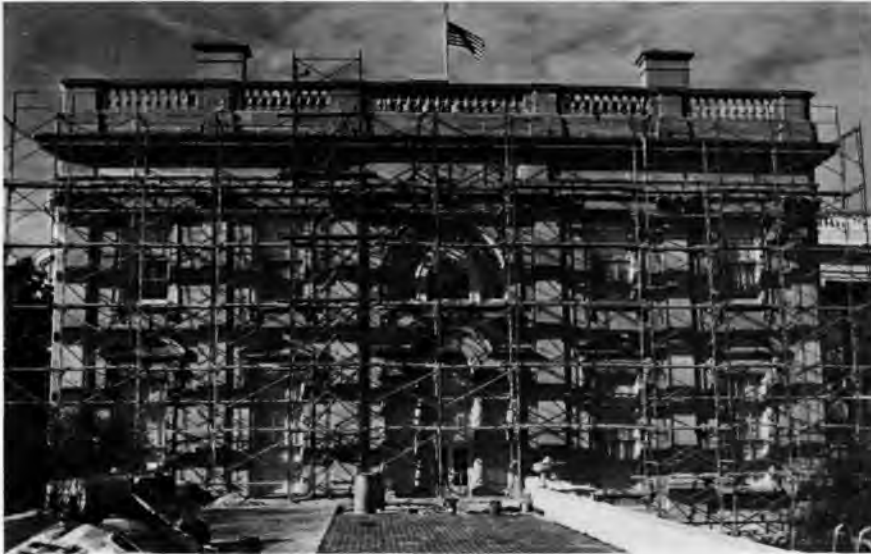
White House, east elevation with scaffolding, after paint removal.

The paint removal process proved to be difficult, because of the multi-layered build-up of different types of coatings. The original base coat was the toughest to remove. RUDCO found it necessary to alter the chemical formulations of the removers at least three times as they worked their way through the 28 layers of paint. Once the paint was removed, the entire elevation was rinsed with a mild solution of acetic acid to balance the alkalinity of the paint removers and

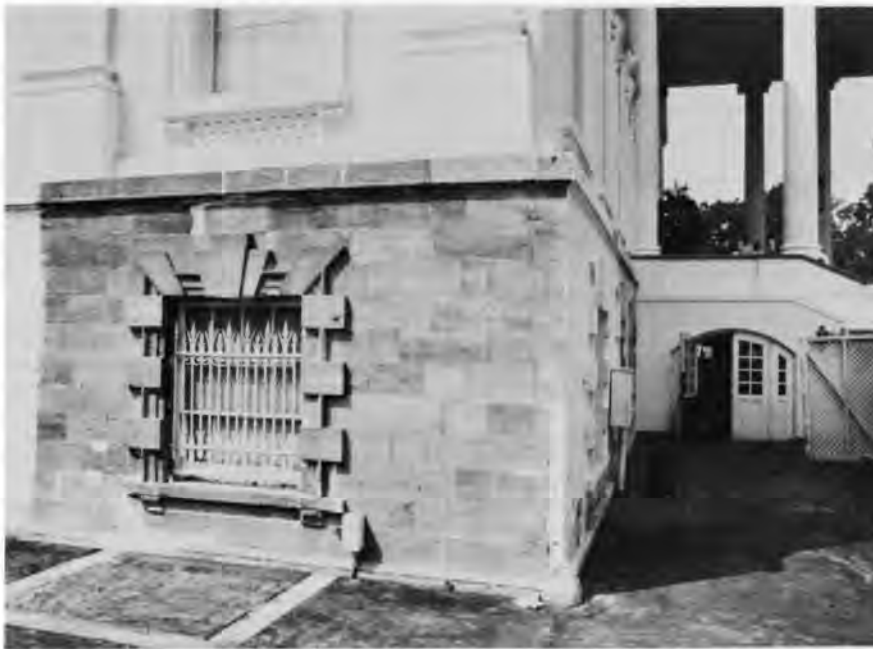
Test area B (see diagram to the left) after paint removal.

were taken to protect the structure and surrounding landscape. All liquid effluent from the chemical/water spray removal process was collected by wet vacuum and pumped into 55-gallon (209 liter) drums for transport from the site. Windows were protected from accidental damage by fitting solid covers over them during paint removal operations. And plastic hand scrapers replaced the normal wire brush tools to reduce the potential for gouging the soft sandstone.

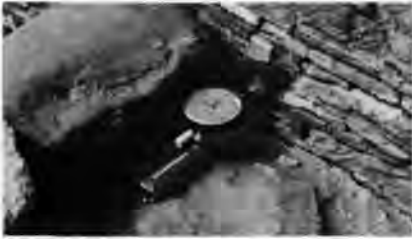
This dial gauge installation produced the data in the line chart. The gauge is mounted on top of a wall on one side of the crack. A metal plate is attached to the taller back wall. The spring-loaded spindle of the gauge rests on the metal plate, but is not attached to it. As crack width changes, the spindle moves and changes the position of the gauge hands.

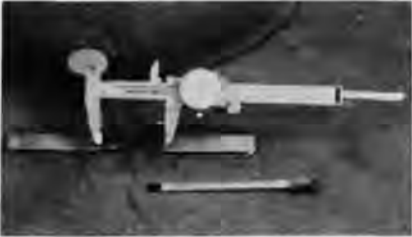
A custom made gauge system. The machinist's calipers have been modified by putting a small hole in each jaw. The holes fit over the stainless steel cones of the gauge points during reading. One set of calipers is used to read numerous gauge points at one site. Caliper accuracy is checked by taking readings on stainless steel rods of known length.

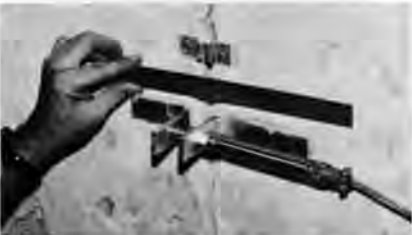
An electronic gauge in place. This gauge is a linear variable differential transformer (LVDT). Its operation is similar to the dial gauge with a spring-loaded spindle resting on a bracket except that it produces a voltage output that can be read at a remote location.

For the ceiling cracks, however, the mechanical gauges may not be appropriate. It is necessary to get to the gauge to read it, and erecting scaffolding every month may be far more expensive than the cost of electronic gauges with a remote readout. The wires from several gauges can go to a central point where the power supply and readout meter are located. All gauges can be read from one meter by plugging in the cables from each gauge, one at a time. In some applications, strip chart recorders are useful in detecting the effects of wind, seismic activity, sonic booms, and other temporary loads. In most cases, however, continuous recording only produces more data than is needed, and the great volume of paper produced is often stored without being analyzed. Periodic readings, recorded manually, and plotted as a function of time, will show long-term trends in structural movement.

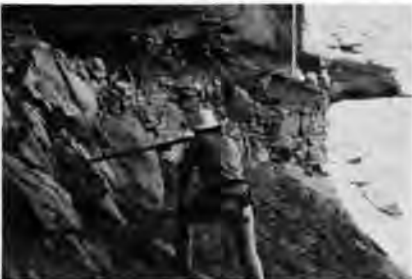
Precise leveling equipment being used to measure settlement of ruins. While similar to conventional surveying in technique, specialized equipment allows direct readings of 1/10 mm with estimates to 1/100 mm.
