Death Valley Floods 2015

October 18 Storm

Flooding at Scotty's Castle

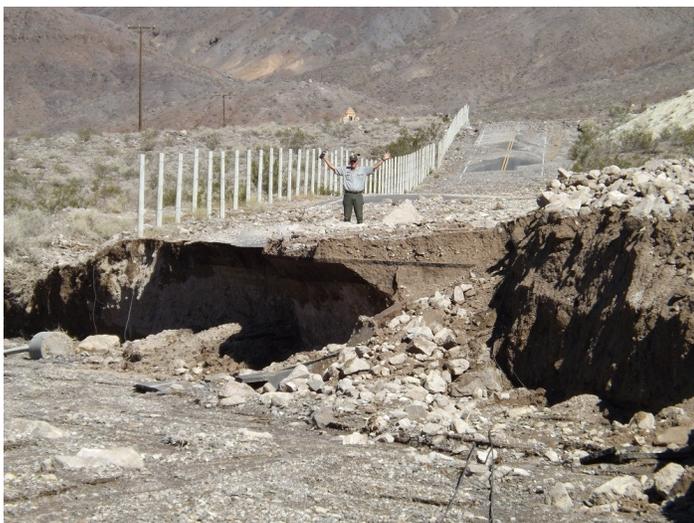
Large sections of Scotty's Castle Road and historic fence were destroyed.

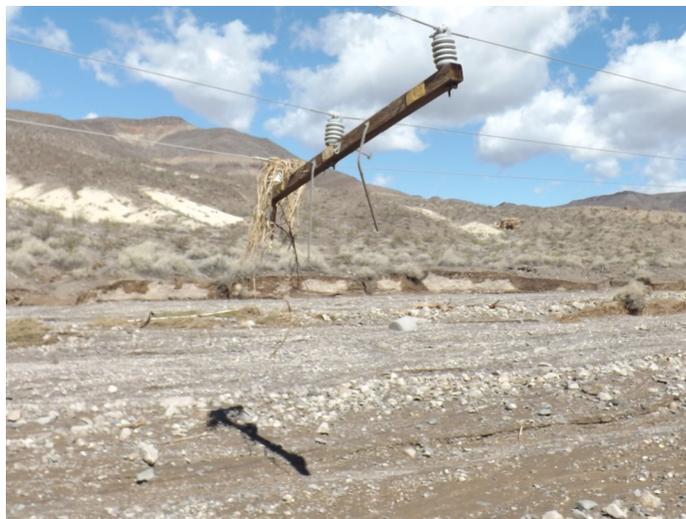
24 power poles that supplied electricity to Scotty's Castle were washed away.

- Water system: The spring house, one of two reservoirs, and the pipeline were destroyed.
- Electricity: Over 20 power poles were washed away.
- Sewer: The leach field was damaged.
- Historic Pool: Was filled with mud and water.
- Historic Bridge: Footings were undercut and the bridge moved slightly but is structurally sound.
- Historic Fence: Over a mile of historic concrete fence posts were washed out.
- Grounds: Mud and rocks up to four feet deep surrounded several buildings and covered the parking lot and picnic area.

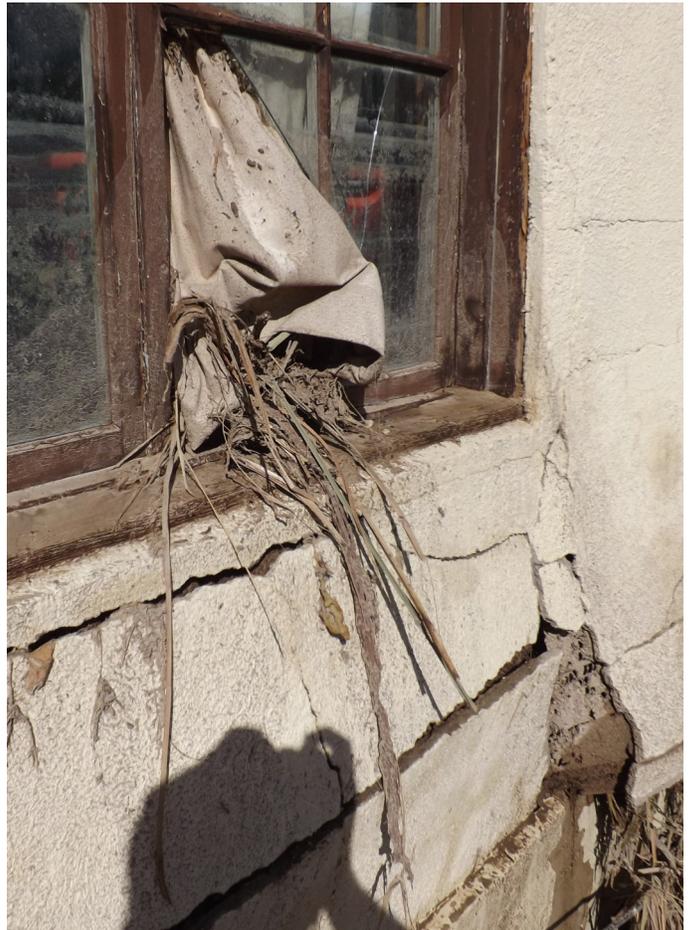
South wall of the Visitor Center was punched out by the force of the flood inside the building. Another section of exterior wall was pushed 18 inches off the foundation.

Flood water surrounded multiple buildings in the Death Valley Scotty Historic District. The most severely damaged historic building was the Garage/Longshed, which functions as the Scotty's Castle Visitor Center. The flood forced open doors, broke windows, broke interior walls, and smashed one exterior wall. Flood waters 4 feet deep left several feet of mud and rocks inside the building.

- Hacienda building: interior wall damage due to 1-4 feet of mud deposited inside.
- Visitor Center (Garage/Longshed): interior wall damage, exterior wall damage, broken doors, broken windows.
- Scotty's Castle (Main House & Annex): The roof leaked in several places, allowing moisture into the building.
- Museum collection: 65,000 archives, furnishings, and other artifacts are threatened by lack of heating, air conditioning, humidity control and fire suppression.
