Preserving Fort Jefferson

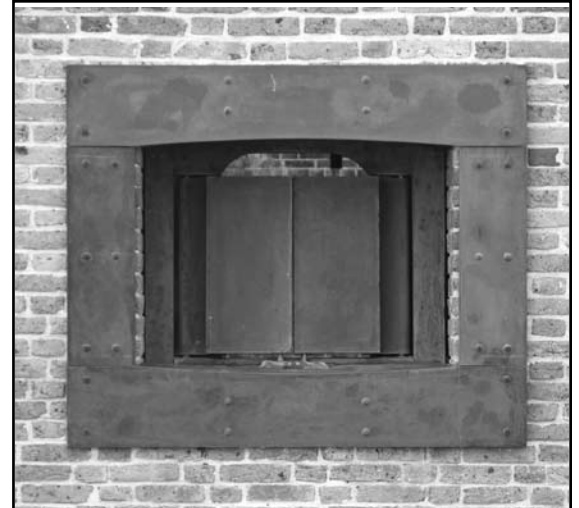
Replica Totten shutter installed on restored north wall of Fort Jefferson, 2007.

The last step is to restore the Totten shutters “in kind” per the Secretary of the Interior’s Standards for the Treatment of Historic Properties. A good example of the “finished product” can be seen on a walk about halfway around the moat, where the wall has been restored and the replica Totten shutters have been installed.
