# Natural Resources Management

## Cape Sable Canals

National Park Service  
U.S. Department of the Interior

South Florida Natural Resources Center  
Everglades National Park

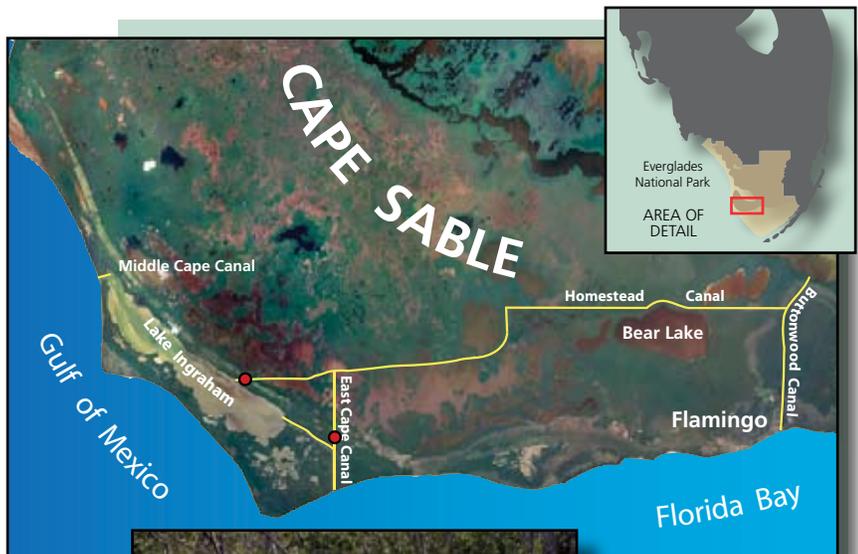
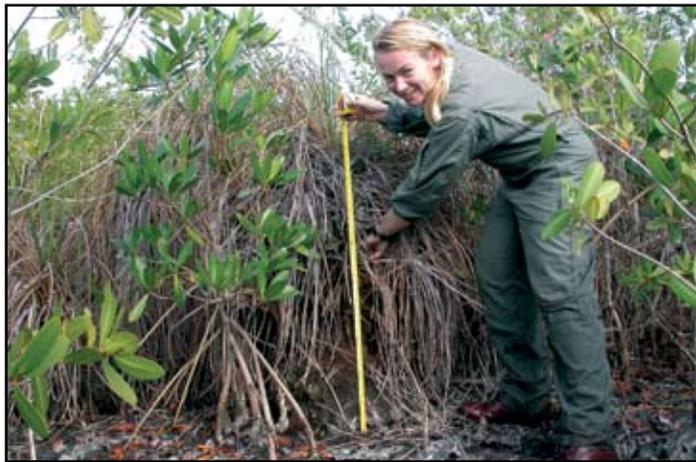
Saline water entering Cape Sable has resulted in the collapse of freshwater marshes and the subsequent erosion of over two feet of soil. Photo courtesy of Harold Wanless, University of Miami.

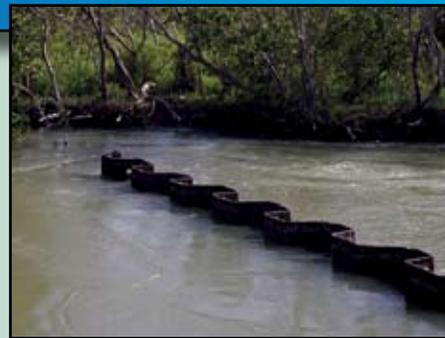
• **Failed Dams**  
Breaches in two sheet-piling dams at East Cape and Homestead Canals have reduced their ability to stop the inflow of saltwater. Photo by Mike Savage, ENP.

The park plugged several of the canals at the marl ridge with earthen dams in the late 1950s and early 1960s. Over time, natural forces compromised two of these early structures and, by 1992, they had failed. The earthen dams were replaced in 1997 with sheet-piling dams, though these also failed. Funded in part by the U.S. Fish and Wildlife Service, park managers are currently evaluating alternatives for repairing or replacing these sheet-piling dams in the near future.

Park managers are currently investigating how best to rehabilitate the failed barriers, while simultaneously providing safe access for non-motorized vessels in the future. In the interim, the park has installed temporary cables and floats to discourage illegal entry by motorboats. Canoes and kayaks, though still permitted to cross, are encouraged to avoid the cabled area due to swift currents that can make navigation a difficult and dangerous task.
