FORT VANCOUVER EXCAVATIONS - IV  
Chief Factor's House and Kitchen

by  
J. J. Hoffman  
and  
Lester A. Ross

National Park Service

Fort Vancouver National Historic Site

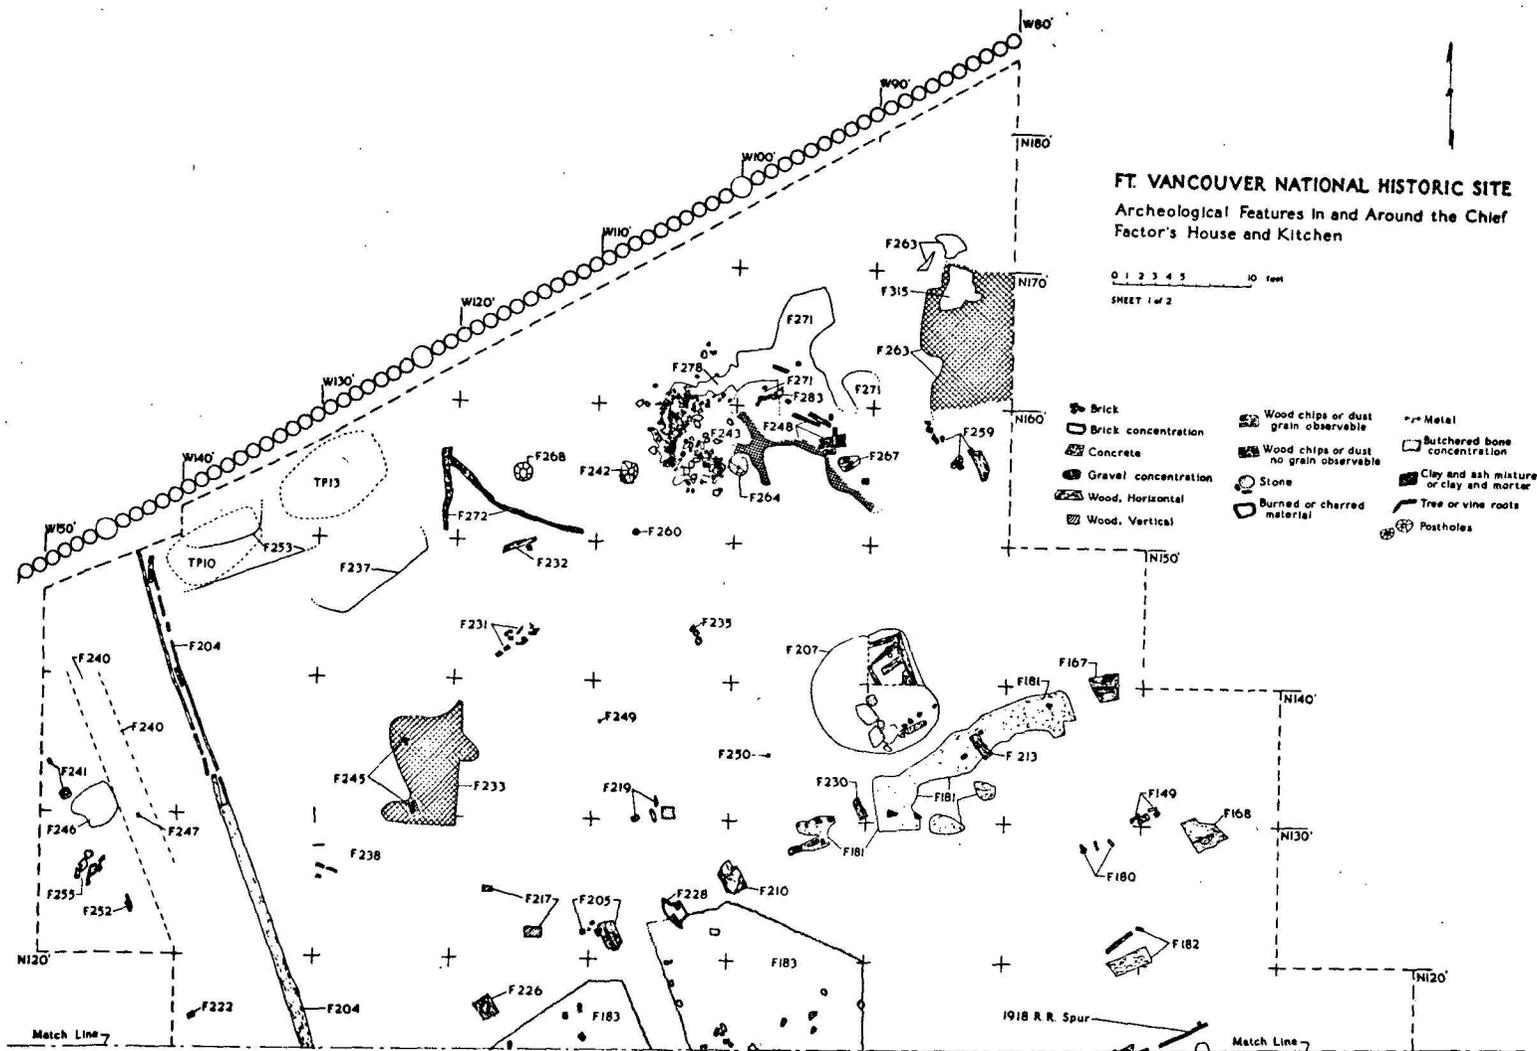
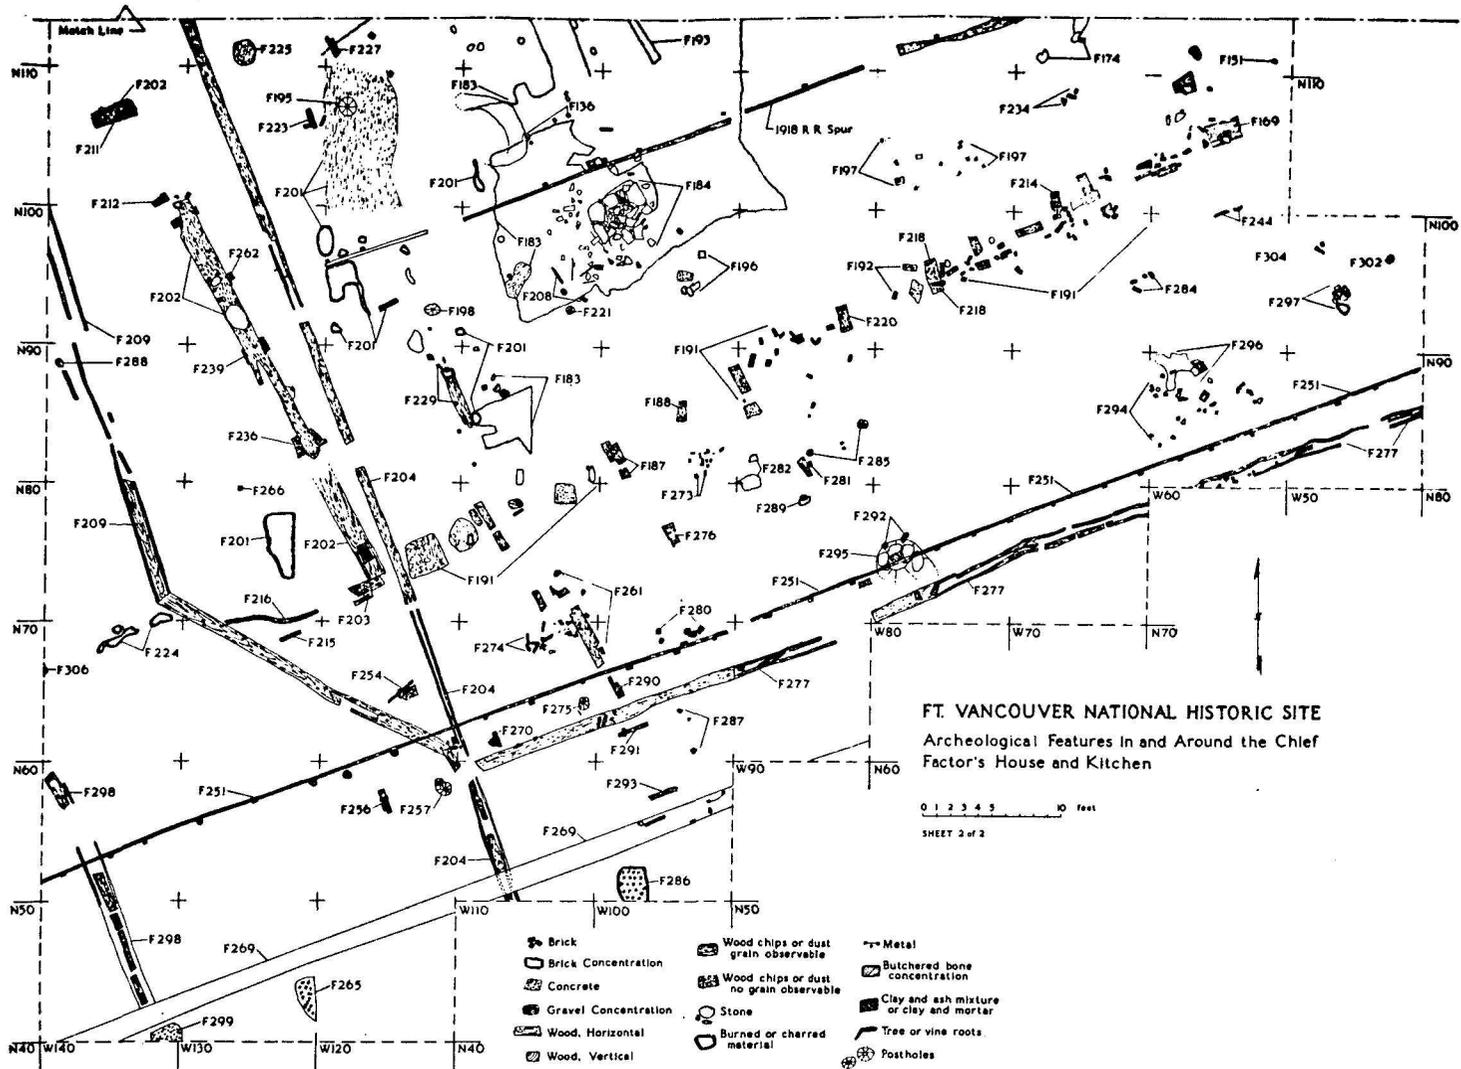
Fig. 1.1

Figure		page
1.1 & 1.2	Archeological features exposed in and around the Chief Factor's House and Kitchen.....	4
2.	Hudson's Bay Company features exposed in and around the Chief Factor's House and Kitchen.....	15

Vancouver Barracks remains of the 1918-19 period were amply found in the southern areas of excavation. Wooden ballast dividers of 2 railroad spurs were found crossing portions of the Chief Factor's House (Fig. 1.2). The northern divider was a continuation of one discussed in the first and third reports of this series (Hoffman and Ross 1972, 1973). The southern divider crossed over the wood-lined drains of an earlier period. Also crossing the drains was a narrow trench that appeared to have been dug by machinery and was probably intended, if not used, as a water line. Paralleling the south side of the trench were trash pits and a concrete footing of a World War I lumber mill. A large posthole of a utility line was found north of the northern ballast divider, and intrusive to the carbonized straw deposits. Wooden pieces

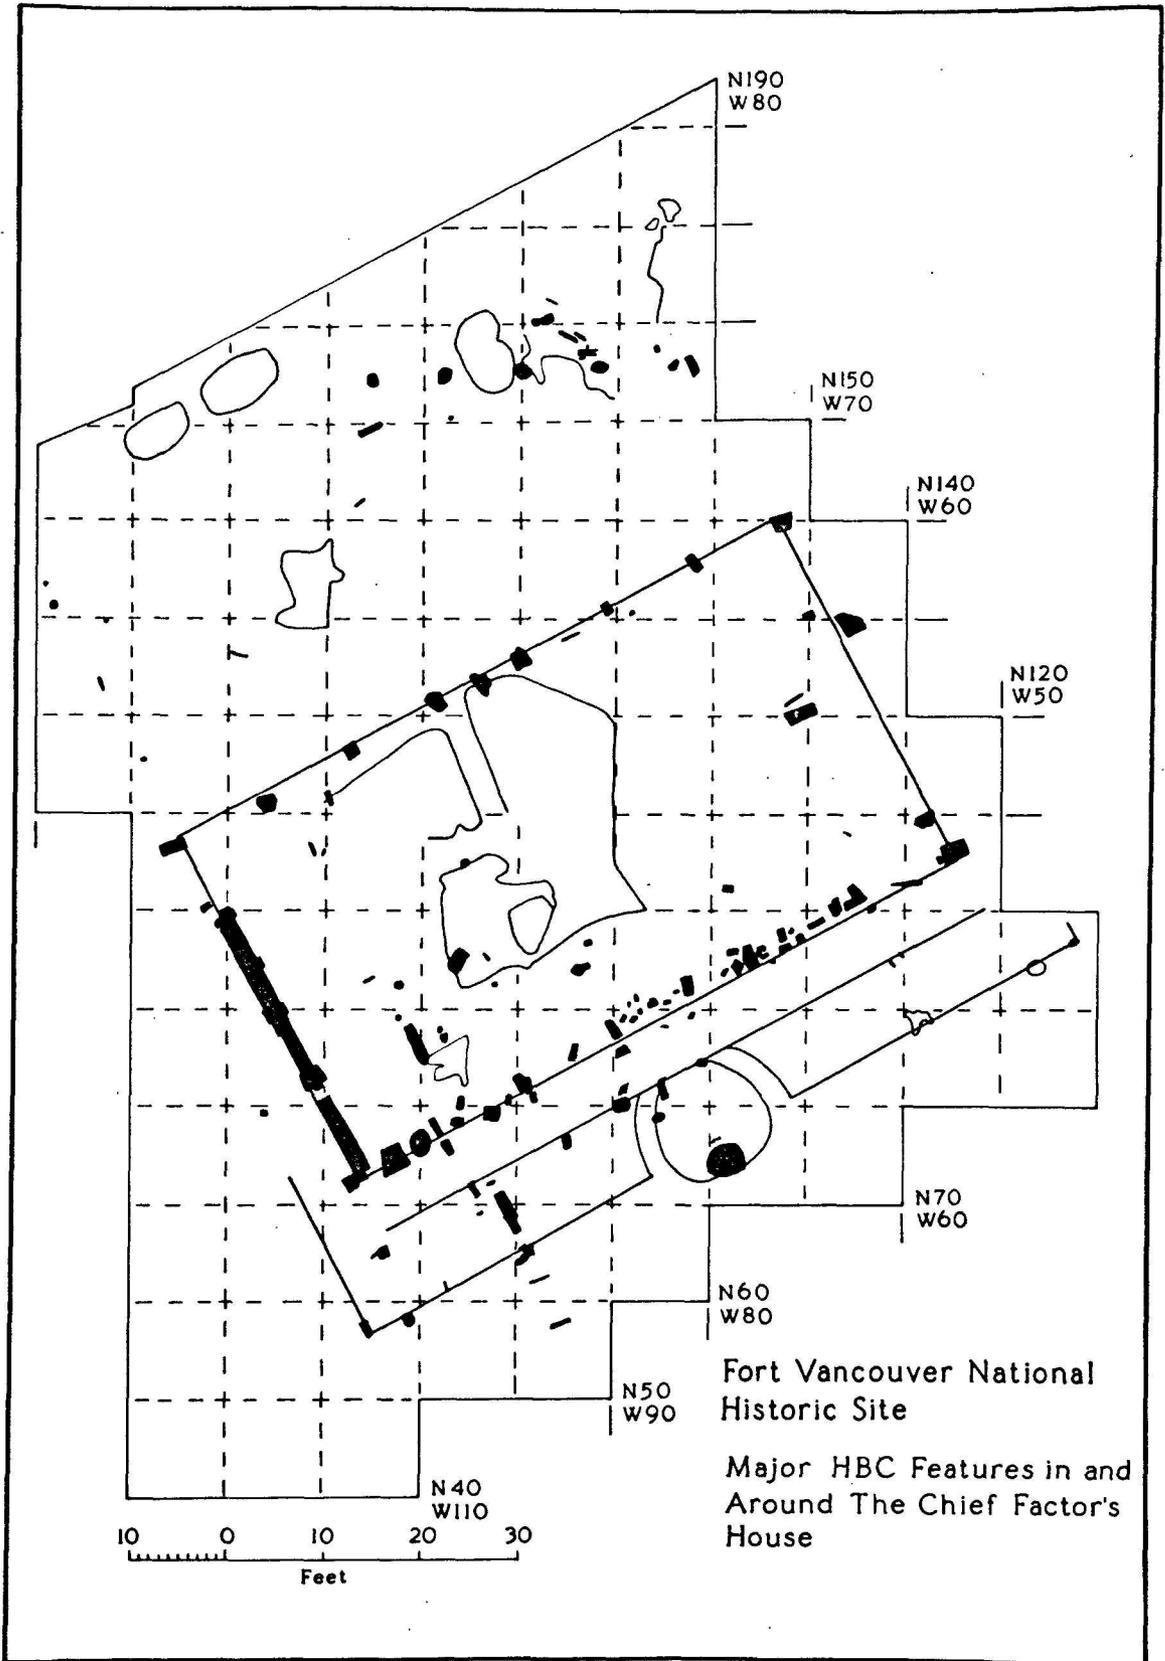
Fig. 2

Balance of remains found in excavation were attributable to the Hudson's Bay Company occupation. These are illustrated on Figure 2 which show only the HBC features. Figs. 3.1 through 3.9 are enlarged sheets of the feature map that are included for clarity of illustration.

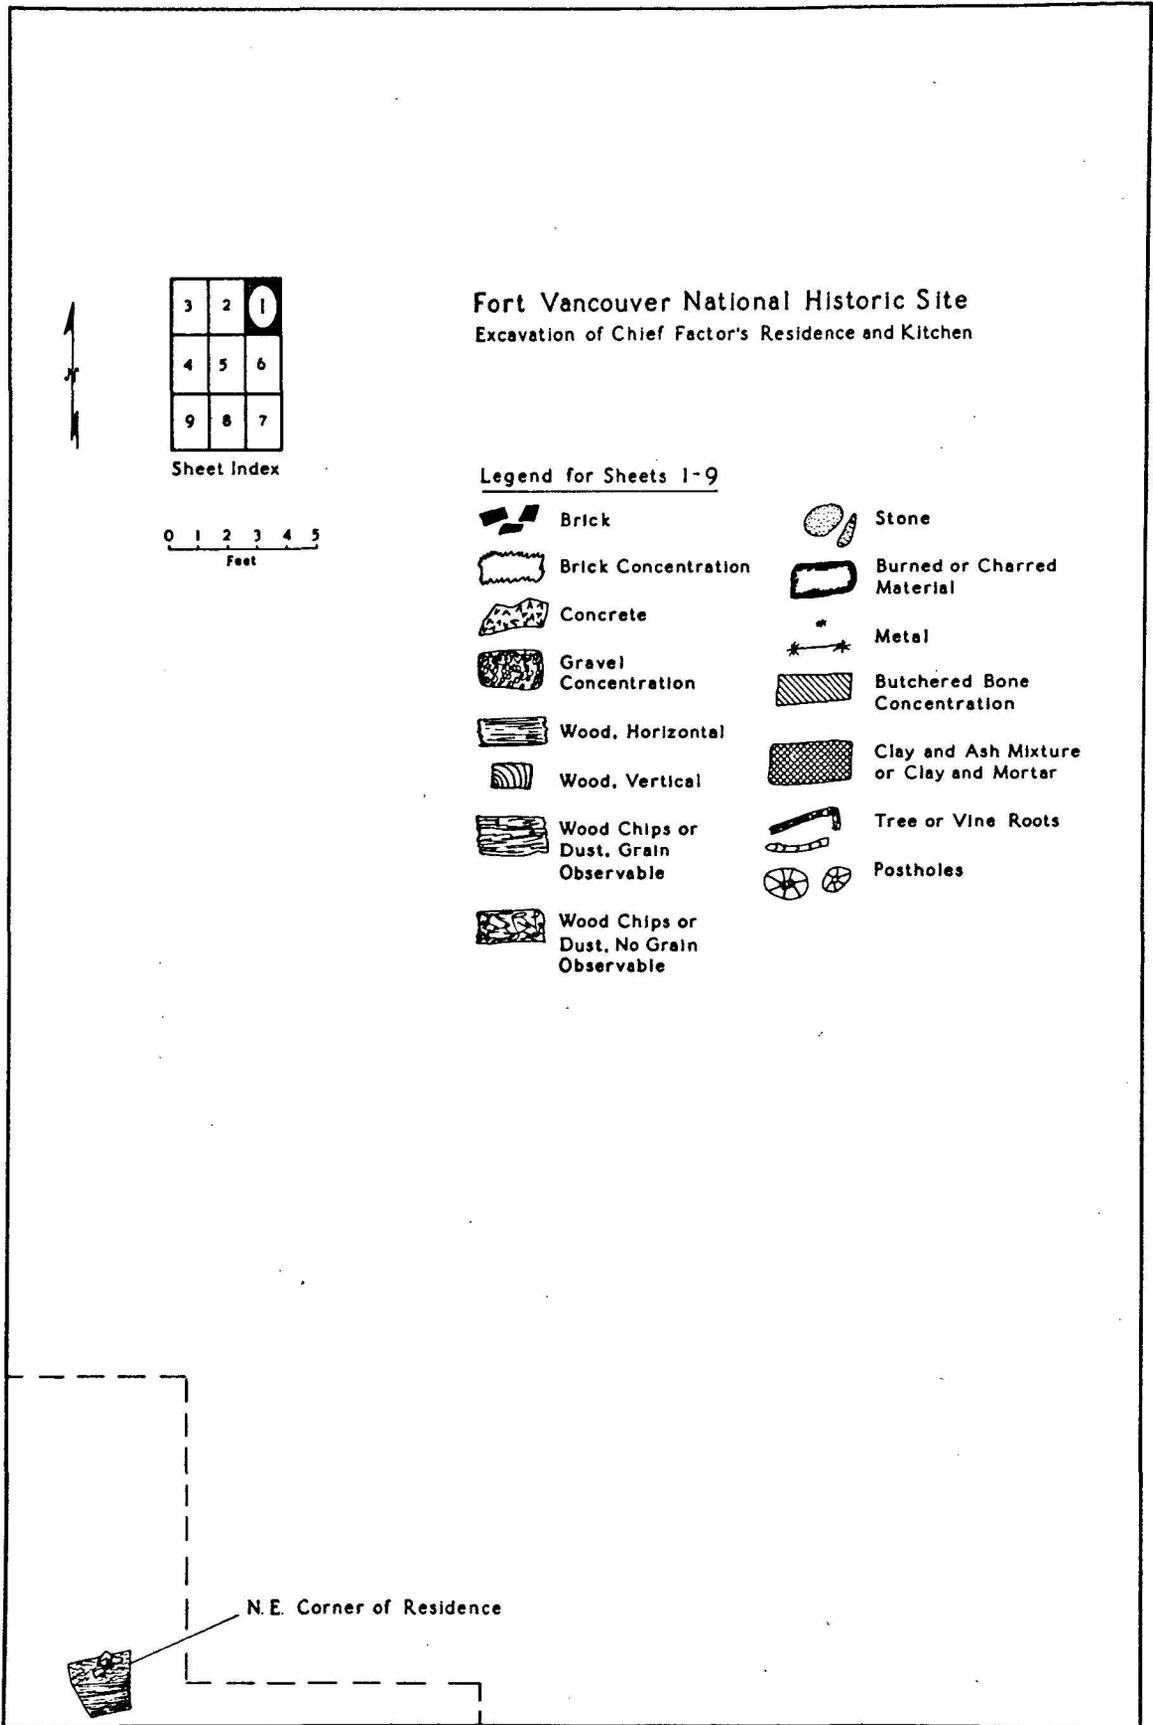
Fig. 3.1

3.1 thru 3.9	Enlarged sections of map showing Hudson's Bay Company features in and around the Chief Factor's House and Kitchen.....	18
4.	Structural footings of the Chief Factor's House.....	28

A small piece of the northern framing sill was found overlaying the northeastern corner footing (Fig. 3.1). This situation was interpreted during exploratory operations as a two-piece, superimposed footing (Caywood 1955:16). However, the relative rarity of two-piece footings in the wall lines (Tables 2-5) plus the discovery of a west sill fragment laying on the northwestern corner footing suggest otherwise. We now believe that the two-piece corner footings reported from exploratory operations consisted of sill fragments laying on footings. The northern sill fragment we found on the northeastern corner footing was oriented east-west. Remnant dimensions were 1.75 ft. long, 1.20 ft. wide, and 0.30 ft. thick. A photograph of this corner taken during exploratory operations (ibid.:Pl. III B) indicates these data to be virtually identical as seen by two different excavations.

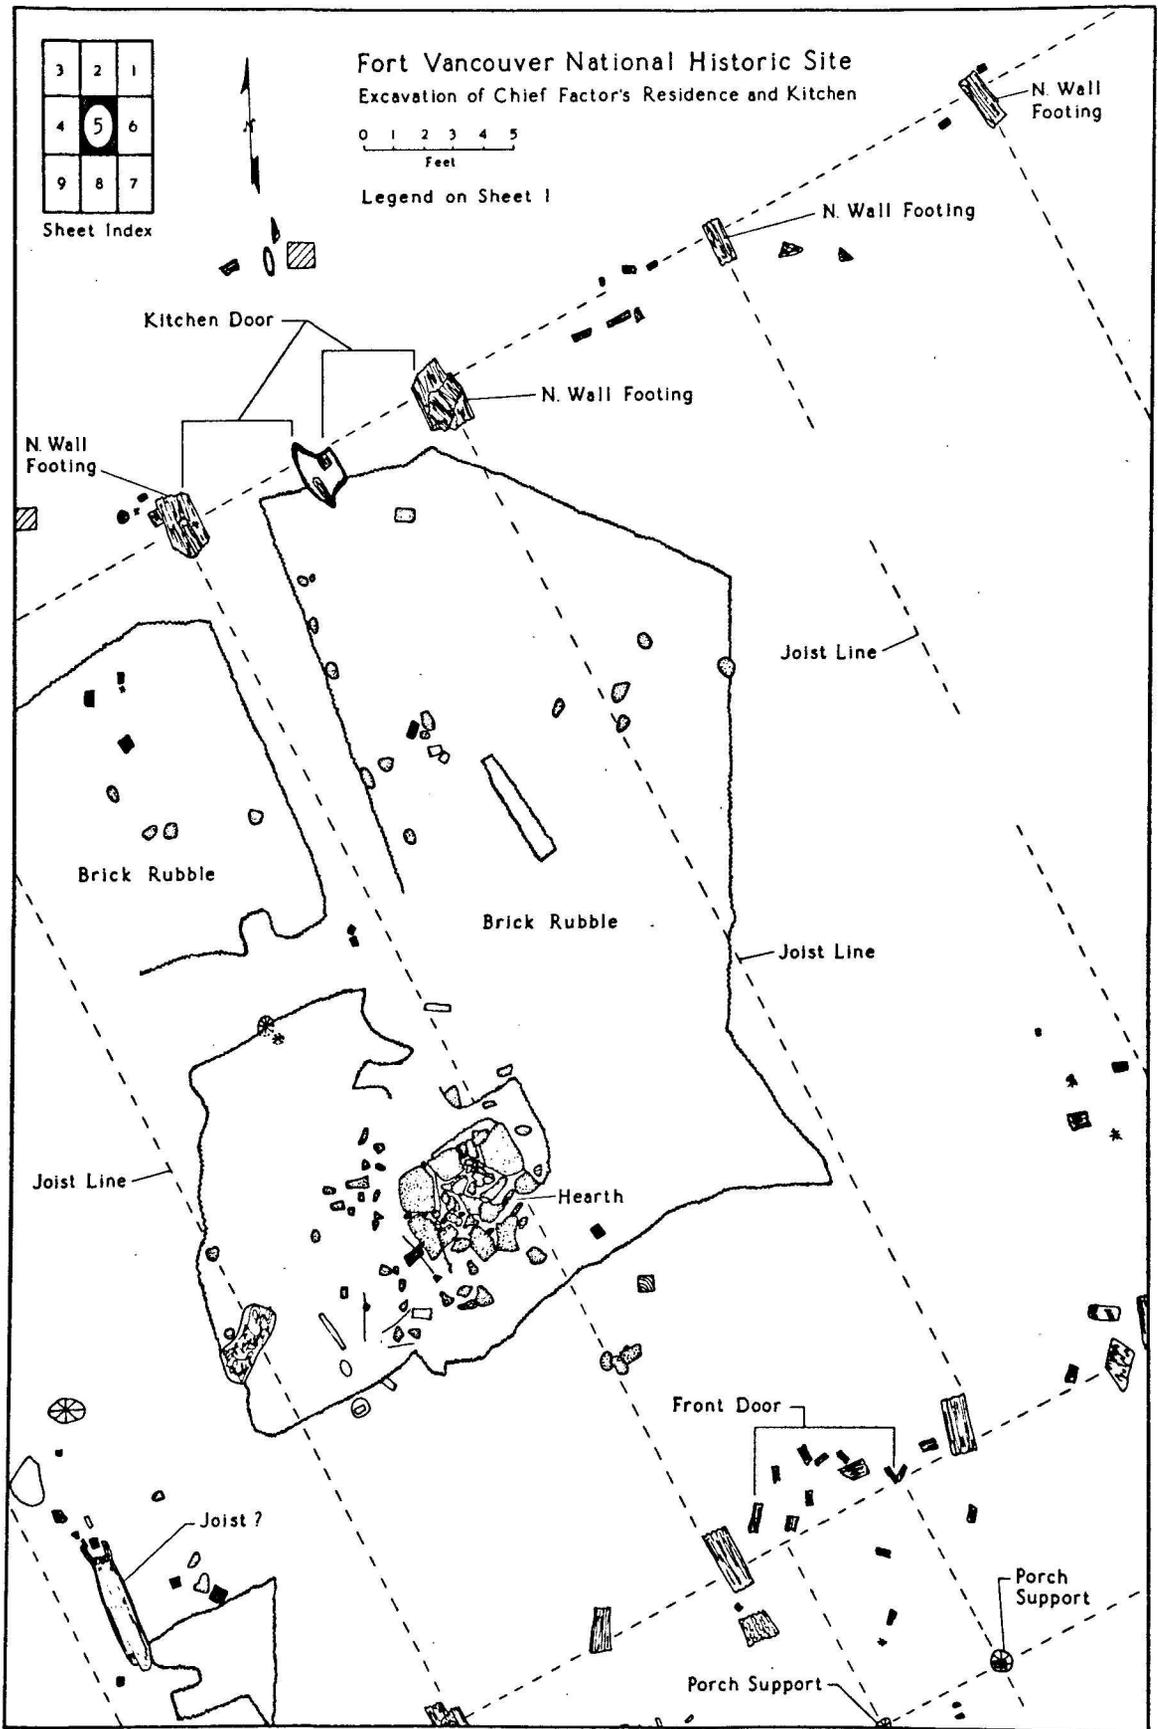
Fig. 3.5

Spacings of footings along the north wall indicate an attempt by the builders to set the blocks at 10 ft. intervals (Table 2). This regularity is broken at the center of the north wall by a supernumerary footing, F228 (Fig. 3.5). We believe this footing to mark one edge of a door or passage that is historically known to have connected the north wall of the House to the Kitchen (Hussey 1972:121). Unfortunately, we have no evidence as to which side of the door is represented by the extra footing; it could be either east or west. One thing appears certain -- this back door was not at the center of the House wall. Moreover, it was likely no wider than 3.3 to 3.725 ft., the effective clearance between the footings on either side of the extra footing.

A mass of small wooden fragments was found along the position of the south wall sill (Figs. 3.5, 3.6, 3.8). Most were too small or badly skewed for meaningful description. Some were charred, others were badly rotted. A large fragment was found overlaying the southeast corner footing. This piece, oriented east-west, was 1.7 ft. wide, 1.9 ft. long, and 0.3 ft. thick.

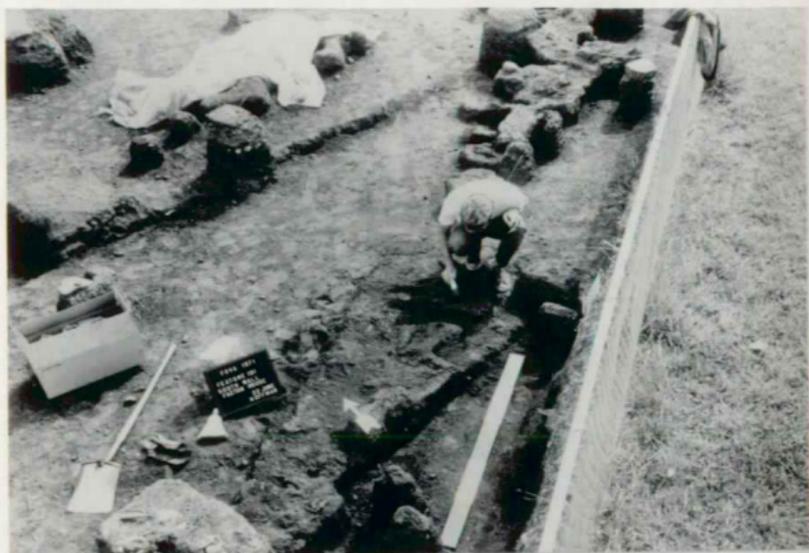
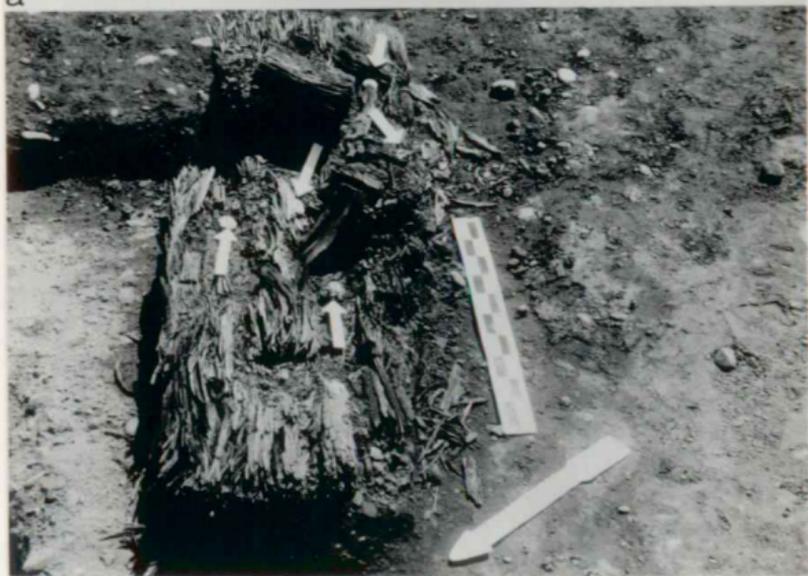
- a - Excavations along the south wall of house; earthen pedestals contain wooden footing and sill remnants (FOVA neg. 069.51-71/200)
- b - Wooden footing in the south wall of the house; small arrows point to musket balls embedded in the wood (FOVA neg. 069.51-71/227)

Excavations along the south wall of the House disclosed a high density of wood remains (Fig. 5a). Other than corners, those pieces oriented north-south and found at lower elevations were considered footings, while pieces found at higher elevations and oriented east-west were considered remains of the south wall sill (Figs. 3.5, 3.6, 3.9). The southeastern and southwestern corner footings were oriented the same as the northeastern and northwestern corners. Footings of the south wall were all wood blocks that varied from 0.65 to 2.95 ft. in width, 1.40 to 4.00 ft. in length, and 0.10 to 1.75 ft. thick in remnant dimensions (Table 4). Spacings of the footings indicate an attempt to set the original blocks at 10 ft. intervals.

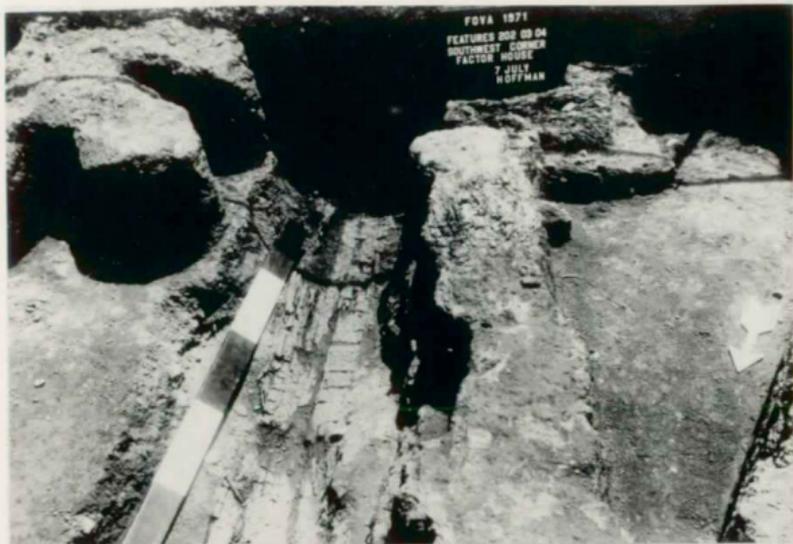
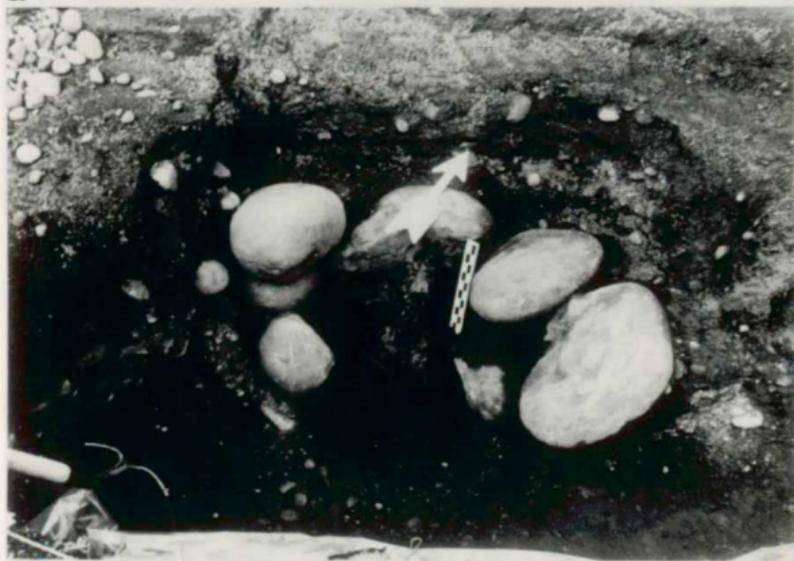
- a - Charred remains of the west wall (right), a wooden sill resting on wooden footings. Sign board rests on wooden block of the southwestern house corner. Intrusive, wood-lined drain of Vancouver Barracks (left) parallels house wall (FOVA neg. 069.51-71/208)
- b - Stone-packed post butt under the southern extension of the porch; possibly the base of a flagstaff (FOVA neg. 069.51-71/286)

The best evidence for framing sills was found along the west wall of the House (Fig. 6a). Here, the charred remains of a sill were found laying directly on the subsurface footings (Figs. 3.4, 3.9). The remnant length of 30.5 ft. contained sufficient wood to establish that the grain ran north-south. The remnant sill had a maximum width of 1.75 ft. but its thickness varied from only 0.10 to 0.50 ft. An irregularly shaped piece of the same sill was found directly overlaying the northwestern corner footing (Fig. 3.4); again, the wood grain was north-south. This piece was 0.60 ft. wide and 0.25 ft. thick. No evidence of the sill remained along the east wall of the House.

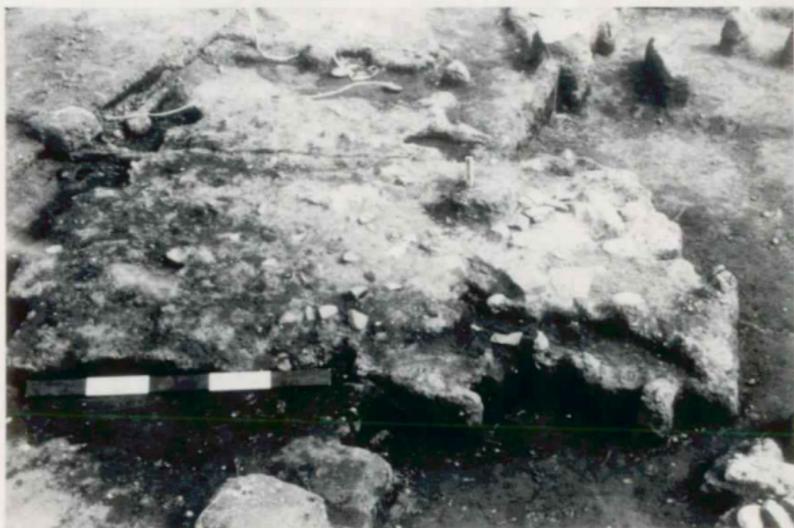
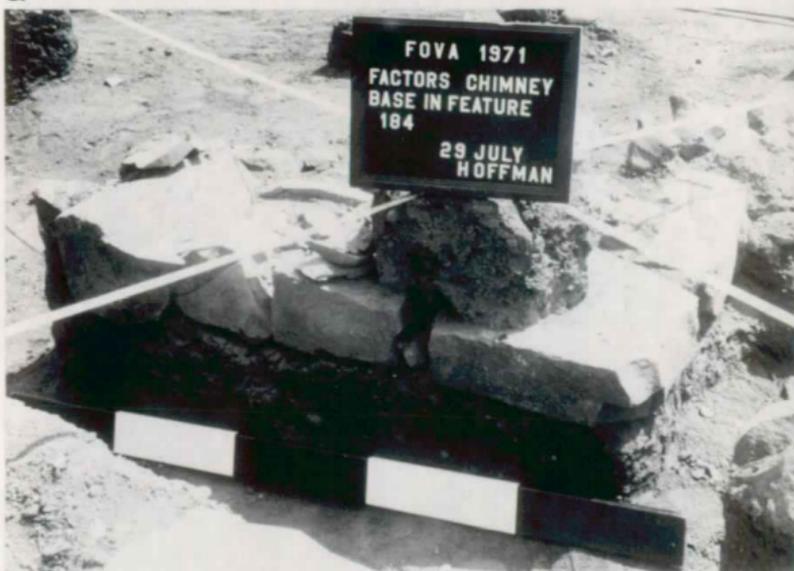
- a - Stone foundation of chimney base surrounded by brick rubble of the collapsed chimney; eastern portion of rubble is largely removed (FOVA neg. 069.51-71/202)
- b - North side of the stone chimney base after removing the brick rubble (FOVA neg. 069.51-71/232)

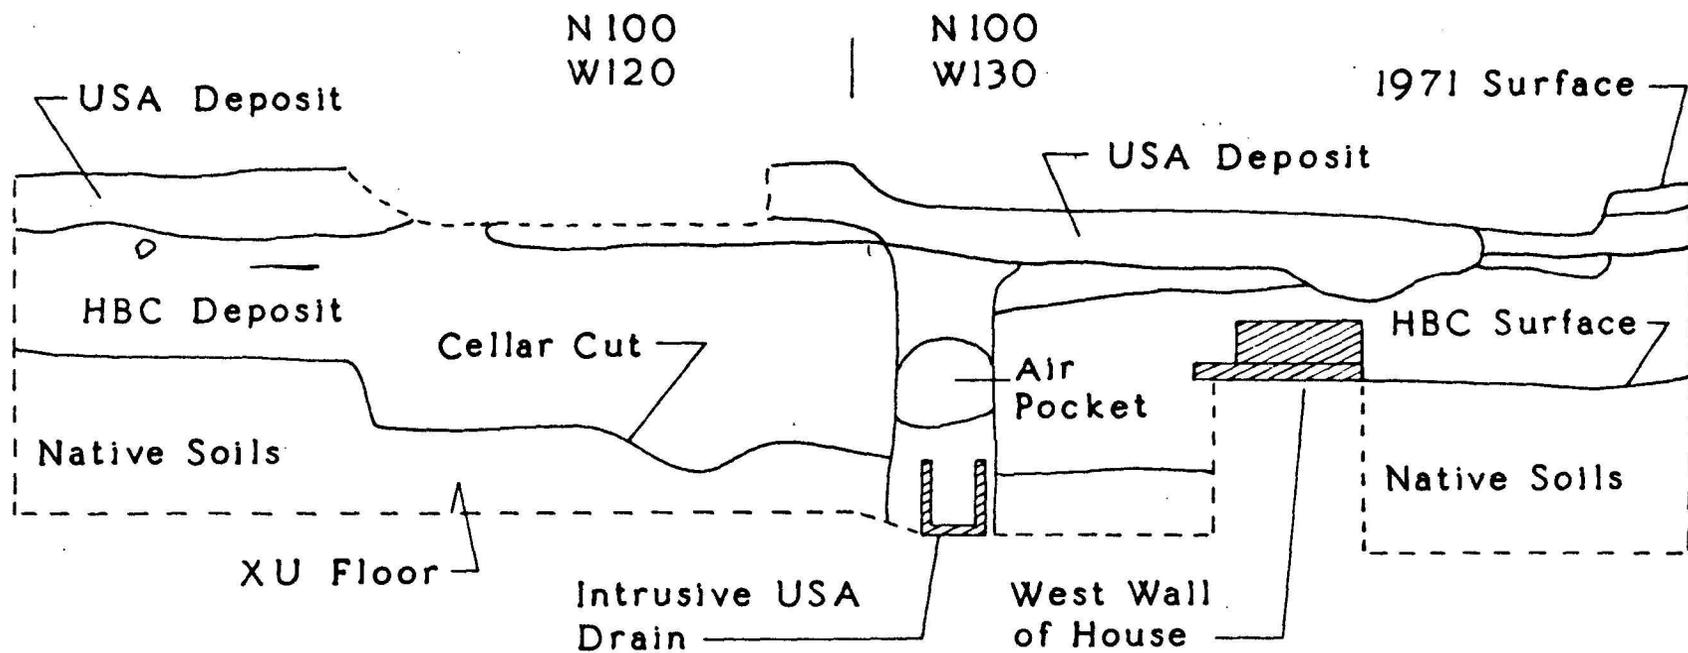
8.	Vertical position of the cellar inside the west wall of the Chief Factor's House.....	42
9.	Structural remains of the Chief Factor's House and Kitchen.....	49

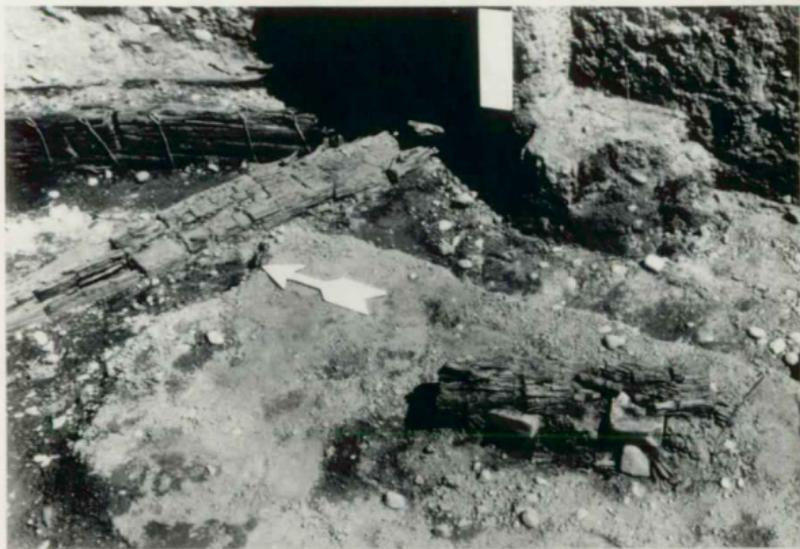
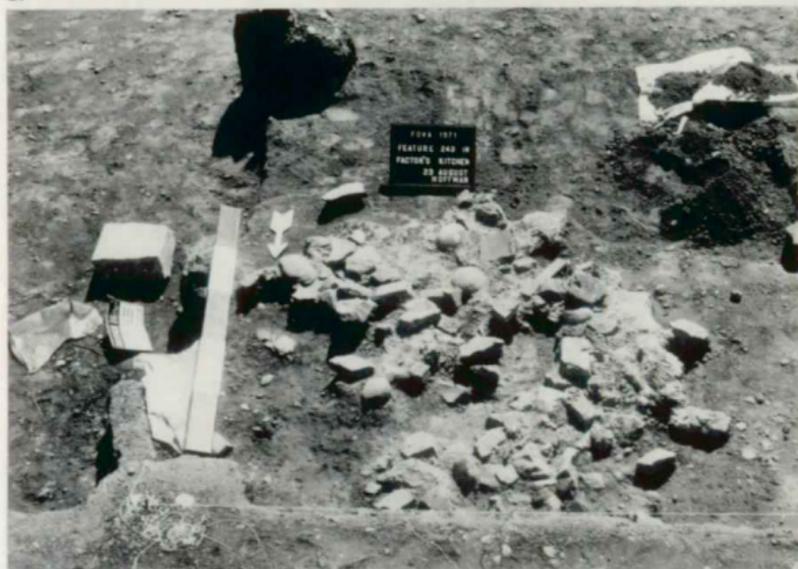
- a - Wooden post-in-sill on brick footing support for the southwestern corner of the fence in front of the Chief Factor's House (foreground); 2 rectangular wooden posts of the fence support (background) to right of photo scale. Intersection of 2 intrusive Vancouver Barracks drains to left of photo scale (FOVA neg. 069.51-71/279)
- b - Stone, brick, and metal rubble of collapsed cooking facility in the Chief Factor's Kitchen (FOVA neg. 069.51-71/280)

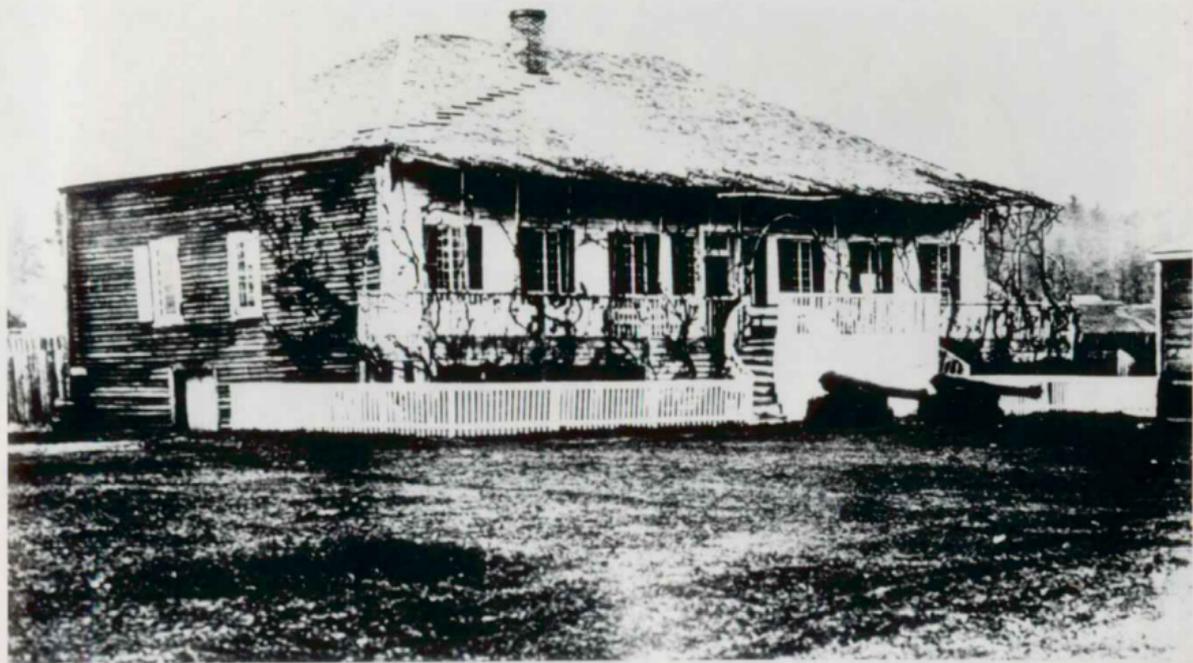
Fig. 10 - Southwestern elevation of the Chief Factor's House as photographed in May 1860 (FOVA neg. 069.55-73/99). Courtesy, Archives of the Royal Engineers, Brampton Barracks, Kent, U.K.

We have yet to obtain positive identification of the roots, but we believe them to represent domesticated vines that grew on the southern face of the porch and the adjacent areas of the House. That at least some of these vines were grapes and were planted by 1841 is well documented in the historical research (Hussey 1972: 104, 136). The vines were largely supported by the porch superstructure as well as devices connecting the porch railing with the southern roof eave (Fig. 10).

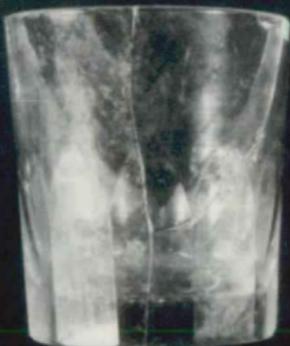
A

- a - Faceted tumbler, Variety #2002A (Caywood, #1741)
- b - Plain tumbler, Variety #2004 (Caywood, #261)
- c - Freeblown stemmed glassware, Variety #1006 (Caywood, #772)
- d - Pressed glass dish (Caywood, Note: item in display case)

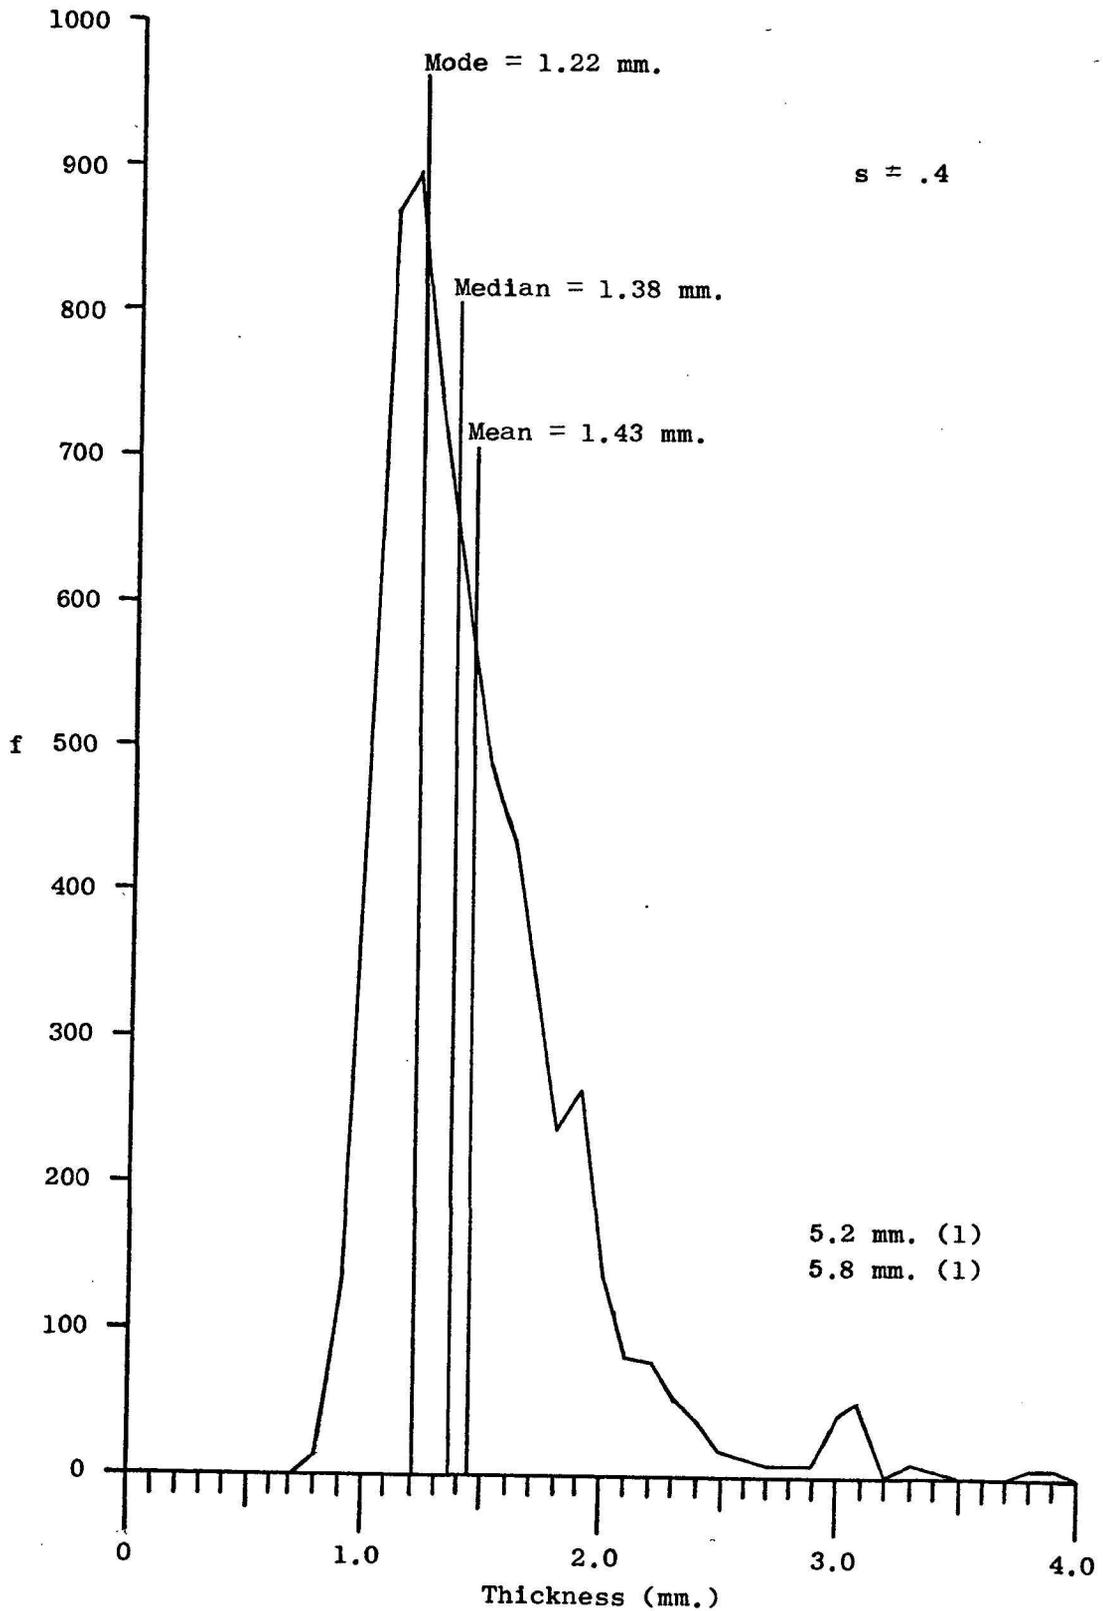
Fig. 22 --Frequency of Window Glass Thickness for the Area of the Chief Factor's Residence (N=5989)

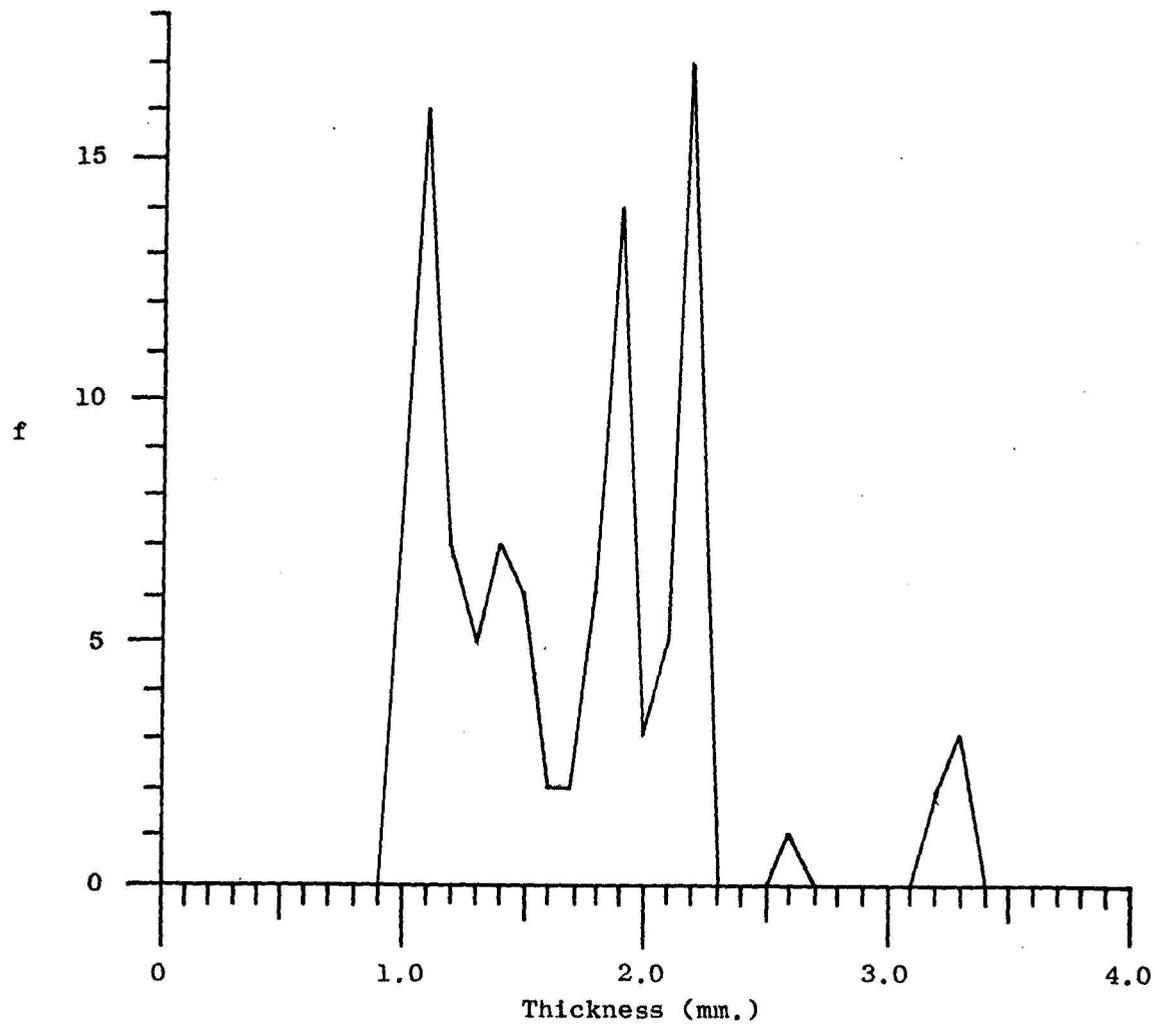
Fig. 23 --Frequency of Mirror Glass ("Looking Glass") Thickness for the Area of the Chief Factor's Residence (N=105)

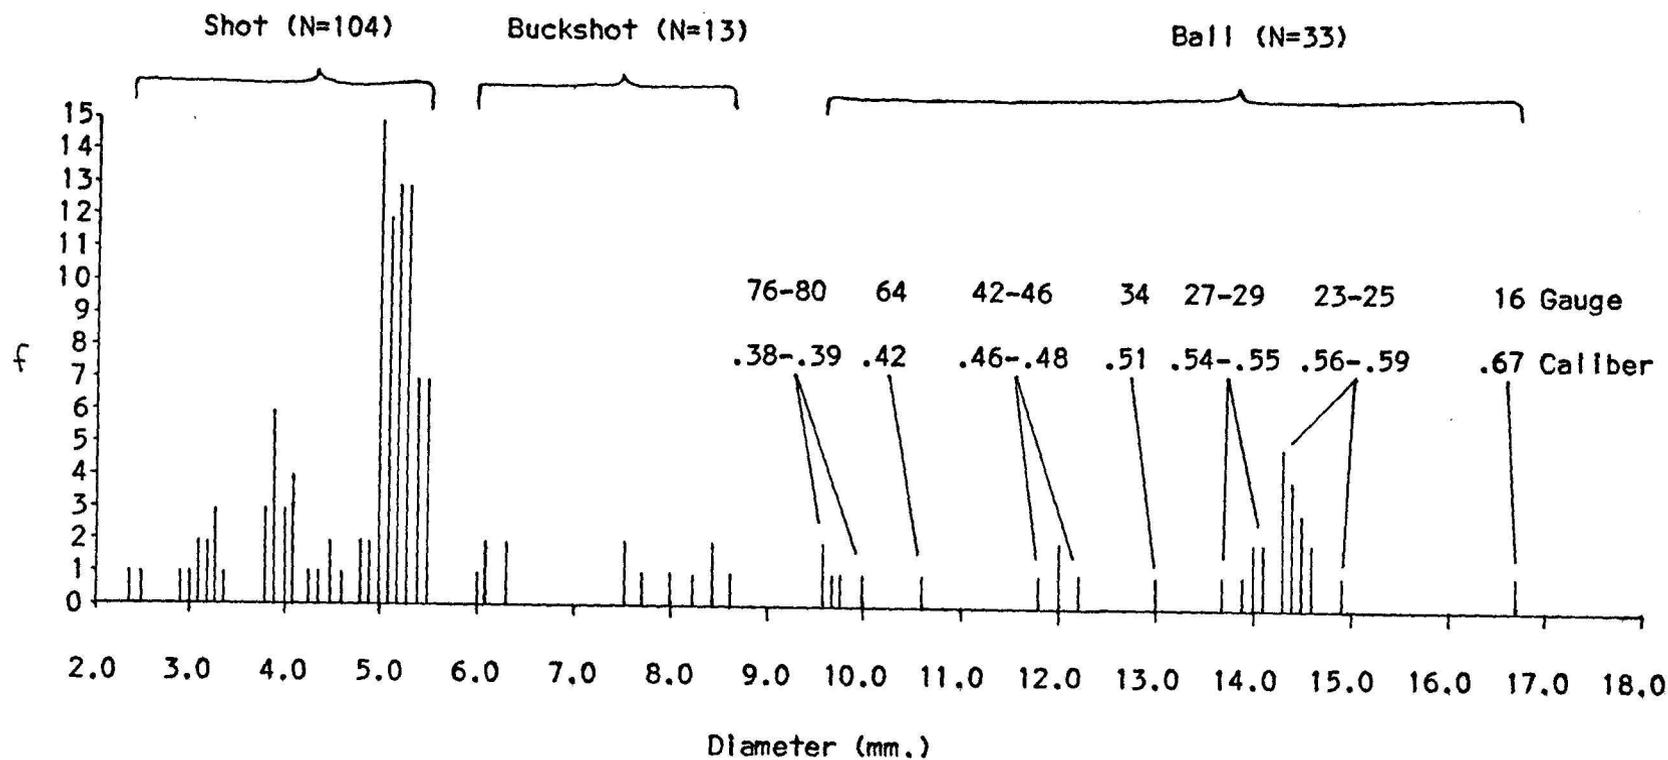
Fig. 38 - Lead shot, buckshot, and ball from the Chief Factor's Residence (N=150).

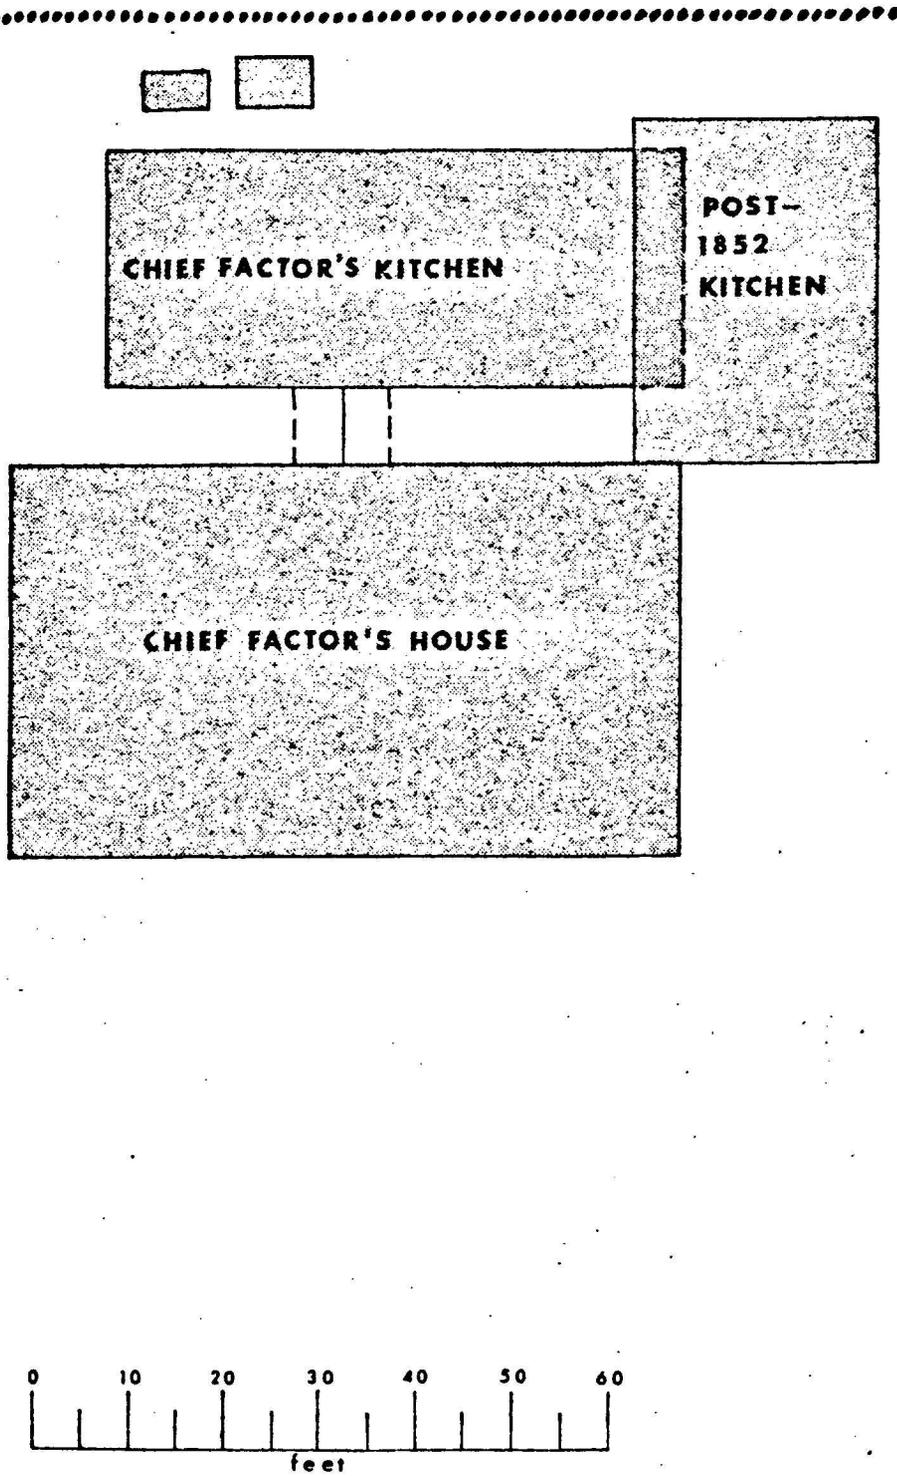
Fig. 40 - Structural positioning in area of the Chief Factor's House. Porch and fences not shown.

From an archeological point of view, our schematic arrangement of the observation deck or southern porch extension is entirely conjectural. This arrangement is made to accommodate the historical
