FORT VANCOUVER EXCAVATIONS - IV  
Chief Factor's House and Kitchen

by  
J. J. Hoffman  
and  
Lester A. Ross

National Park Service

Fort Vancouver National Historic Site

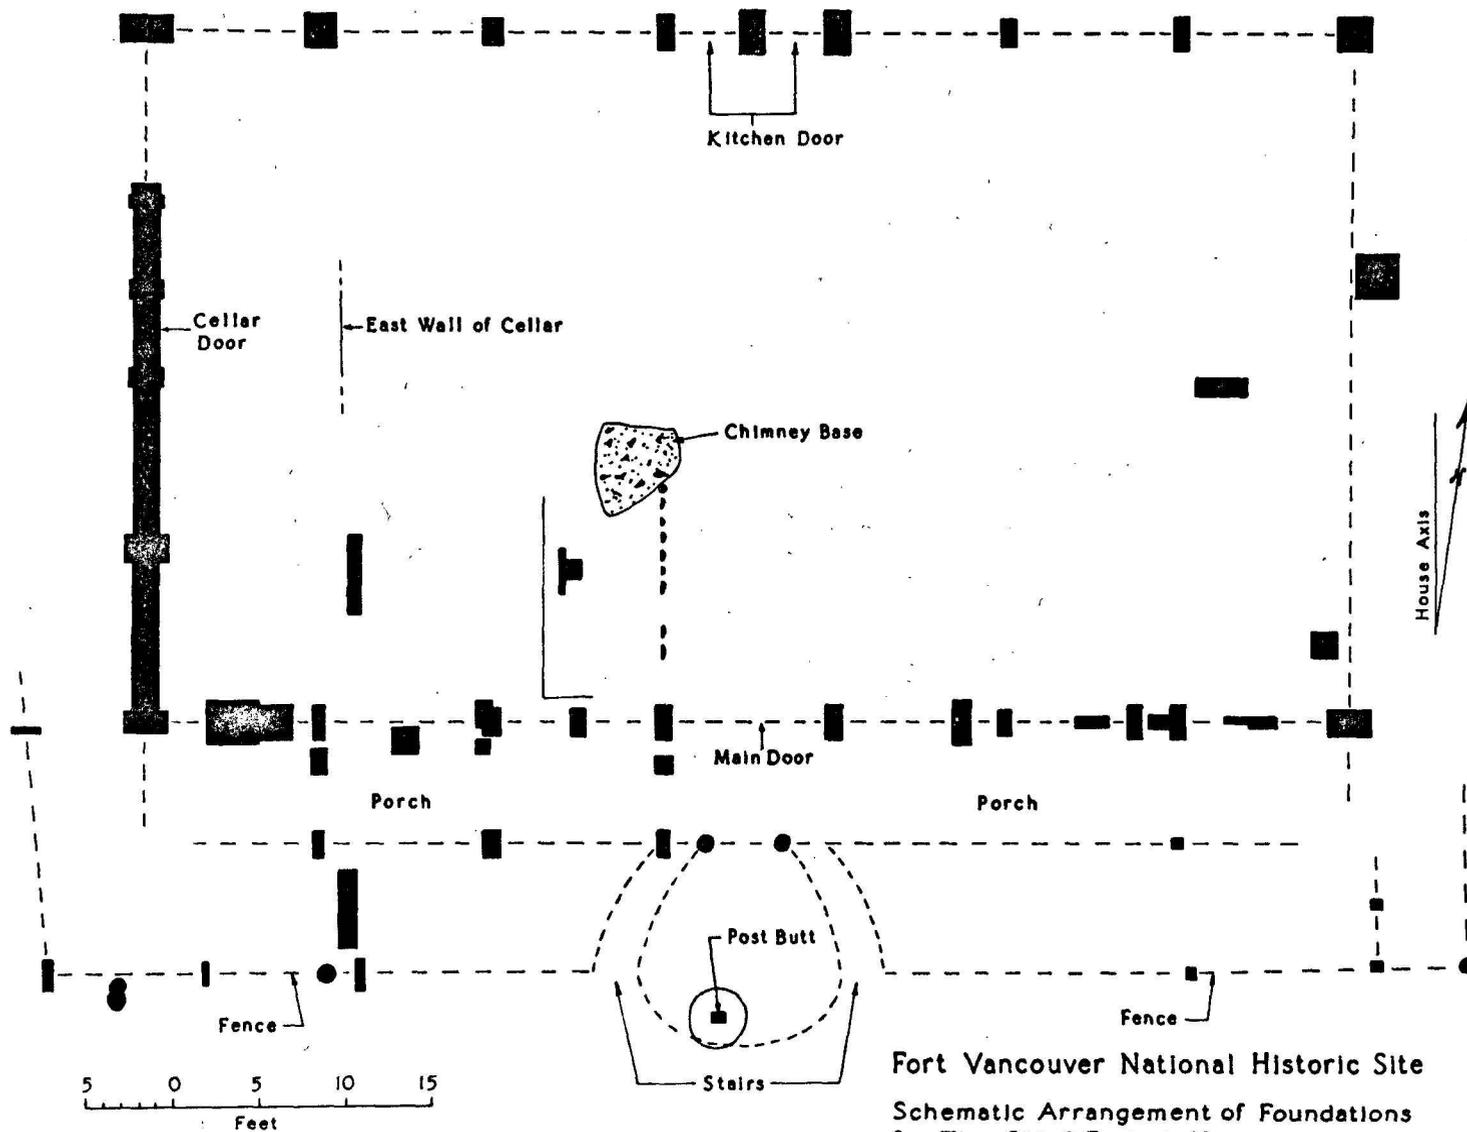
Fig. 41

Fort Vancouver National Historic Site  
 Schematic Arrangement of Foundations  
 for The Chief Factor's House

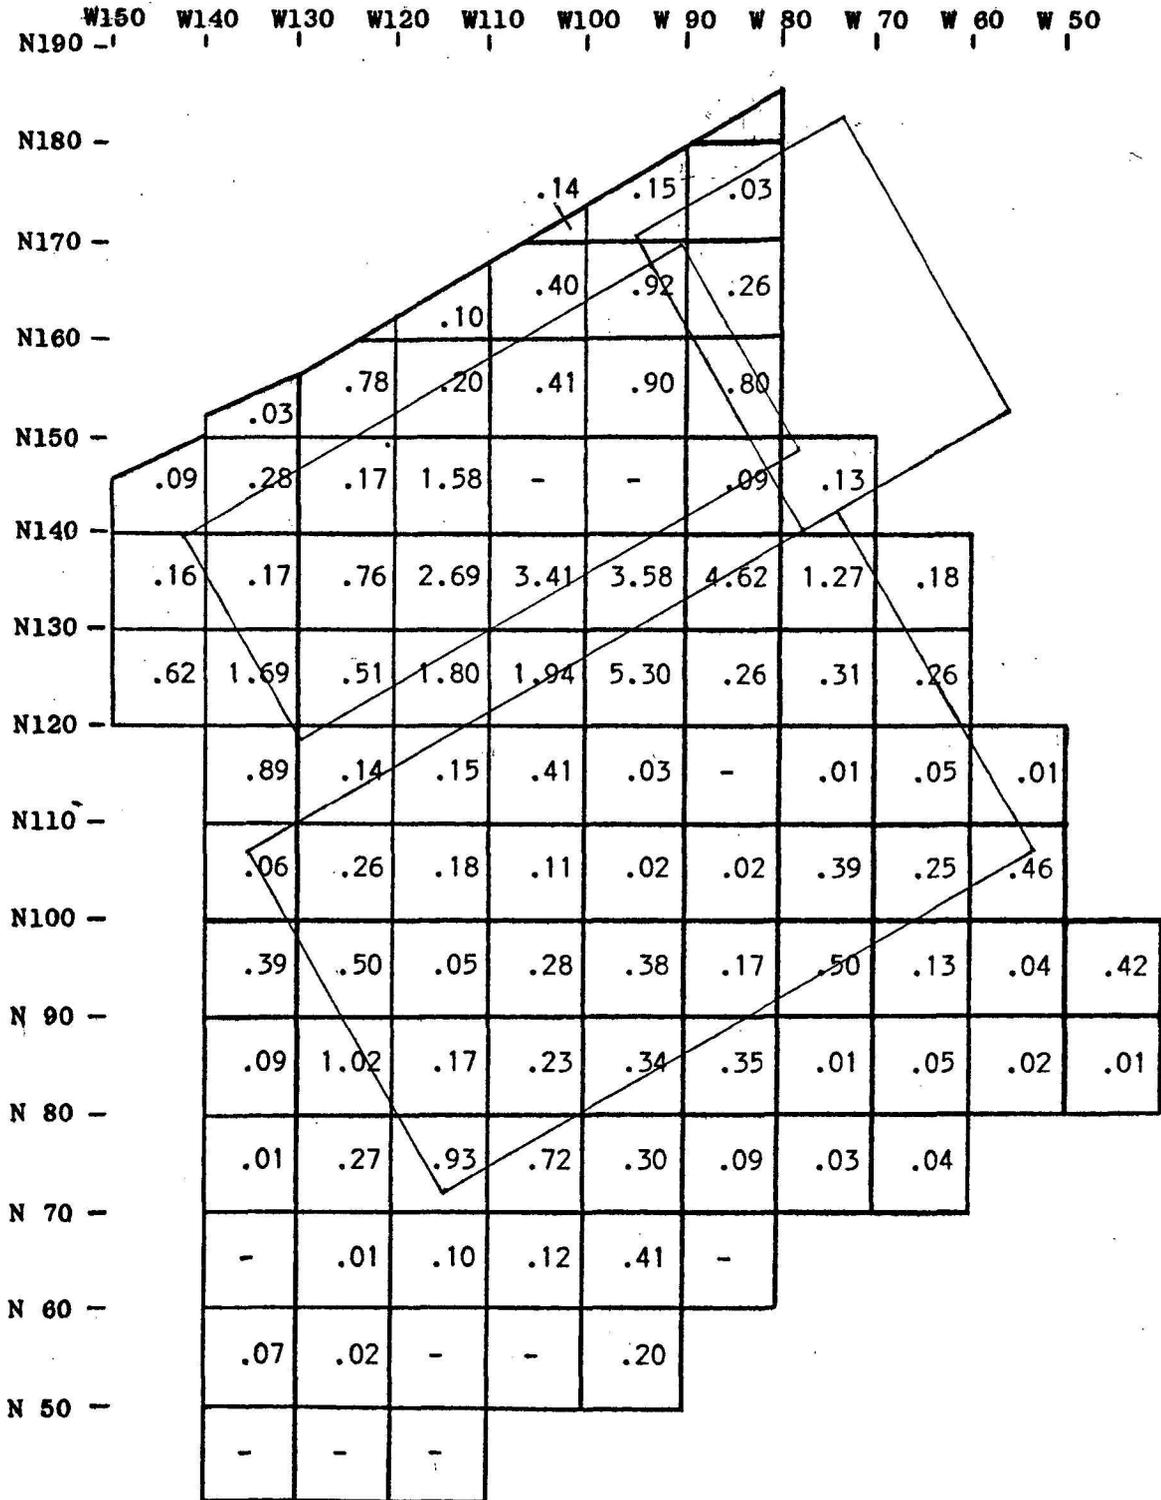
Fig. 42 - Relative frequencies of window glass fragments ( $f/ft^3$ ).

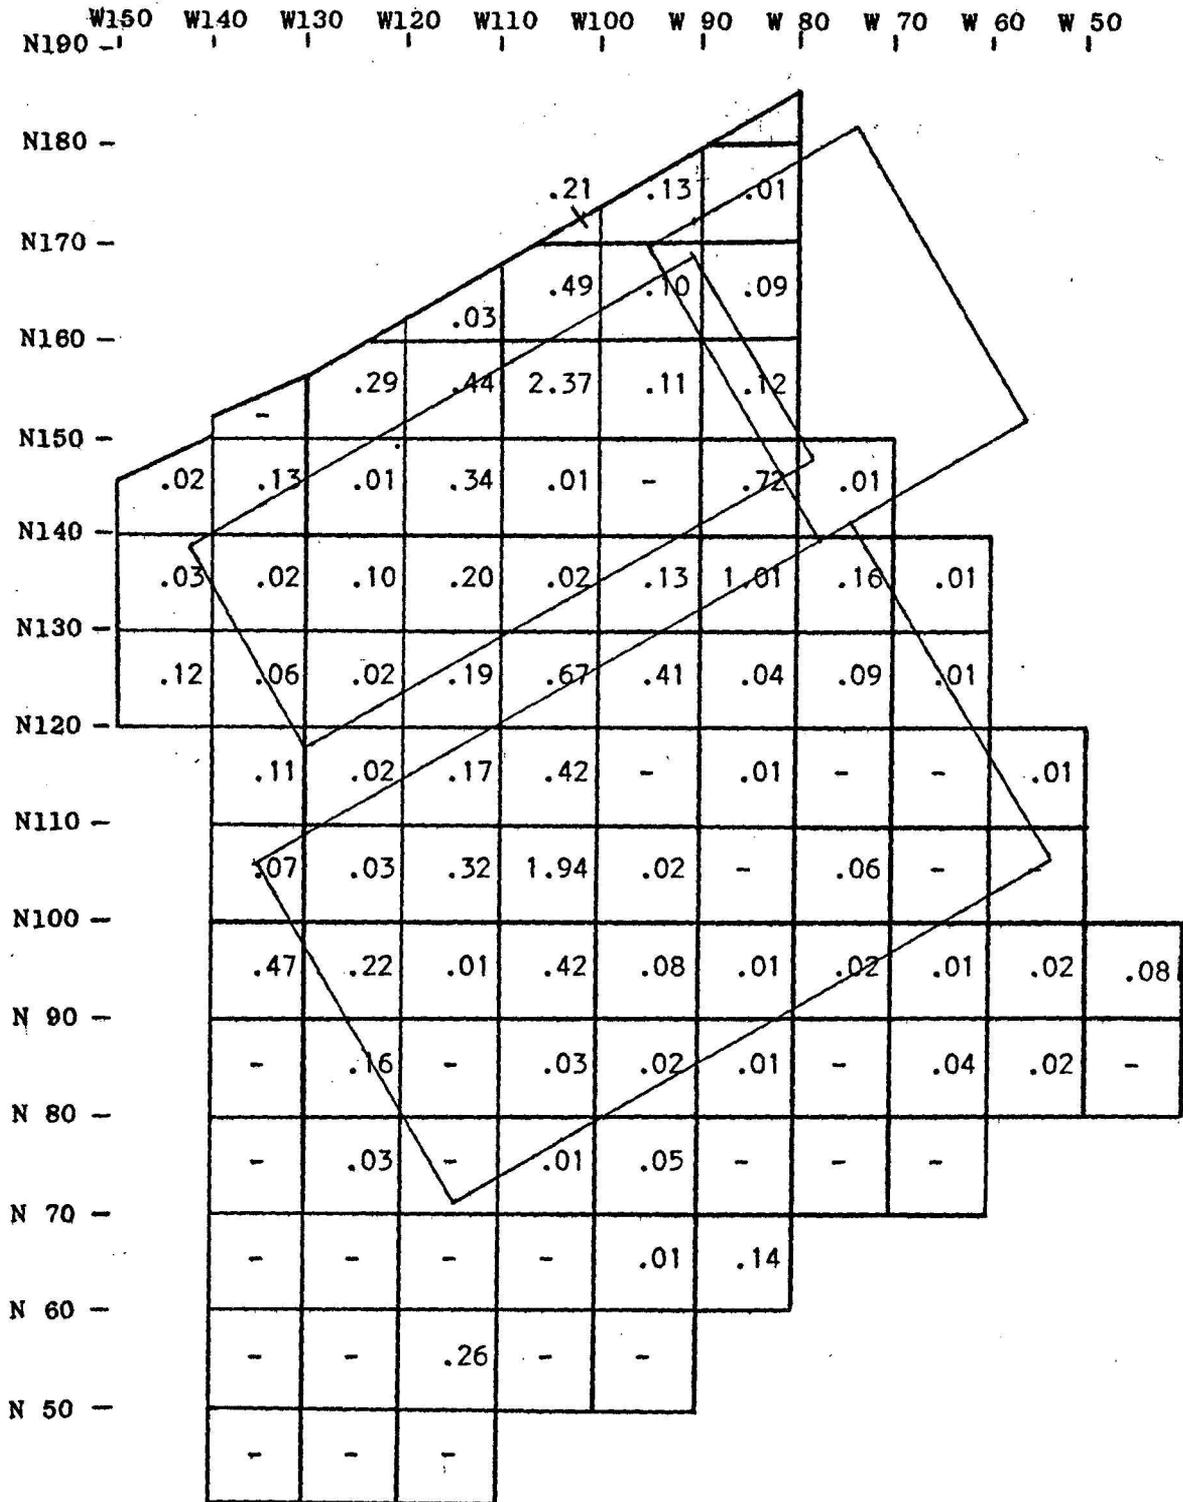
Fig. 47 - Relative frequencies of coal fragments ( $f/f+3$ ).

The highest frequency of coal centers about the cooking facility of the Chief Factor's Kitchen (Fig. 47). Either the facility was fired with coal or its position was used as a coal dump after the destruction of the Kitchen. In a previous report (Hoffman and Ross 1973:62), we deduced the post-1852 Kitchen to have a large, coal-fired stove.

There is an S-shaped distribution beginning at the west wall of the post-1852 Kitchen, proceeding through the north-central wall of the House, and continuing south to the west side of the chimney base. This may be only a blending of 2 coal storage areas, one outside the post-1852 Kitchen and the other at the eastern extremity of the storage space under the House. Storage under the House is definitely indicated by a small density that straddles the western wall of the House at about the cellar door (Fig. 47).

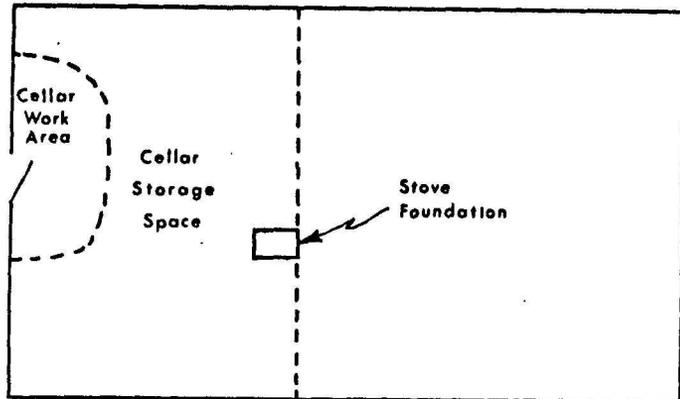
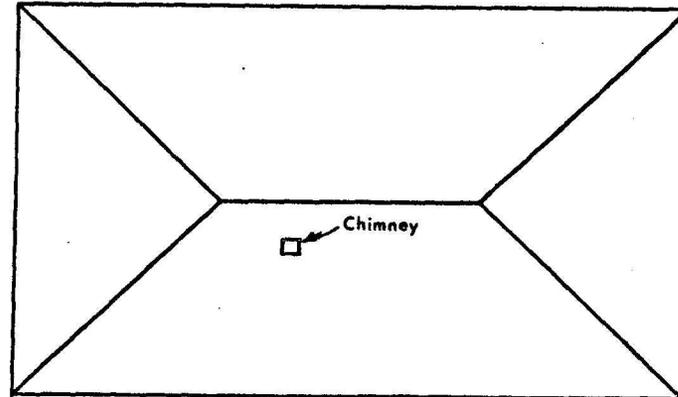
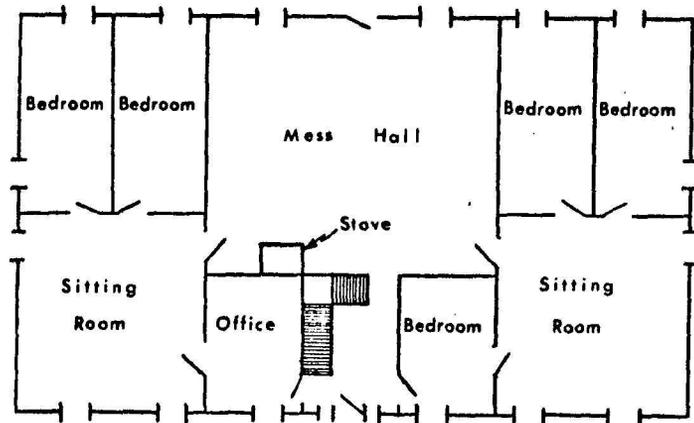
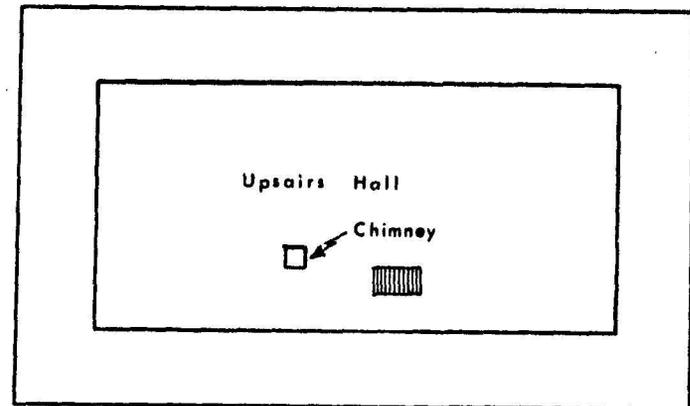
CELLAR

ROOF

MAIN FLOOR

UPSTAIRS

Our hypothesized version of the main floor plan is almost identical to that proposed by Hussey. For instance, the number and positions of the windows, doors, and half windows are the same. However, we believe the widths of the windows to be about 3 ft. Another
