FORT VANCOUVER EXCAVATIONS - VIII

Fur Store

United States Department of the Interior

National Park Service

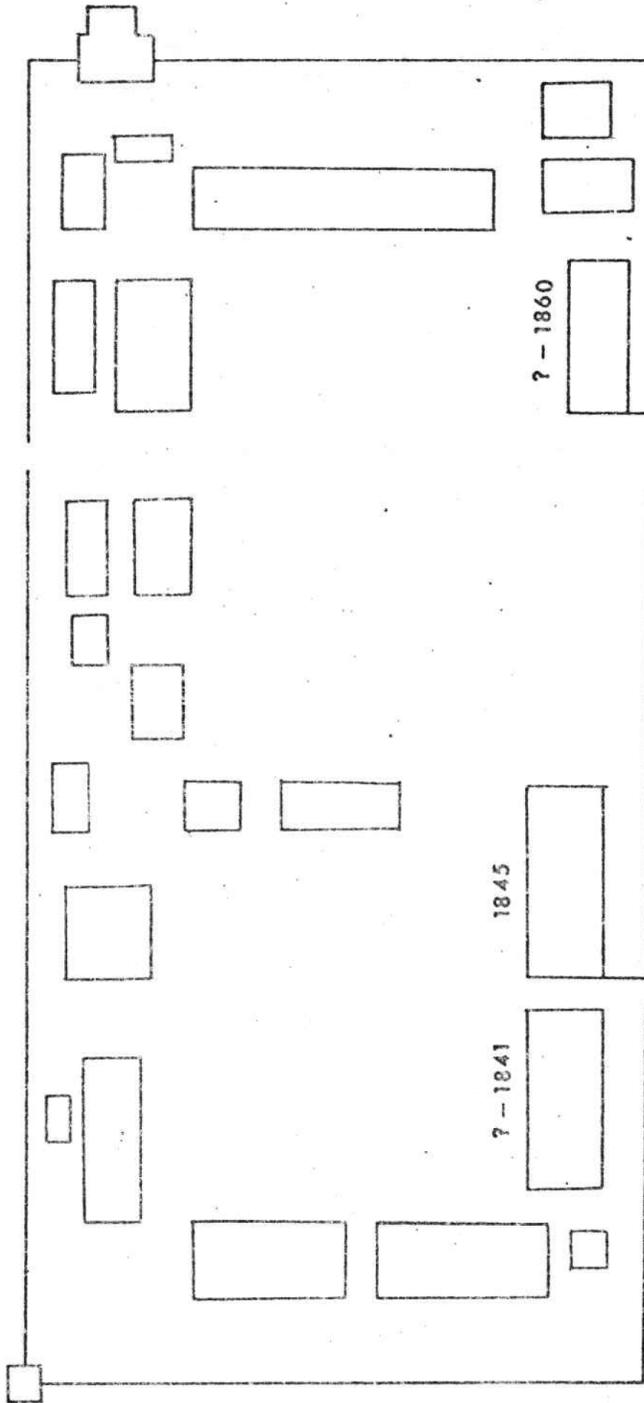
Fig. 1 - Locations of the Fur Stores on the Vavasour map of 1845
(after Hussey 1972:Pl. VII).

Summarily, 3 different buildings functioned or were identified as fur stores at Fort Vancouver. The second of these, located at the south-central sector of the Fort, is the subject of this report (Fig. 1).

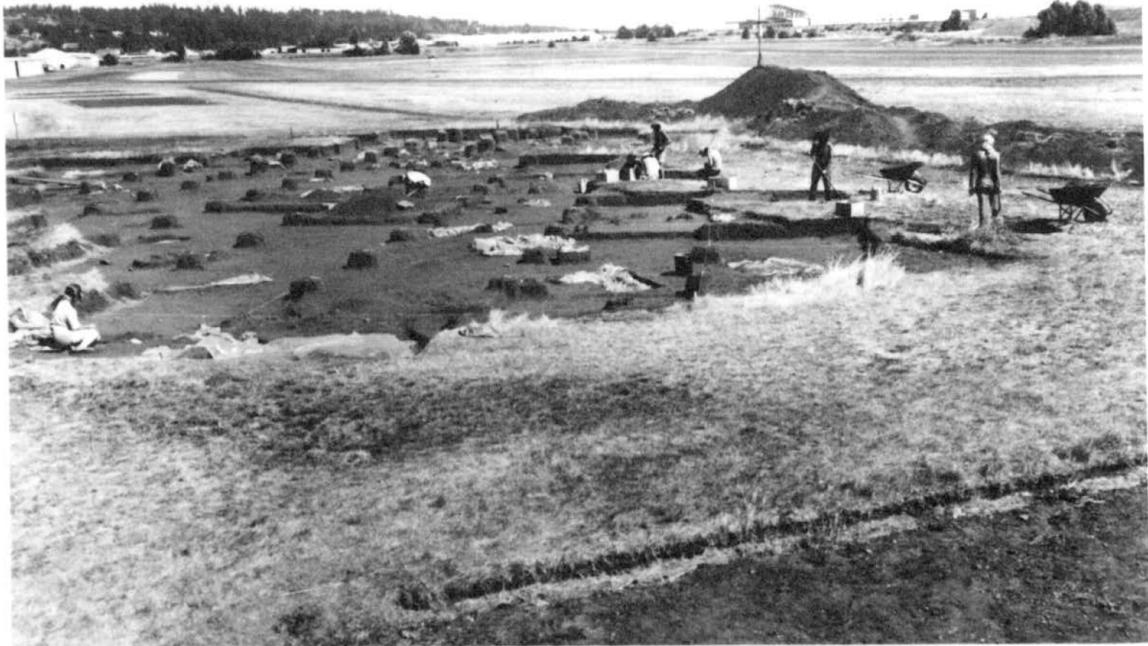
Fig. 4 - Fur Store excavations.

- a - General view of the excavated area looking east (FOVA neg. 069.51-72/208).
- b - Forge remains located east of the Fur Store; not completely excavated (FOVA neg. 069.51-72/190).

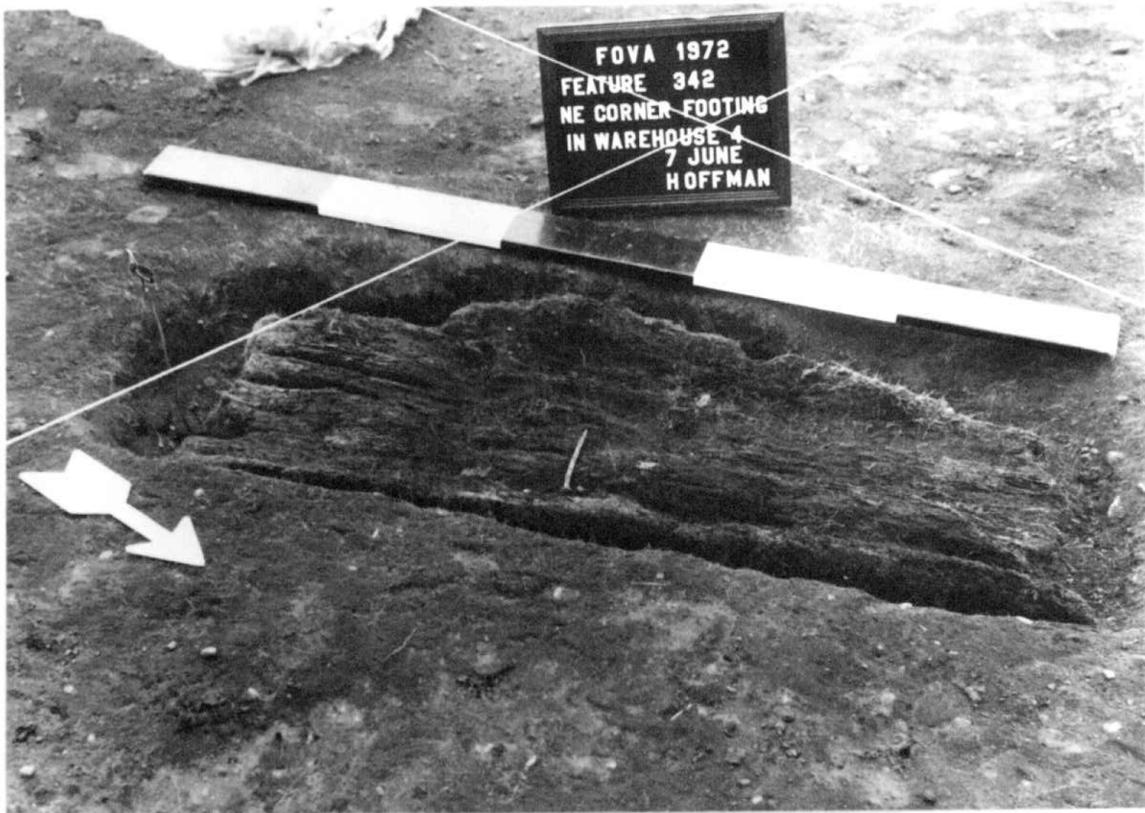
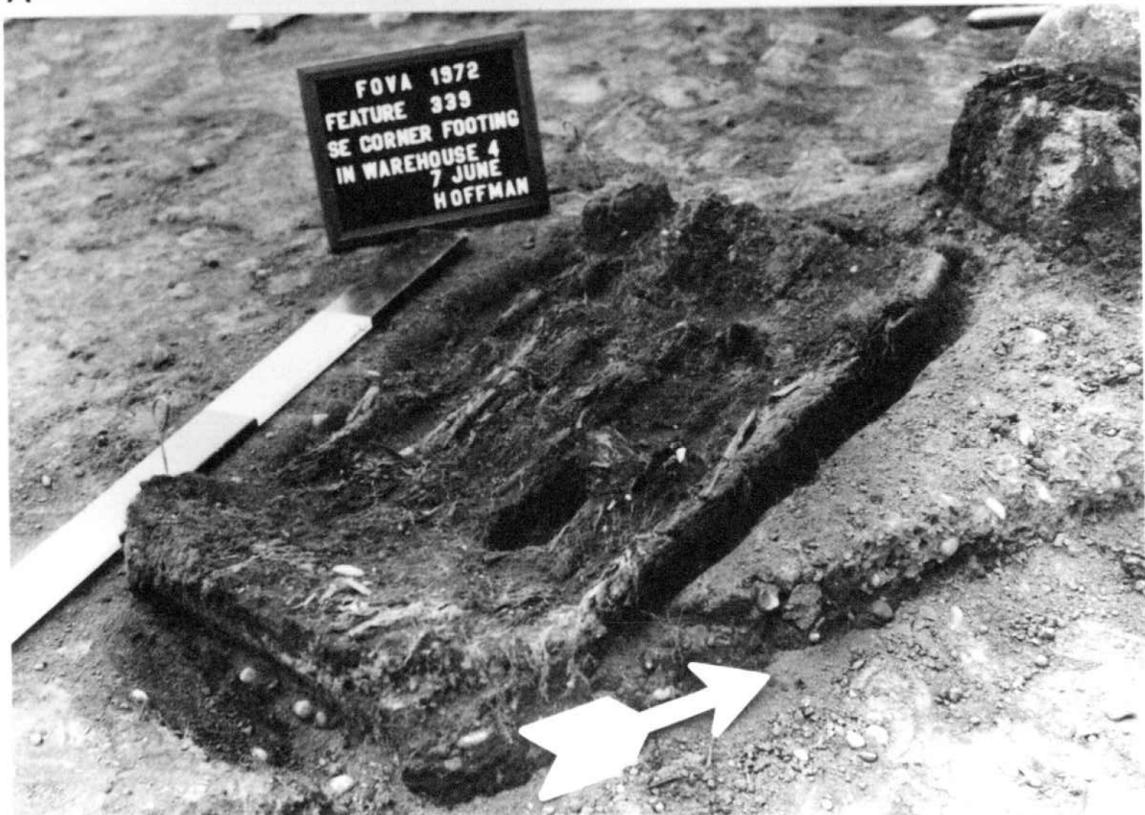
a - Northeast corner footing with transverse metal spike in situ (FOVA neg. 069.51-72/41).

b - Southeast corner footing showing mortise in upper face (FOVA neg. 069.51-72/40).

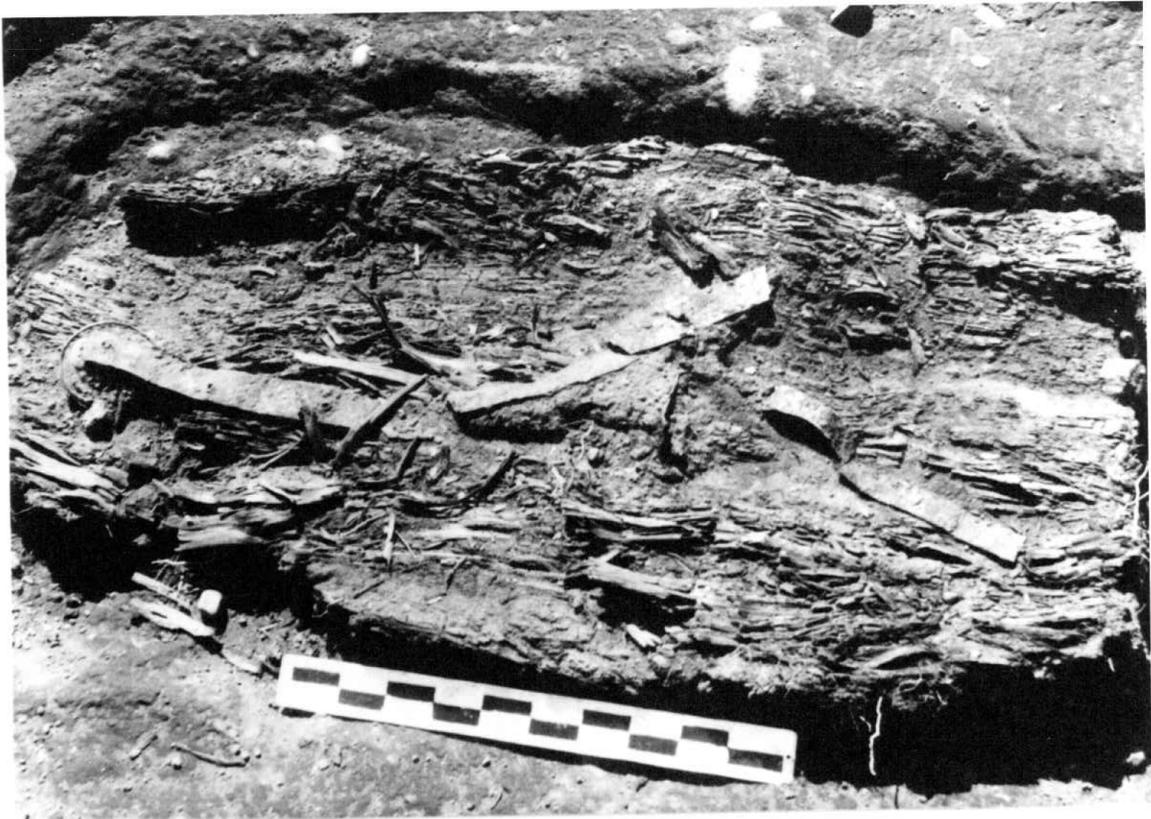
Fig. 7 - Structural remains of the Fur Store.

a - Medial footing overlaid with perforated metal straps (FOVA neg. 069.51-72/29).

b - North wall footing with transverse metal pin projecting from west side (FOVA neg. 069.51-72/57).

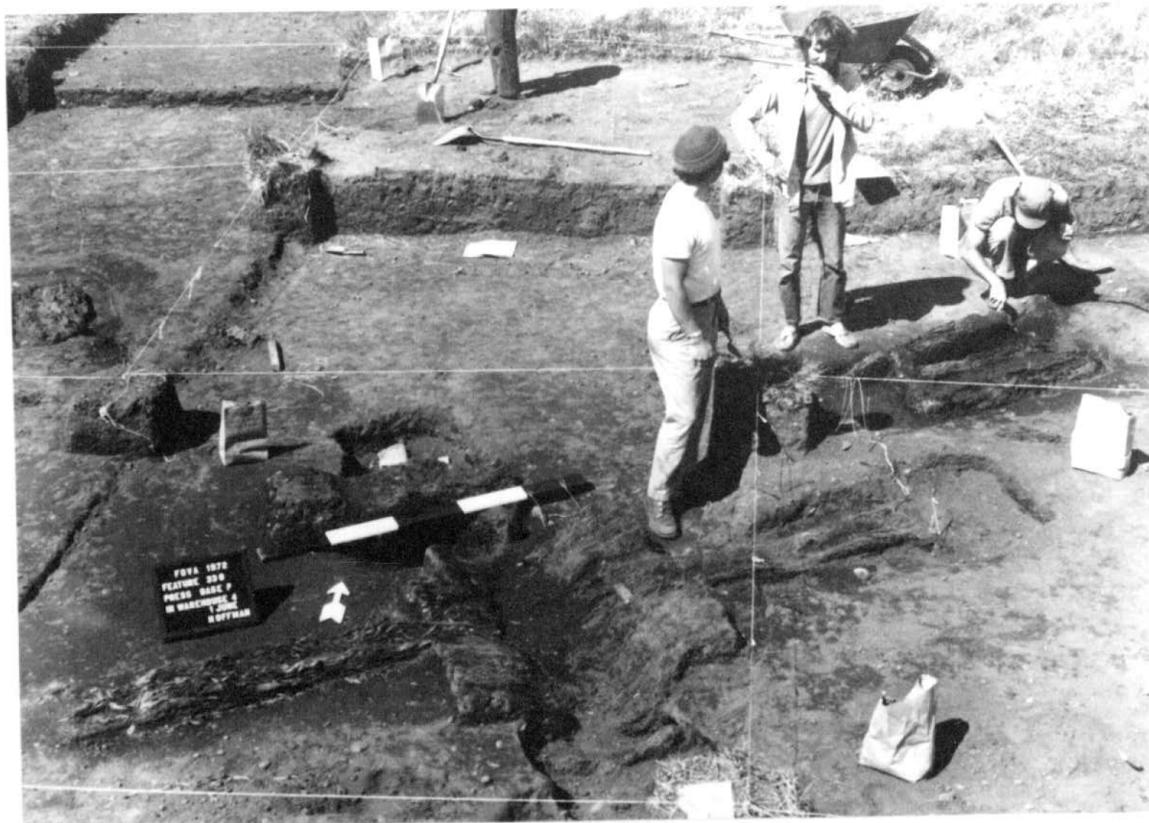
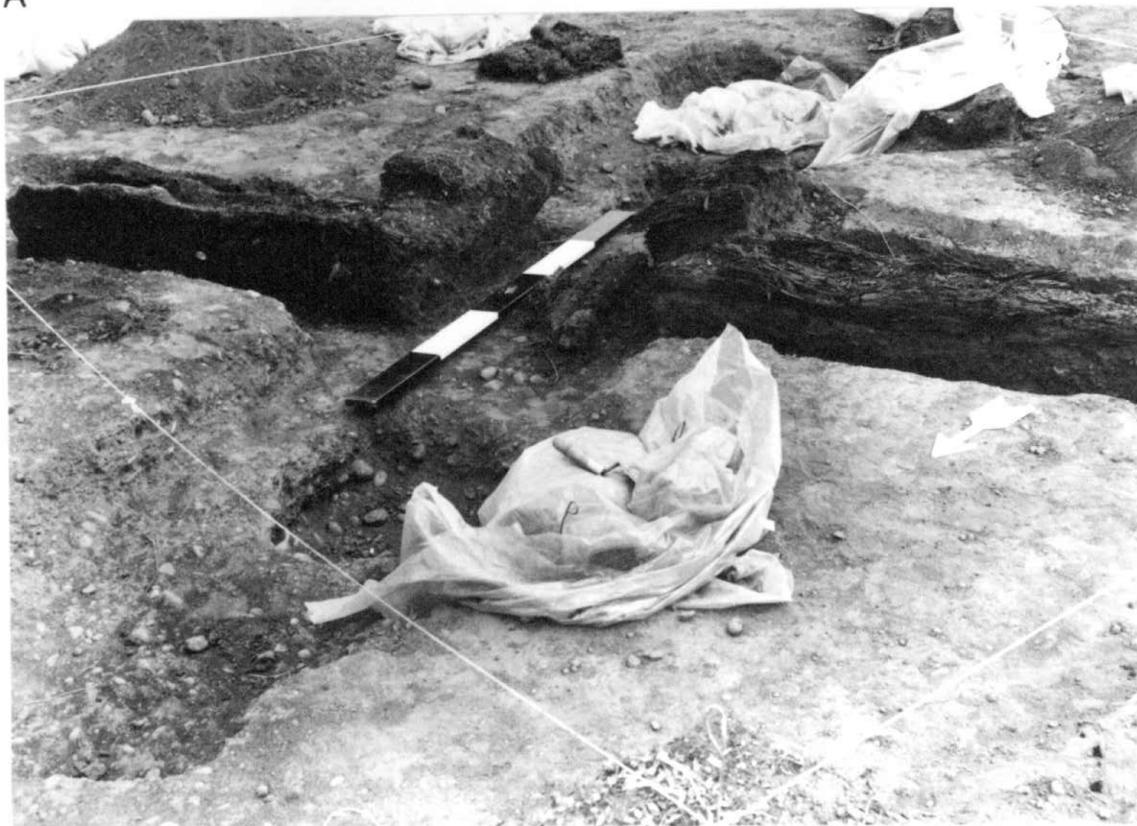
Fig. 9 - Remains of baling press base in the Fur Store.

- a - Beginning exposure of the press base. East-west oriented wood is depressed along north-south axis (FOVA neg. 069.51-72/31).
- b - After excavation; note hole at base of northern trench. Long east-west piece rests on fill within the cross trench (FOVA neg. 069.51-72/55).

A rather unusual feature found in the southeast corner of the Fur Store was the base of a large baling press (Fig. 3.4). It consisted of crossed trenches 14.7 and 15.2 ft. long that were oriented to the Store foundations. The north-south trench had two flat-bottomed pits at the base of its "arms" (Fig. 10). East-west oriented wood rested on prepared backfill within the trenches in such a way as to be higher in elevation than the surrounding surface (Fig. 9). At the center of the crossed trenches, smaller fragments of north-south oriented wood were found under the east-west wood. Centers of the

east-west wood were severely depressed along a north-south axis, as if by tremendous pressure (Fig. 9a).

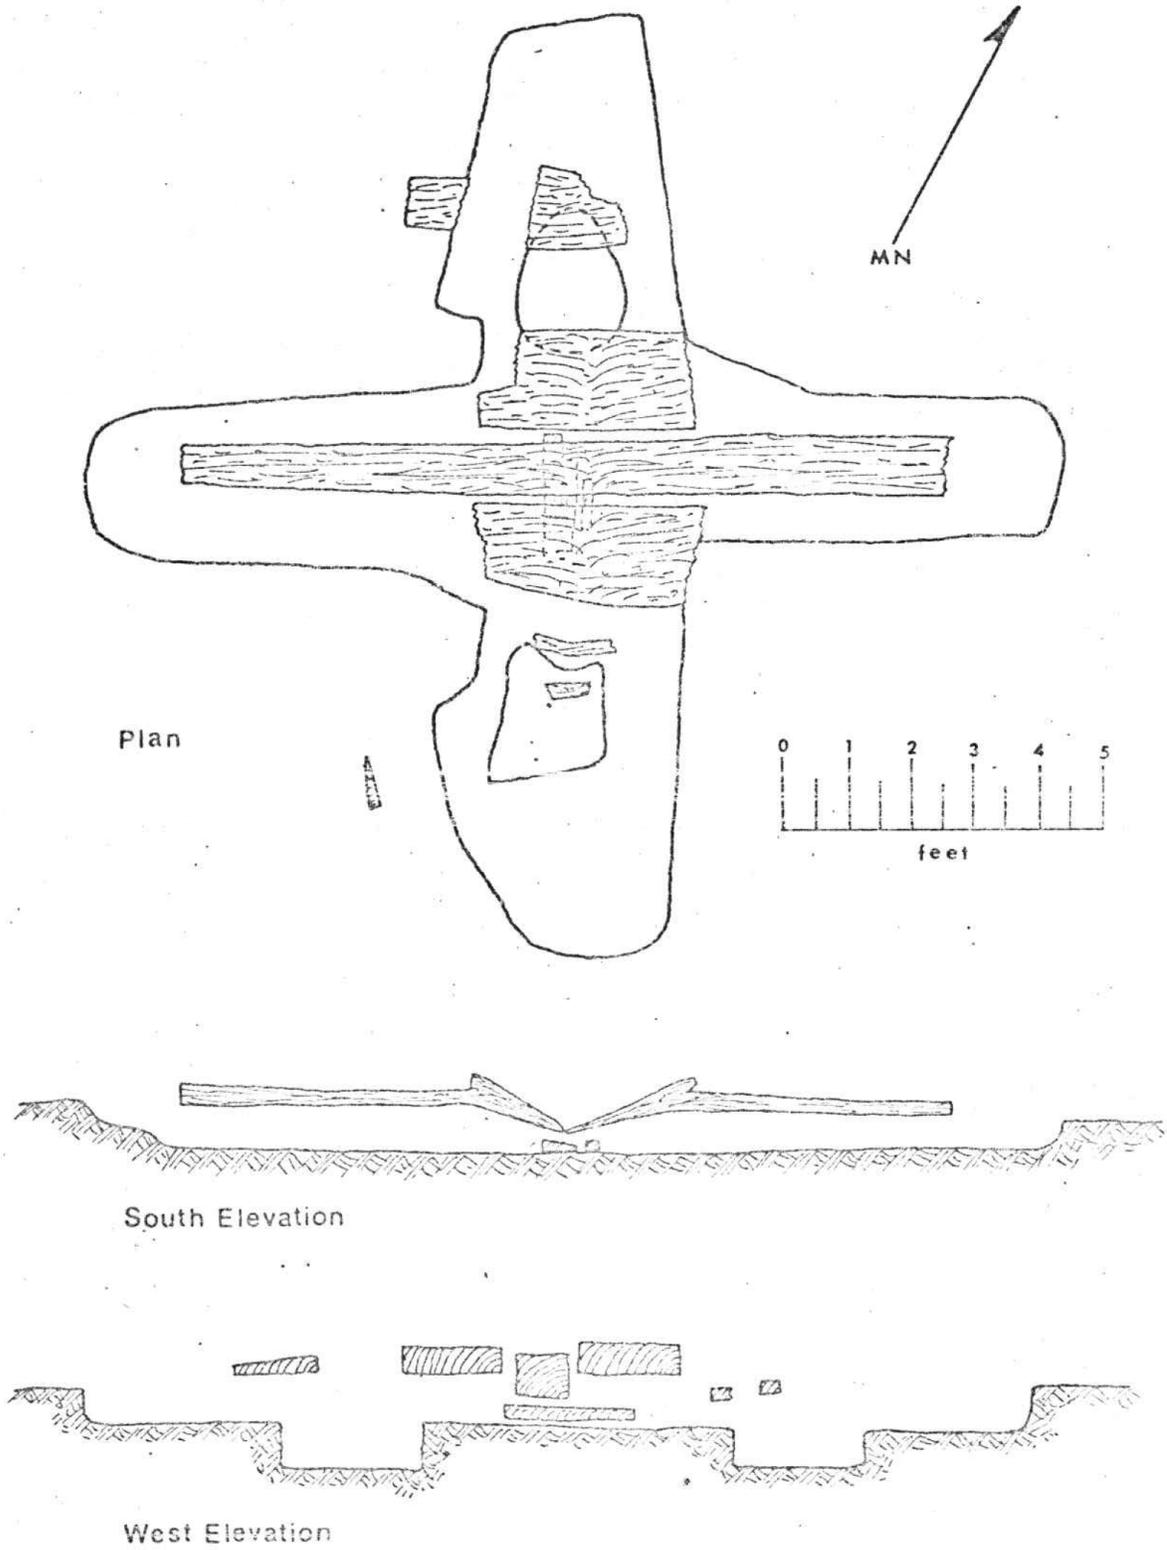
Fig. 10 - Detail of baling press base in the Fur Store.

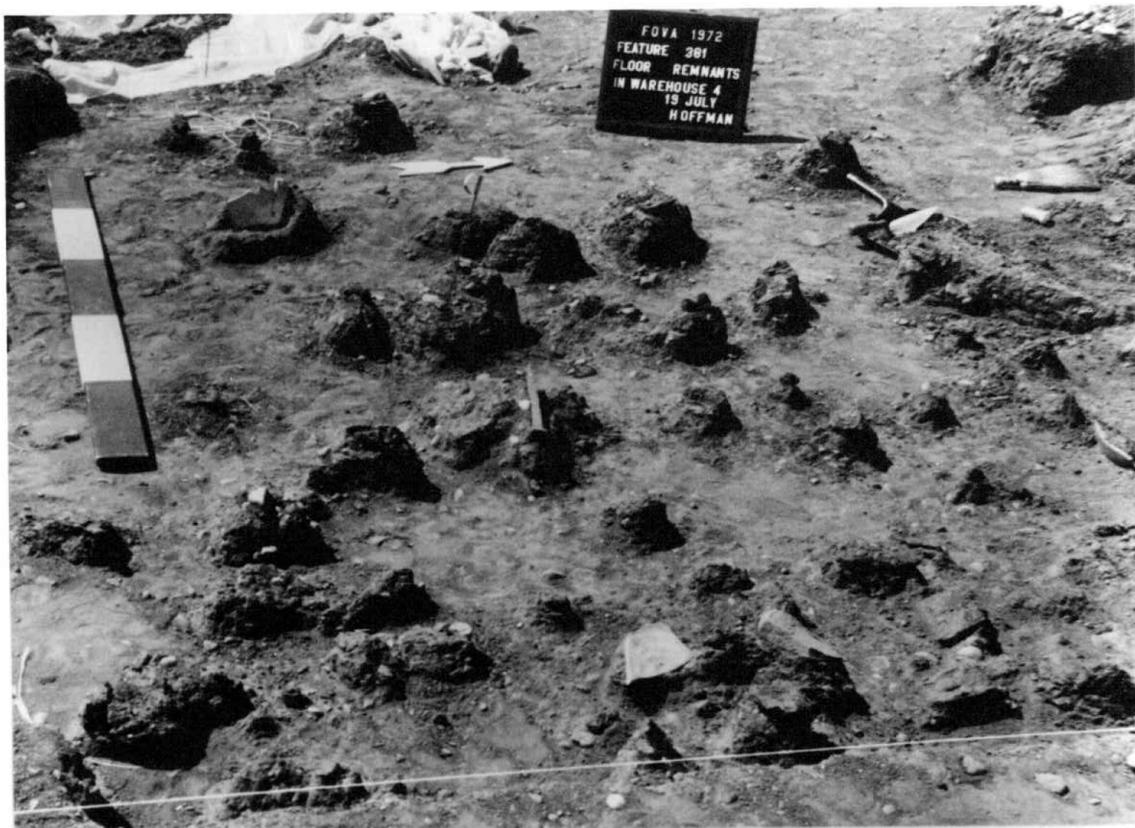
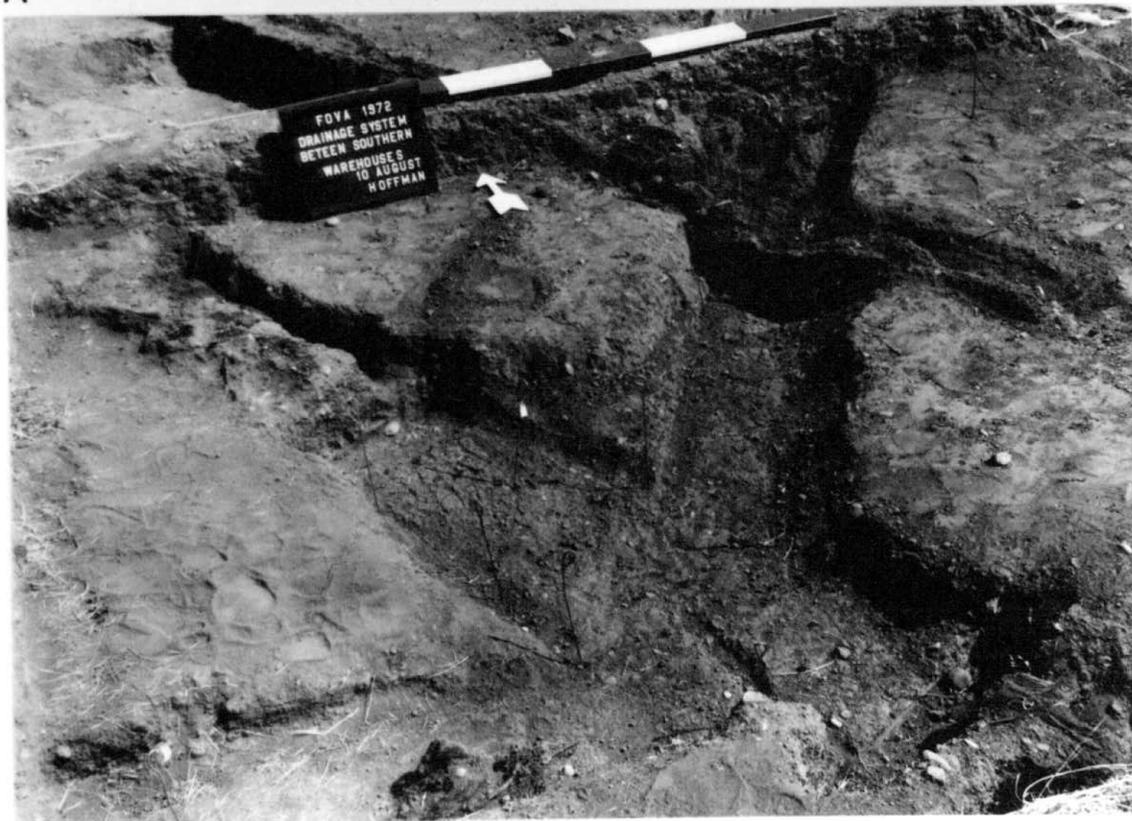
Fig. 11 - Fur Store excavations.

- a - Asphalt coated wooden fragments: probable floor remnants. Note large sherds and metal in situ (FOVA neg. 069.51-72/194).
- b - Drainage system west of the Store. Angled lateral trenches feed into central trench. Puncheon in background is eastern support for plank road over the trenches (FOVA neg. 069.51-72/199).

Scattered chunks of asphalt and asphalt-coated wood were also found east and southeast of the asphalted footing (Figs. 2.1, 11a). The scattering was quite limited and mixed with metal pieces and large sherds of stoneware (Fig. 11a). None of the asphalt was burned. While the chunks were mainly found at shallow elevations of 0.5 ft. or less, careful excavation showed that they were not part of the asphalt interpretive slab that once covered the Fur Store position. In fact, some of the asphalted wood was found 1.1 ft. below surface. Delineation of the nearby asphalted footing convinced us that the asphalt deposits were real Fur Store features. Presently, we believe the asphalted wood to have been remains of a portion of the Fur Store floor that was asphalted for some reason. This situation is discussed further in Chapter IV.

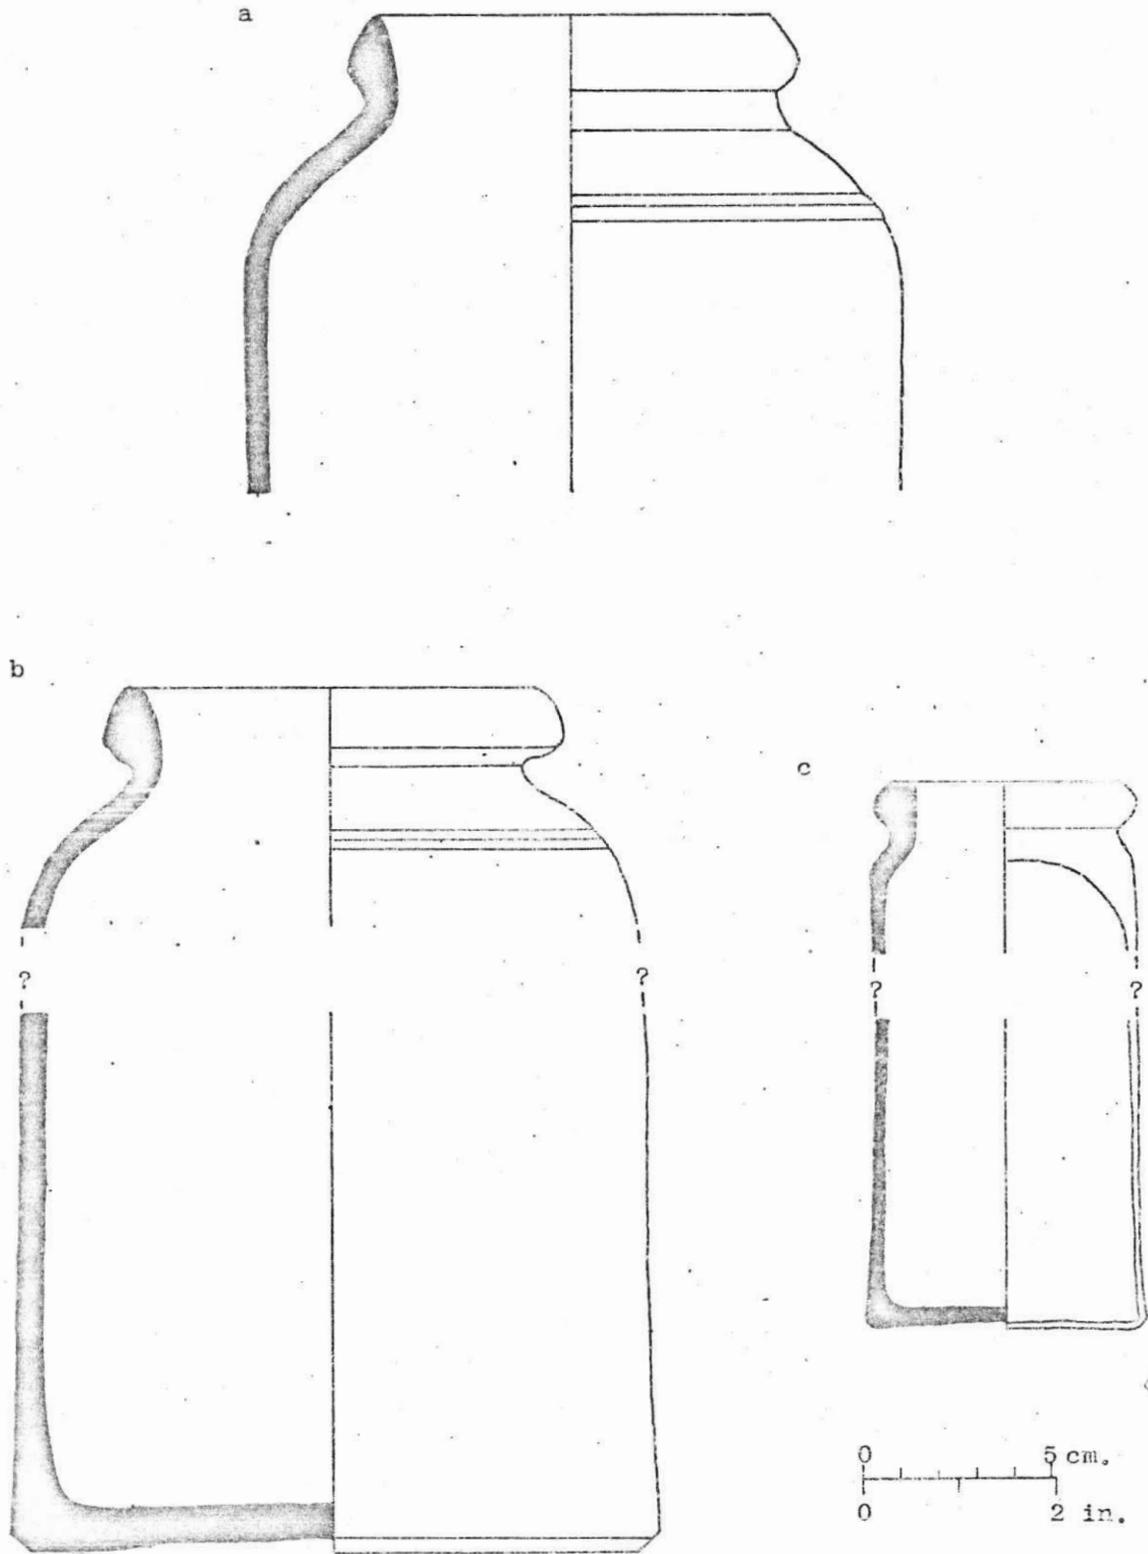
Fig. 13 . Reconstructed stoneware containers SC1, SC2 and SC3 from the Fur Store area.

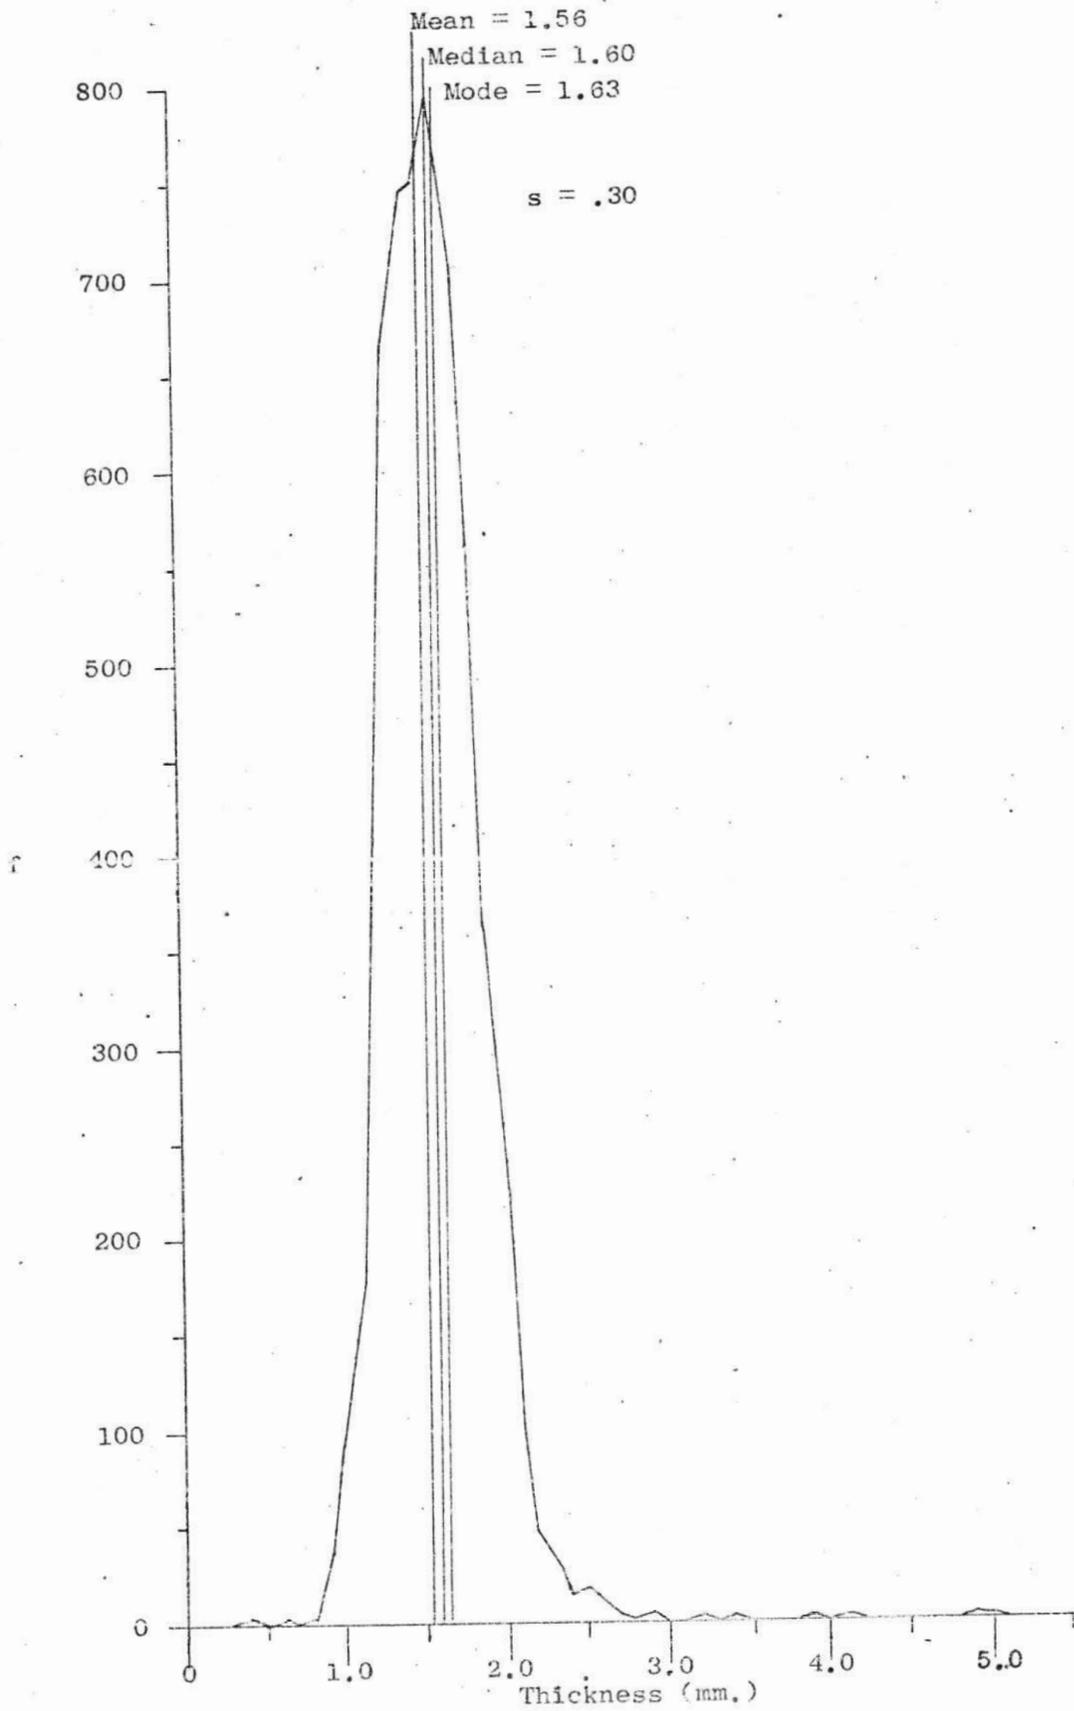
Fig. 16 . Frequency of window glass thickness for the Fur Store area (N = 5780).

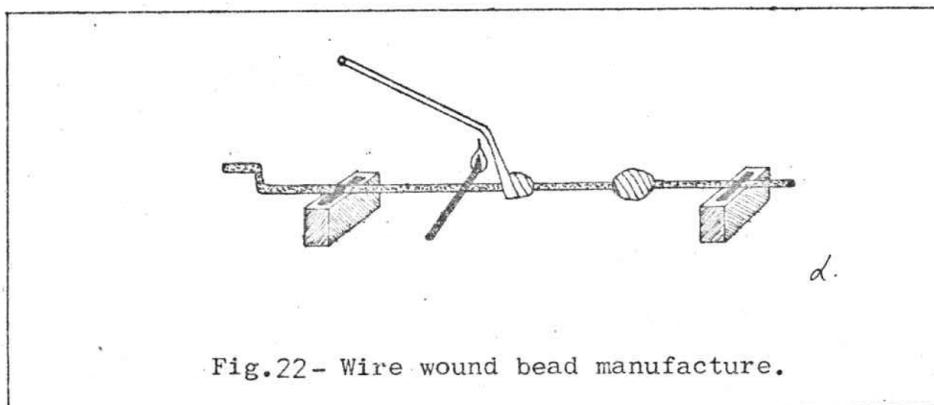
Fig.22- Wire wound bead manufacture.

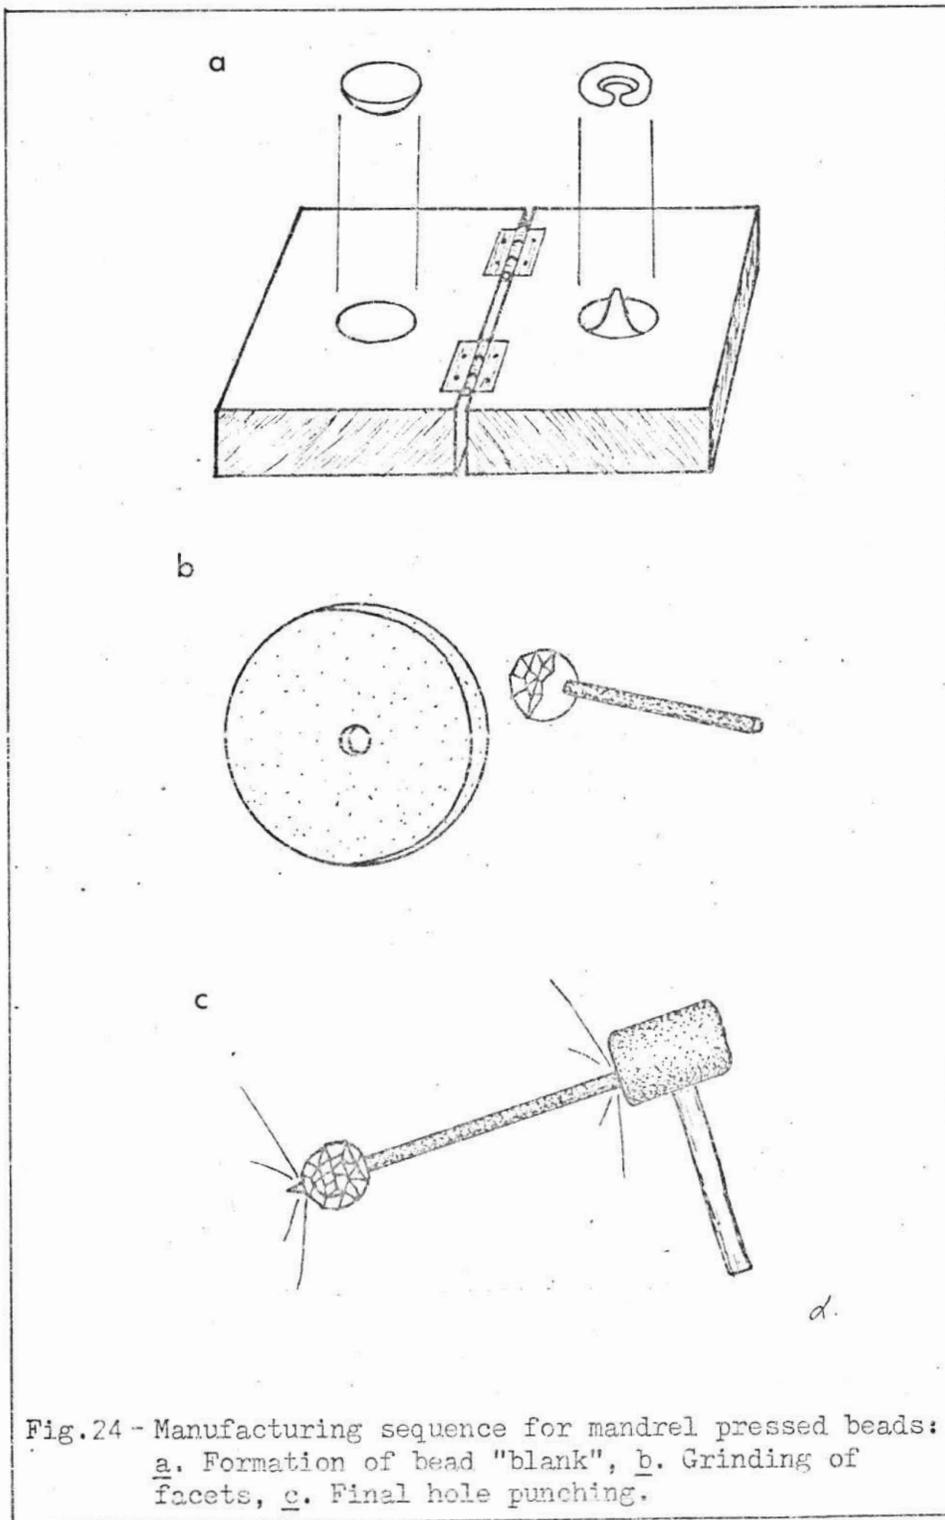
Fig.24 - Manufacturing sequence for mandrel pressed beads:
a. Formation of bead "blank", b. Grinding of facets, c. Final hole punching.

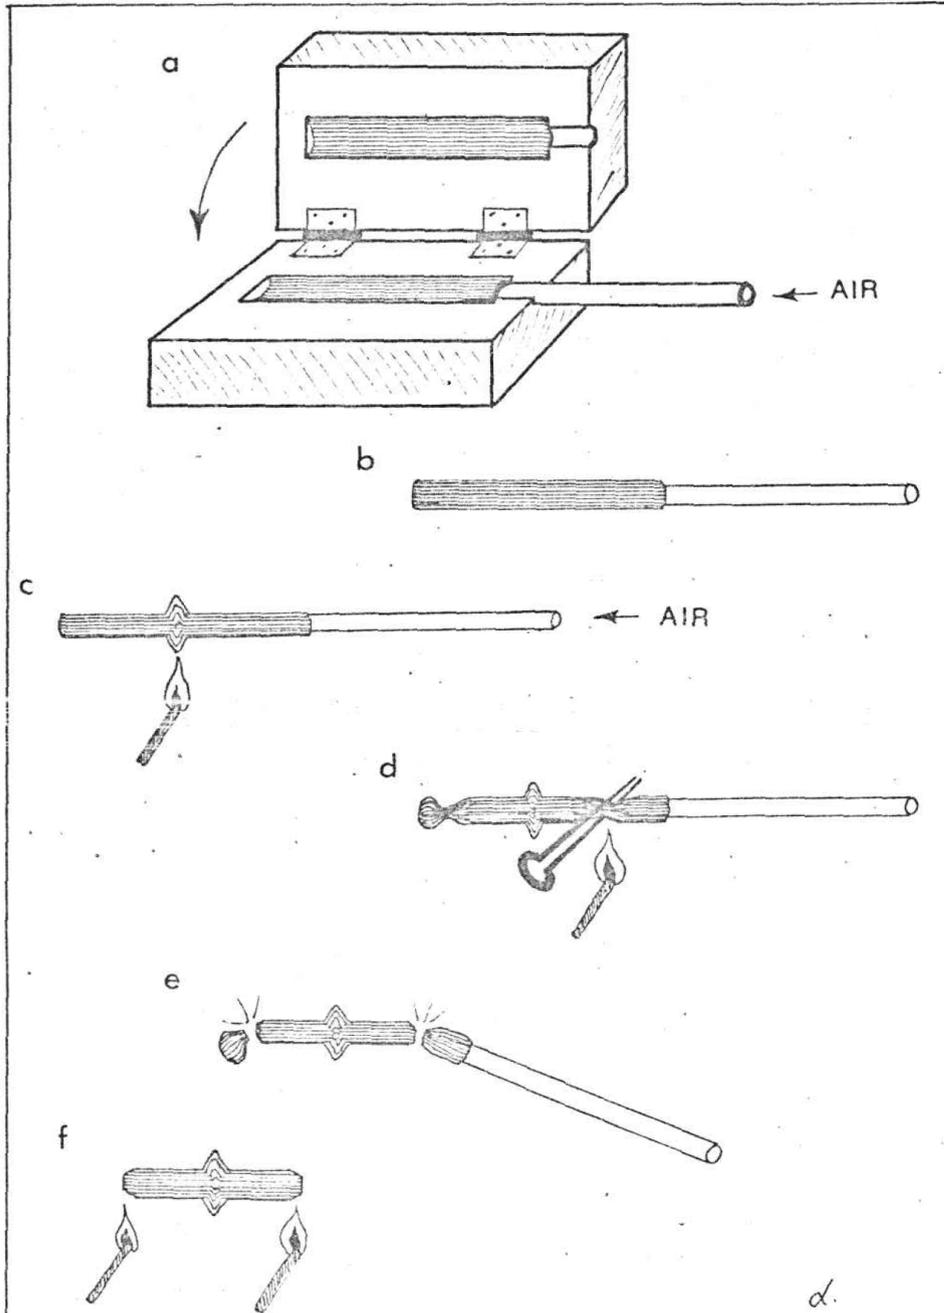
Fig.25 - Manufacturing sequence for blown beads: a. Glass tube blown in mold, b. Grooved tube removed and cooled, c. Upset decoration formed, d. Tube crimped, e. Ends snapped, f. Ends fire polished.

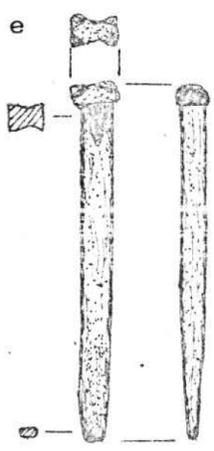
Fig. 63 - New wrought rod nail varieties from the Fur Store area.

- a - Variety #1007 (FOVA 17375) -- L=8.8 cm.
- b - Variety #1043 (FOVA 17498) -- L=25.0 cm.
- c - Variety #1051 (FOVA 14099) -- L=7.3 cm.
- d - Variety #1062 (FOVA 16746a) -- L=23.5 cm.
- e - Variety #1063 (FOVA 17851) -- L=19.8 cm.
- f - Variety #1065 (FOVA 16111) -- L=9.5 cm.
- g - Variety #1066 (FOVA 17584) -- L=15.3 cm.
- h - Variety #1068 (FOVA 16659) -- L=5.5 cm.
- i - Variety #1073 (FOVA 15186) -- L=4.7 cm.
- j - Variety #1075 (FOVA 15870) -- L=13.3 cm.
- k - Variety #1081 (FOVA 15042) -- L=24.8 cm.
- l - Variety #1082 (FOVA 14557) -- L=24.3 cm.

Variety #1007 -- This variety was manufactured from square nail rods with the shank being uniformly tapered on 4 sides to a sharp point (Fig. 63). The head was faceted with at least 4 hammer blows to form a "rosette" type head, slightly assymetrical on the shank. On the basis of the correlation of nail length with average shank thickness, 2 tentative populations have been defined, ca. 10d and 16d, encompassing all measurable nails (Table 21). The illustrated specimen reported for the Chief Factor's House (Hoffman and Ross 1973b:Fig. 24g) has been judged not representative of this variety and subsequently assigned to Variety #1064. The correct illustration of Variety #1007 appears in the present report (Fig. 63a). Of the 35 specimens recovered from all excavations, 30 have been clenched at a point 2 1/2 inches from the base of the head. This variety may have been used for door or shutter construction, and its function would have been to laminate 2 or more wooden planks together to form a complete door or shutter with a thickness of 2 1/2 inches. These nails were probably not used to fasten building hardware to wood since iron work usually required a round-shanked fastener.

Variety #1081 -- Thus far, this variety has only been recovered from the Fur Store area, and all specimens were found in situ in the wood block footings of the Fur Store. The variety was manufactured from square-rectangular nail rods, the shank being tapered on 4 sides to a tip which is flat and spatulate in shape. The head was struck and domed over a shank-holding device that was rigid on 2 opposing sides such that a rectangular-shaped head was formed. A representative specimen is illustrated as Fig. 63k. The size range is consistent for a ca. 10 inch spike (Table 21). The context and stylistic/metric regularity of the spike suggests that all were associated with timbers of a structure predating the construction of the Fur Store. These timbers containing the spikes were cut to appropriate lengths for use as footings in the Fur Store.

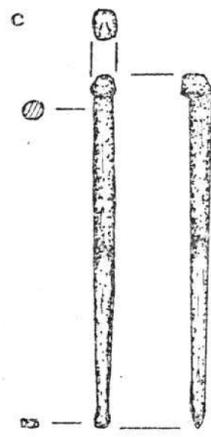
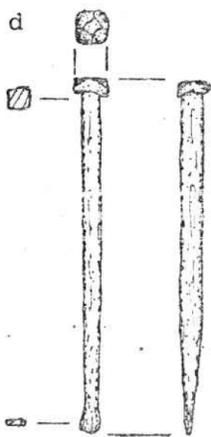
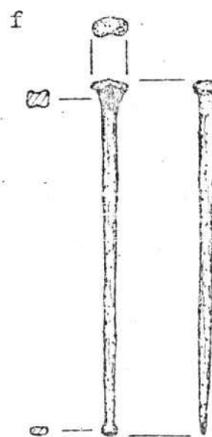
Fig. 65 - New wrought rod nail varieties from the Fur Store area.

- a - Variety #1095 (FOVA 16769) -- L=28.3 cm.
- b - Variety #1096 (FOVA 16963) -- L=6.8 cm.
- c - Variety #1097 (FOVA 17103) -- L=23.9 cm.
- d - Variety #1098 (FOVA 17375) -- L=12.3 cm.
- e - Variety #1099 (FOVA 17525) -- L=5.7 cm.
- f - Variety #1100 (FOVA 17564) -- L=14.5 cm.
- g - Variety #1101 (FOVA 17564) -- L=3.2 cm.
- h - Variety #1102 (FOVA 17842) -- L=9.4 cm.
- i - Variety #1103 (FOVA 17881) -- L=25.6 cm.
- j - Variety #1104 (FOVA 17493) -- L=6.3 cm.

specimen is illustrated as Fig. 65j. Correlation of nail lengths to average shank thickness (taken in the head region) indicates that this variety ranged in size from 1 1/2 to 2 1/2 inches (Table 21). Examination of horse and muleshoes indicates that this variety was probably utilized in shoeing mules, and therefore may be associated with USA activities.

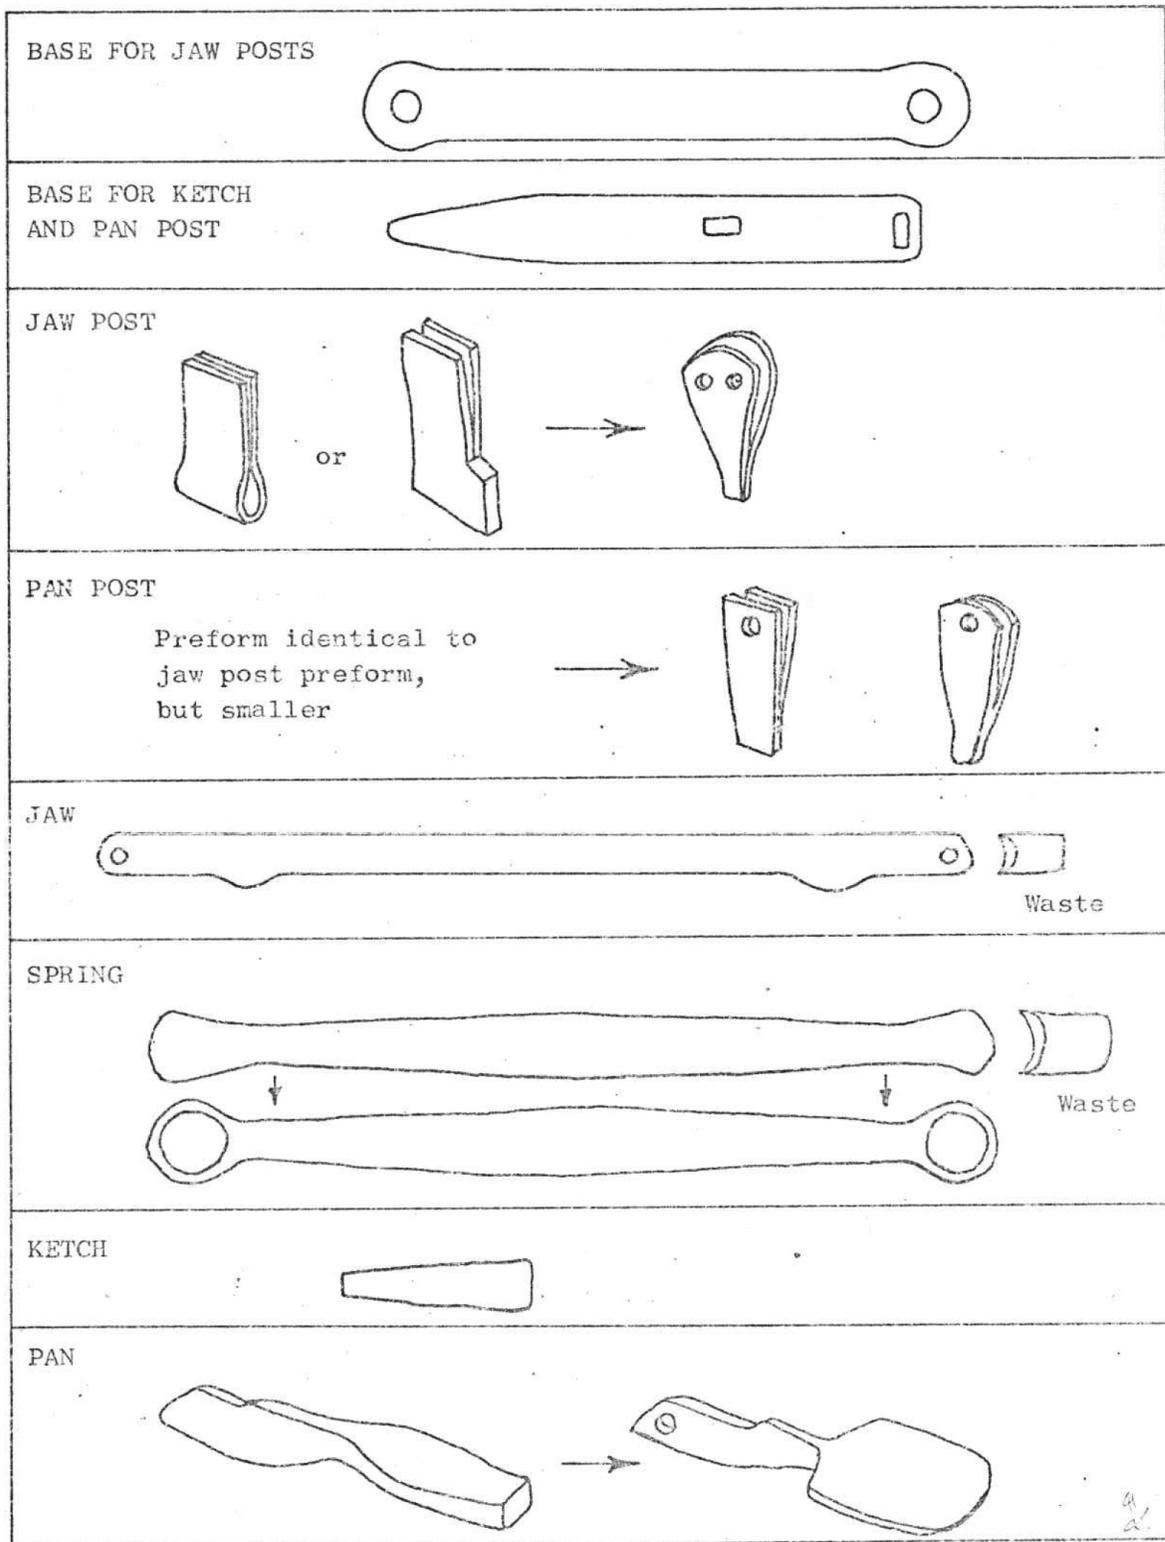
Fig. 80 - Trap parts, preforms and metal waste associated with the manufacturing of "country-made" traps from Fort Vancouver.

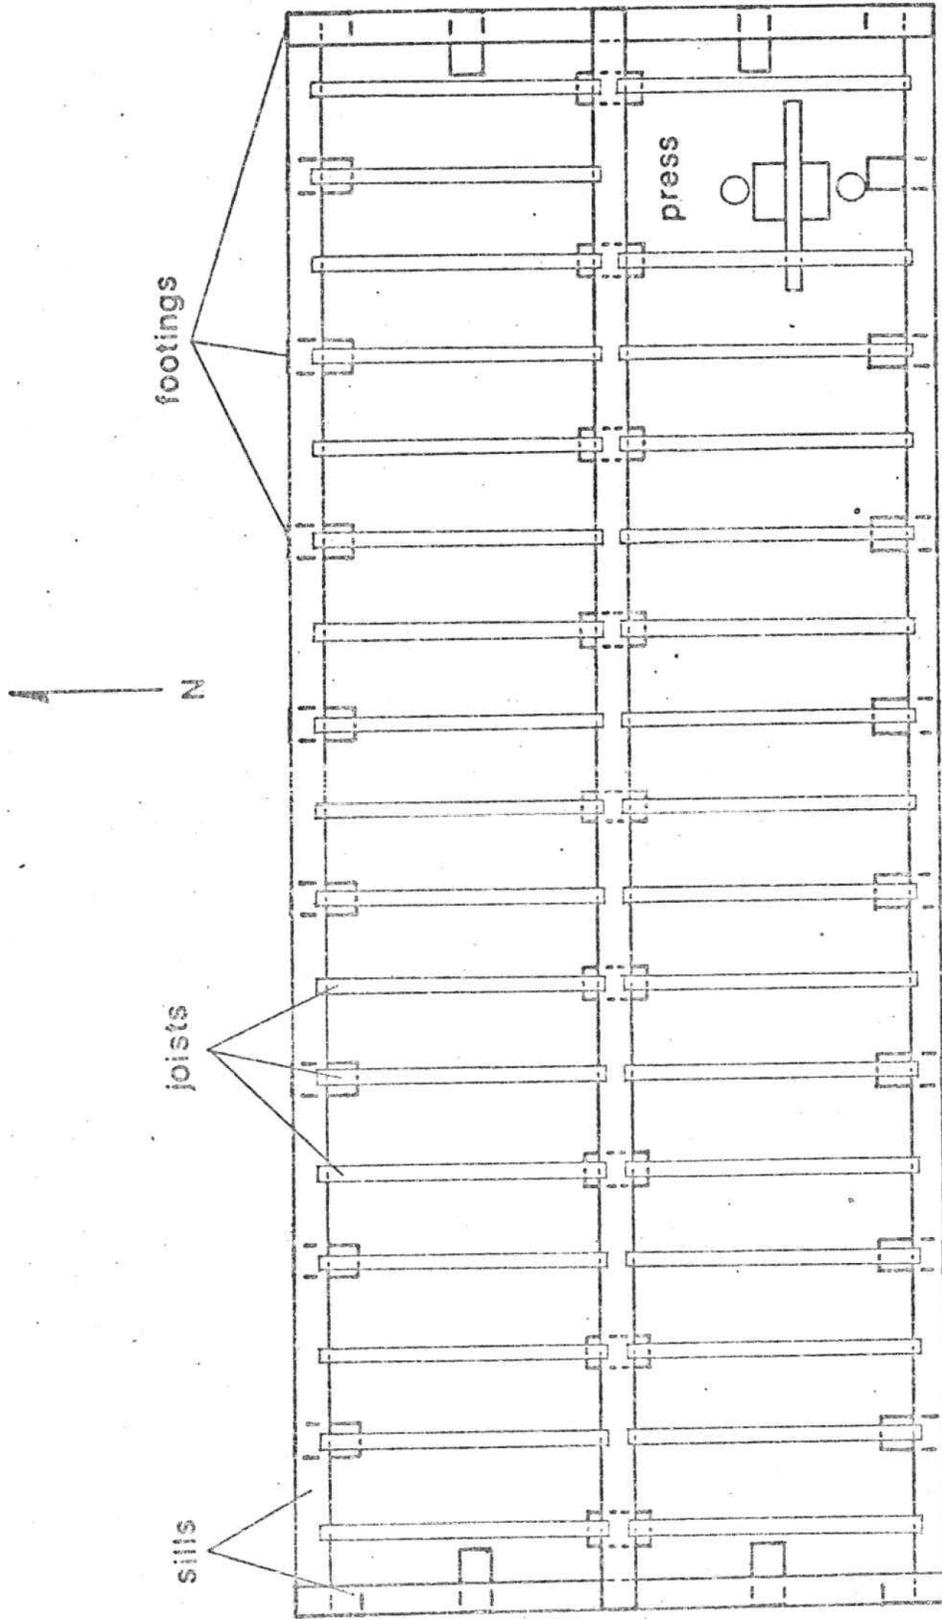
Fig. 88 - Hypothetical joisting at ground floor of the Fur Store. Footings are standardized at 2 by 4 ft., sills are arbitrarily 2 ft. square, and joists are one ft. square.
