FORT VANCOUVER EXCAVATIONS - VIII

Fur Store

United States Department of the Interior

National Park Service

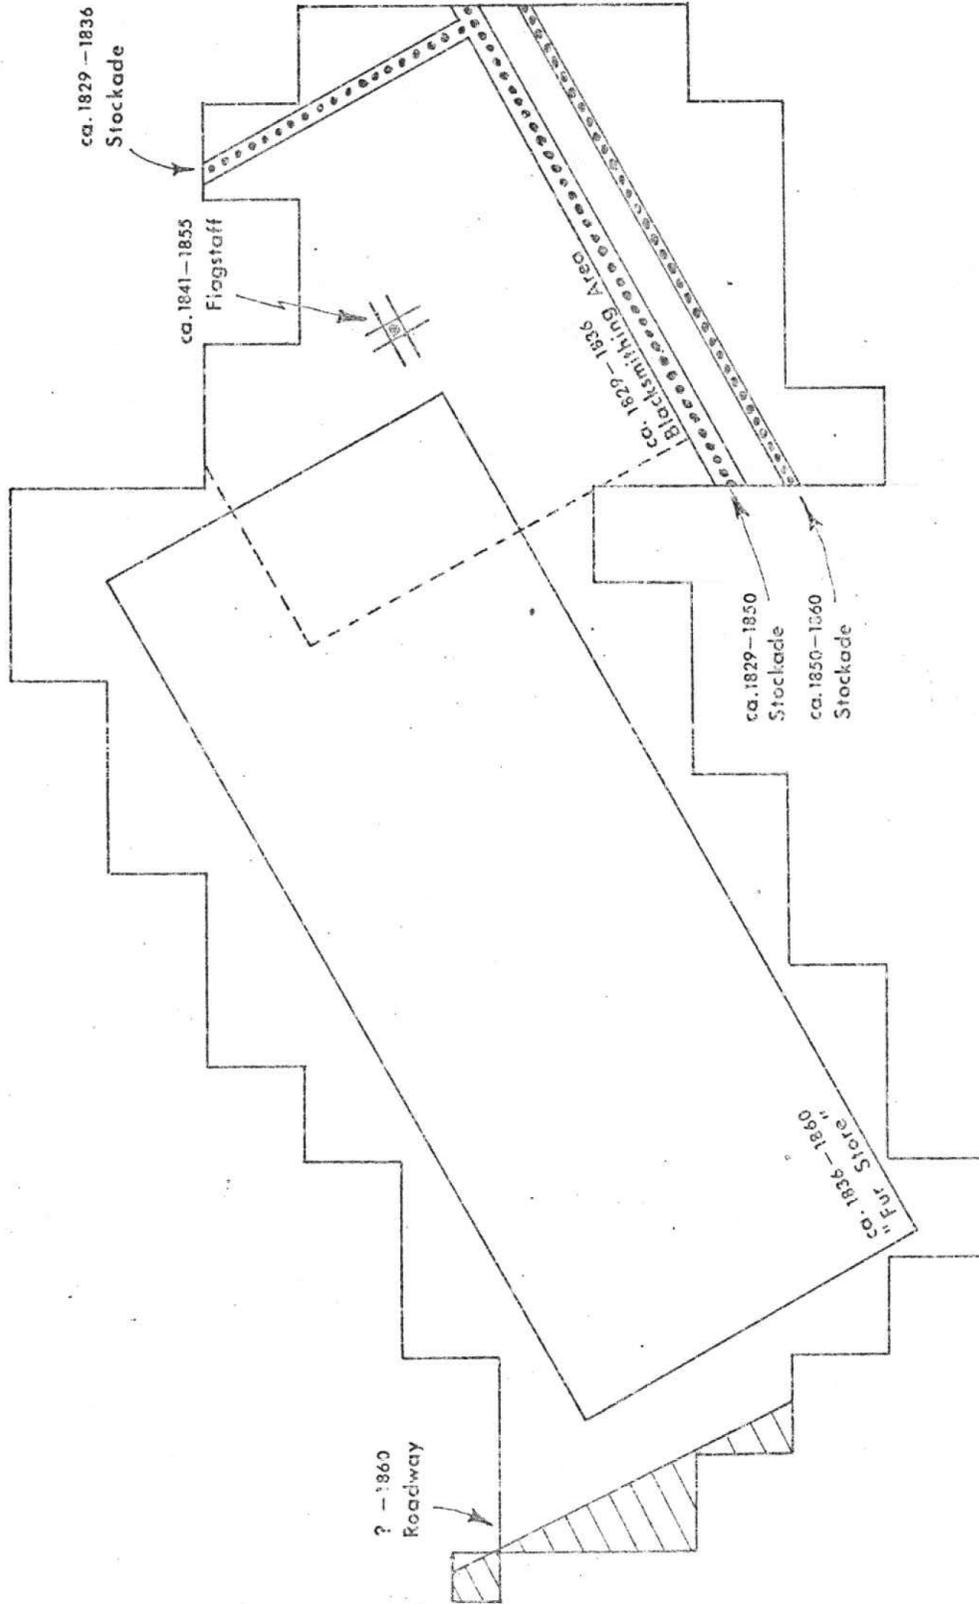
Fig. 89 - Spatial locations of historical archaeological structures and cultural activity areas within the Fur Store area.

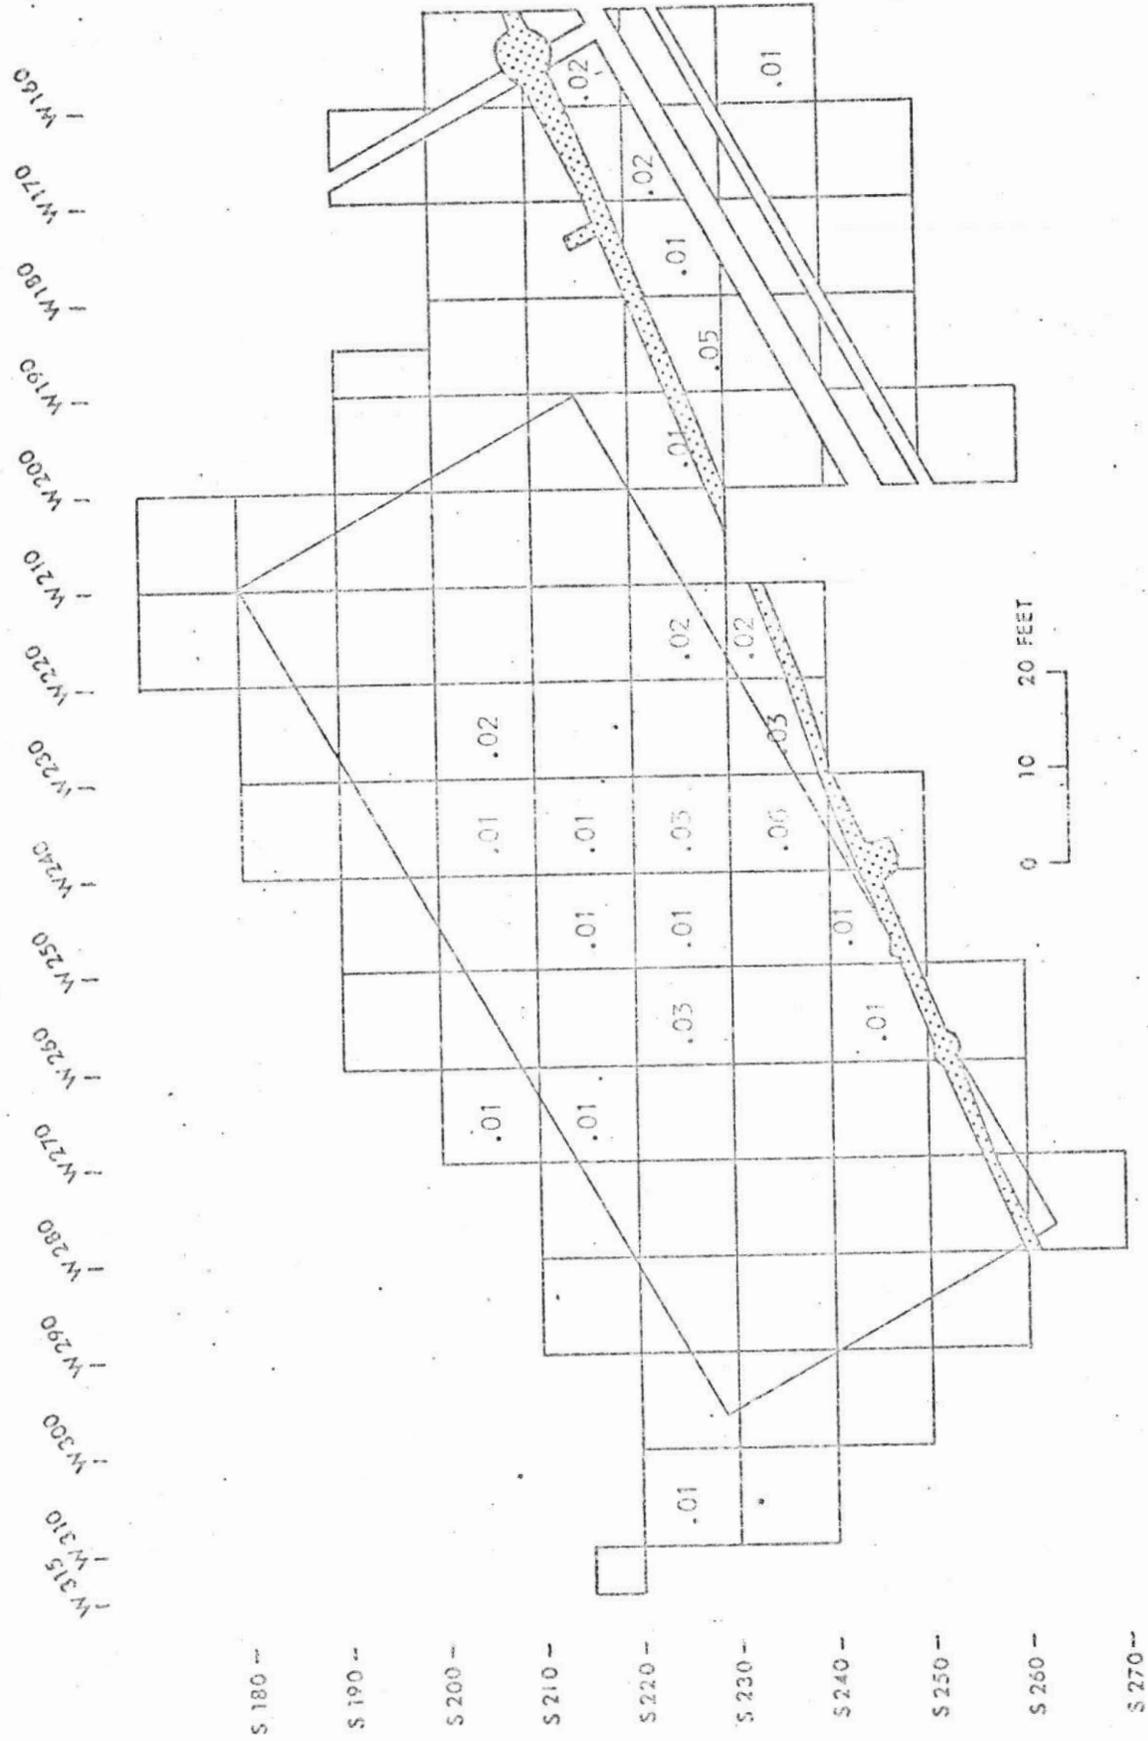
Fig. 113 - Distribution of screws in the Fur Store area (t/ft²).

Screws were concentrated in the central portion of the Store (Fig. 113) and were probably either trade goods or quartermaster stores. Screws in the smithing area may have been manufactures.
