CULTURAL LANDSCAPE REPORT

FORT VANCOUVER NATIONAL HISTORIC SITE

**CULTURAL LANDSCAPE REPORT:
FORT VANCOUVER NATIONAL HISTORIC SITE
Volume I
VANCOUVER, WASHINGTON**

**NATIONAL PARK SERVICE * DEPARTMENT OF THE INTERIOR
CULTURAL RESOURCES DIVISION * PACIFIC NORTHWEST REGION
SEATTLE, WASHINGTON
1992**

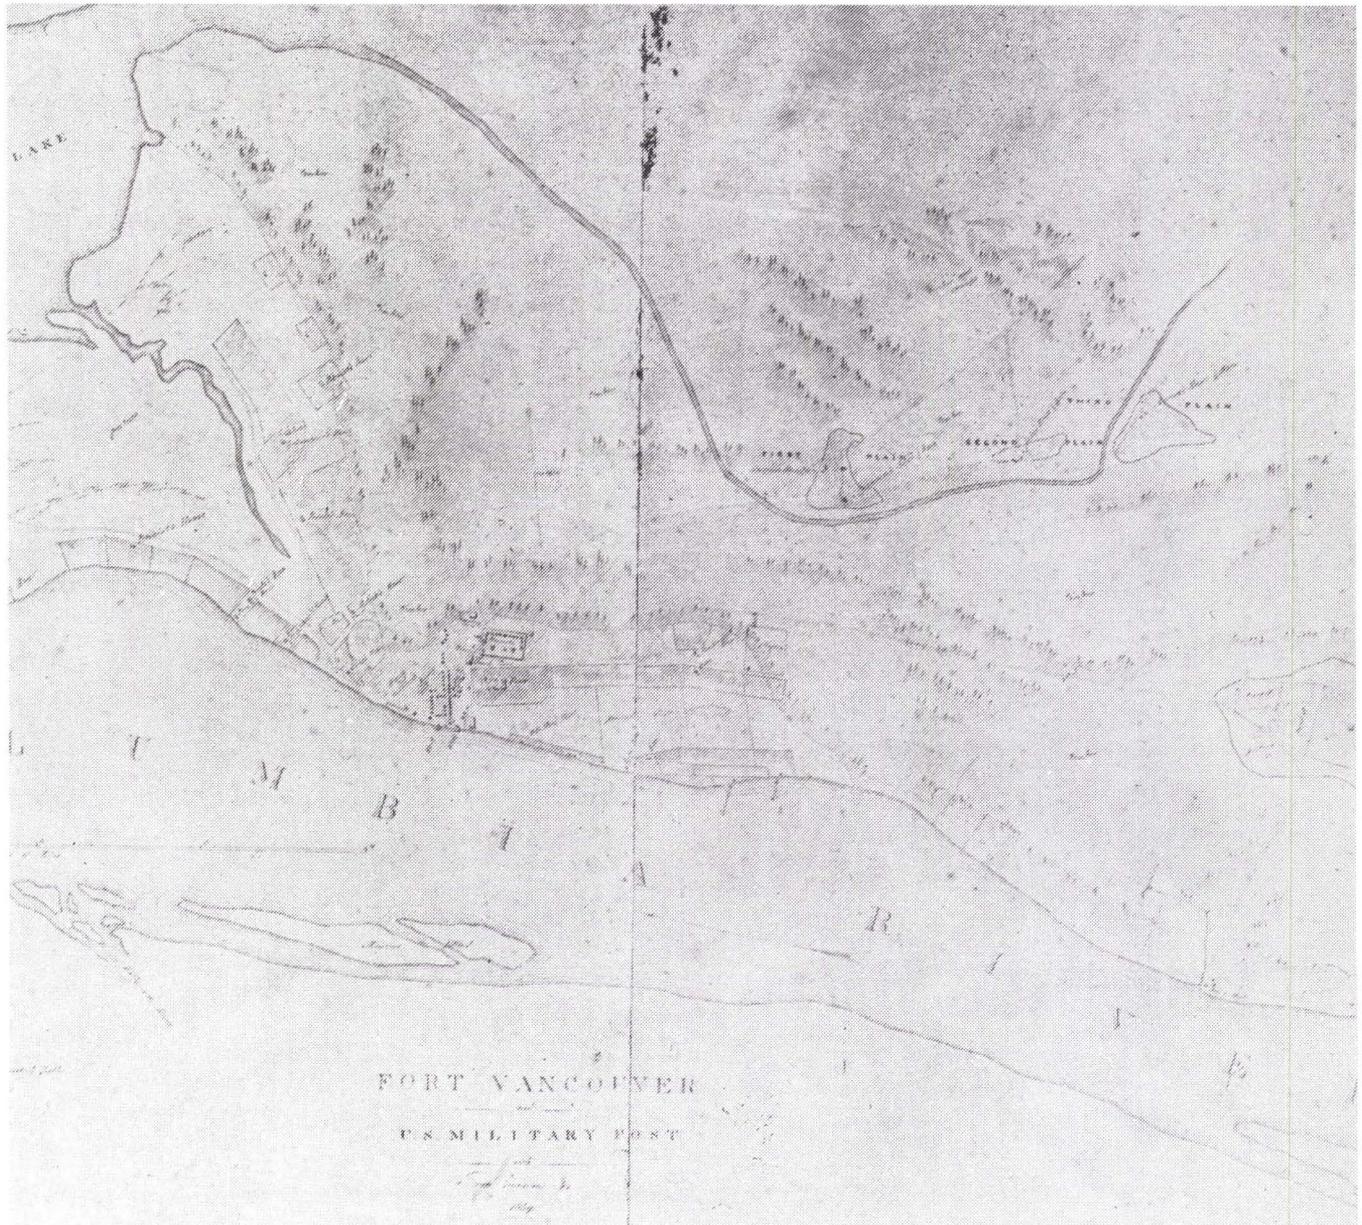
1859 map by Richard Covington showing the overall organization of Fort Plain. Fort Vancouver N.H.S. photo file.

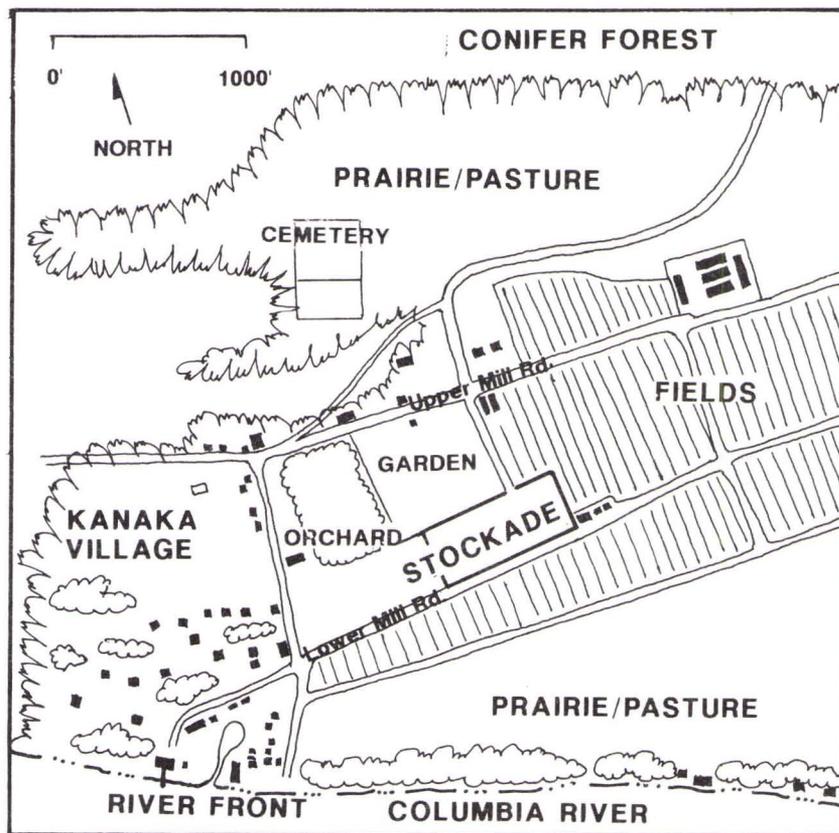
Schematic map of the western third of historic Fort Plain showing response to natural features.

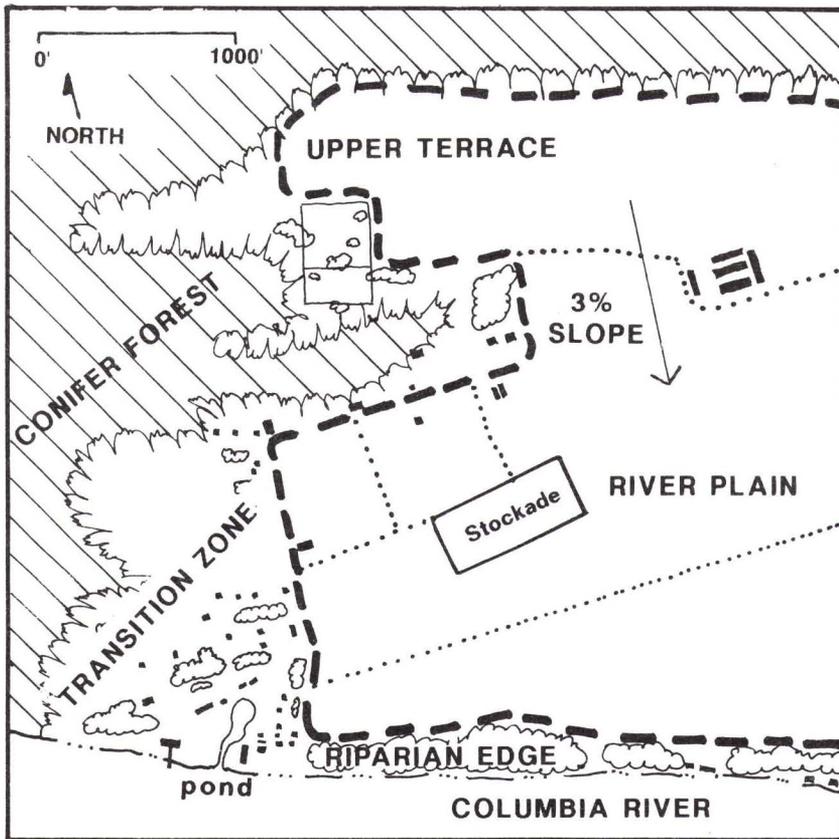
Schematic map of the western third of historic Fort Plain showing overall organization.

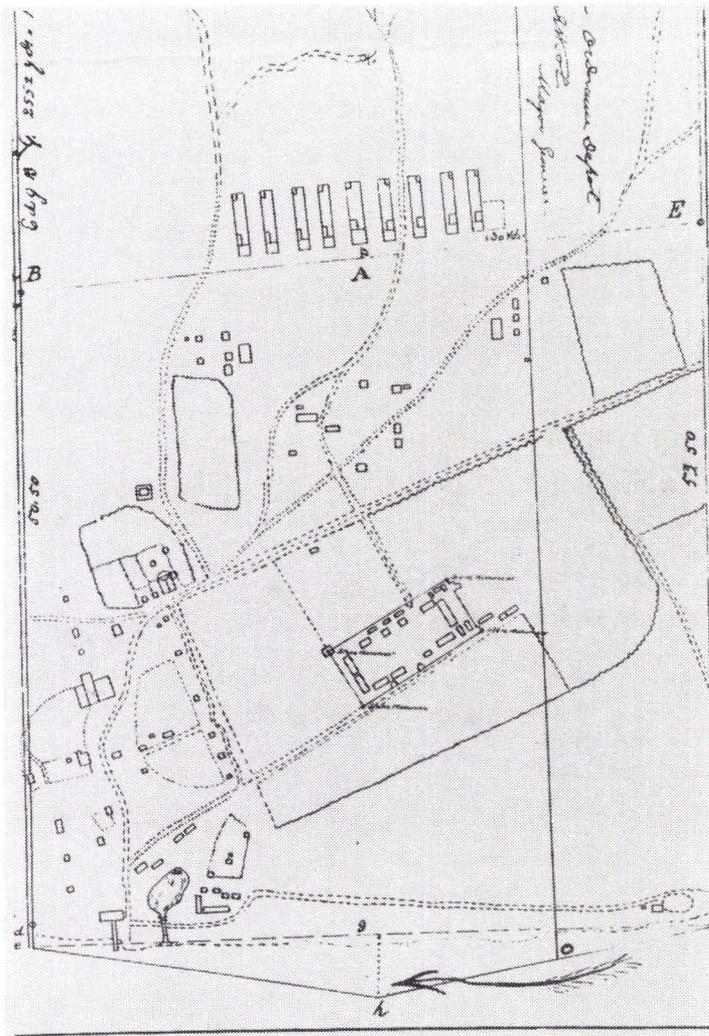
Detail of the 1854 map of the Military Reservation of Fort Vancouver by Lt. Col. B.L.E. Bonneville, showing changes to the HBC landscape as the U.S. Army development grew. Fort Vancouver N.H.S. map file.

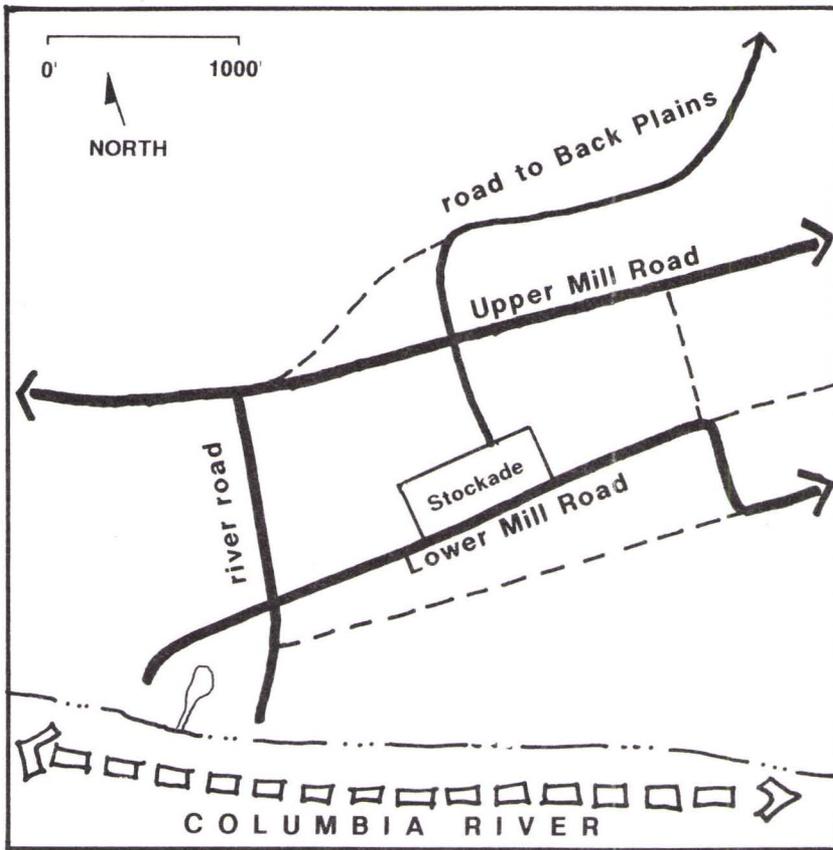
Schematic map of the western third of historic Fort Plain showing circulation patterns.

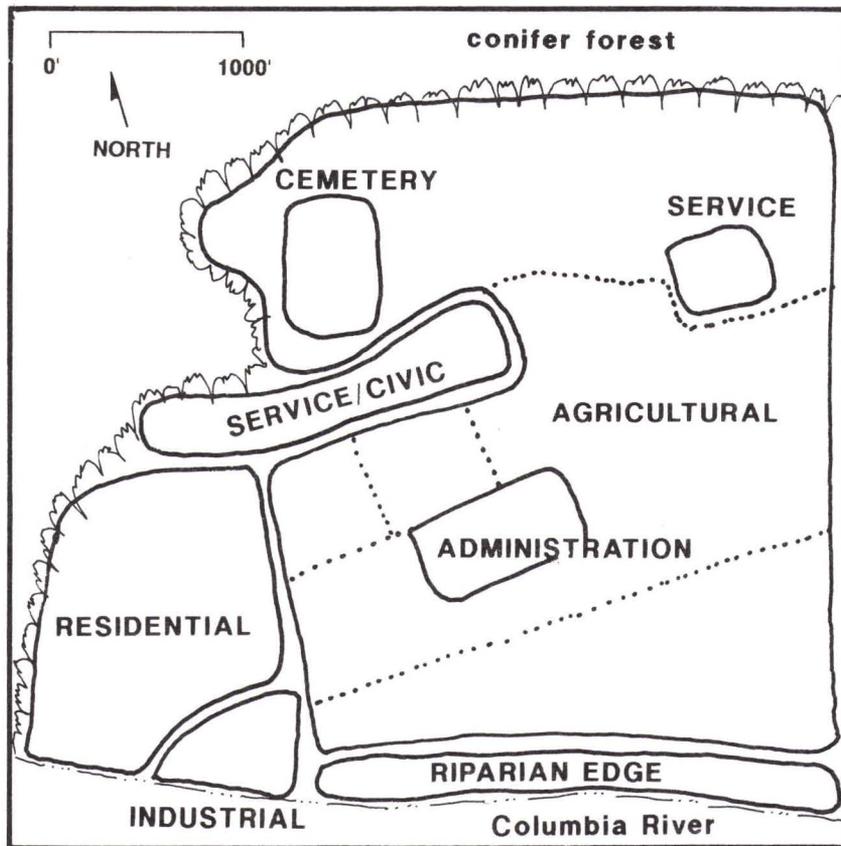
Schematic map of the western third of historic Fort Plain showing land uses and activities.

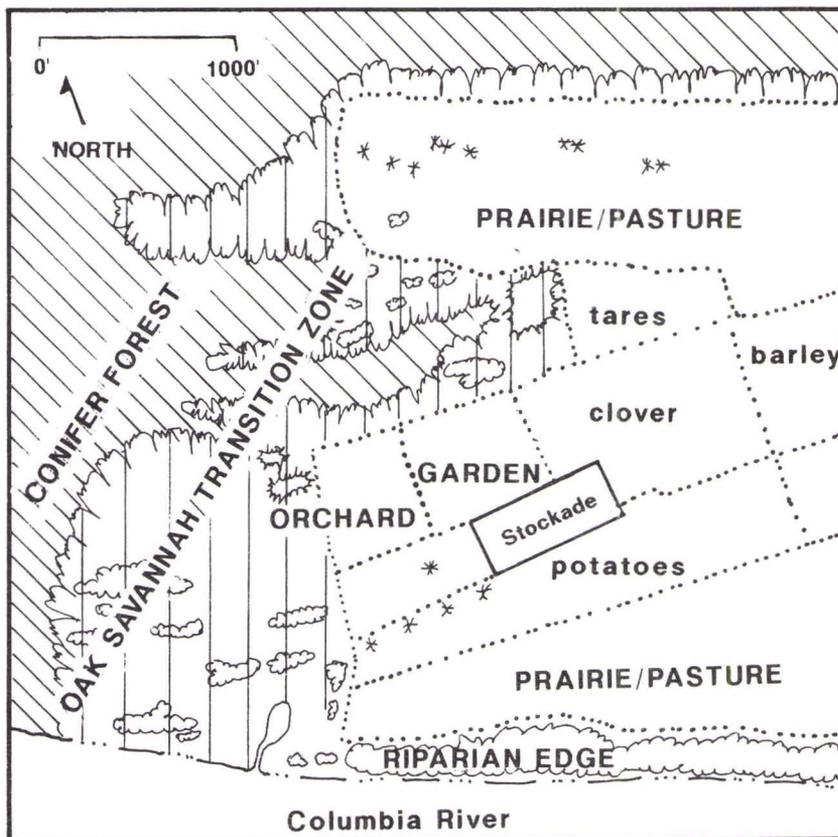
Schematic map of the western third of historic Fort Plain showing vegetation.

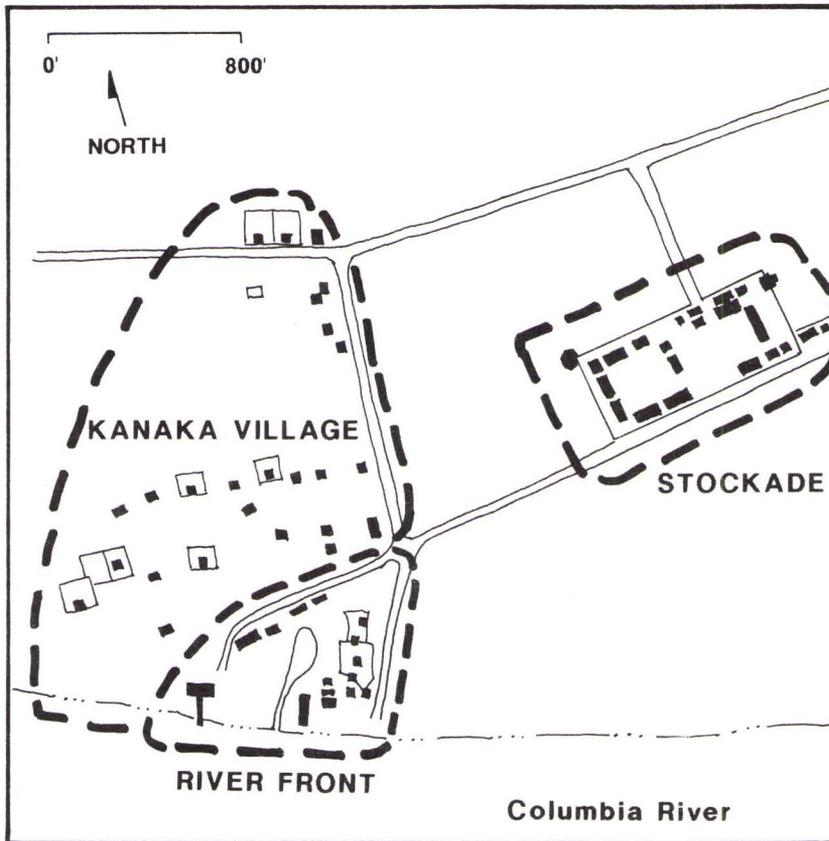
Schematic map of the western third of historic Fort Plain showing cluster arrangements.

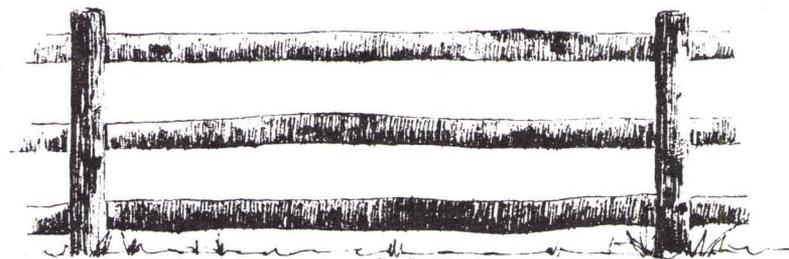
Sketch of the post and rail fence depicted in the 1846-47 Stanley painting.

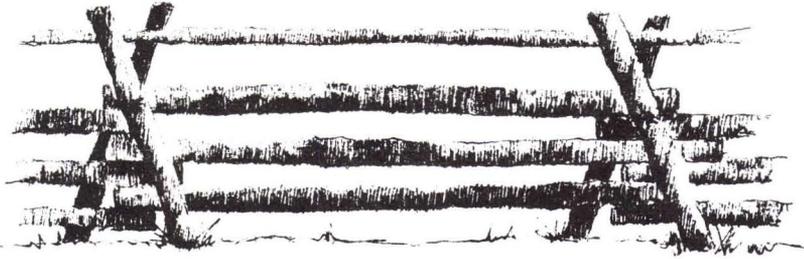
Sketch of the zigzag (or Virginia rail, or common rail) fence depicted in the 1855 Covington illustration.

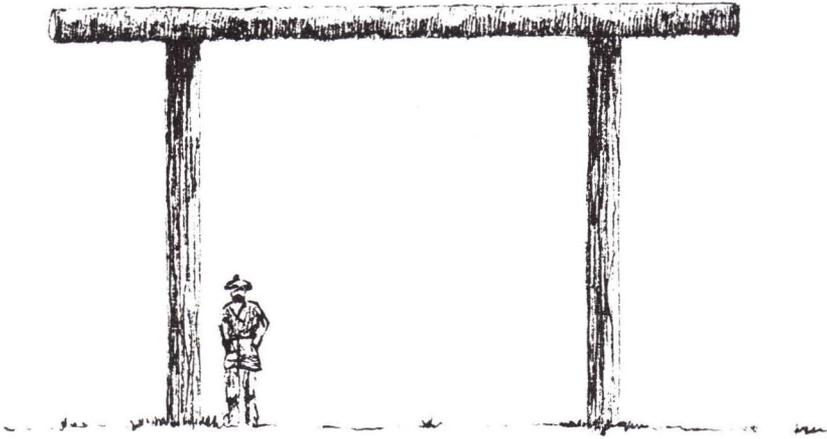
Conceptual drawing of the entry gate, based on the 1846 Stanley painting.

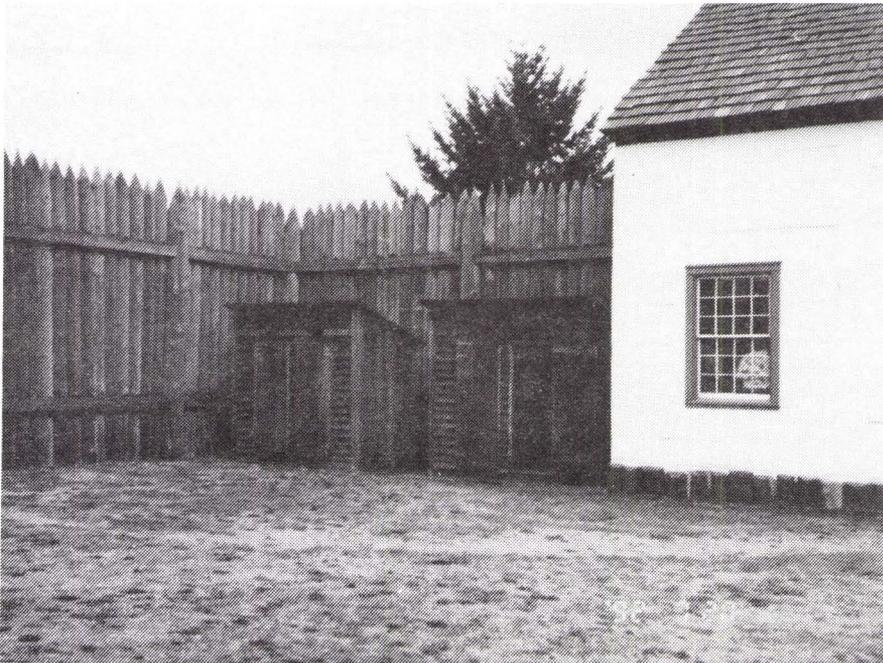
Two reconstructed privies located north of the reconstructed third bakery, 1992. Pacific Northwest Region photo file.
